## **Investigation into the *in situ* thermal performance of 2 static caravans - Assessing the change in heat loss behaviour due to thermally superior replacement windows.**

**Client:** Camden Group  
Steeple Road Industrial Estate  
Antrim  
Northern Ireland  
BT41 1AB

**Site Address:** Units C05 & C10, Holly Bank  
Blue Dolphin Holiday Park  
Filey  
North Yorkshire  
YO14 9PU

April, 2015

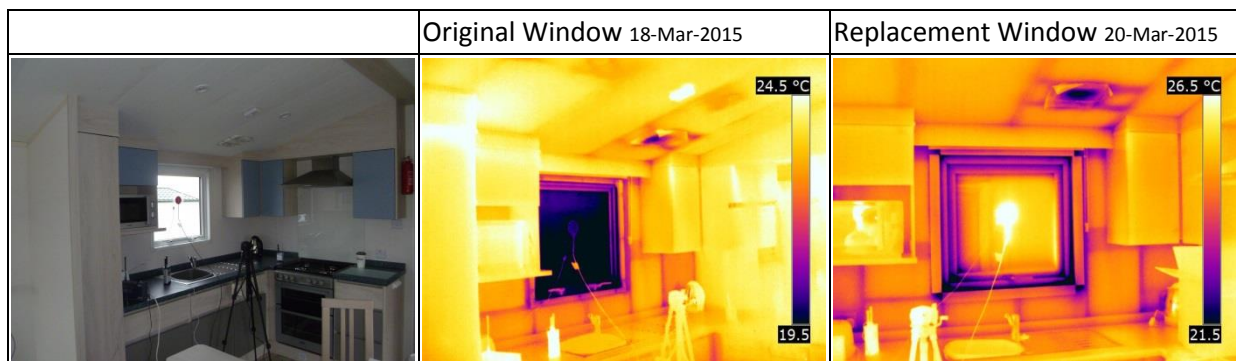
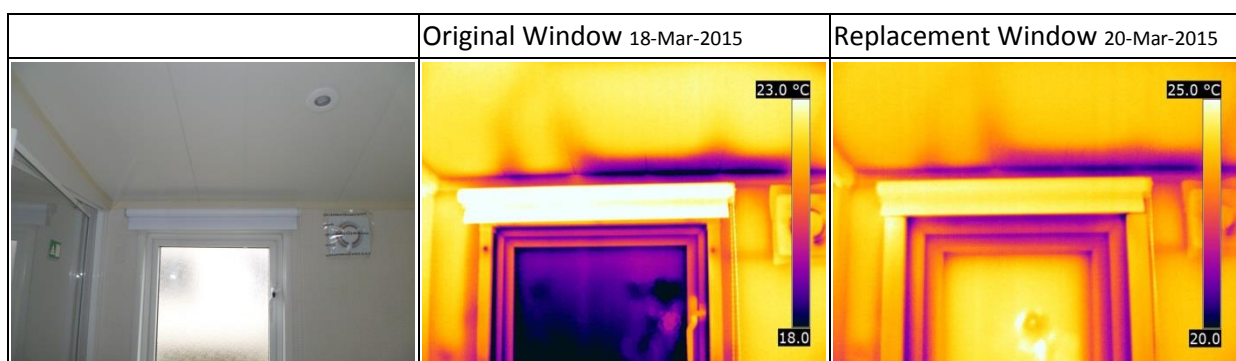
Figure 1 & Figure 2 show the original and replacement windows in C05. In both examples the thermal images were captured on arrival at the site (on the 18<sup>th</sup> and 20<sup>th</sup> March respectively) prior to any other access being gained to the caravan that morning. Additionally, both sets of thermal images were set to a temperature span of 5 °C to allow better direct comparisons to be made between them. The difference in surface temperature, and hence heat loss, due to the replacement glazing is stark; the surface temperatures of the original glazing were the lowest observable temperatures in the images, indicating the maximum heat loss and the first or most likely areas to foster surface condensation.

Figure 1: C05 Kitchen window – original and replacement

What is also noticeable in Figure 1 & Figure 2 is the surface temperature of the opaque elements and window frames. The window frames on the original windows are consistently cooler than the structural timber within the walls and ceiling. In contrast, the replacement frames display frame surface temperatures much closer to that of the areas of the plane elements with timber beneath.

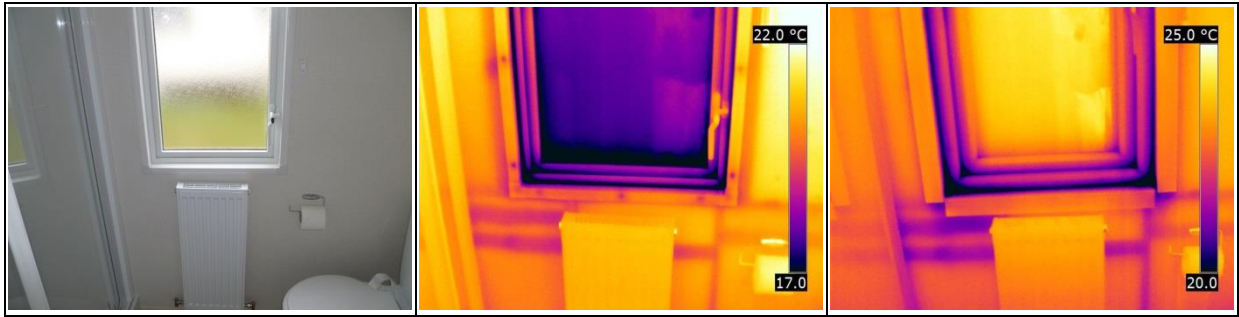
Figure 2: C05 Bathroom window – original and replacement

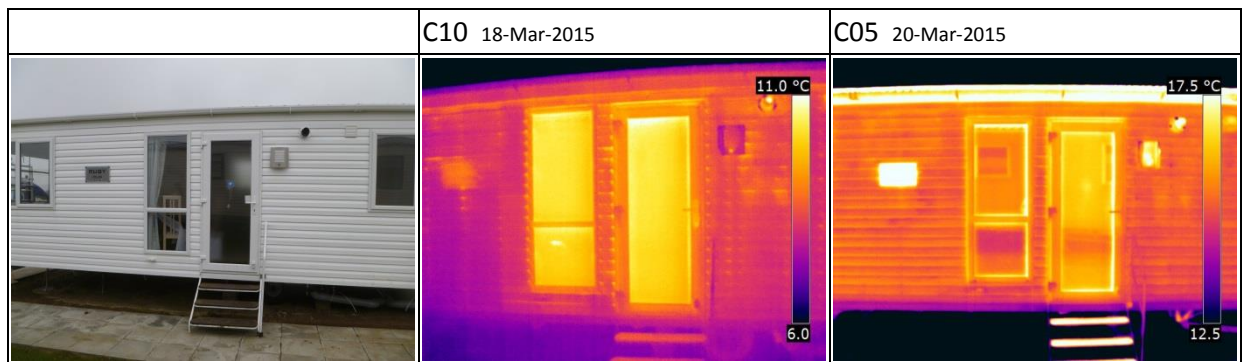
The difference between the original window performance and the replacement glazing can be seen most clearly on caravan C05, where the window adjacent to the door was replaced prior to the door being upgraded. Figure 3 displays some difference between the 2 types of glazing when viewed from the outside, although variations in atmospheric conditions and reflection prevent any accurate analysis.

Figure 3: Doors and adjacent window showing difference in external surface temperature

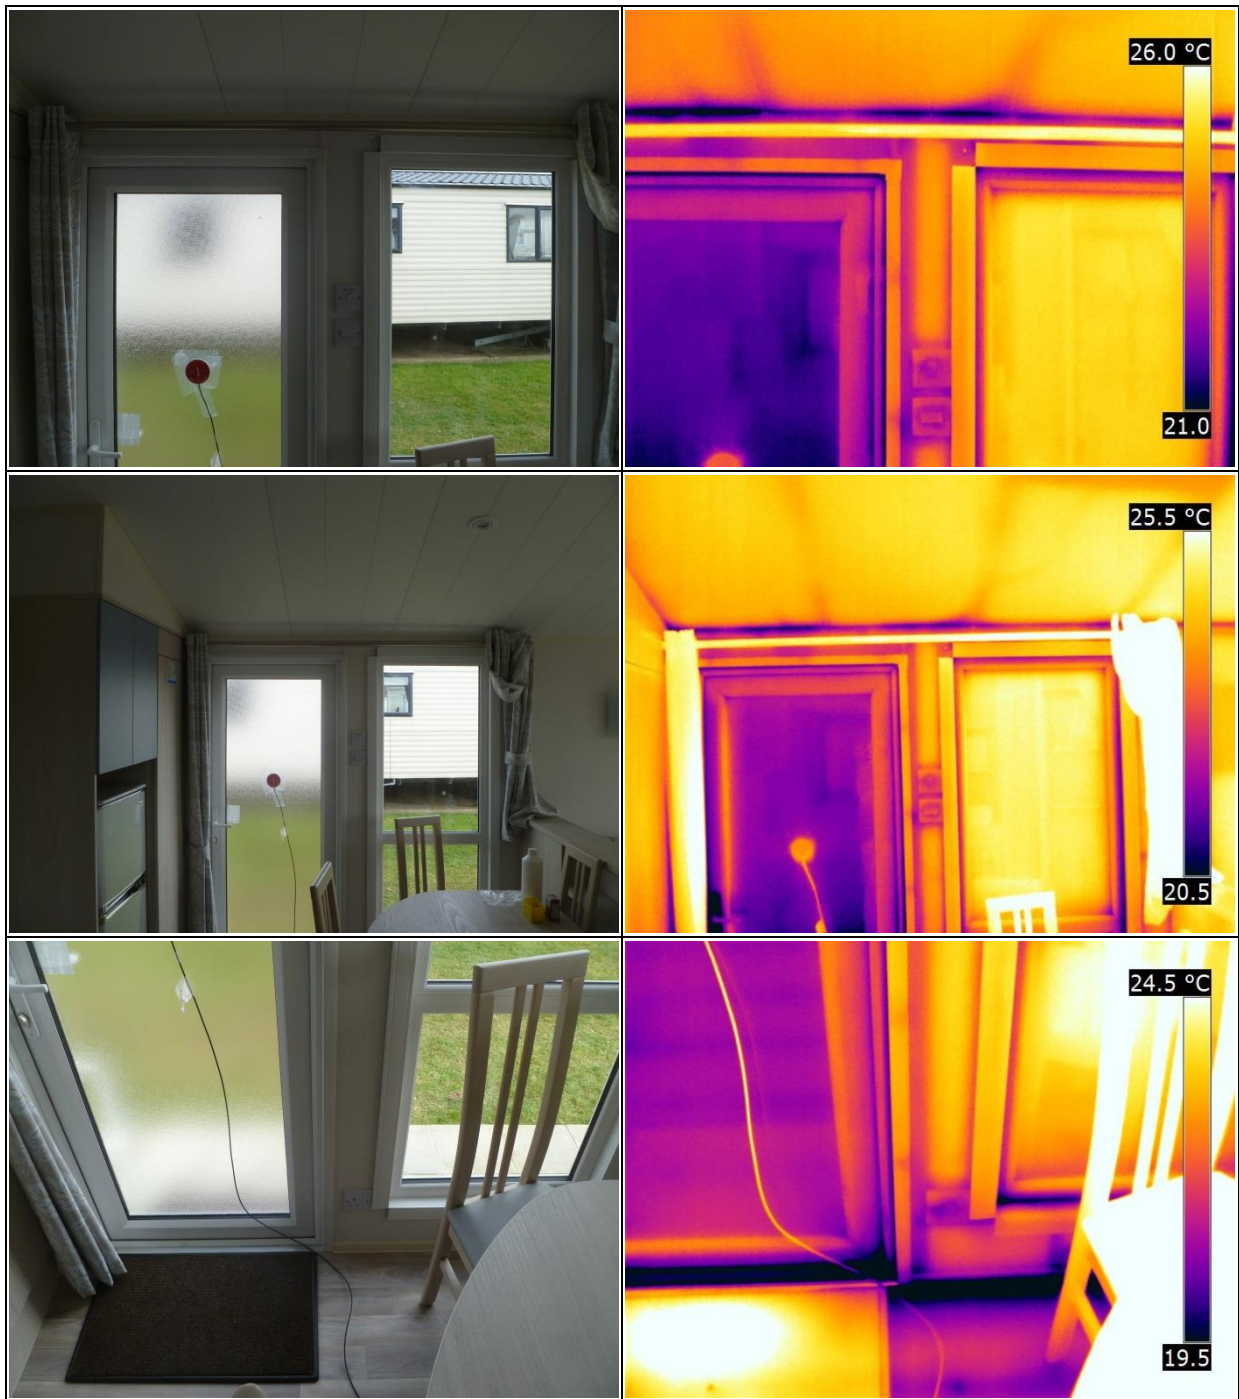
Figure 4 shows the same door and adjacent window in C05, but with the images captured from within the caravan. Taken immediately after the image in Figure 3, the internally captured thermal images in Figure 4 show around a 3.5 °C difference in surface temperature between the original glazing in the door and that of the replacement glazing in the adjacent window.

Figure 4: Internal images of C05 original door with adjacent window replaced – 20-Mar-2015

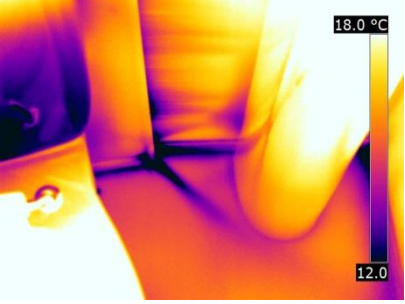
<p>16-Mar-2015 C10 – Bathroom Air leakage from the boxed-in services for the toilet was detected.</p>

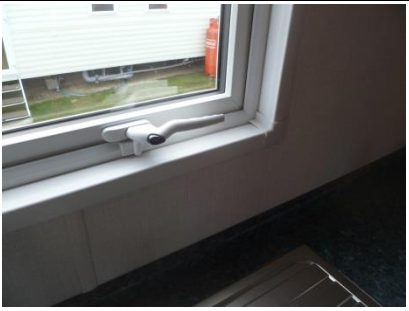
<p>16-Mar-2015 C05 – Kitchen Infiltration around the kitchen window was detected.</p>

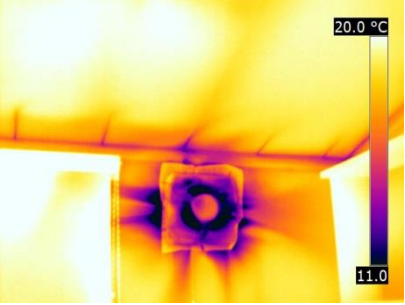
<p>16-Mar-2015 C05 – Kitchen Air leakage was detected around the sealed extract fan and around the window.</p>

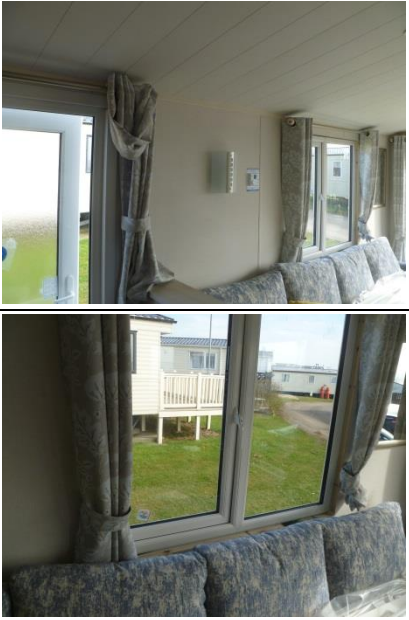
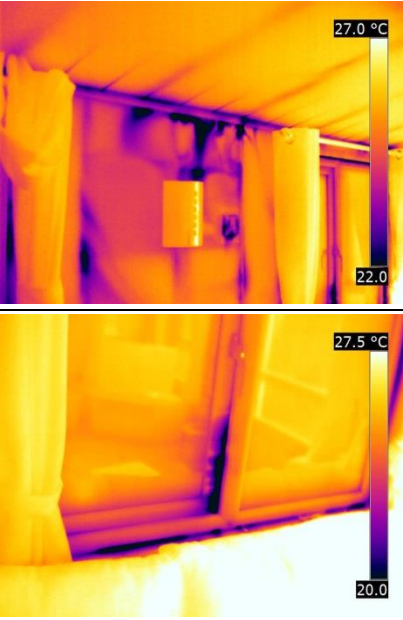
<p>20-Mar-2015 C05 – Lounge Air leakage was detected around electrical penetrations and at the wall/roof junction. One of the replacement window was also incorrectly sized and air leakage observed around the casement. This window was subsequently replaced with one that was correctly sized.</p>

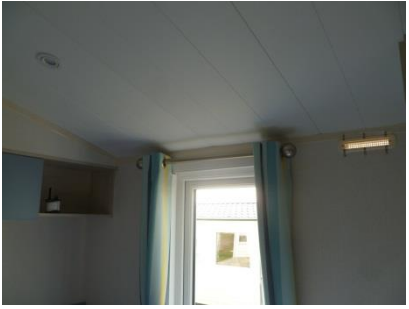
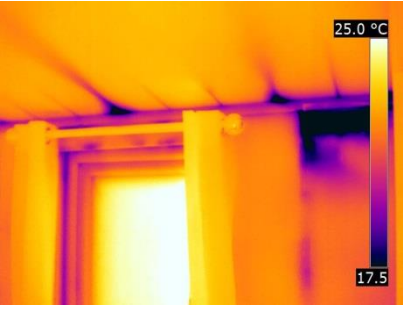
<p>20-Mar-2015 C05 – Small Bedroom The wall vent had been sealed temporarily on the inside, but external air appeared to be entering the wall cavity from the outside.</p>

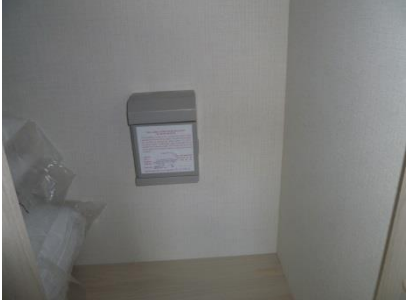
<p>20-Mar-2015 C05 – Main Bedroom Air leakage around the consumer unit emerged at warmer temperatures than directly infiltrating air due to a longer air leakage path.</p>

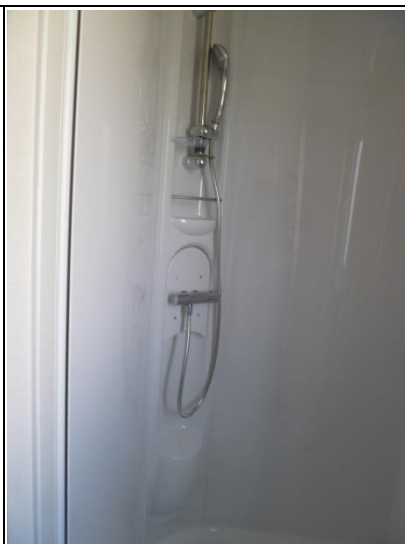
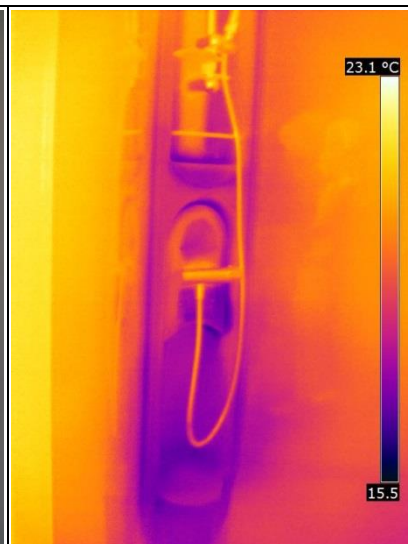
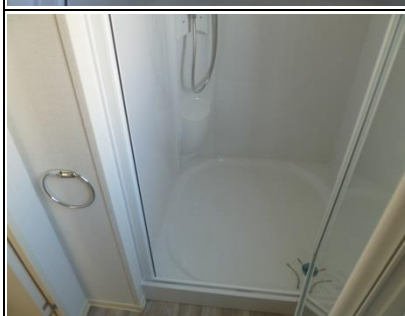
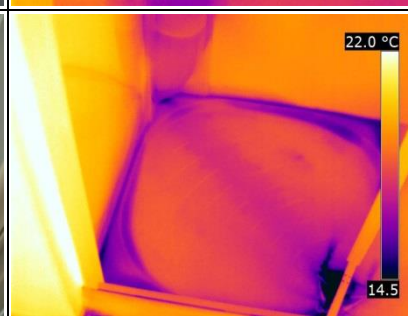
20-Mar-2015  
C05 – Bathroom  
Air leakage emerging from around the shower controls could be traced back down underneath the shower tray to the location where the waste pipe penetrated through the caravan floor.

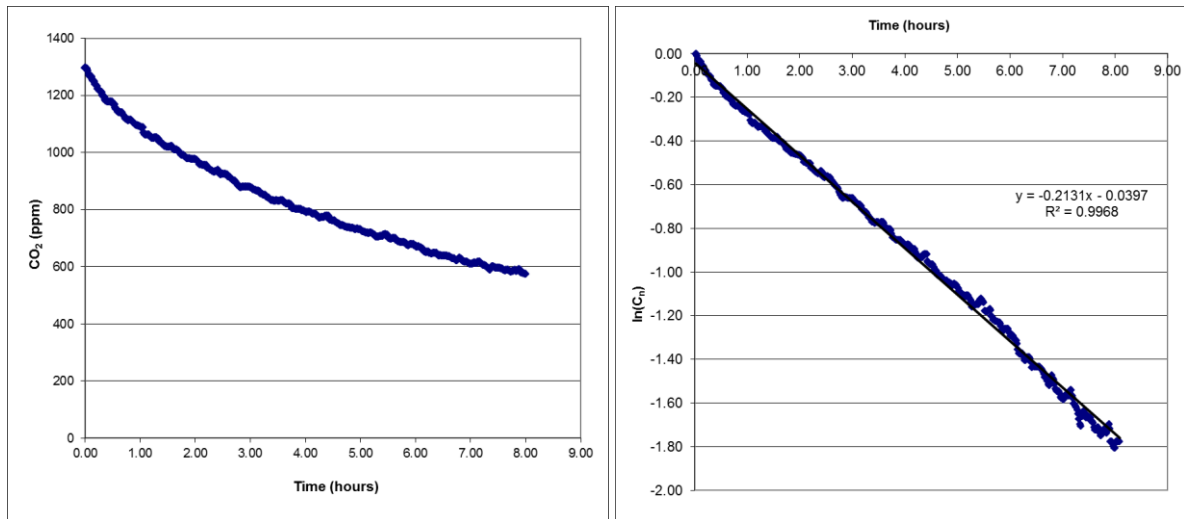
Figure 5: CO<sub>2</sub> decay curves for caravan CO5 stage 1 test

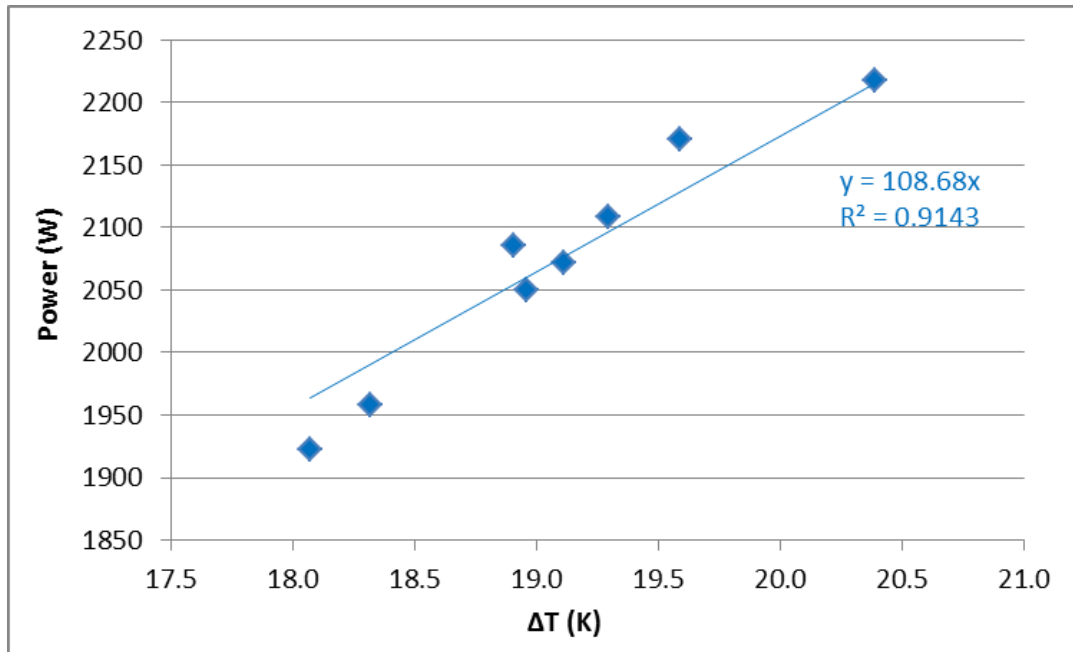
Figure 8 provides the coheating analysis of caravan C05 during test period 1. The coheating test produced an estimate of the HLC of 108.7 ( $\pm 0.5$ ) W/K (slope of the regression line). The low thermal mass of the caravan is evident by the strong relationship between mean hourly power demand and  $\Delta T$  ( $r^2$  of 0.91). This relationship provides confidence that reasonable estimate of the HLC can be obtained over a short time period.

Figure 8: Coheating test 1 analysis for caravan C5 (regression forced through origin)

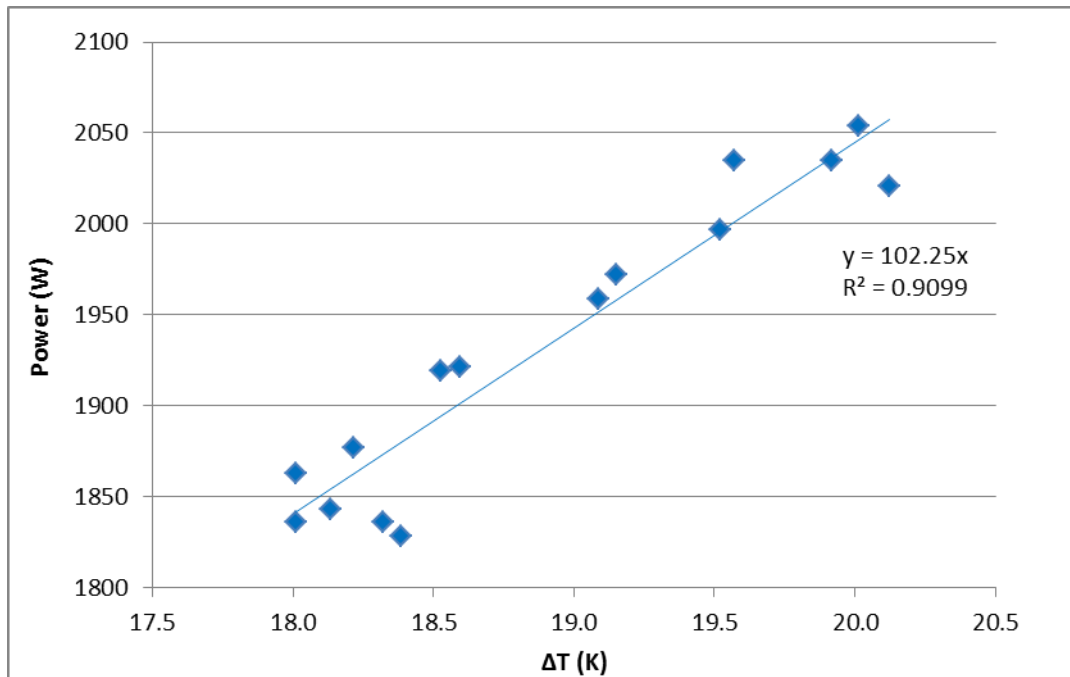
Figure 11: Coheating test 2 analysis for caravan C5 (regression forced through origin)

Figure 11 provides the coheating analysis of caravan C05 during test period 2. It is clear that there is a strong relationship between the mean hourly power demand and  $\Delta T$  ( $r^2$  of 0.91). The coheating test produced an estimate of the HLC of 102.3 ( $\pm 0.3$ ) W/K. This represents a reduction in HLC of 6.5 W/K (5.9%) from test period 1. As the airtightness of the caravan remained almost unchanged following test period 1, this reduction can primarily be attributed to the installation of the replacement windows.

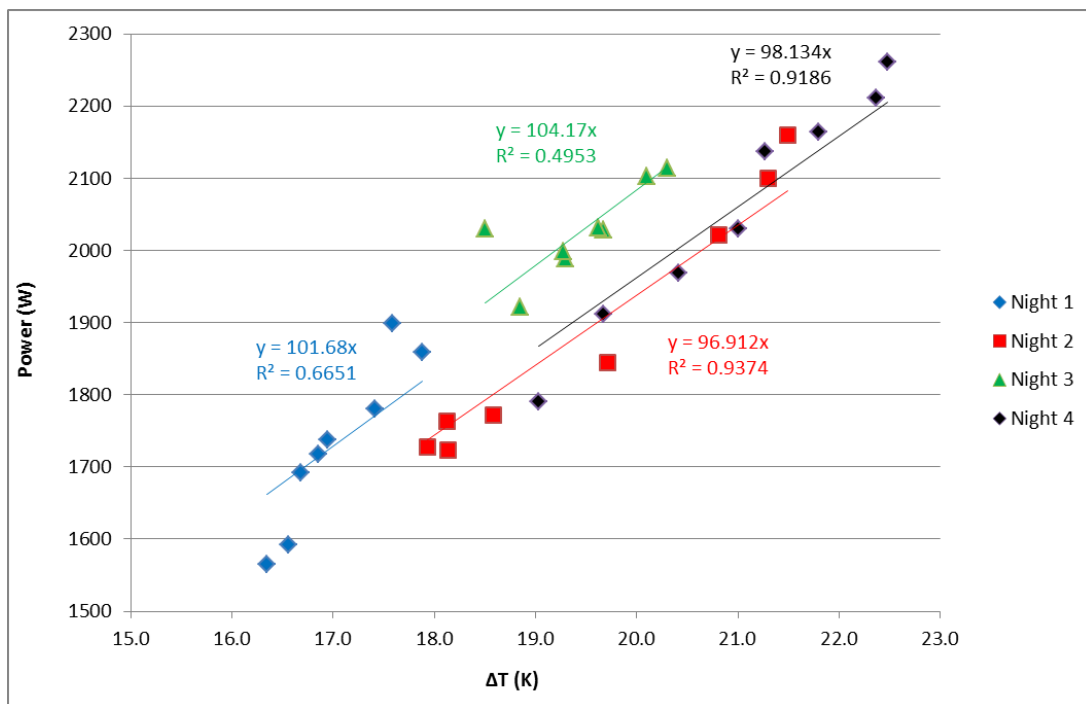
Figure 13 shows the coheating analysis for the four successive nights during test period 3. It can be seen that there is poor consistency between the HLC measured across the test period.

Figure 13: Individual nights coheating test 3 analysis for caravan C05 (regression forced through origin)

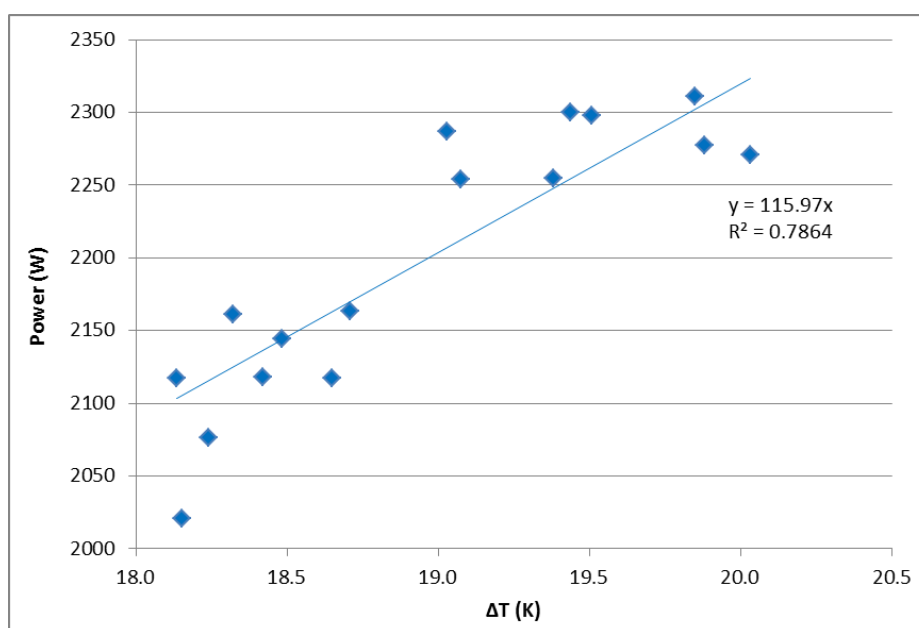
Due to a malfunction of the energy metering equipment in caravan C10, it was not possible to estimate a HLC for test period 1; the issue with the logging equipment was resolved prior to test period 2. Caravan C10 did not have any glazing replaced, thus the HLC estimate for test period 2 is for the caravan in its original condition. The coheating analysis for caravan C10 is provided in Figure 17. The coheating test produced an estimate of the HLC of 116 ( $\pm 0.6$ ) W/K. There is a reasonable degree in confidence with the HLC estimate due to the correlation between power input and  $\Delta T$  ( $r^2$  of 0.79).

Figure 17: Coheating test analysis for caravan C10 (regression forced through origin)

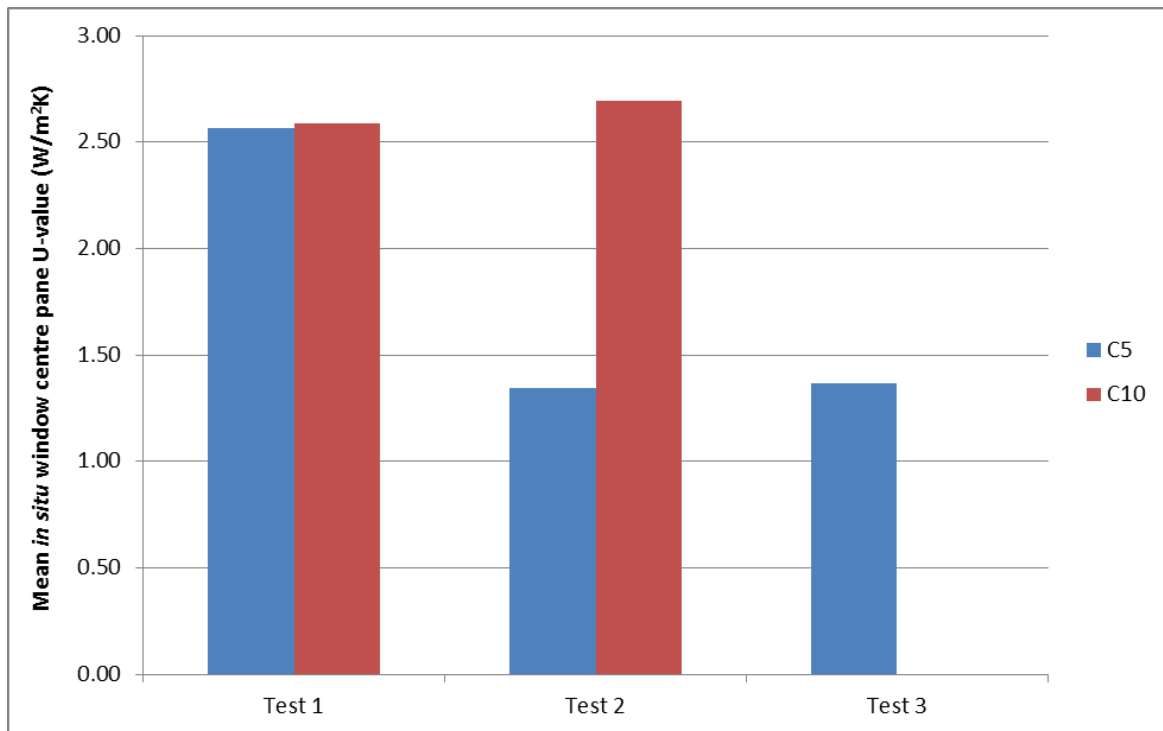
There was a high level of consistency between *in situ* glazing centre pane U-values measured across both caravans (mean 2.60 W/m<sup>2</sup>K, SD 0.06 W/m<sup>2</sup>K) in test period 1. The *in situ* U-values of non-glazed thermal elements in each caravan remained reasonably consistent across each of the test periods, this supports the assertion made in the coheating analysis that the reduction in HLC of caravan C05 is primarily due to the installation of replacement glazing and door. In addition, the mean *in situ* window centre pane U-value in caravan C05 reduced from 2.57 W/m<sup>2</sup>K to 1.37 W/m<sup>2</sup>K following the installation of the replacement windows. Figure 18 illustrates the reduction in mean *in situ* window centre pane U-value that was measured across the test periods.

Figure 18: Mean *in situ* window centre pane U-value for each caravan during the 3 test periods (windows only).
