Johnston, D and Farmer, D and Miles-Shenton, D (2016) Bourne Leisure Ltd. Thermal Performance Measurement Report. Project Report. Centre for the Built Environment (CeBE) Group, Leeds Sustainability Institute, Leeds Beckett University., Leeds, UK.

## **Bourne Leisure Ltd. Thermal Performance Measurement Report**

May 2016

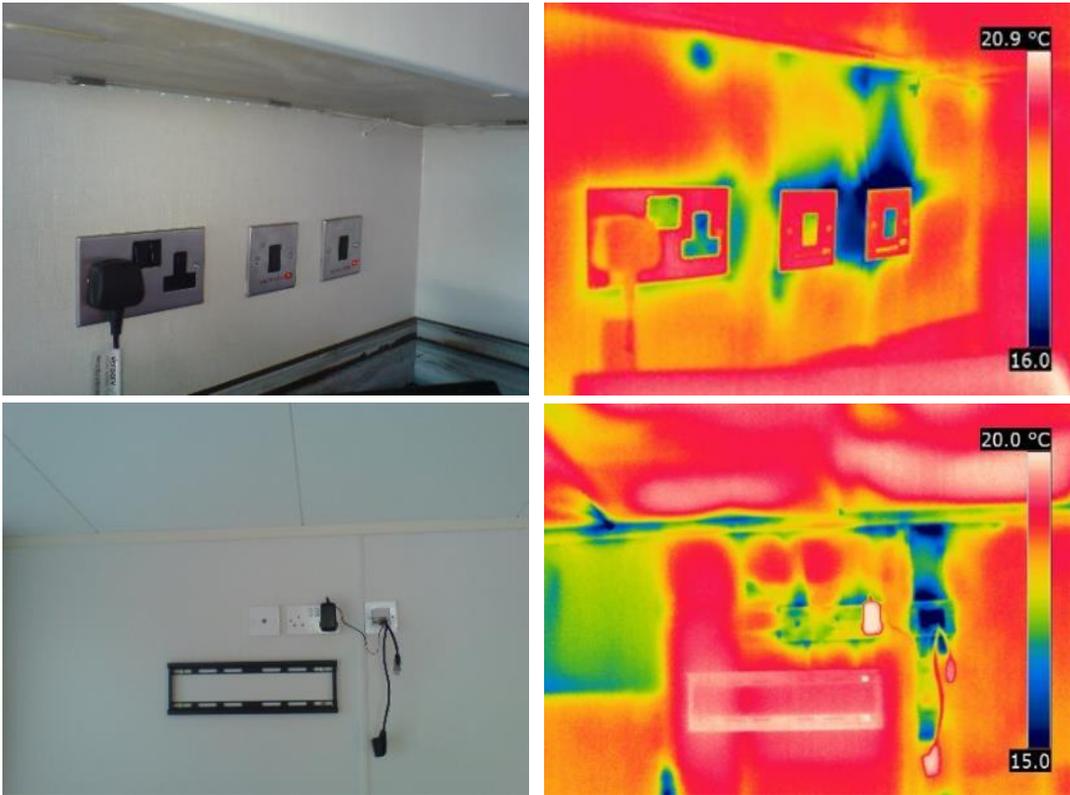
Figure 8 Air leakage around external wall sockets.

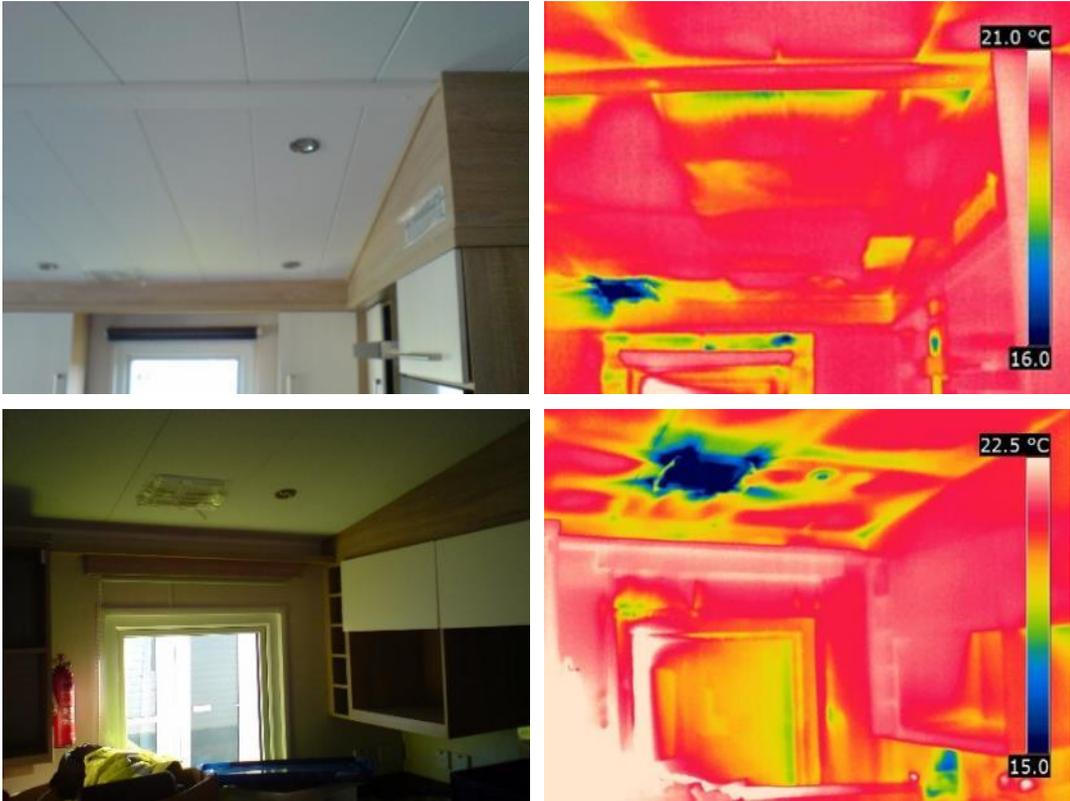
Figure 9 Air leakage around ceiling mounted extract grilles.

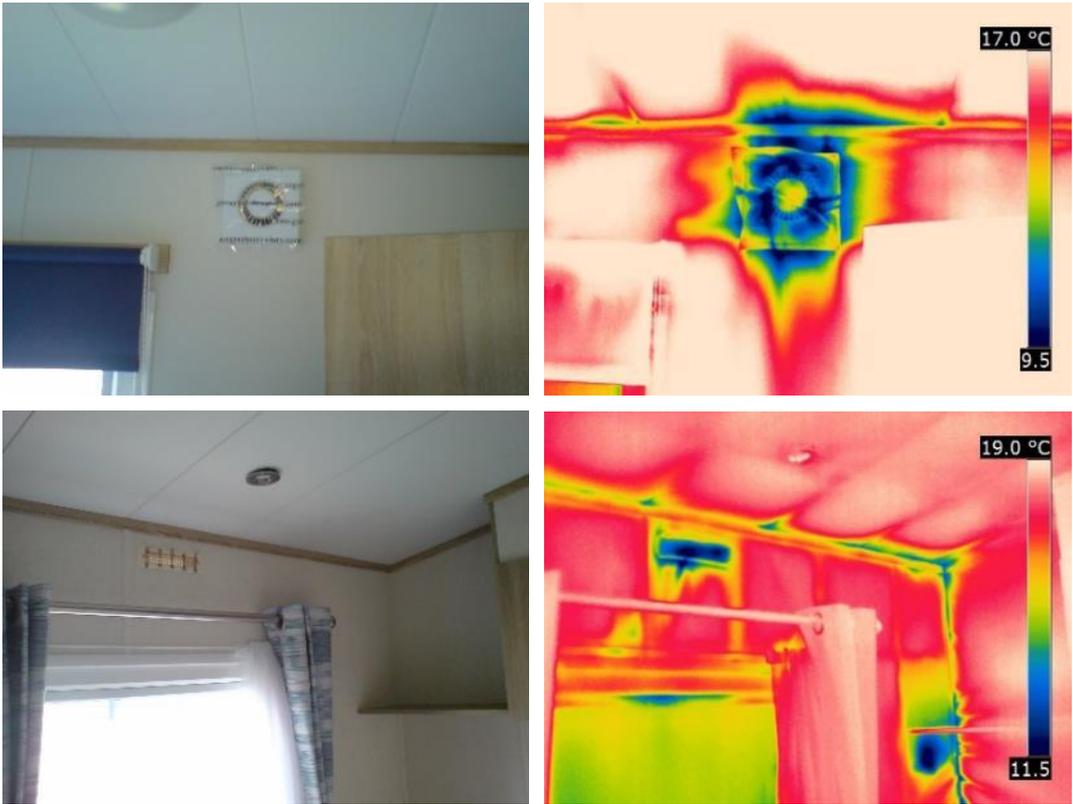
Figure 10 Air leakage around wall mounted extract fans (top) and grilles (bottom).

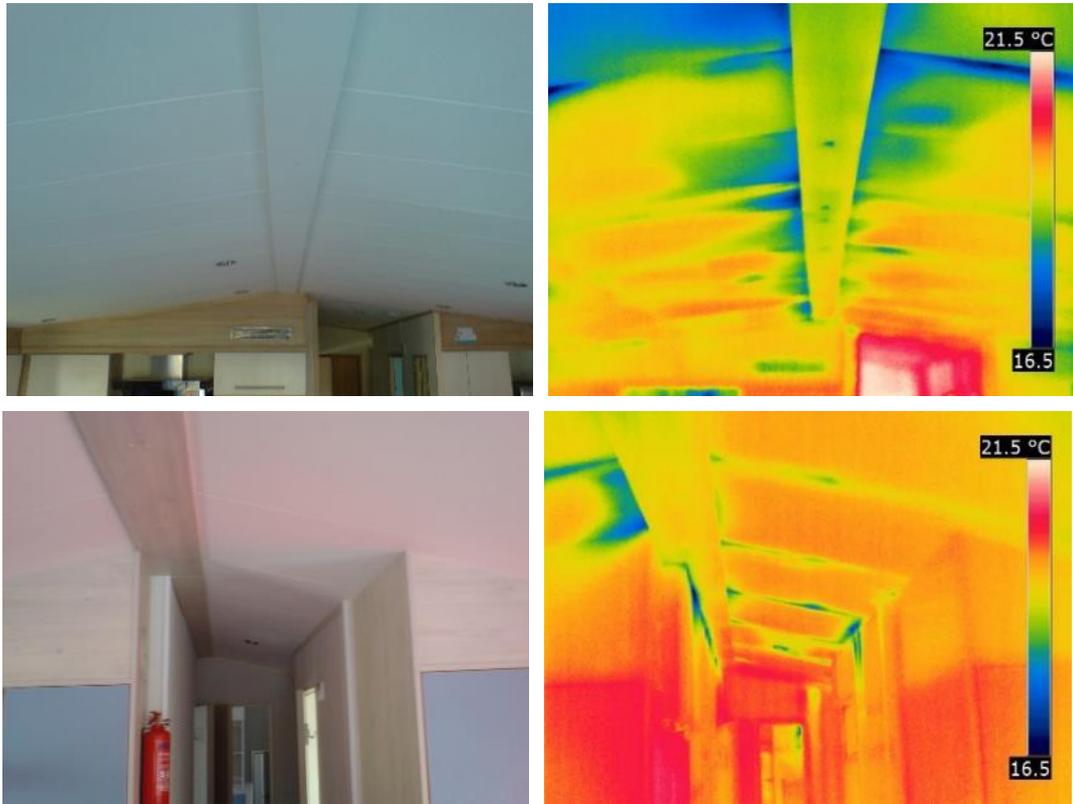
Figure 11 Air leakage at the ceiling ridge junction.

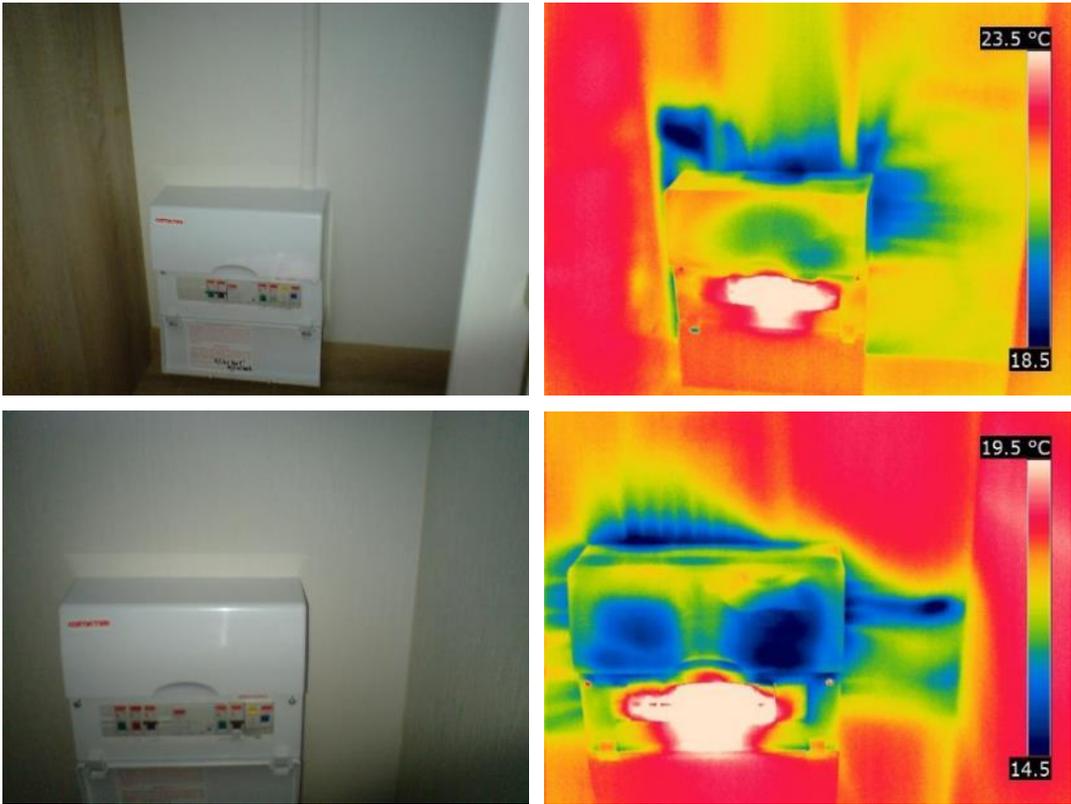
Figure 12 Air leakage around the consumer unit.

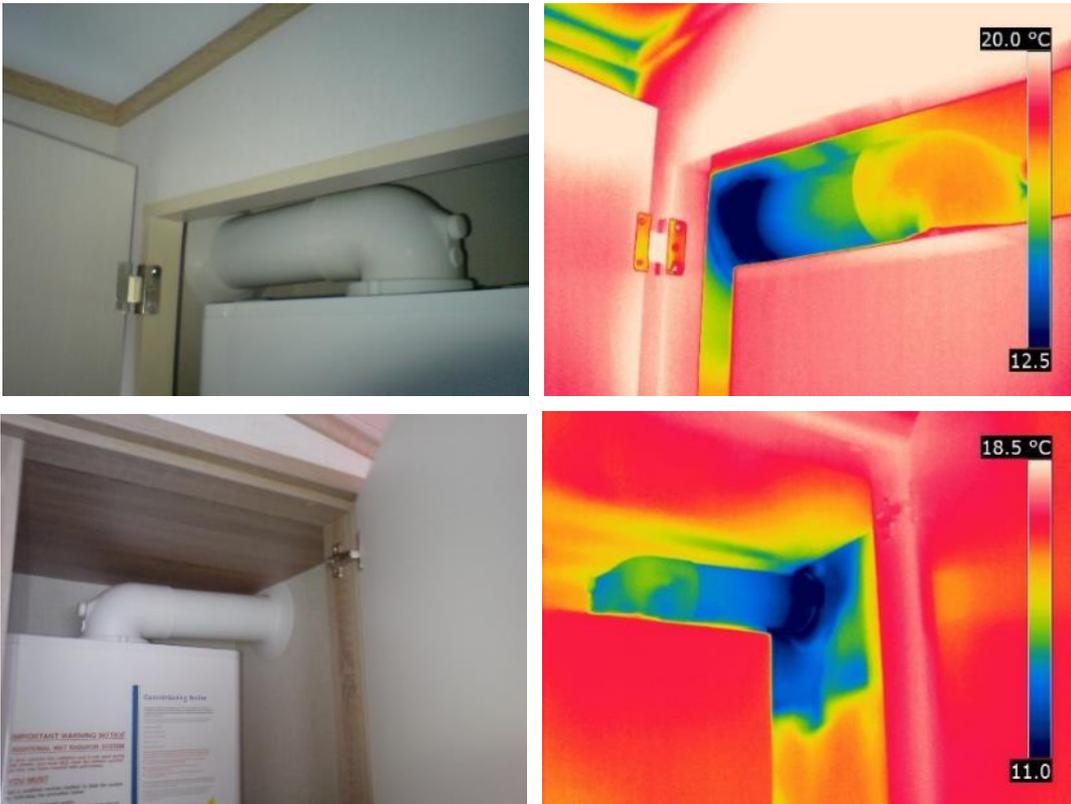
Figure 13 Air leakage around the boiler flue.

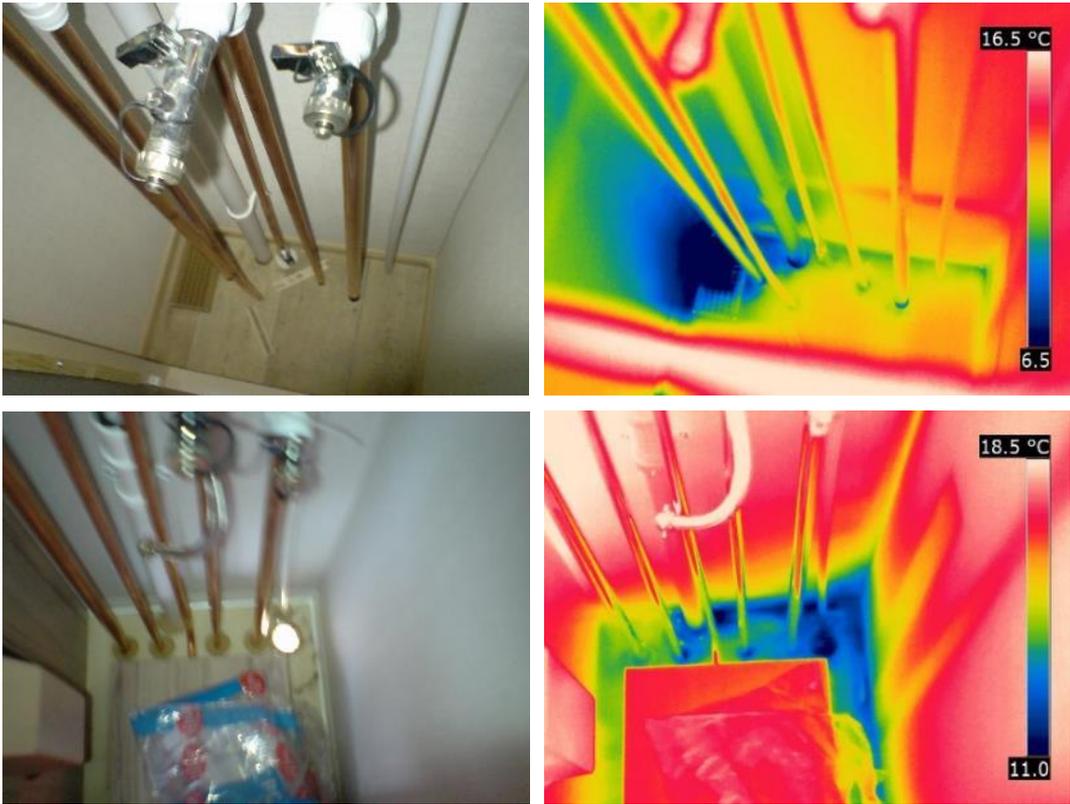
Figure 14 Air leakage around the water pipes, gas pipes and condensate drain at the boiler.

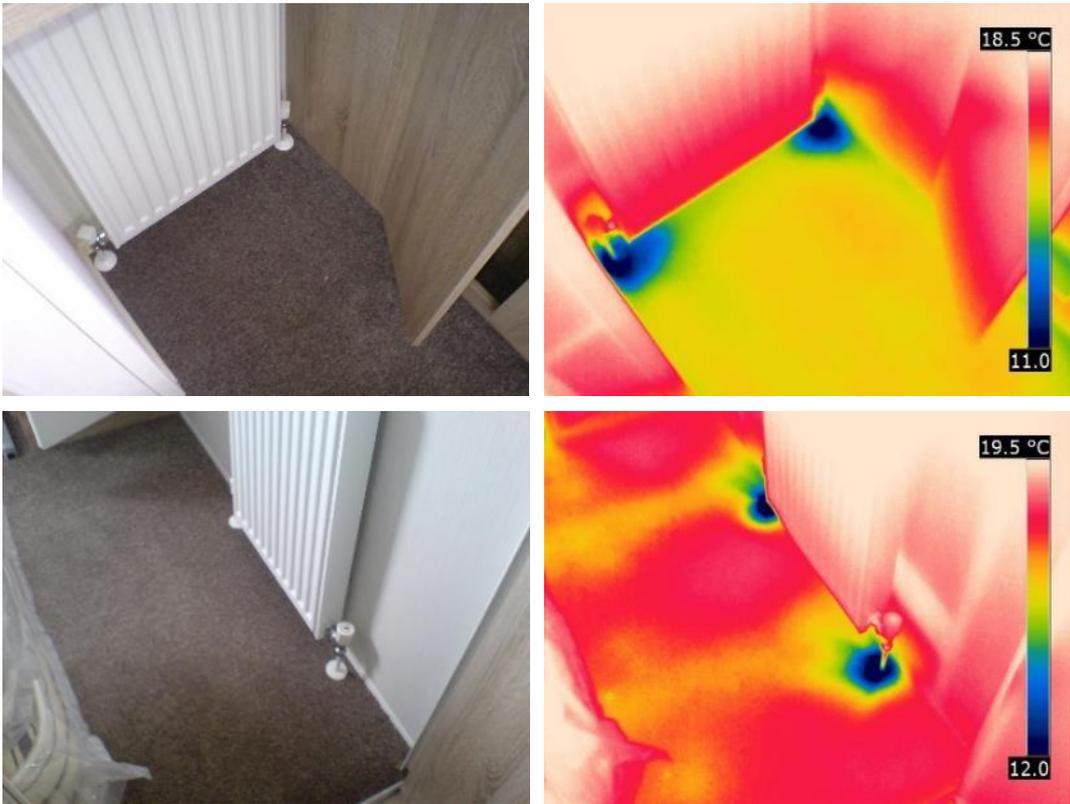
Figure 15 Air leakage around the central heating pipes where they penetrate through the ground floor.

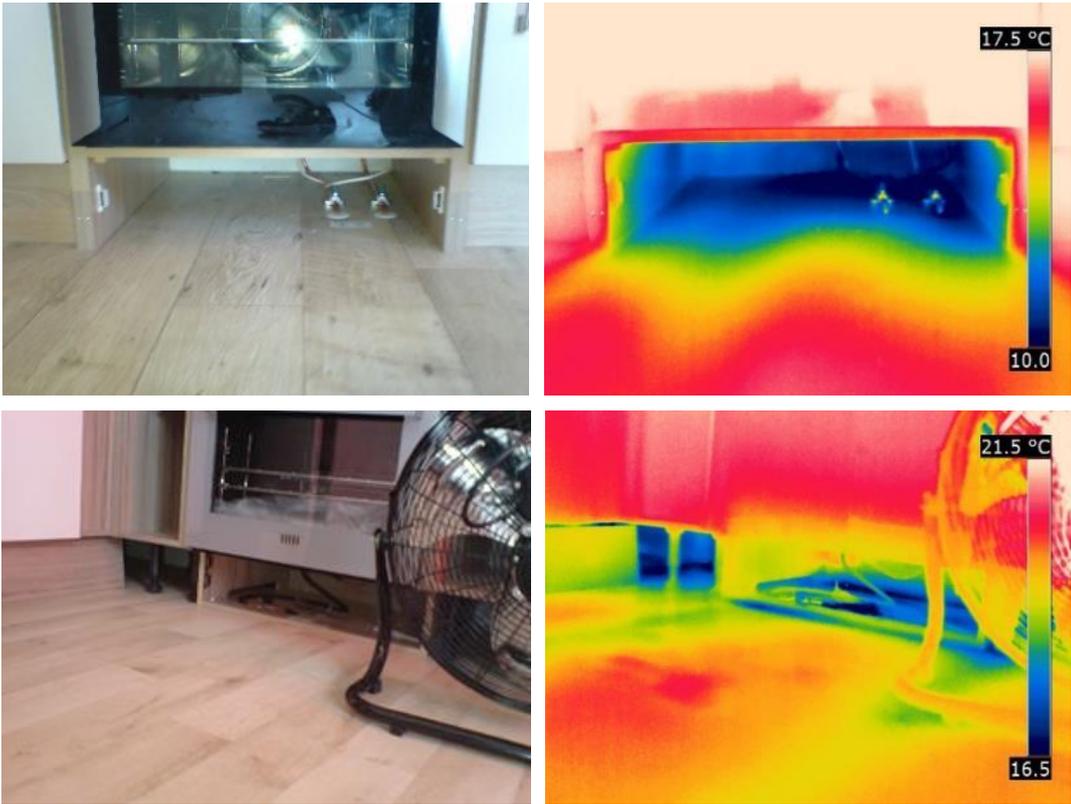
Figure 16 Air leakage around the gas pipes to the cooker.

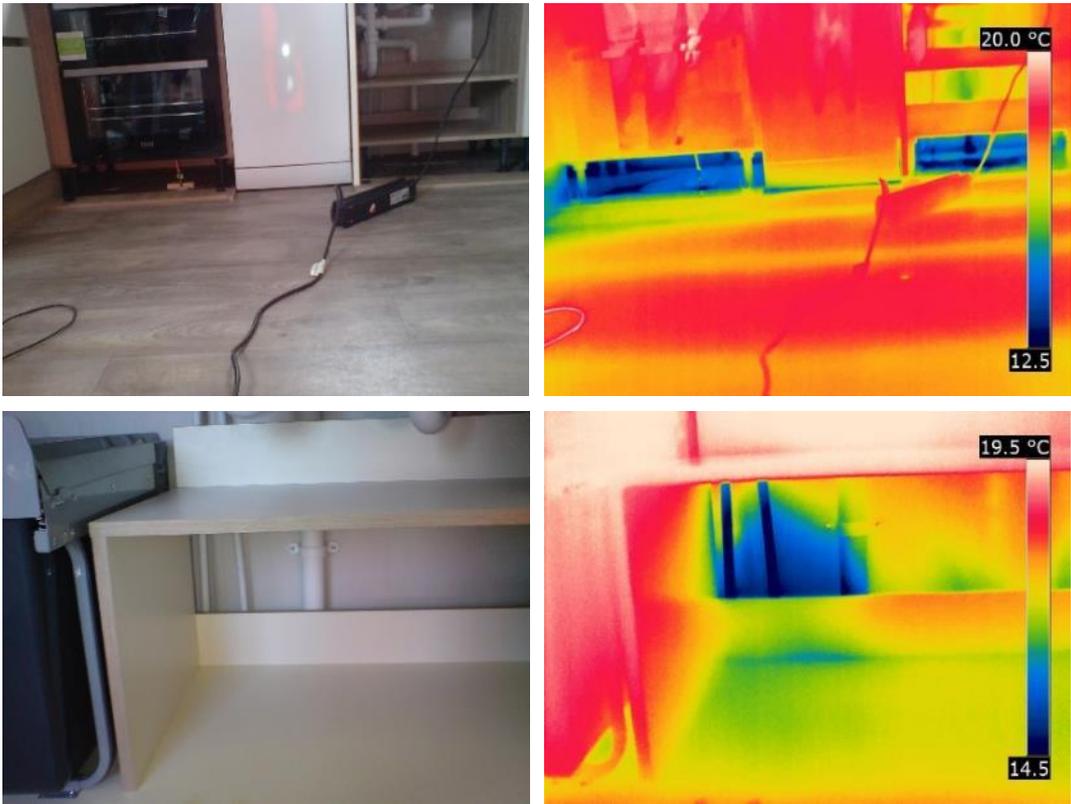
Figure 17 Air leakage around waste and water pipes under the kitchen units.

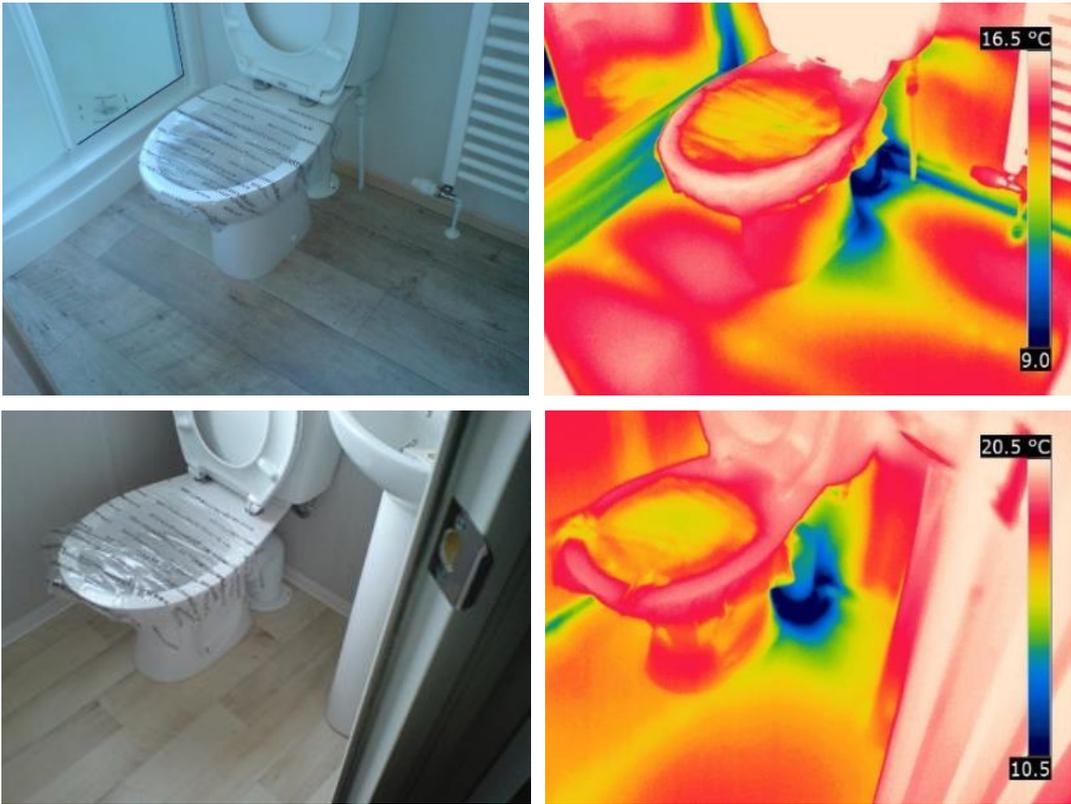
Figure 18 Around the toilet waste pipe.

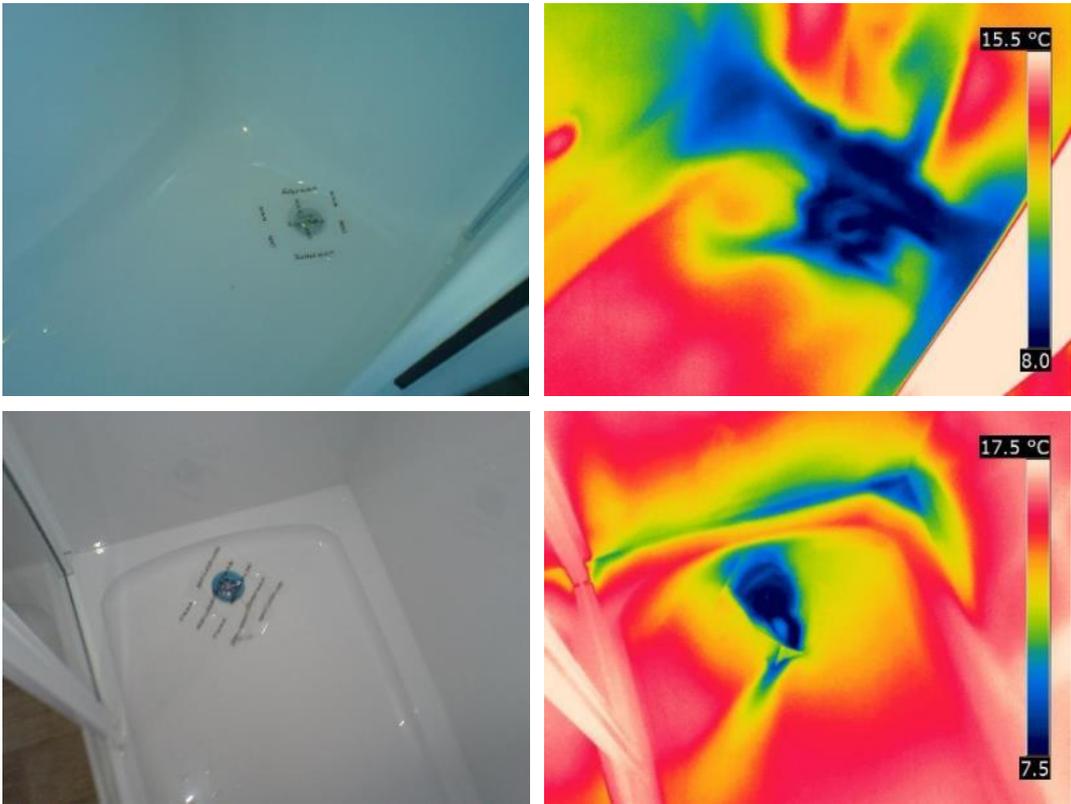
Figure 19 Air leakage from service penetrations beneath the shower tray.

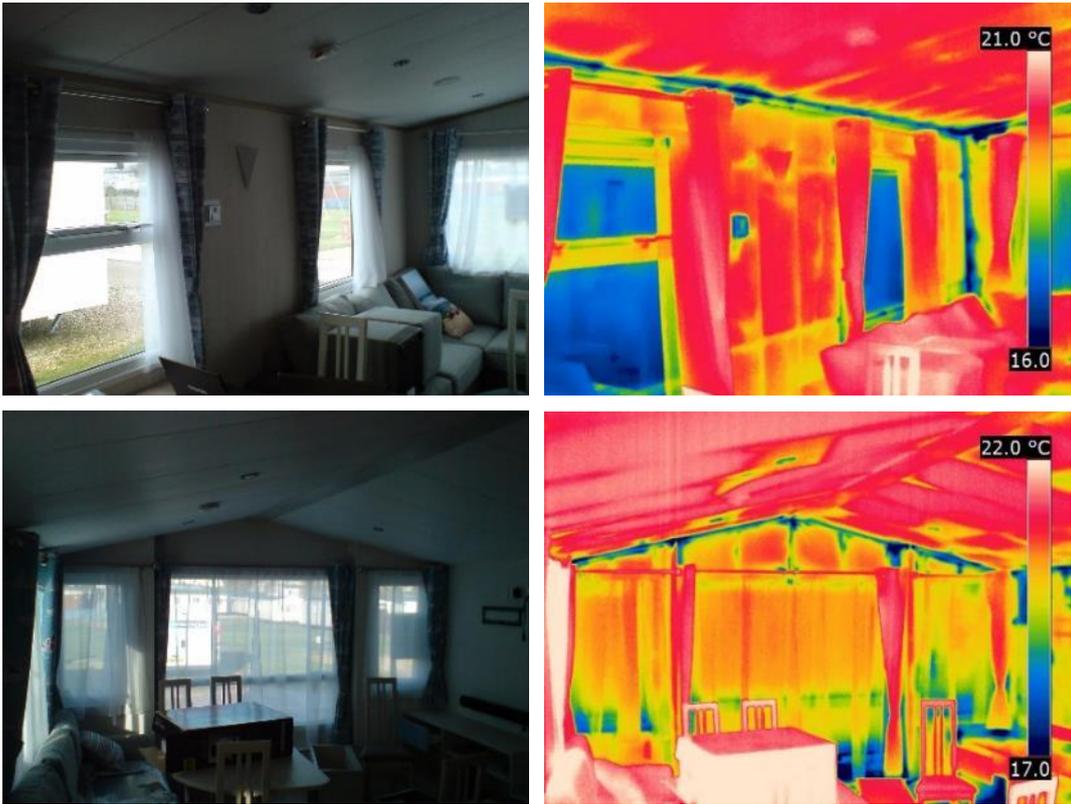
Figure 20 Air leakage at the external wall/ceiling junction (top and bottom) and at external wall corners (top).

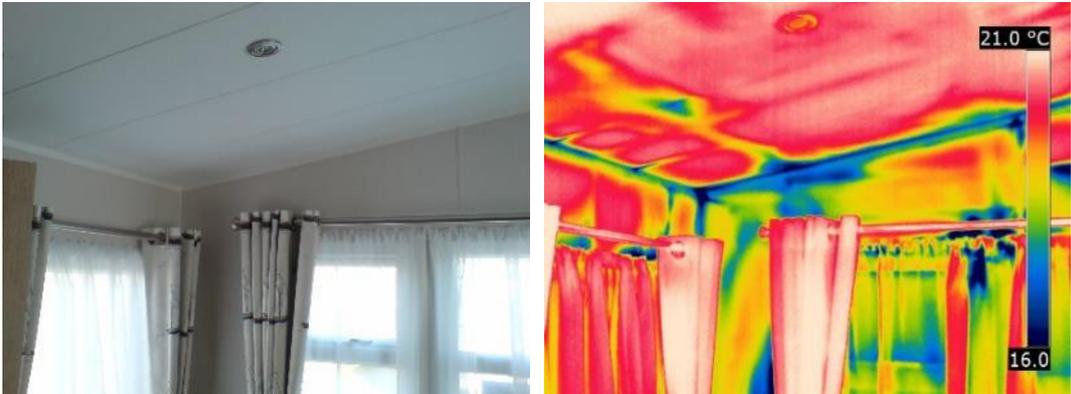
Figure 21 Air leakage at the external wall/ceiling junction in caravan D.

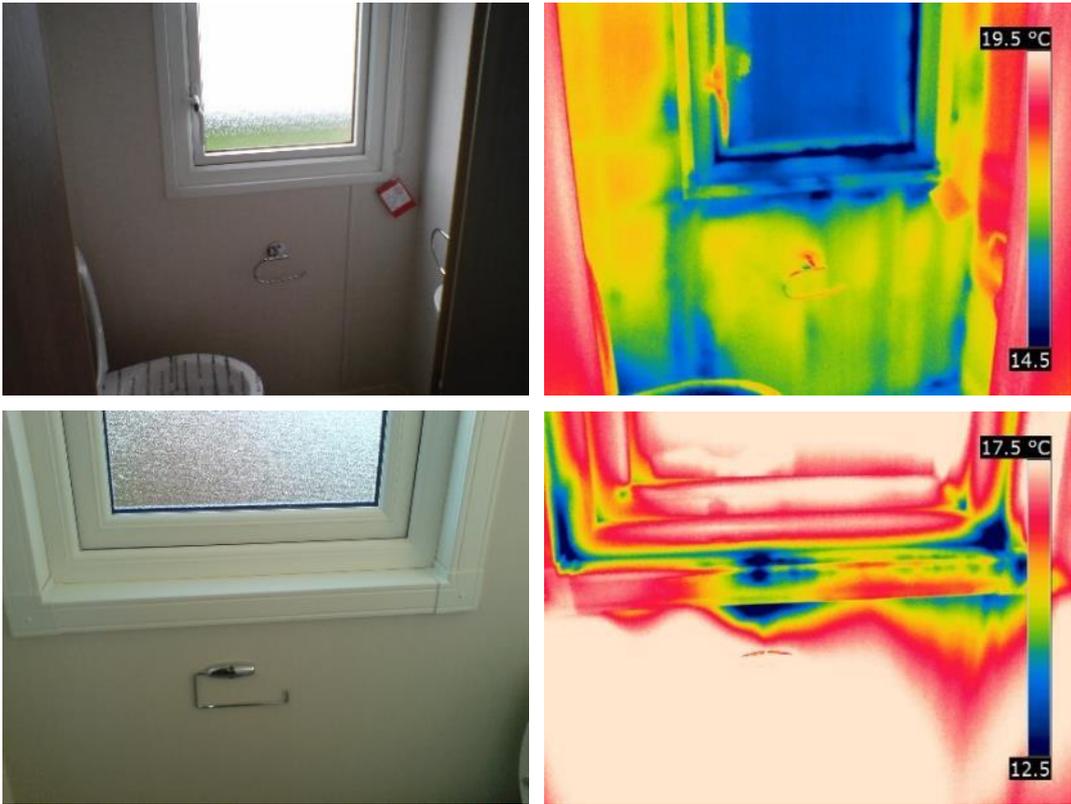
- Around the window frames (see Figure 22).
- 32 In addition, there were a much smaller number of areas of air leakage identified that were specific to particular test caravans. These were as follows:

Figure 22 Air leakage around the window frames.

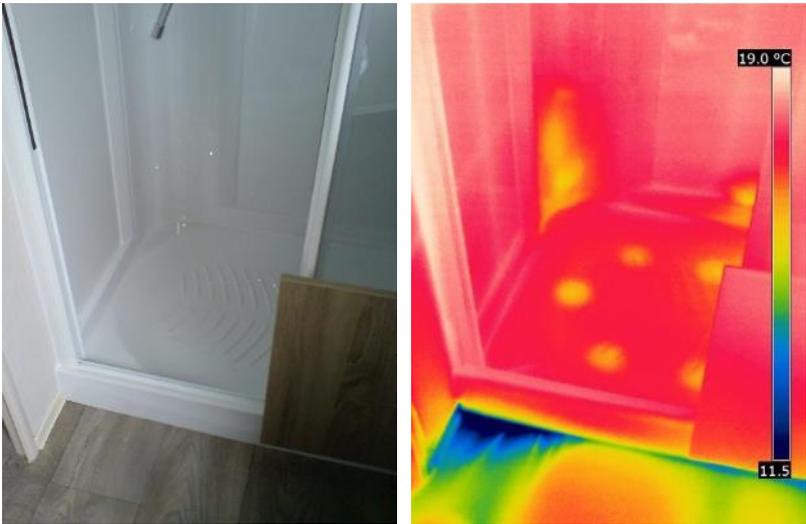
Figure 23 Air leakage at the shower tray/floor junction in caravan B.

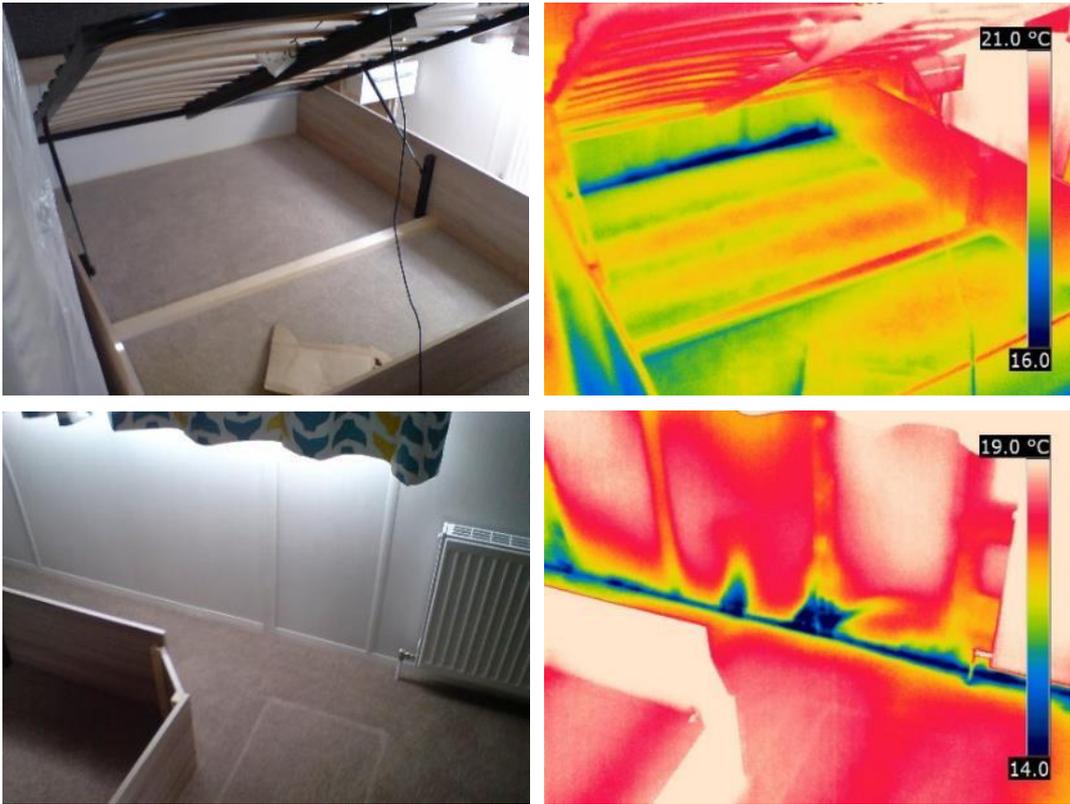
Figure 24 A leakage at the external wall/floor junction in the master bedroom of caravan A (top) and caravan E (bottom).

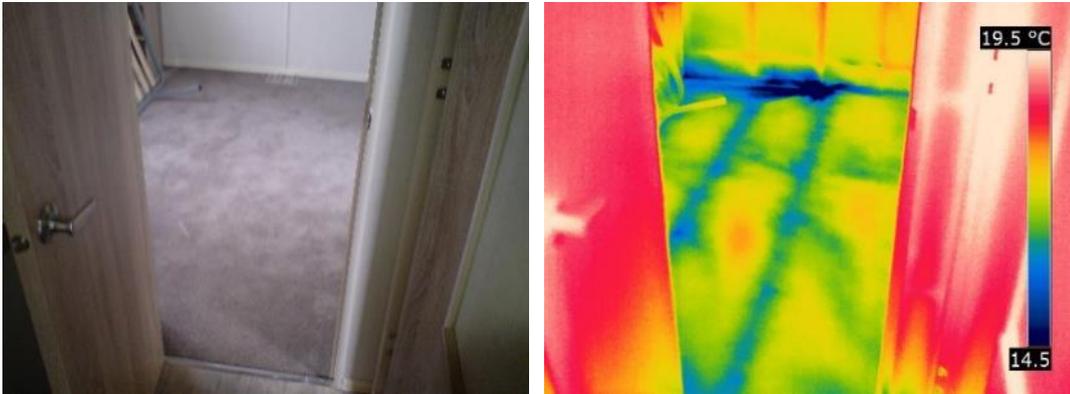
- Beneath the carpet in the master bedroom of caravan B (see Figure 25).
  - Around the front door of caravan C (see Figure 26).

Figure 25 Air leakage resulting in the carpet lifting under depressurisation in the master bedroom of caravan B.

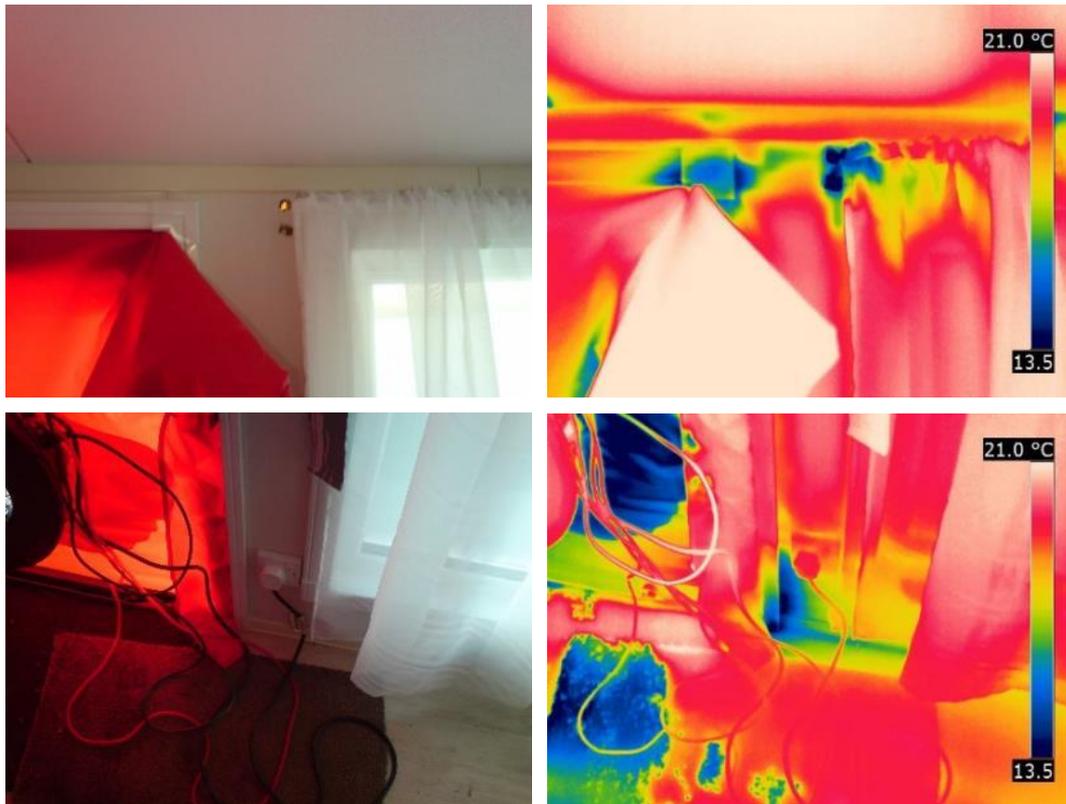
Figure 26 Air leakage around the front door of caravan C.

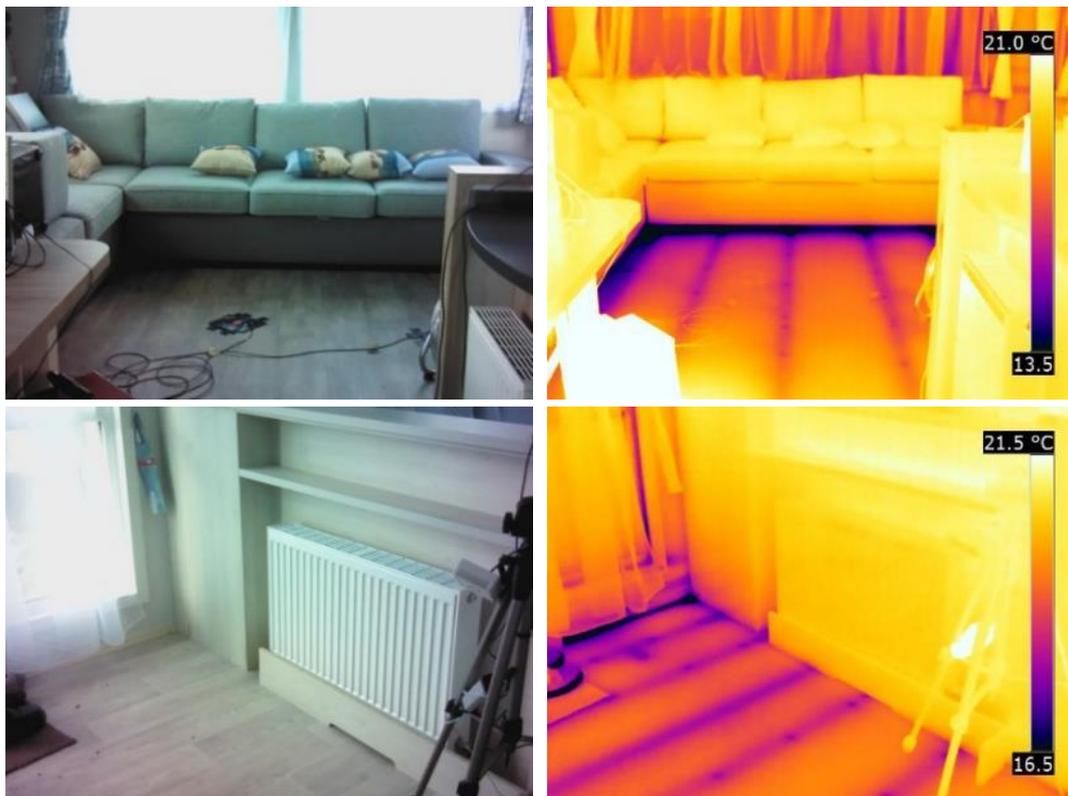
Figure 27 Thermal bridging at the ground floor joists.

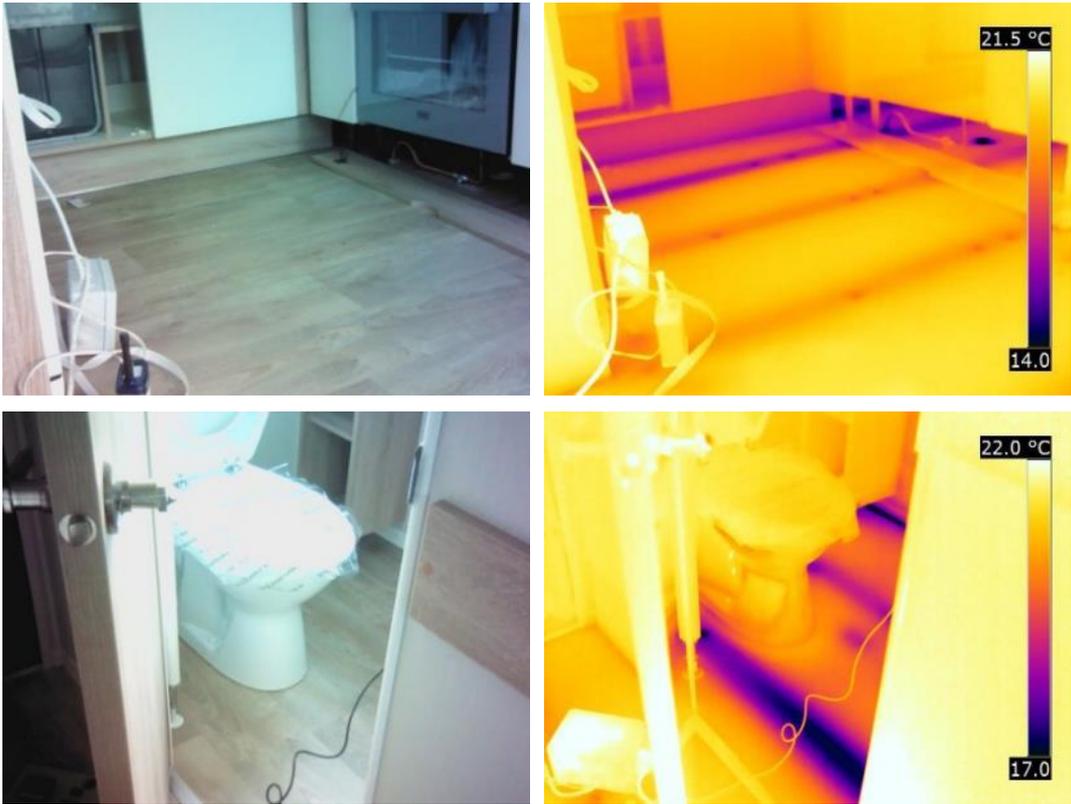
Figure 28 Steel chassis members clearly visible in the kitchen/living area (top) and bathroom (bottom) floor of caravan D.

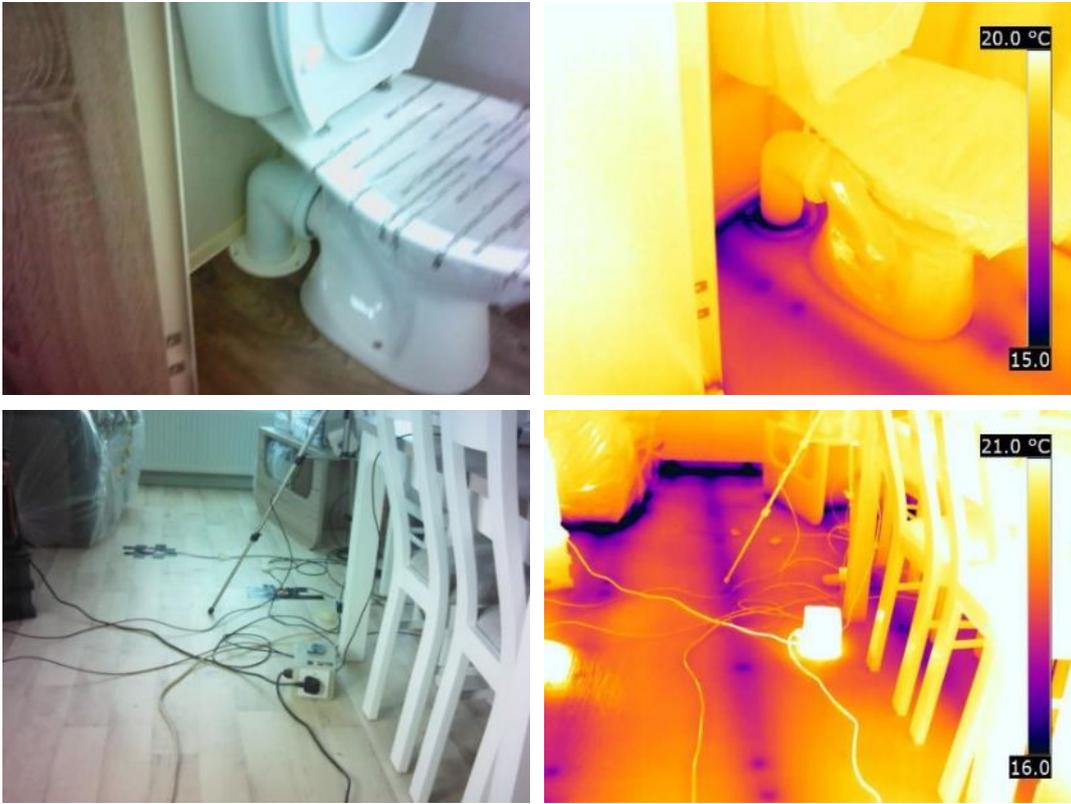
Figure 29 Joist fixings clearly visible on the floor of a number of the test caravans.

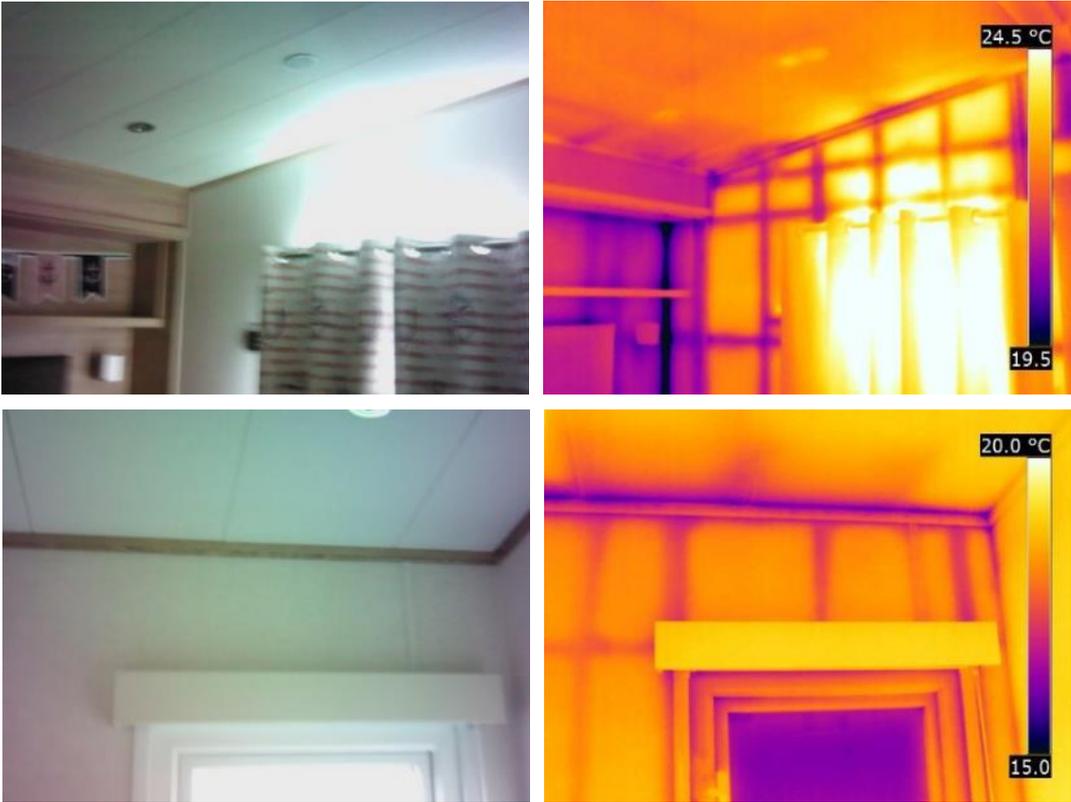
Figure 30 Thermal bridging at the vertical and horizontal studs in the external walls.

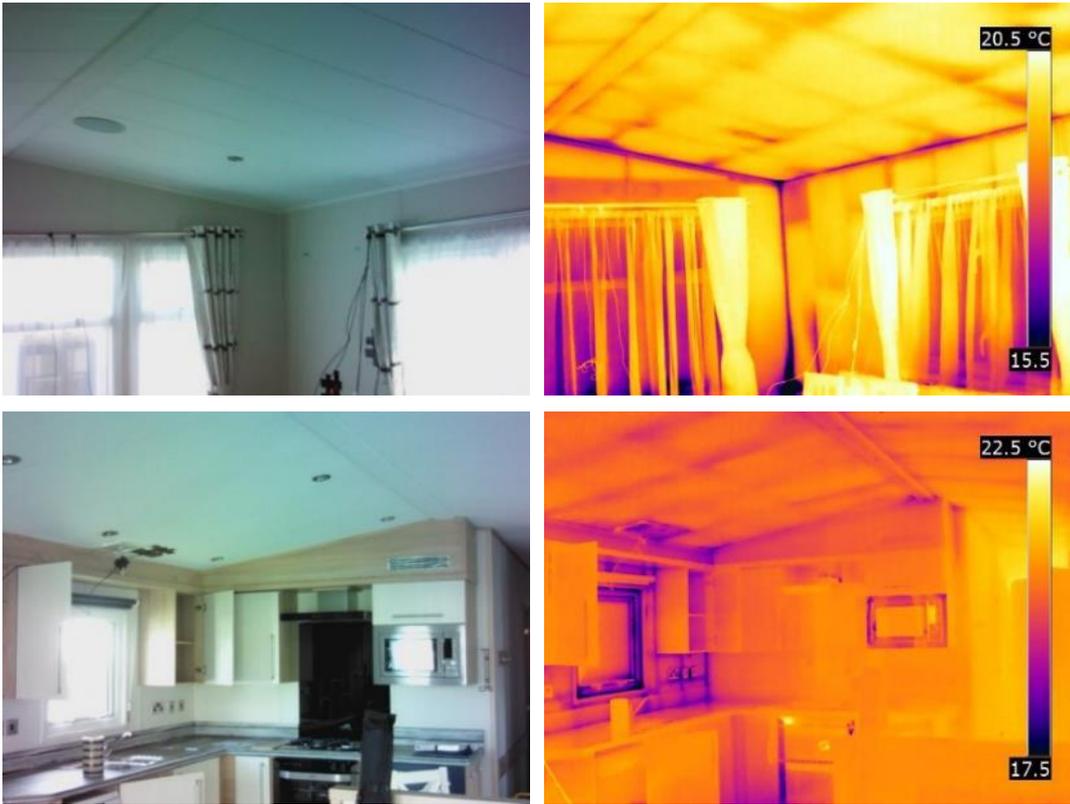
Figure 32 Thermal bridging at the roof joists and noggins.

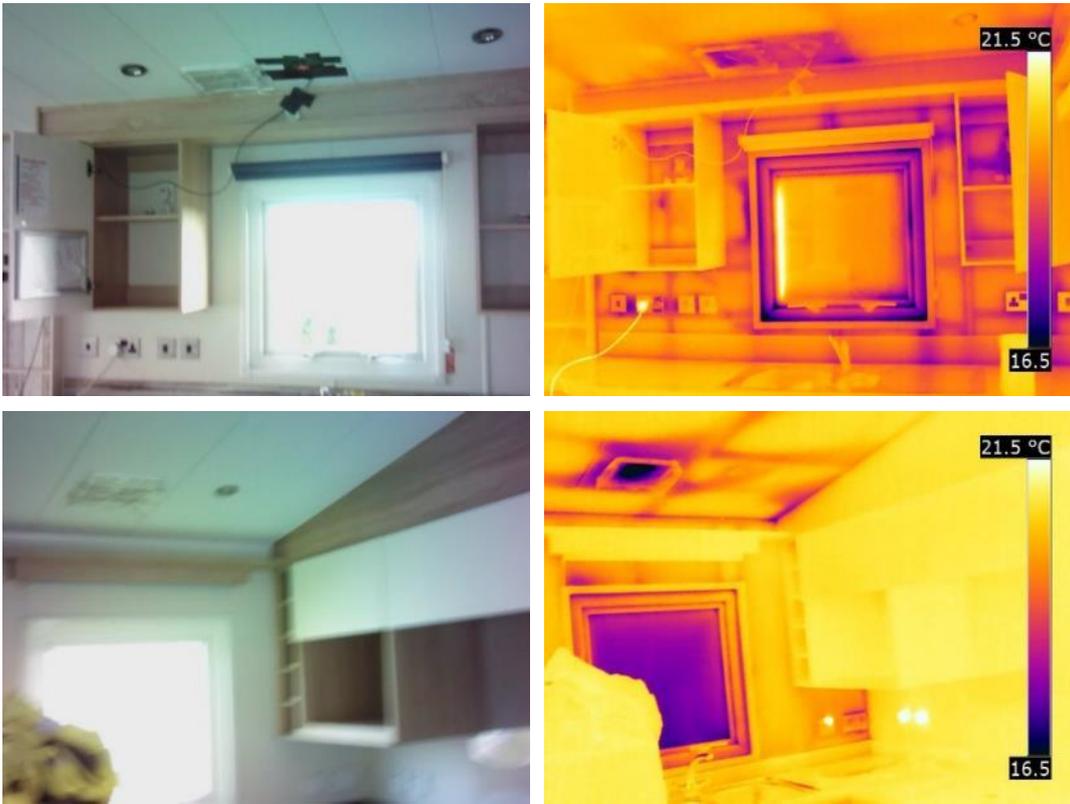
Figure 33 Thermal bridging around the ceiling mounted extract fan in the kitchen/living area.

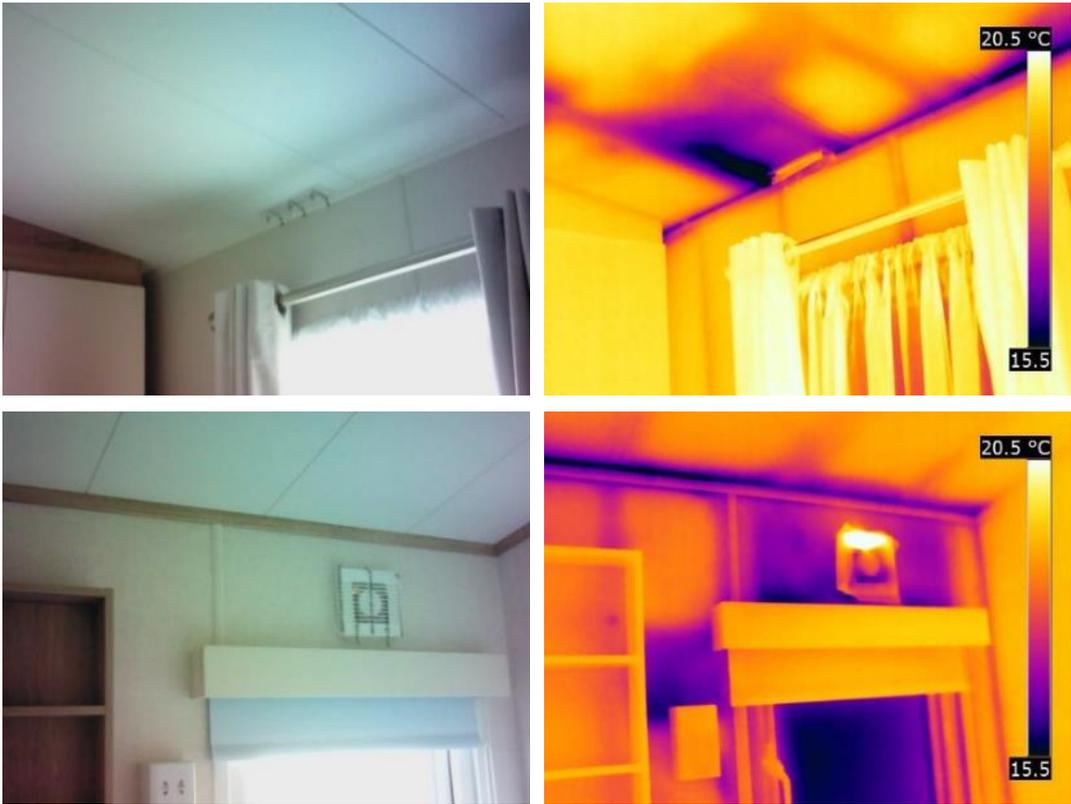
Figure 34 Thermal bridging around ceiling and external wall mounted vents.

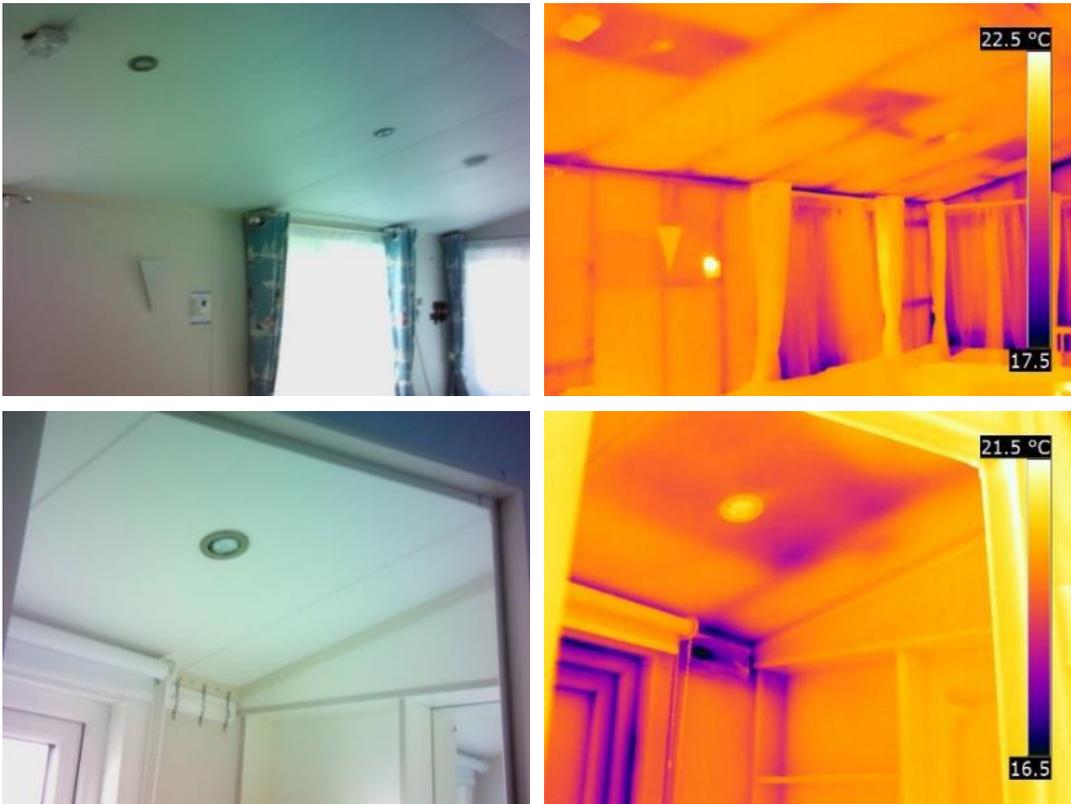
Figure 35 Thermal bridging around spotlights.
