Johnston, D and Farmer, D and Miles-Shenton, D (2016) Bourne Leisure Ltd. Thermal Performance Measurement Report. Project Report. Centre for the Built Environment (CeBE) Group, Leeds Sustainability Institute, Leeds Beckett University., Leeds, UK.

## **Bourne Leisure Ltd. Thermal Performance Measurement Report**

May 2016

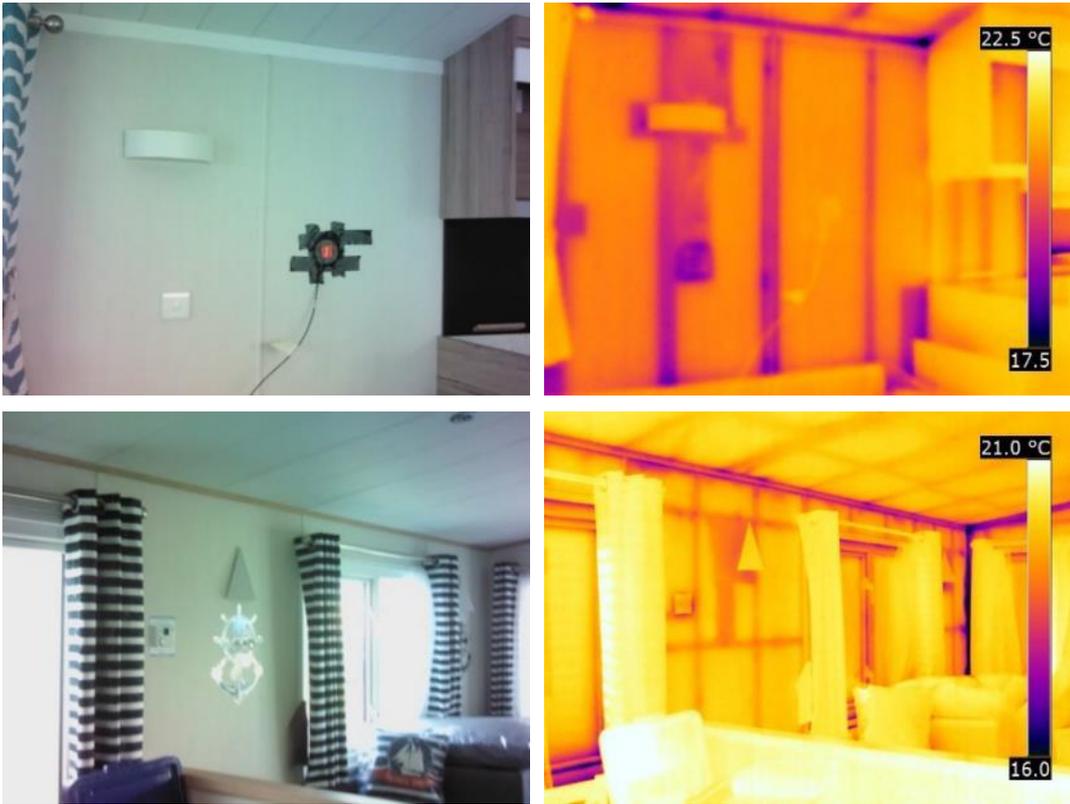
Figure 36 Thermal bridging around wall and light switches, particularly where there are cable runs.

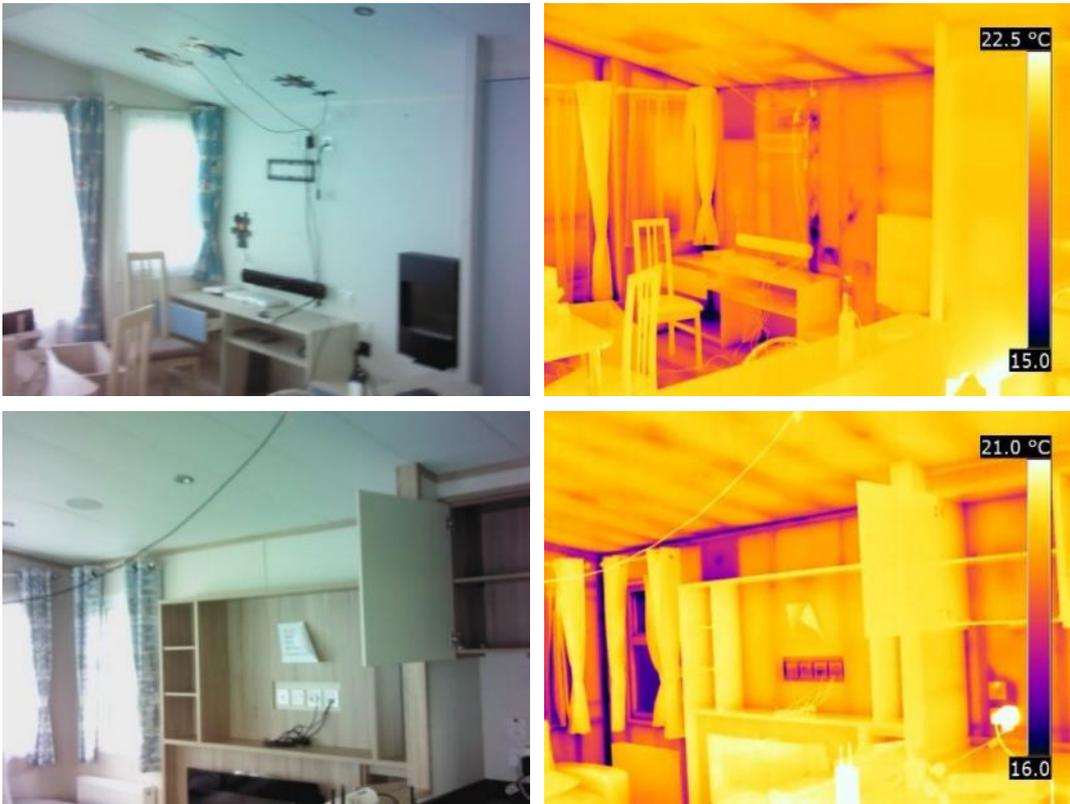
Figure 37 Thermal bridging at the external aerial fixing point.

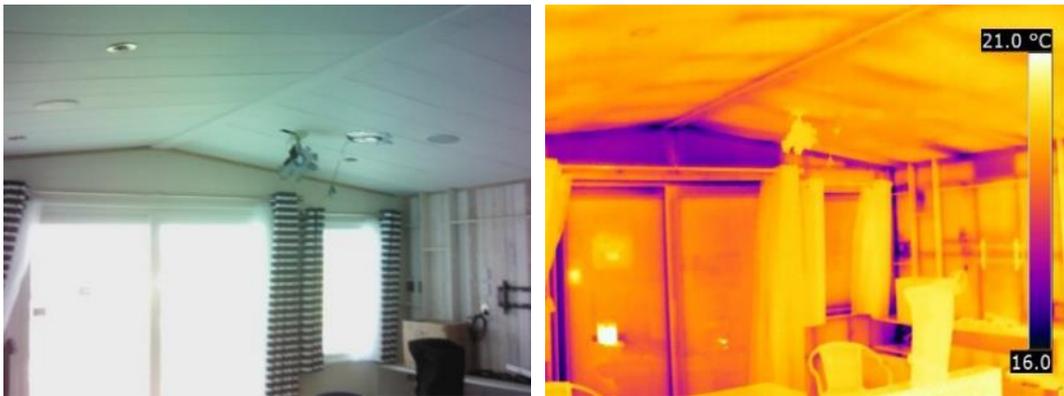
- At the external wall/floor junction in the master bedroom of caravan A (see Figure 38).
- Below the kitchen/living area window in caravan E (see Figure 39).
- Close to the ridge on the master bedroom end wall of caravan A (see Figure 40).
- At the sloping section of the kitchen/living area end wall in caravan A (see Figure 41).

**Figure 41** Thermal bridge at the sloping section of the kitchen/living area end wall in caravan A.

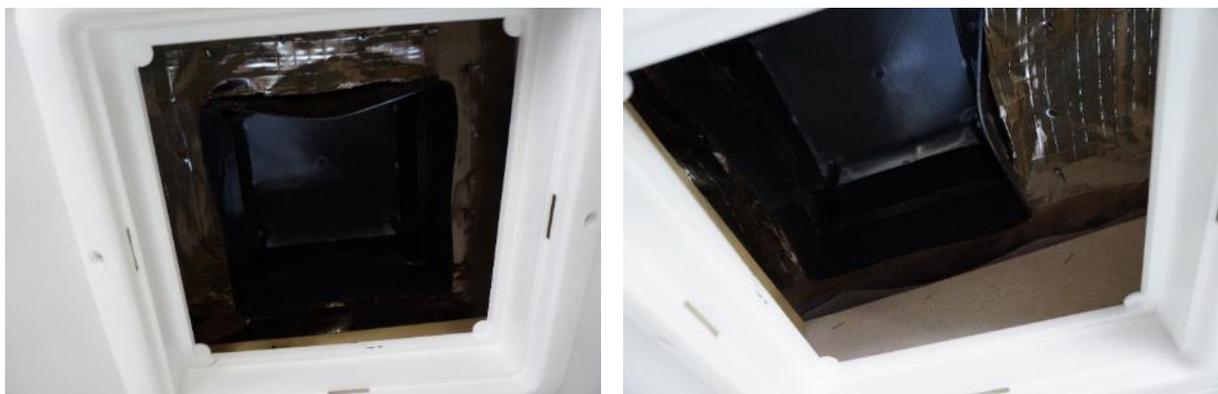
- 46 It is also clear from Figure 46 and Figure 48 that the *in situ* U-values measured at the external wall and roof anomalies are significantly higher than the design intent steady-state U-values. This can be attributed to the excessive thermal bridging that was observed at these locations. In the case of the external wall anomaly, the thermal bridging was caused by the insertion of additional timber at this location to enable the mounting of an external aerial. With respect to the ceiling anomaly, removal of the ceiling extract grille revealed either a lack of, or the omission of insulation surrounding the extract grille (see Figure 51).

Figure 51 Lack of insulation around ceiling extract vent in kitchen area of caravan B.

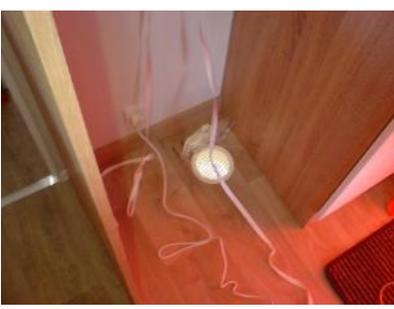
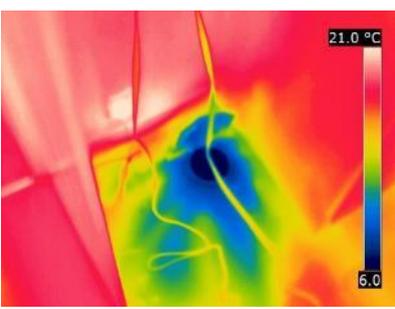
<p>Room – Lounge/Kitchen Span – 10 °C Excessive air leakage observed from under the fridge.</p>

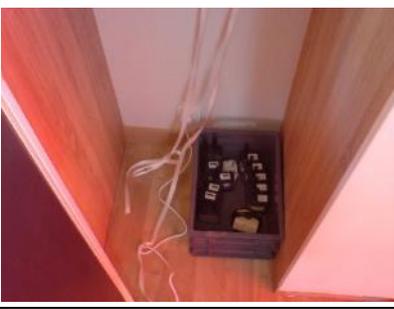
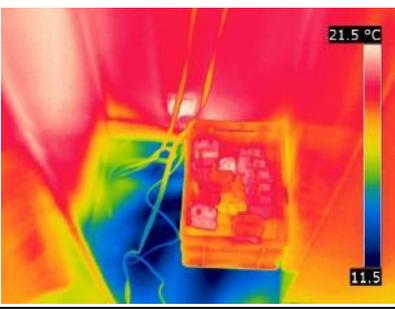
<p>Room – Lounge/Kitchen Span – 15 °C Fridge removed to reveal the temporary sealing below the fridge had become displaced.</p>
