Taylor Wimpey – Thermal Imaging Project

Site: Newton Farm
Cambuslang
G72 8QF

Visit Date: 13th November 2017

Plot(s): 268
267

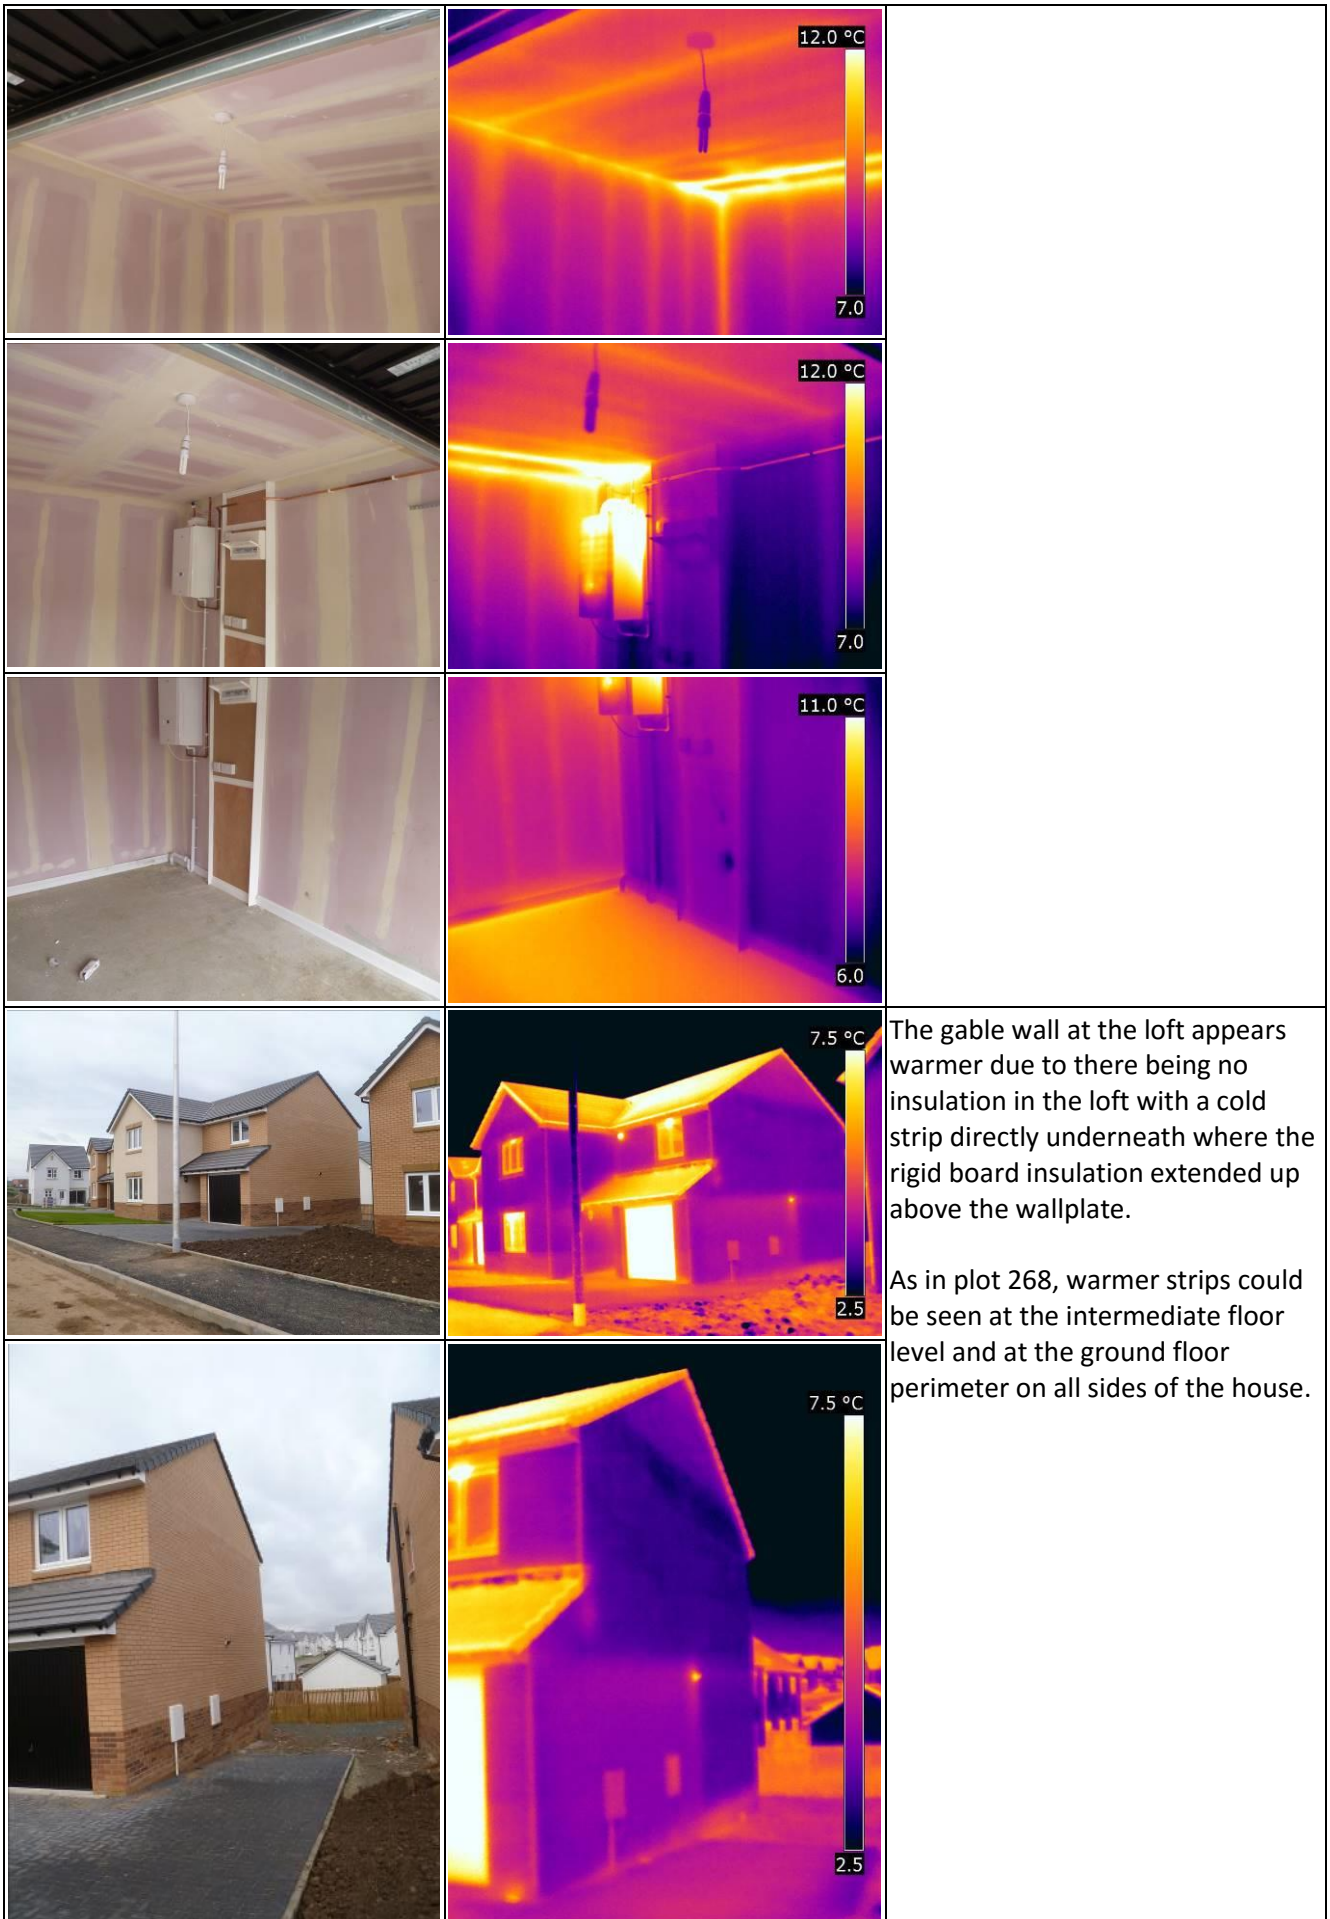
External - Under natural conditions

<p>The garage was open in this property so it was possible to also look inside and see the extent to which the boiler and heat transfer from inside the property were heating the garage. Again the garage appeared warmer than the rest of the house from the external imaging of the gable wall. The thermal gradient across the garage floor is only 3° but looks more severe due to the colder temperatures around it:</p>
		<p>The heating and hot water pipes from the boiler can be seen providing additional heat to the garage.</p>

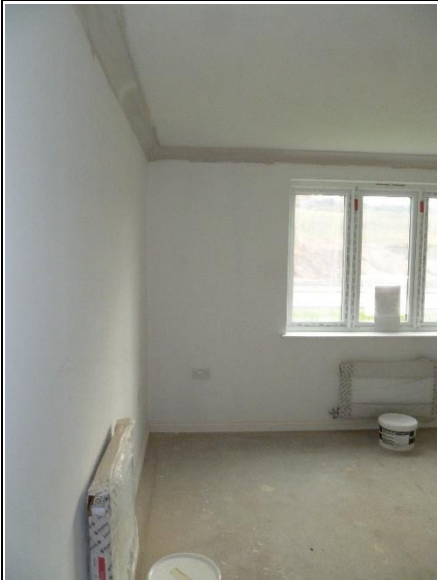
Lounge – Under natural conditions

With lower internal temperatures, and hence a lower internal/external temperature differential, similar issues were observed as in plot 268 but do not show up on the thermal images quite as strikingly.

The timber frames were again clearly visible, and some infiltration observed around the window and at the open pattress box on the external wall.

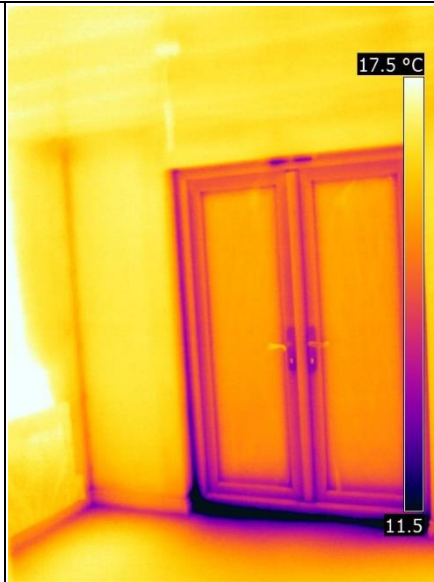
Dining – Under natural conditions

The patio doors appeared much like those in the Family/Breakfast Room in plot 268, with a very cold section at the infilled section at the threshold.

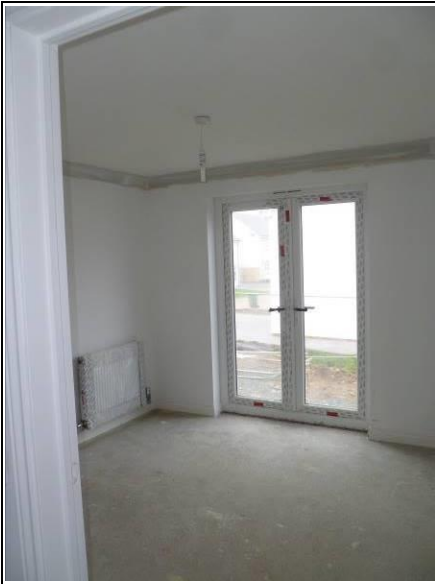
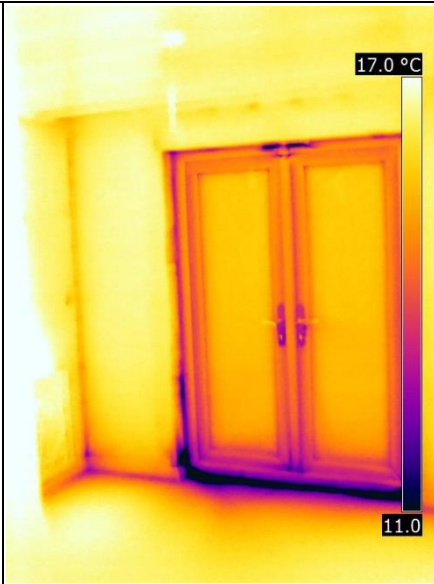
Dining – Under depressurisation

The patio doors themselves appeared to prevent air movement through them very well, with just a small amount coming through at the top and bottom of the doors; however there was more significant air movement around the frame and up into the walls on either side of the infilled section between the floor slab and door frame.

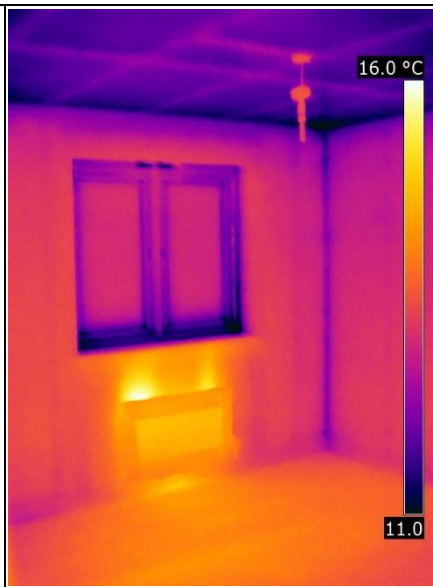
Bedroom 4 – Under natural conditions

As seen in previous bedrooms.
The pipework from the boiler to the cylinder cupboard retained heat much better than the rest of the upstairs without loft insulation installed.

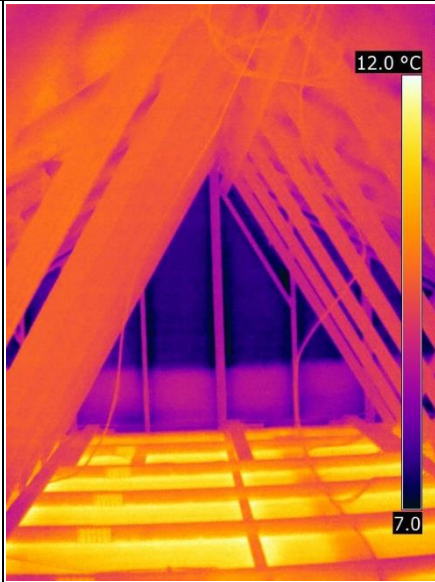
Loft – Under natural conditions

Looking towards the gable wall above garage the additional rigid board insulation on the outside of the timber frame is easily discernible:

Without insulation the loft itself is around 9~10°C, compared to ~4°C in plot 268.

Looking towards the opposing gable wall it is quite easy to see how some of the cold areas of ceiling observed in plot 268 came about. With so many nogs, braces and additional timbers, as well as electrical cabling, it is understandable that gaps between loft insulation and the ceiling will result, compromising the performance of the loft insulation.
