Taylor Wimpey – Thermal Imaging Project

Site: Pipers Green
 Crigglestone
 WF4 3HY

Plot(s): 288

House Type: PA48 – Shelford
 Full-fill Masonry, 2-Storey, 4-Bed Detached

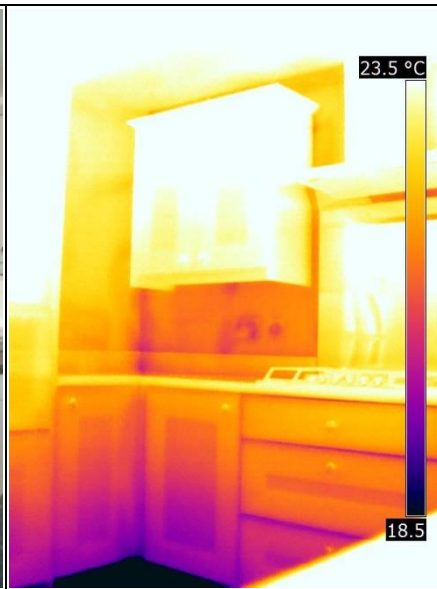
The floor surface at the patio doors does not change significantly under depressurisation, indicating again this is a bridging issue rather than to do with air movement. Air infiltration is an issue, with both direct infiltration from outside around the windows and indirect air movement around service penetrations, into the boxed-in service riser and into the intermediate floor void.

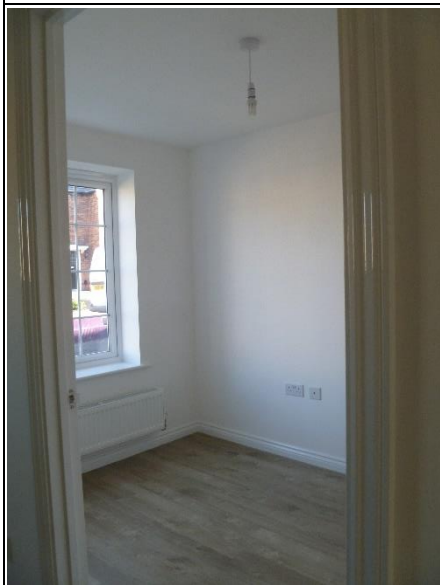
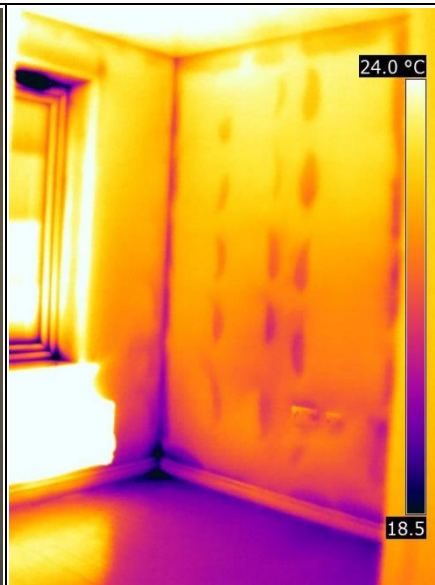
Study – Under natural conditions

Plasterboard adhesive dabs appear coolest where the utilities meter boxes are situated on the external walls. Some temperature stratification across the intermediate floor void can be observed, but it is unclear whether this is heat from the heating system pipework spreading toward the outside or cooler air from the gable wall junctions spreading inside.

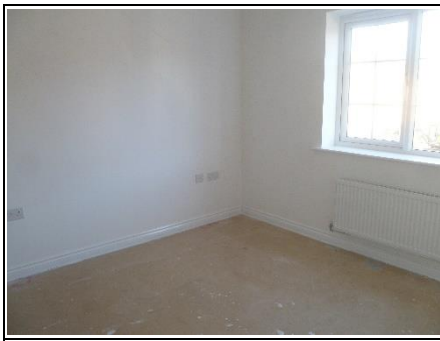
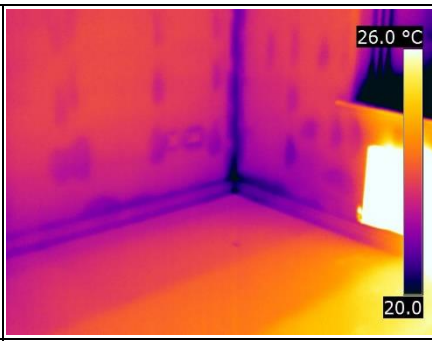
from direct contact with the ceiling are not excessive.

The stratification of temperatures of the intermediate floor void visible from below is also clear from above.

Thermal bridging at jambs/head/sill is also apparent but not excessive.

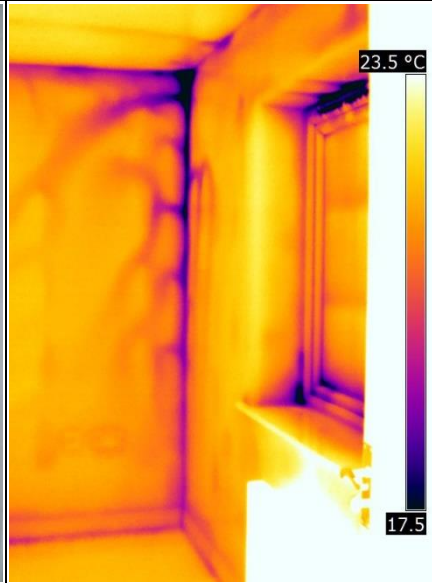
Bedroom 1 – Under depressurisation

Under depressurisation colder air can be seen being drawn in from the loft through ceiling penetrations, into the void behind the plasterboard dry lining and into some partition wall voids and emerging at places at the intermediate floor perimeter. The external wall at the ceiling perimeter, in particular, looks significantly colder than under natural conditions due to the change in air movement direction suggesting that air movement has a greater effect here than any thermal bridging or insulation discontinuity issues.

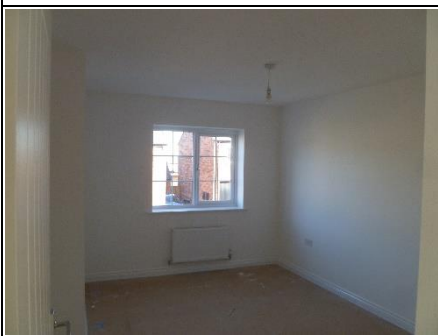
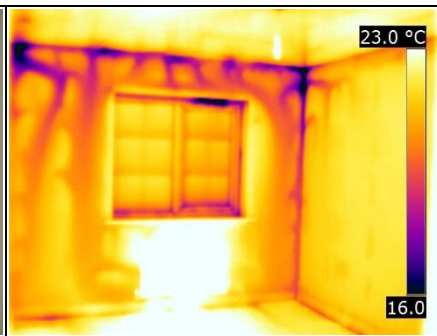
Bedroom 2 – Under depressurisation

As previously observed in other bedrooms.

Air can also clearly be observed being drawn down the junction of the partition wall with the external wall backing on to the service void in the En-suite, this void appear to link to the void behind the plasterboard on the external wall.

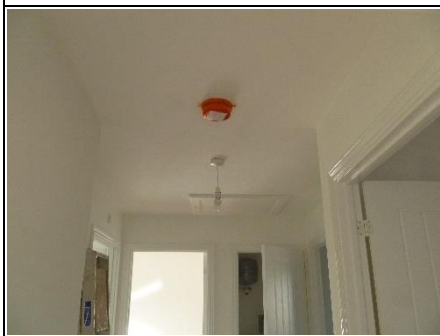
Landing – Under depressurisation

Under depressurisation air could be seen infiltrating directly around ceiling penetrations, most significantly around the loft hatch door. Air could also be seen entering the internal partition wall voids.

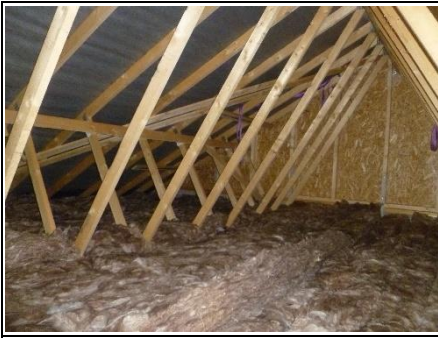
Direct solar on the SE gable hampered thermal imaging, but again no excessive thermal bridging beneath the spandrel panel was observed.

The loft insulation itself appeared from above to be laid particularly diligently; many commonly observed errors had been avoided, with insulation inserted into the small gaps and well placed around awkward truss angles and penetrations.
