Miles-Shenton, D (2018) Small Scale Forensic Thermal Imaging Study. Technical Report. Knauf Insulation.

# Taylor Wimpey – Thermal Imaging Project

Site: Hele Park  
 Newton Abbot  
 TQ12 6JN

Plot(s): 294 & 297

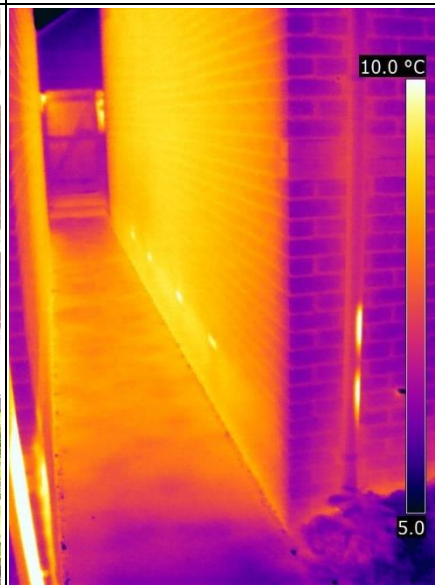
The North West facing gable wall was not exposed to solar, but is reflecting the adjacent heated property's gable wall rather than the clear sky so appears warmer in the thermal image.

Warmer strips are again visible at the ground floor perimeter and also at the intermediate floor level adjacent to the staircase.

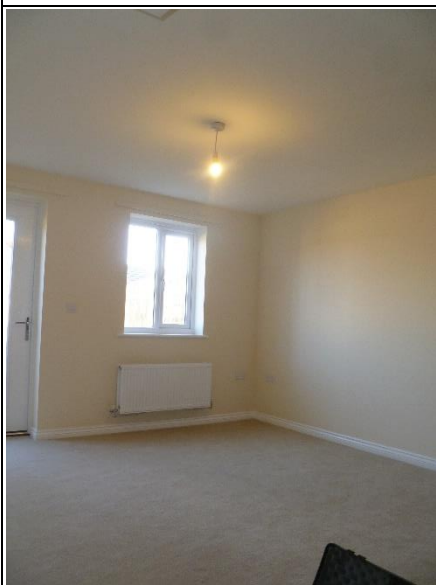
Under natural conditions there is a slight cooler area at the ground floor perimeter, a cold spot on the rear wall where the outside tap is sited, indications of air leakage around the back door (particularly around the 3 door hinges) and a very cold threshold.

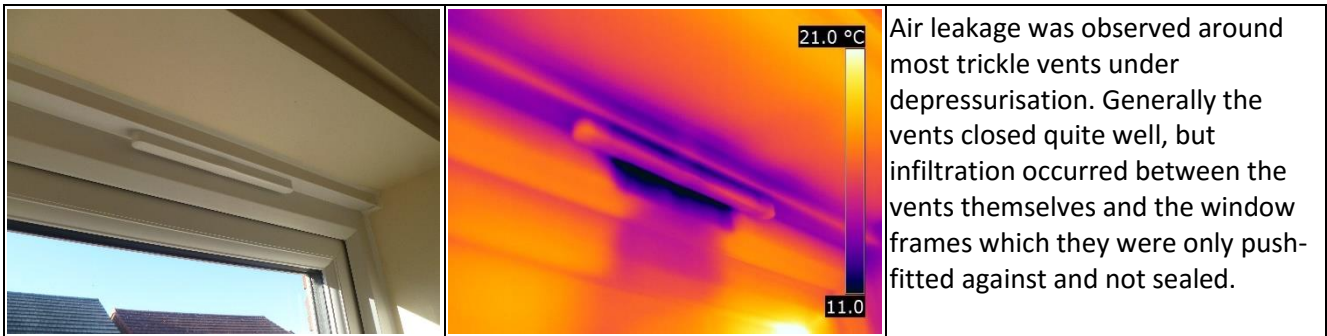
Air leakage was observed around most trickle vents under depressurisation. Generally the vents closed quite well, but infiltration occurred between the vents themselves and the window frames which they were only push-fitted against and not sealed.

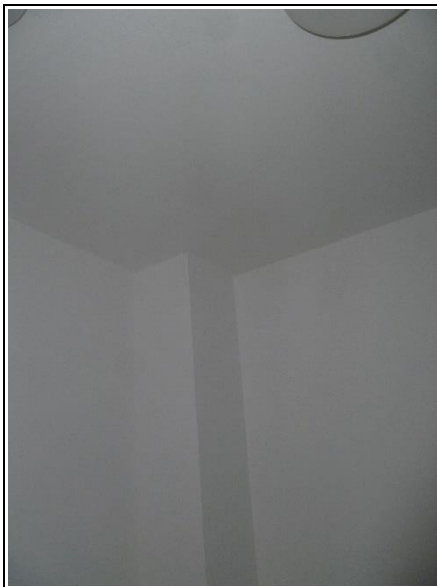
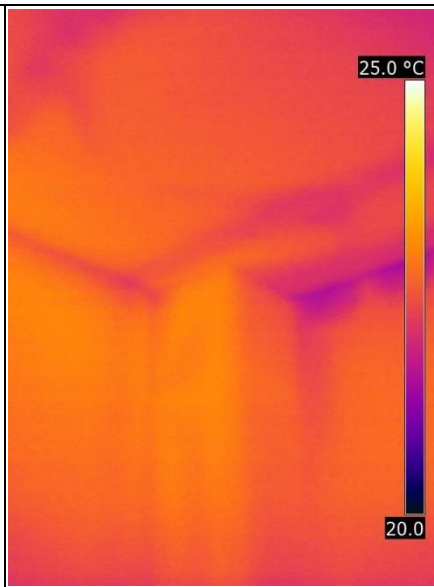
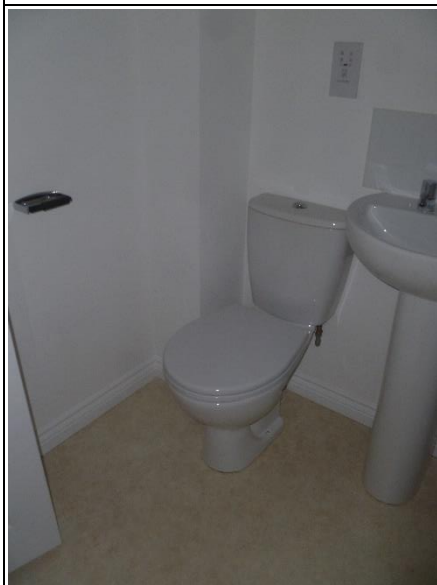
Much like the party wall in bedroom 2, the bathroom was pretty much isothermal throughout under natural conditions.

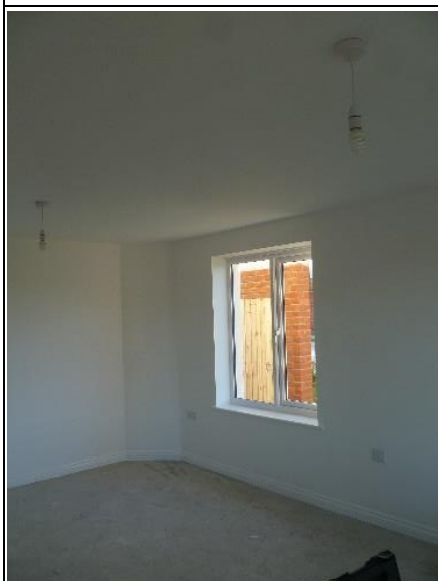
The infiltration observed under natural conditions was exacerbated under depressurisation on both the front elevation and on the South West facing gable wall.

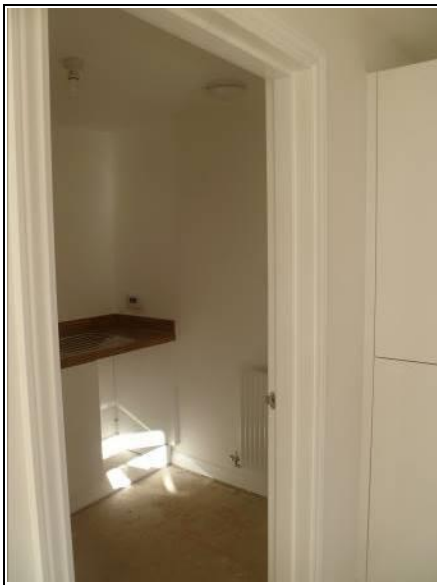
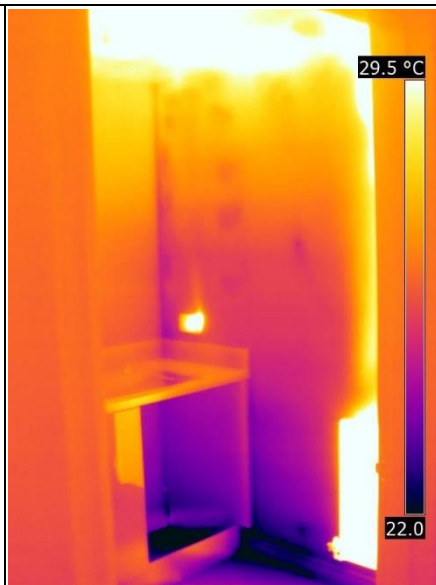
Utility – Under natural conditions

The floor wall junction backing on to the garage looked cooler, but as this room was warmer than the rest of the house it was hard to tell if this was significant.

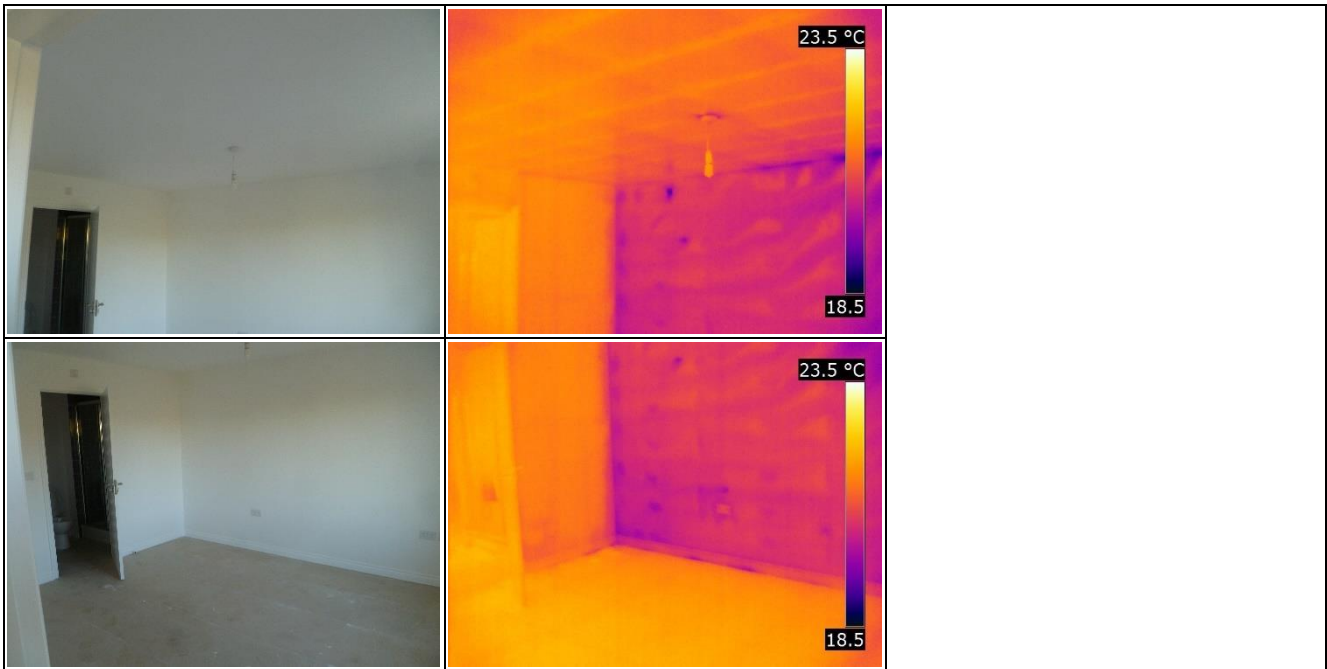
Under depressurisation air is again drawn into the dry lining void from around the windows, and also downwards from the eaves more so than from the gable. The gable wall appears to show air moving across through this void rather than downwards.

Again cold spots are seen where air appears to be coming through the blockwork.

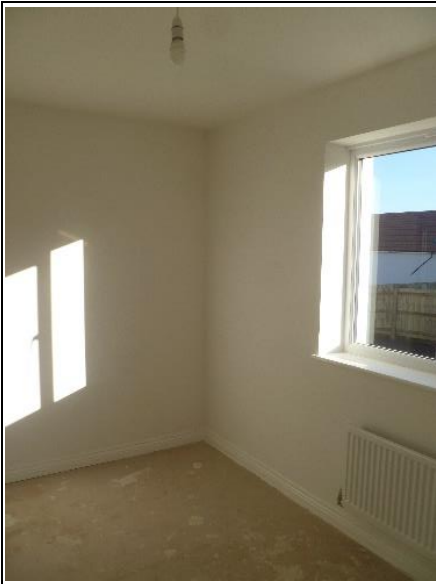
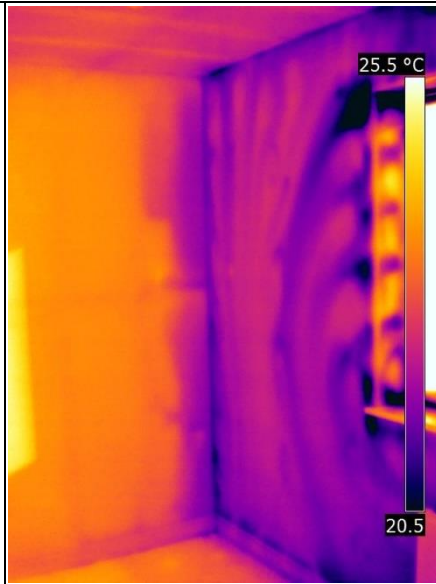
Again cold spots appear under depressurisation which coincide with mortar joints in the inner leaf blockwork.

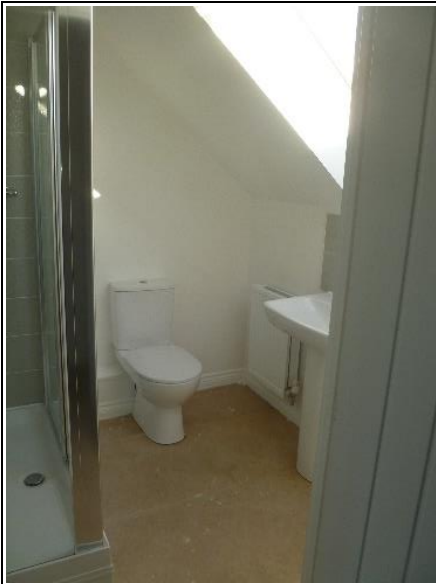
Under depressurisation air can be seen drawn in from above around the central light, and at the floor/wall junctions on both external facades. Again, there was too much direct solar to view most of the room.
