# Taylor Wimpey – Thermal Imaging Project

Site: Kingsbrook Place  
 Elmstree, Bury St Edmunds  
 IP30 9HA

Visit Date: 15<sup>th</sup> November 2017

Plot(s): 8 & 9

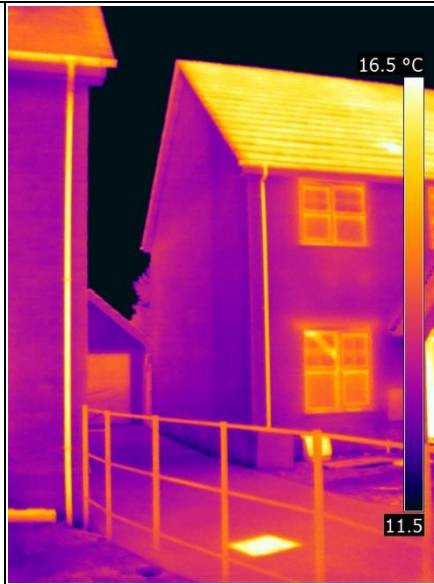
**Plot 8 External - Under natural conditions**

<p>There had been recent direct solar and drizzle prior to the external thermal survey for this property, affecting apparent surface temperatures. Even reducing the thermal image span to 2.5° to intensify any surface temperature differences little extra can be observed besides warmer areas of walls where radiators are positioned internally:</p>
		<p>The heat loss observed in the previous survey of this house type at the ground floor perimeter (Pipers Green, 08-Nov-2017) was not apparent on this site.</p>

Issues around meter boxes had been observed on this house type in a previous survey (Pipers Green), although then both utility boxes were positioned on the gable wall adjacent to the study rather than on the front façade; no significant issues were observed here.

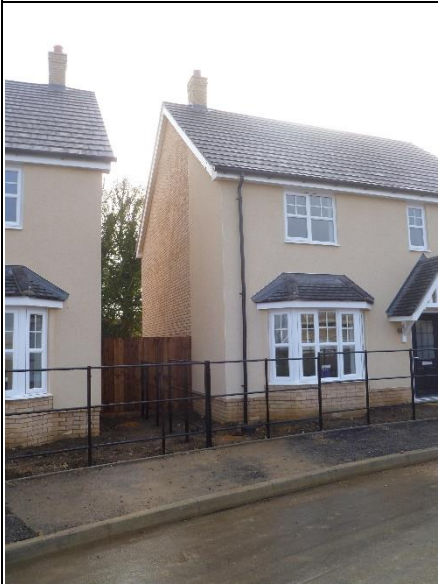
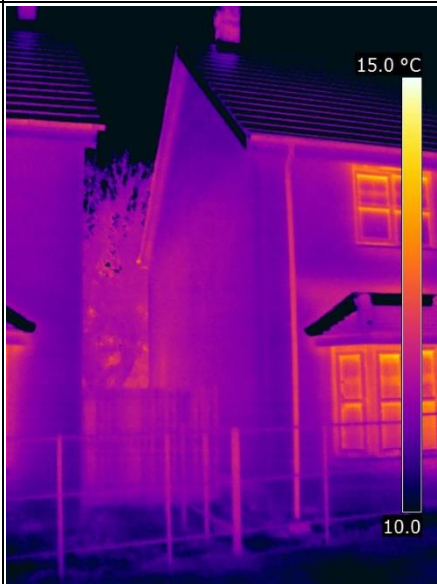
Plot 9 External - Under natural conditions

No significant thermal anomalies were seen from outside the property; slightly warmer areas were again observed adjacent to the bedroom radiators, the meter boxes showed no reasons for concern.

Warmer areas were observed on the external wall at window openings, particularly heads, and above the bay roof but these only appeared significant when manipulating the thermal image span to 2.5° to accentuate any differences:

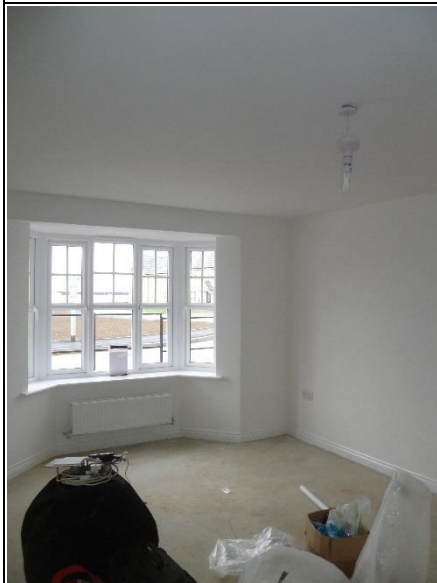
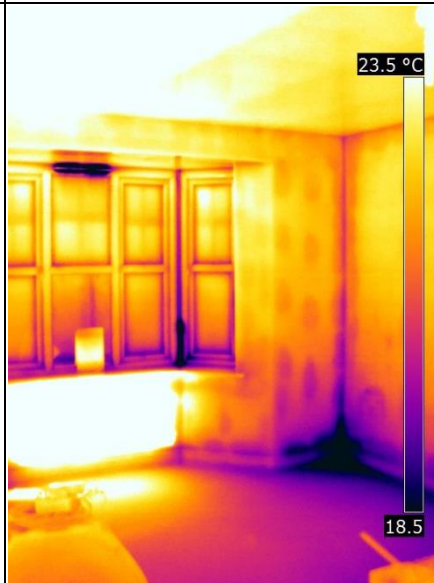
Plot 9 Lounge – Under natural conditions

Again, the external wall appeared marginally cooler at the bottom than was expected from just the natural temperature stratification in the room and the fact that the top part of the wall reflected the warm ceiling and the bottom part reflected the colder floor.

The bay roof again showed minor cooler spots along the lines of the external wall above. There was also some noticeable cold air infiltration at the bay window without any induced negative pressure.

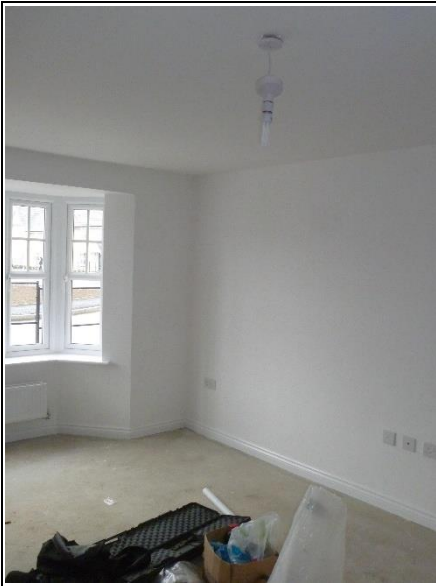
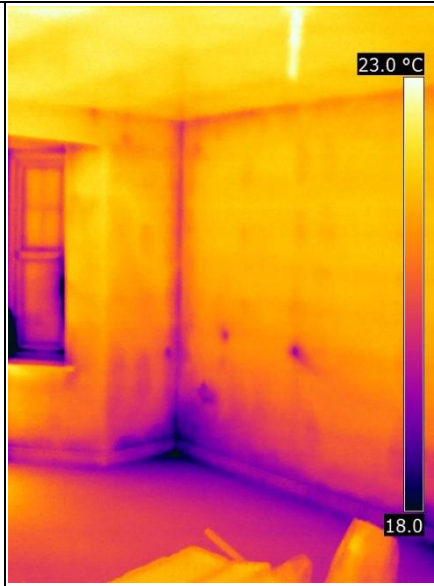
Plot 9 Lounge – Under depressurisation

There appear to be some spots on the external wall where air is being drawn into the void behind the plasterboard directly from the external wall cavity, most probably due to gaps in the mortar in the inner leaf blockwork. This air from the cavity appears to have cooled the void behind the plasterboard

enough to reduce the temperature differential between areas of dry lining directly over and away from the adhesive dabs. The line of the external wall is more distinct on the bay ceiling, as is air infiltration around the window and through/around the closed trickle vent.

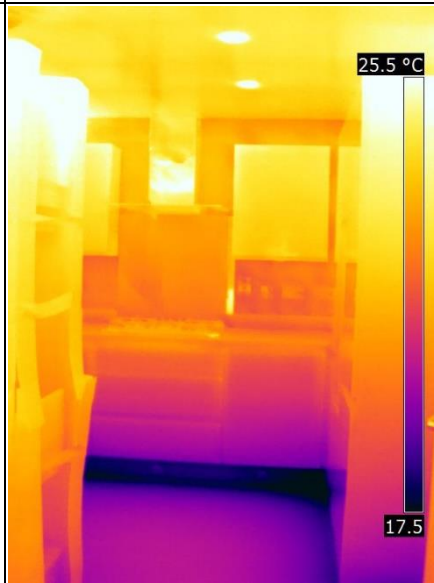
Plot 9 Dining / Kitchen – Under natural conditions

This was much as in Plot 8, but the floor to ceiling thermal gradient was more like that observed in the lounges. Another unexplained cold vertical strip, as seen in the lounge in plot 8 was visible to the right of the patio doors

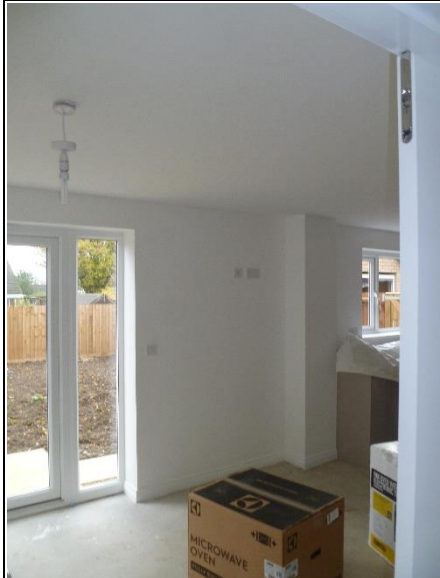
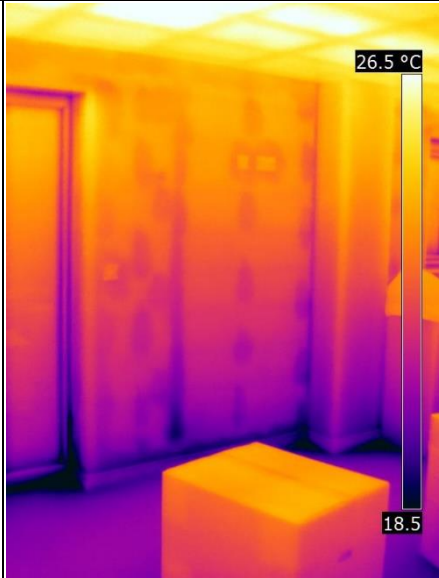
Plot 9 Dining / Kitchen – Under depressurisation

<p>Cold air infiltration was detected around some electrical service penetrations into the void behind the dry lining, including the outside light by the patio doors, and at the floor/ceiling junction by the boxed-in SVP.</p>
		<p>The patio doors appeared to allow a greater amount of air movement between the doors, between the doors and side lights and through/around the trickle vent.</p>

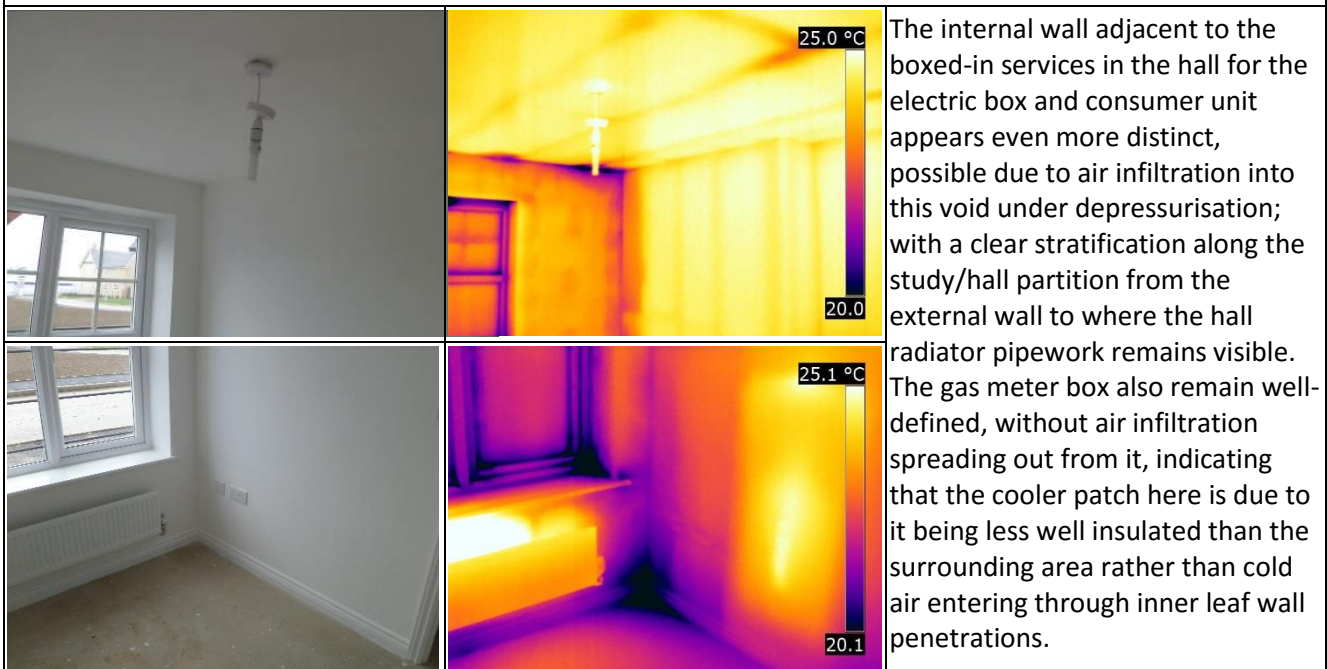
Plot 9 Study – Under depressurisation

The internal wall adjacent to the boxed-in services in the hall for the electric box and consumer unit appears even more distinct, possible due to air infiltration into this void under depressurisation; with a clear stratification along the study/hall partition from the external wall to where the hall radiator pipework remains visible. The gas meter box also remain well-defined, without air infiltration spreading out from it, indicating that the cooler patch here is due to it being less well insulated than the surrounding area rather than cold air entering through inner leaf wall penetrations.

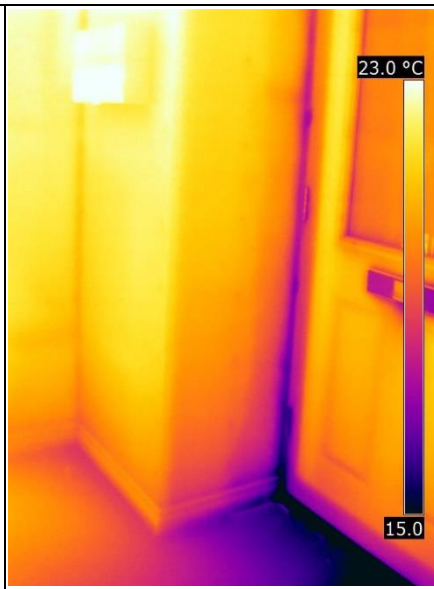
Plot 9 Hall – Under depressurisation

Under depressurisation it appears that colder air is being drawn into the boxed-in service void, as differing wall temperatures can be seen below the consumer unit.

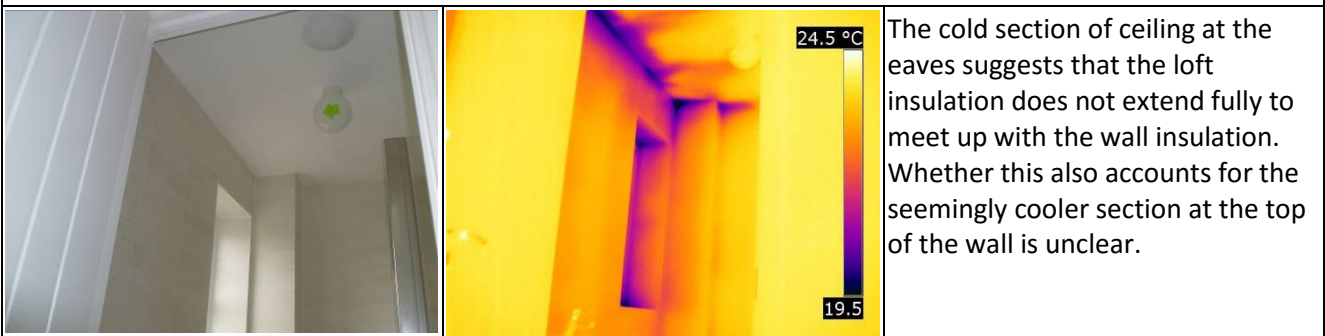
Plot 8 En-Suite – Under natural conditions

The cold section of ceiling at the eaves suggests that the loft insulation does not extend fully to meet up with the wall insulation. Whether this also accounts for the seemingly cooler section at the top of the wall is unclear.

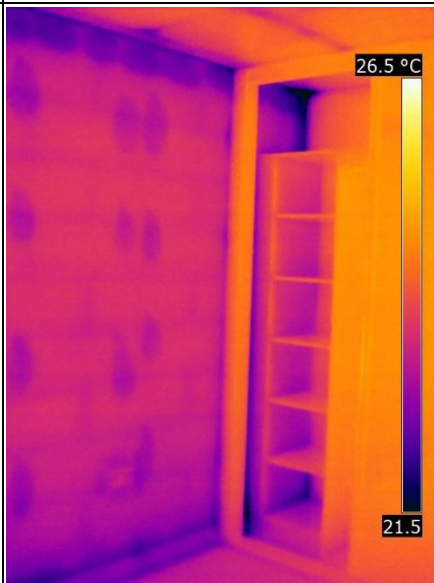
Plot 9 Bedroom 1 – Under depressurisation

Under depressurisation colder air can be seen being drawn down the dry lining voids on the external wall through gaps in the adhesive ribbons.

Cold air in the loft can also be seen tracking the cabling for the central ceiling light, emerging at the rose fitting.

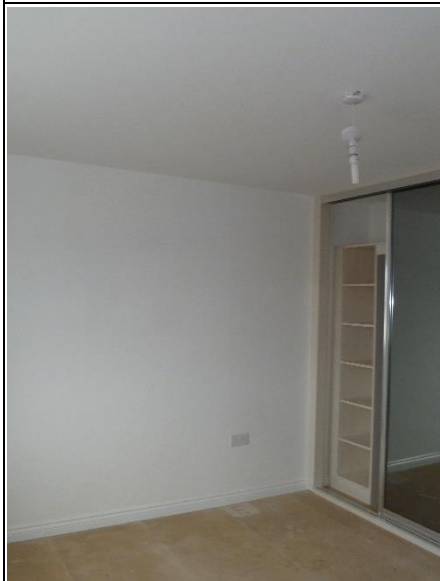
Plot 8 Bedroom 4 – Under natural conditions

The issues at the eaves observed in Bedroom 1 appear more pronounced at the rear of the dwelling. The window head reveal appears slightly cooler than the jamb reveal.

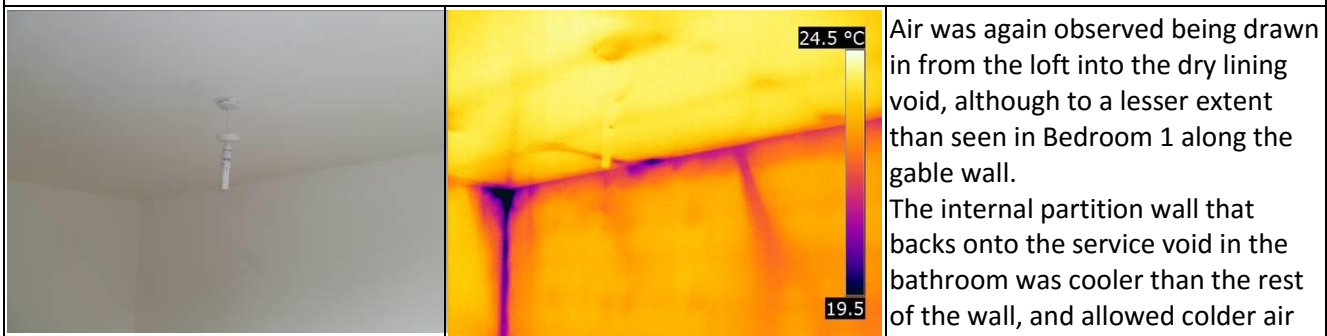
Plot 9 Bedroom 4 – Under depressurisation

Air was again observed being drawn in from the loft into the dry lining void, although to a lesser extent than seen in Bedroom 1 along the gable wall. The internal partition wall that backs onto the service void in the bathroom was cooler than the rest of the wall, and allowed colder air

to enter the dry lining void along its full height and air to emerge around the floor/wall junction at the bottom.  
Direct air infiltration at the window was also clear.

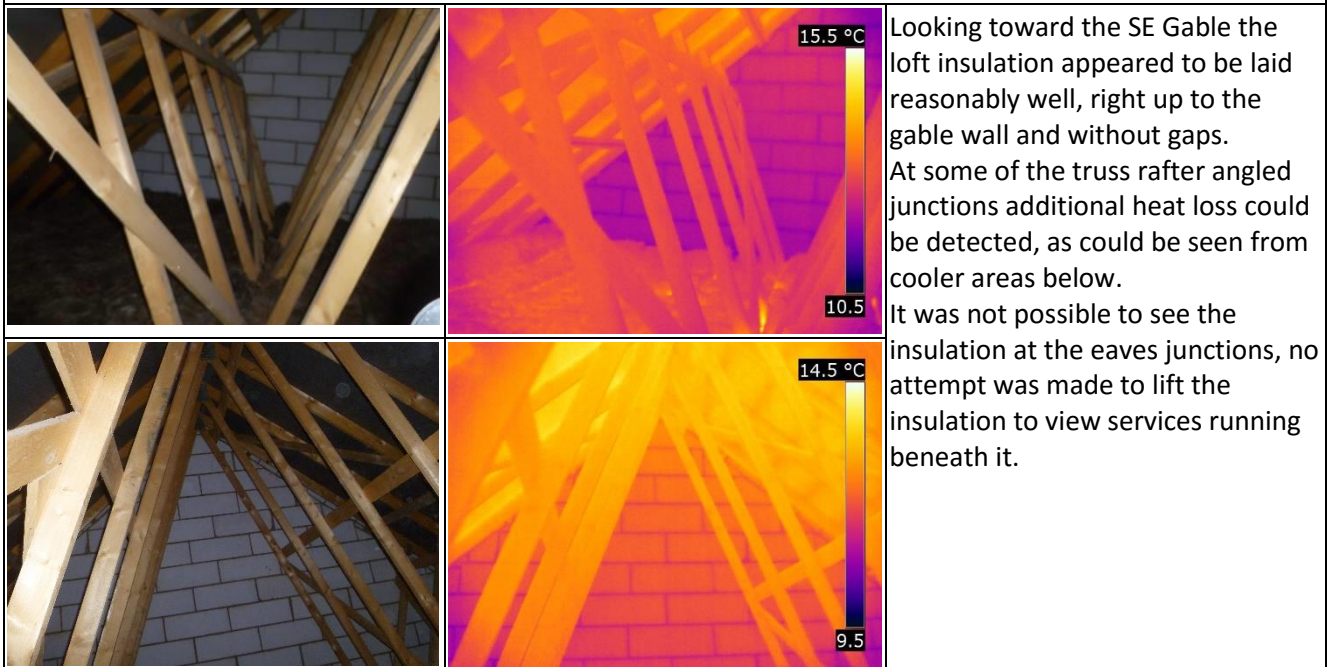
Plot 9 Loft – Under natural conditions

Looking toward the SE Gable the loft insulation appeared to be laid reasonably well, right up to the gable wall and without gaps. At some of the truss rafter angled junctions additional heat loss could be detected, as could be seen from cooler areas below. It was not possible to see the insulation at the eaves junctions, no attempt was made to lift the insulation to view services running beneath it.
