## **Condensation Risk – Impact of Improvements to Part L and Robust Details on Part C**

## **Interim report number 7: Final report on project fieldwork**

**Malcolm Bell, Melanie Smith & Dominic Miles-Shenton**  
Buildings and Sustainability Research Group  
Leeds Metropolitan University

## Interim report to ODPM Building Regulations Division under the Building Operational Performance Framework

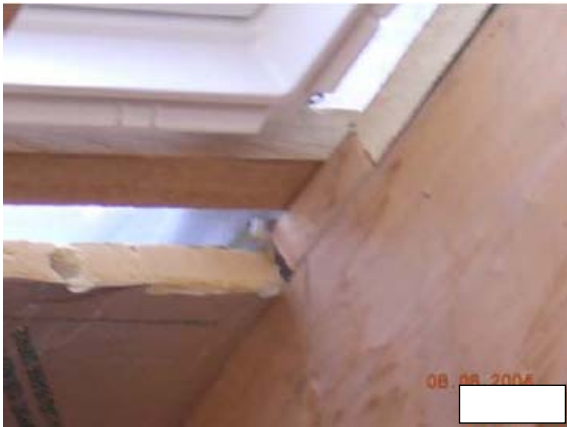
82. Although, as with other site observations, it is hard to know for certain if defects will be identified and rectified by site quality control, the observations made during visits suggested that the insertion of small strips of insulation and the accurate cutting of boards around rooflight openings was not always done with the level of care required. Figure 3.62 shows a typical gap in external insulation and figure 3.63 shows a framing board at the “sill” of the rooflight, which, when investigated proved to have no insulation in the space behind nor evidence of an air/vapour barrier. This would certainly give rise to airtightness problems and poor thermal performance, both of which may lead to increased condensation risk. A number of observations of the space available for lining insulation to the sides of rooflight openings suggested that achieving the required resistance ( $R \geq 0.34 \text{ m}^2\text{K/W}$ ) would be difficult especially if decorative linings were also to be applied. As a general observation missing insulation (particularly when small strips are required) around roof lights was a common occurrence on most sites.

Figure 3.62 Gaps in external insulation around

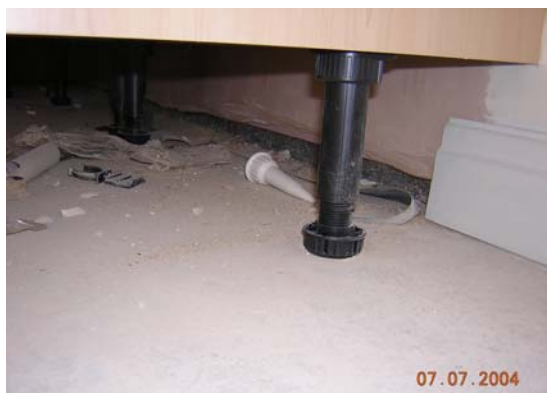
Figure 3.82 Plasterboard finish stopped short of the floor under kitchen fittings.
