Ogunmakinde, O and Egbelakin, T and Omotayo, T and Sojobi, A (2023) Seismic vulnerability and inventory of at-risk elements in the wine industry: Auckland region case study. Structures, 58. pp. 1-14. ISSN 2352-0124 DOI: <https://doi.org/10.1016/j.istruc.2023.105346>

Seismic vulnerability and inventory of at-risk elements in the wine industry: Auckland region case study

Olabode E. Ogunmakinde^a, Temitope Egbelakin^b, Temitope Omotayo^{c,*}, Adebayo Sojobi^d

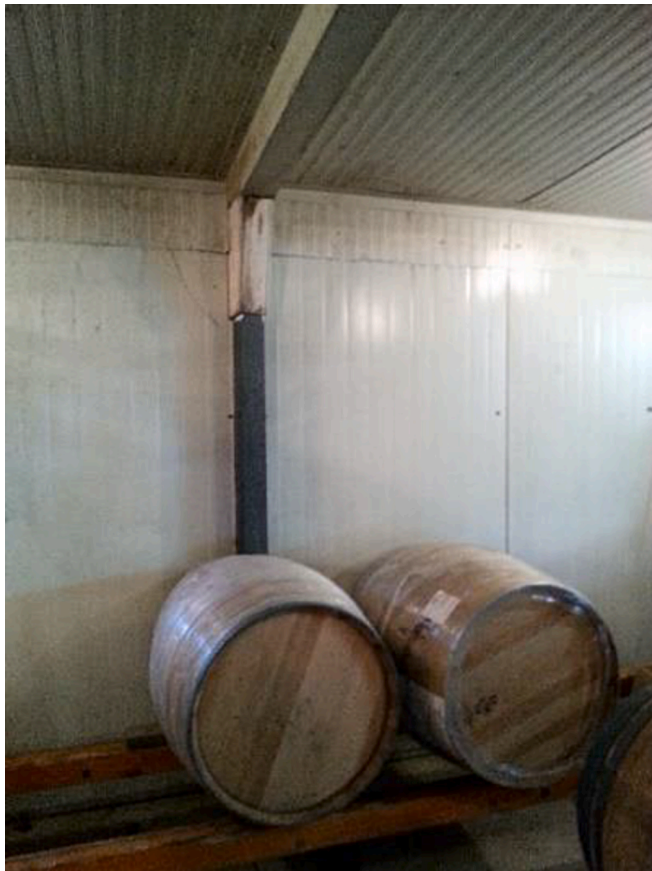
Fig. 4. Winery (w) 02 interior wall.

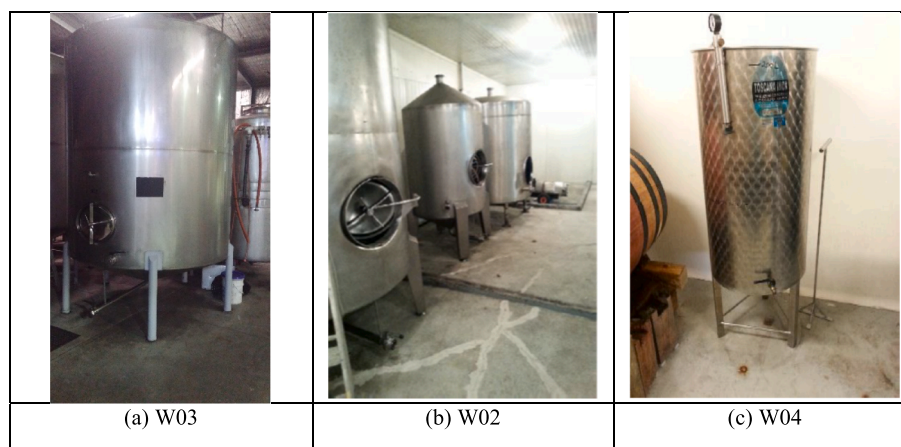
Fig. 5. Slender and small legged tanks used in wineries (W).

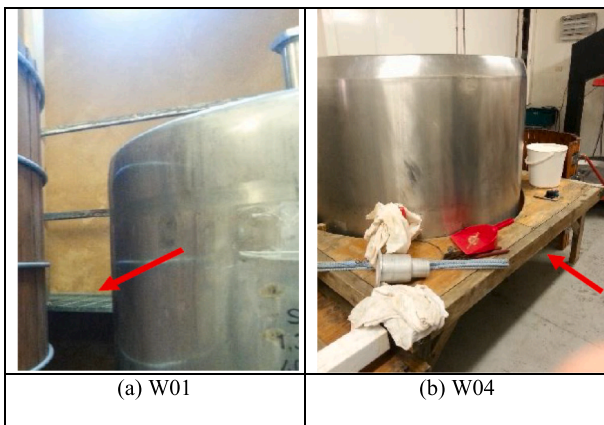
The extent of damage is determined by the method of support, according to Dizhur et al. [11]. As a result, the metsupport method was used to assess the vulnerability of the catwalks. Self-supported catwalks are more seismically resilient than tank-supported catwalks. Damage to catwalks was typically caused by tank-supported systems, including damage to the plates welded to the sides of the tank's wall. Concerning the vulnerability assessment for the catwalks, it is challenging to determine the precise level of vulnerability because 48% of the wineries

Fig. 13. Catwalks used in wineries.

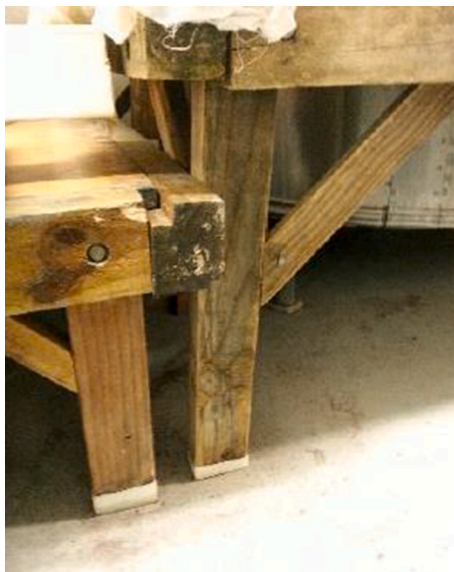
Fig. 14. Legs and top of catwalk used in W04.

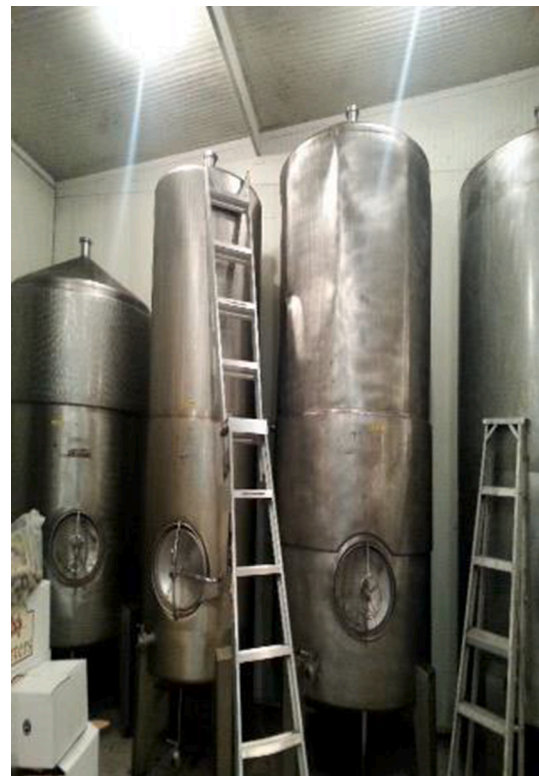
Fig. 15. Ladders used to access top of storage tanks.

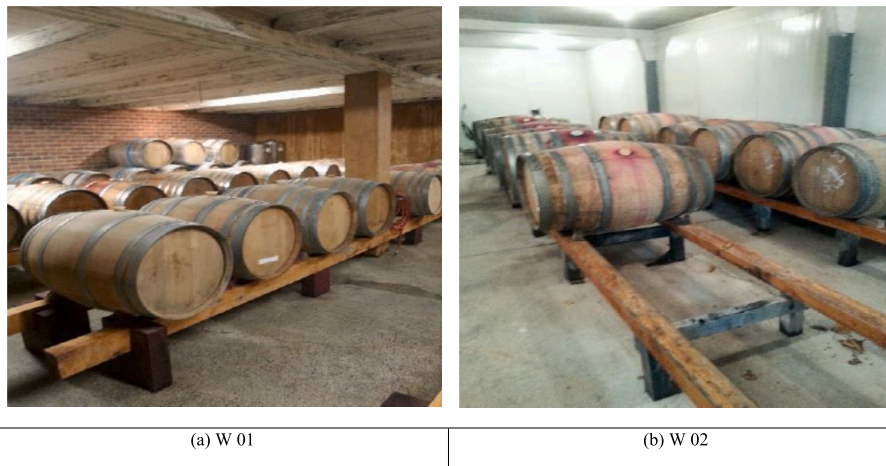
Fig. 16. Layout of barrel racks.

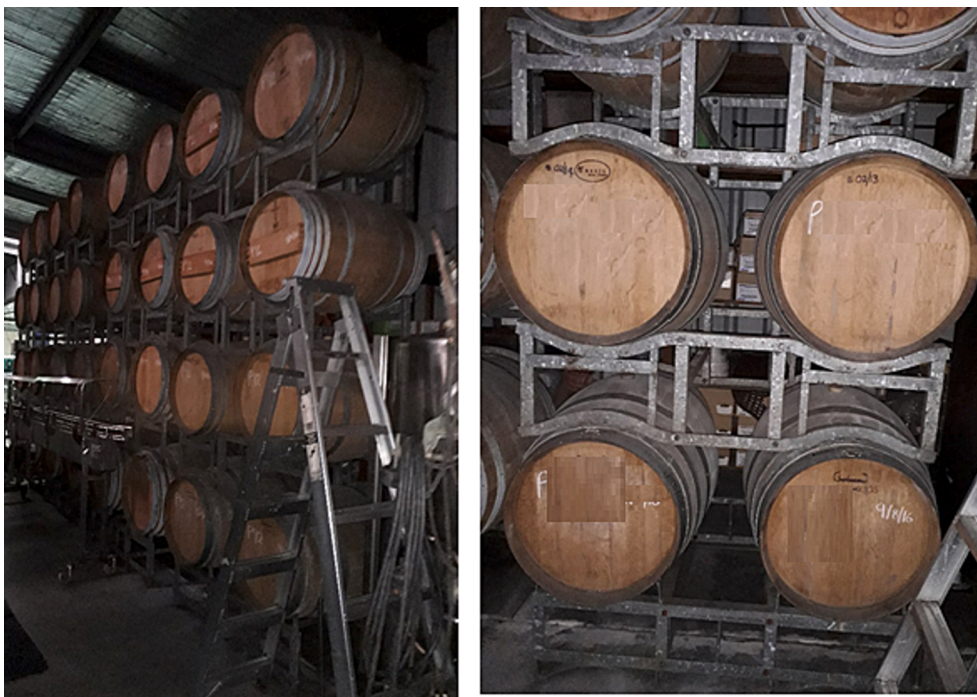
Fig. 17. Racking system used in the winery 03.
