Glew, DW and Smith, M and Miles-Shenton, D and Gorse, C (2017) Assessing the quality of retrofits in solid wall dwellings. International Journal of Building Pathology and Adaptation. ISSN 2398-4708  
DOI: <https://doi.org/10.1108/IJBPA-05-2017-0022>

**Assessing the quality of retrofits in solid wall dwellings**

The purpose of the paper is to provide a detailed appraisal of the quality of domestic retrofits.

This paper presents the results of technical surveys on 51 retrofits undertaken before, during and after the retrofits.

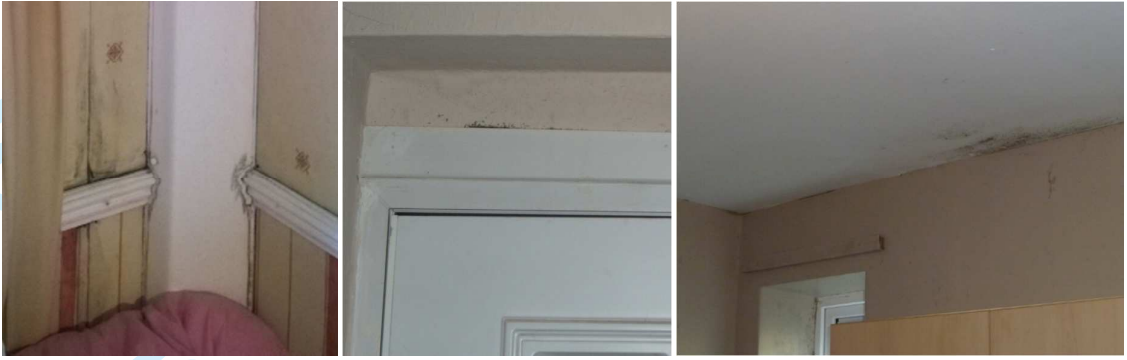
Figure 1 suggests 72% of the properties had damp issues prior to installation, an example of which is shown in Figure 2. Mould was observed to generally be removed prior to applying IWI, though not for EWI. Remedial action to address causes of damp was not seen to be systematic and only observed in the 'deep' retrofits. Table 3 describes the types of issues observed.

Figure 2 Examples of moisture issues observed prior to retrofit

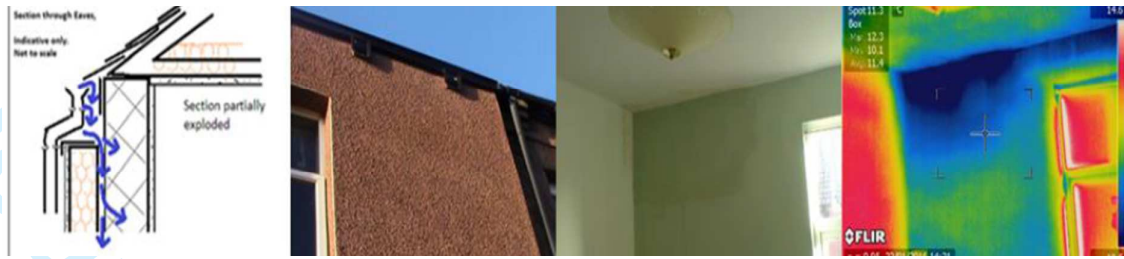
In addition, product or process failure can cause moisture problems (e.g. leaks). This was identified in one of the post retrofit surveys; rain water ingress occurred due to inadequate sealing between the EWI top capping and the wall causing damp patches, as shown in Figure 3.

Figure 3 Photographic and thermographic observation of damp and schematic to show route of water ingress behind EWI

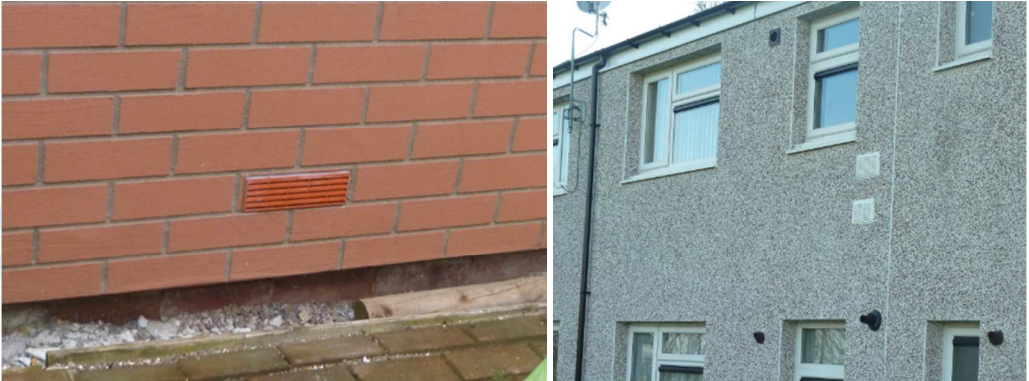
Figure 4 Maintenance and addition of ventilation post EWI retrofit

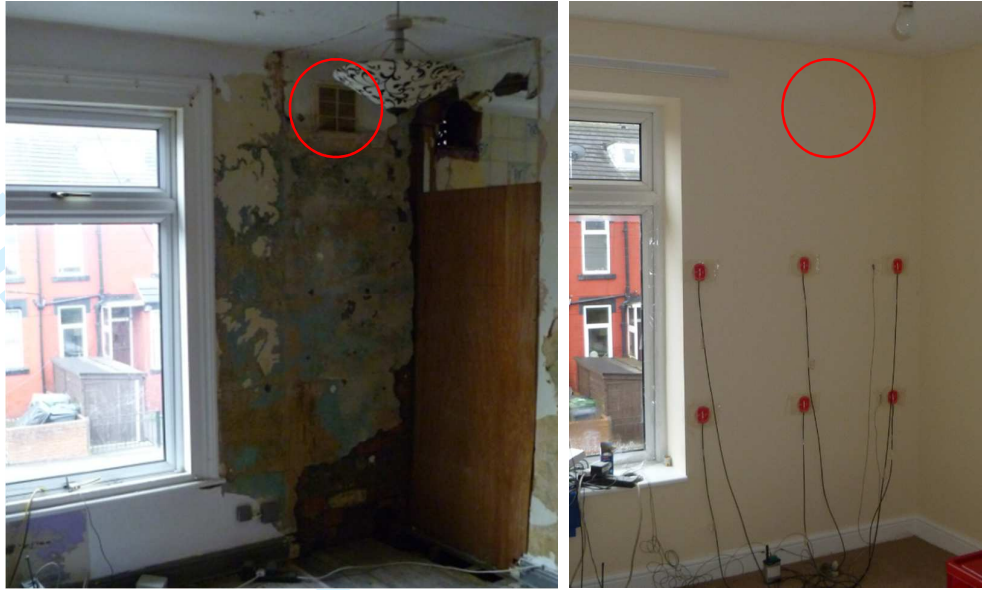
Figure 5 Air brick covered over after IWI installed

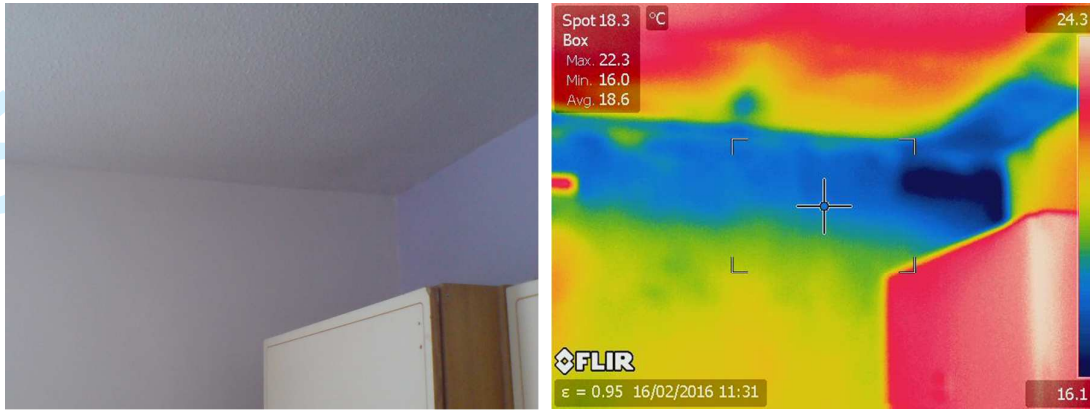
53  
54 Only where a dwelling was undergoing a 'deep' retrofit, and was void for a period of time, were  
55  
56 complimentary insulation measures installed or other existing measures checked for effectiveness.  
57  
58 Figure 6, shows an example of inadequately maintained loft insulation that was not rectified by the  
59  
60

installers as part of the EWI retrofit. A cold strip at the eaves is also evident here, representing missing insulation from the retrofit, this phenomenon will be discussed later.

Figure 6 Incomplete insulation at loft and eaves after EWI retrofit

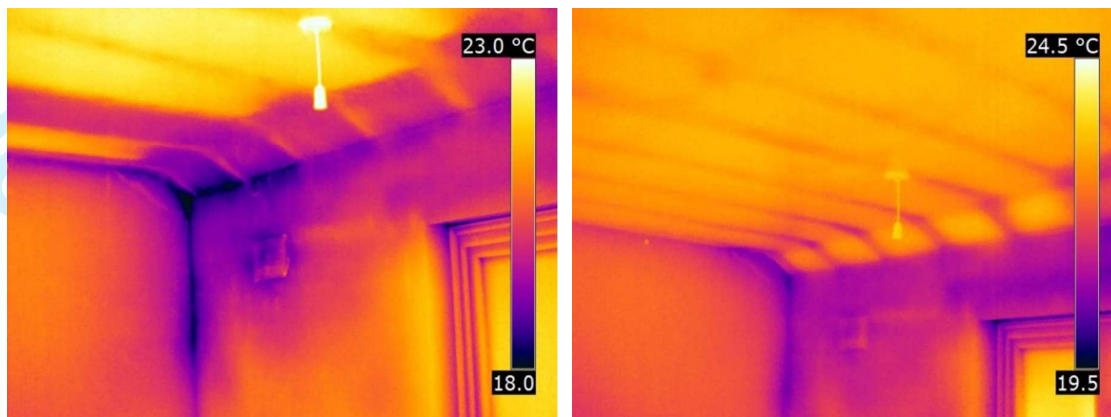
Another example of a lack of consideration of adjacent elements is shown in Figure 7 illustrating raked eaves (sloping roof detail at the external wall junction) where a significant thermal bridge only emerged once the wall and loft were insulated, as prior to retrofit the raked eaves and external wall displayed similar surface temperatures. A solution to this one particular installation was recommended by the research team and a standard mineral wool cavity wall batt was inserted from inside the loft between the rafters to insulate this 'forgotten' area while still allowing airflow over the top to ensure the loft space remained adequately ventilated. As can be seen in Figure 7, this appeared to resolve the problem and the final solution was separately as part of this research project eventually calculated to no longer pose a condensation risk according to BR 497 (Ward and Sanders, 2007).

Figure 7 Raked eaves without (left) and with (right) mineral wool cavity batt inserted

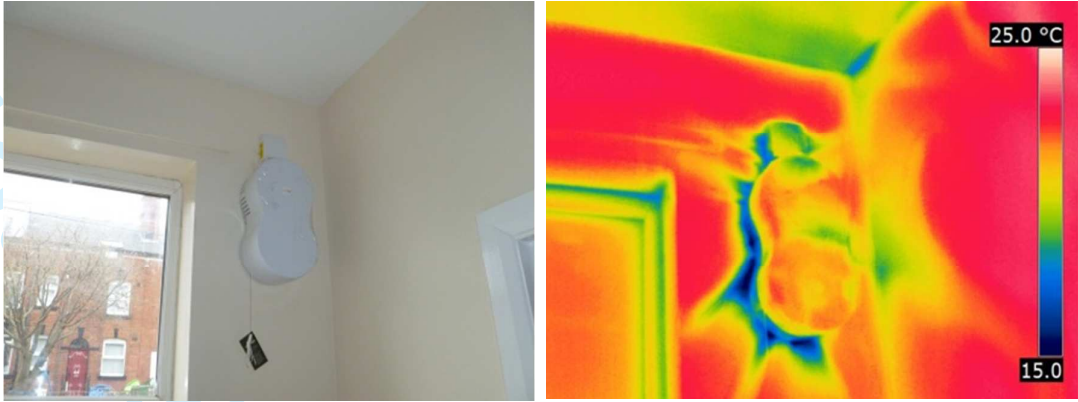
One common observation was a lack of sealing around breaches in the air barrier, in particular around service penetrations as shown in Figure 8. Another issue shown in Figure 9 was inadequate and inconsistent contact between EWI and the external wall surface, which could allow air to circulate behind the insulation, reducing the EWI's effectiveness, as had previously been observed on other projects (Siddall, 2009).

Figure 8 Inadequate sealing of penetrations (extract fan) through IWI seen during depressurisation

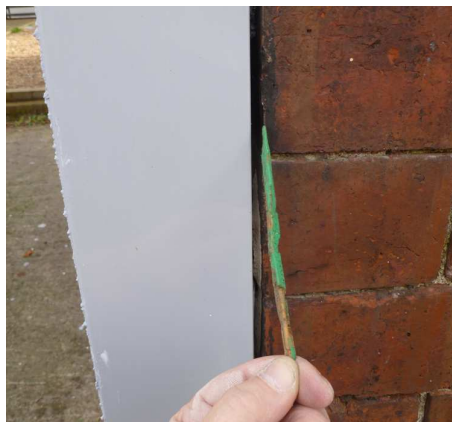
Figure 9 Poor contact of EWI and brickwork

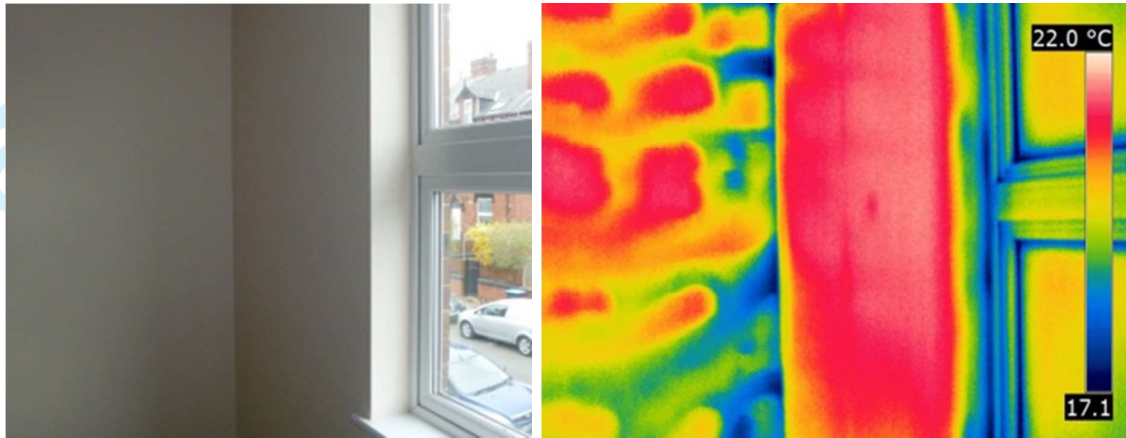
In some instances, thermal bypasses (where warm air is able to escape through gaps in the fabric) will not be visible; Figure 10 shows a solid wall that had an embedded bypass which permitted external air to seep into the dwelling. This was not rectified by the IWI since dot and dabs were used, i.e. the insulating batts were not bonded and sealed to the external wall. This is likely to reduce the overall effectiveness of the retrofit, and allow moist air to travel into this relatively colder cavity behind the insulation, and foster potential interstitial condensation.

Figure 10 Thermal bypass showing external air entering the dwelling behind the IWI on the external wall under dwelling depressurisation and moving into the void behind the plasterboard on the adjacent internal partition wall.

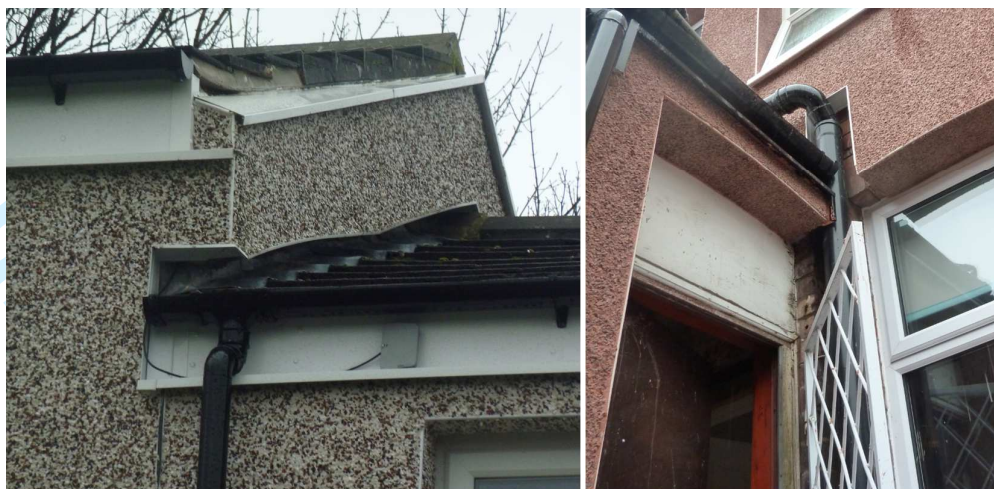
PAS2050 requires that complex details should be supported by detailed drawings for installers, yet this study found that in 64% of cases installers adapted installations on-site without reference drawings. These are listed in Table 7 and some examples are shown in Figure 11.

Figure 11 Unusual bespoke EWI detailing solutions designed onsite

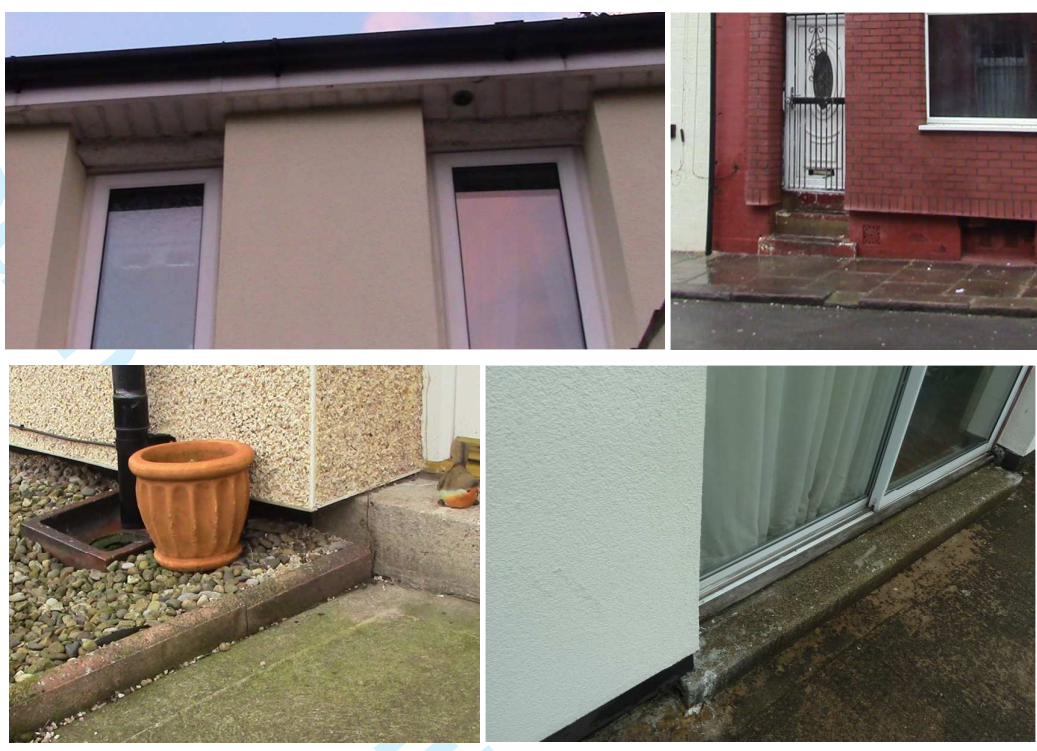
Figure 12 Common EWI details causing thermal bridging

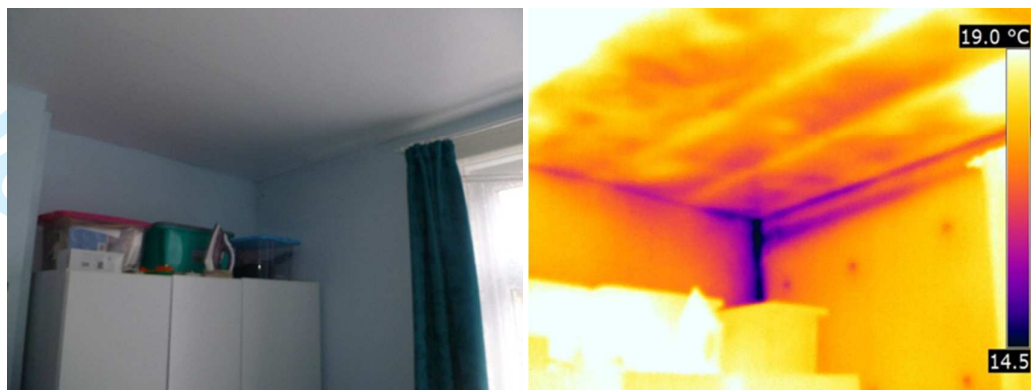
Figure 13 IWl does not extend into intermediate floor void

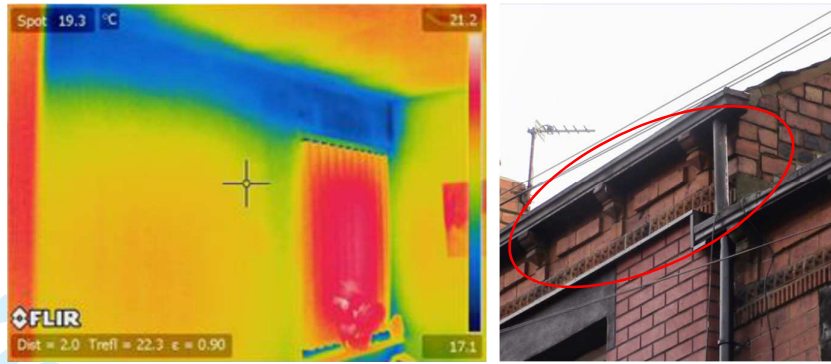
24 Another regularly repeated design problem was observed where there was architectural detailing  
25 around the eaves or where the rainwater gutter system would be in the way of the EWI unless the  
26 roof was extended outwards. This resulted in EWI not being fully installed up to the eaves, as shown  
27 in Figure 14 (and also in Figure 6), this resulted in a strip of uninsulated masonry, introducing a long  
28 thermal bridge, at what may already be considered an exposed interface at risk of condensation.  
29  
30  
31  
32  
33  
34  
35  
36  
37

39  
40 Corbelling, and other details like this, are relatively common on pre-war solid wall properties built  
41 prior to the 1940's and so this omission may be replicated across the country on a relatively large  
42 scale, indeed it can also be seen in the properties in Figure 4 and has previously been observed in  
43 the literature (Glew et al., 2017, Hopper, 2012).  
44  
45  
46  
47  
48  
49

Figure 14 EWI commonly missing at eaves

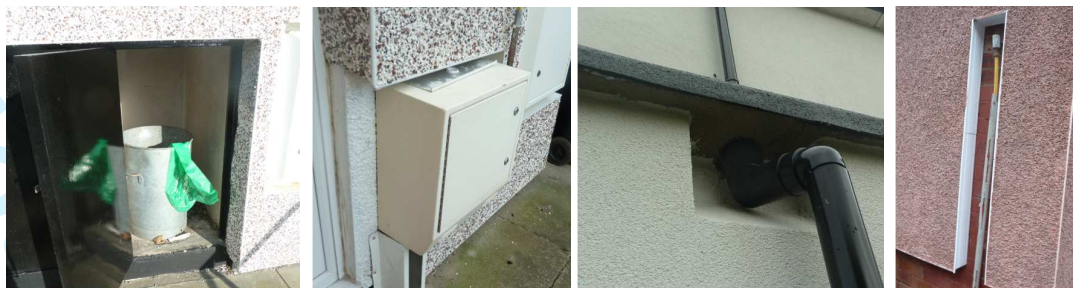
external lights, drainage pipework and fences. According to PAS2030 each of these items should be remounted after the EWI is fitted; however, this was not always undertaken (as shown in Figure 15.), potentially causing adverse thermal bridging. It was not clear why this was the case, for example, a lack of understanding, confusion over responsibilities of installer roles, or cost. It is important to note that in some instances externally mounted features were observed to have been appropriately integrated into the design as in.

Figure 15 EWI discontinuities at internal bin store and wall mounted gas meter and pipework
