**Assessing the quality of retrofits in solid wall dwellings**

Journal:	<i>International Journal of Building Pathology and Adaptation</i>
Manuscript ID	IJBPA-05-2017-0022.R1
Manuscript Type:	Original Article
Keywords:	Domestic energy efficiency, Moisture, Policy, Retrofit, Survey, Unintended consequences

The purpose of the paper is to provide a detailed appraisal of the quality of domestic retrofits.

This paper presents the results of technical surveys on 51 retrofits undertaken before, during and after the retrofits.

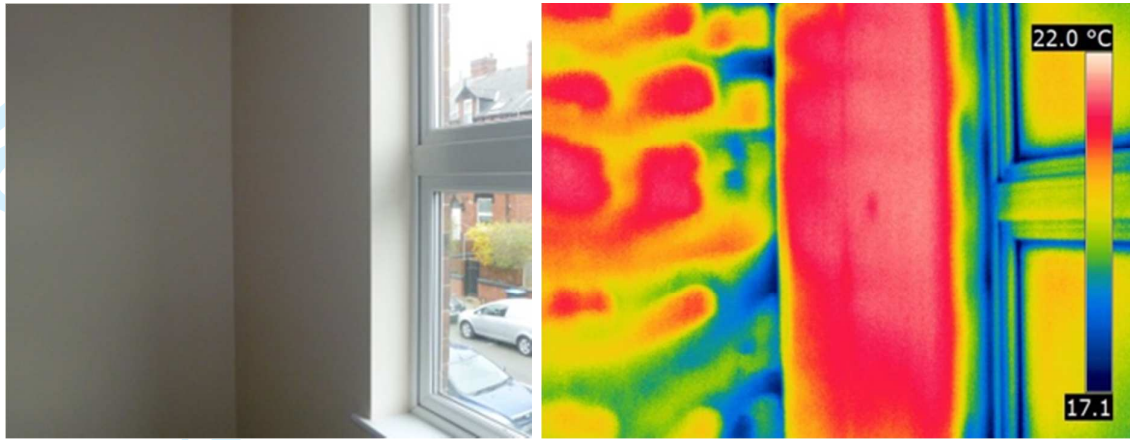
In some instances, thermal bypasses (where warm air is able to escape through gaps in the fabric) will not be visible; Figure 10 shows a solid wall that had an embedded bypass which permitted external air to seep into the dwelling. This was not rectified by the IWI since dot and dabs were used, i.e. the insulating batts were not bonded and sealed to the external wall. This is likely to reduce the overall effectiveness of the retrofit, and allow moist air to travel into this relatively colder cavity behind the insulation, and foster potential interstitial condensation.

Figure 10 Thermal bypass showing external air entering the dwelling behind the IWI on the external wall under dwelling depressurisation and moving into the void behind the plasterboard on the adjacent internal partition wall.
