Taylor Wimpey – Thermal Imaging Project

Site: Newton Farm
 Cambuslang
 G72 8QF

Visit Date: 13th November 2017

Plot(s): 268
 267

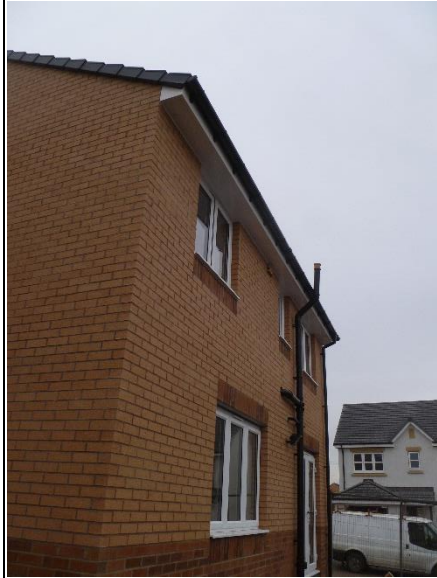
The ground floor perimeter was much warmer than the rest of the external wall. It was unclear whether this was expected or unintended heat loss at ground floor perimeter. Additional heat loss was observed at the patio door threshold which was not completely finished.

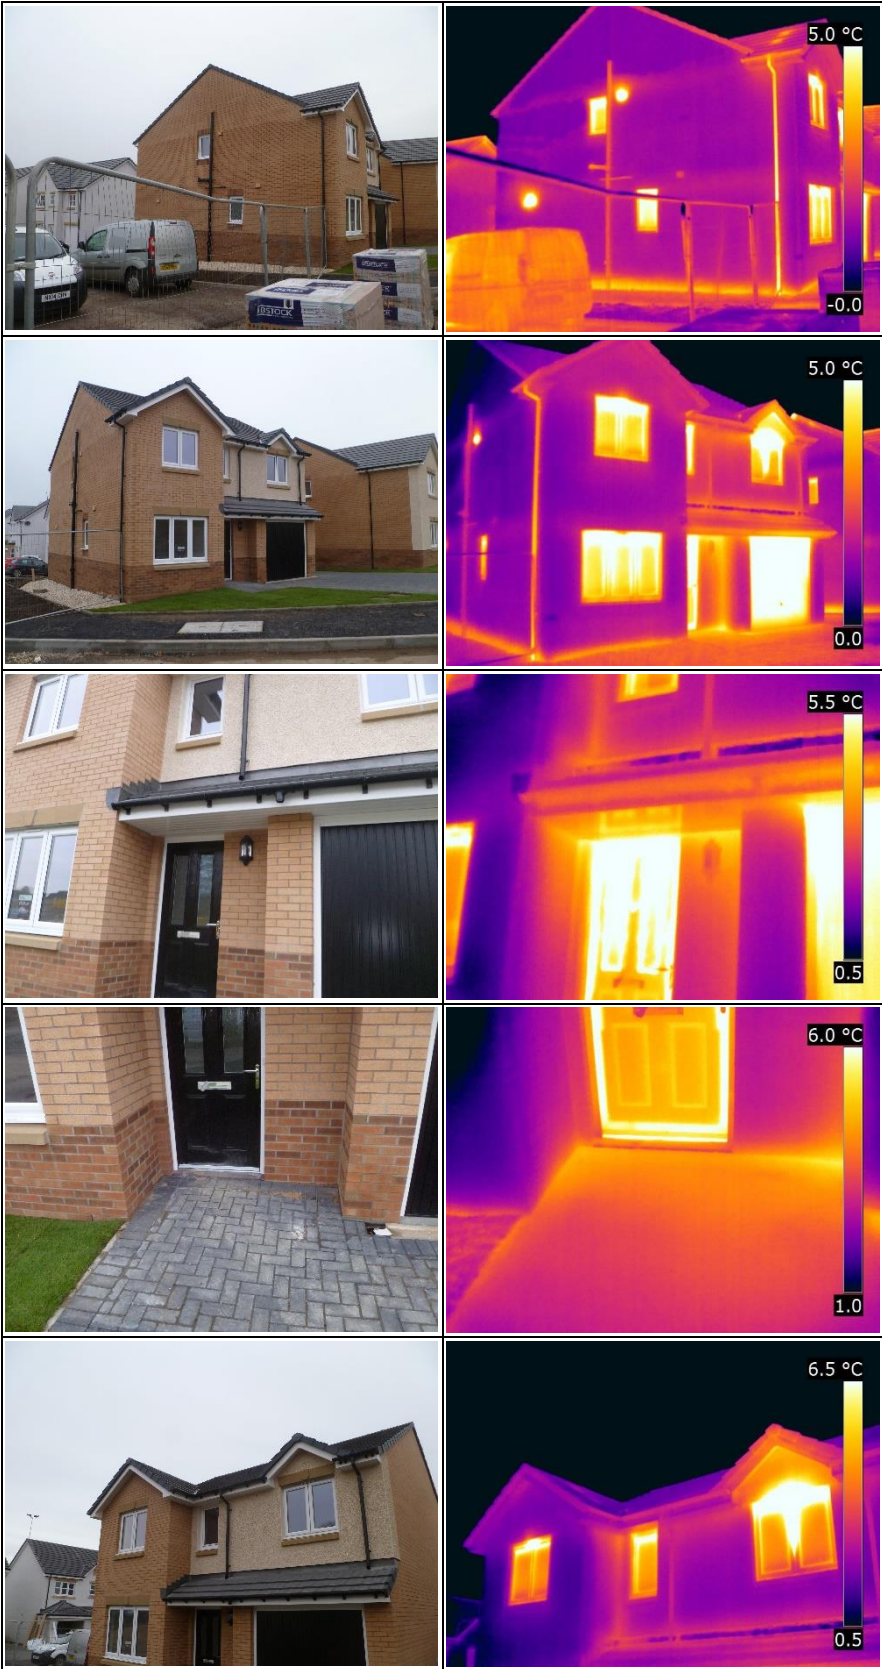
Similarly, the gable windows on the front elevation appeared to show different levels of thermal performance from outside, particularly at the window heads and gable above. However, on internal inspection it appears most probably due to the trickle vents being left open in Bedroom 2 (above the garage) and closed in Bedroom 1 prior to the thermal survey being undertaken.

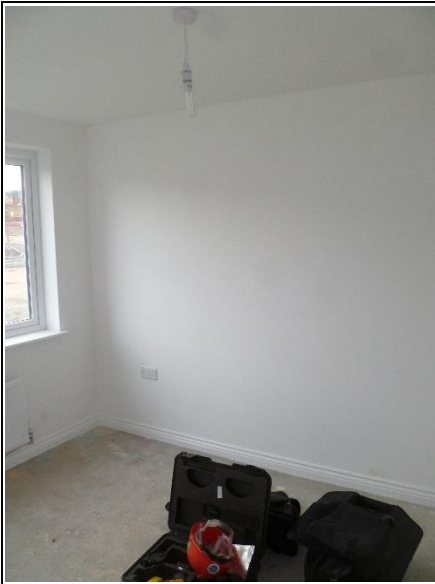
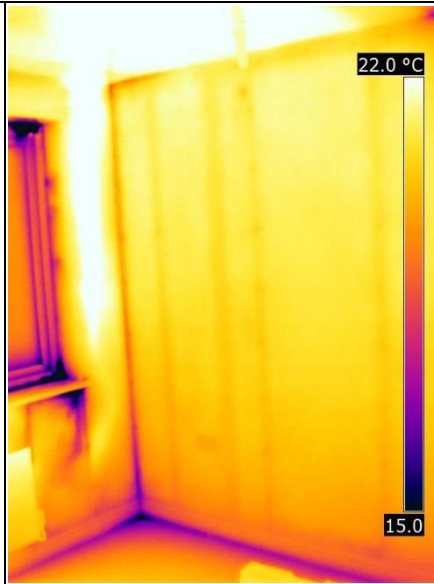
Dining – Under depressurisation

The differences in surface temperature of the hall/external sections of the same wall appeared to increase under depressurisation, with a number of points at the top and bottom of the external wall section indicating air movement into the wall panels.

Although the window seals appeared to work well, infiltration between the window frame and opening was apparent, particularly around the sill board.

The stratification of the intermediate floor void and cooler sections at the floor junctions did not seem to change much under depressurisation for their appearances under natural pressures, suggesting these were due to thermal issues rather than air movement.

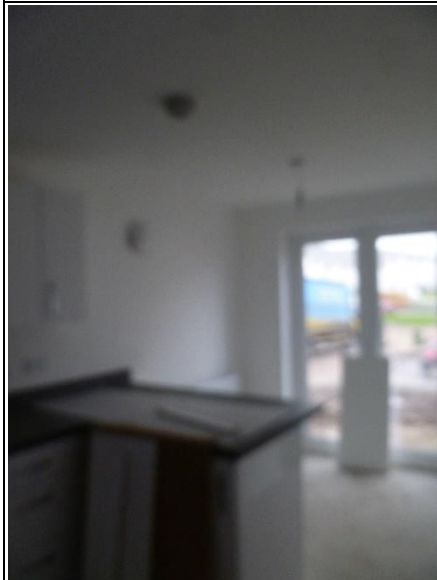
Family / Kitchen – Under depressurisation

Under depressurisation air infiltration was detected emerging around a number of service penetrations; above the kitchen units this air appeared to be drawn from the intermediate floor perimeter as this was where it looked coolest, below the kitchen units the emerging air appeared to be spreading up from the ground floor.

Infiltration around the patio doors was also observed; directly into the room around the doors and frame, and indirectly into the walls around the solid timber lintel and at the base of the jambs.

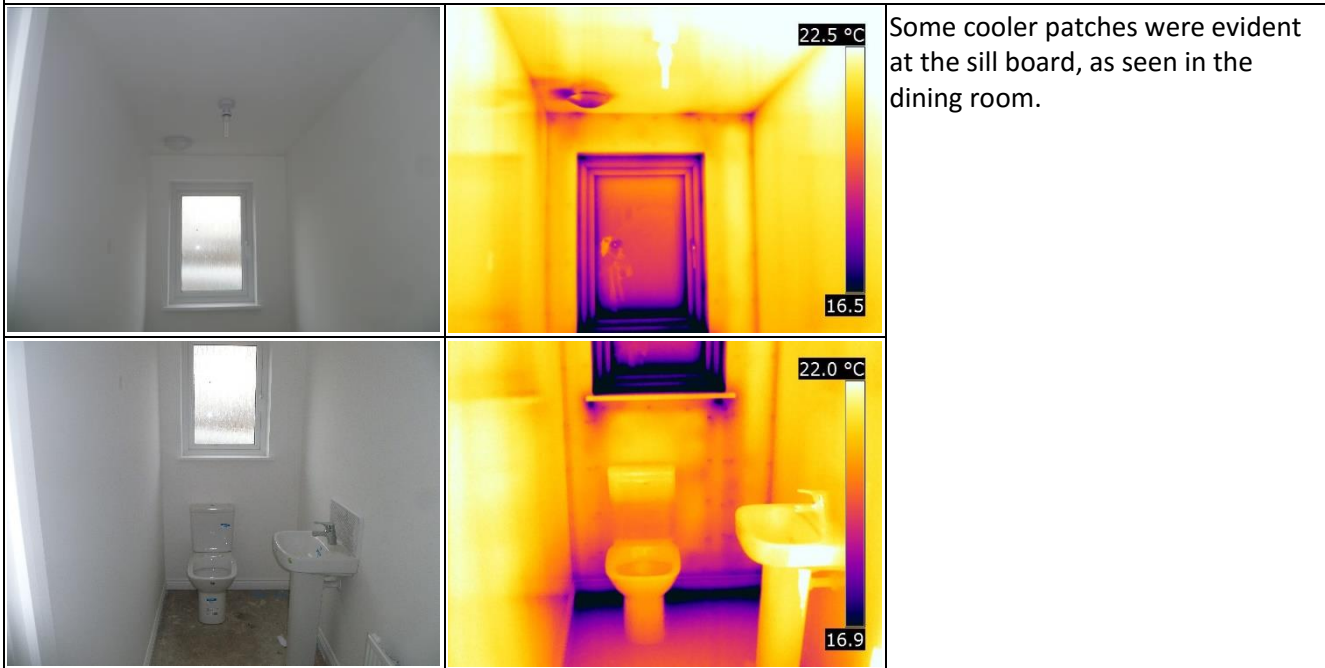
Ground Floor WC – Under natural conditions

Some cooler patches were evident at the sill board, as seen in the dining room.

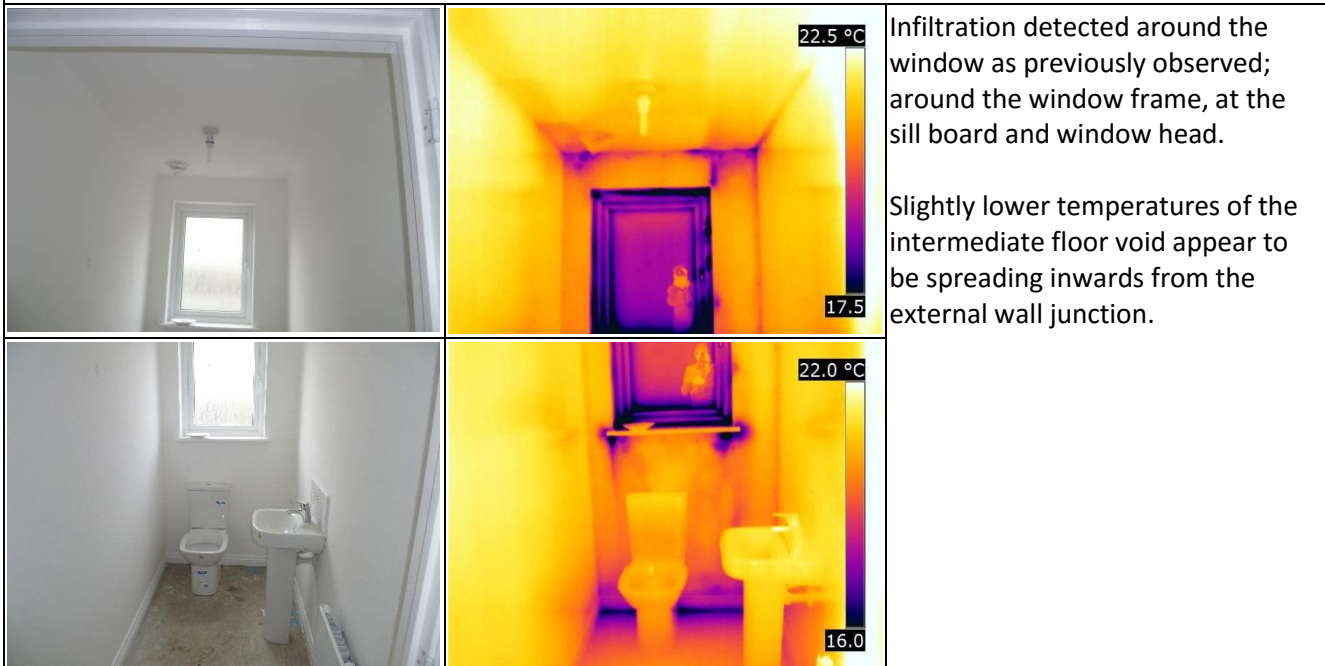
Ground Floor WC – Under depressurisation

Infiltration detected around the window as previously observed; around the window frame, at the sill board and window head.

Slightly lower temperatures of the intermediate floor void appear to be spreading inwards from the external wall junction.

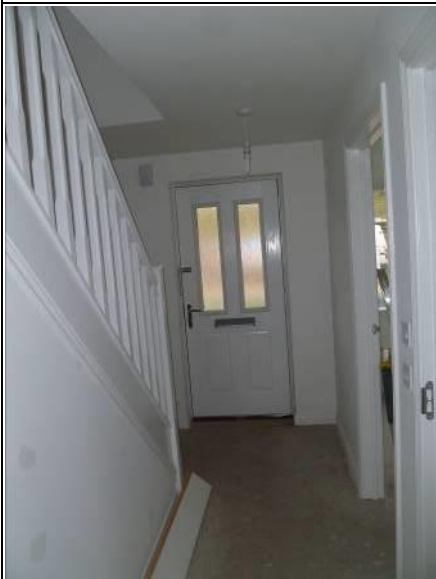
Hall – Under natural conditions

As in the Lounge, there is a cold spot on the external wall which corresponds to the position of the exterior light.

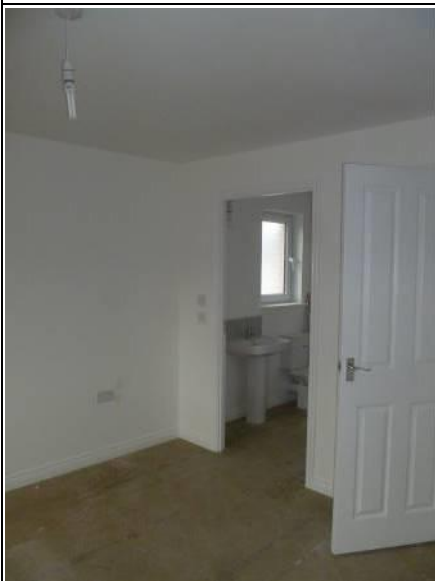
En-Suite – Under depressurisation

Under depressurisation the usual issues are apparent around the window as seen elsewhere throughout the house.

Air infiltration around the soil pipe penetration appears significantly worse, as does the air flow from the loft being drawn in around the central light fixing.

Air is also detected entering at the intermediate floor junction with the external wall, it is unclear whether this is entering around the soil pipe penetration and tracking across

behind the skirting and there is a only a very slight increase in emerging air temperature moving away from the penetration.

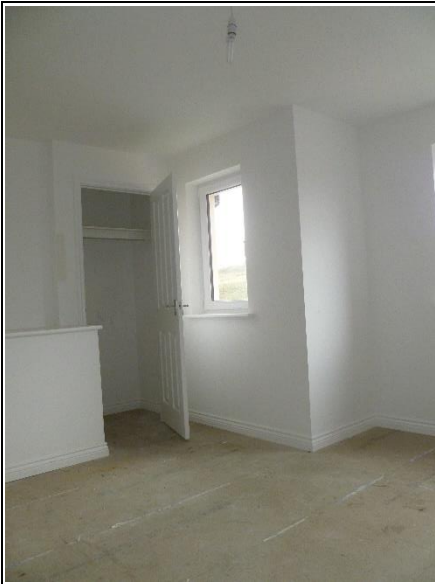
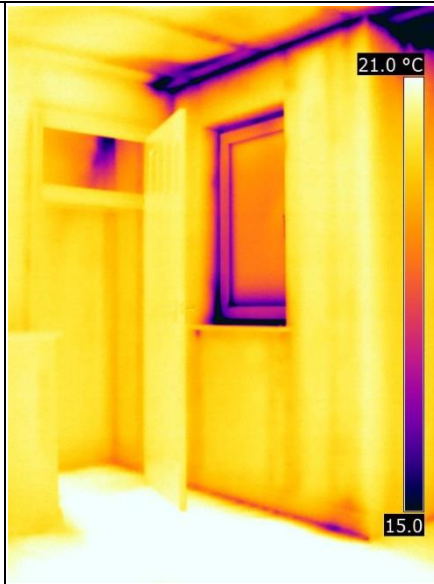
Bedroom 1 – Under depressurisation

Under depressurisation cold air could be observed spreading out from the previously identified colder areas and being drawn down the external wall panels.

Air infiltration was detected again around the window and at the intermediate floor junctions with the external walls

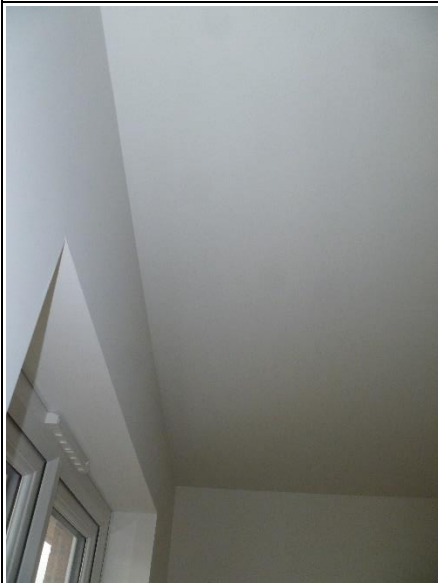
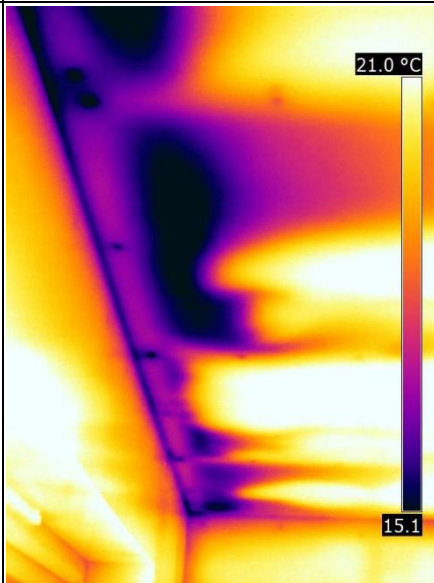
Bedroom 3 – Under natural conditions

As Bedroom 4, but loft insulation issues at the eaves appear even more severe.

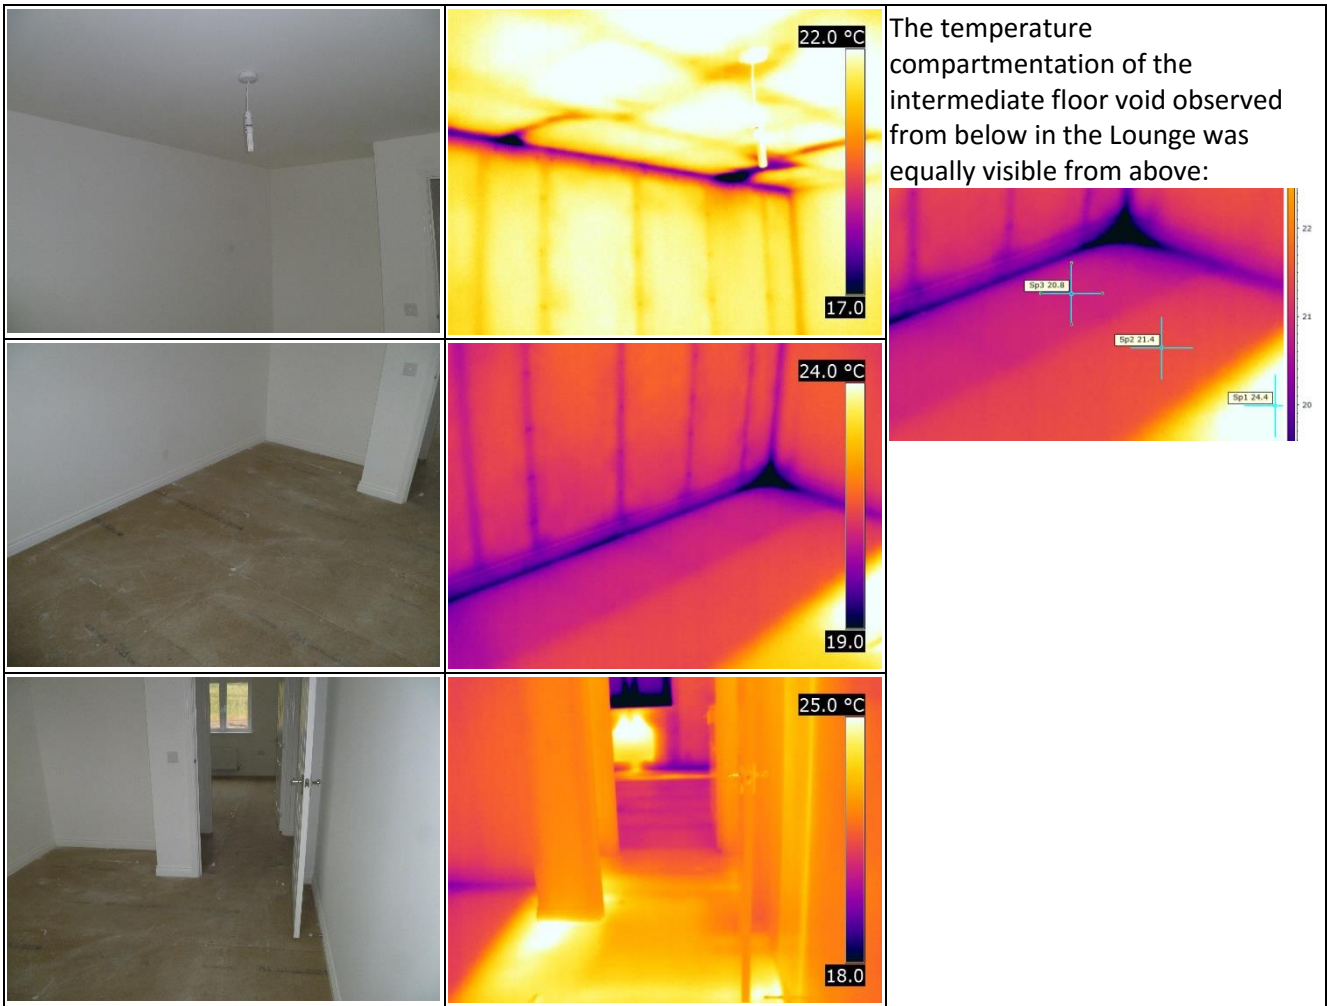
The temperature compartmentation of the intermediate floor void observed from below in the Lounge was equally visible from above:

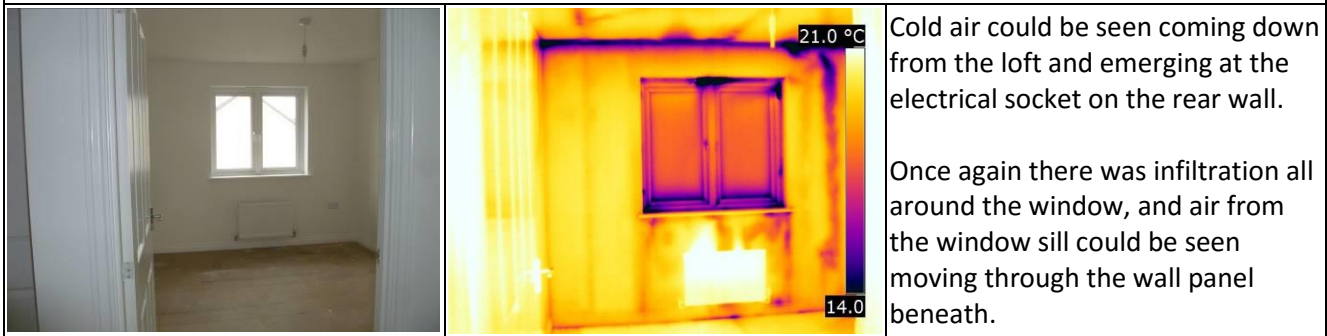
Bedroom 3 – Under depressurisation

Cold air could be seen coming down from the loft and emerging at the electrical socket on the rear wall.

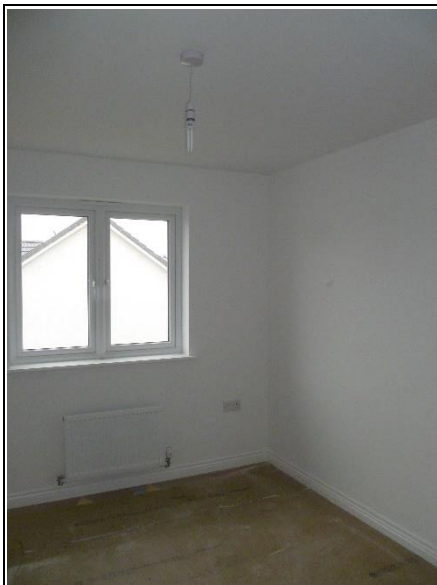
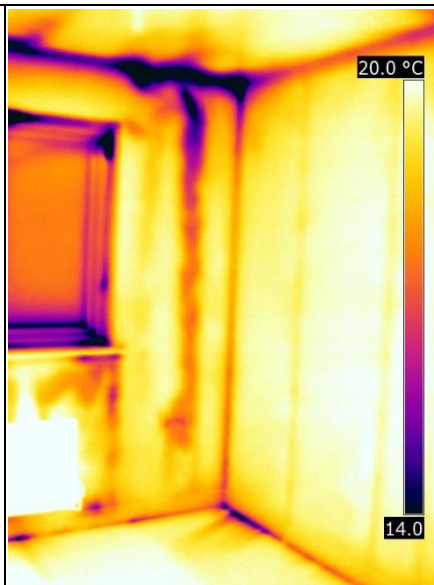
Once again there was infiltration all around the window, and air from the window sill could be seen moving through the wall panel beneath.

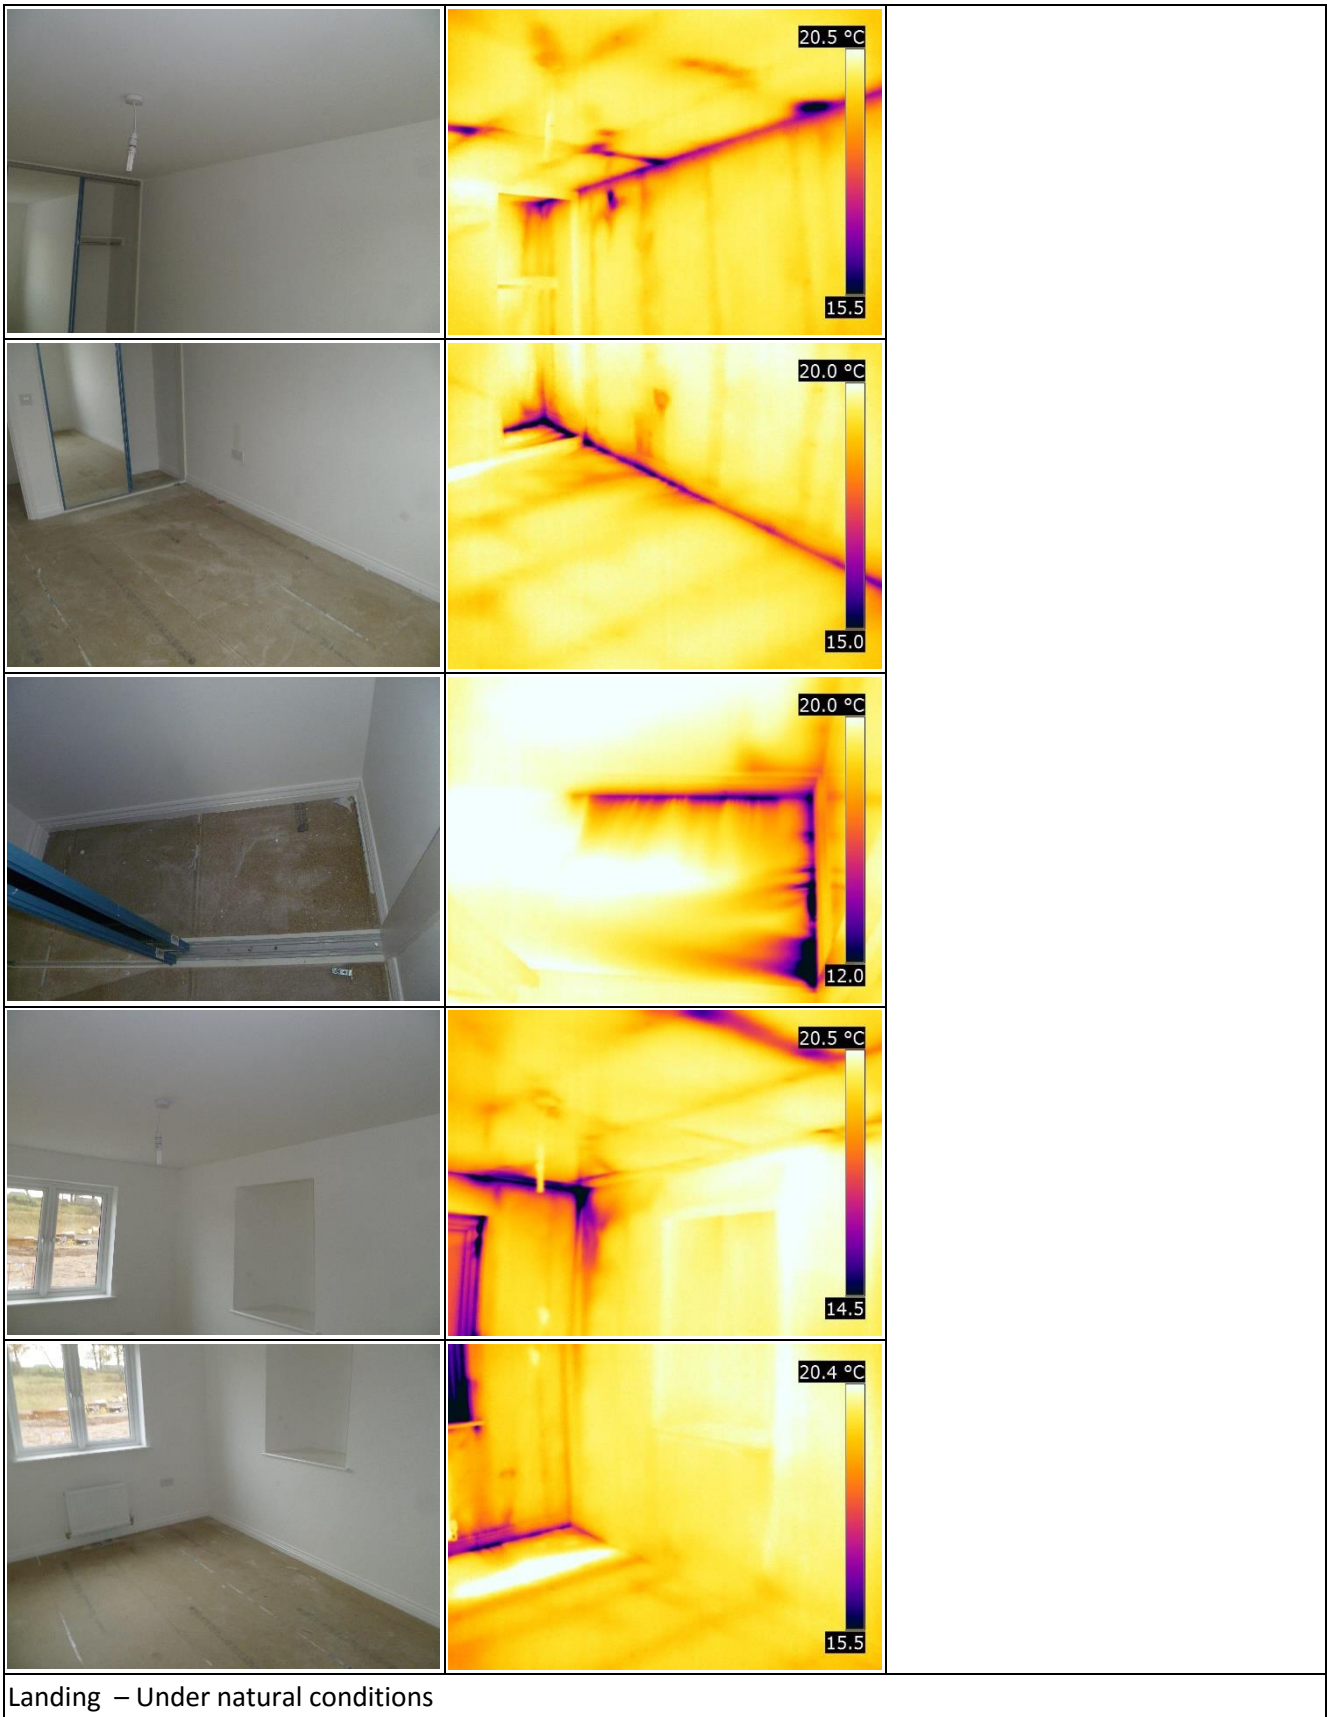
Repeating what was seen in the other bedrooms; however, with increased infiltrations observed around the intermediate floor perimeter, particularly at the built-in wardrobe.

Some colder areas are visible where the loft insulation appears to not be in direct contact with the ceiling plasterboard.

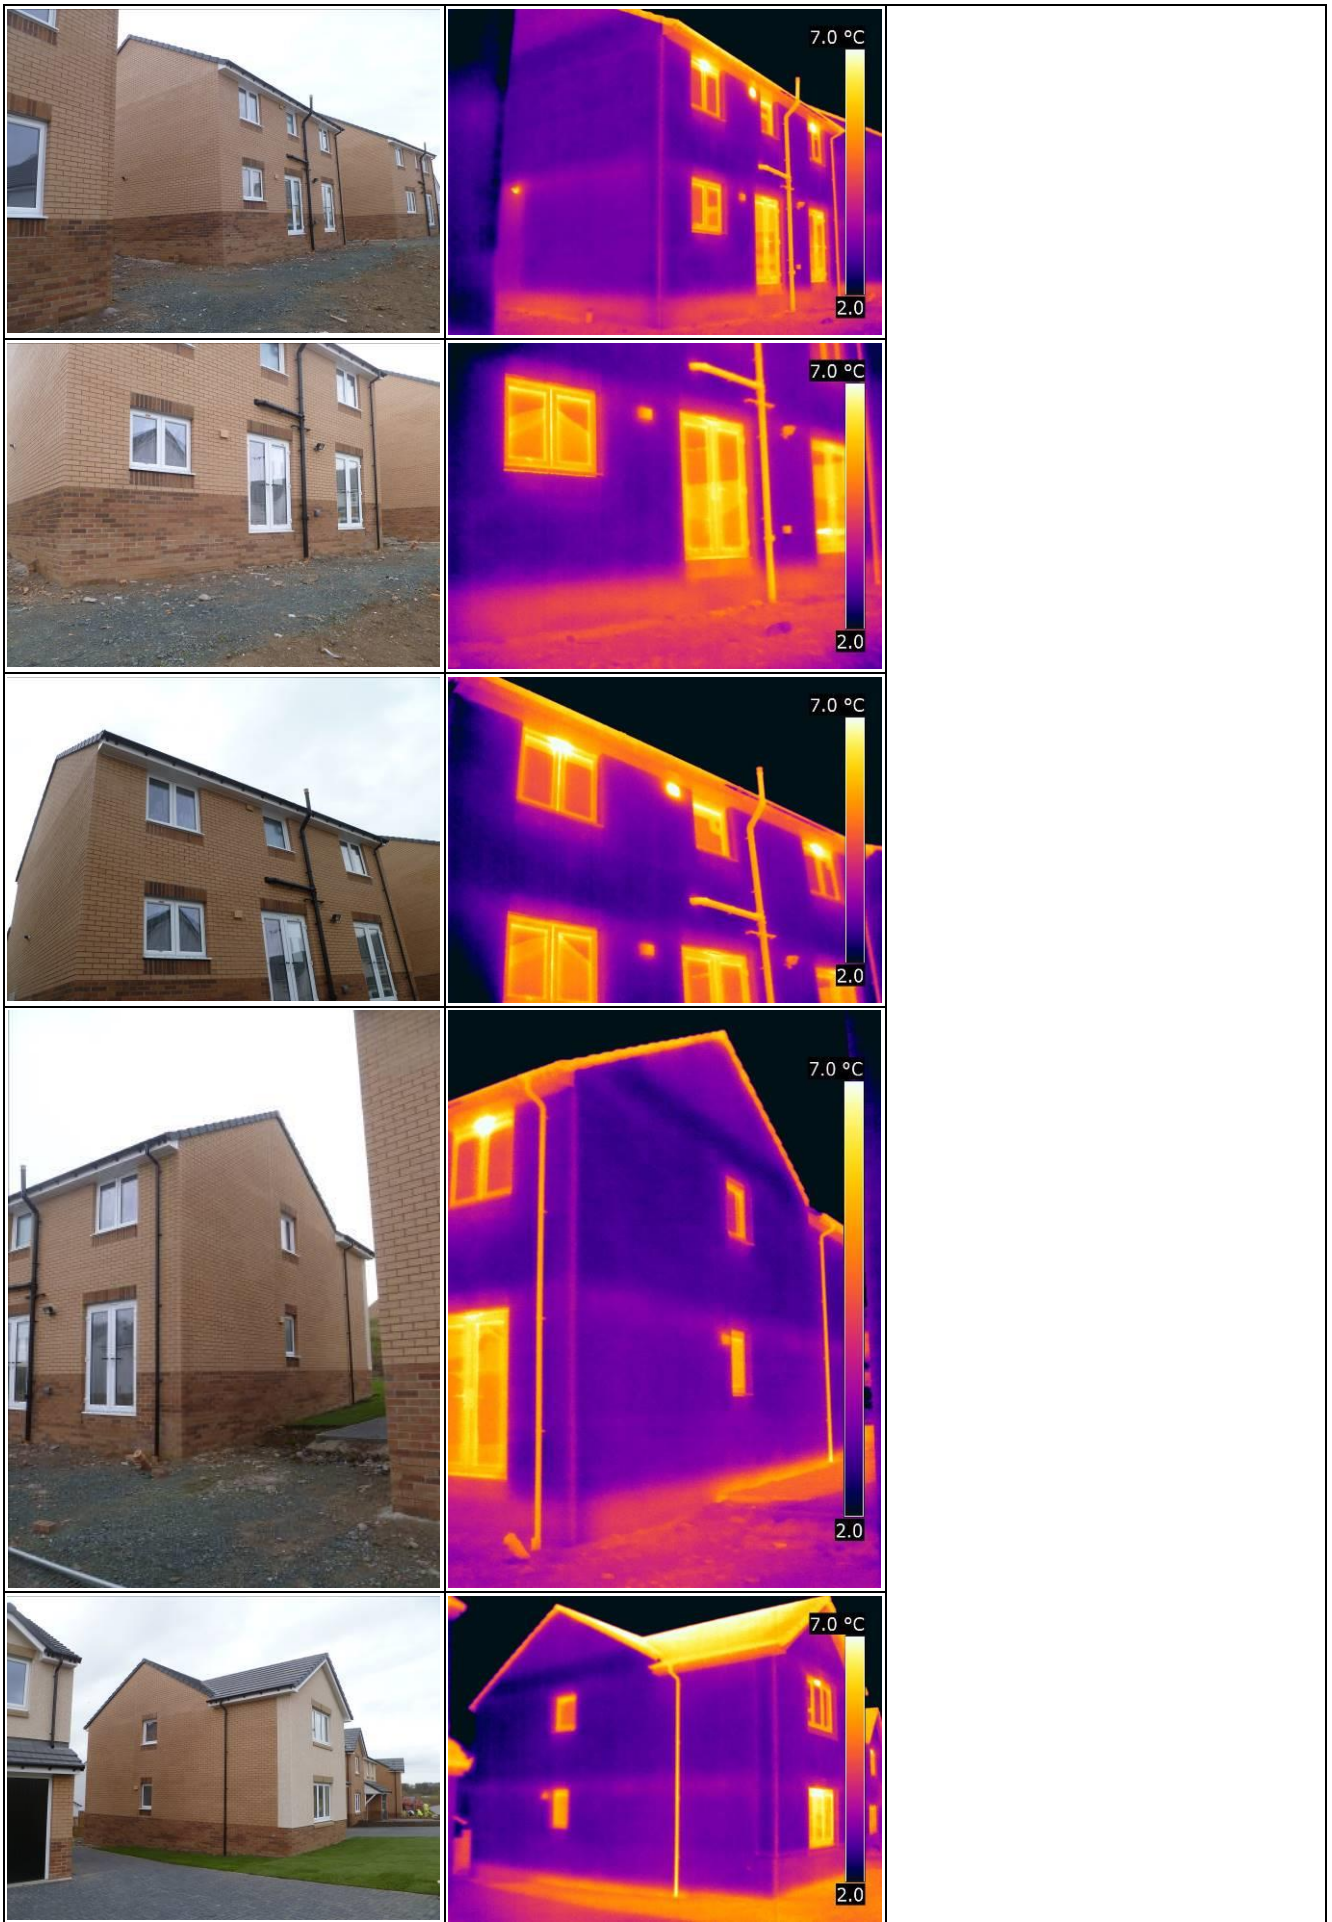
The gable wall at the loft appears warmer due to there being no insulation in the loft with a cold strip directly underneath where the rigid board insulation extended up above the wallplate.

As in plot 268, warmer strips could be seen at the intermediate floor level and at the ground floor perimeter on all sides of the house.

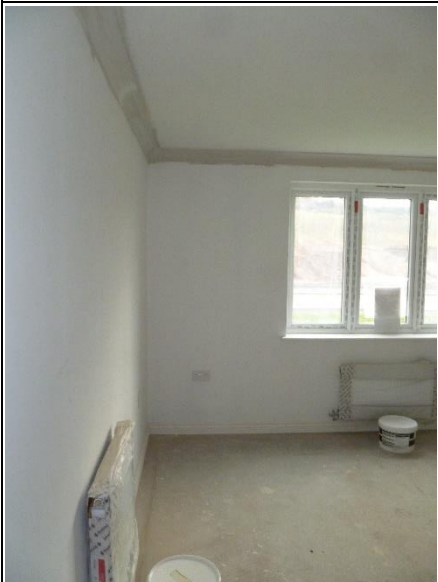
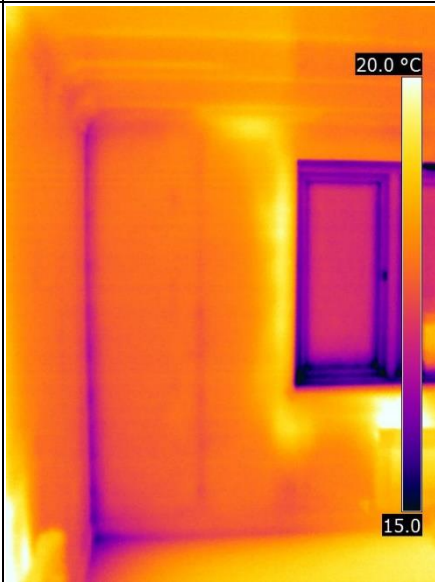
With lower internal temperatures, and hence a lower internal/external temperature differential, similar issues were observed as in plot 268 but do not show up on the thermal images quite as strikingly.

The timber frames were again clearly visible, and some infiltration observed around the window and at the open pattress box on the external wall.

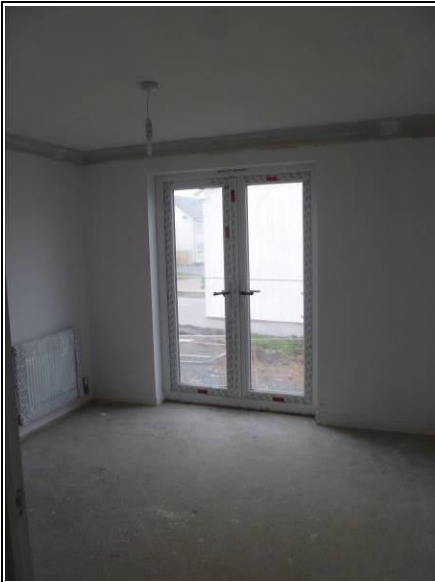
Dining – Under natural conditions

The patio doors appeared much like those in the Family/Breakfast Room in plot 268, with a very cold section at the infilled section at the threshold.

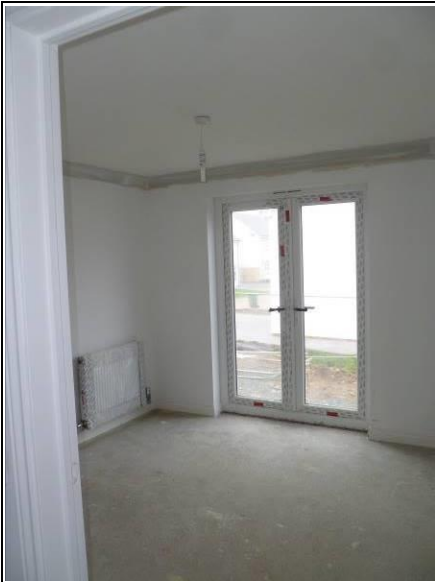
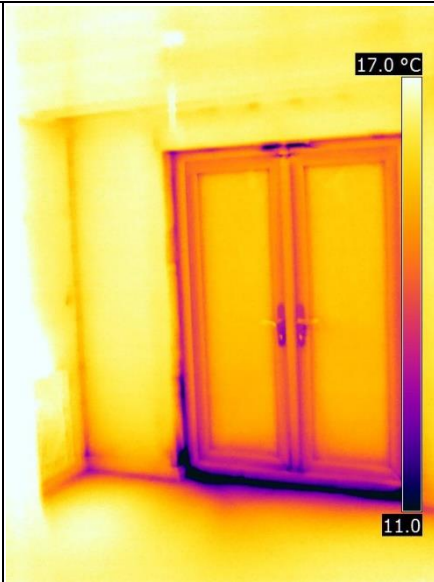
The patio doors themselves appeared to prevent air movement through them very well, with just a small amount coming through at the top and bottom of the doors; however there was more significant air movement around the frame and up into the walls on either side of the infilled section between the floor slab and door frame.

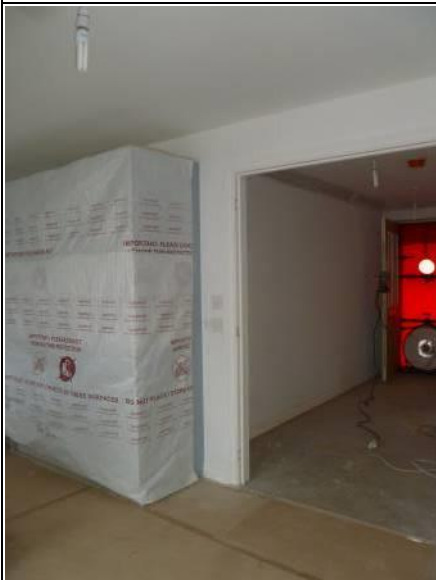
The ground floor and the water in the heating/DHW system appeared to have retained their heat more than the rest of the dwelling, with the floor and the section of intermediate floor containing the pipework remaining the warmest areas in the images opposite.

The internal walls did not lose much additional heat over the 40 minutes between the thermal survey under natural conditions and under depressurisation:

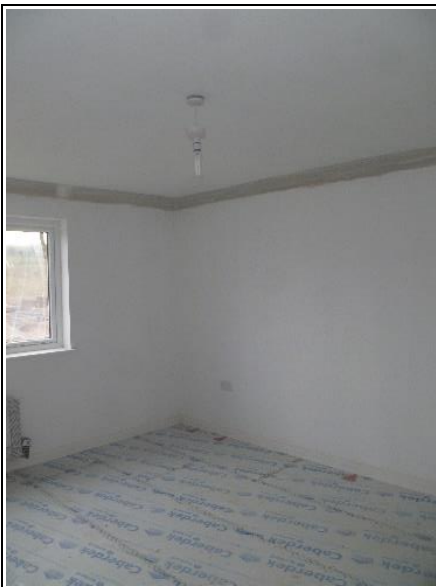
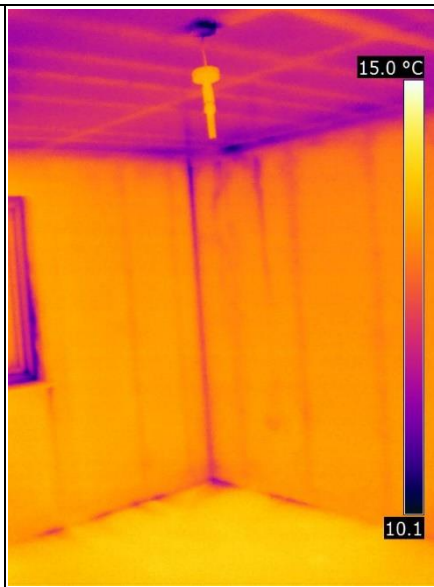
Infiltration at the ceiling penetration, window jamb were now perceptible.

Air could also be seen being drawn into the wall panel at the side of the gable window where issues had been seen in plot 268.

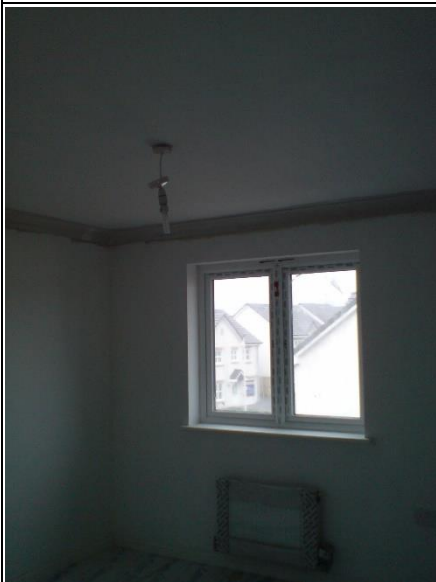
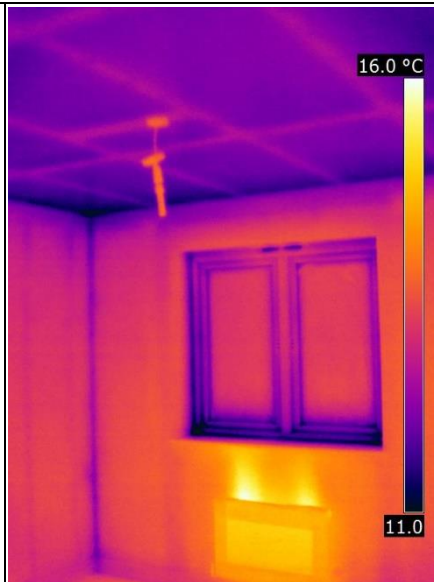
Bedroom 3 – Under natural conditions

As Bedroom 1.

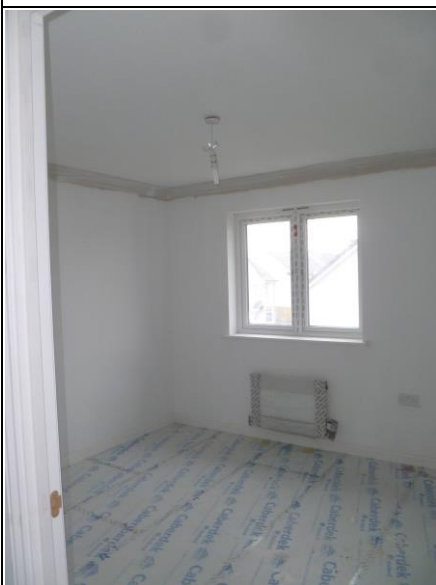
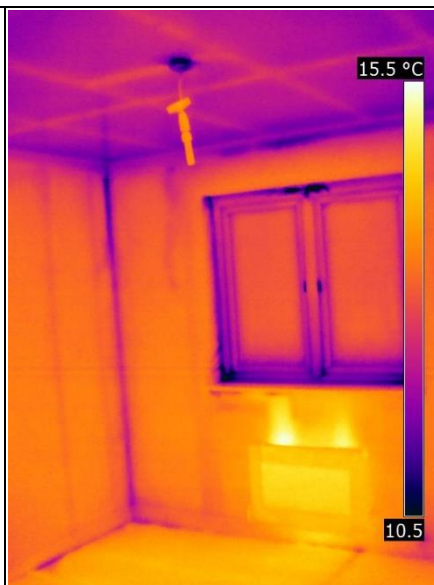
Bedroom 3 – Under depressurisation

As Bedroom 1; again some air was observed being drawn into the wall panels, but was difficult to detect entering the actual room as it was emerging at the intermediate floor perimeter at room temperature (so not showing up on the thermal camera).

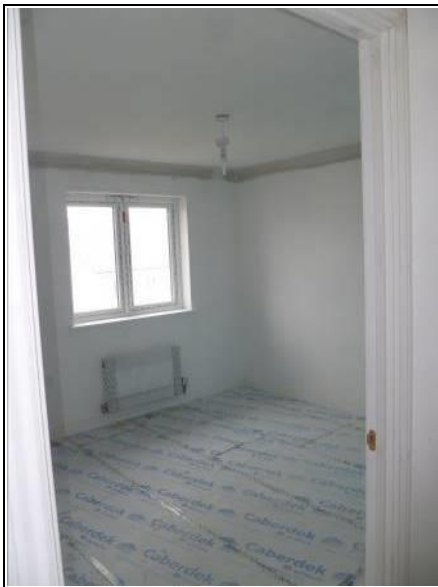
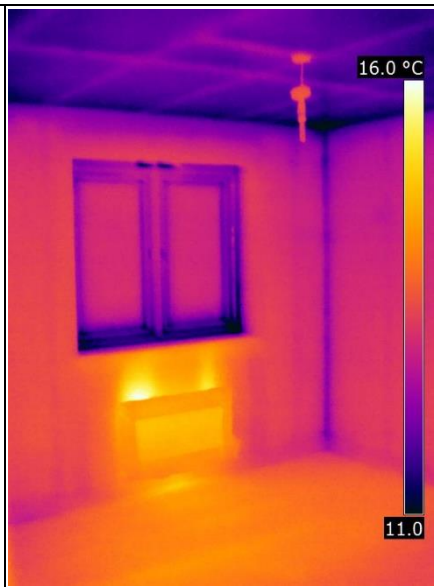
Bedroom 4 – Under natural conditions

As seen in previous bedrooms.

The pipework from the boiler to the cylinder cupboard retained heat much better than the rest of the upstairs without loft insulation installed.

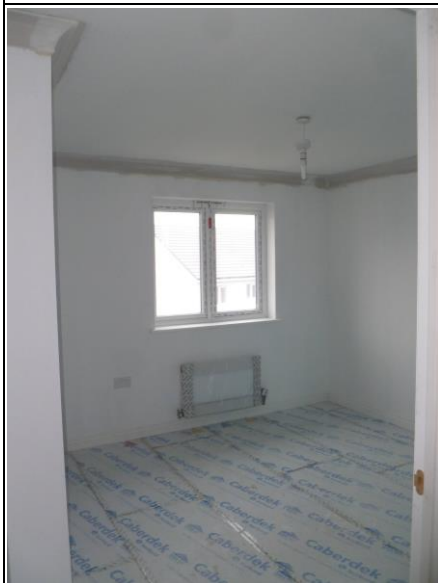
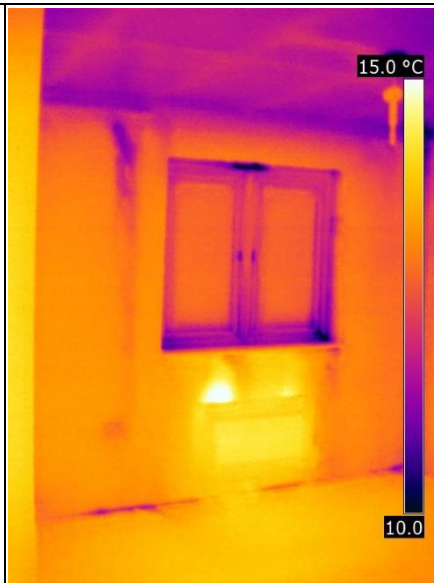
Bedroom 4 – Under depressurisation

As in Bedroom 1, cooler air was seen tracking down the wall the external wall along the cabling route for an electrical socket.

Cooler air could be seen infiltrating around the window and at the intermediate floor perimeter.

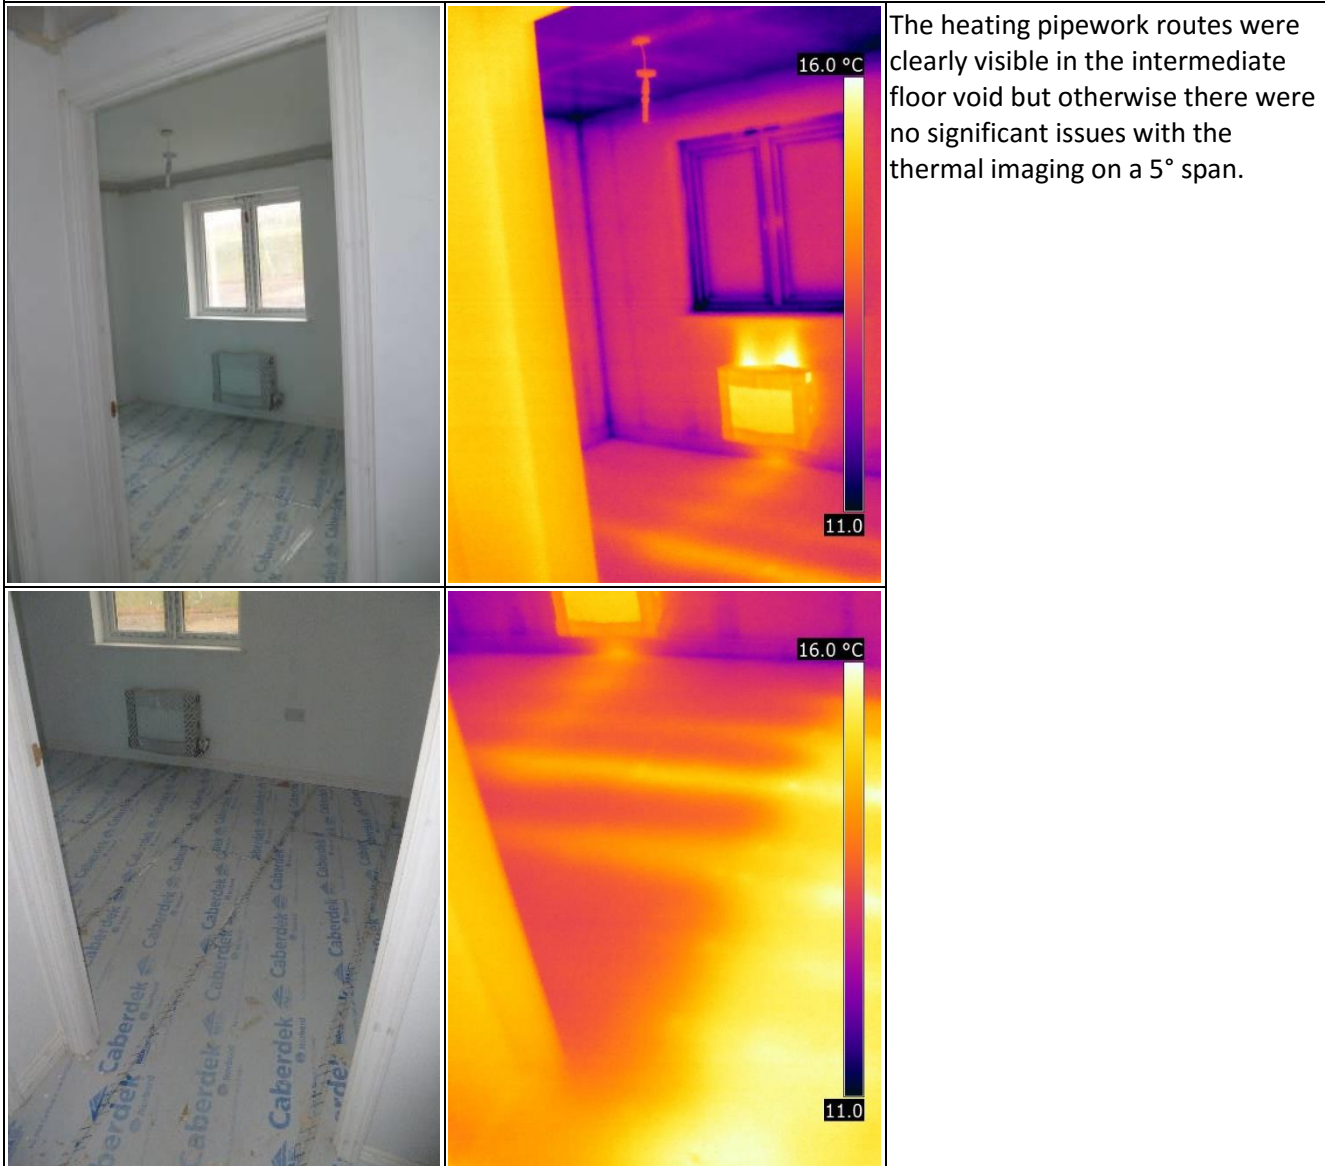
Bedroom 2 – Under natural conditions

The heating pipework routes were clearly visible in the intermediate floor void but otherwise there were no significant issues with the thermal imaging on a 5° span.

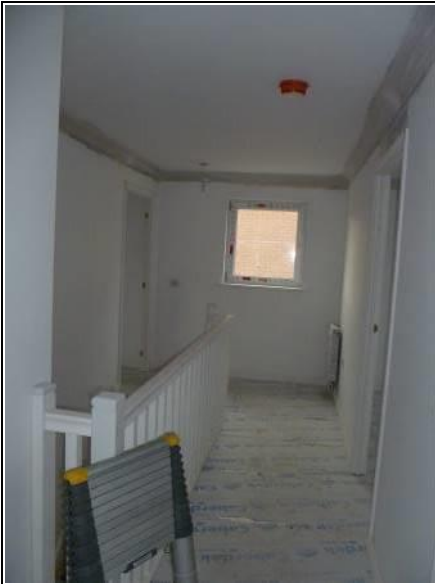
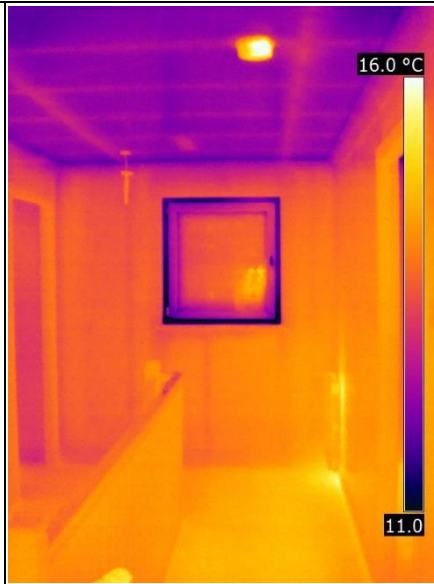
Landing – Under natural conditions

No significant issues with the thermal imaging on a 5° span.

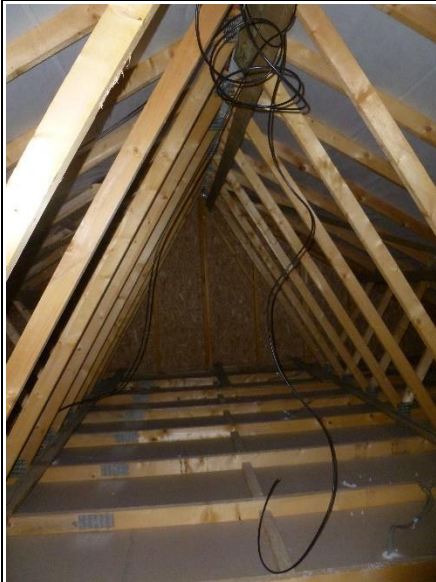
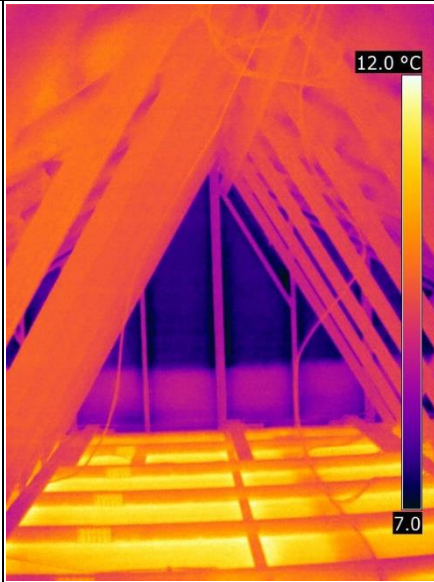
Loft – Under natural conditions

Looking towards the gable wall above garage the additional rigid board insulation on the outside of the timber frame is easily discernible:

Without insulation the loft itself is around 9~10°C, compared to ~4°C in plot 268.

Looking towards the opposing gable wall it is quite easy to see how some of the cold areas of ceiling observed in plot 268 came about. With so many nogs, braces and additional timbers, as well as electrical cabling, it is understandable that gaps between loft insulation and the ceiling will result, compromising the performance of the loft insulation.
