Taylor Wimpey – Thermal Imaging Project

Site: Pipers Green
 Crigglestone
 WF4 3HY

Plot(s): 288

House Type: PA48 – Shelford
 Full-fill Masonry, 2-Storey, 4-Bed Detached

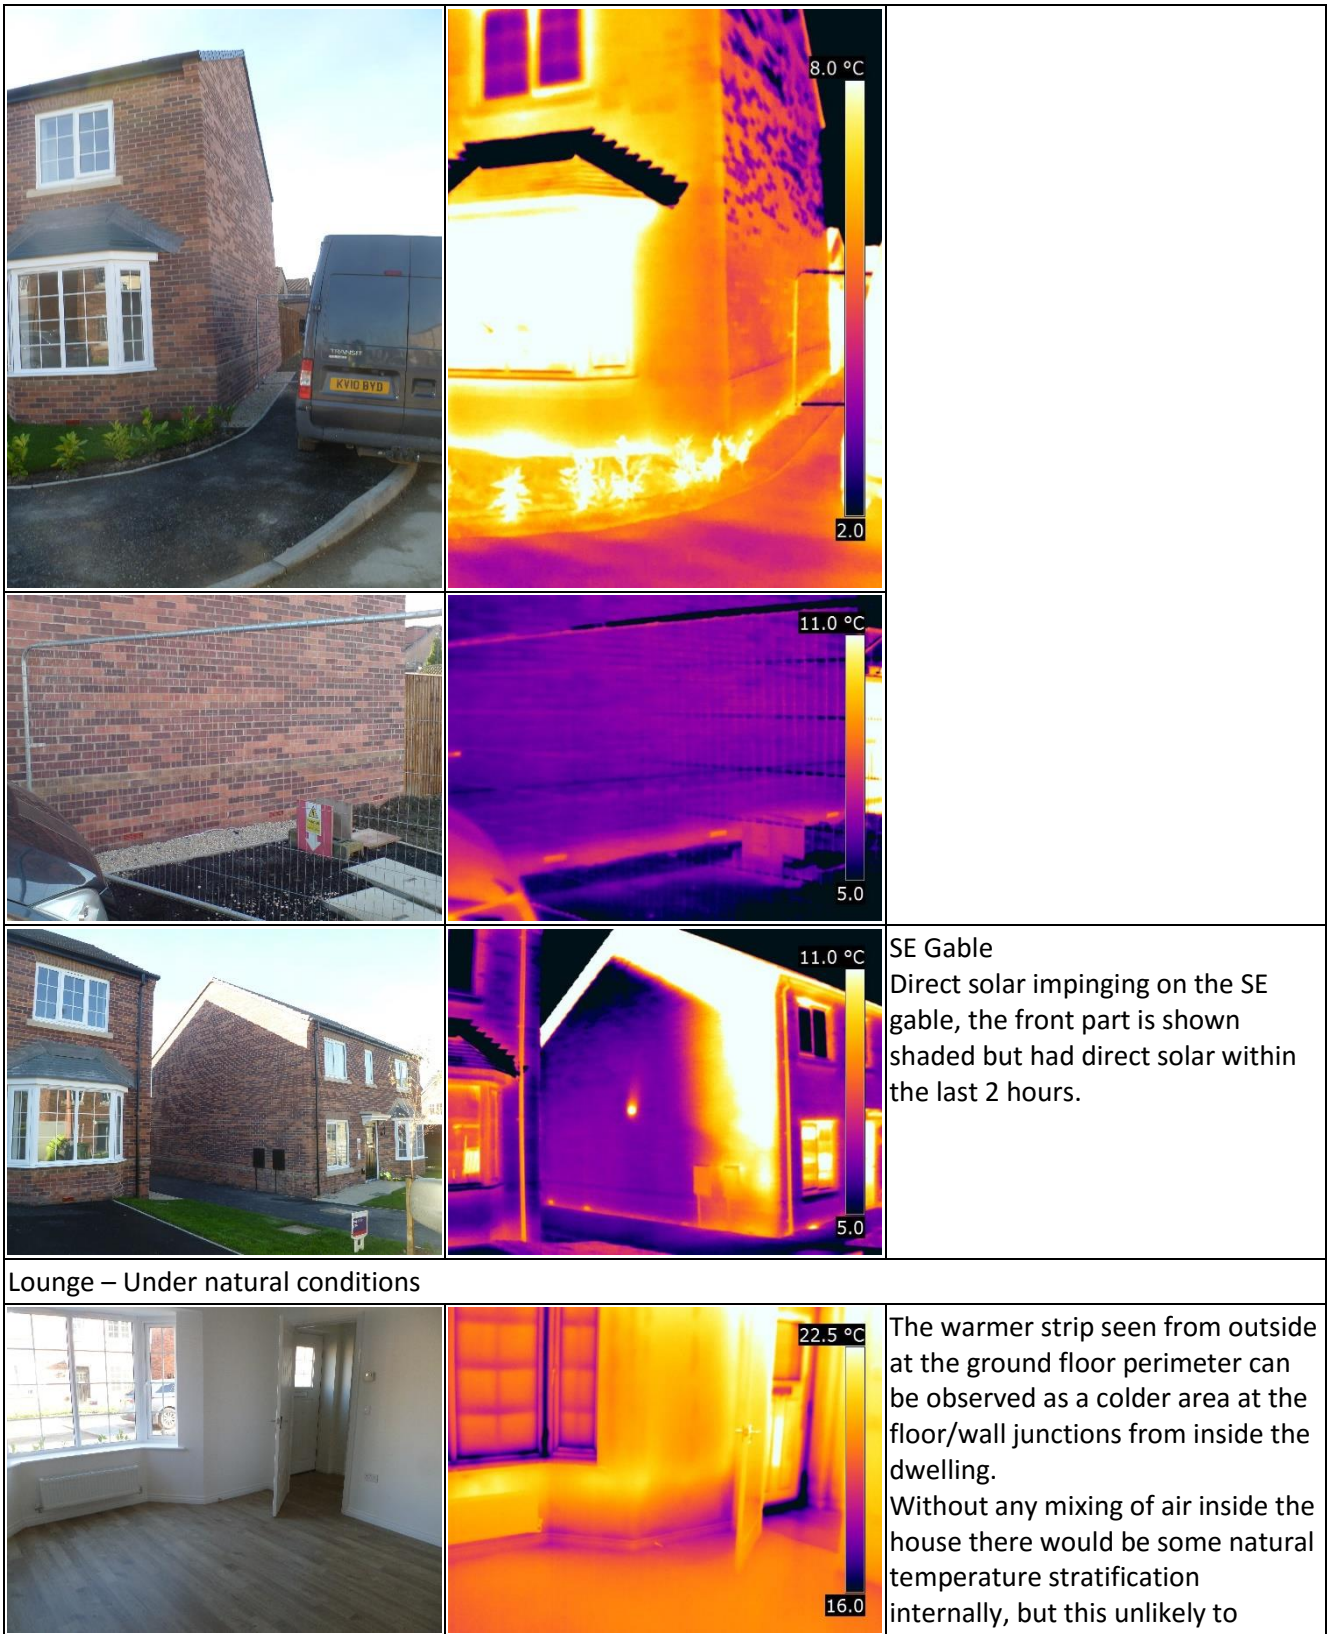
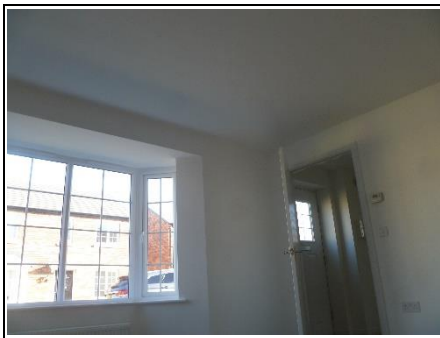
External - Under natural conditions		
		<p>NE Front Façade Some direct sunlight on the East-facing bay wall is apparent. First floor trickle vents had been left open making it difficult to assess whether there is additional unplanned heat loss at the eaves. Warmer area above bay roof possibly due to a radiator directly under the window in Bedroom 1.</p>
		<p>Southerly wind resulted in warm air emerging from the underfloor vents. There also appears to be a warmer band around the ground floor perimeter which extends around the whole dwelling, possibly due to a thermal bridge as the internal IR images also show the floor/wall junction to be cooler than expected. I don't know if a cavity tray was fitted preventing the blown insulation getting down below, but this resemble instances where I have observed this previously.</p>
		<p>NW Gable</p>

account for the significantly cooler surface temperatures at the base of the external walls. The temperature difference between the wall surface on and off the plasterboard adhesive dabs appears to reduce near the base of the wall.

The internal surface of the bay roof appears cooler than the external elements around it, but due to cold air ingress at the trickle vents and reflection of the cooler windows it is difficult to analyse.

The bay window jambs appear to show no significant issues, an area where problems are commonplace.

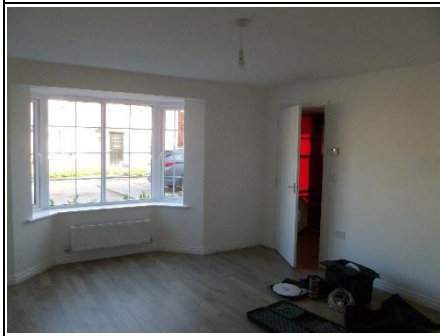
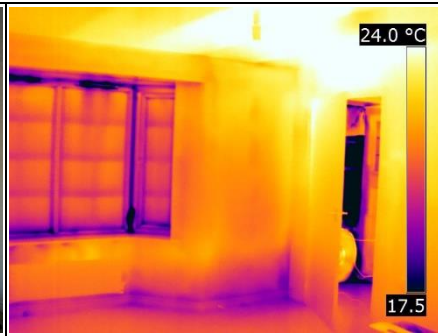
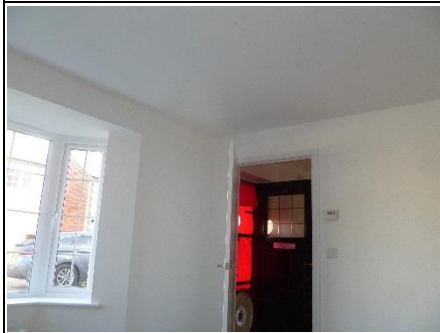
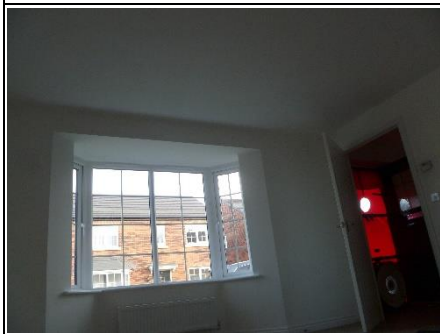
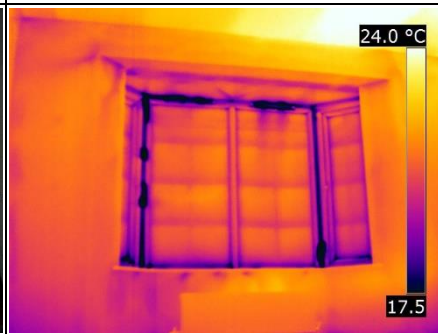
Lounge – Under depressurisation

Under depressurisation cooler air could be observed infiltration around the windows, with air entering through and around the closed trickle vents, at junctions between the lights and around the sill board. The thermal anomalies on the bay appear to worsen under depressurisation, where air movement is forced from cold external air to inside the structure, with a much clearer cold strip at the junction with the external wall above. This would indicate that gaps at interfaces play a part at this detail, whereas at the floor/wall junction the difference in IR images between natural and depressurised conditions is marginal suggesting that the increased heat loss at this junction is more likely due to conductive heat loss with discontinuities or disruptions of the insulation layer.

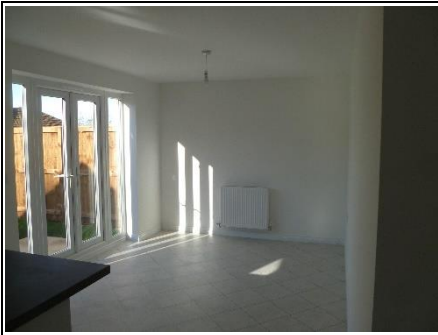
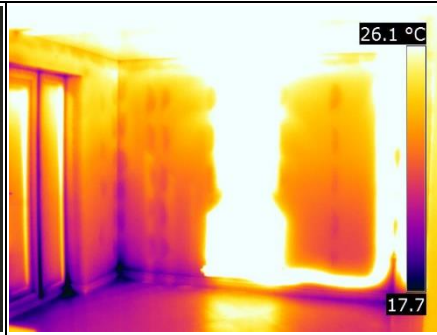
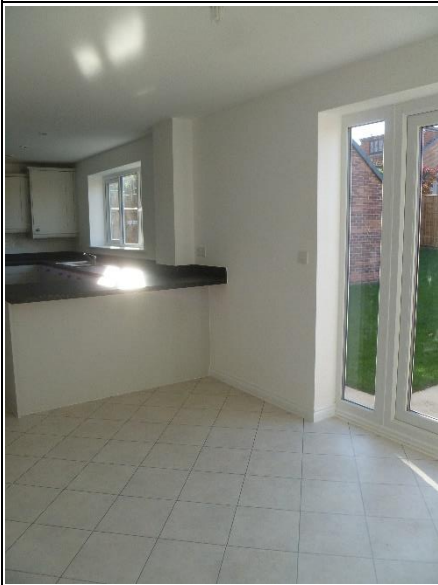
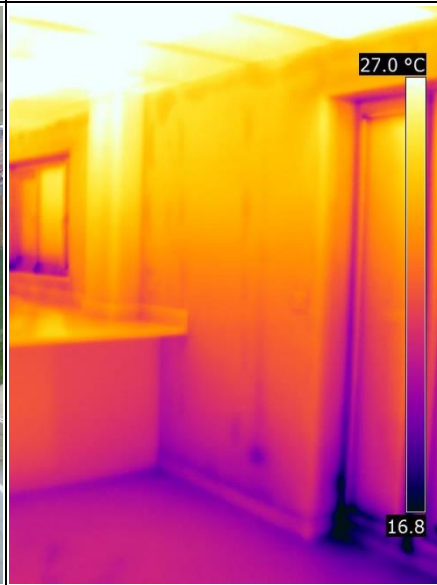
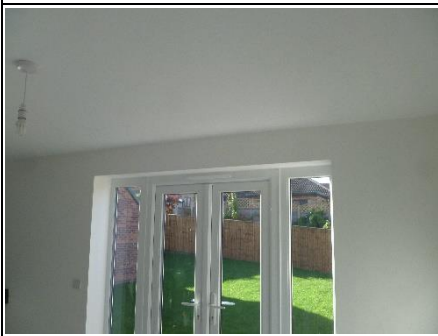
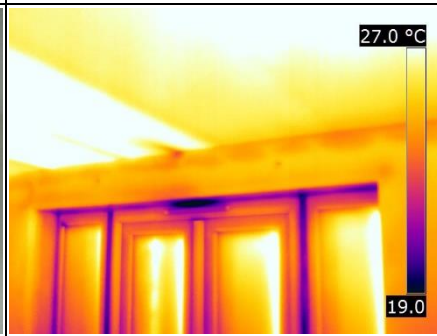
Dining / Kitchen – Under natural conditions

The previously observed phenomena at the floor/wall junction was again apparent. Where the patio doors are positioned further out in the external wall the floor surface appears to get noticeably cooler, possibly due to greater thermal bridging.

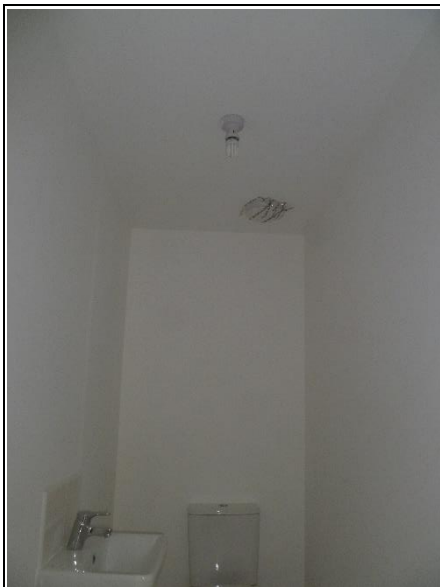
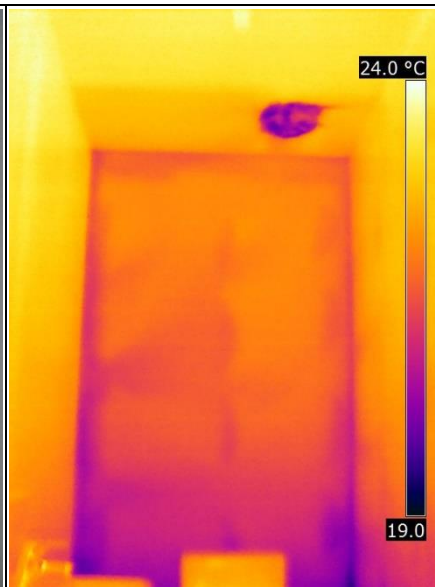
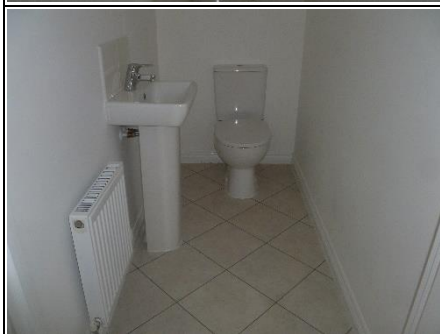
Ground Floor WC – Under depressurisation

Some air movement behind the plasterboard dry lining observed, it is unclear of the source and direction of movement but tends to look as if the air is coming from the adjacent study.

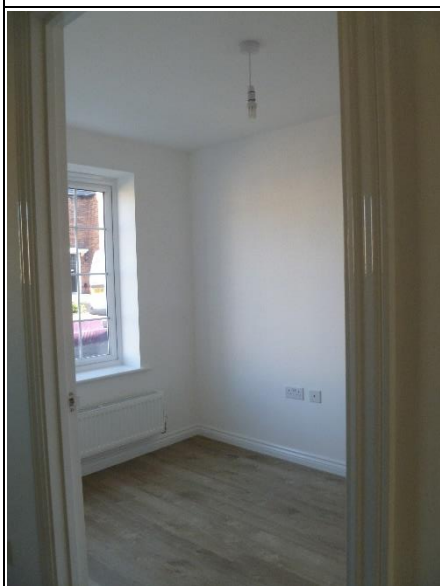
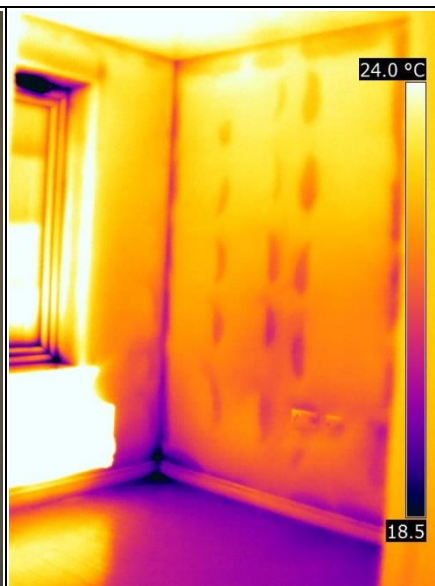
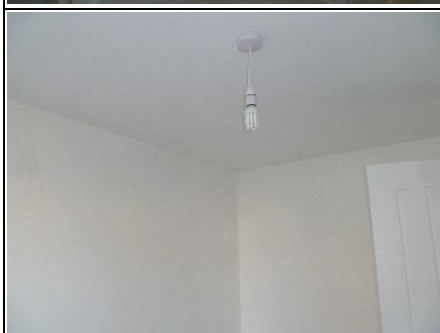
Study – Under natural conditions

Plasterboard adhesive dabs appear coolest where the utilities meter boxes are situated on the external walls. Some temperature stratification across the intermediate floor void can be observed, but it is unclear whether this is heat from the heating system pipework spreading toward the outside or cooler air from the gable wall junctions spreading inside.

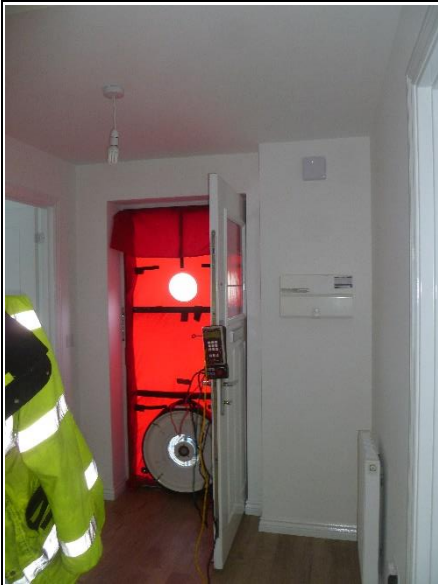
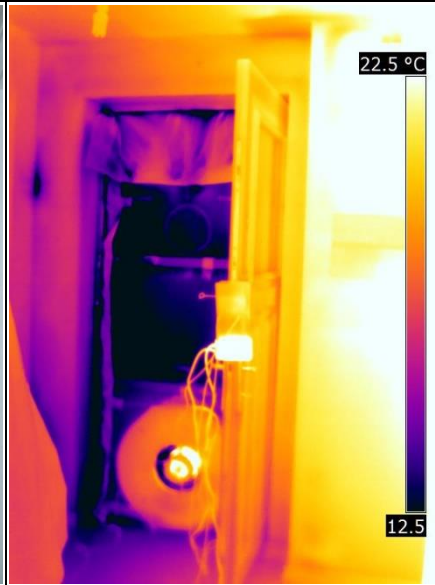
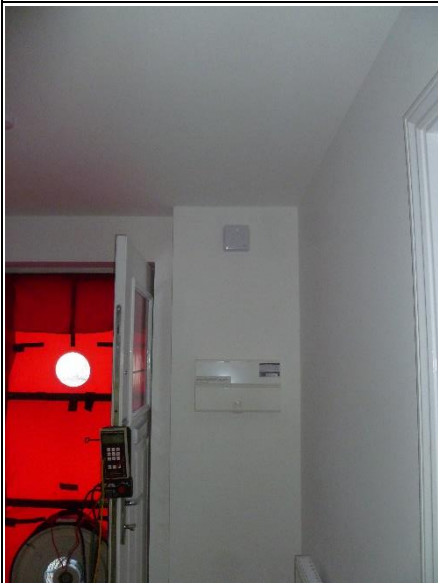
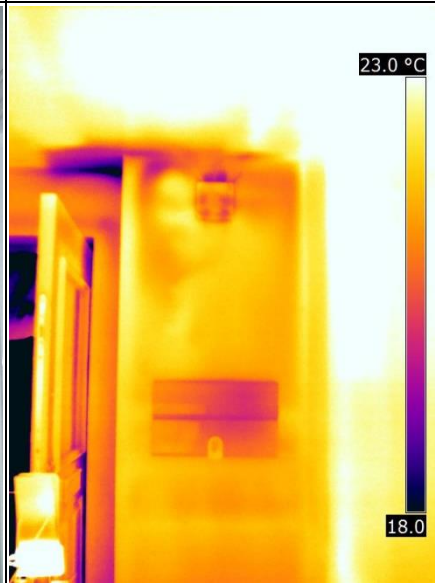
Hall – Under depressurisation

The indirect infiltration by the external wall junction with the lounge wall appears to be due to the penetration for the outside light.
 The colder area at the junction of the external wall with the intermediate floor and boxed void appeared to worsen under depressurisation, this is deemed due to increased air movement which can be seen extending down the service void.

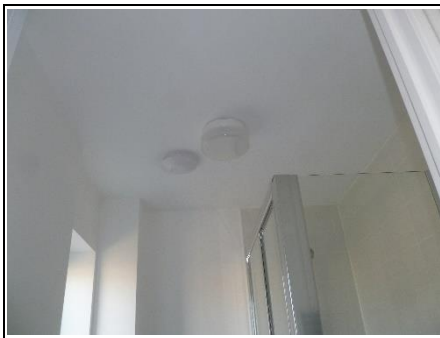
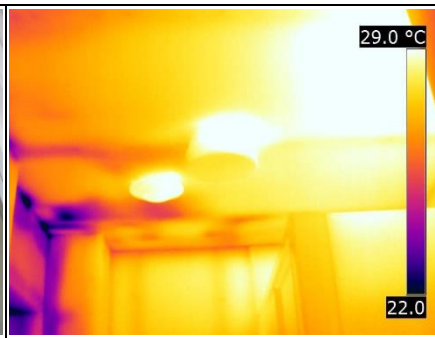
En-Suite – Under natural conditions

Colder areas are visible at the junction of the ceiling and external wall, extending down the service void to the right of the window. The service void to the left of the window show warmer timbers than the air voids behind but no distinct thermal gradient beyond the natural temperature stratification in the room. This void was not present on the drawings supplies:

Additionally, there appears to be some dislocation of the loft insulation around ceiling penetrations.

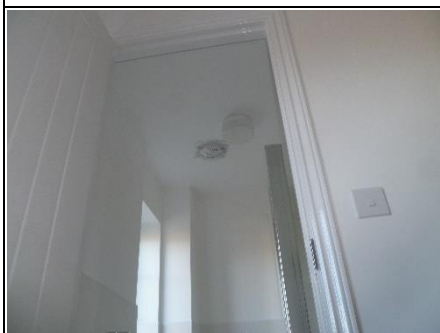
En-Suite – Under depressurisation

Air being drawn in from the loft space was observed into the service voids, around ceiling penetrations and into the internal partition wall by the shower cubicle.

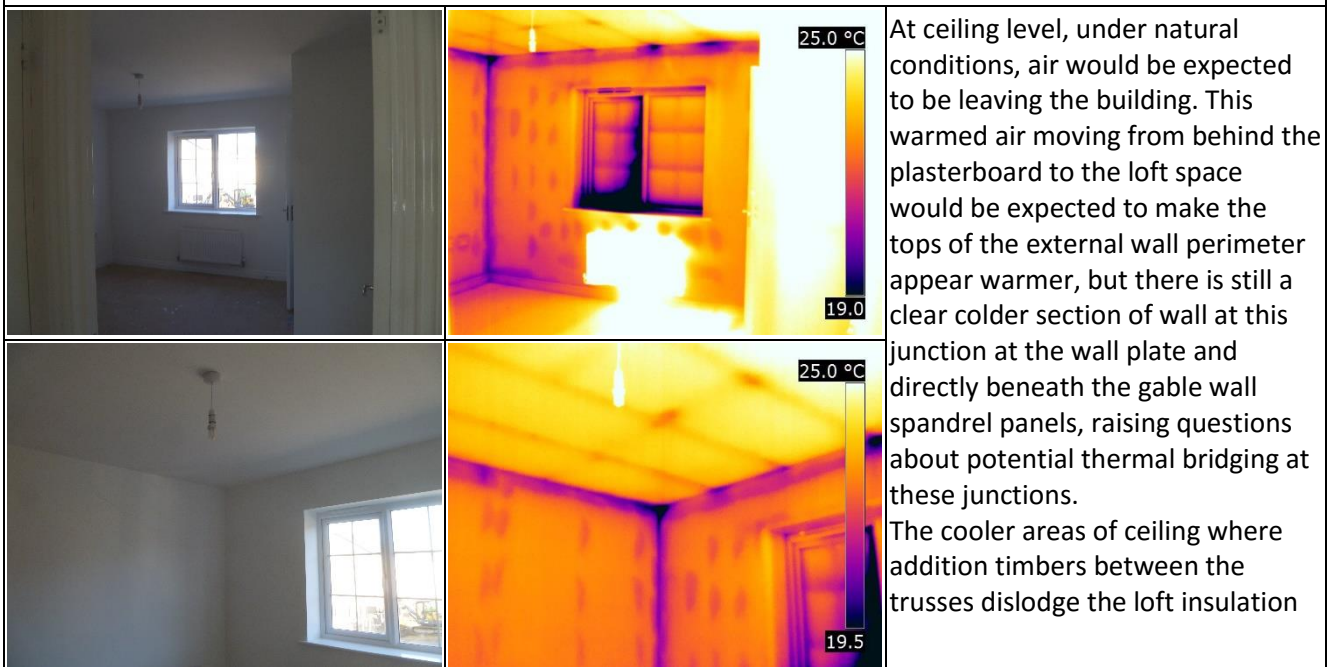
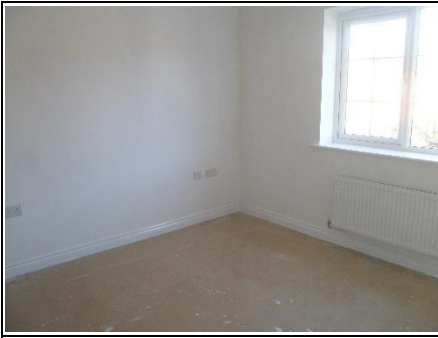
Bedroom 1 – Under natural conditions

from direct contact with the ceiling are not excessive.

The stratification of temperatures of the intermediate floor void visible from below is also clear from above.

Thermal bridging at jambs/head/sill is also apparent but not excessive.

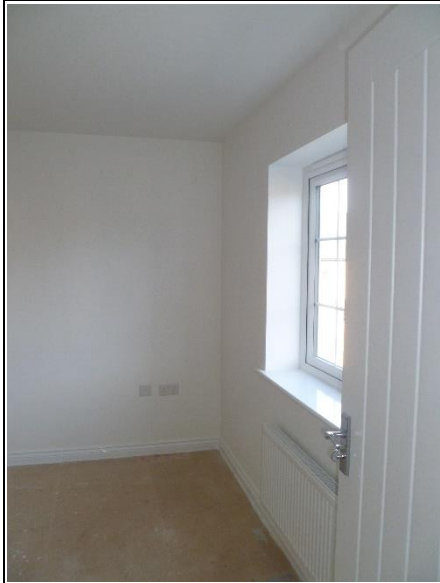
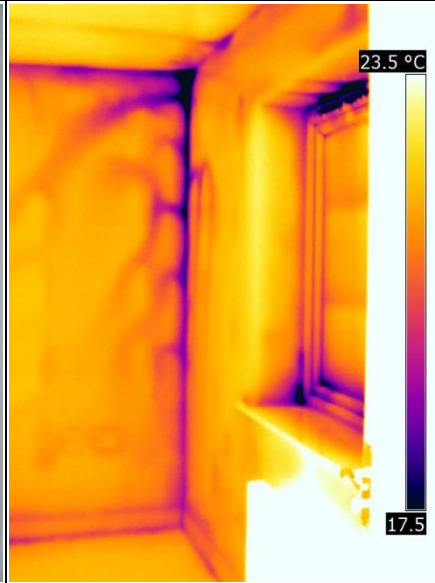
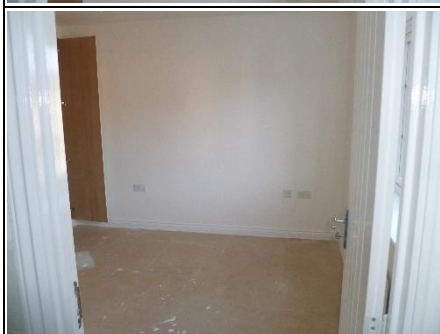
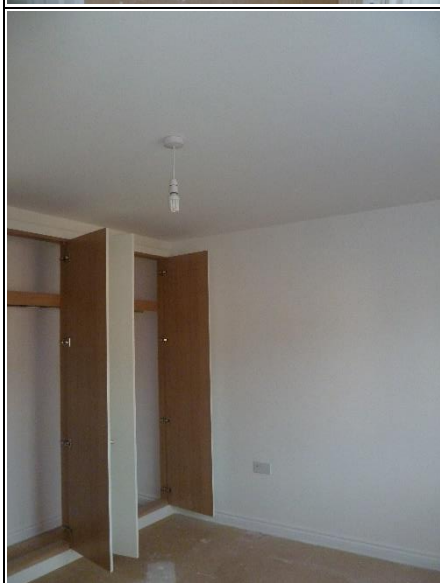
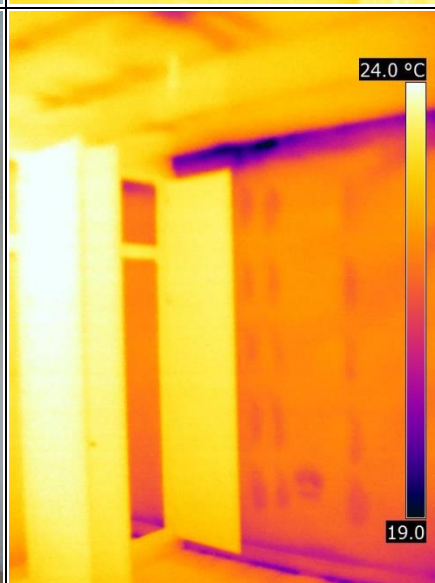
Bedroom 1 – Under depressurisation

Under depressurisation colder air can be seen being drawn in from the loft through ceiling penetrations, into the void behind the plasterboard dry lining and into some partition wall voids and emerging at places at the intermediate floor perimeter. The external wall at the ceiling perimeter, in particular, looks significantly colder than under natural conditions due to the change in air movement direction suggesting that air movement has a greater effect here than any thermal bridging or insulation discontinuity issues.

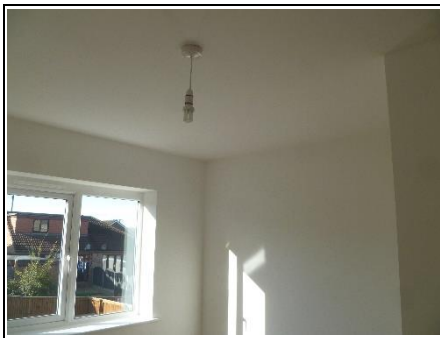
Bedroom 3 – Under natural conditions

As previous bedrooms.

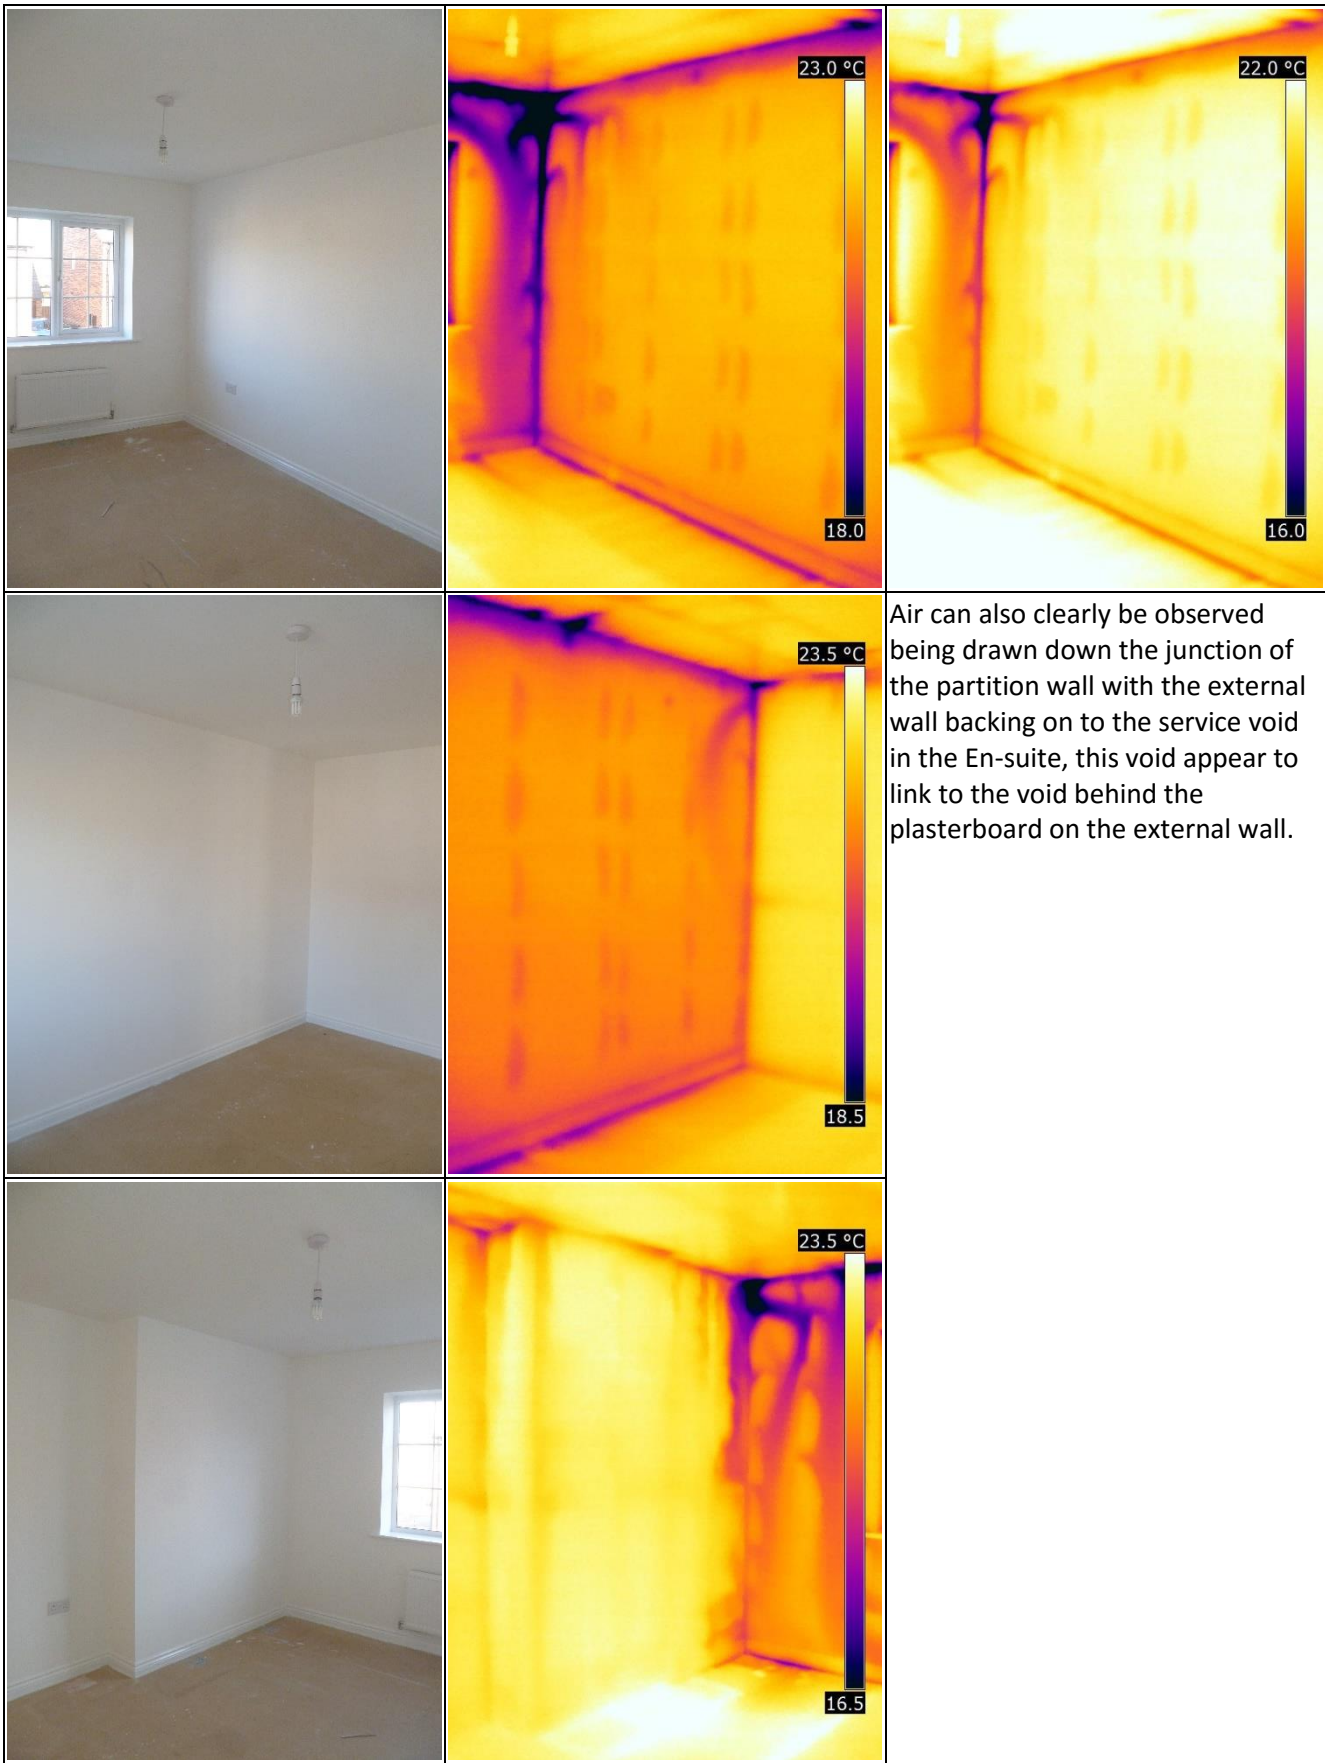
Air can also clearly be observed being drawn down the junction of the partition wall with the external wall backing on to the service void in the En-suite, this void appear to link to the void behind the plasterboard on the external wall.

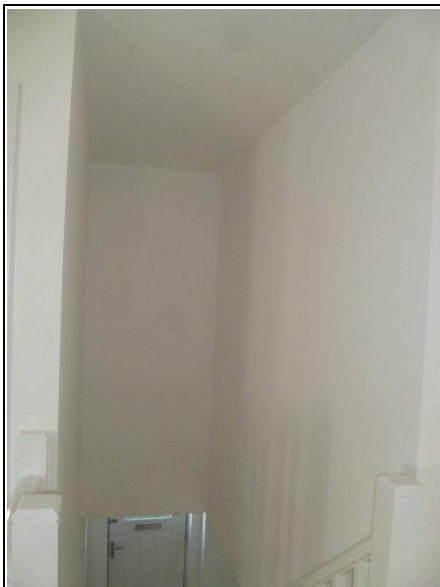
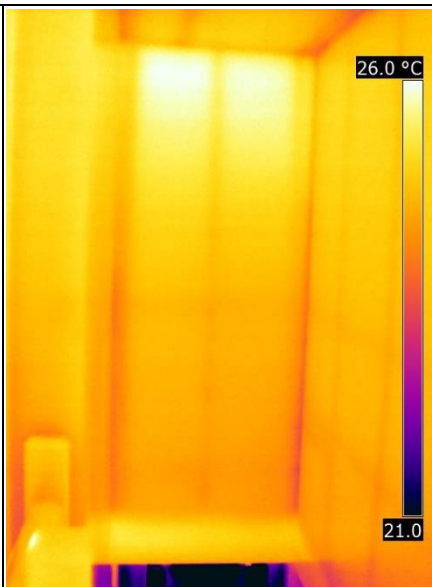
Landing – Under natural conditions

Some areas of dislodged loft insulation appear, the level and span of the thermal image makes some of these appear worse than they are (e.g. the minimum temperature of 22.7 °C in the adjacent image) due to the nearby hot water cylinder.
