Miles-Shenton, D (2018) Small Scale Forensic Thermal Imaging Study. Technical Report. Knauf Insulation.

Taylor Wimpey – Thermal Imaging Project

Site: Hele Park
 Newton Abbot
 TQ12 6JN

Plot(s): 294 & 297

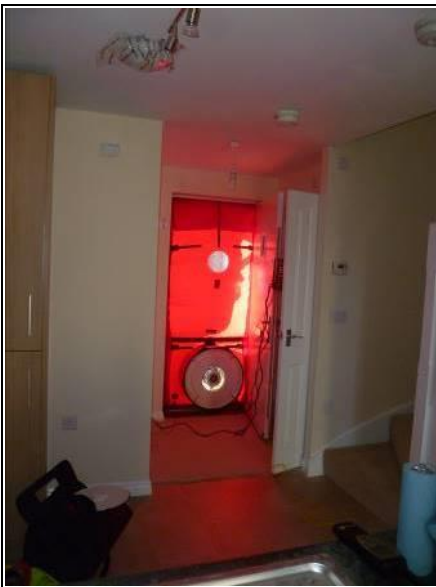
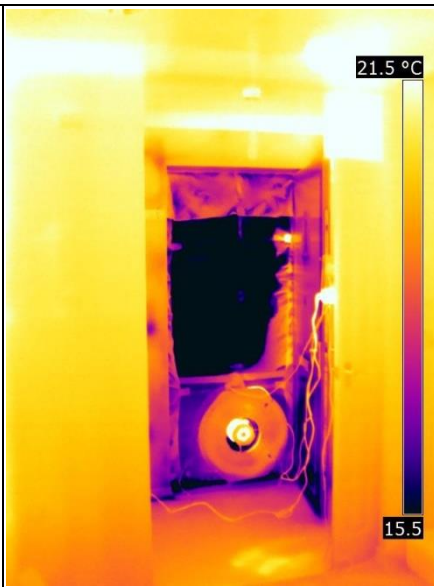
Hall – Under depressurisation

Under depressurisation air is blown out of the property through the blower door fan, allowing cooler air to enter the dwelling through uncontrolled ventilation paths (controlled ventilation such as extract vents and trickle vents are either closed or temporarily sealed for the purposes of this test).

The penetrations through the inner leaf blockwork observed previously are now more obvious as the internal/external pressure difference is held at around -50 Pascal. Cooler air can also be seen moving into the void behind the dry lining plasterboard around the door head and at the base of the door jamb.

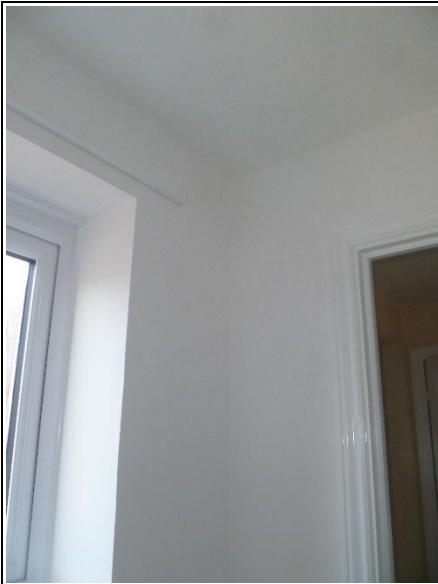
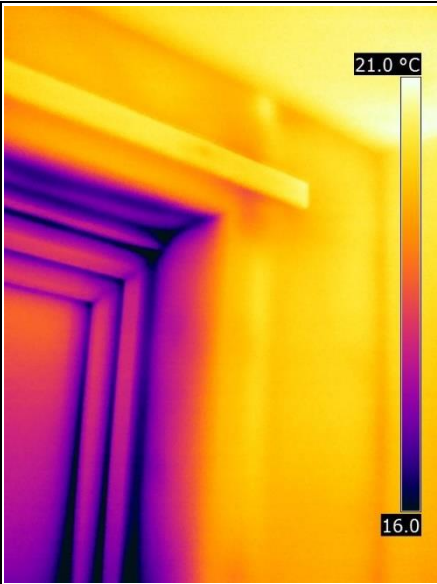
The window reveals varied between jamb and head, with the thermal bridge at the head continuing further than that at the jamb. Possibly there is just plasterboard and no insulation beneath the base plate of the lintel?

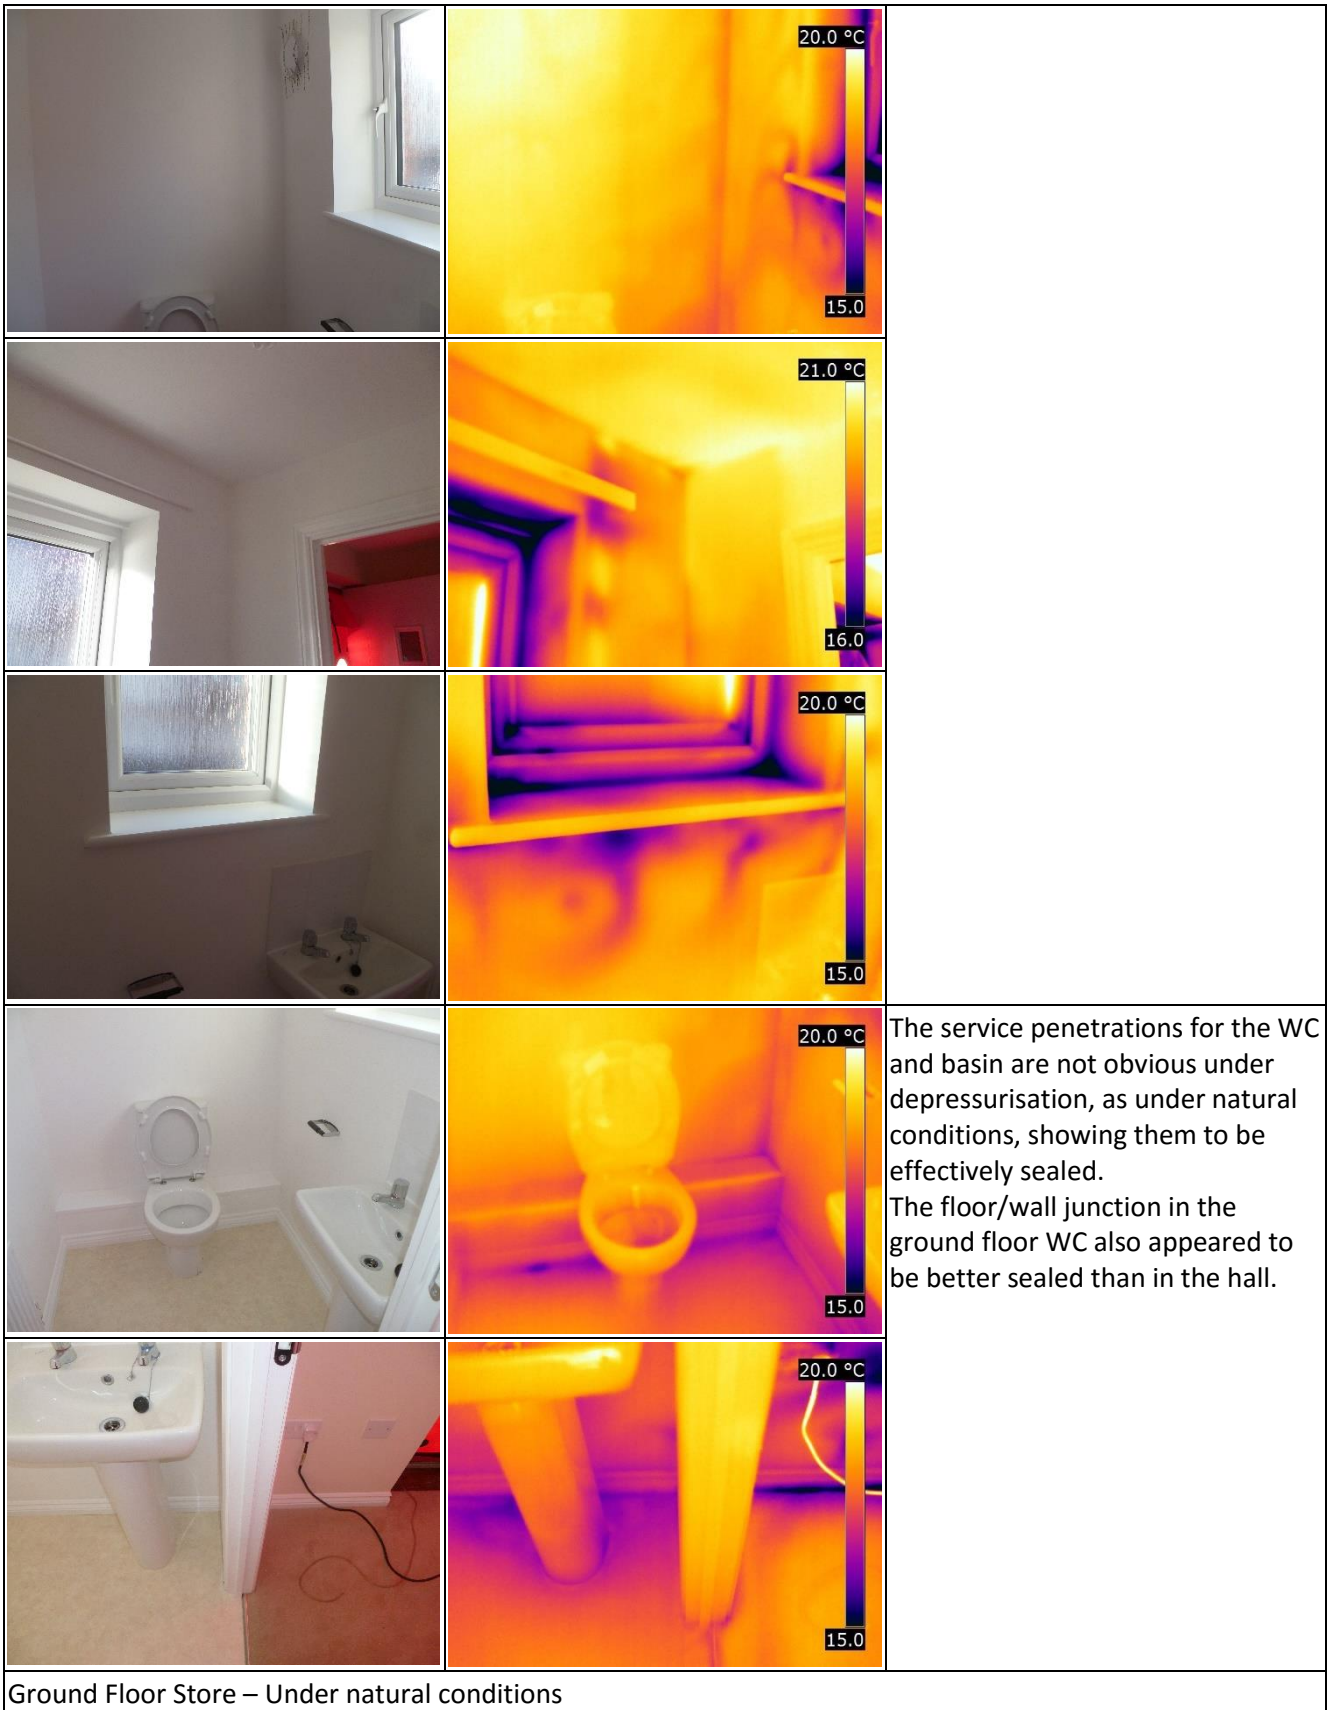
Under depressurisation air can be seen entering the void behind the dry lining and moving around the external wall and into the adjacent void on the party wall. The main points of entry appear to be around the window opening and particularly around the sill board.

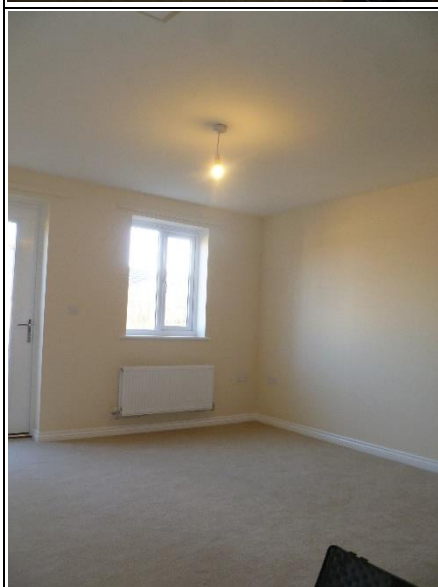
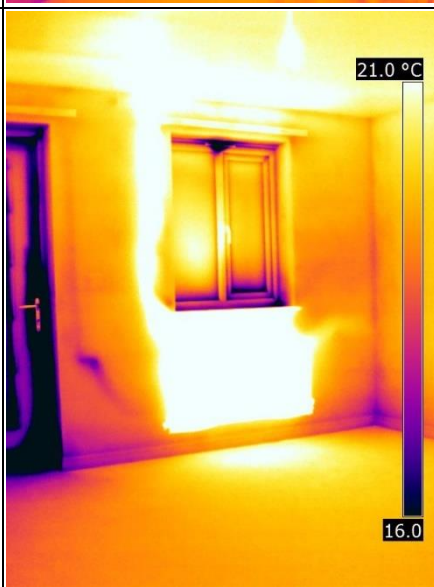
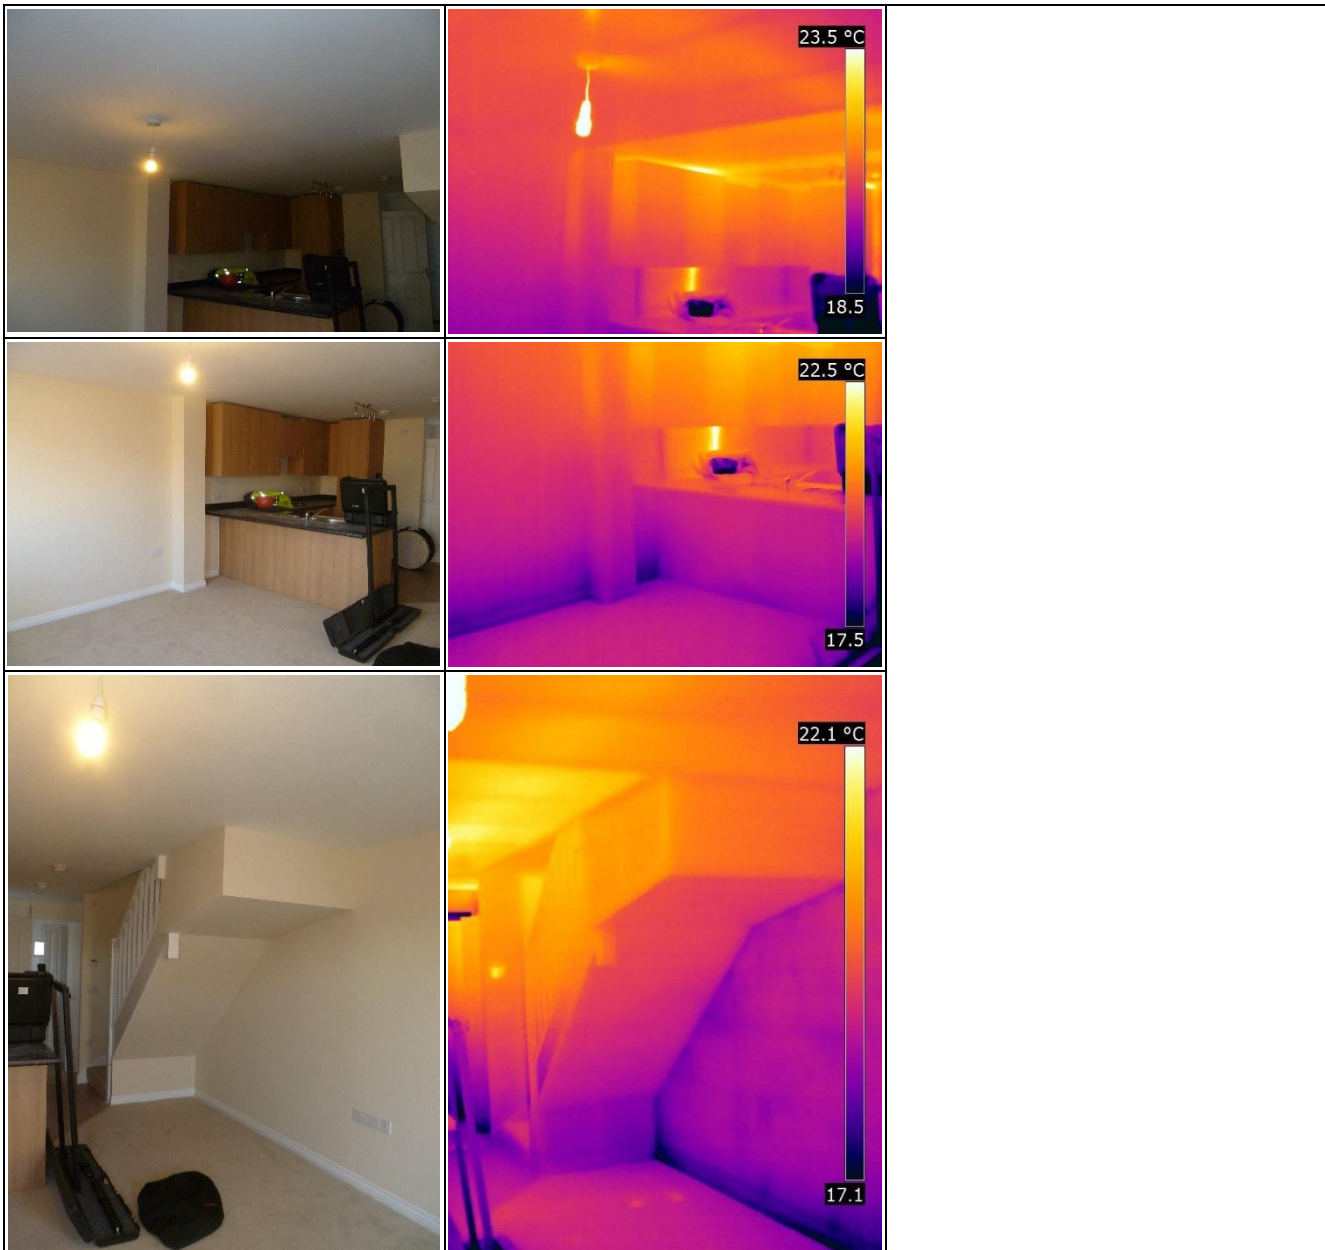
Under natural conditions there is a slight cooler area at the ground floor perimeter, a cold spot on the rear wall where the outside tap is sited, indications of air leakage around the back door (particularly around the 3 door hinges) and a very cold threshold.

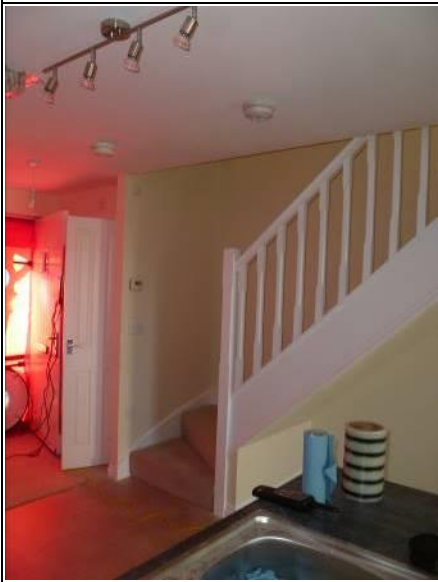
Under depressurisation cold air from the loft was observed being drawn down behind the dry lining on the gable wall, around the plasterboard adhesive dabs. Although nothing appeared to be being drawn down the internal partition voids.

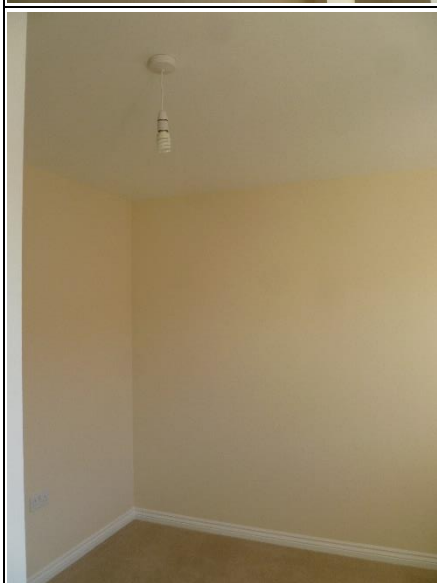
Air leakage was observed around most trickle vents under depressurisation. Generally the vents closed quite well, but infiltration occurred between the vents themselves and the window frames which they were only push-fitted against and not sealed.

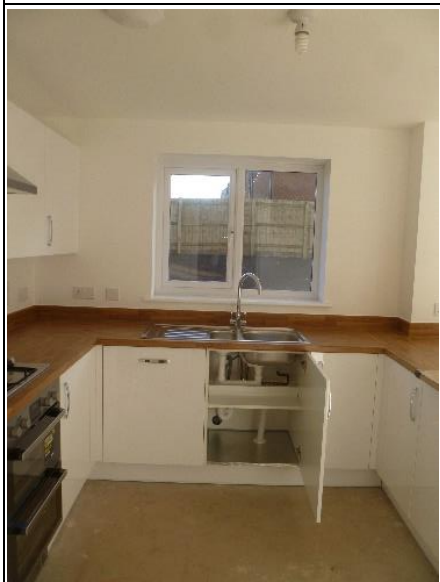
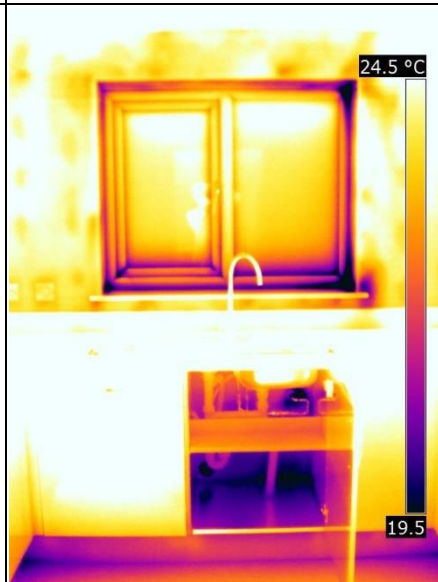
The Dining/Kitchen extended across the entire rear elevation at the ground floor; unlike the Lounge and Study this was on the leeward side of the dwelling and infiltration around the windows under natural conditions was much reduced. However the patio door jambs and threshold appeared particularly cool. The jamb adjacent to the kitchen was even colder than the window head, but this was partially due to shading by the frame. The threshold also appeared very cool.

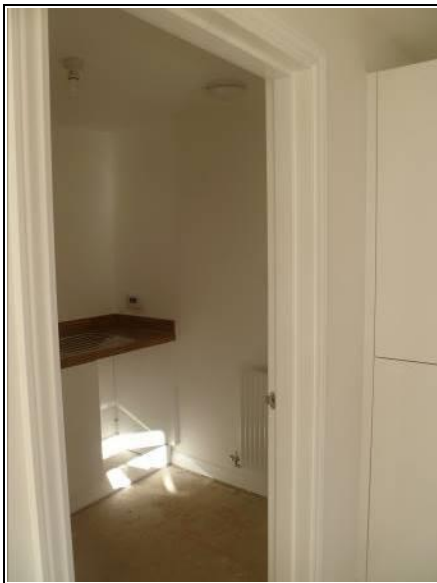
The floor wall junction backing on to the garage looked cooler, but as this room was warmer than the rest of the house it was hard to tell if this was significant.

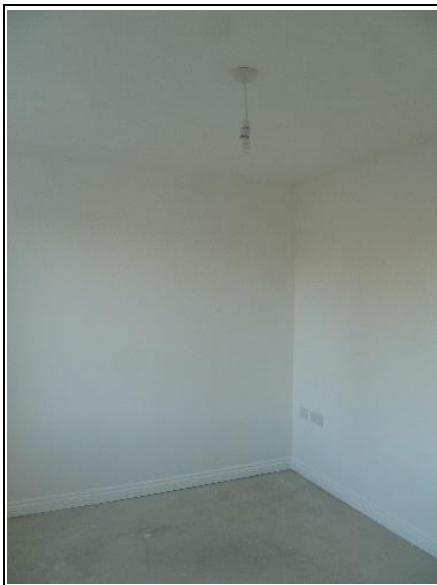
On the gable wall there are a couple of spots that again appear to line up with the inner leaf mortar courses. However, the position of the electricity meter box is not visible internally under pressurisation, unlike what was observed with fully filled walls behind meter boxes.

As with most windows and trickle vents observed on this site; the windows function well but allow significant air exchange between the void behind the dry lining and the external wall cavity, and the trickle vents close effectively but are not actually sealed to the window frames.

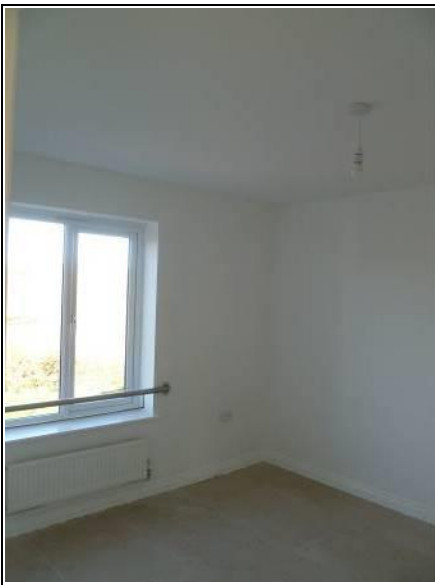
Bedroom 5 – Under natural conditions

The cooler North corner shows some cold spots possibly due to gaps in the inner leaf blockwork.

As in bedroom 3 warm air can be seen being drawn up from the intermediate floor void into the dry lining void under natural conditions on both external walls above
