Miles-Shenton, D (2018) Small Scale Forensic Thermal Imaging Study. Technical Report. Knauf Insulation.

Taylor Wimpey – Thermal Imaging Project

Site: Kingsbrook Place

Visit Date: 15th November 2017

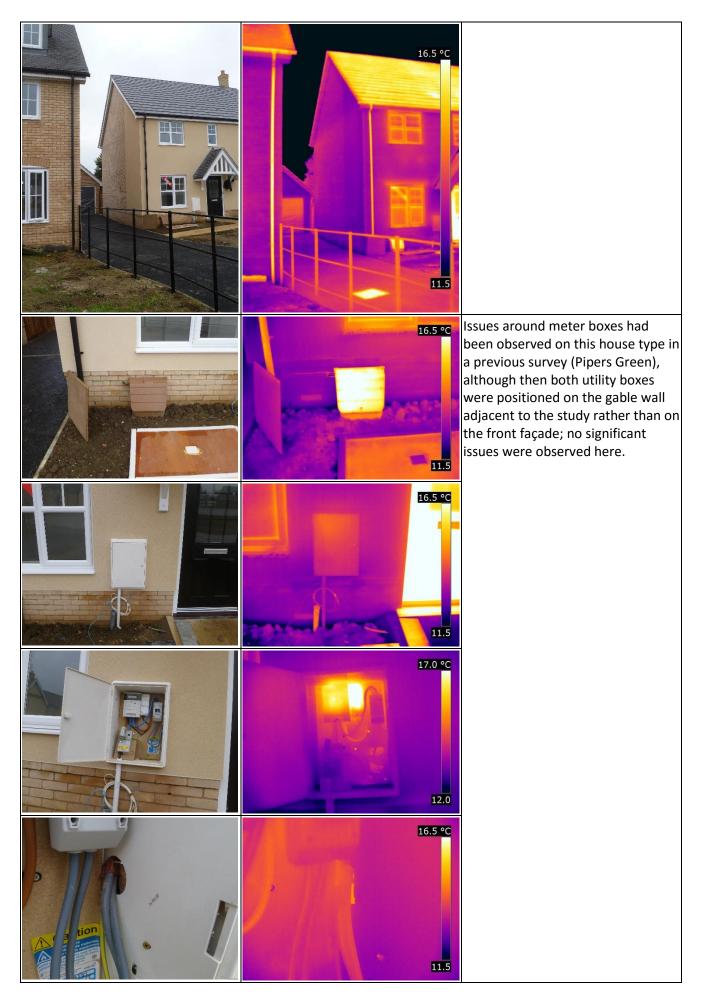
Plot 8 External - Under natural conditions

temperatures.
Even reducing the thermal image span to 2.5° to intensify any surface temperature differences little extra can be observed besides warmer areas of walls where radiators are positioned internally:

The heat loss observed in the previous survey of this house type at the ground floor perimeter (Pipers Green, 08-Nov-2017) was not apparent on this site.

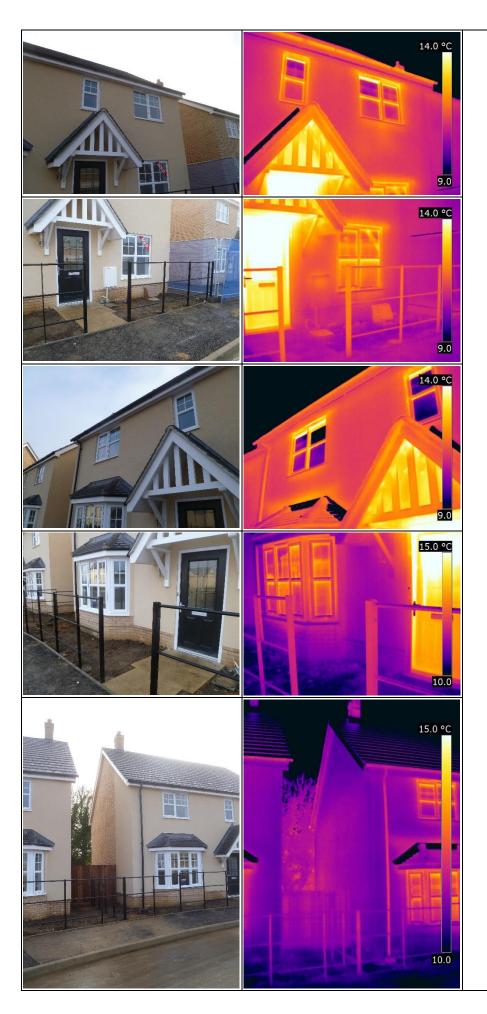
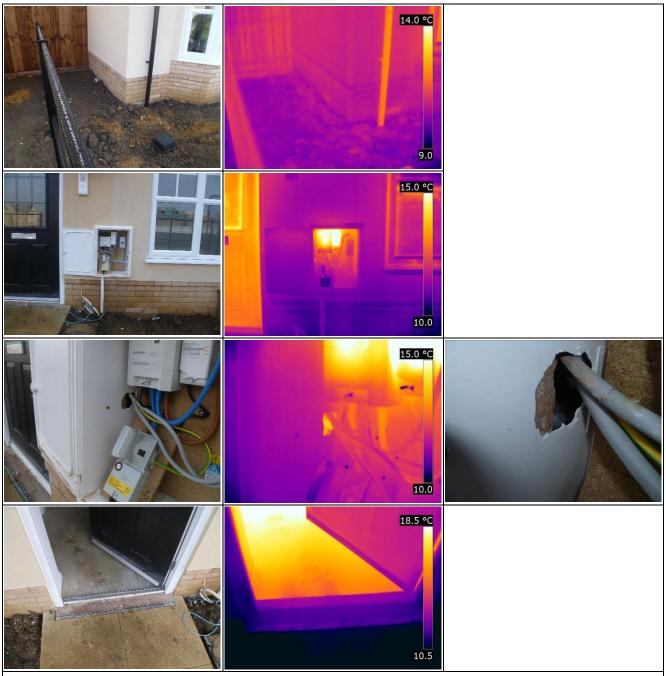
Plot 9 External - Under natural conditions

No significant thermal anomalies were seen from outside the property; slightly warmer areas were again observed adjacent to the bedroom radiators, the meter boxes showed no reasons for concern.

Warmer areas were observed on the external wall at window openings, particularly heads, and above the bay roof but these only appeared significant when manipulating the thermal image span to 2.5° to accentuate any differences:

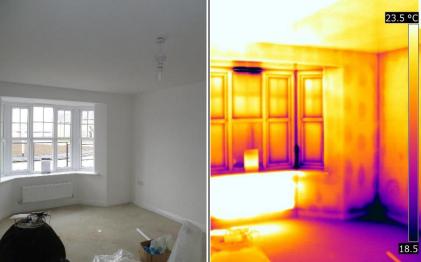
Plot 9 Lounge – Under natural conditions

Again, the external wall appeared marginally cooler at the bottom than was expected from just the natural temperature stratification in the room and the fact that the top part of the wall reflected the warm ceiling and the bottom part reflected the colder floor. The bay roof again showed minor cooler spots along the lines of the external wall above. There was also some noticeable cold air infiltration at the bay window without any

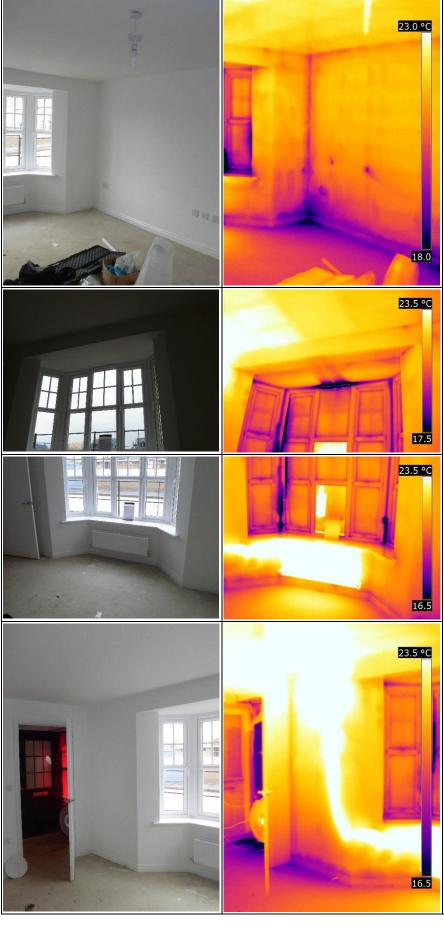
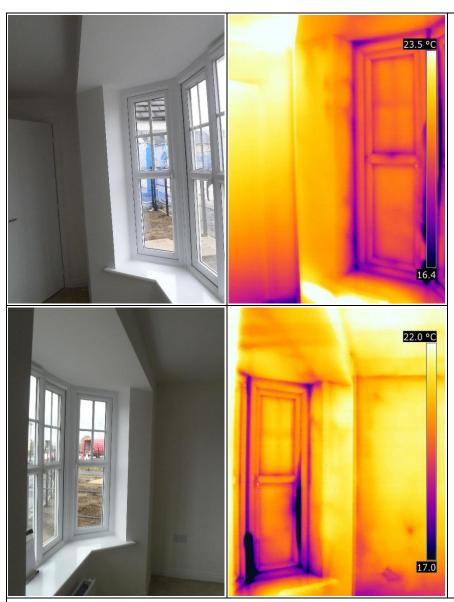
Plot 9 Lounge – Under depressurisation

There appear to be some spots on the external wall where air is being drawn into the void behind the plasterboard directly from the external wall cavity, most probably due to gaps in the mortar in the inner leaf blockwork. This air from the cavity appears to have cooled the void behind the plasterboard

enough to reduce the temperature differential between areas of dry lining directly over and away from the adhesive dabs.

The line of the external wall is more distinct on the bay ceiling, as is air infiltration around the window and through/around the closed trickle vent.

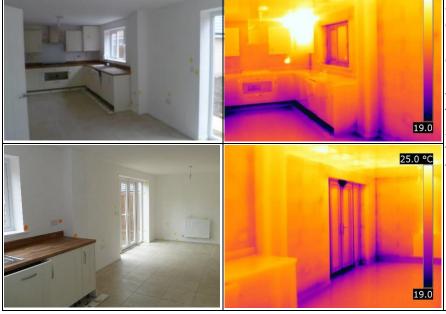
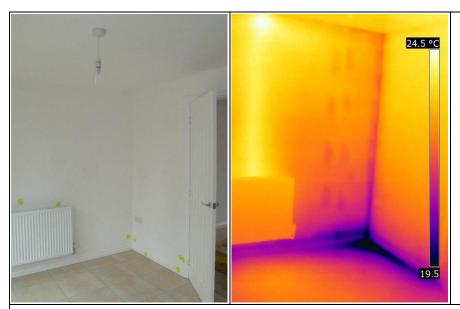
Plot 8 Dining / Kitchen – Under natural conditions

Some additional thermal bridging around the patio doors was observed, in comparison to the kitchen window, where the patio doors were positioned further out into the external wall than the window, but nothing substantial. The external walls appeared to show a slightly decreased temperature gradient to those in the lounge.

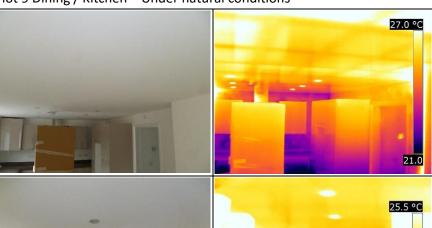
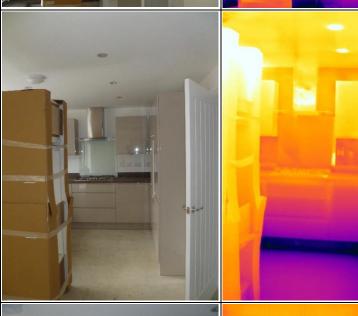
Plot 9 Dining / Kitchen – Under natural conditions

This was much as in Plot 8, but the floor to ceiling thermal gradient was more like that observed in the lounges.

Another unexplained cold vertical strip, as seen in the lounge in plot 8 was visible to the right of the patio doors

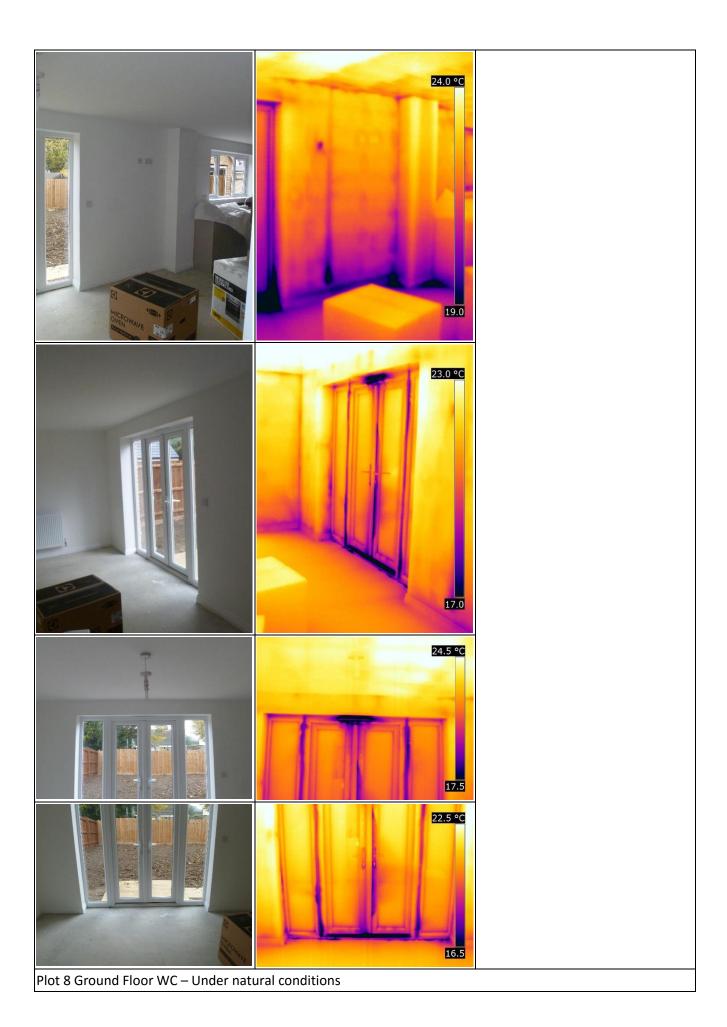
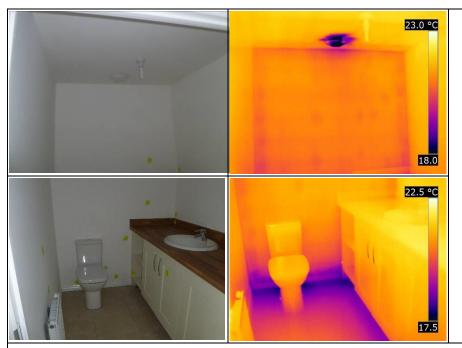
Plot 9 Dining / Kitchen – Under depressurisation

Cold air infiltration was detected around some electrical service penetrations into the void behind the dry lining, including the outside light by the patio doors, and at the floor/ceiling junction by the boxedin SVP.

The patio doors appeared to allow a greater amount of air movement between the doors, between the doors and side lights and through/around the trickle vent.

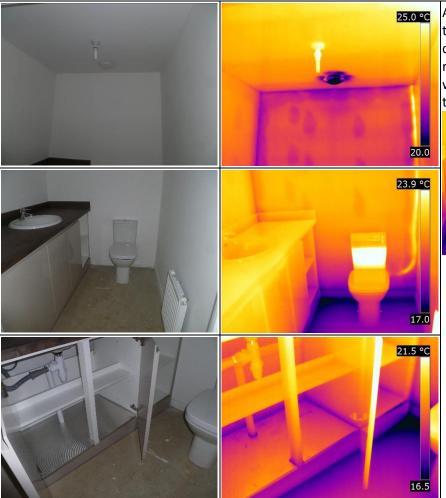
Plot 9 Ground Floor WC – Under natural conditions

As observed in plot 8, apart from the curiously warm water in the cistern at over 26°C (this had been recently flushed to ensure all traps were full, but it was still warmer than the rest of the house).

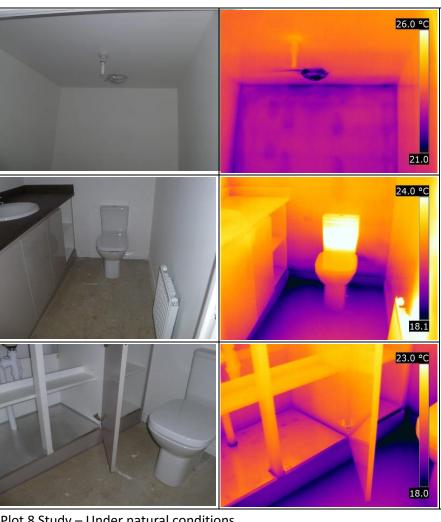
Plot 9 Ground Floor WC – Under depressurisation

No real differences were observed under depressurisation, although in the 1hr 20min since the previous thermal images the temperature of the cistern has dropped to 25.5°C and the supply pipe fallen to the ambient temperature of the external wall.

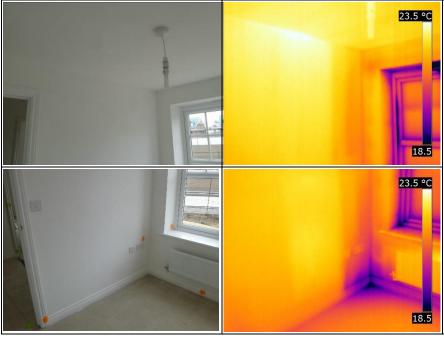
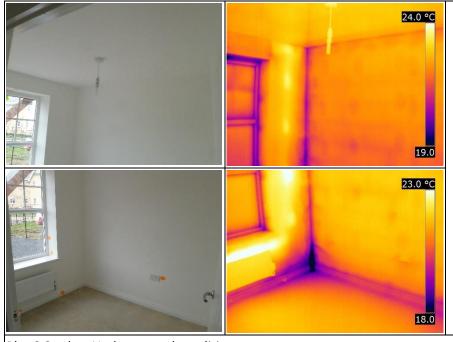
Plot 8 Study – Under natural conditions

A cooler section was seen on the internal wall adjacent to the boxedin services in the hall where the electric box and consumer unit were sited, this was noticeably cooler nearer the floor junction. The external corner on the front façade backing onto the gas meter box also appeared cooler.

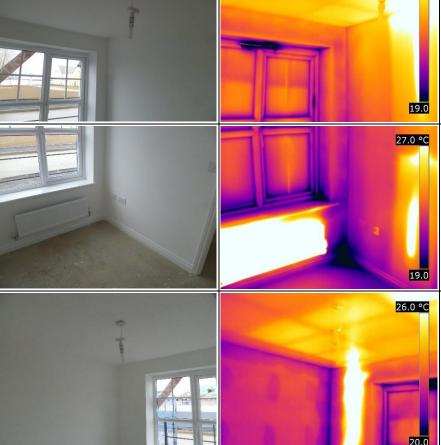
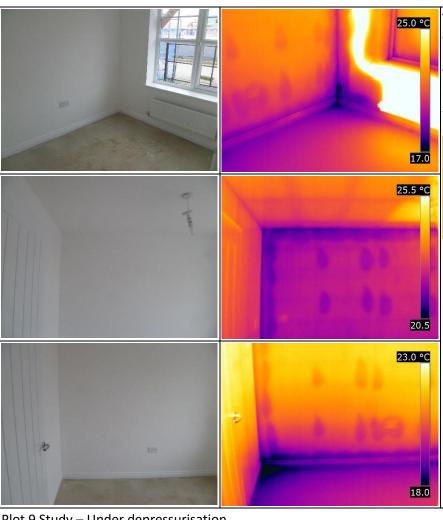
Plot 9 Study – Under natural conditions

As in plot 8 a cooler section was seen on the internal wall adjacent to the boxed-in services in the hall for the electric box and consumer unit. This appears worse due to the hot spot on the internal wall where the hall radiator pipework was visible.

Again, the external corner where the gas meter box was positioned was noticeably cooler than the surrounding areas, even considering corner effects of the thermal imaging (where colder surfaces are reflecting each other making the internal corners appear cooler than they actually are).

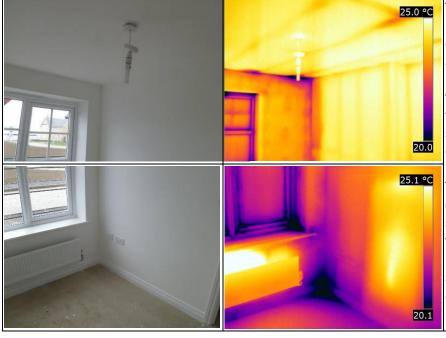
Plot 9 Study – Under depressurisation

The internal wall adjacent to the boxed-in services in the hall for the electric box and consumer unit appears even more distinct, possible due to air infiltration into this void under depressurisation; with a clear stratification along the study/hall partition from the external wall to where the hall radiator pipework remains visible. The gas meter box also remain welldefined, without air infiltration spreading out from it, indicating that the cooler patch here is due to it being less well insulated than the surrounding area rather than cold air entering through inner leaf wall penetrations.

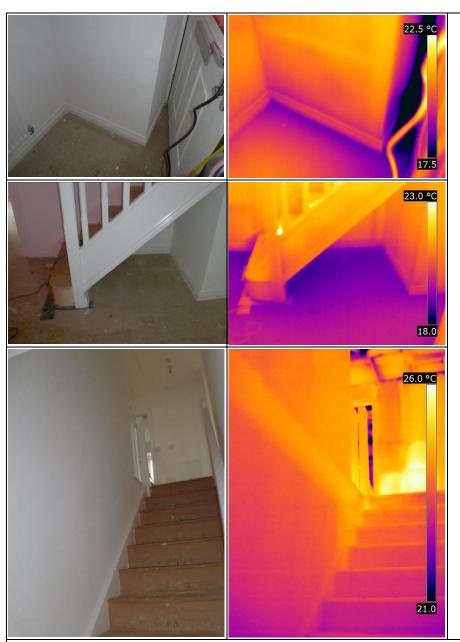
Plot 9 Hall – Under depressurisation

Under depressurisation it appears that colder air is being drawn into the boxed-in service void, as differing wall temperatures can be seen below the consumer unit.

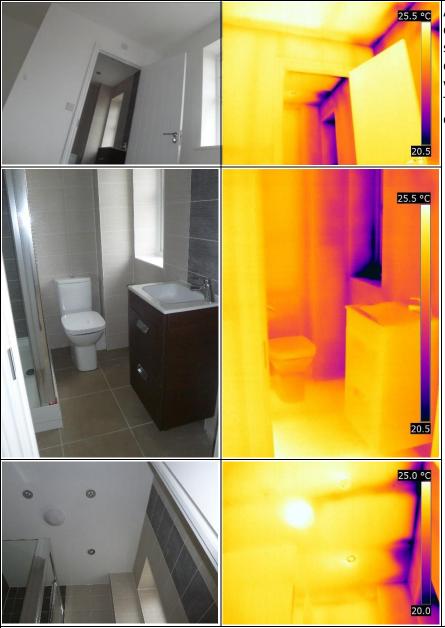
Plot 9 En-Suite - Under natural conditions

As in plot 8, the cold section of ceiling at the external wall junction suggests that the loft insulation does not extend fully to meet up with the wall insulation. The boxed-in SVP also appears to be cooler.

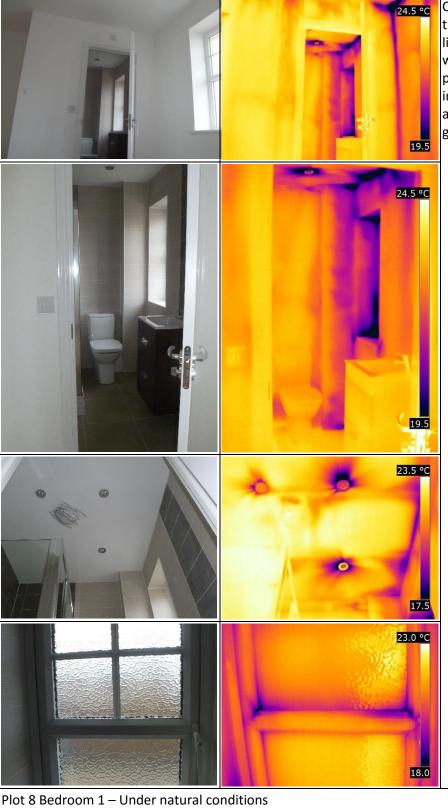
Plot 9 En-Suite – Under depressurisation

Cooler air is detected drawn in from the loft around recessed ceiling lights, into the internal partition walls, into the void behind the plasterboard on the external walls, into the bowed-in SVP riser and around some of the beading of the glazing panels.

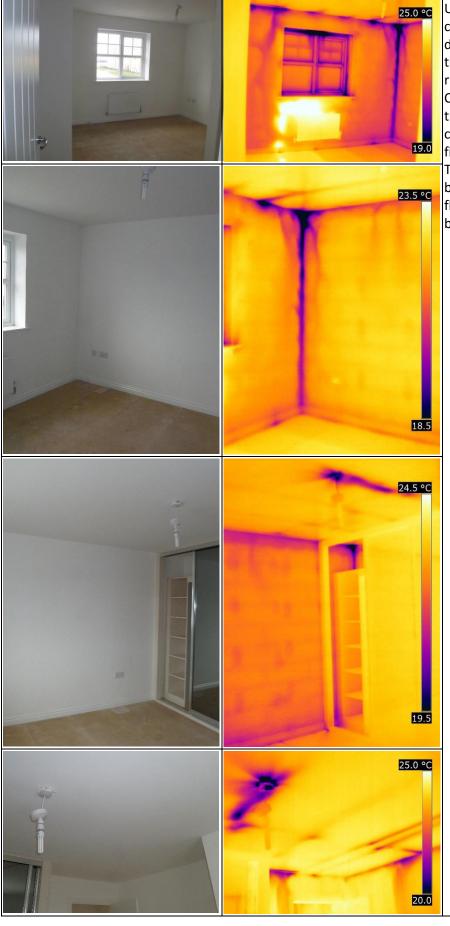
Plot 9 Bedroom 1 – Under depressurisation

Under depressurisation colder air can be seen being drawn down the dry lining voids on the external wall through gaps in the adhesive ribbons.

Cold air in the loft can also be seen tracking the cabling for the central ceiling light, emerging at the rose fitting.

There is some stratification between joists of the intermediate floor which was not observed from beneath.

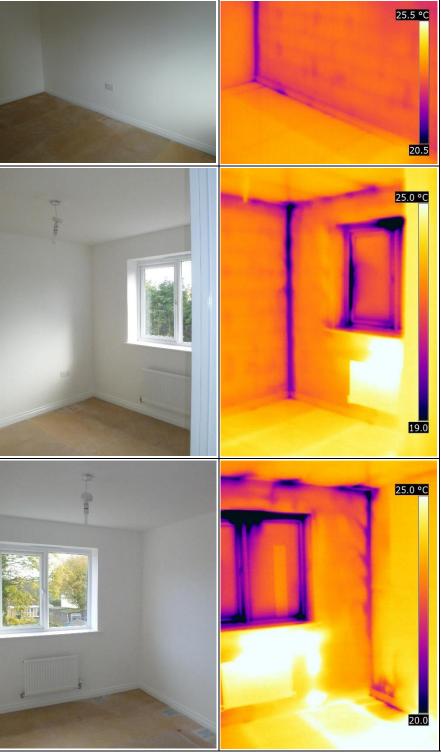
Plot 9 Bedroom 4 – Under depressurisation

Air was again observed being drawn in from the loft into the dry lining void, although to a lesser extent than seen in Bedroom 1 along the gable wall.

The internal partition wall that backs onto the service void in the bathroom was cooler than the rest of the wall, and allowed colder air

to enter the dry lining void along its full height and air to emerge around the floor/wall junction at the bottom.

Direct air infiltration at the window was also clear.

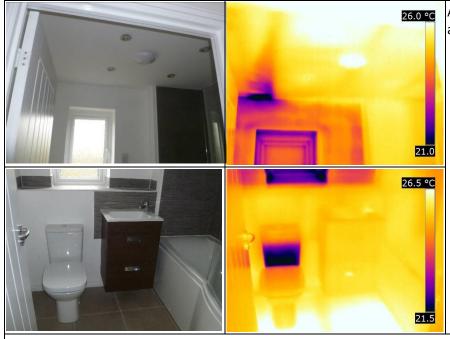
Plot 9 Bathroom - Under natural conditions

As in plot 8, the coldest surface appears to be at the eaves junction.

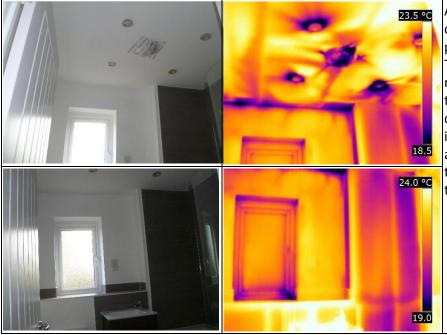
Plot 9 Bathroom - Under depressurisation

As in the En-suite, cooler air is drawn in from the loft in many places.

The boxed-in service void to the right of the window was warmer than the external wall under natural conditions, under depressurisation it is now markedly cooler. Air was also detected in the void behind the toilet and basin, emerging around the soil pipe penetration.

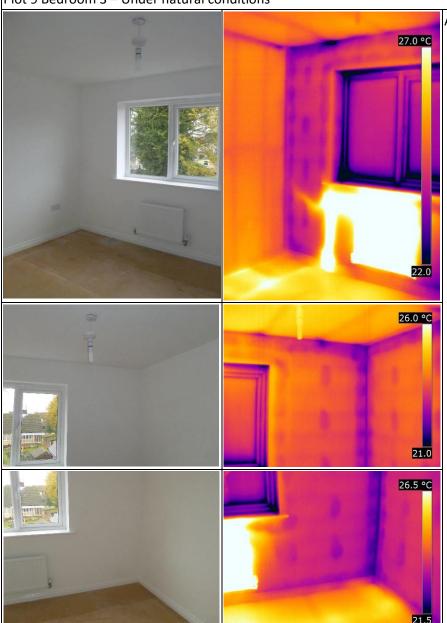
Plot 9 Bedroom 3 – Under natural conditions

As observed in previous bedrooms.

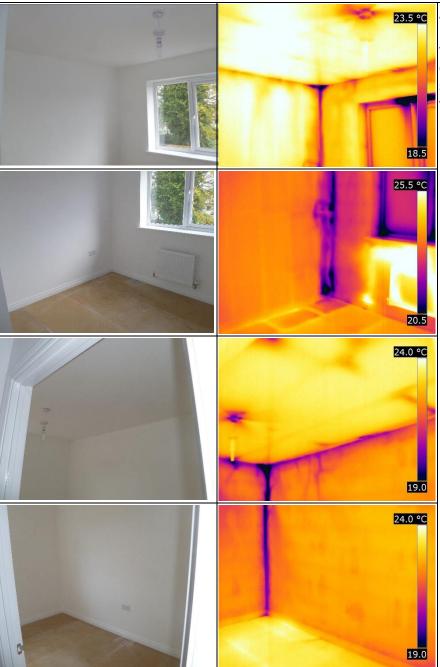
Plot 9 Bedroom 3 – Under depressurisation

As observed in Bedroom 4; here the partition wall backing onto a service void in the bathroom was even cooler with cooler air appearing to spread into the intermediate floor void.

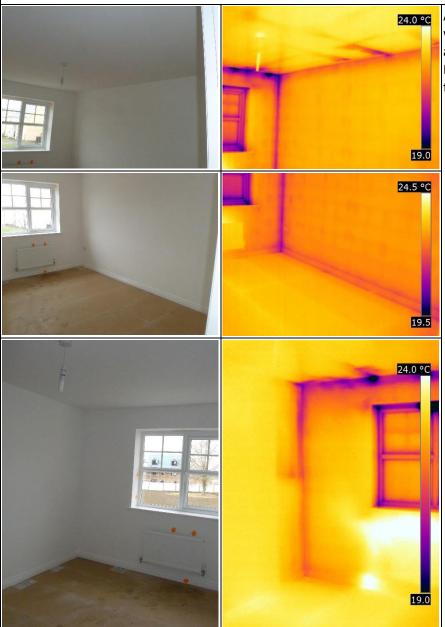
Plot 8 Bedroom 2 – Under natural conditions

As observed in previous bedrooms, with the section of partition wall adjacent to the service void in the En-suite clearly visible in the thermal image.

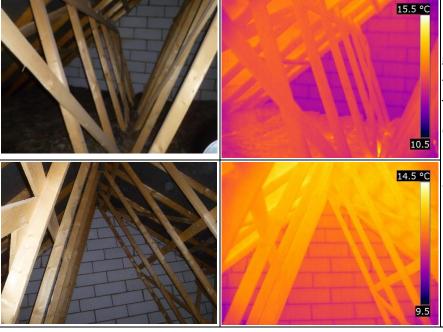
Plot 9 Loft - Under natural conditions

Looking toward the SE Gable the loft insulation appeared to be laid reasonably well, right up to the gable wall and without gaps.
At some of the truss rafter angled junctions additional heat loss could be detected, as could be seen from cooler areas below.

It was not possible to see the insulation at the eaves junctions, no attempt was made to lift the insulation to view services running beneath it.
