Taylor Wimpey – Thermal Imaging Project

Site: Kingsbrook Place
 Elmstree, Bury St Edmunds
 IP30 9HA

Visit Date: 15th November 2017

Plot(s): 8 & 9

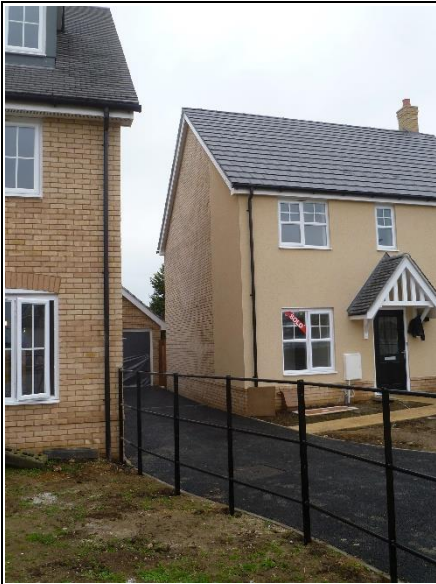
Plot 8 External - Under natural conditions

<p>There had been recent direct solar and drizzle prior to the external thermal survey for this property, affecting apparent surface temperatures. Even reducing the thermal image span to 2.5° to intensify any surface temperature differences little extra can be observed besides warmer areas of walls where radiators are positioned internally:</p>

<p>The heat loss observed in the previous survey of this house type at the ground floor perimeter (Pipers Green, 08-Nov-2017) was not apparent on this site.</p>

Issues around meter boxes had been observed on this house type in a previous survey (Pipers Green), although then both utility boxes were positioned on the gable wall adjacent to the study rather than on the front façade; no significant issues were observed here.

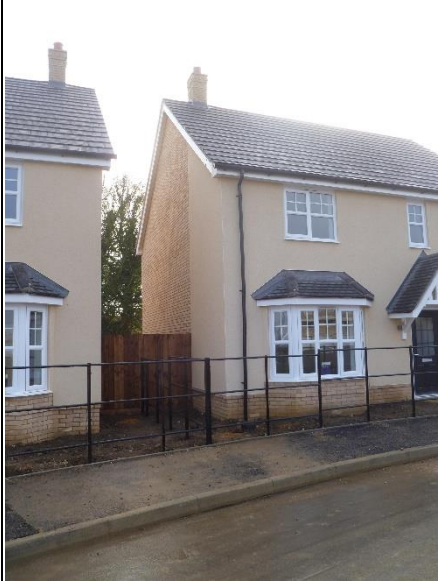
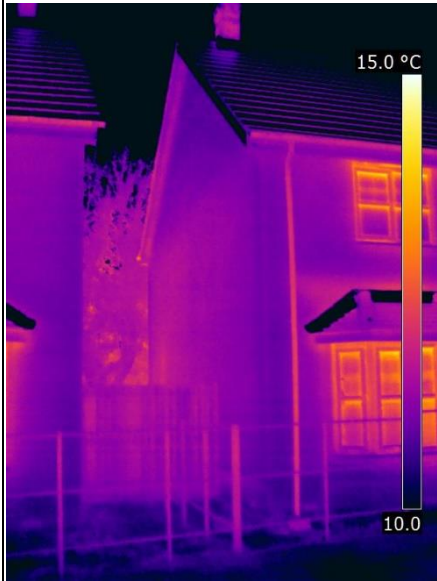
Plot 9 External - Under natural conditions

No significant thermal anomalies were seen from outside the property; slightly warmer areas were again observed adjacent to the bedroom radiators, the meter boxes showed no reasons for concern.

Warmer areas were observed on the external wall at window openings, particularly heads, and above the bay roof but these only appeared significant when manipulating the thermal image span to 2.5° to accentuate any differences:

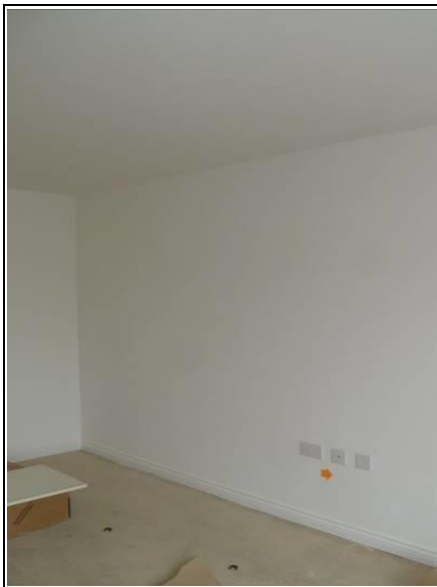
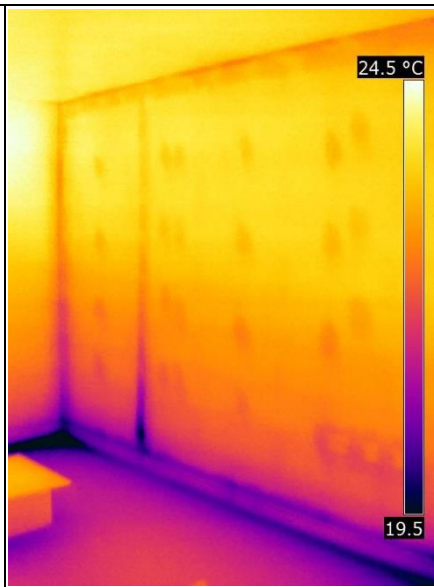
Plot 8 Lounge – Under natural conditions

still appeared slightly cooler than expected, although this was not reflected in the external images.

There was also colder vertical strip which was not observed from outside due to the fence between the dwellings.

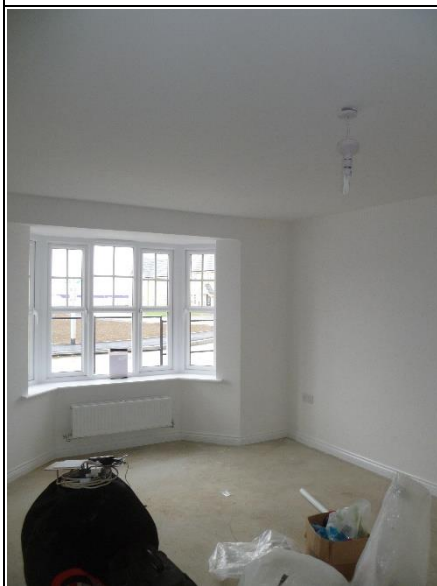
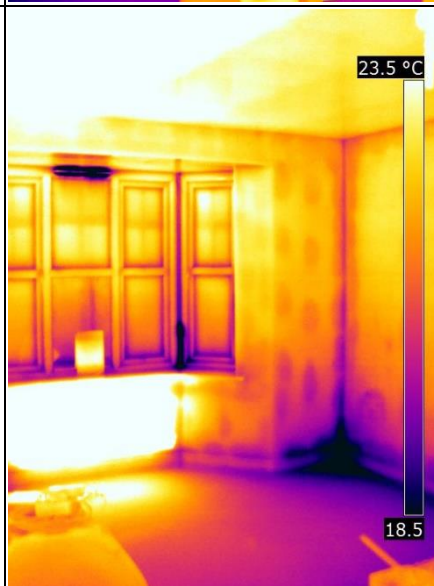
Plot 9 Lounge – Under natural conditions

Again, the external wall appeared marginally cooler at the bottom than was expected from just the natural temperature stratification in the room and the fact that the top part of the wall reflected the warm ceiling and the bottom part reflected the colder floor.

The bay roof again showed minor cooler spots along the lines of the external wall above. There was also some noticeable cold air infiltration at the bay window without any induced negative pressure.

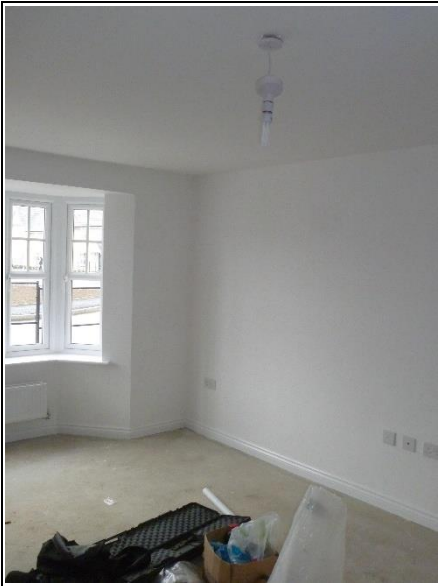
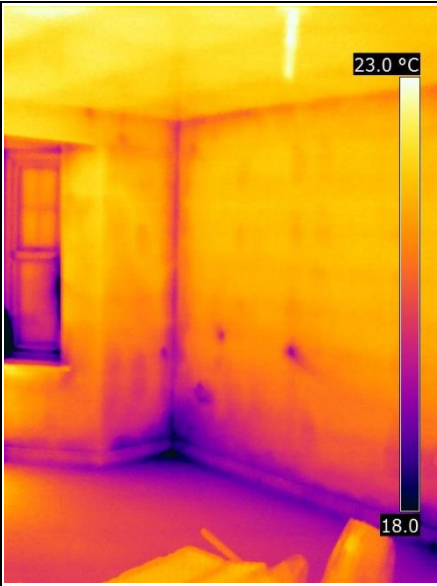
Plot 9 Lounge – Under depressurisation

There appear to be some spots on the external wall where air is being drawn into the void behind the plasterboard directly from the external wall cavity, most probably due to gaps in the mortar in the inner leaf blockwork. This air from the cavity appears to have cooled the void behind the plasterboard

enough to reduce the temperature differential between areas of dry lining directly over and away from the adhesive dabs.

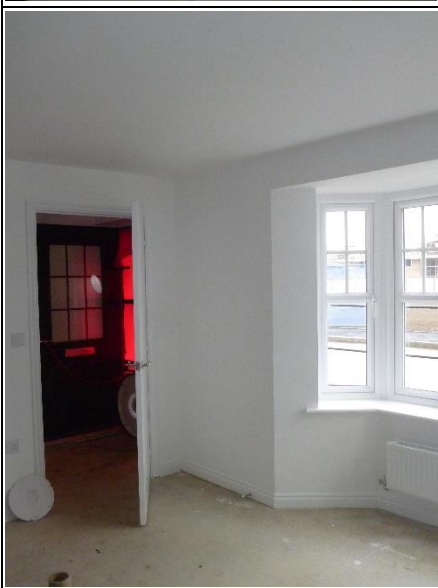
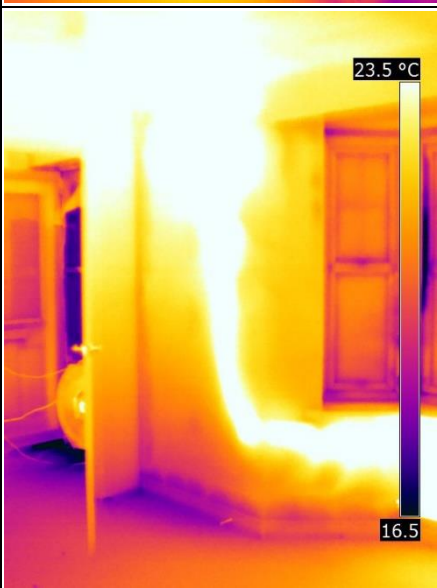
The line of the external wall is more distinct on the bay ceiling, as is air infiltration around the window and through/around the closed trickle vent.

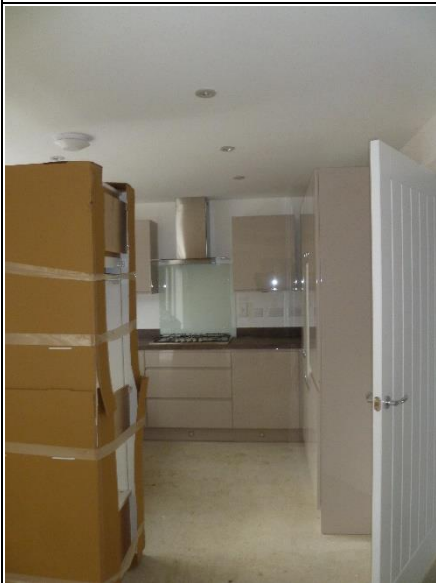
Plot 9 Dining / Kitchen – Under natural conditions

This was much as in Plot 8, but the floor to ceiling thermal gradient was more like that observed in the lounges.
Another unexplained cold vertical strip, as seen in the lounge in plot 8 was visible to the right of the patio doors

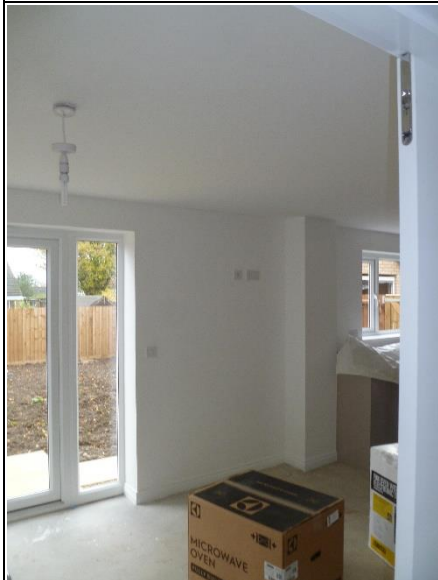
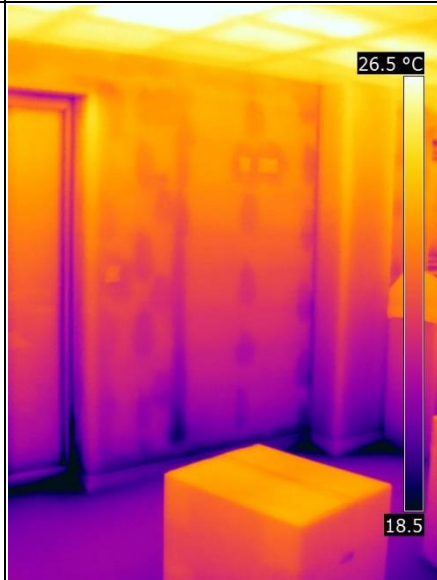
Plot 9 Dining / Kitchen – Under depressurisation

<p>Cold air infiltration was detected around some electrical service penetrations into the void behind the dry lining, including the outside light by the patio doors, and at the floor/ceiling junction by the boxed-in SVP.</p>
		<p>The patio doors appeared to allow a greater amount of air movement between the doors, between the doors and side lights and through/around the trickle vent.</p>

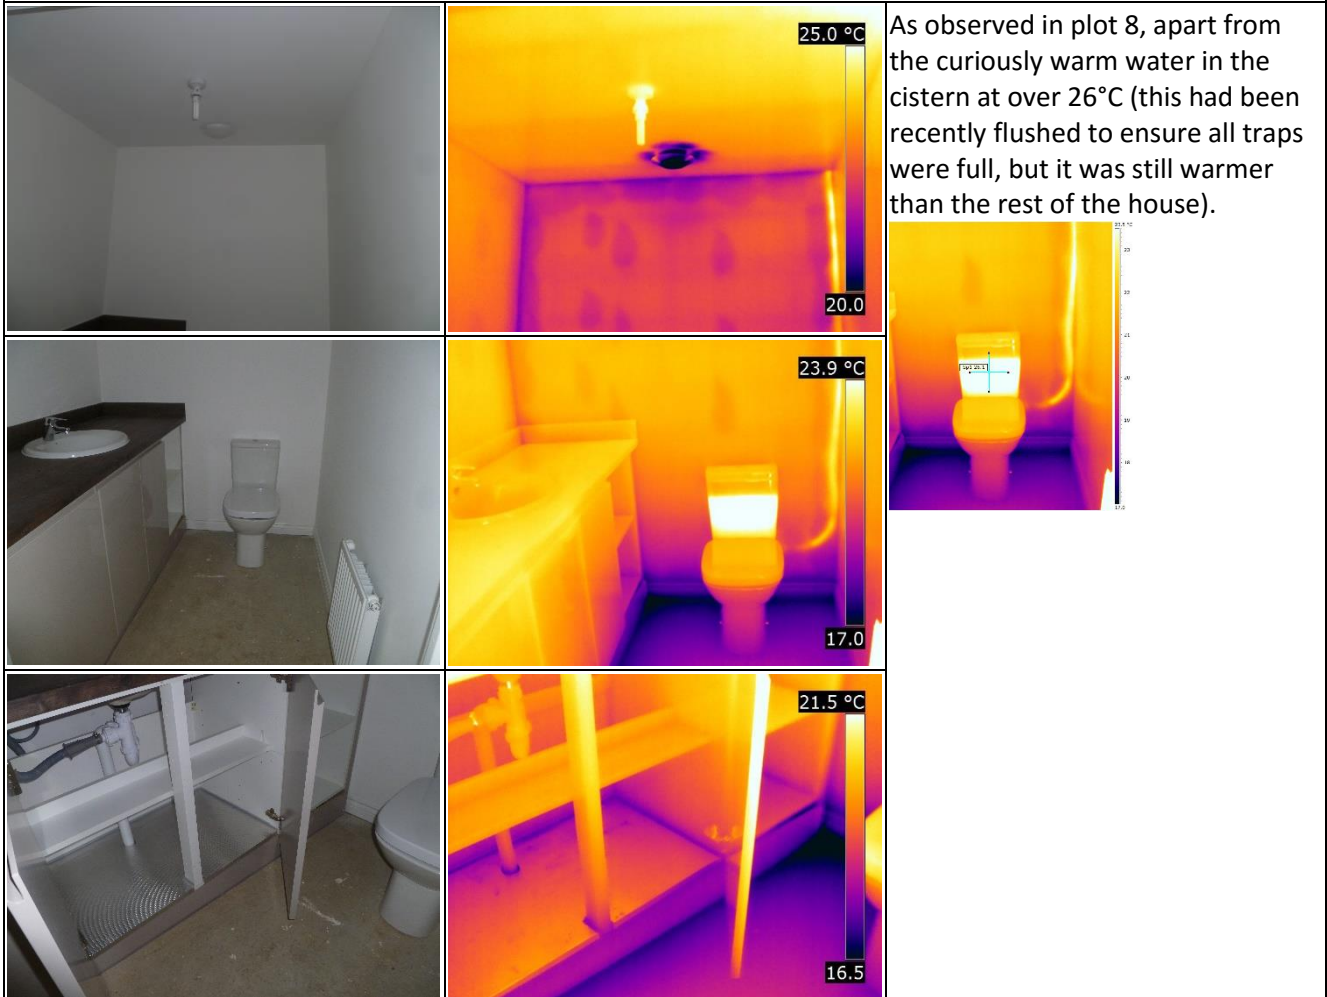
Plot 9 Ground Floor WC – Under natural conditions

As observed in plot 8, apart from the curiously warm water in the cistern at over 26°C (this had been recently flushed to ensure all traps were full, but it was still warmer than the rest of the house).

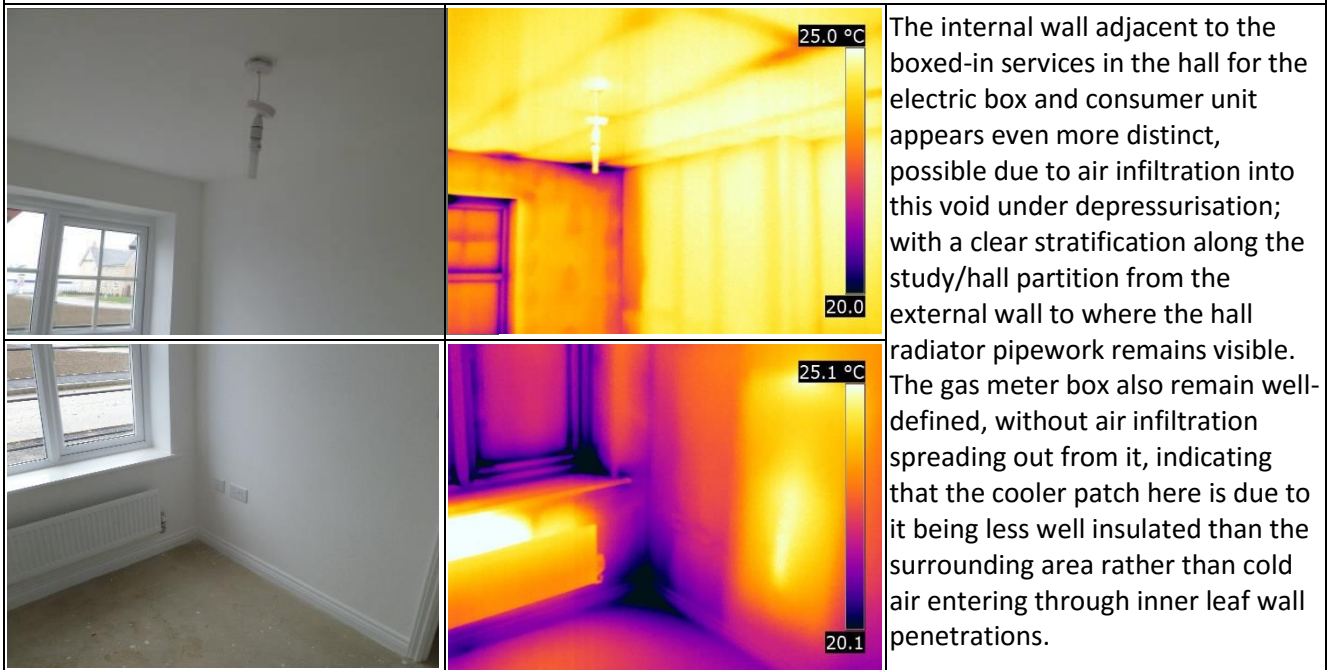
Plot 9 Study – Under depressurisation

The internal wall adjacent to the boxed-in services in the hall for the electric box and consumer unit appears even more distinct, possible due to air infiltration into this void under depressurisation; with a clear stratification along the study/hall partition from the external wall to where the hall radiator pipework remains visible. The gas meter box also remain well-defined, without air infiltration spreading out from it, indicating that the cooler patch here is due to it being less well insulated than the surrounding area rather than cold air entering through inner leaf wall penetrations.

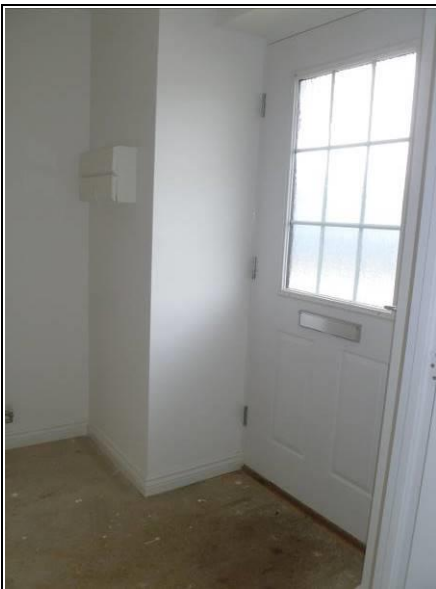
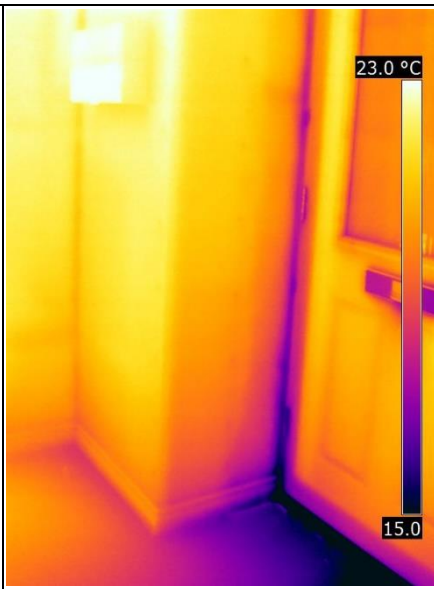
Plot 9 Hall – Under depressurisation

Under depressurisation it appears that colder air is being drawn into the boxed-in service void, as differing wall temperatures can be seen below the consumer unit.

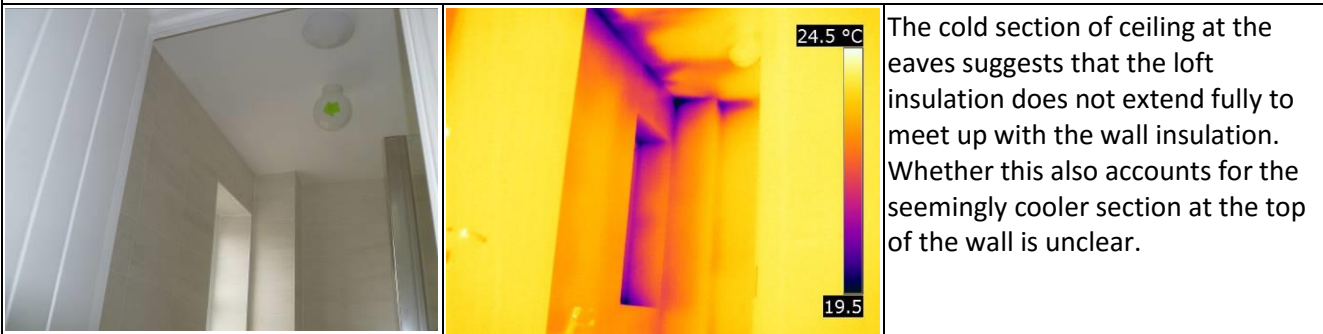
Plot 8 En-Suite – Under natural conditions

The cold section of ceiling at the eaves suggests that the loft insulation does not extend fully to meet up with the wall insulation. Whether this also accounts for the seemingly cooler section at the top of the wall is unclear.

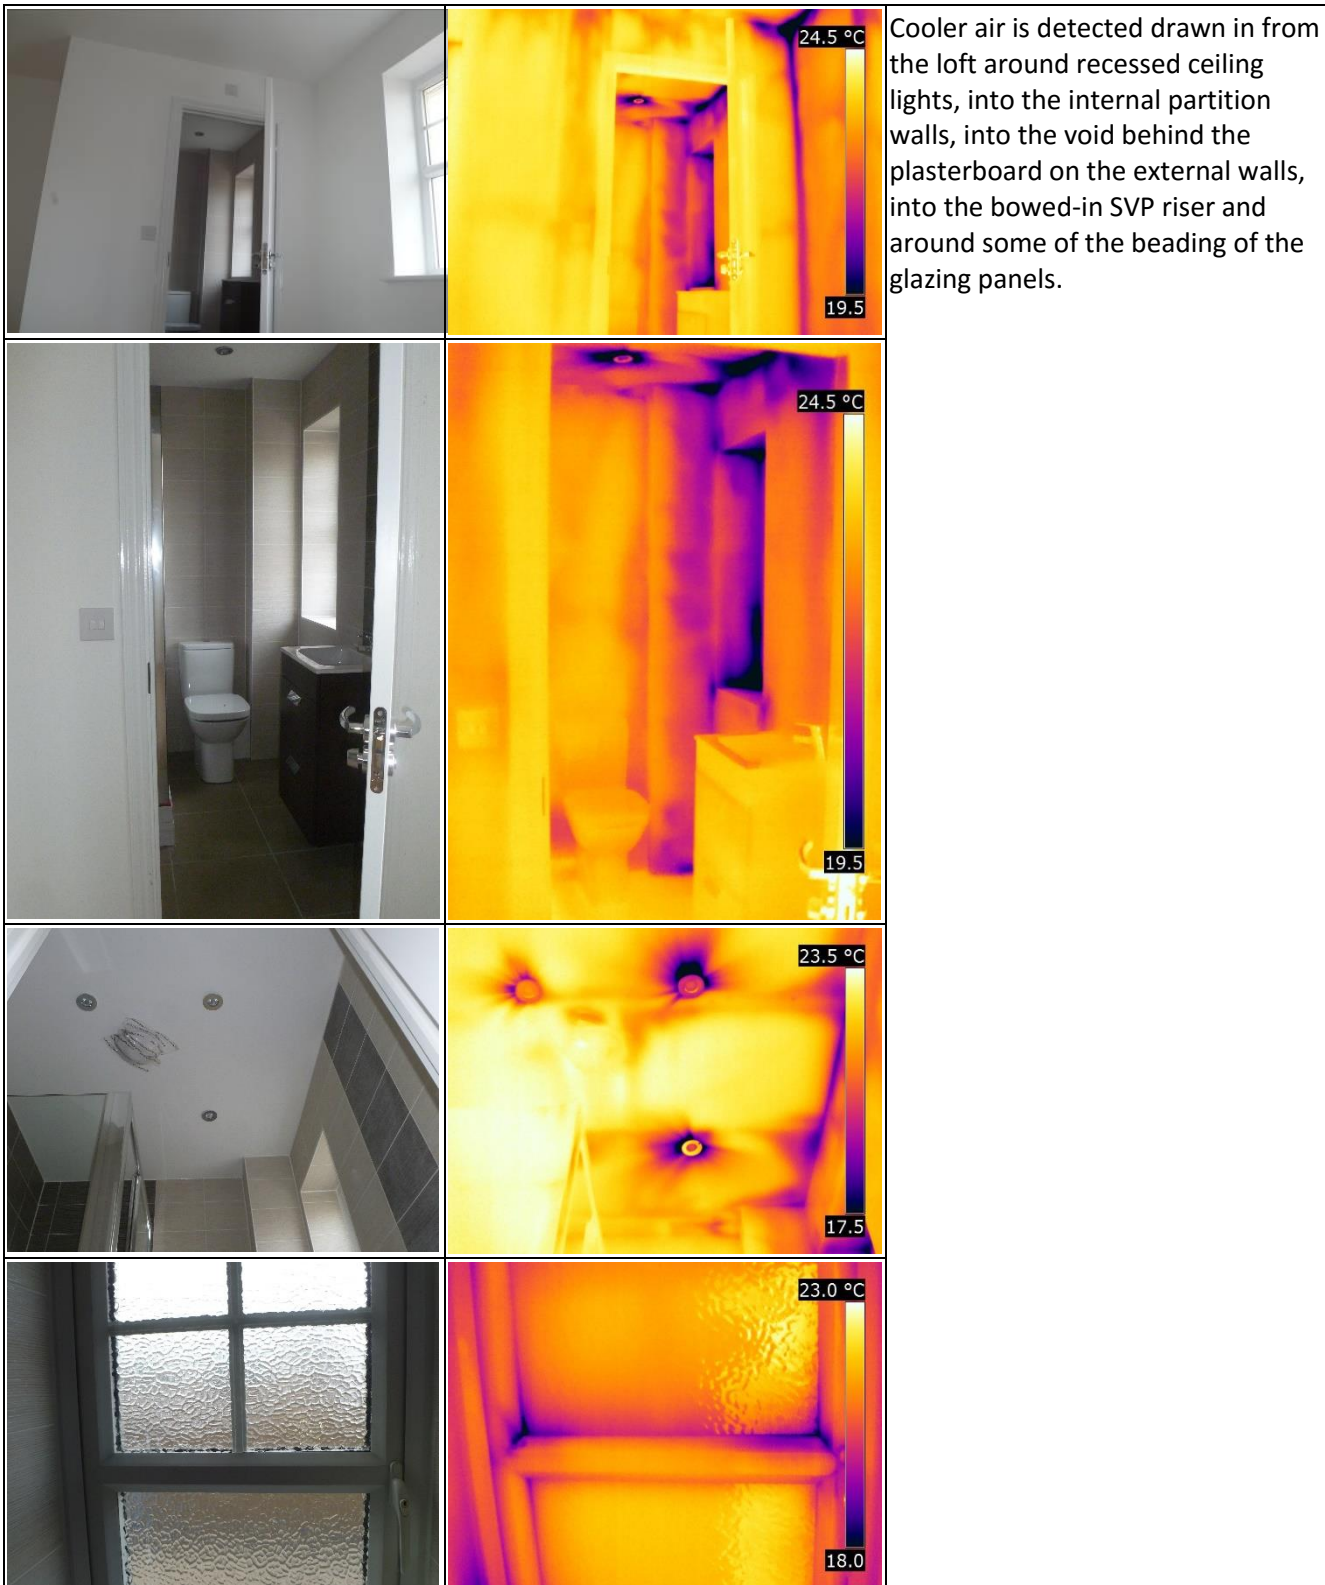
Plot 9 En-Suite – Under depressurisation

Cooler air is detected drawn in from the loft around recessed ceiling lights, into the internal partition walls, into the void behind the plasterboard on the external walls, into the bowed-in SVP riser and around some of the beading of the glazing panels.

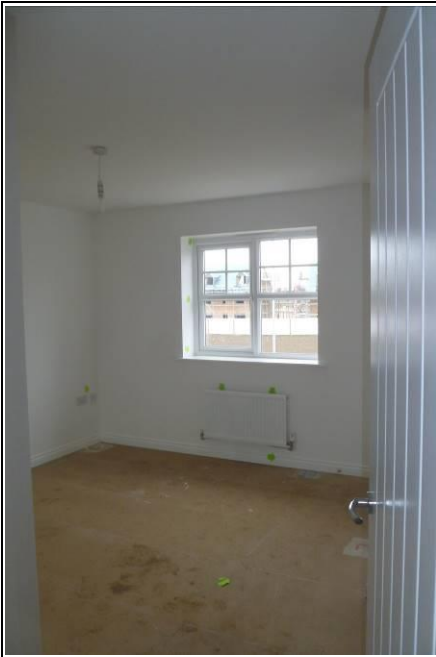
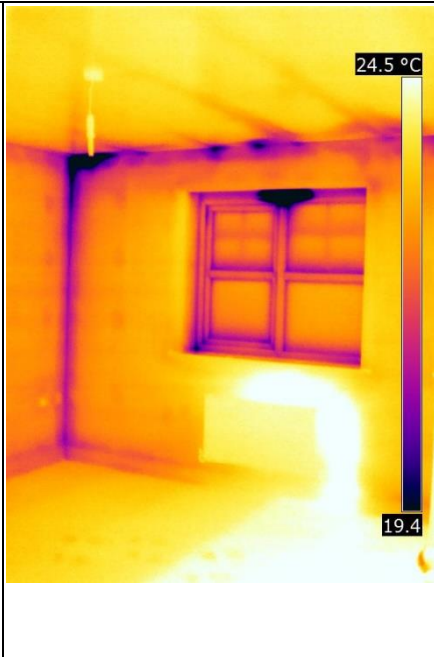
Plot 8 Bedroom 1 – Under natural conditions

As in the En-suite there are some issues at the eaves but not as pronounced. The thermal gradient from floor to ceiling observed downstairs on the external walls is not present on the first floor where the floor and ceiling appear to be similar temperatures.

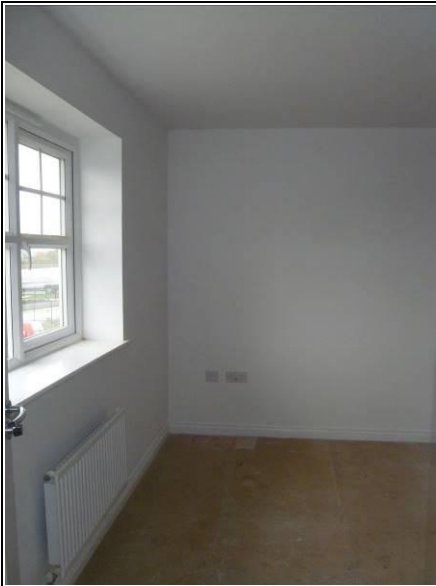
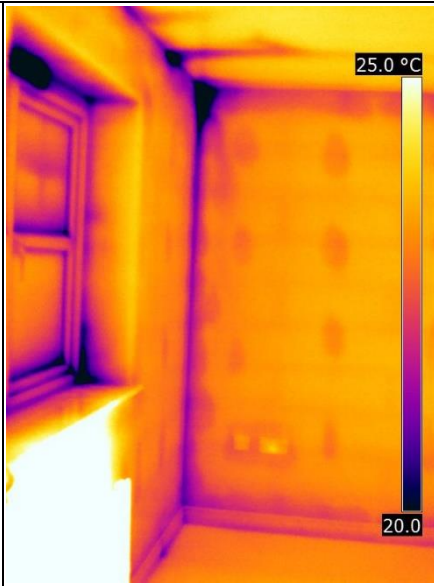
Plot 9 Bedroom 1 – Under natural conditions

As observed in plot 8.
There also appears to be additional cooler patches in the ceiling where the trussed rafter angled junctions prevent the loft insulation from being laid as effectively.

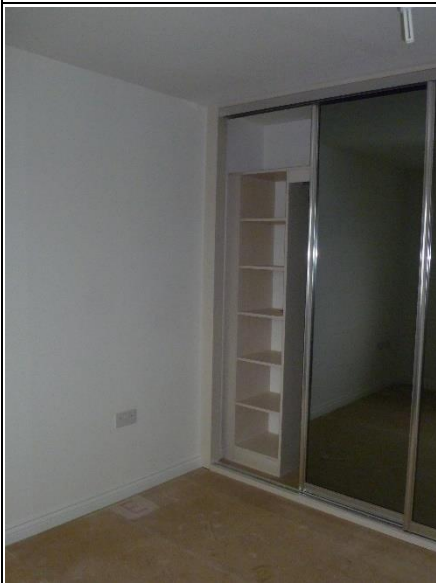
Plot 9 Bedroom 1 – Under depressurisation

Under depressurisation colder air can be seen being drawn down the dry lining voids on the external wall through gaps in the adhesive ribbons.
Cold air in the loft can also be seen tracking the cabling for the central ceiling light, emerging at the rose fitting.

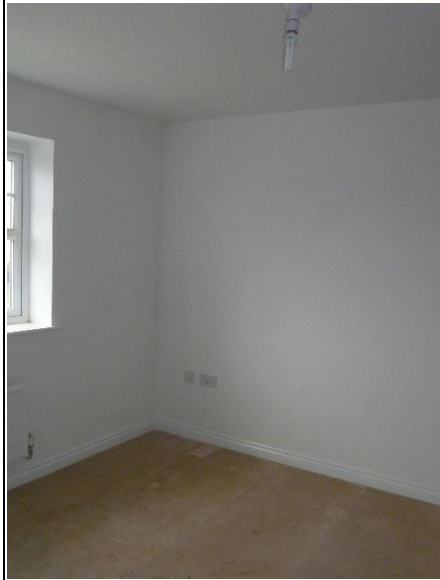
There is some stratification between joists of the intermediate floor which was not observed from beneath.

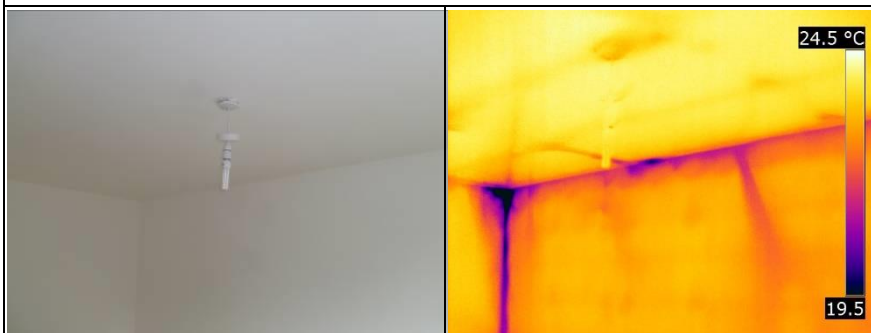
Plot 9 Bedroom 4 – Under depressurisation

Air was again observed being drawn in from the loft into the dry lining void, although to a lesser extent than seen in Bedroom 1 along the gable wall. The internal partition wall that backs onto the service void in the bathroom was cooler than the rest of the wall, and allowed colder air

to enter the dry lining void along its full height and air to emerge around the floor/wall junction at the bottom.
Direct air infiltration at the window was also clear.

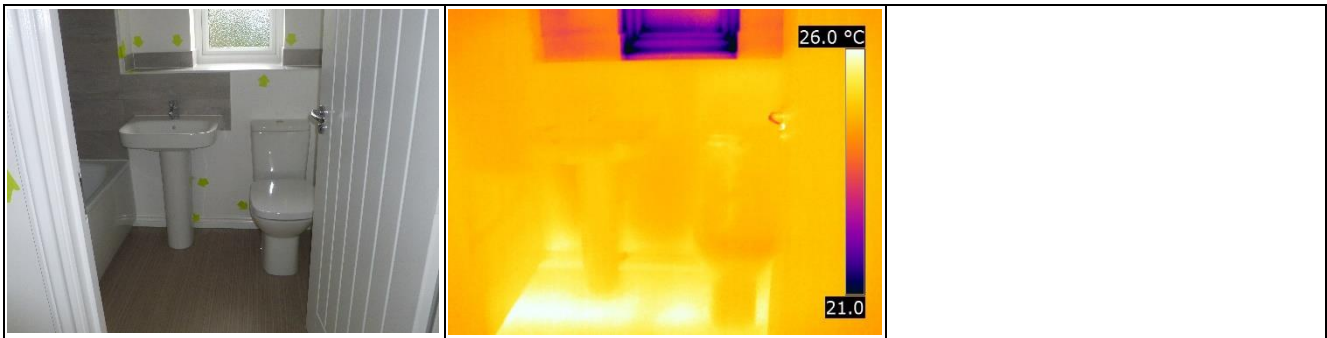
Plot 8 Bathroom – Under natural conditions

As seen previously there are colder patches at the eaves junction; these appear cooler than the window frame, and if condensation forms in the bathroom it will form on the coldest surfaces first, so may cause future issues.

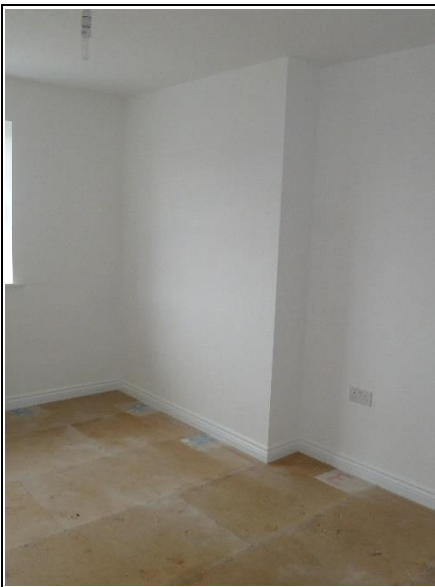
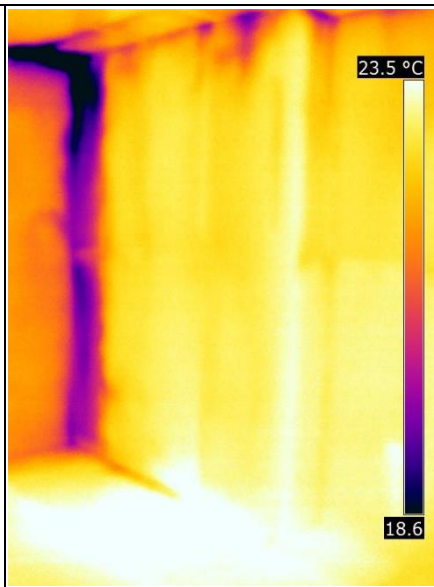
Plot 8 Landing – Under natural conditions

Some colder areas where the loft insulation appears to not be in full contact with the ceiling plasterboard.

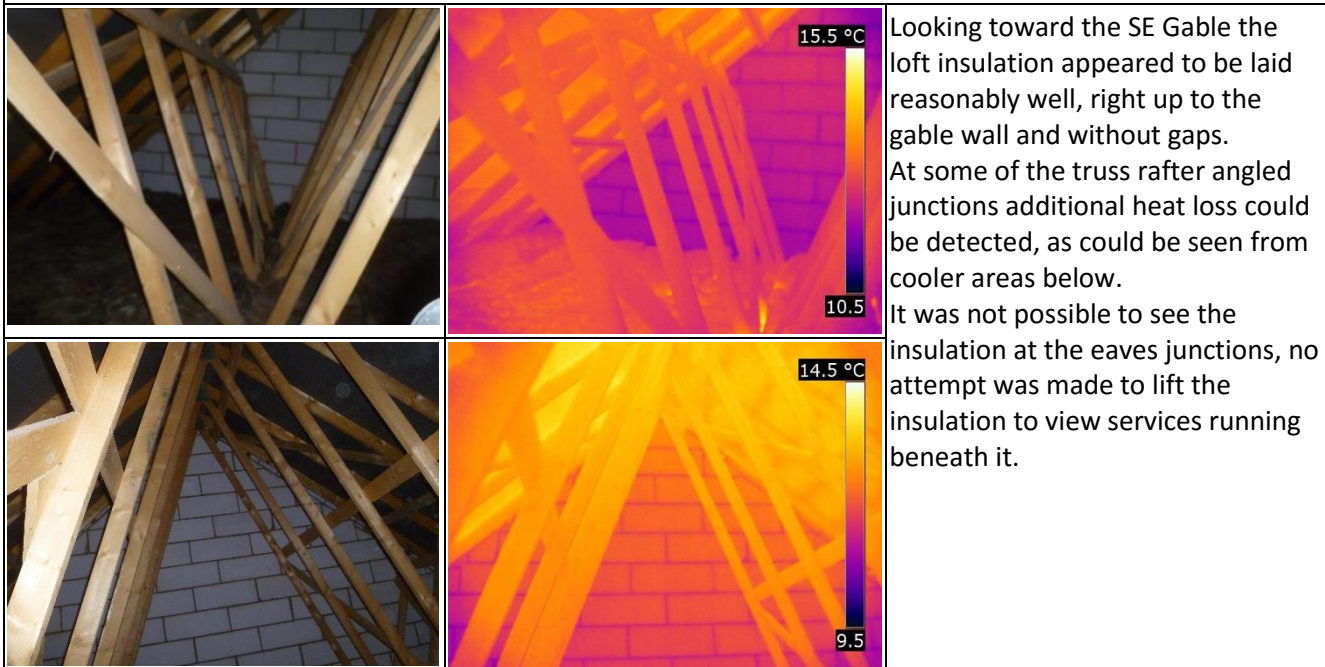
Plot 9 Loft – Under natural conditions

Looking toward the SE Gable the loft insulation appeared to be laid reasonably well, right up to the gable wall and without gaps. At some of the truss rafter angled junctions additional heat loss could be detected, as could be seen from cooler areas below. It was not possible to see the insulation at the eaves junctions, no attempt was made to lift the insulation to view services running beneath it.
