## **Condensation Risk – Impact of Improvements to Part L and Robust Details on Part C**

Project Reference Number: CI 71/6/1 BD2414

## **Interim report number 7: Final report on project fieldwork**

## Interim report to ODPM Building Regulations Division under the Building Operational Performance Framework

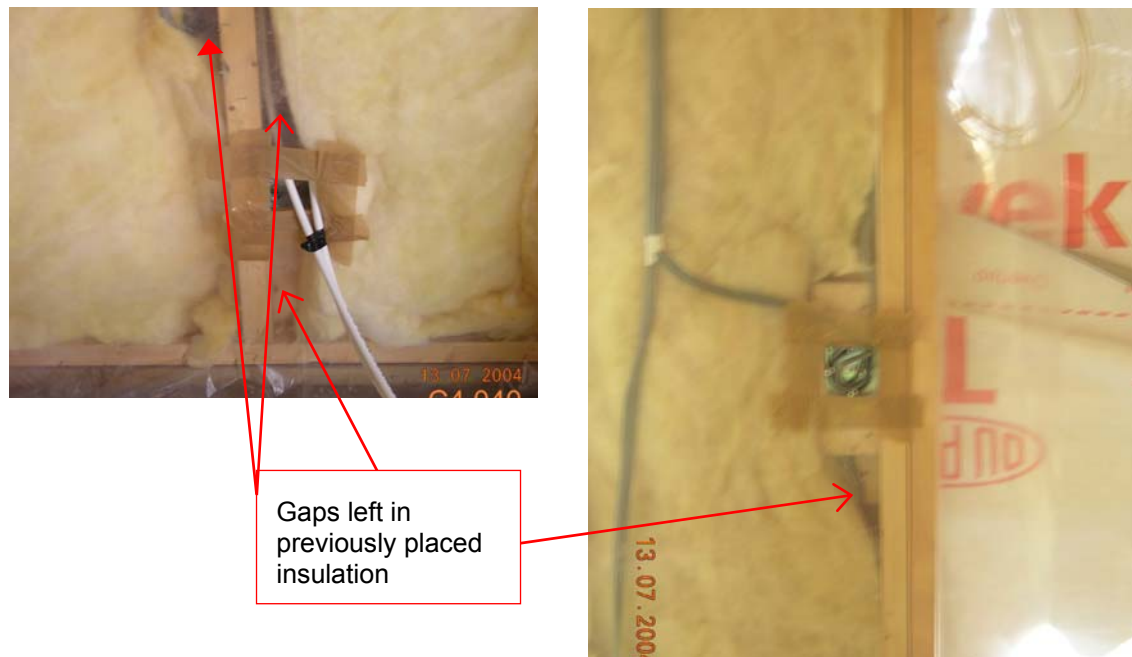
43. Creating defect free construction requires not only the provision of detailed design information to the operatives who are to carry out certain operations but also a more general awareness of the requirements among others who may have an impact on the work in question. This is of particular relevance in the case of one trade following another, for example services installers following joiners. Figure 3.03 shows how the work of an electrician resulted in gaps in the insulation despite the initial efforts of the joiner to ensure a good fit.

Figure 3.03 Insulation laid by one trade is moved by a following trade to create gaps.

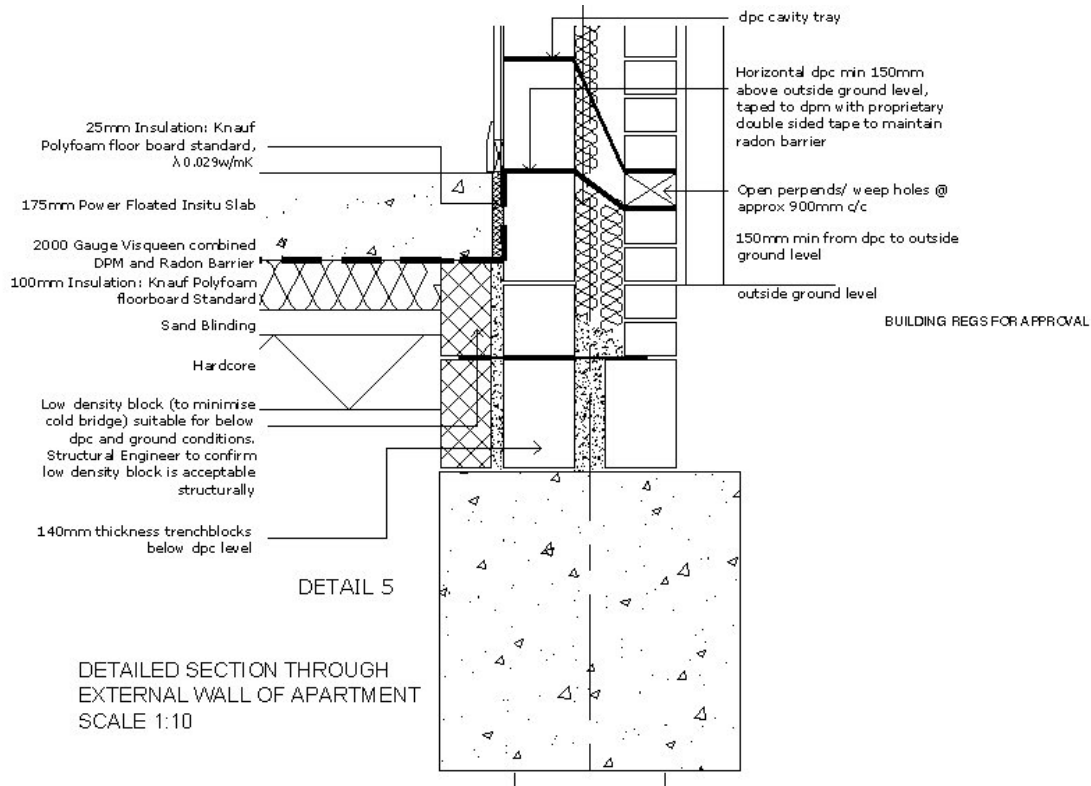
Figure 3.07 Ground floor slab detail – partial fill masonry site.

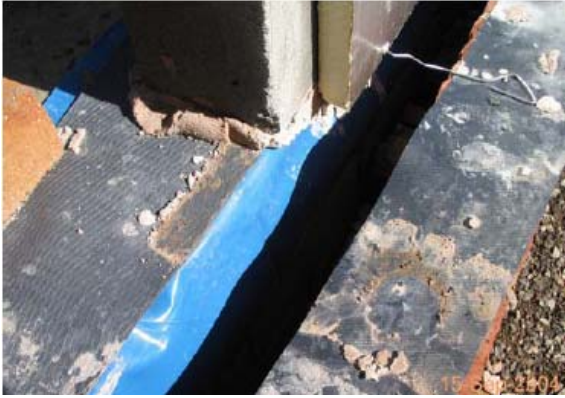
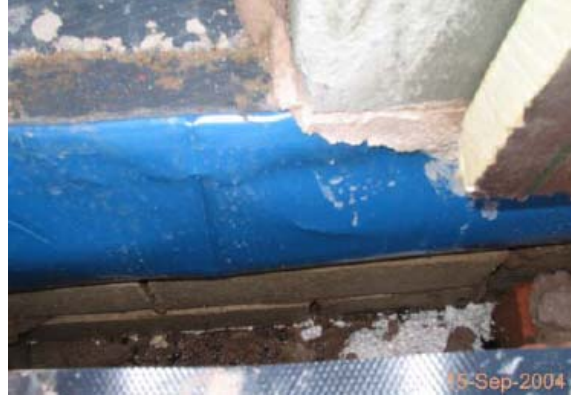
Figures 3.08 and 3.09 Partial-fill masonry construction, slab edge detail.

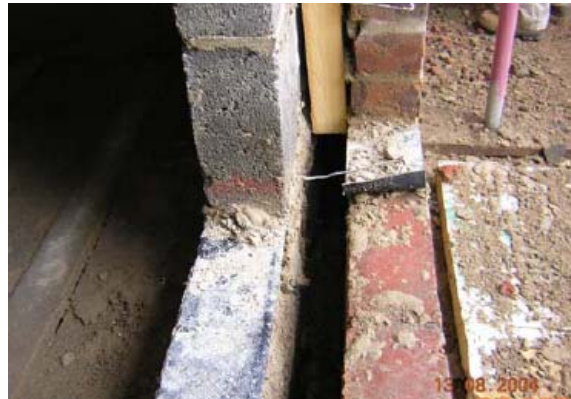
Figure 3.11 Perimeter insulation missing below dpc in masonry construction.

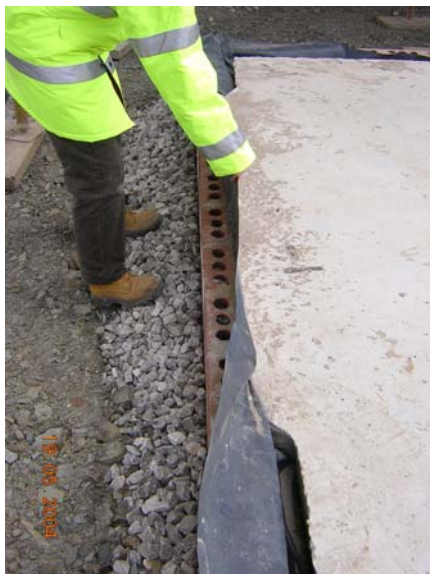
Figure 3.12 Omission of edge insulation at patio door reveal – and RD 8.06.

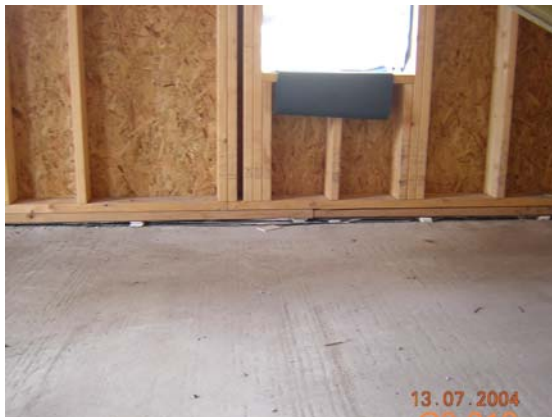
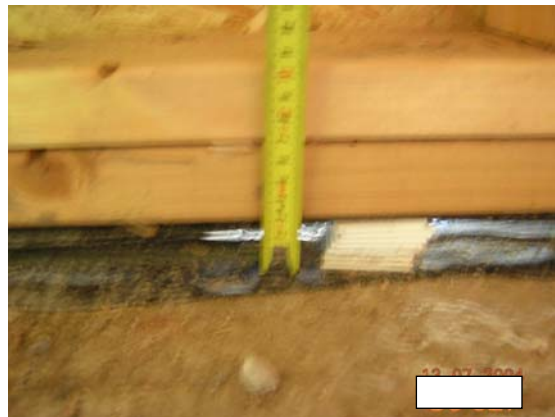
Figures 3.14 and 3.15 Plastic spacers used to level timber frame.

49. The significance of such gaps lies in the potential created for reduced airtightness and thermal performance both of which will tend to result in local cooling of the floor slab and the space behind the skirting board with increased risk of surface and interstitial condensation. Figure 3.16 shows a sketch of the detail, as constructed, with edge insulation missing. Carlsson et al (1980) show clearly how this problem can be overcome through the use of a gasket between the slab and the sole plate of the wall.

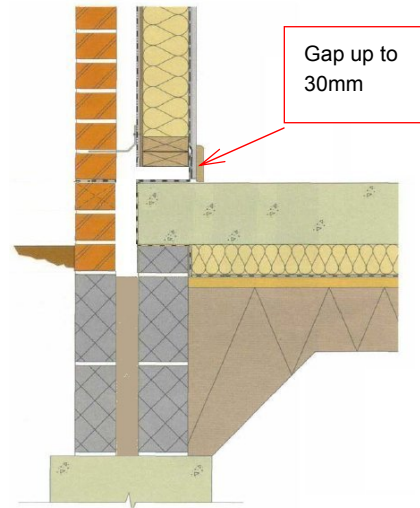
Figure 3.16 Timber frame on in-situ RC suspended slab - as constructed<sup>1</sup>. (this figure is intended to stress the modified from

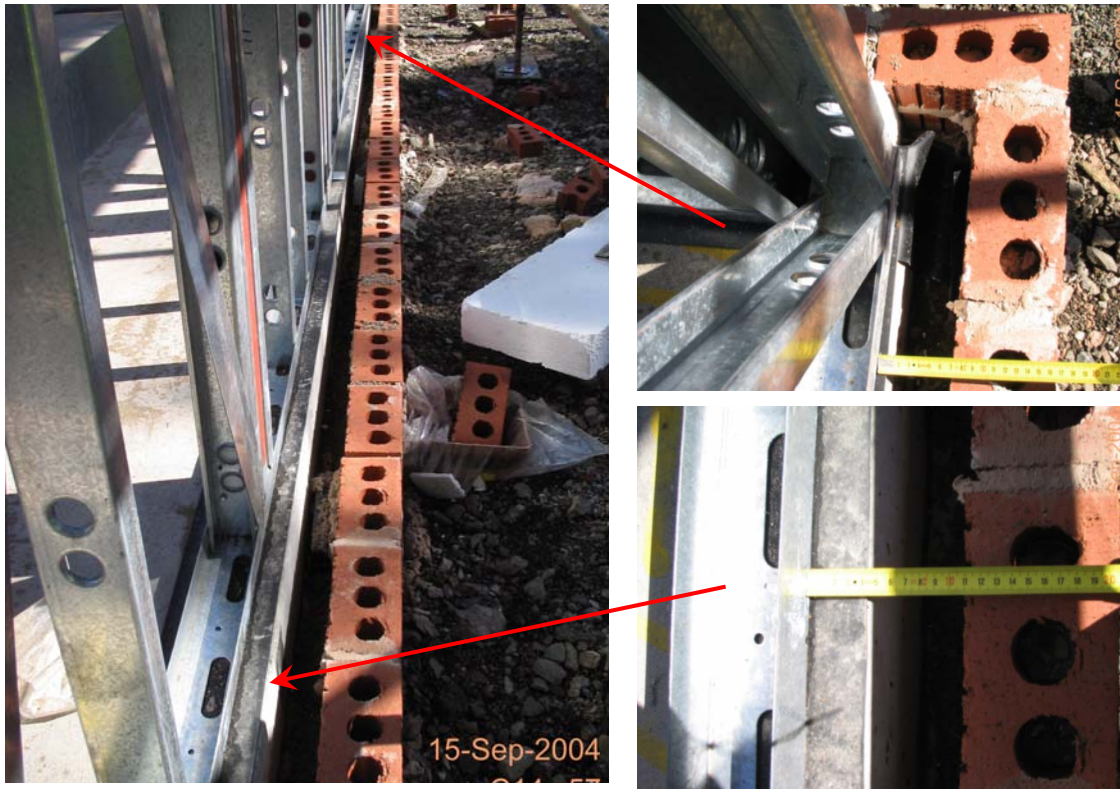
Figure 3.18 Slab not square in steel frame construction.

51. Whatever the cause of the misalignment (setting out of the base or manufacturing errors in the steel frame) its effect was to make it very difficult to maintain continuity in the external insulation. The practical response to this problem was two-fold; either the wall insulation was stopped at dpc level and a separate piece of insulation placed in the

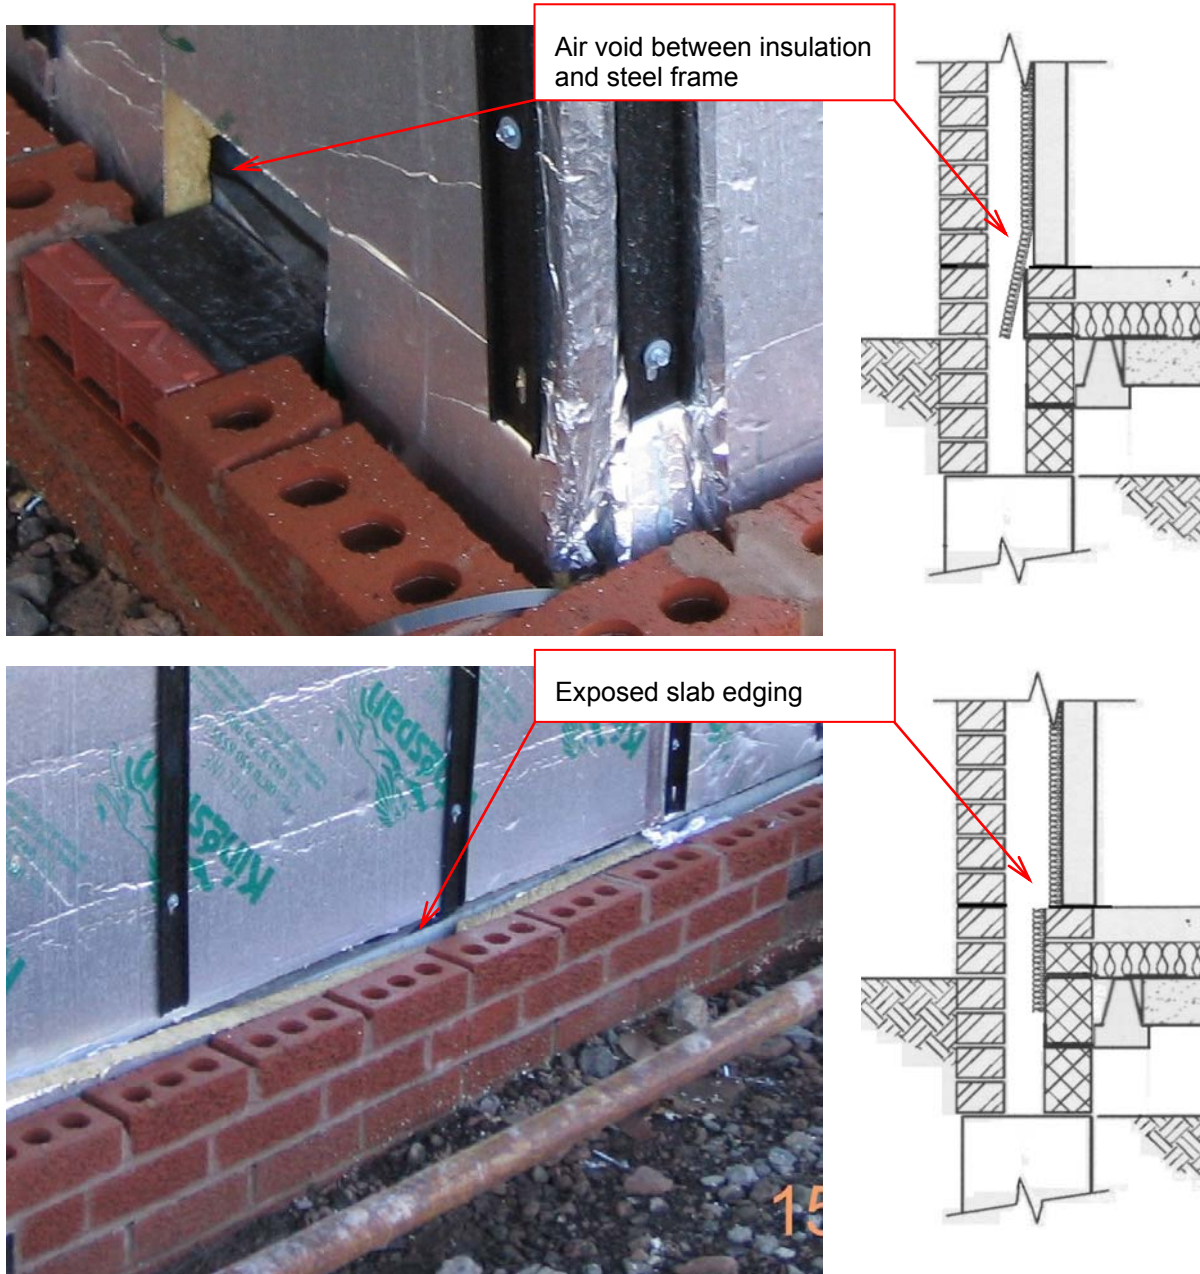
cavity, leaving gaps in insulation, or the wall insulation was bent over the protruding slab leaving an air space around the base of the steel frame. The sketches in figures 3.19 and 3.20 illustrate this together with examples of site observations. Although the resulting gaps appear to be small, they have implications for the effectiveness of the insulation around the junction and airtightness. The integrity of the insulation layer is of particular importance in warm steel frame construction since it has an additional function as the prime air and vapour control layer.

Figure 3.19 and 3.20 Placement of cavity wall insulation, above and below slab, in steel frame construction with misalignments of steel frame and slab.

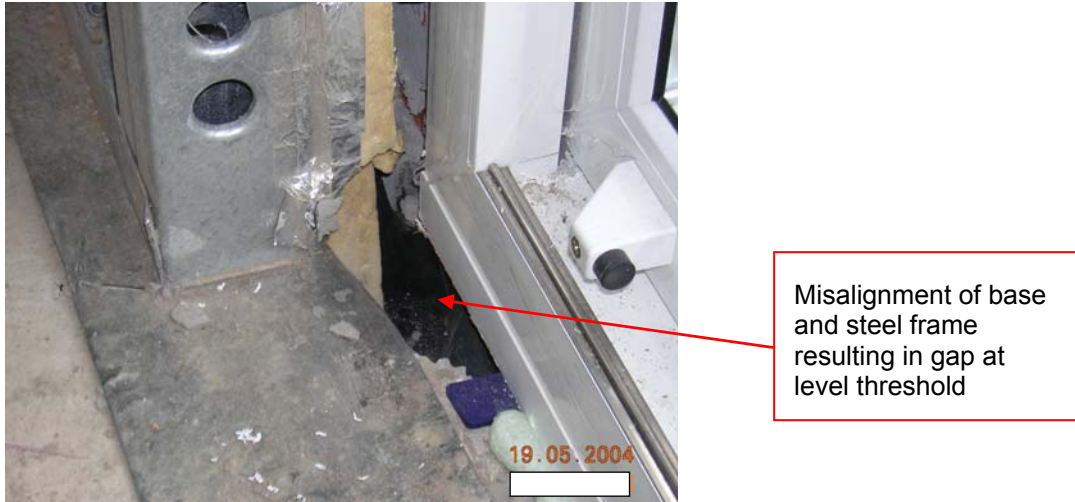
as an integral part of the base prior to frame erection. If there are minor setting out errors in casting the base (or minor changes to the frame in manufacture) the threshold does not line up with the door opening in the frame resulting in holes in the floor at the threshold as illustrated in figure 3.21. Although this could be rectified when the steel frame and its insulation was erected, it is often left until a much later time when satisfactory remedial work is more difficult to carry out. We did not observe cases where it was rectified. We have highlighted this as a problem in steel frame construction, but it was observed also in other forms. As with other similar defects its significance lies in the potential for small areas that could be susceptible to surface and interstitial condensation.

Figure 3.21 Gap at level threshold.

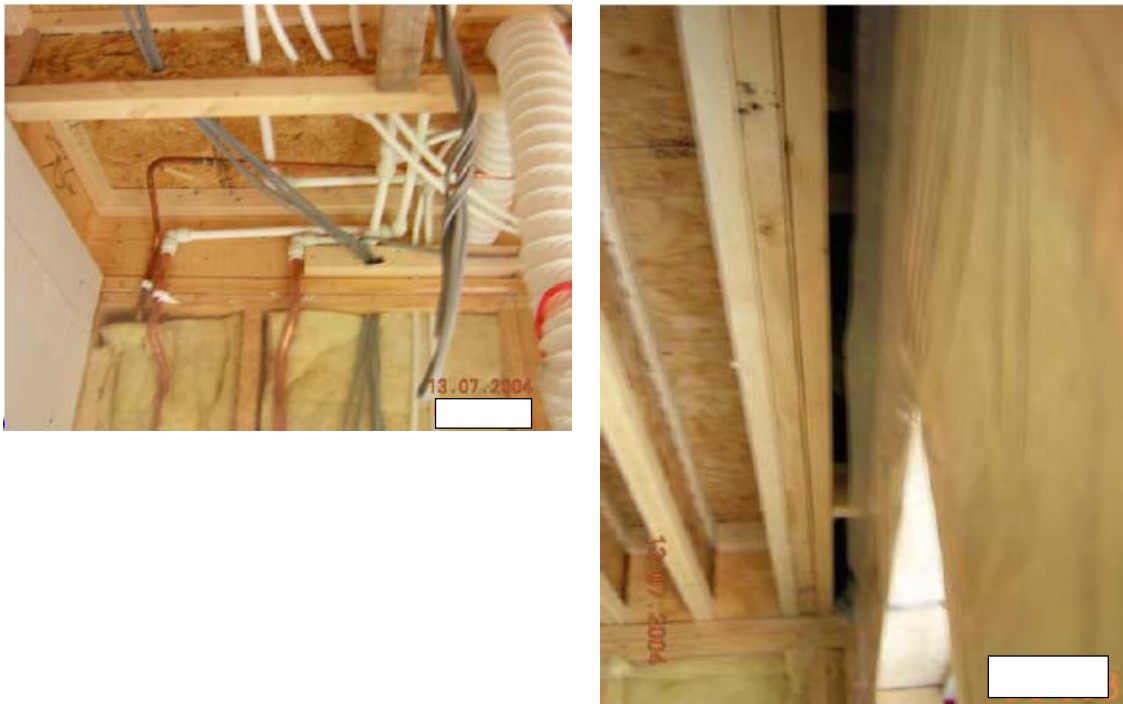
55. Despite the perimeter insulation shown in design drawings, site observations revealed little evidence that it was actually placed. Figure 3.25 shows external walls with wall insulation and vapour control layers in place but no perimeter insulation at intermediate floor level. Although it is possible that insulation would be placed at a later date, this was considered unlikely as it would have required a second visit by the insulation gang. In any case the proliferation of services runs (figure 3.25) would make placement difficult as would the narrow space between the multiple joist and the wall. On some sites there seems to have been an assumption that the timber I-beam floor cassettes would have perimeter insulation fitted at the factory. In one case the site team had an opportunity to check this assumption through a hole in the perimeter space, which was cut for a gas pipe. As shown in figure 3.26 no insulation was evident. Evidence from another timber frame site where access to the floor edge<sup>1</sup> was available provided another example of an uninsulated void (see figure 3.27). The lack of perimeter insulation would seem to be a general problem since in none of the timber frame sites visited was the placement of perimeter insulation observed.

Figure 3.25 High concentration of services and close proximity of I-beam to external wall reduce both access and the likelihood of effective insulation at intermediate floor perimeter.

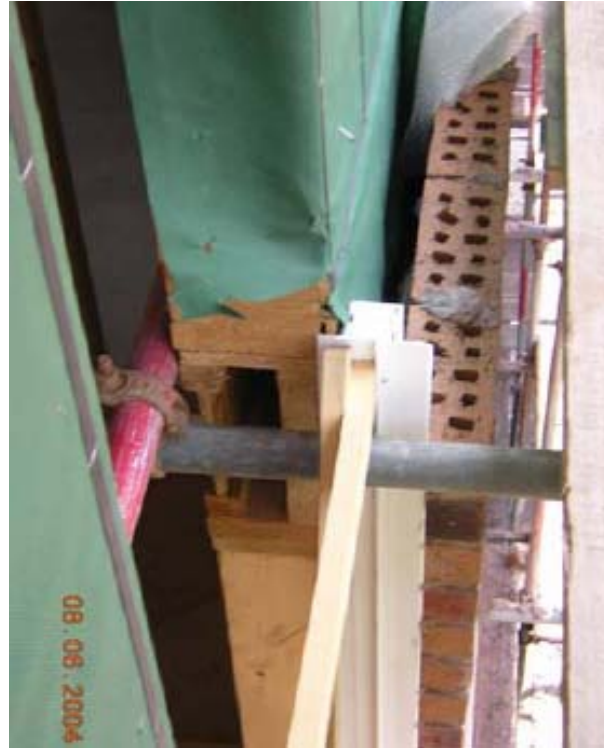
Figure 3.27 Uninsulated edge beam to timber frame intermediate floor.

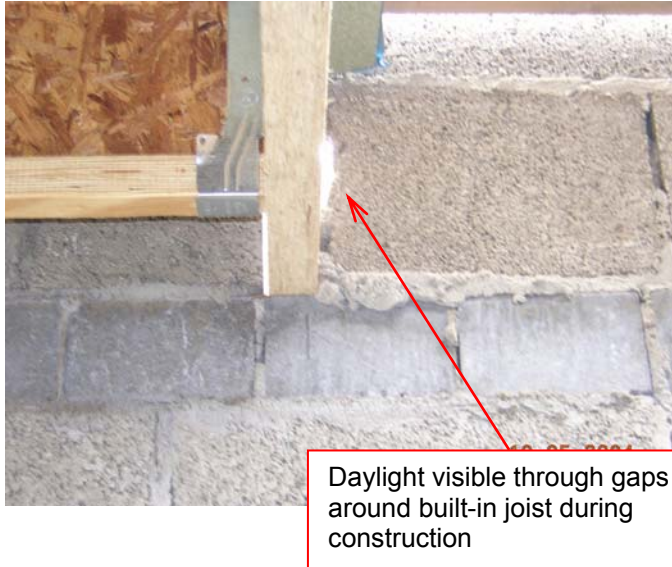
an illustration of the difficulties of insulating across the joist ends. In figure 3.31 the joist ends protrude into the partially filled cavity but instead of trimming the joists to a tight fit the insulation has been cut back, not only reducing the insulation thickness but also leaving room for air flow which bypasses the insulation. This is, perhaps, something of a curio in this project and the problem is not particularly severe but it is conceivable that in extreme cases, even greater thicknesses of insulation could be removed.

Figure 3.30 Built-in joists in masonry external walls<sup>1</sup>.

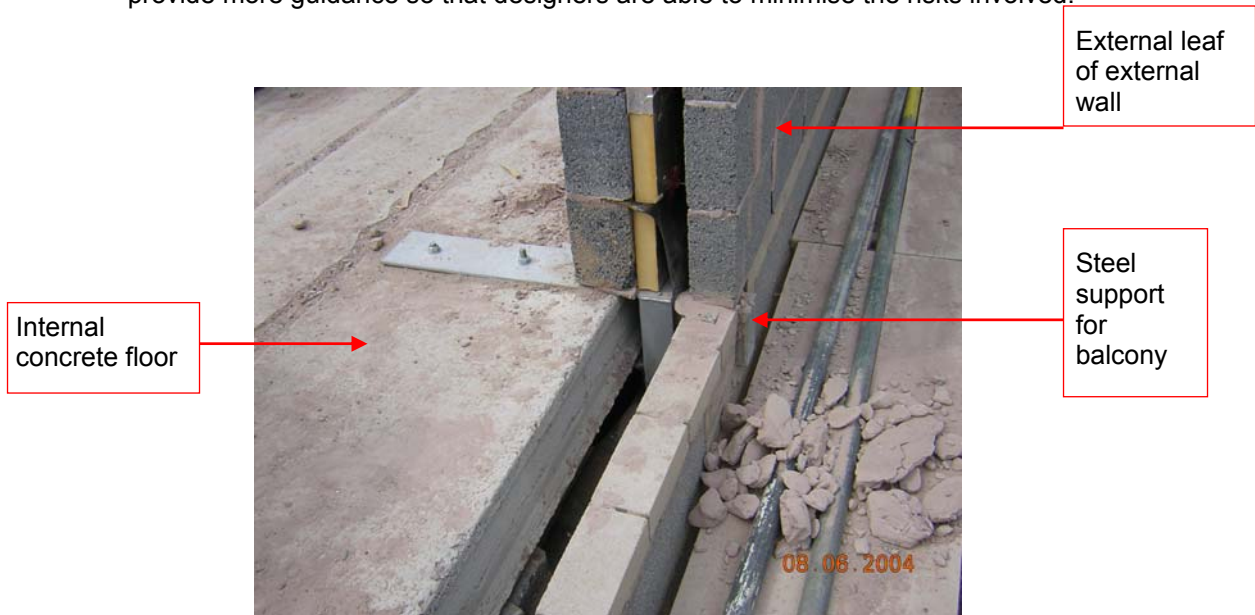
61. In general site observations indicated that a reasonable level of care had been taken to minimise the bridging problems created by through fixings. However for structural reasons fixings for two types of balcony consisted of substantial steel sections that penetrate the insulation layer. Figures 3.33 and 3.34 show some of the fixings used on a partial-fill masonry site and a timber frame site respectively. Although it is not within the remit of this project to carry out the detailed three dimensional analysis that would be required to understand the impact of such fixings, revisions to Robust Details should provide more guidance so that designers are able to minimise the risks involved.

Figure 3.33 Balcony support through partial-fill masonry construction.

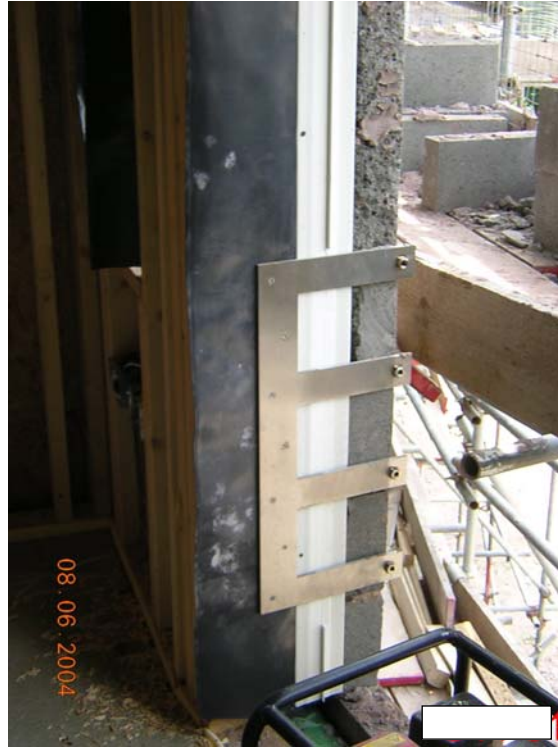
Figure 3.34 Balcony support through timber-frame construction.

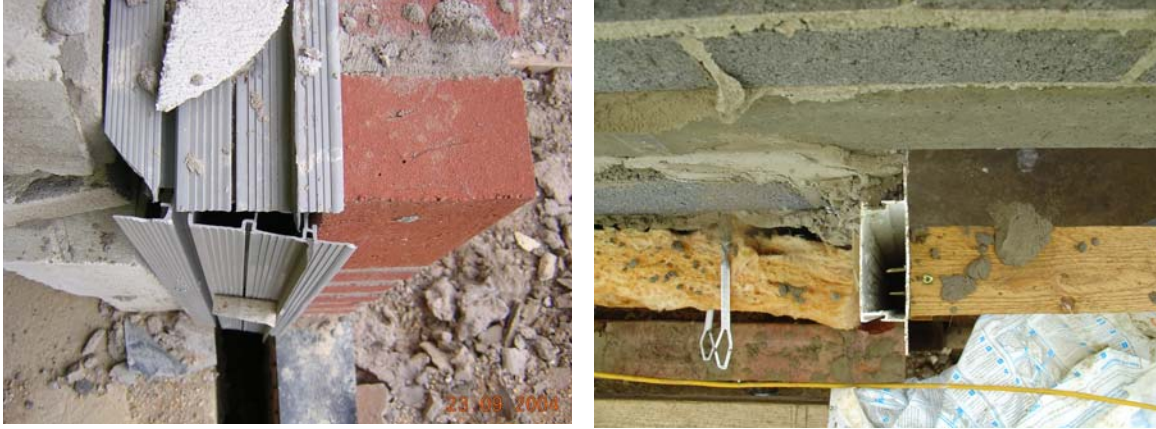
63. In the majority of cases where cavity masonry construction was adopted (both fully filled and partially filled) openings were designed using propriety cavity closers at sills and jambs. These usually consisted of plastic box section extrusions that fitted into the cavity to a depth of between 40 and 50 mm with fixing flanges overlapping the brick and block work reveals. Although on some sites the box sections were filled with a foam insulant, in the majority of sites sections were uninsulated. This is illustrated in figures 3.35 and 3.36.

Figures 3.35 and 3.36 Uninsulated closers.

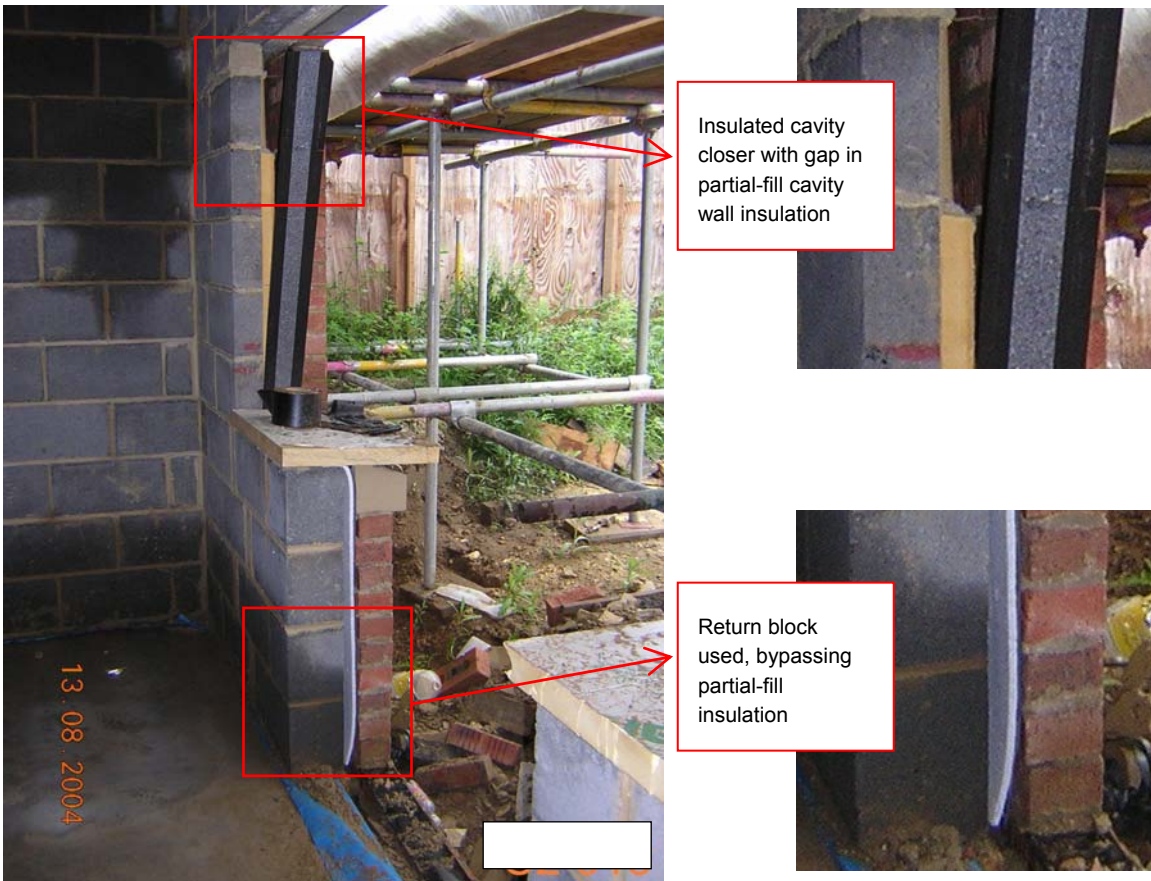
Figure 3.39 Inconsistencies in cavity closure detailing.

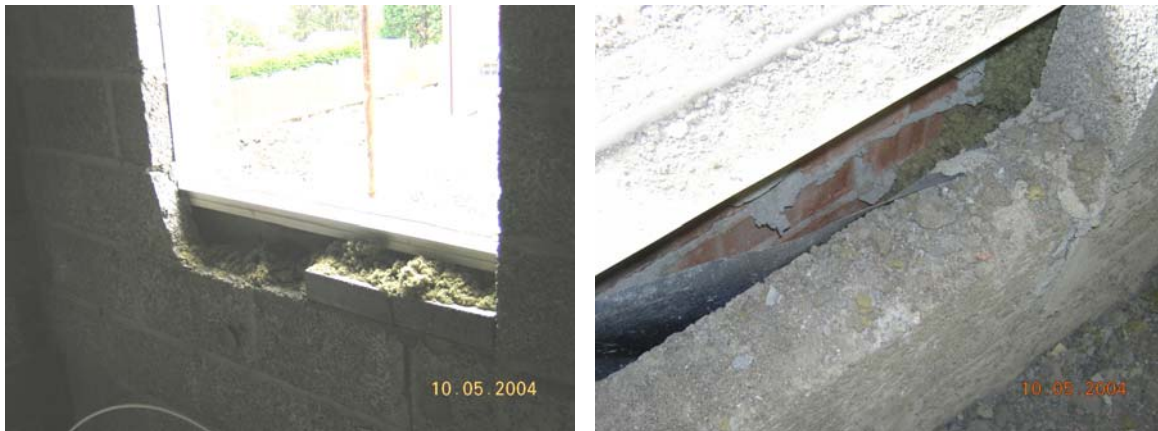
67. The problem of ensuring that full-fill cavities are completely filled with insulation and that partial-fill insulation bats are fitted with no gaps has been generally recognised for some years. The observations in the cases studies provide a number of examples of this problem, particularly around window openings. Figures 3.40 and 3.41 show a fully filled cavity in which the filling work has been completed before the internal blockwork had been completed to sill level. This appeared to be a reasonably common occurrence and although it was not possible to ascertain whether insulation bats were placed in the cavity as blockwork was built up to the sill, it is likely that, at least in some cases, the additional insulation would be missed out. This would lead to increased thermal bridging and, depending on the thermal properties of the internal blockwork, increased risk of surface condensation problems.

Figures 3.40 and 3.41 Blown fibre, full-fill cavity wall insulation at incomplete sills

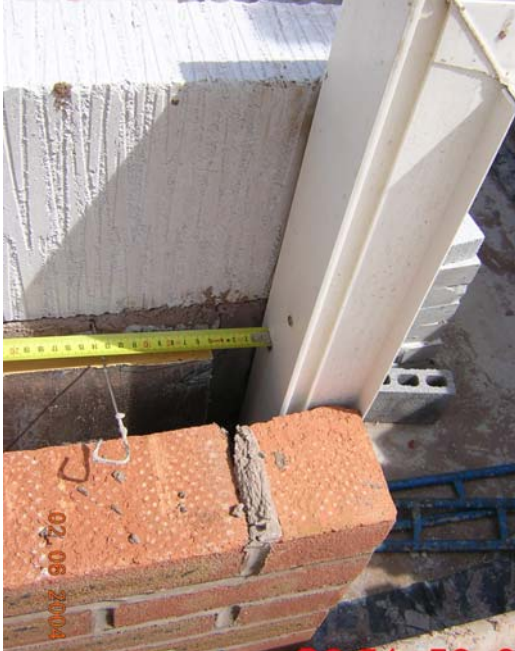
68. A similar problem was observed in a number of cases involving partial fill. Figures 3.42 and 3.43 illustrate a window jamb arrangement in which a gap of some 50mm between the cavity closure and the partial-fill cavity insulation was observed. A similar problem was shown in Figure 3.39. In other cases partial fill was loosely fitted and combined with other problems, such as mortar build up on cavity trays, to reduce thermal performance and increase not only condensation risk but also other moisture problems (see figure 3.44). Over all, this type of problem was recorded in 5 out of the 12 masonry cavity sites visited and, since we did not have access to open construction at window and door reveals on all sites, the number of observations may be an underestimate of the frequency of occurrence.

Figure 3.42 Gap observed between cavity closer and partial-fill cavity wall insulation.

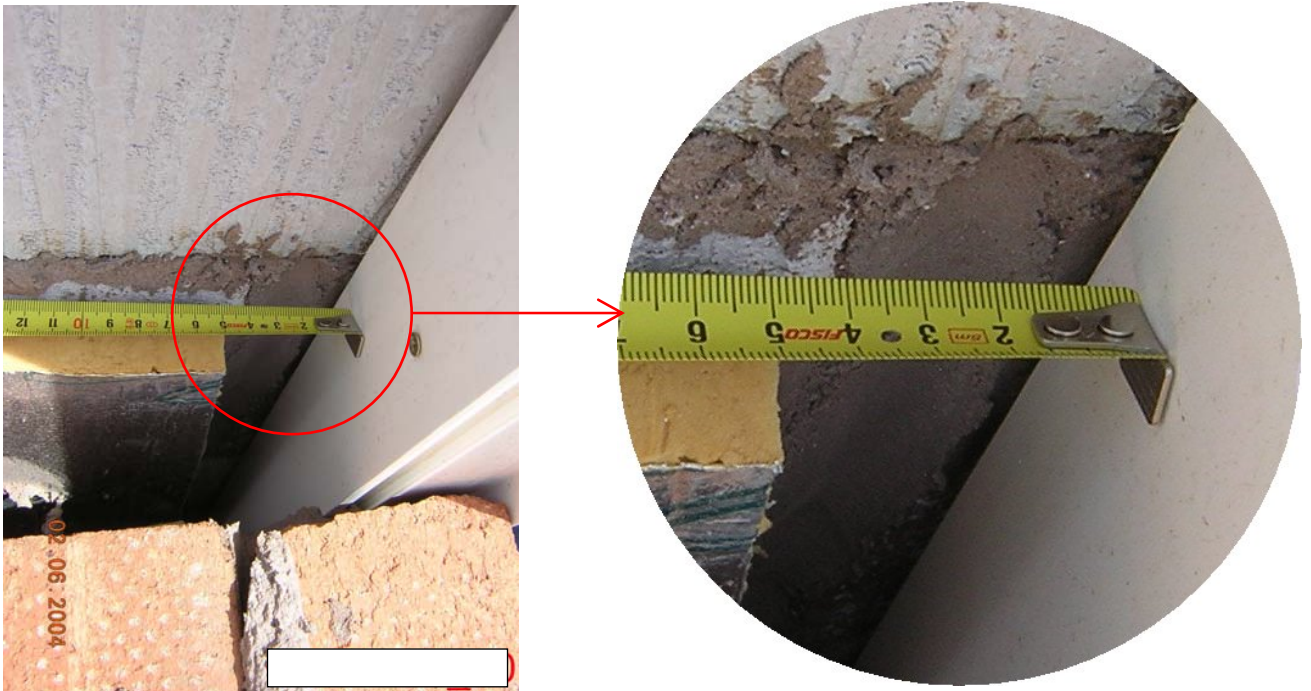
Figure 3.43 Up to 50mm of uninsulated area around jambs and reveals, causing potential thermal bridging problems.

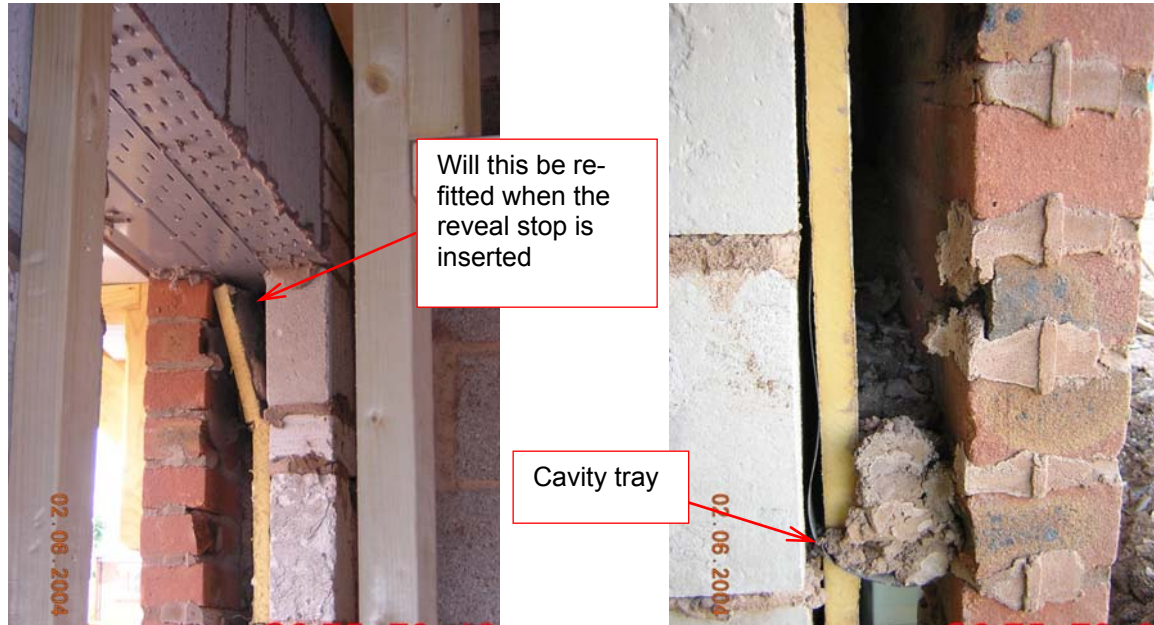
Figure 3.44 Partial-fill cavity insulation – gaps and mortar build-up on cavity tray.

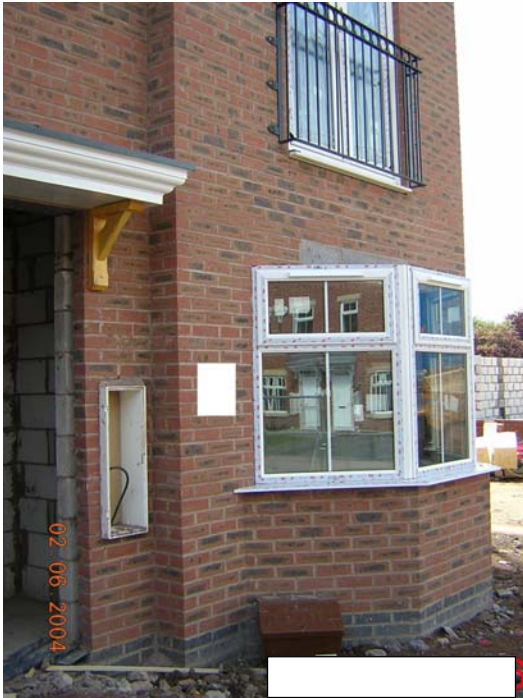
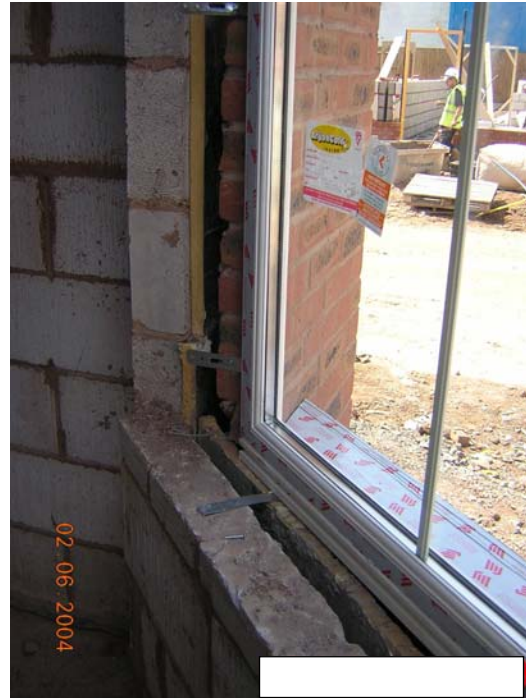
71. Although design drawings, where sufficiently detailed, tended to adhere to the recommendations of Robust Details, site observations suggested practice that was a little more variable with instances of inadequate overlap distances being observed on 5 out of 10 masonry sites where window openings were observed in detail. Where windows are placed in main wall sections, overlap distances of 30 mm were more likely to be achieved than in the case of bay windows. These situations gave rise to particular concern. The more so because they are not explicitly included in the Robust Details document. Figures 3.48 and 3.49 illustrate a typical arrangement in which, having constructed the wall of the bay window, the bay window frame is put into position and secured to the outside leaf of the main wall with reveal straps. This results in the sill being positioned on the outside leaf with very little or no overlap of the frame with the insulation layer at all. This arrangement must occur also at the window head if the bay continues for another storey. No insulating reveals were stated to be intended, but there was insufficient tolerance to be able to apply a significant insulating layer. The bridging in these locations is likely to be very large with a considerable risk of surface condensation adjacent to the window frames in all areas but particularly at the jamb and head.

Figures 3.48 and 3.49 No overlap of insulation layer at a bay window.

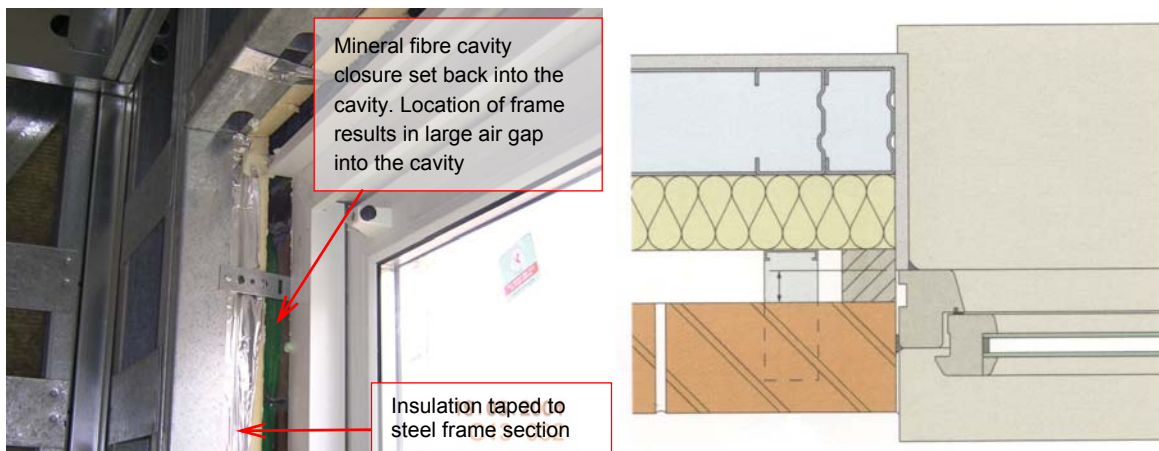
72. Problems of window location and insulation at cavity closures were observed also in steel frame construction. Figure 3.50 shows a door frame set forward of the external insulation layer by about 40mm. Although the insulation is fully taped, as recommended by RD 7.06, the fact that the cavity closure has been pushed well back in to the cavity creates a discontinuity of insulation. This, together with the location of the frame significantly reduces the resistance path from inside to outside. In addition, unless an air/vapour control layer is introduced in the jamb the detail will reduce overall airtightness.

Figure 3.50 Door opening in steel frame construction (as constructed) compared with robust detail 7.06.

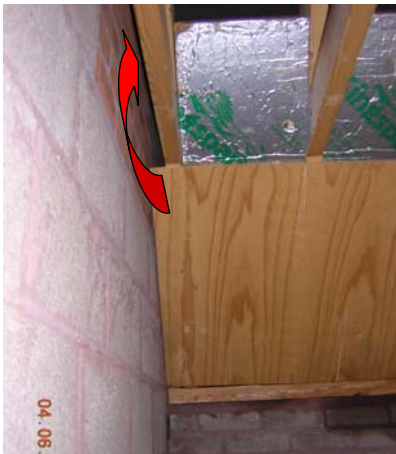
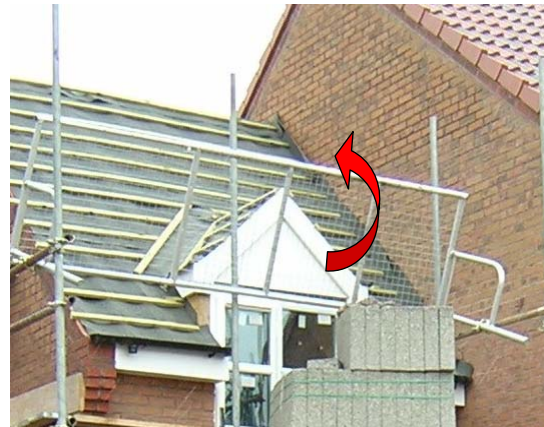
Figure 3.53 Gap in insulation adjacent to gable wall and structural thermal bridge (arrows).

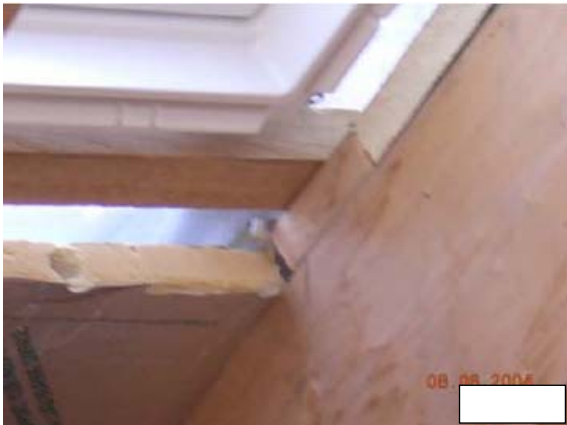
82. Although, as with other site observations, it is hard to know for certain if defects will be identified and rectified by site quality control, the observations made during visits suggested that the insertion of small strips of insulation and the accurate cutting of boards around rooflight openings was not always done with the level of care required. Figure 3.62 shows a typical gap in external insulation and figure 3.63 shows a framing board at the “sill” of the rooflight, which, when investigated proved to have no insulation in the space behind nor evidence of an air/vapour barrier. This would certainly give rise to airtightness problems and poor thermal performance, both of which may lead to increased condensation risk. A number of observations of the space available for lining insulation to the sides of rooflight openings suggested that achieving the required resistance ( $R \geq 0.34 \text{ m}^2\text{K/W}$ ) would be difficult especially if decorative linings were also to be applied. As a general observation missing insulation (particularly when small strips are required) around roof lights was a common occurrence on most sites.

Figure 3.62 Gaps in external insulation around

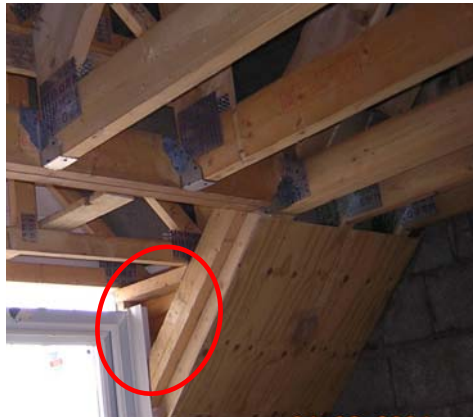
Figure 3.64 Small triangle of external wall difficult to fill with insulation.

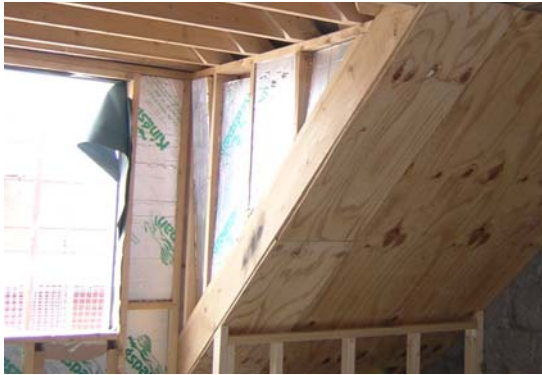
84. As in other cases the main problems related to the fitting of the insulation board. Figures 3.65 and 3.66 illustrate typical fitting problems with gaps around boards and missing insulation in small sections, sections that can be very small indeed requiring considerable attention to detail (see figure 3.64). The missing insulation in the corner section (figure 3.66) is of particular concern since this is one of the most exposed areas of the external envelope.

Figure 3.65 Irregular fitting of 35mm insulation boards.

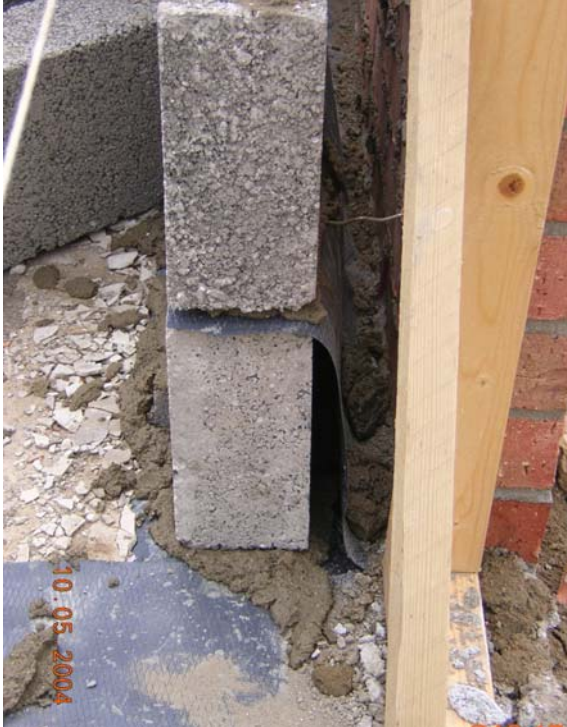
Figure 3.68 Injected insulation unlikely behind cavity tray. Mortar droppings will impair performance.

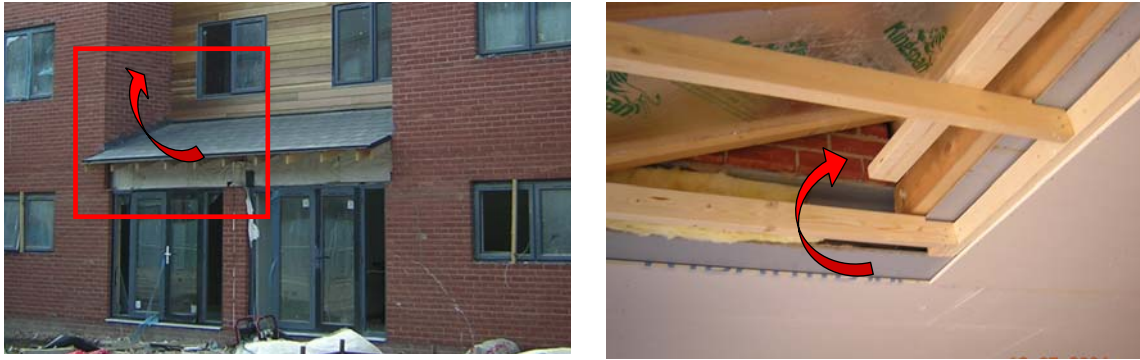
90. Figure 3.72 shows a different arrangement where the thermal bridge is, perhaps less obvious. In this case the ground floor “projection” fits between two flanking walls. However the flanking walls do not extend to the foundations but, in order to create a large unobstructed space below, they are supported by steel sections within the first floor void. The internal view of the construction in figure 3.73 shows the steel beam with some insulation between the flanges and the sloping roof with insulation at rafter level. Although this may seem like a reasonable detail, due to the fact that there is no insulation below and around the steel (as opposed to between the flanges) considerable heat loss would be expected into the brickwork above resulting in a relatively low surface temperature of the flange and increased condensation risk. Since steel has a very low thermal resistance the insulation between the flanges has almost no effect on heat flow or the surface temperature of the lower flange.

Figures 3.72 and 3.73 Thermal bridging through structural steel in first floor space.

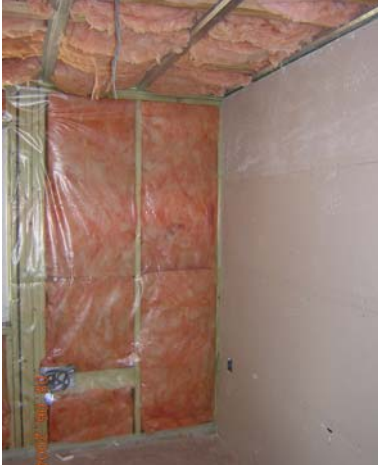
92. Thermal bridging in timber frame walls is often allowed for by specifying an appropriate timber fraction in the calculation of U values<sup>1</sup>. However the timber fractions used in the calculations often underestimate the amount of timber present (Bell and Overend 2001). Similarly, the impacts of the concentrations of timber that occur around openings and at areas of point loading in the structure have not been extensively analysed from the point of view of thermal and moisture performance. The highest concentration of timber (studs or head/sole plates) shown in any of the details in section 6 (timber frame) of the Robust Details document, is a doubling of the relevant timber section. This can be seen in figure 3.74, showing the double stud at a door or window jamb (RD 6.10). In practice, timber concentrations at openings and other areas where structural strengthening is provided (not all of which are structurally efficient) can be much higher than shown in the Robust Details document. Figures 3.75 and 3.76 show examples of timber concentrations ranging from 6 studs adjacent to and below a window opening to a corner arrangement that includes 11 studs supporting the double I-beams above.

Figure 3.75 High timber concentration at window jamb.

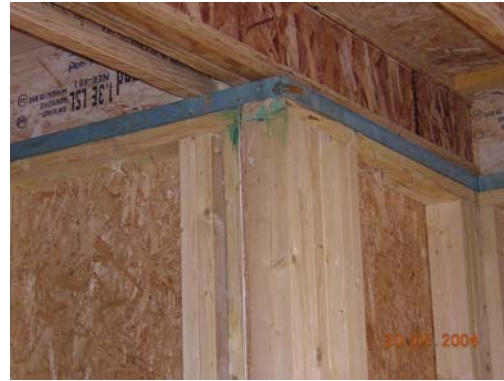
Figure 3.76 High timber concentration at corner post.

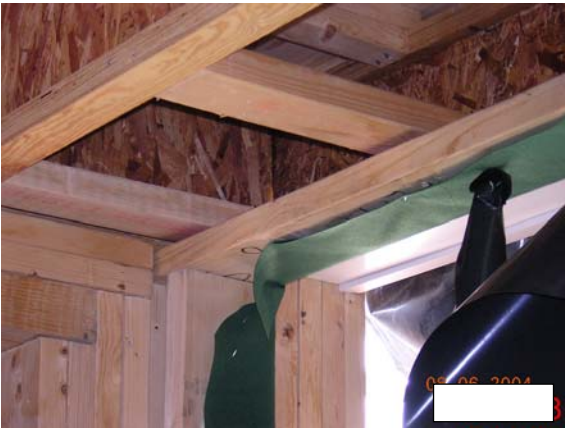
93. Other examples include difficulties at corners in general and at other junctions. Figures 3.77 and 3.78 show a particular instance where timber detailing has ignored the thermal performance of the junction. The sketch (figure 3.78) not only indicates the amount of timber but also the small gap in the framing that would require assiduous attention to detail on site if it were to be filled. The existence of such small strips where insulation is omitted is something that was observed time and time again, figures 3.79 and 3.80 are typical examples. The impact of such air gaps may be considerable since the resistance of the cavity is about three times less than that of an equivalent section of timber and many times less than that provided by insulation.

Figure 3.77 High timber concentration at opening to balcony.

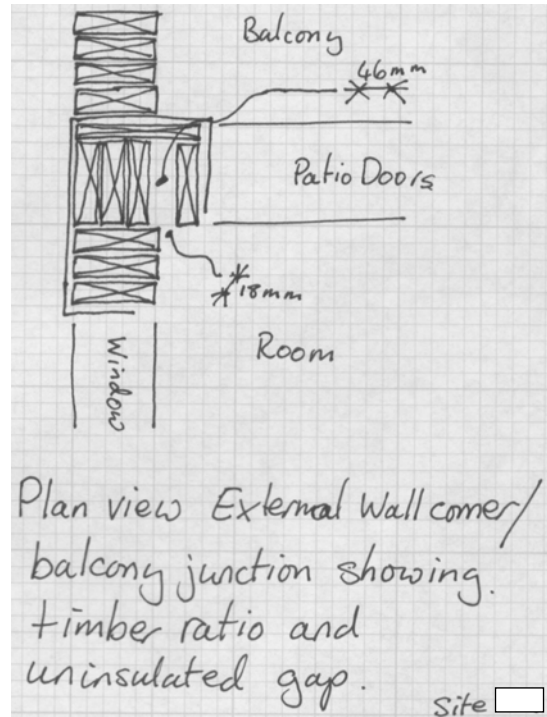
Figure 3.78 High timber concentration at opening to balcony.

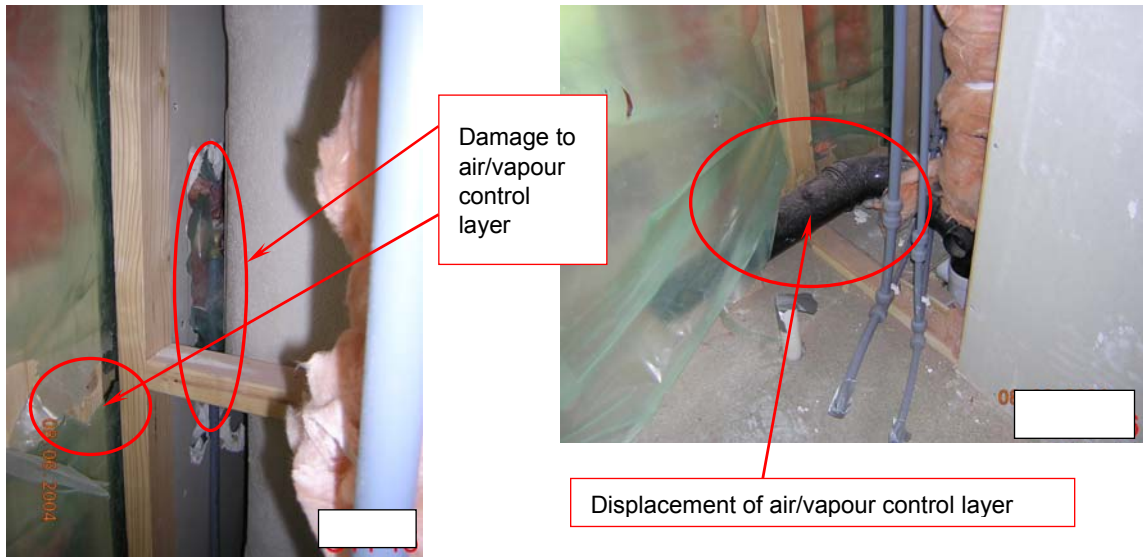
96. Areas where continuity of the air/vapour control layer is particularly vulnerable are behind baths, shower trays and kitchen units and in services voids. Figure 3.81 illustrates the construction of a services duct in a bathroom (timber frame dwelling) showing damage to the air/vapour control layer and internal lining to the services duct.

Figure 3.81 Damage to and displacement of the air/vapour control layer.
