## **Condensation Risk – Impact of Improvements to Part L and Robust Details on Part C**

Project Reference Number: CI 71/6/1 BD2414

## **Interim report number 7: Final report on project fieldwork**

## Interim report to ODPM Building Regulations Division under the Building Operational Performance Framework

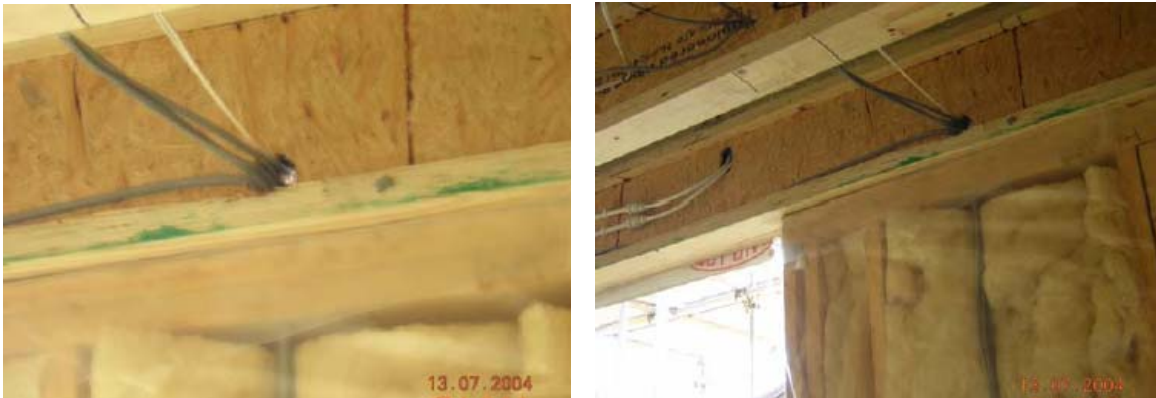
Figures 3.85 and 3.86 Holes in floor perimeter for electrical services.

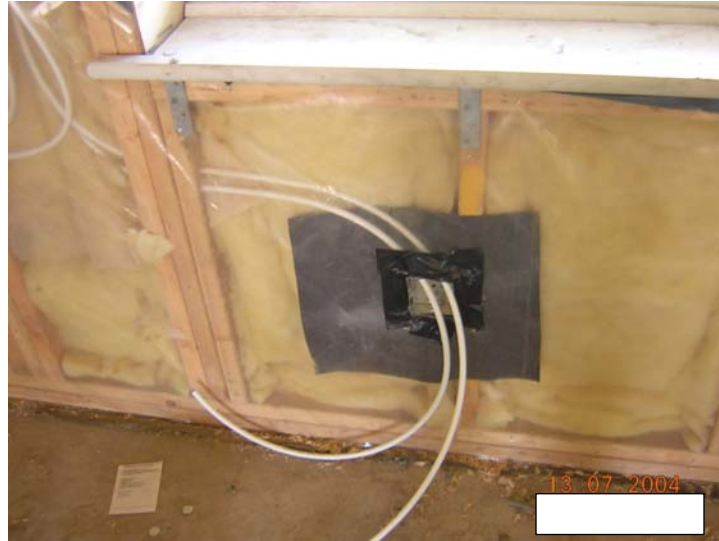
Figure 3.87 Air/vapour control layers not lapped to DPC<sup>1</sup>.

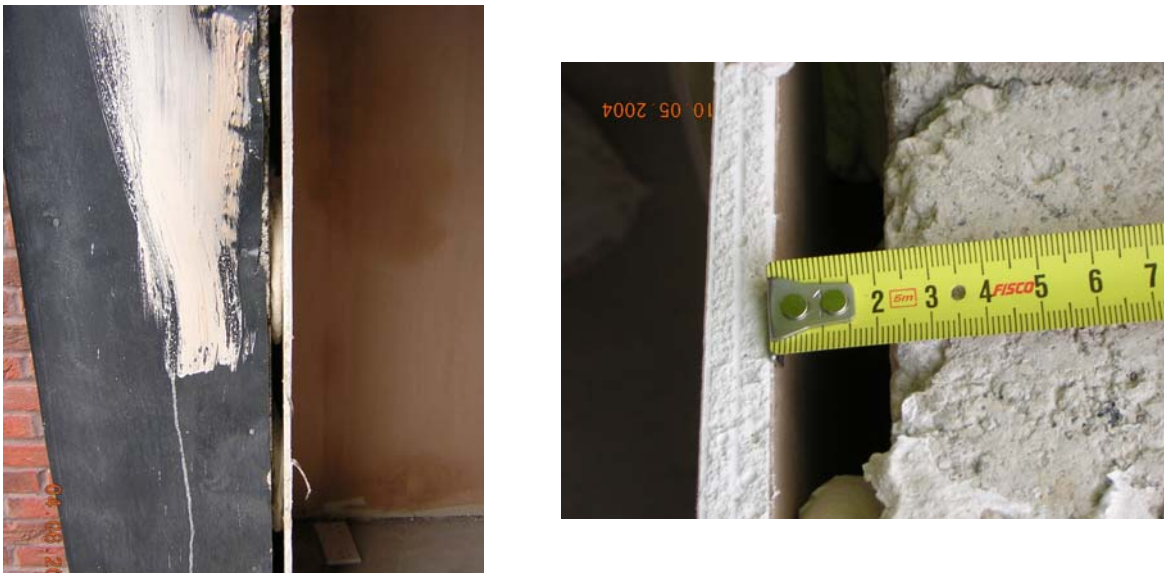
Figure 3.91 Lack of continuity of plaster adhesive to plasterboard lining.

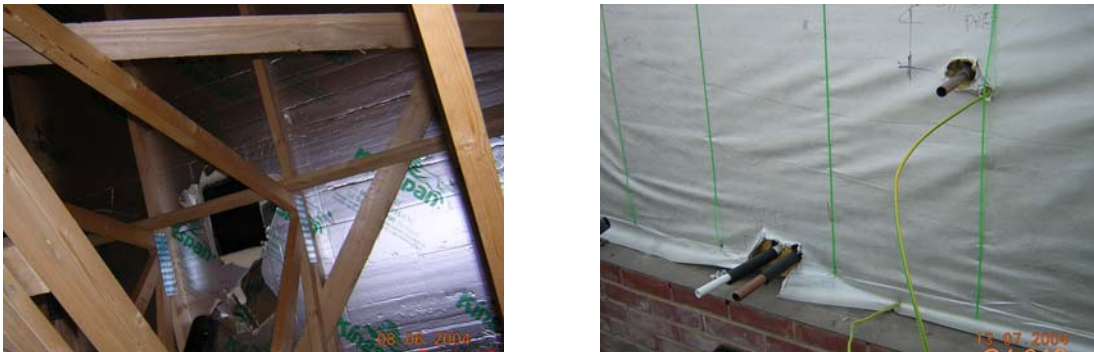
Figure 3.93 Service penetrations through the insulation and air/vapour layers in roofs and walls.

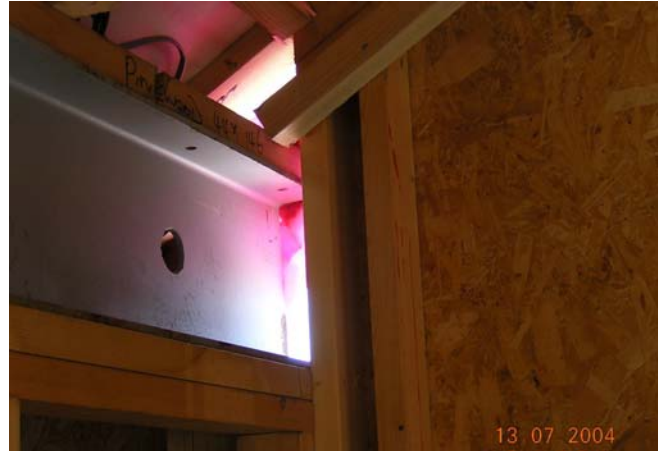
Figure 3.95 Penetration of timber frame wall by steelwork.

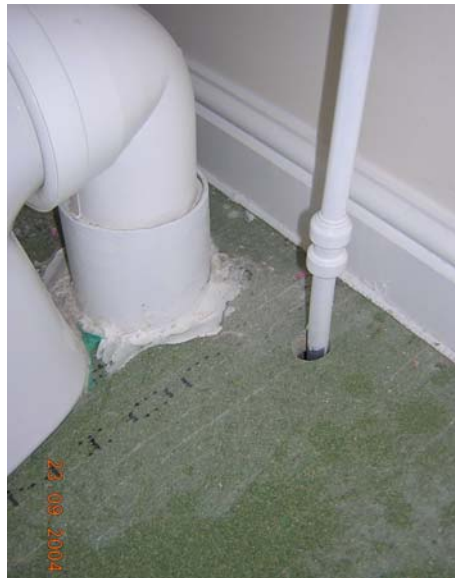
Figure 3.97 Sealing around soil pipe – water pipe yet to be sealed?
