Condensation Risk – Impact of Improvements to Part L and Robust Details on Part C

Project Reference Number: CI 71/6/1 BD2414

Interim report number 7: Final report on project fieldwork

Malcolm Bell, Melanie Smith & Dominic Miles-Shenton
Buildings and Sustainability Research Group
Leeds Metropolitan University

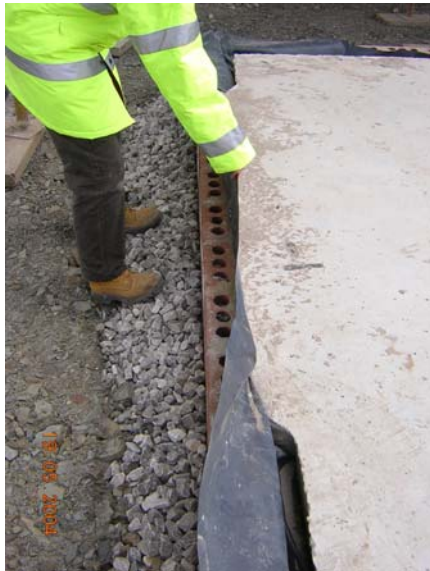
Figure 3.12 Omission of edge insulation at patio door reveal – and RD 8.06.

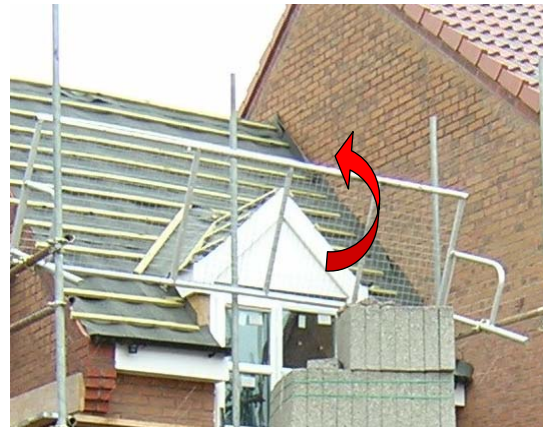
Figure 3.53 Gap in insulation adjacent to gable wall and structural thermal bridge (arrows).
