York Passivhaus Building Performance Evaluation

Report prepared for Dr Jenny Brierley by:
Dr Kate Morland, Dr Martin Fletcher,
Dr Jim Parker, Dr Felix Thomas, Mark Collett

April 2024

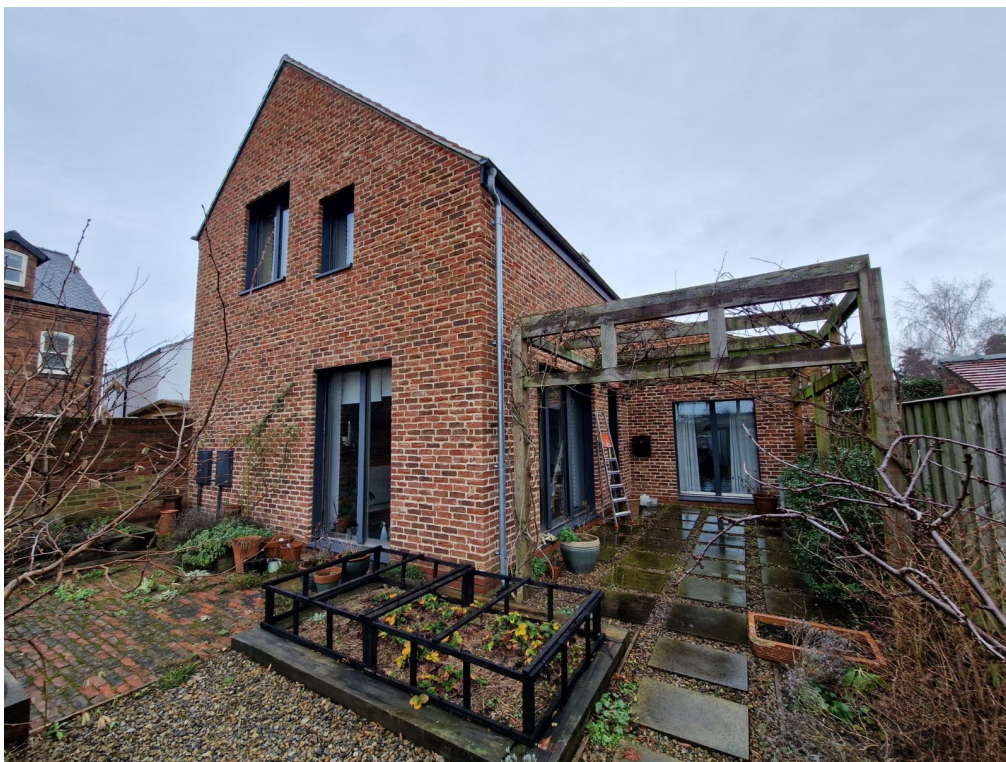
It is built using brick-faced masonry construction with a 300mm full-fill cavity and a wet plaster internal finish. A solid concrete floor sits on top of 400mm rigid insulation. The roof is insulated with a combination of sheep's wool and recycled cellulose insulation to a depth of 450mm. The windows and doors are triple-glazed. Space and water heating are provided by a combination gas boiler. Space heating is delivered by a single radiator and a wood-burning stove. Mechanical ventilation heat recovery (MVHR) is provided through a Paul Focus 200 system. There are no renewables installed and there is a gas hob for cooking.

Figure 1-1 Photo of the York Passivhaus, taken in winter 2022.

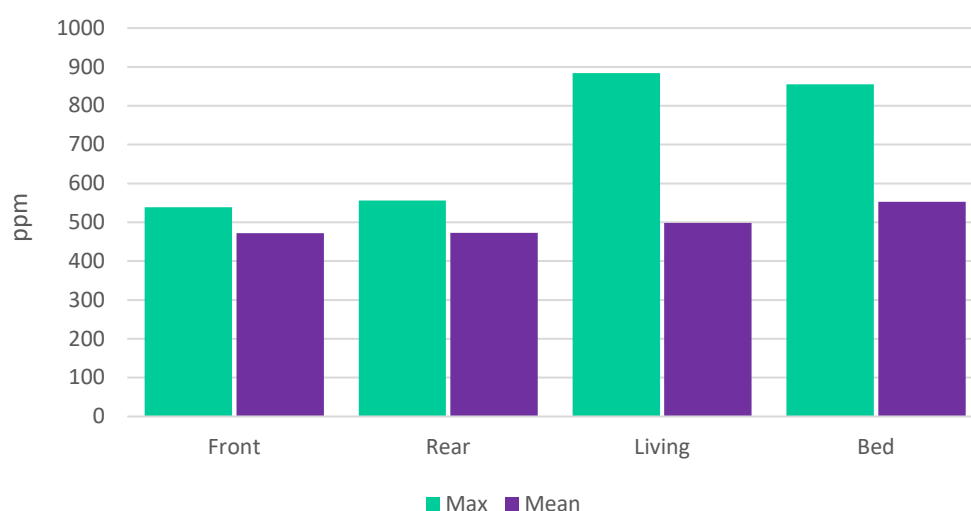
Average and maximum levels for the daily mean of CO₂ ppm can be seen in Figure 3-5. These results suggest that high levels of air quality in terms of CO₂ concentration were maintained throughout the monitoring period. The average concentration is well within the range defined as having a high level of IAQ (<872 ppm). The average value for the bedroom is slightly higher than the living space which would be expected due to the smaller volume of the space and the extended periods of constant occupation during the night.

Figure 3-5 Maximum 24-hour average and annual mean values of CO₂ concentration

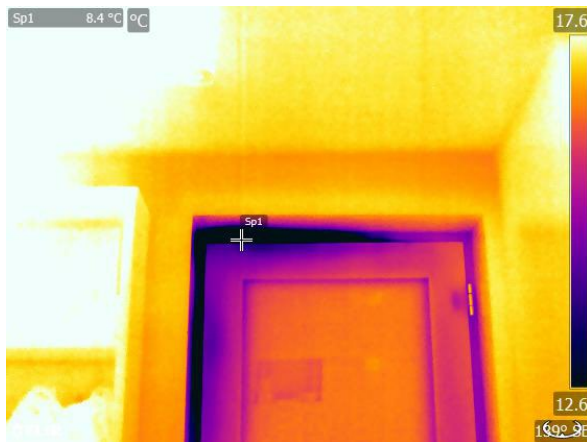
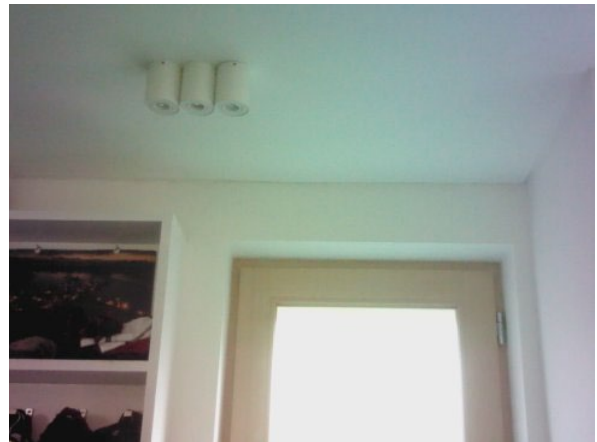
Front door

It appears that while the front door is closed, there is some cooling visible between the door and frame in the top corner. This may be due to the door seal becoming less effective, as the weight of the door over time has caused it to sag slightly in the frame, or it could be due to the door being recently open.

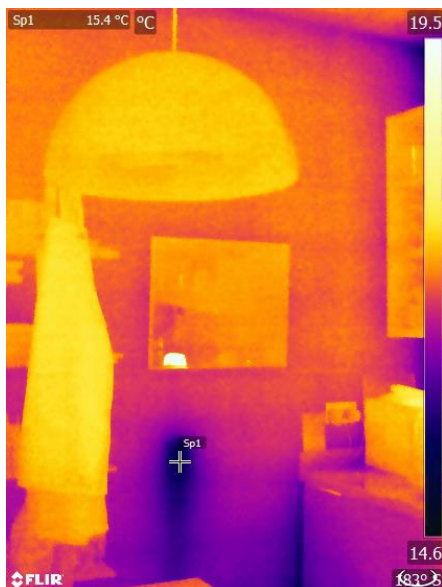
Kitchen/dining area

It is possible to see the wall mounted meter box location (and presumably gas supply) from inside the house, as the wall is colder behind it.

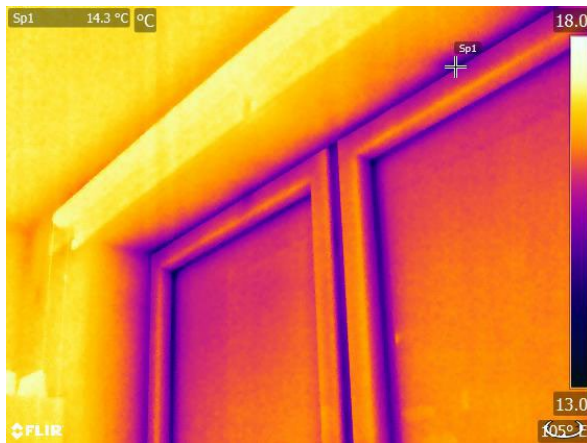
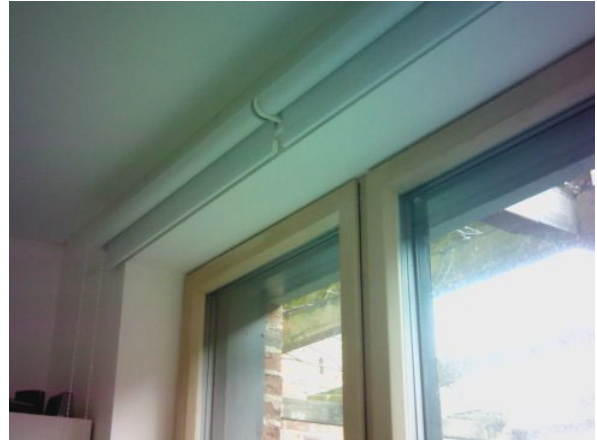
Dining area

Under normal conditions, there appears to be no evidence of increased air leakage between the frames and French doors.

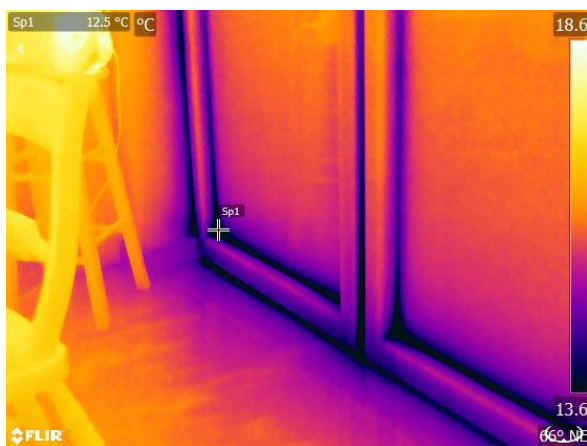
Dining area

However, some cooling is evident where the French door meets the ground and skirting board in the door reveal and at the threshold.

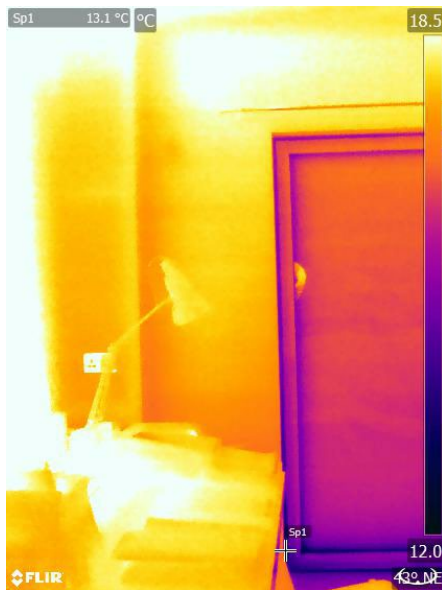
Study space in open plan area

While the external door appears cooler at the bottom, it appears that the seal around the door and frame are functioning satisfactorily.

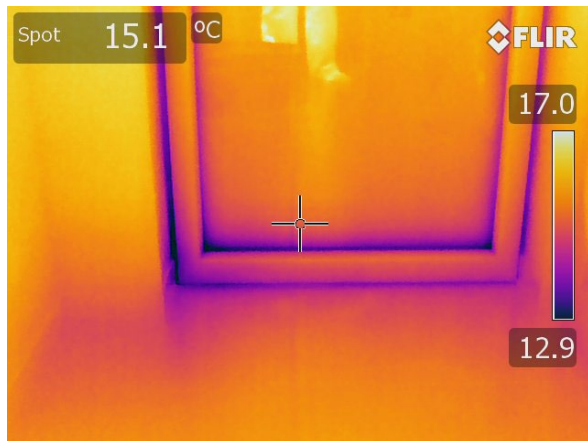
Utility room

While the bottom of the door looks slightly cooler than the top, the seals around the bottom of the door appear to be working well.

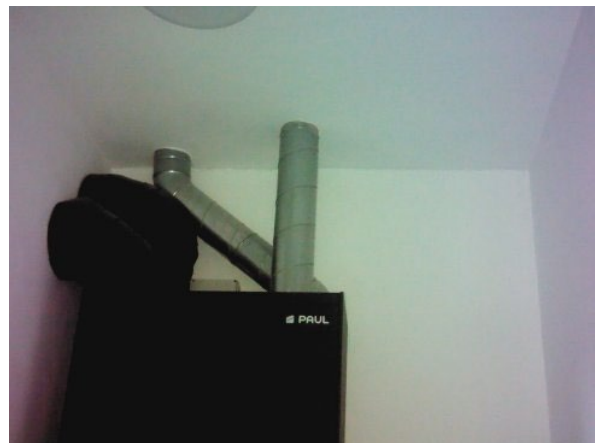
Utility room

The wall is cooler around the ducts from outside and warmer where internal pipe work meets the ceiling, which is to be expected. There appears to be no signs of leakage under passive conditions.

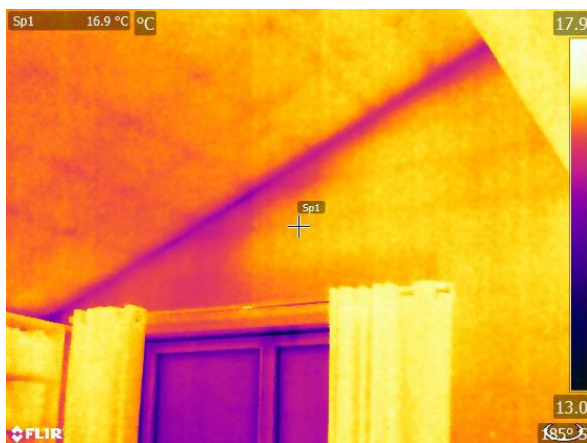
Living area

There is a change in surface temperature across the wall above the door, suggesting cooler air circulation at the junction where the sloping ceiling meets the corner of the wall. This could indicate slightly less insulation in this area, or that there is some uneven heat distribution in the room. It is worth noting that dead zones in corners like this are not uncommon in homes that have MVHR where the supply is distant from the corner and the velocity is low.

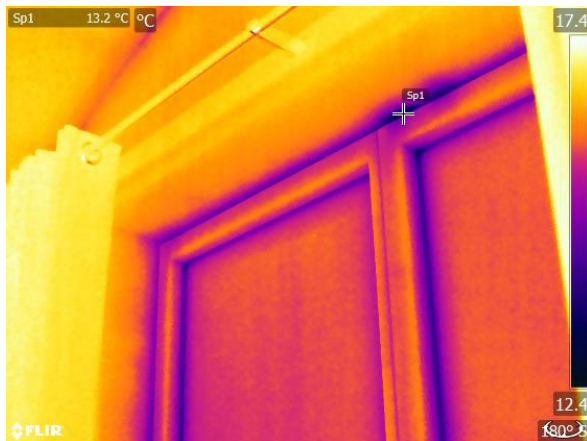
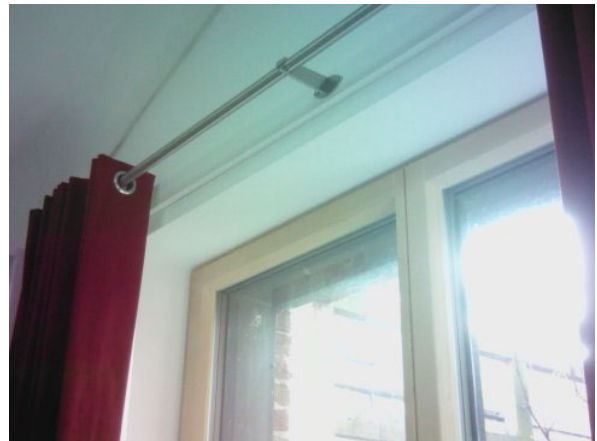
Living area

The larger area of purple where the spot temperature is suggests that the seal between the window and reveal is potentially starting to degrade.

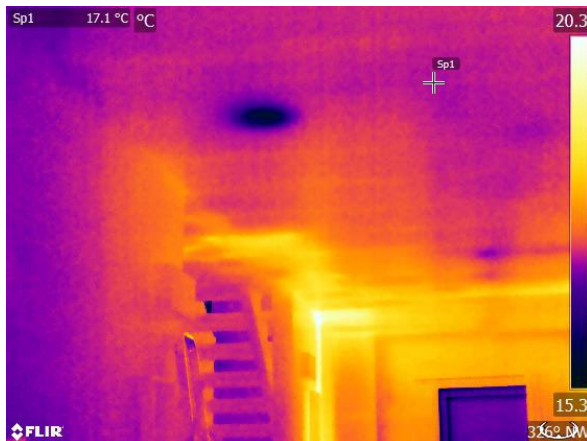
Living area

The dark spot in the ceiling indicates a slow water leak coming from the floor above.

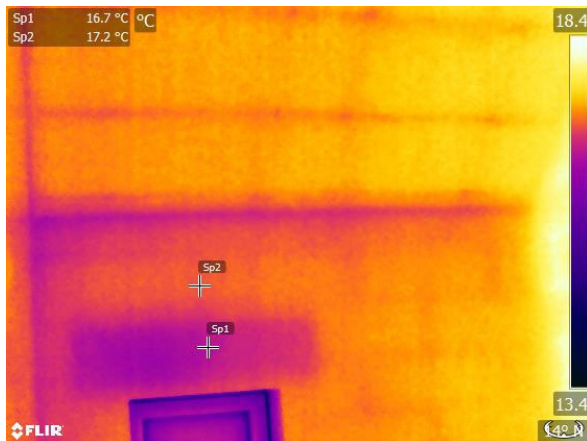
Landing

The different thermal properties between the wall and lintel can be seen in this image, as the lintel is slightly cooler.

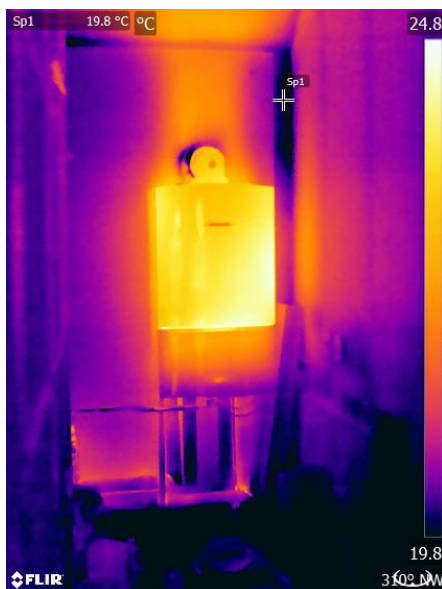
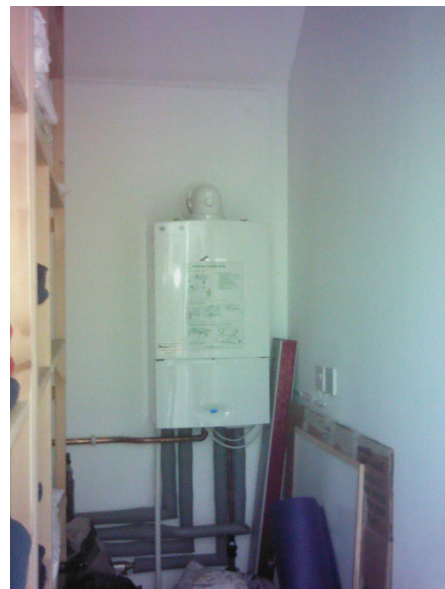
Airing cupboard

There appears to be a small amount of cooler air coming into the room from around the boiler flue.

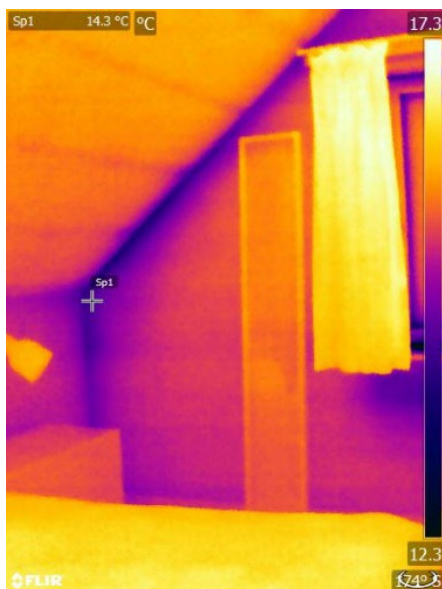
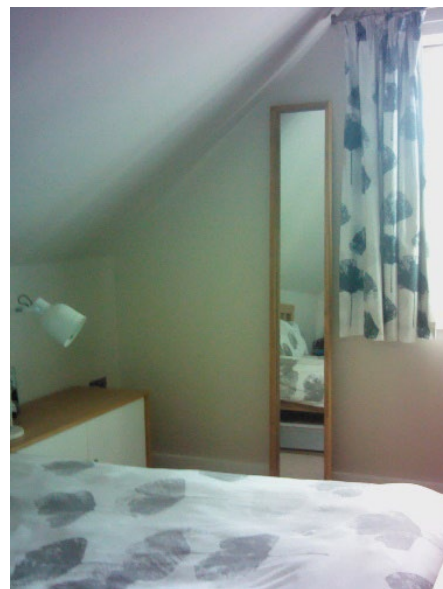
Bedroom 2

This junction appears satisfactory under passive conditions.

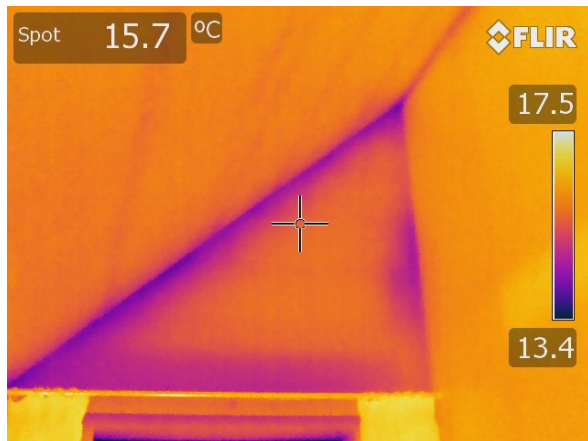
Bedroom 2

The lower corner where the wall meets the ceiling looks slightly cooler, as the purple line along the junction is uneven. This could be due to a thermal bridge at the eaves junction. Cooler surface temperatures are also observed above the window where the lintel is.

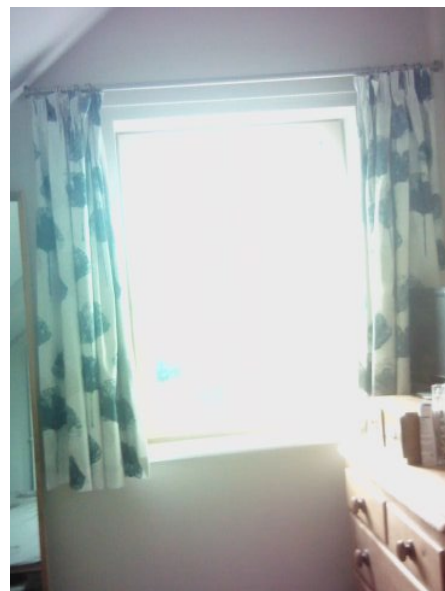
Bedroom 2

There is some sign of cooling across the wall underneath the window. This could be due to a change in material to frame out the window.

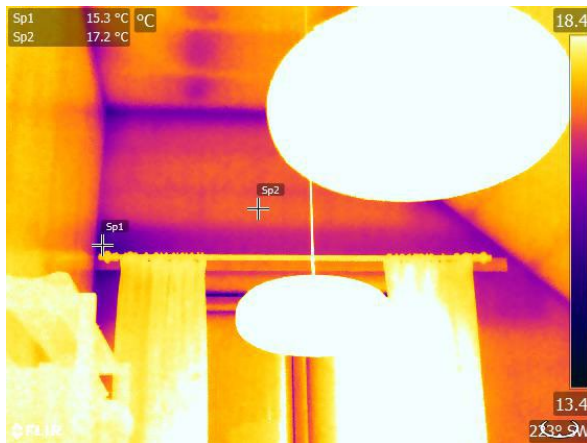
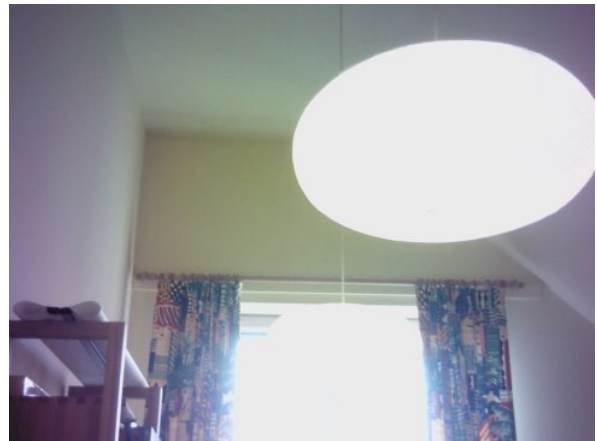
Bedroom 3

In a similar way to Bedroom 2, the ceiling to wall junction looks slightly cooler, which could be attributed to a thermal bridge at the eaves junction. There is also a more pronounced cooler area where the lintel is compared to the wall. The dark line in the ceiling suggests that the ceiling level insulation may not have been laid evenly.

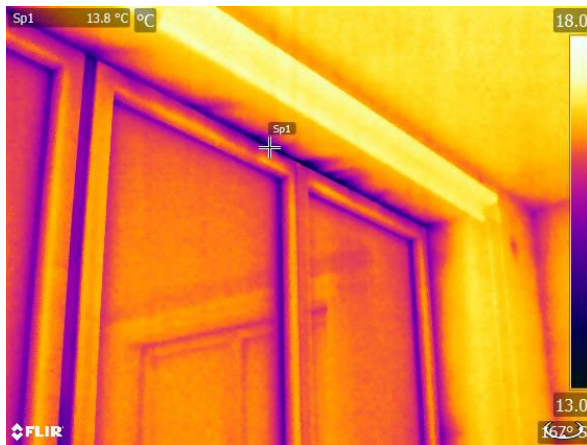
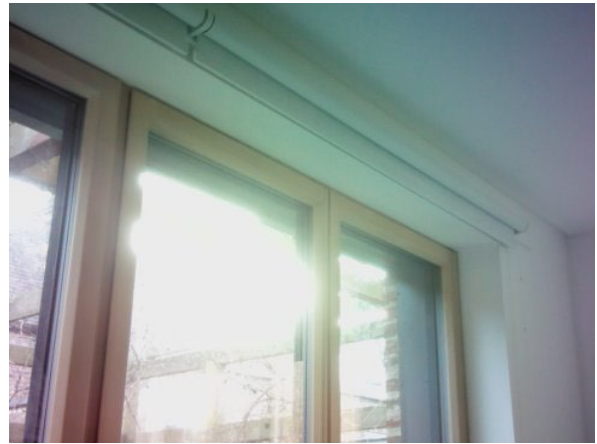
Dining area

It is possible to see cold air movement between the door frame and reveal, suggesting that the seals are starting to fail.

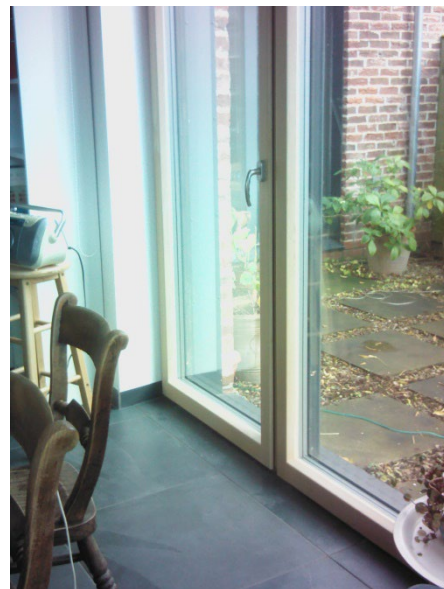
Dining area

Similarly, it appears that the seal between the door and wall is also starting to degrade.

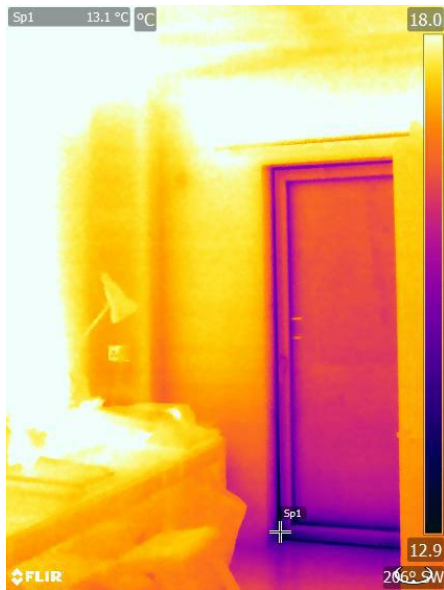
Study

For this door, there appears to be little change under depressurisation, suggesting that the seals are relatively intact.

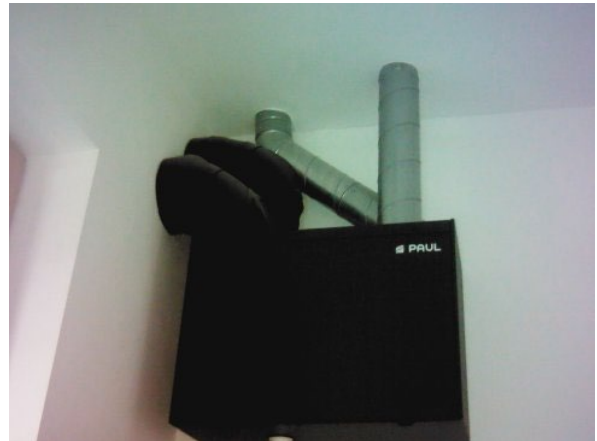
Utility room

For the airtightness test, the internal ducts of the MVHR system were sealed, but not the external ducts. The change in surface temperature across the unit and internal pipework suggests that under negative pressure, a small amount of cooler external air is being pulled into the system, as the external ducts were not sealed. This may suggest that the internal ducts were not quite 100% sealed. However, the image does imply that the seal between larger diameter MVHR ductwork and outside appears to be functioning well.

It is worth noting that there are several different materials captured in this image, each with a different emissivity, or ability to emit infrared energy. Therefore, this makes what is happening in the image somewhat challenging to interpret.

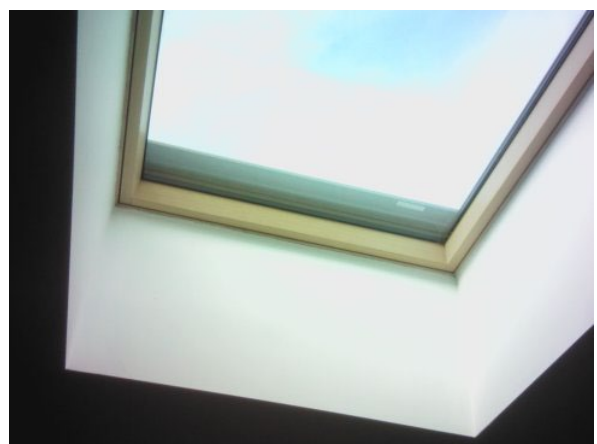
Living area

The ripples of cooler air indicate signs of air movement at the interface between the window frame and the plasterboard.

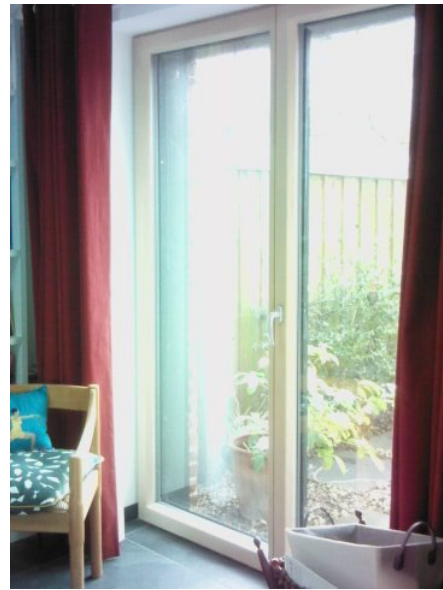
Living area

The areas of cooler air coming in between the interface between the door and frame, particularly at the top, indicate that the seals around the frame may be starting to degrade when under pressure.

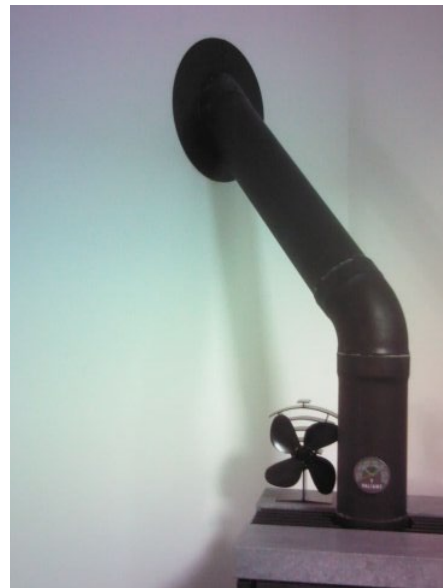
Living area

There do not appear to be any signs of air leakage coming from the living area fire flue.

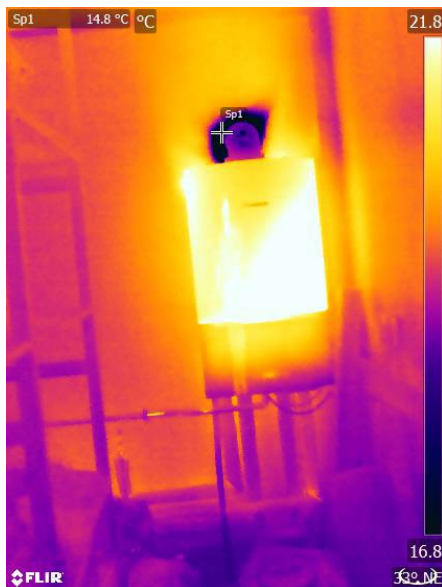
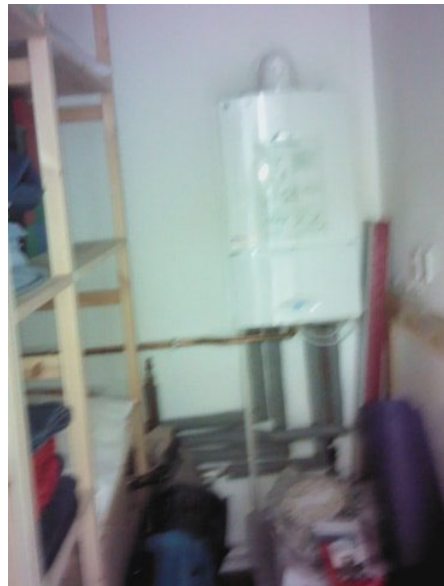
Airing cupboard

Under negative pressure, it is possible to see a significant amount of cooler air being drawn in past the boiler flue

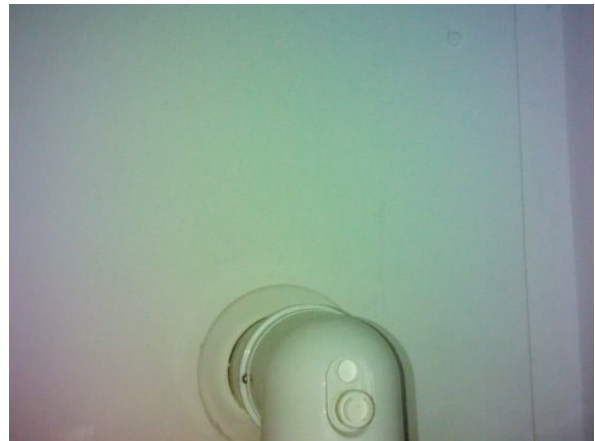
Airing cupboard

Looking at this in more detail, cooler air appears to be coming from all around the flue and not just in one area as shown in the image where there was no pressure differential.

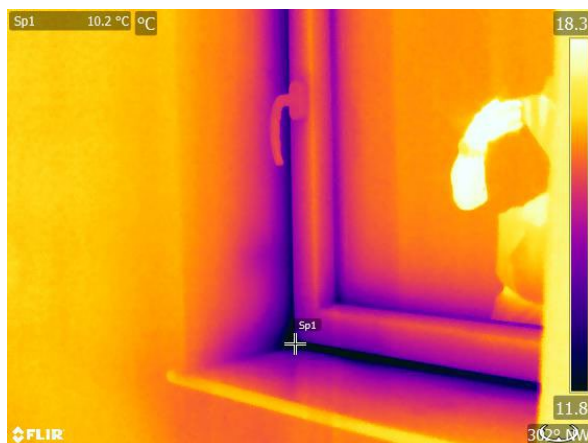
Bedroom 1

Under depressurisation, there appears to be some cooler air coming in at the bottom corner of inward opening windows. This may be due to seals starting to degrade or a characteristic of the window, i.e., trying to open inwards, when under negative pressure.

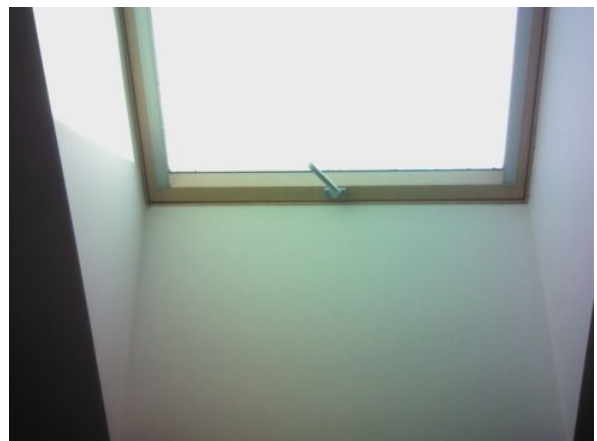
Bedroom 1

The cooler area under the window to the right suggests that there may be air circulating behind the plasterboard.

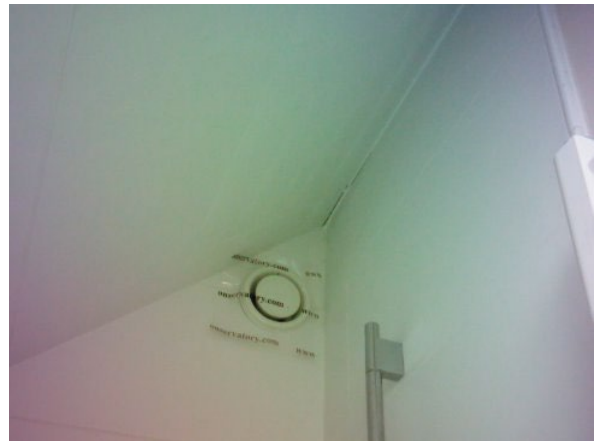
Bathroom

This area looks the same as when it was photographed without any pressure differential. This suggests that the surface moisture content in the corner is higher than the surrounding area, rather than evidence of thermal bridging. This is not surprising given it is above a bath and shower.

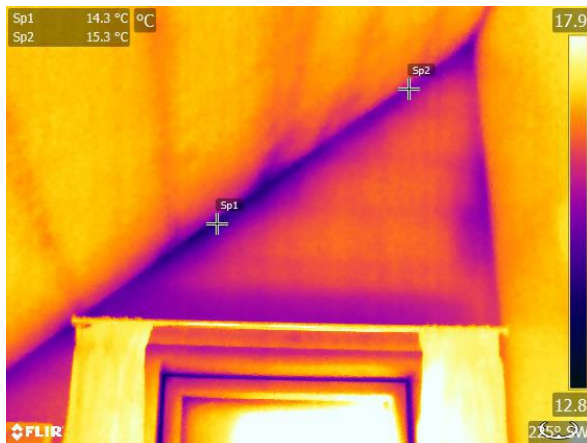
Bedroom 2

The change in colour and shape of the darker areas at the wall to ceiling junction indicates that air is being drawn in within the roof and ceiling structure.

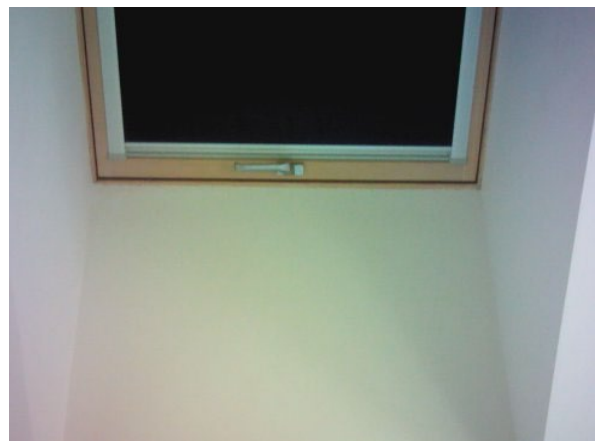
Bedroom 2

It looks as though all the first floor rooflights in the home show some movement of cooler air behind the window reveal plasterboard as it is evident in this room too.

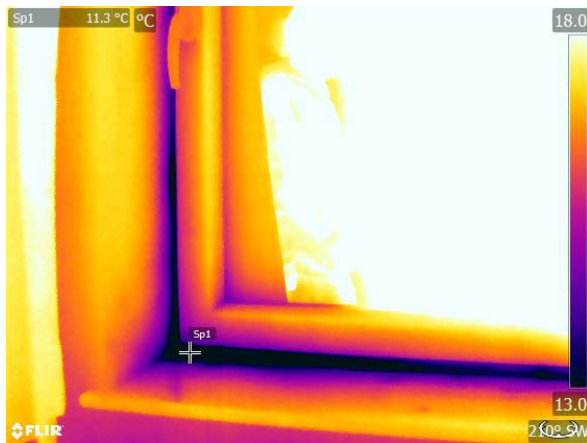
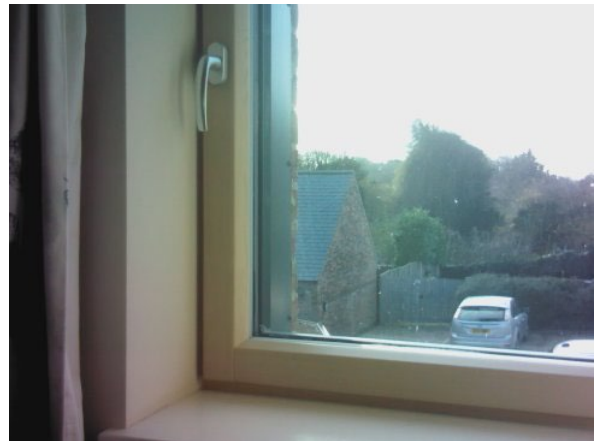
Bedroom 2

The darker purple at the bottom corner of the window suggests that, under negative pressure, there is minor air leakage here.
