## Adding Value and Meaning to Coheating Tests

Anne Stafford, David Johnston, Dominic Miles-Shenton, David Farmer, Matthew Brooke-Peat and Chris Gorse

*Centre for the Built Environment (CeBE), Leeds Metropolitan University, Leeds, UK*

### Structured Abstract:

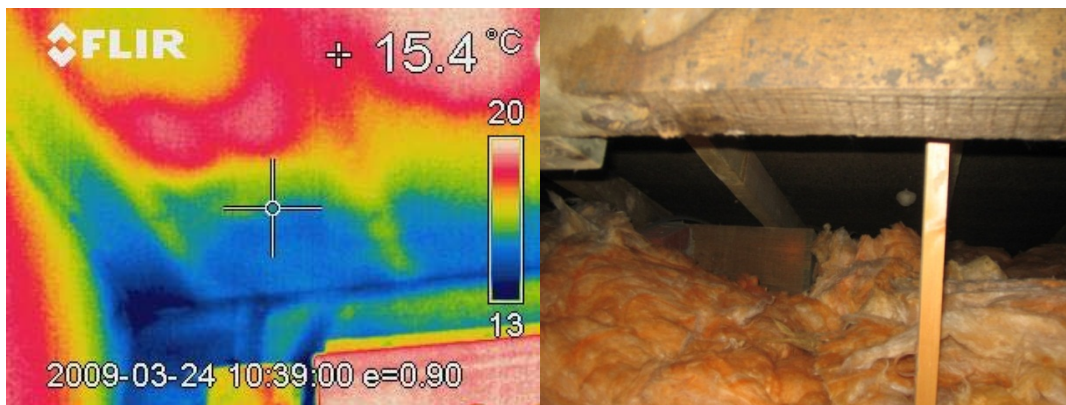
*Figure 1: Cooler areas near ceiling edge found to be a result of missing loft insulation behind purlin in eaves area.*

The following figures show examples of issues identified by thermography (figs 1 and 2) or by a combination of thermography and smoke testing (figs 3 and 4). Fig. 2 is taken from the report 'Understanding the gap between designed and real performance: Lessons from Stamford Brook' (Wingfield et al., 2011b).

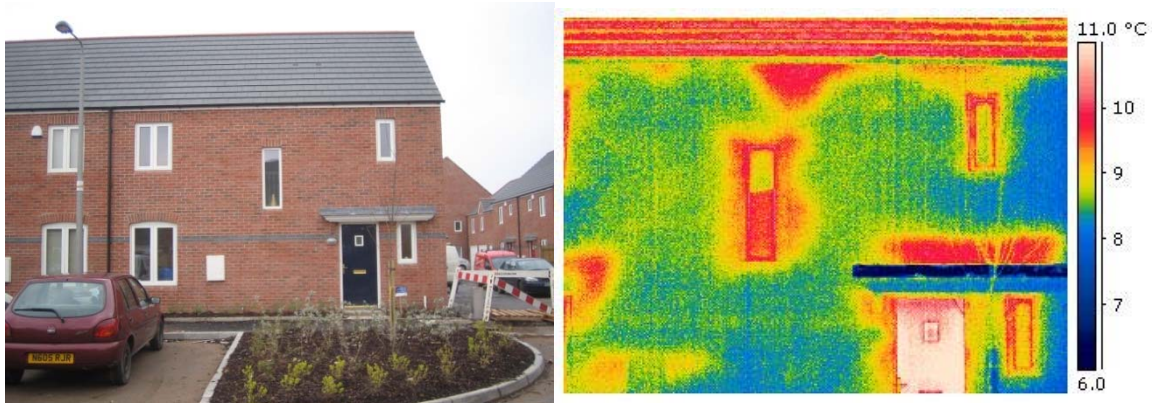
Figure 2: Example of missing, slumped or incomplete cavity wall insulation. Taken from the report 'Understanding the gap between designed and real performance: Lessons from Stamford Brook' (Wingfield et al., 2011b)

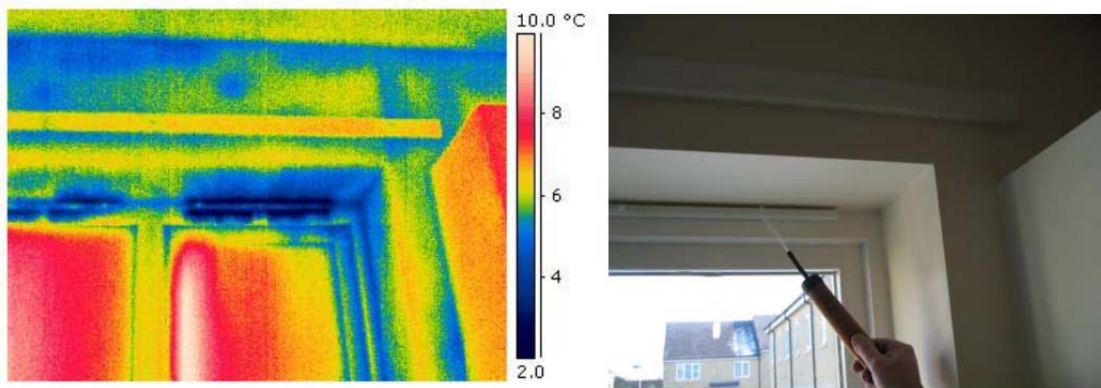
Figure 3: Air leakage through and around poorly fitting and/or poorly closing window trickle vents.

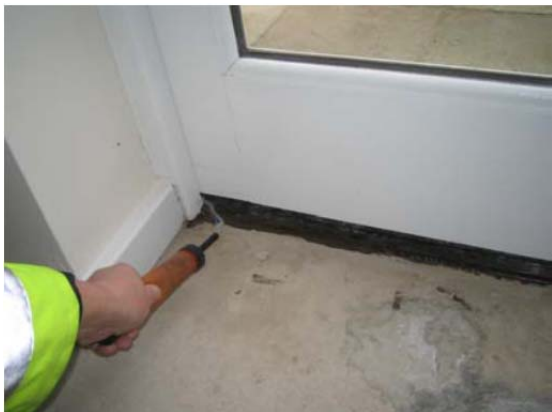
Figure 4: Air leakage under patio doors.

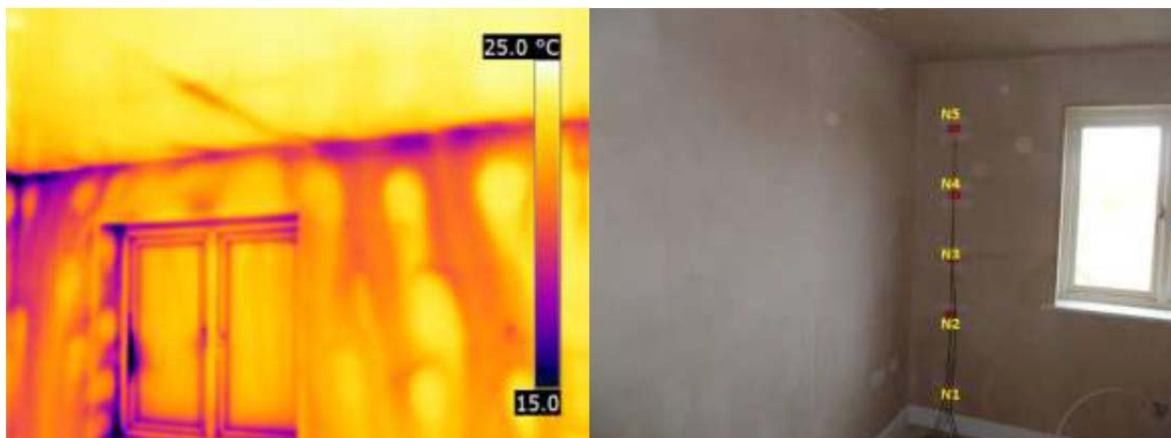
Figure 5: Thermal image influencing placement of heat flux sensors. Images supplied by D. Farmer (private communication).

Thermal imaging can identify potential areas of interest so that heat flux sensors can be placed appropriately to quantify differences in *in situ* U-value. For example, the thermal image in Figure 5 below suggested the presence of air movement behind the internal plasterboard which was subsequently investigated further using a vertical array of heat flux sensors to give a better estimate of the overall *in situ* wall U-value.

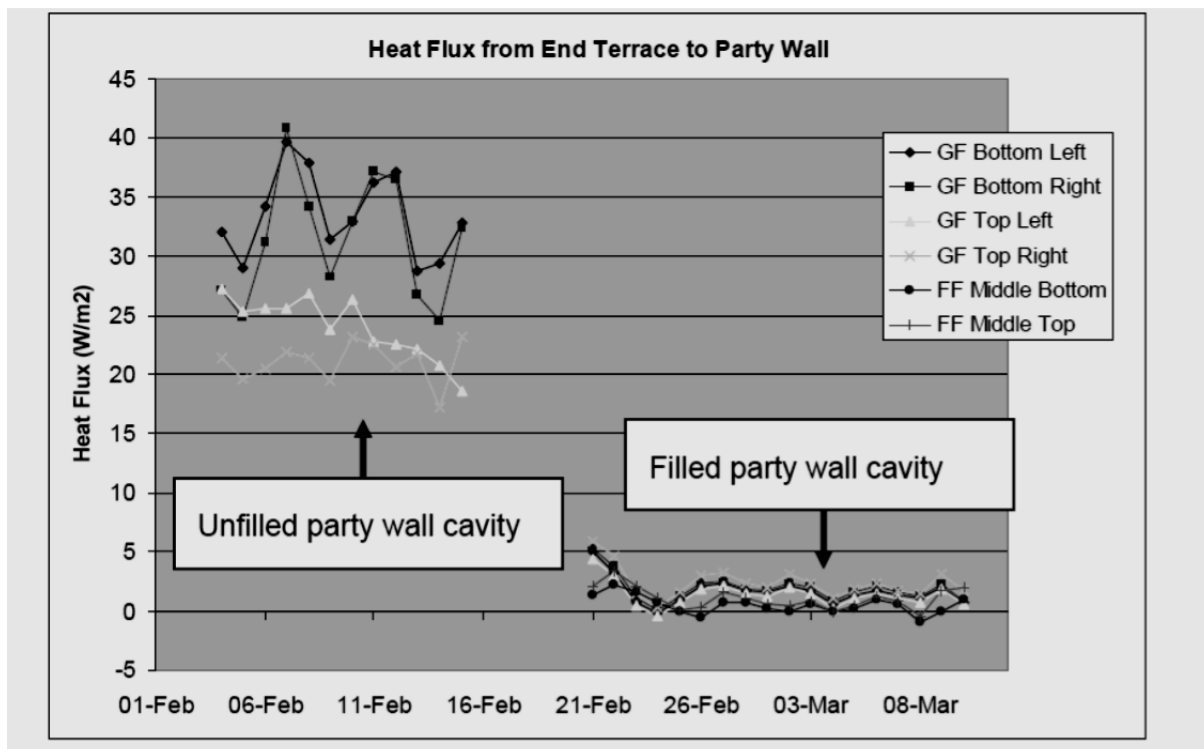
Figure 8: Heat flux data before and after fully filling and edge sealing of a party wall cavity. Taken from Wingfield (2010).

In a similar way, heat flux measurements have also been used in this context to identify and estimate the effects of thermal bypasses, for example the bypass associated with unfilled cavity party walls, which was formally recognised in the 2010 UK Building Regulations, following work done by Bell and Wingfield at Leeds Metropolitan University. The mechanism was first posited following work done at Stamford Brook (Lowe et al., 2007), but the example shown in fig 8 below is taken from the Technical Note on Measurement of Heat Loss via Thermal Bypasses in Separating Party Wall Cavities (Wingfield, 2010)

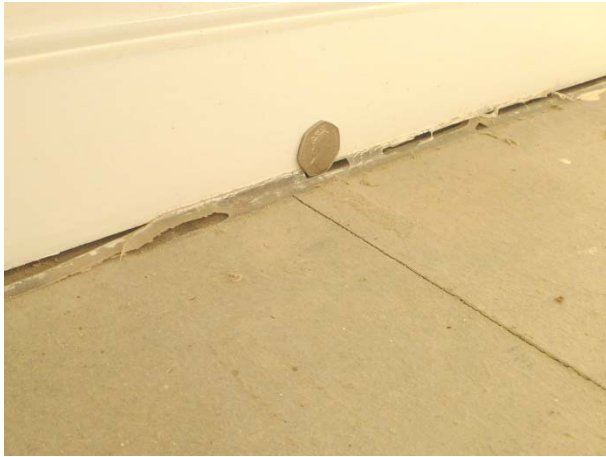
*Figure 6: Failure of mastic seals due to accelerated drying during test.*

Of course detailed observation of the construction or refurbishment process may not always be possible. However, even in a completed building, observation can often suggest a need for further testing, and is another example of the advantages of testing being undertaken by experienced researchers. A very simple example is observation of the failure of mastic seals due to accelerated drying out during a coheating test, causing deterioration in the airtightness of the dwelling, as shown in Figure 6 below.

Under these circumstances, increased air leakage through shrinkage cracks is expected, especially where the airtight barrier relies on secondary sealing to maintain its integrity, and this can have a significant effect on the overall measured heat loss of the property. Although this is not always preventable, the employment of pulse and decay CO<sub>2</sub> measurements throughout the testing phase allows identification of any step changes in ventilation rate, which can subsequently be accounted for in the heat loss calculations.

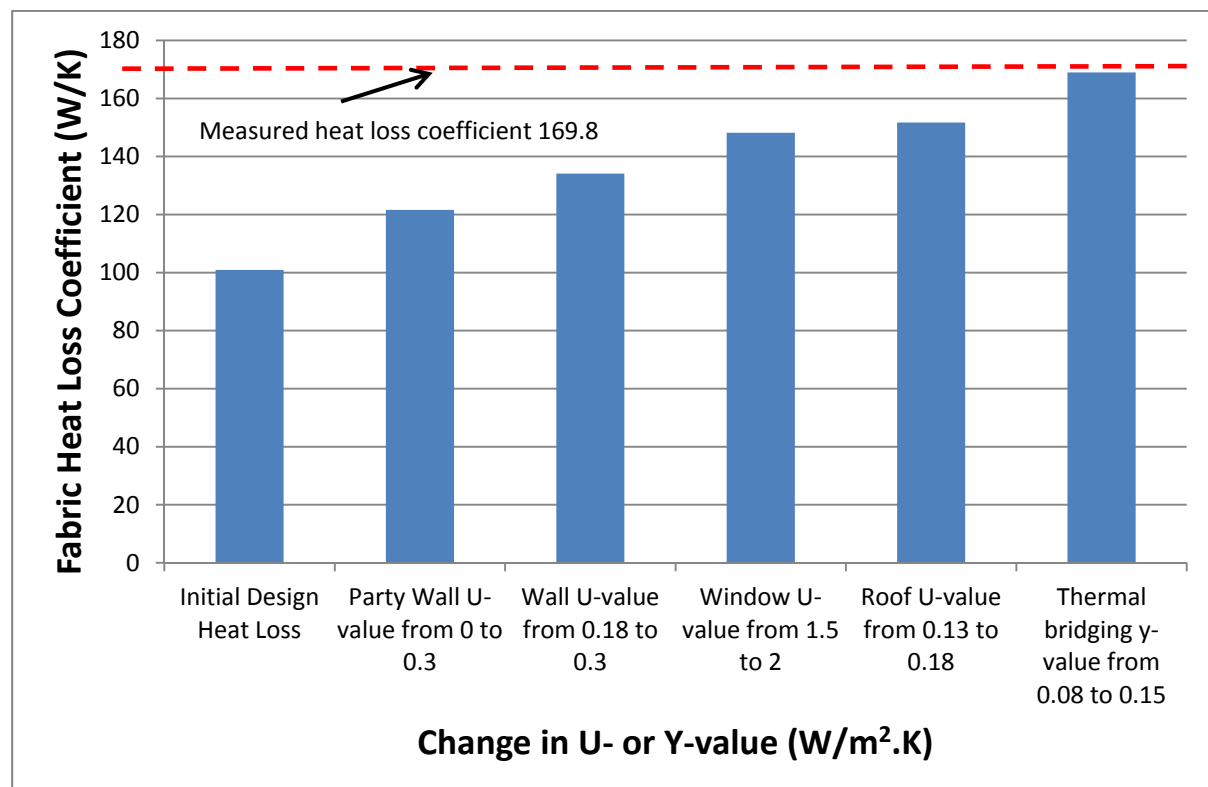
Figure 7: Taken from Elm Tree Mews Field Trial – Evaluation and Monitoring of Dwellings Performance - Final Technical report (Wingfield et al., 2011a) Fig. 108, p92.

This approach is sometimes called “closing the loop” and arguably should ideally be the ultimate aim of the investigative process. Again, the Elm Tree Mews Field Trial (Wingfield et al., 2011a) provides a good example (Figure 7). Here, the measured heat loss coefficient was effectively fully explained by differences in U-values of building elements (compared with design values) and differences in thermal bridging. These differences were quantified (or realistically estimated) from evidence collected on-site, and the close match between the effects of these investigations and the observed discrepancy in HLC supports the reliability and quality of the coheating test in this instance.
