Scholz, M and Uzomah, VC and Al-Faraj, FAM (2016) Potential tree species for use in urban areas in temperate and oceanic climates. *Heliyon*, 2 (9). ISSN 2405-8440 DOI: <https://doi.org/10.1016/j.heliyon.2016.e00154>

# Potential tree species for use in urban areas in temperate and oceanic climates

This study aims to assess the potential of trees for integration in urban development by evaluating the damage caused by trees in relation to various tree characteristics. Tree damage to permeable pavement systems and other urban structures such as impermeable pavements, kerbs, roads, retaining walls, footpaths, walls and buildings were assessed to identify the most suitable trees for the urban environment. One hundred square sites of 100 m × 100 m were randomly selected in Greater Manchester for this representative example case study to demonstrate the assessment methodology. Among tree species in this study, *Acer platanoides* L. (Norway maple) occurred most frequently (17%); others were *Tilia spp.* L. (Lime; 16%), *Fraxinus excelsior* L. (common ash; 12%), *Acer pseudoplatanus* L. (sycamore; 10%) and *Prunus avium* L. (wild cherry; 8%). The study concludes that 44% of the damage was

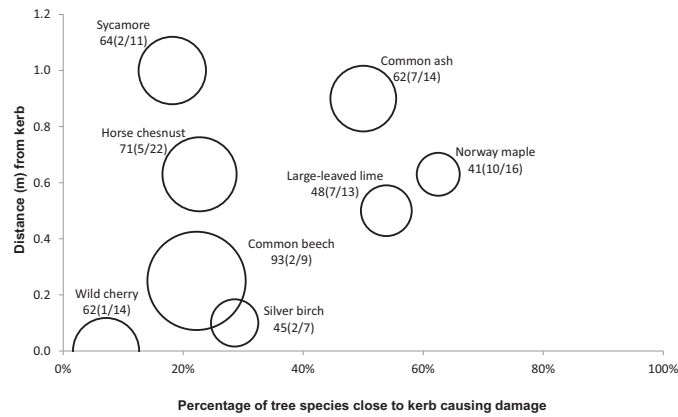
**Fig. 4.** Relationships of tree diameters at breast height (DBH (cm); represented by circles), average distances of trees away from kerbs, and the proportion of trees within 10 m to these structures subjected to moderate to severe damage. Note: x(y/z), where x represents DBH and z indicates the number of the tree species out of which y trees caused damage.

Kerb damage comprised 19% of all recorded structural damage. *Acer platanoides* caused the most damage to kerbs (10 out of 16 trees were located close to kerbs) from an average distance of 0.6 m and with a mean DBH of 41 cm (Fig. 4). Similar to *A. platanoides* was the impact of *T. platyphyllos* (7 out of 13 nearby *T. platyphyllos*), *A. pseudoplatanus* (2 out of 11 surrounding trees) and *F. excelsior* (7 out of 14 surrounding trees) caused damage to kerbs from the furthest average distance of 1 m (Fig. 4).

Other trees that caused damage were less than 1 m from the kerb as shown in Fig. 4. *Prunus avium* was the best tree suitable for kerbs: only 1 in 14 trees caused moderate to severe damage (Fig. 4). However, most *P. avium* were very closely located (0 m) to kerbs, and their average DBH was 62 cm. This was closely followed by *F. sylvatica*. Although for *F. sylvatica* of an average DBH of 93 cm (indicating trees well-advanced in age) and an average distance of 0.23 m from kerbs, only 2 out of 9 trees caused moderate to severe damage to kerbs (Fig. 4). The worst tree to be located close to kerbs is *A. platanoides*. For trees of this species with an average DBH of 41 cm (indicating middle age) and located about 0.6 m from the kerbs, about 10 out of 16 *A. platanoides* caused moderate to severe damage to kerbs (Fig. 4).

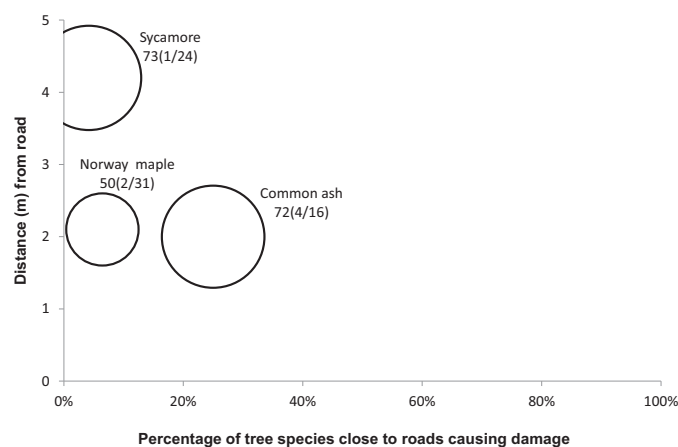
**Fig. 5.** Relationships of tree diameters at breast height (DBH (cm); represented by circles), average distances of trees away from roads, and the proportion of trees within 10 m to these structures subjected to moderate to severe damage. Note: x(y/z), where x represents DBH and z indicates the number of the tree species out of which y trees caused damage.

The percentages of damage to roads and retaining walls were 3% each. Only three trees (*F. excelsior*, *A. platanoides* and *A. pseudoplatanus*) caused moderate to severe damage to roads (Fig. 5). Trees that caused damage to roads were located within an average distance of 2–5 m away from roads, indicating that the majority of them were planted close to the pavements.
