# Developing a Taxonomy for Discontinuities in Internal Wall Insulation

Felix Thomas<sup>1</sup>, Fiona Fylan<sup>2</sup>, David Glew<sup>3</sup> and Christopher Gorse<sup>4</sup>

<sup>1,2,3,4</sup> Leeds Sustainability Institute, Leeds Beckett University, School of the Built Environment and Engineering, Leeds/ LS2 9EN, United Kingdom

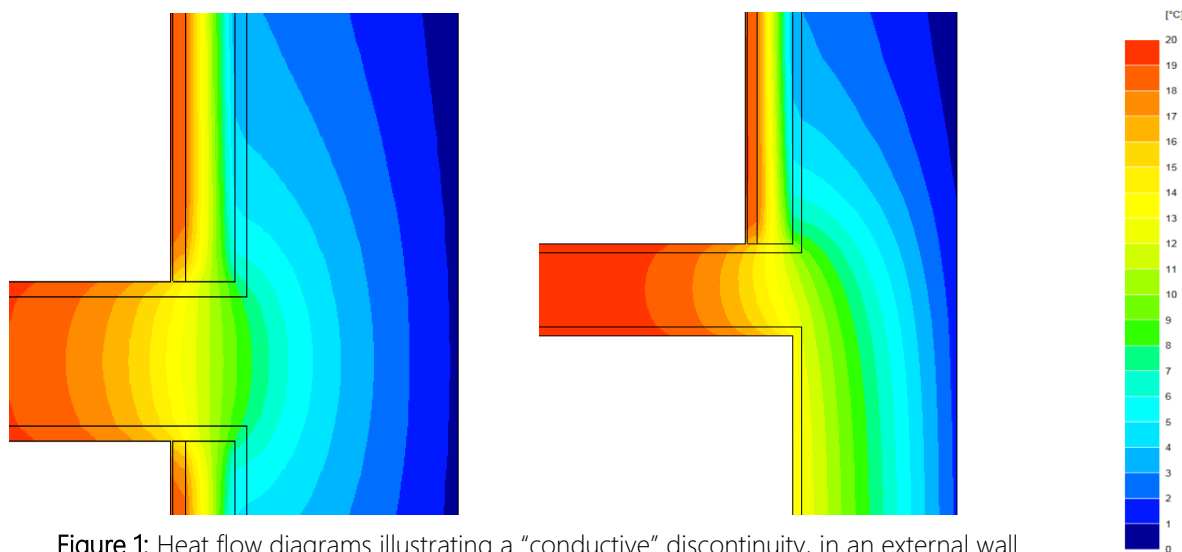
Figure 1: Heat flow diagrams illustrating a “conductive” discontinuity, in an external wall to brick internal partition wall, in plan view. **Left** : symmetrical application of IWI.

“Obstructive solid linear-Symmetrical” **Right** : asymmetrical application of IWI.

“Obstructive, solid Linear-Asymmetrical”

Hens (1998) investigated the hygrothermal behaviour of solid masonry walls fitted with IWI, using calculation based modelling and laboratory tests in an environmental chamber. Hens investigates a T-junction between a masonry envelope and an inside partition wall with insulation fixed only to the external envelope section. The low thermal resistance of the internal partition wall allows heat to be conducted past the insulation layer, forming a thermal bridge.

Cuce and Cuce (2016) measured thermal bridging through a solid masonry partition wall joined to an external masonry cavity wall filled with insulation, an additional 20mm of aerogel insulation was fitted to the external wall on one side of the partition and measurements taken on the insulated side of the wall. Thermal bridging through the partition wall was found to increase significantly after IWI was fitted and although the insulation solution differs, this again represents an “obstructive, solid linear- asymmetrical” discontinuity

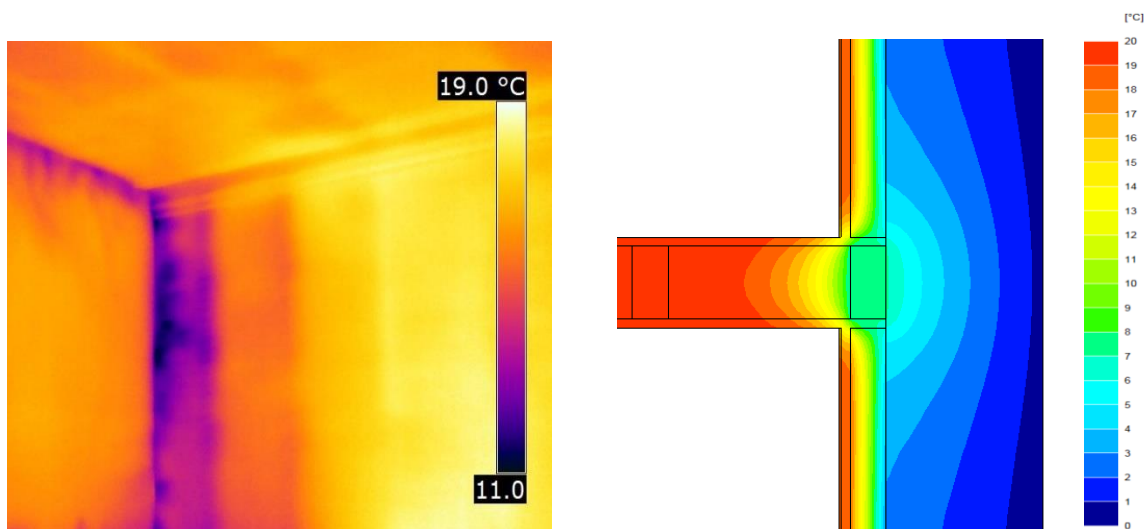
Figure 2: Obstructive, void discontinuity, a stud partition wall to external wall junction. Left : thermogram of an obstructive, void discount, under depressurisation. Right : Heat flow diagram of an obstructive void discontinuity in plan view. "Obstructive, void Linear-Symmetrical"

Obstructive, void discontinuities occur at breaks in the IWI layer due to an obstructive building element that encloses an air void. Air movement within the void allows the IWI layer to be bypassed via convection or advection i.e. air movement into and out of the void is able to take place. Air is able to permeate into and out of the air void, through the often unfinished internal face of the external wall and gaps in wall or floor finishes. Obstructive, void discontinuities share some similarity to exposed discontinuities, as they both involve a section of the face of an external wall that is not covered by insulation, and both can occur simultaneously though their underlying

Obstructive, Void discontinuities were present in three of the four dwellings identified, occurring at intermediate floor to external wall junctions in three dwellings and at stud partition walls in two dwellings. Thermography undertaken during depressurisation indicated that air infiltration was occurring at the obstructive, void discontinuities. In one case an attempt to eliminate the discontinuity at the intermediate floor junction was made, filling the gap in the insulation layer with insulation board offcuts. This appears to have been ineffective at preventing air infiltration.

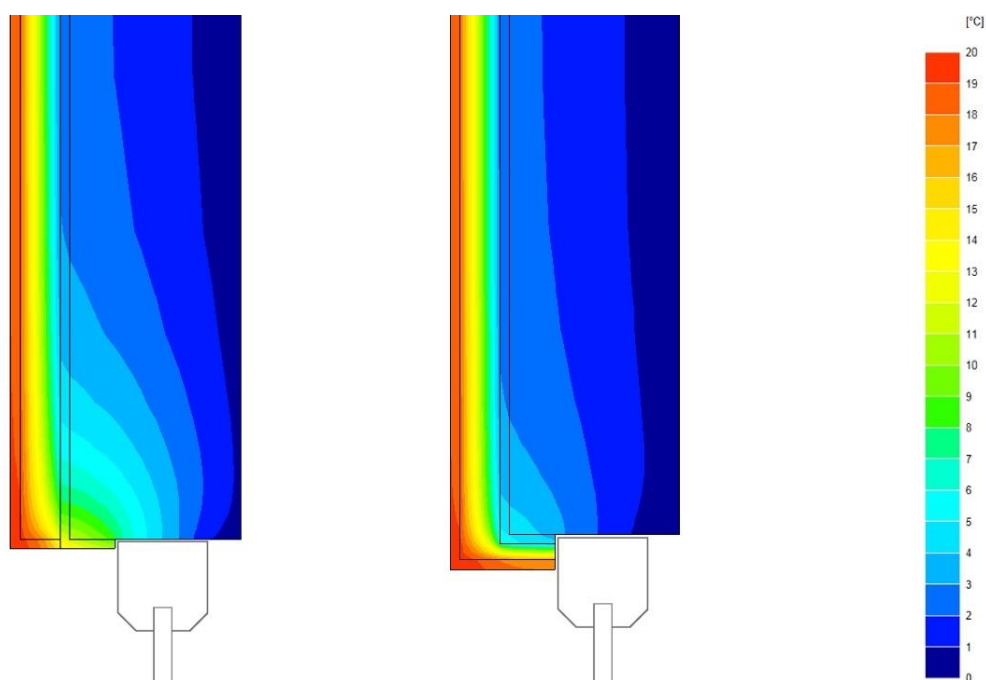
Figure 3: Heat flow diagrams illustrating an “exposed” discontinuity at a window jamb, in plan view. **Left** : IWI fitted to internal face of wall, no insulation to the reveal “exposed opening”. **Right** : Insulation fitted to jamb reveal. No discontinuity

An exposed discontinuity occurs where there is a part of the internal face of the external walls of a dwelling that is exposed to the internal environmental conditions, due to a gap in the coverage of the IWI layer. Marincioni *et al.* (2016) investigates what impact thermal bridging at discontinuities in IWI at the window and door opening reveals has on the overall heat loss coefficient of typical mid and end terraced solid walled dwellings. They model the heads, jambs

and sills of openings in the external walls, with and without insulation applied to the reveals. Uninsulated reveals are shown to account for a large proportion of the heat lost through all junctions, 40-52% in walls with varying thicknesses of IWI, falling to 19-34% with a 20mm thickness of insulation at the reveals. Weeks *et al* (2013) also investigate opening reveals, modelling heads, jambs and sills with 100mm of IWI and uninsulated reveals, and the same junctions with 20 mm of insulation. Their results show a reduction in thermal bridging at the junctions of 75 to 82% when insulation is applied to reveals, application of insulation at the reveals also reduces the risk of condensation formation where the window frame joins the solid wall, as the cold surface temperatures caused by thermal bridging are mitigated by the reveal insulation. This means *exposed* discontinuity can occur on any insulated wall within a single dwelling where there is a break for whatever reason in the insulation layer. Gorse *et al* (2017) observed exposed discontinuities in a number of dwellings, including window and door openings with lintels, jambs and sills that were left uninsulated. Areas of external wall without insulation applied were also
