## **Investigation into the *in situ* thermal performance of 2 static caravans - Assessing the change in heat loss behaviour due to thermally superior replacement windows.**

**Client:** Camden Group  
Steeple Road Industrial Estate  
Antrim  
Northern Ireland  
BT41 1AB

**Site Address:** Units C05 & C10, Holly Bank  
Blue Dolphin Holiday Park  
Filey  
North Yorkshire  
YO14 9PU

April, 2015

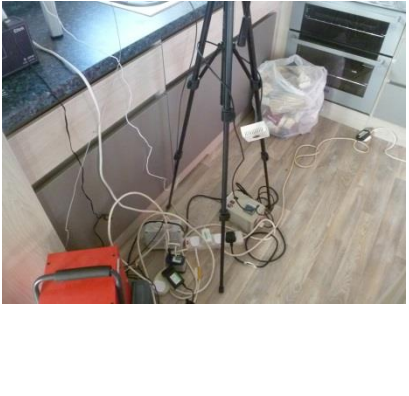
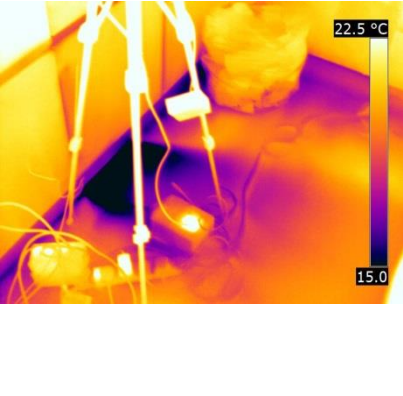
<p>20-Mar-2015 C05 – Kitchen Substantial airflow was detected emerging from beneath the kitchen units, suggesting that there was some drainage or ventilation opening beneath the units remaining unsealed. As access to this area was not possible, no temporary seals were placed in this location.</p>

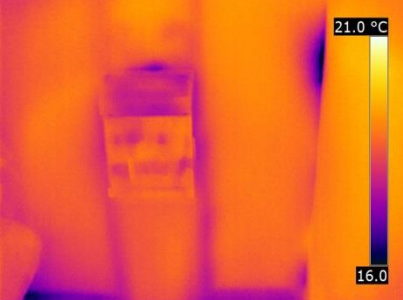
20-Mar-2015  
C05 – Bathroom  
Air leakage emerging from around the shower controls could be traced back down underneath the shower tray to the location where the waste pipe penetrated through the caravan floor.

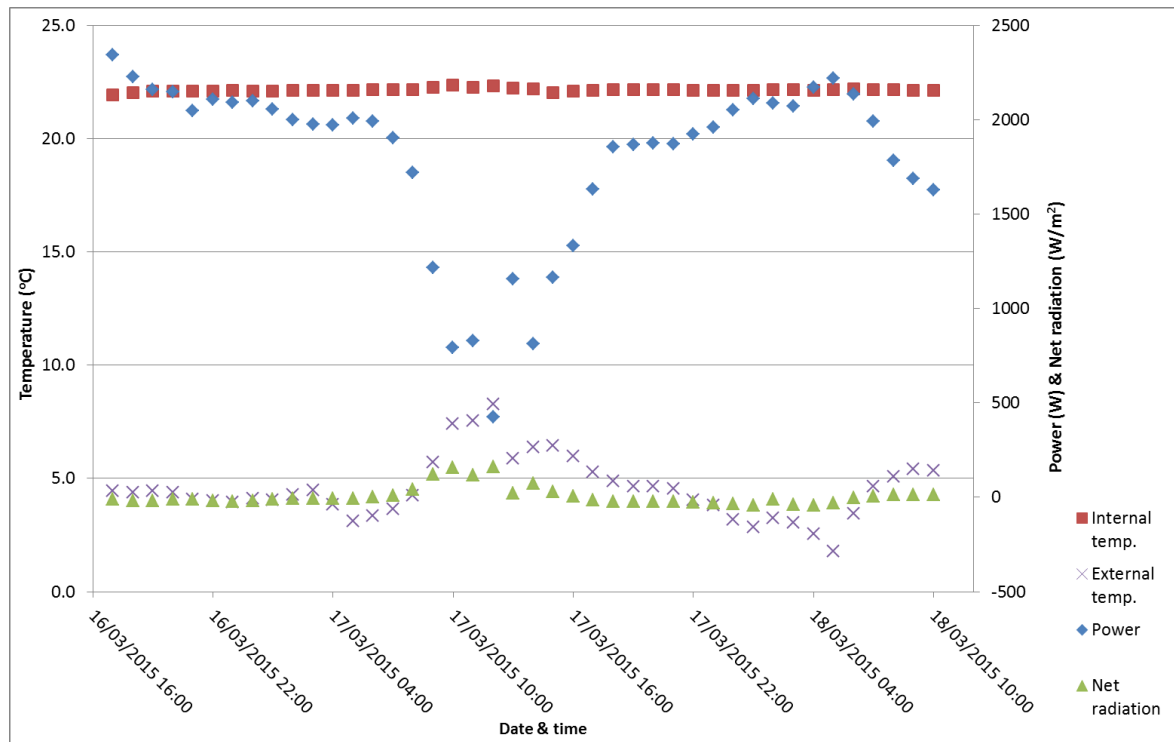
Figure 6: Caravan C05 power and environmental conditions measured during test period 1 (hourly means)

Figure 6 shows the hourly mean power and environmental conditions measured during test period 1 for caravan C05. The decrease in power input to the caravan observed in the first day of testing (16/03/15) is due to a reduction in power required to charge the thermal mass of the caravan following the commencement of heating (approximately 4 hours prior to the start of data logging); thus data from the first night of test period 1 (16/03/15) is excluded from the HLC analysis. The result is only one night of data available for the coheating analysis (17/03/15). The suppression of power input resulting from solar radiation and higher external temperatures is highly evident and justifies the use of overnight data in the coheating analysis. It can also be seen that overnight any

change in  $\Delta T$  results in a change in power input during the same one hour time period; this indicates low thermal mass and suggests that the use of one hour aggregated data in the coheating analysis is both appropriate and acceptable.

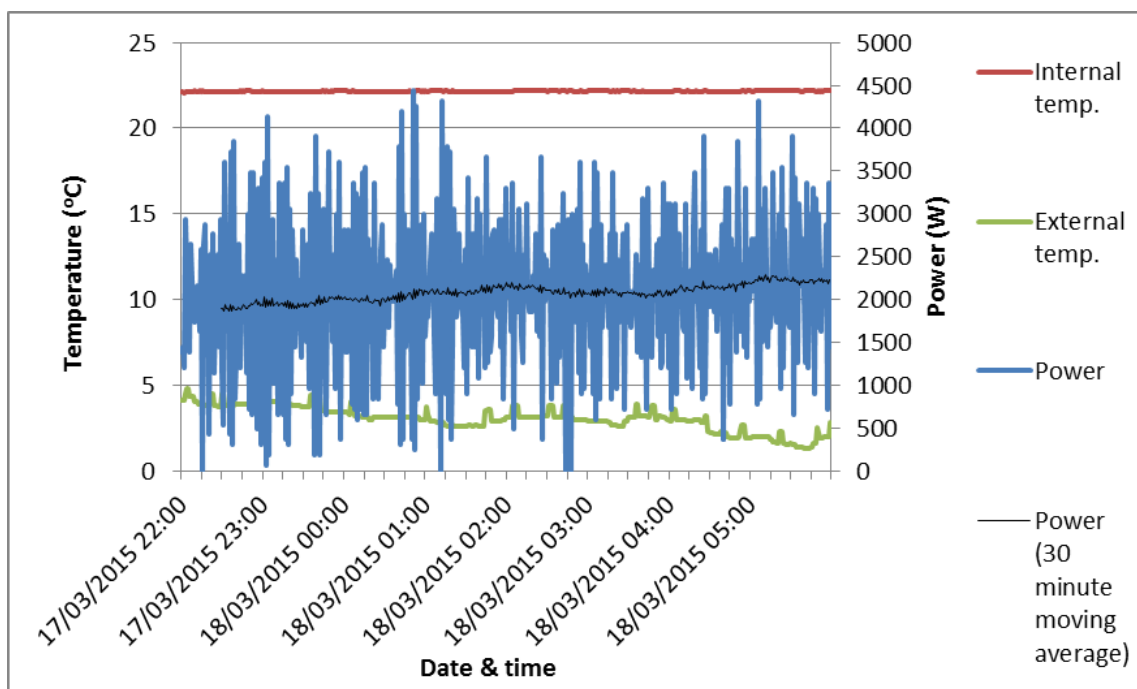
Figure 7: Power and temperatures measured throughout coheating test 1 of caravan C5

Figure 7 illustrates the power input and environmental conditions during the coheating analysis of test period 1. It is evident that a gradual external temperature decrease results in a gradual increase in power input to the caravan to maintain the  $\Delta T$  throughout the test period.

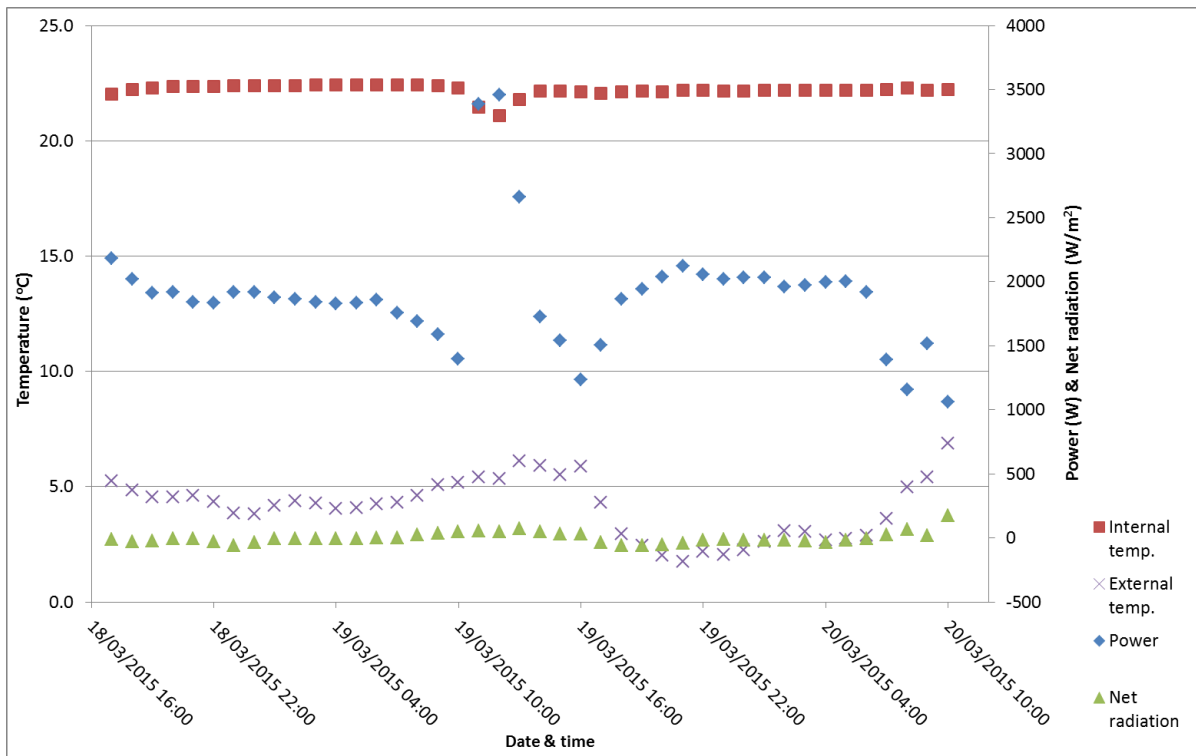
Figure 9: Caravan C05 power and environmental conditions measured during test period 2 (hourly means)

Figure 9 shows the hourly mean power and environmental conditions measured during test period 2 of caravan C05. As the fabric of the caravan remained heated throughout the period of the window replacement on 18/03/15, charging of the thermal mass was complete prior to the first night coheating analysis period. As a result, two nights of coheating data were available for analysis (18 & 19/03/15). It can be seen in Figure 9 that power input into the caravan remained reasonably stable during the coheating analysis periods. There was a reduction in internal temperature in the daytime of 19/03/15 as minor alterations to the internal window trims of the caravan were made. A partial solar eclipse caused the temporary reduction in net radiation measured on the morning of 20/03/15.

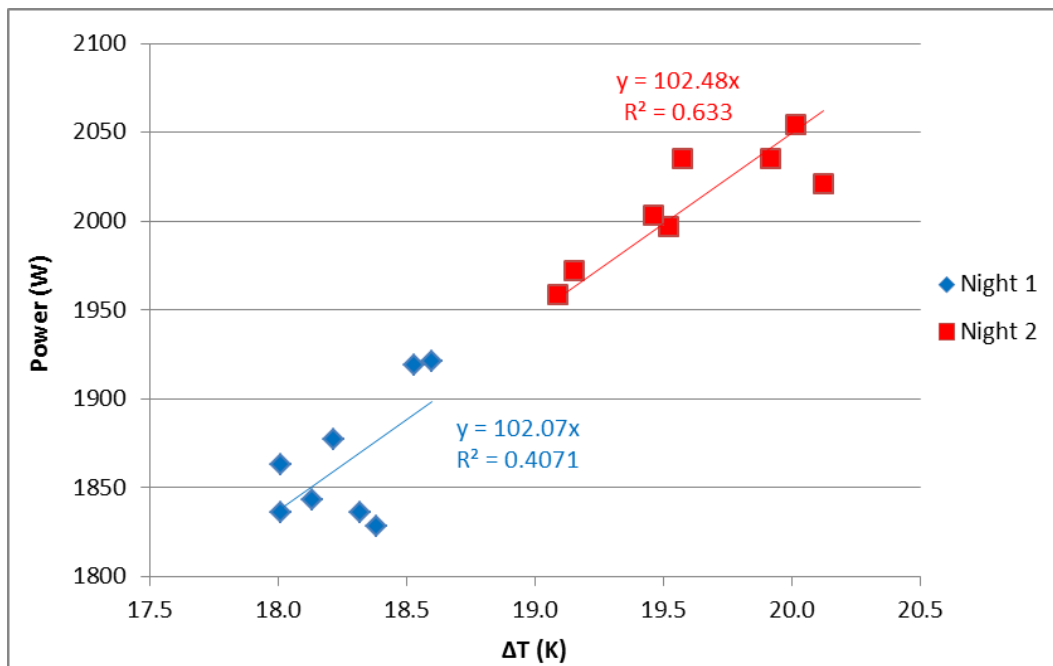
Figure 10: Individual nights coheating test 2 analysis for caravan C05 (regression forced through origin)

Figure 10 shows the coheating analysis for the two successive nights during test period 2. It can be seen that there is good consistency between the HLC measured on successive nights. The HLCs measured suggest that the minor alterations did not have a measureable difference on the thermal performance of the caravan. The cause of the outliers during night 1 corresponds with a reduction in wind speed during the final two hours of the test.

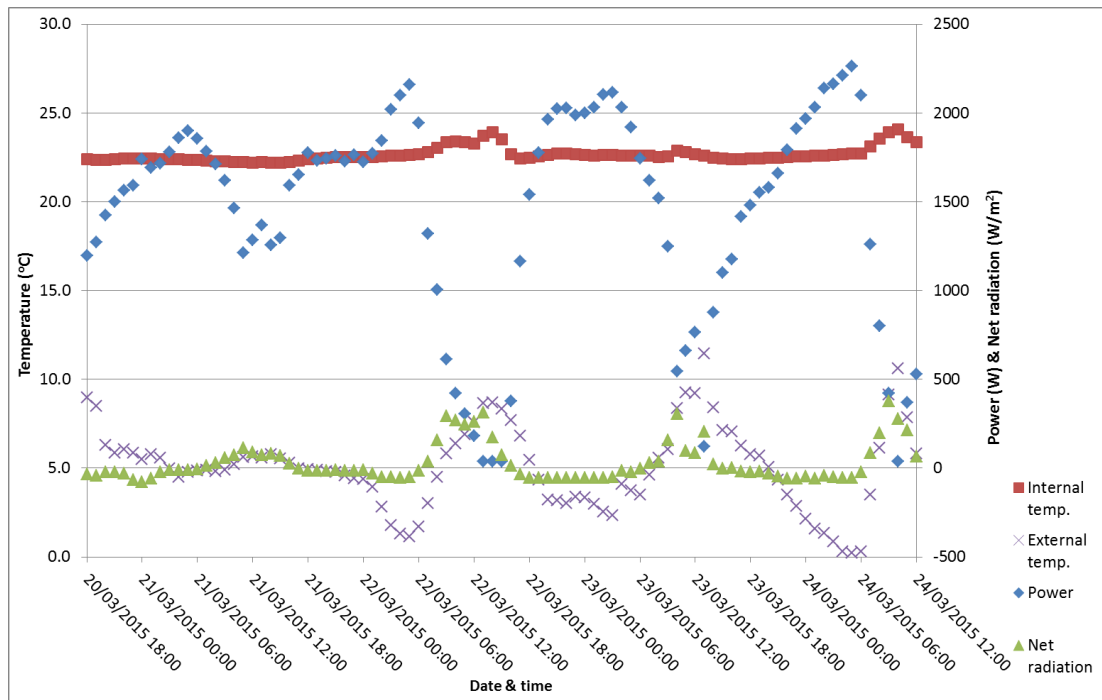
Figure 12: Caravan C05 power and environmental conditions measured during test period 3 (hourly means)

Figure 12 shows the hourly mean power and environmental conditions measured during test period 3 of caravan C05. As the fabric of the caravan remained heated throughout the period of the door replacement on 20/03/15, charging of the thermal mass was complete prior to the first night coheating analysis period. As a result, four nights coheating data were available for analysis (20, 21, 22 & 23/03/15). Test period 3 was characterised by the greatest diurnal fluctuations in external temperature and the greatest changes in net radiation. The influence that these changes in external temperature and net radiation have on the power input to the caravan to maintain the  $\Delta T$  can be clearly seen in Figure 12.

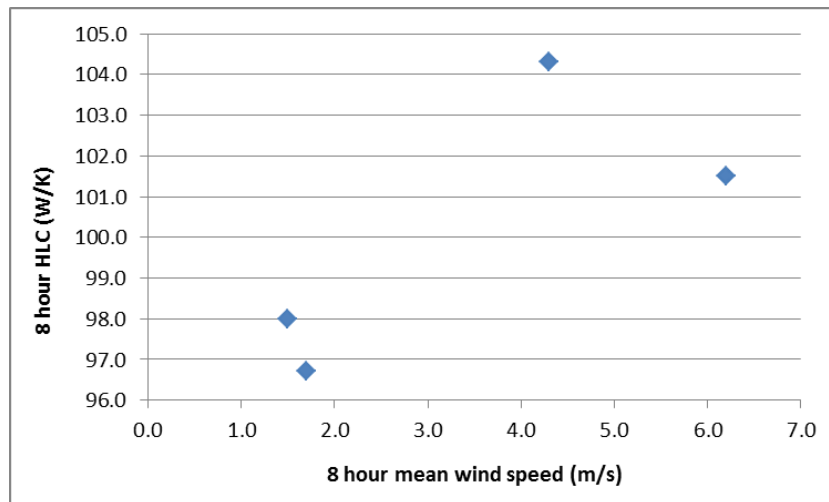
Figure 14: Wind speed vs. nightly HLC for caravan C05 during test period 3

Figure 14 shows the relationship between nightly HLC estimates and mean wind speed measured<sup>1</sup> during the test period. The higher wind speed measured during night 1 and night 3 correlate with the higher HLCs measured and the poorer relationship between power input and  $\Delta T$  measured (lower  $r^2$  value). It is reasonable to assume that the many ventilation points through the caravan structure mean that it is susceptible to increased ventilation heat loss and wind-washing of the insulation during periods of high wind speeds.

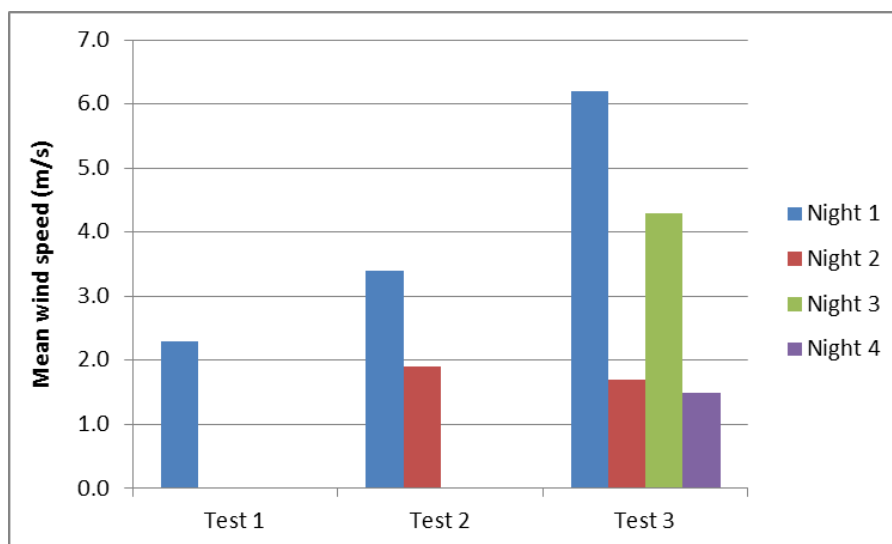
Figure 15: Mean wind speed during each nightly coheating test throughout the test programme

Figure 15 shows the mean wind speed measured during each nightly coheating test period throughout the test programme. The wind speeds measured during night 1 and night 3 of test period 3 were in excess of the other two test periods. To ensure a more suitable comparison between previous test periods these nights have been excluded from the coheating analysis of test period 3.

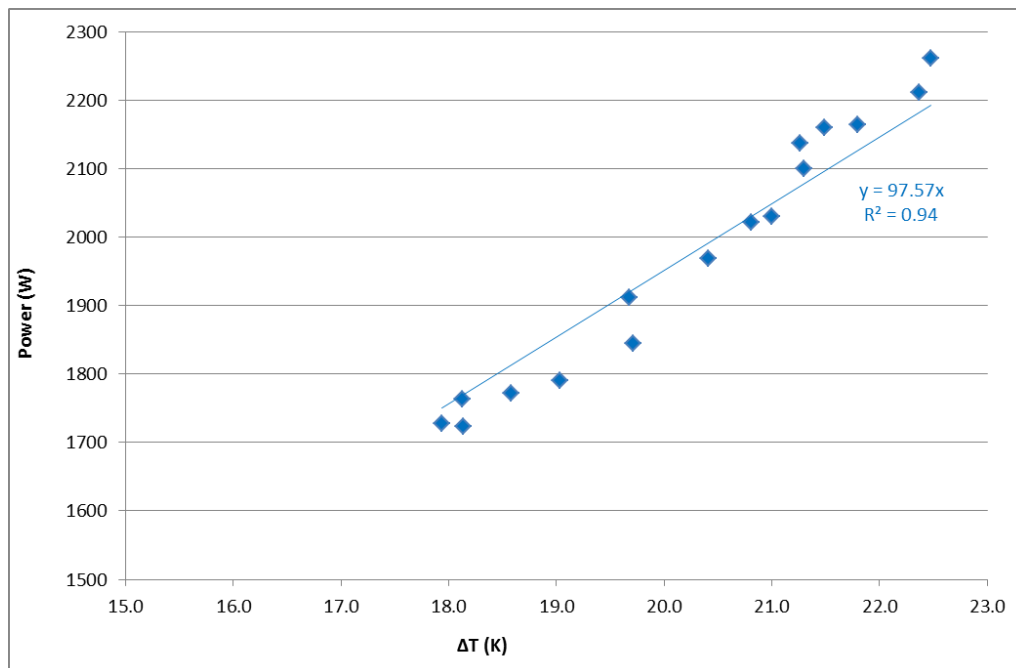
Figure 16: Coheating test 3 analysis for caravan C05 (regression forced through origin)

Figure 16 provides the coheating analysis of caravan C05 during test period 3 using data obtained from night 2 and night 4 only. The coheating test produced an estimate of the HLC of 97.6 ( $\pm 0.6$ ) W/K. This represents a reduction in HLC of 11.1 W/K (11.4%) from test period 1. There is a high degree in confidence with the HLC estimate due to the very strong correlation between power input and  $\Delta T$  ( $r^2$  of 0.94). Unfortunately, it was not possible to measure change in airtightness that may have occurred following the installation of the new door. Assuming that the airtightness of C05 did not significantly change when the door was replaced, the reduction in HLC from test period 1 can primarily be attributed to the installation of the replacement windows and door.

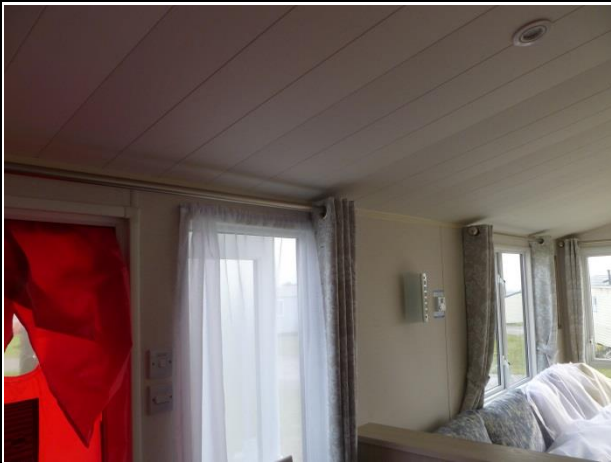
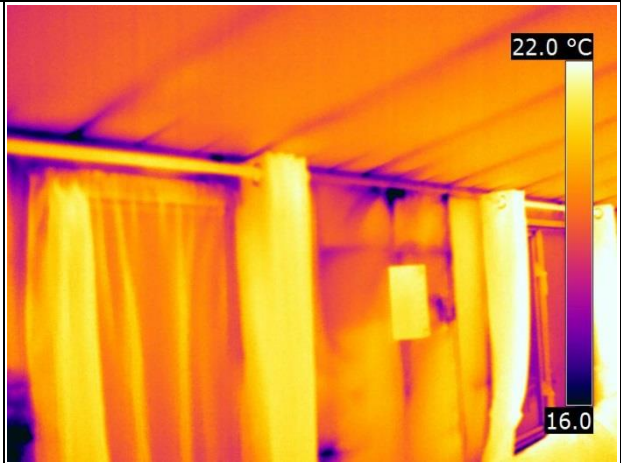
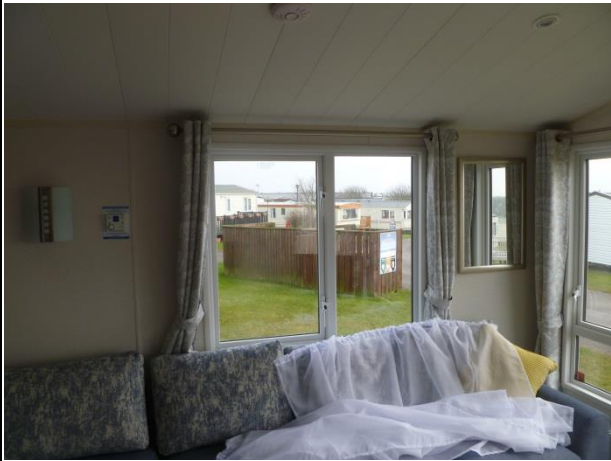
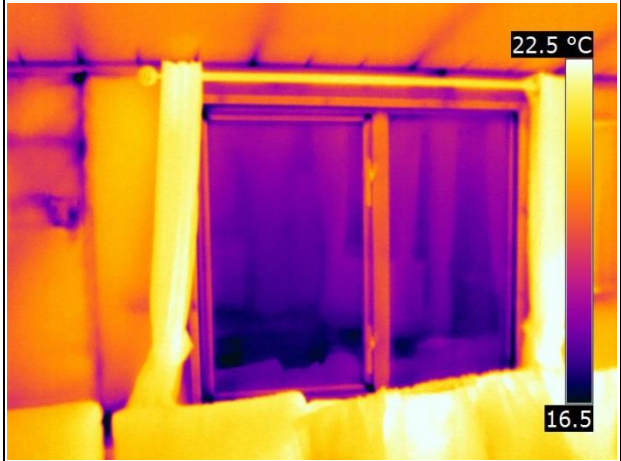
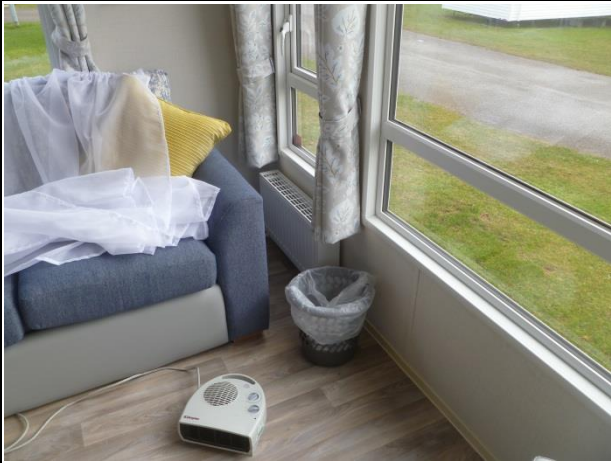
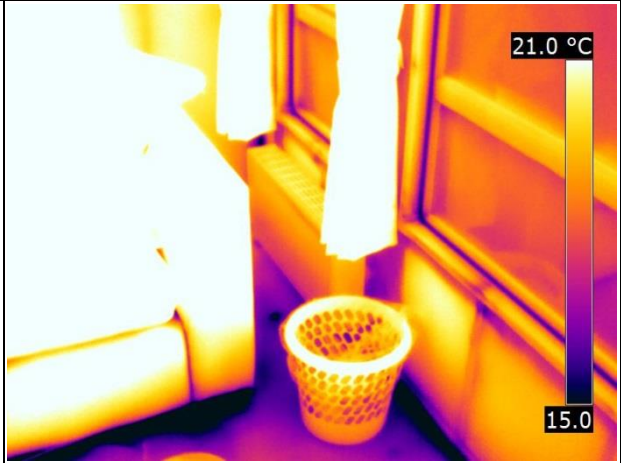
C10 under depressurisation

<p>16-Mar-2015 C10 – Lounge Infiltration detected at junctions and joints between panels and around the concealed lights in the ceiling.</p>

<p>16-Mar-2015 C10 – Kitchen Although the kitchen intermittent extract was temporarily sealed, the fan housing was not sealed around and leakage can be clearly observed.</p>	 	 
<p>16-Mar-2015 C10 – Main Bedroom Cooler air was detected being drawn in at junctions and around electrical penetrations.</p>

<p>16-Mar-2015 C10 – Bathroom Air leakage from the boxed-in services for the toilet was detected.</p>

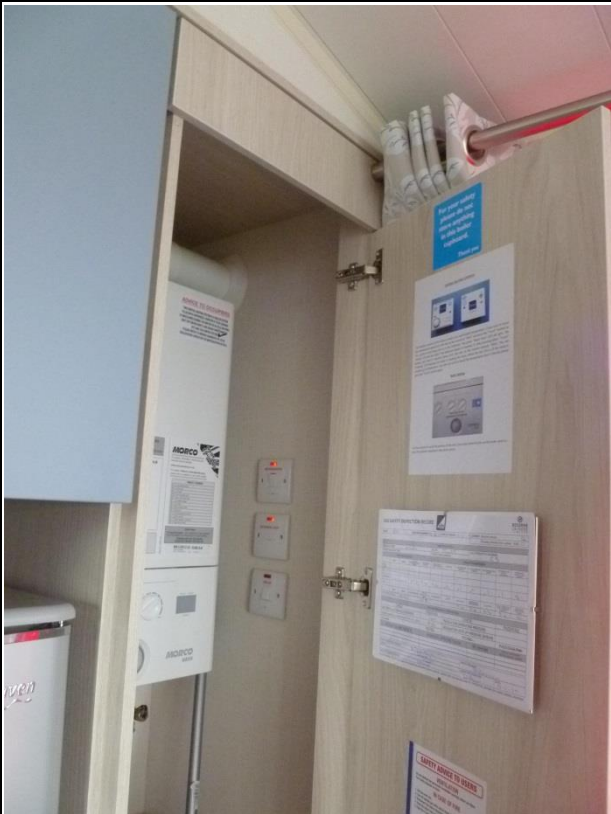
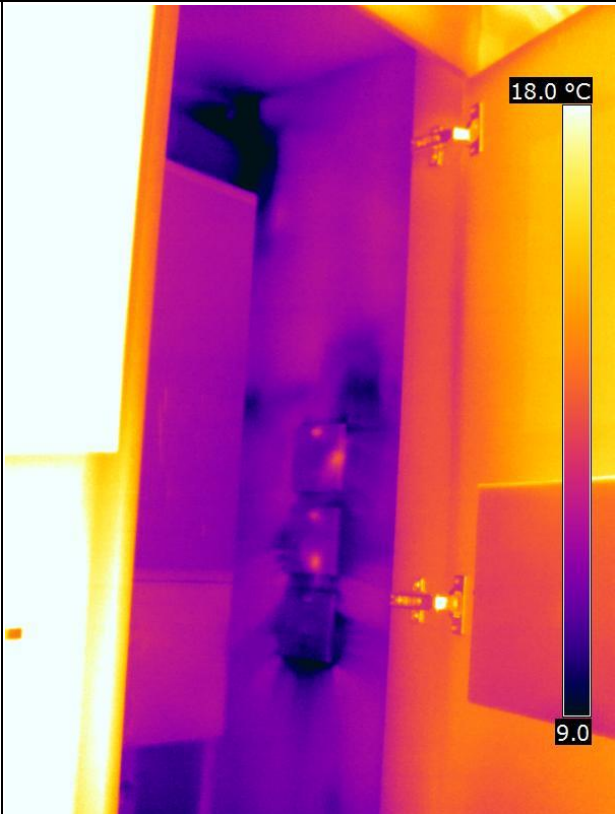
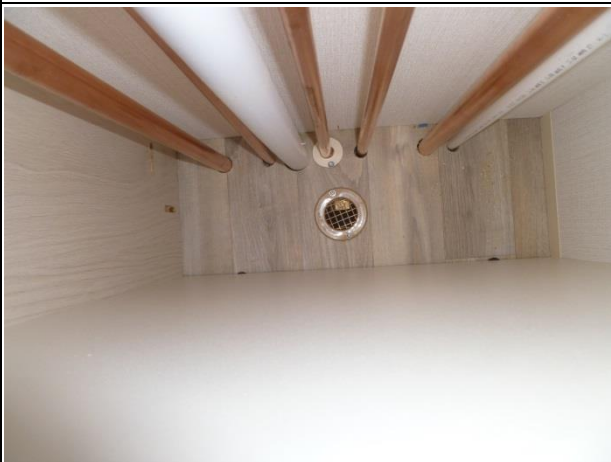
C10 Heated, following pressurisation test, with heat flux sensor placements

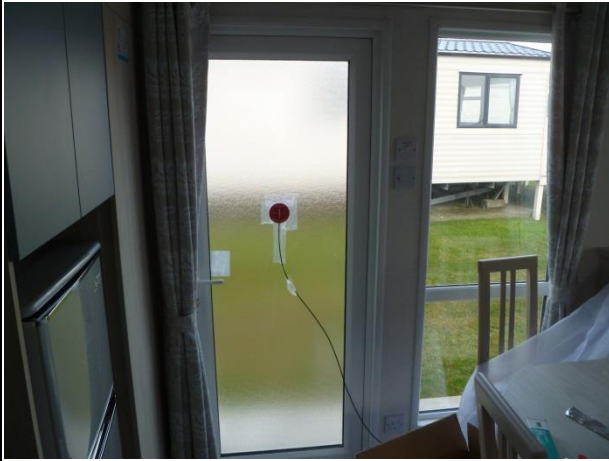
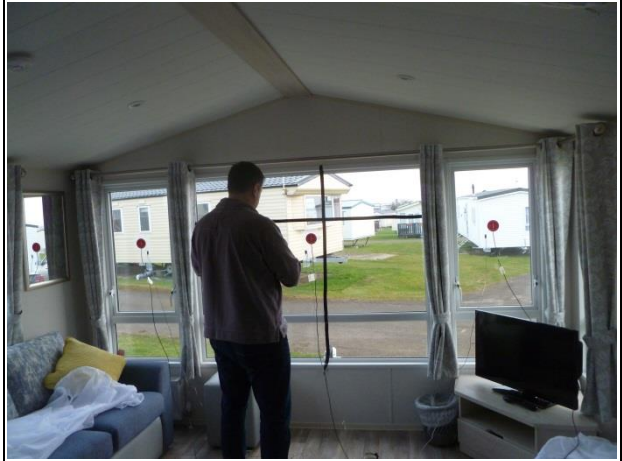
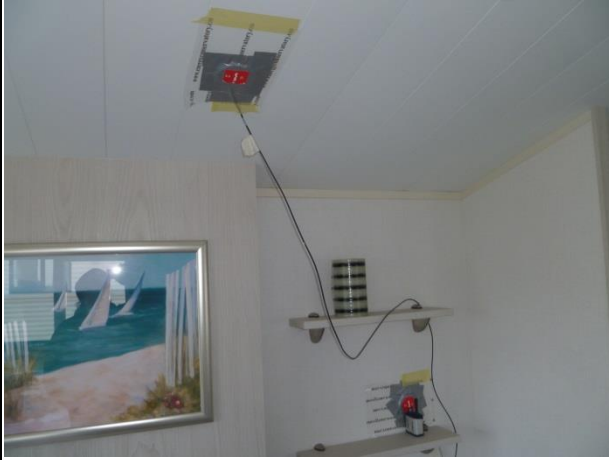
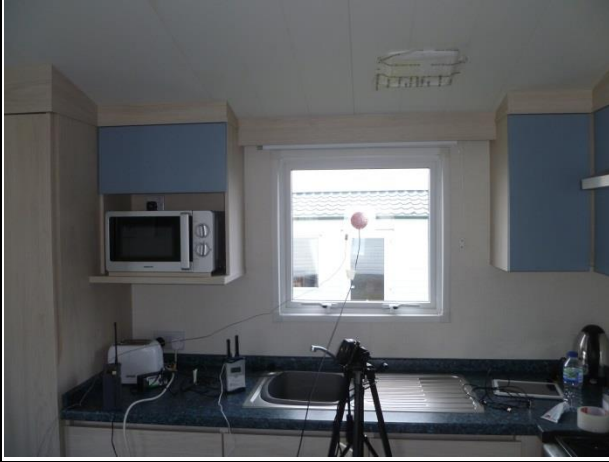
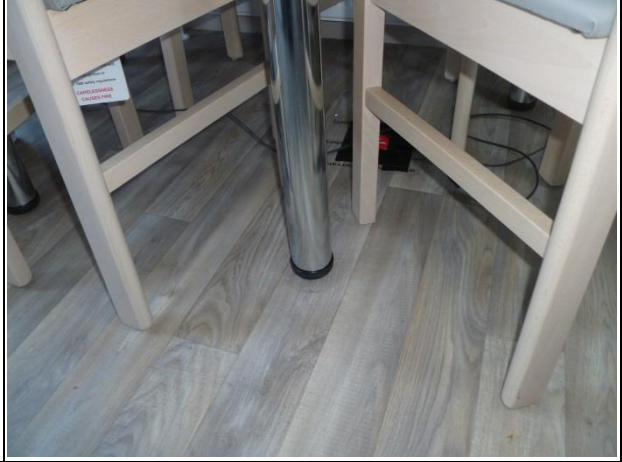
C05 Heat flux sensor placement

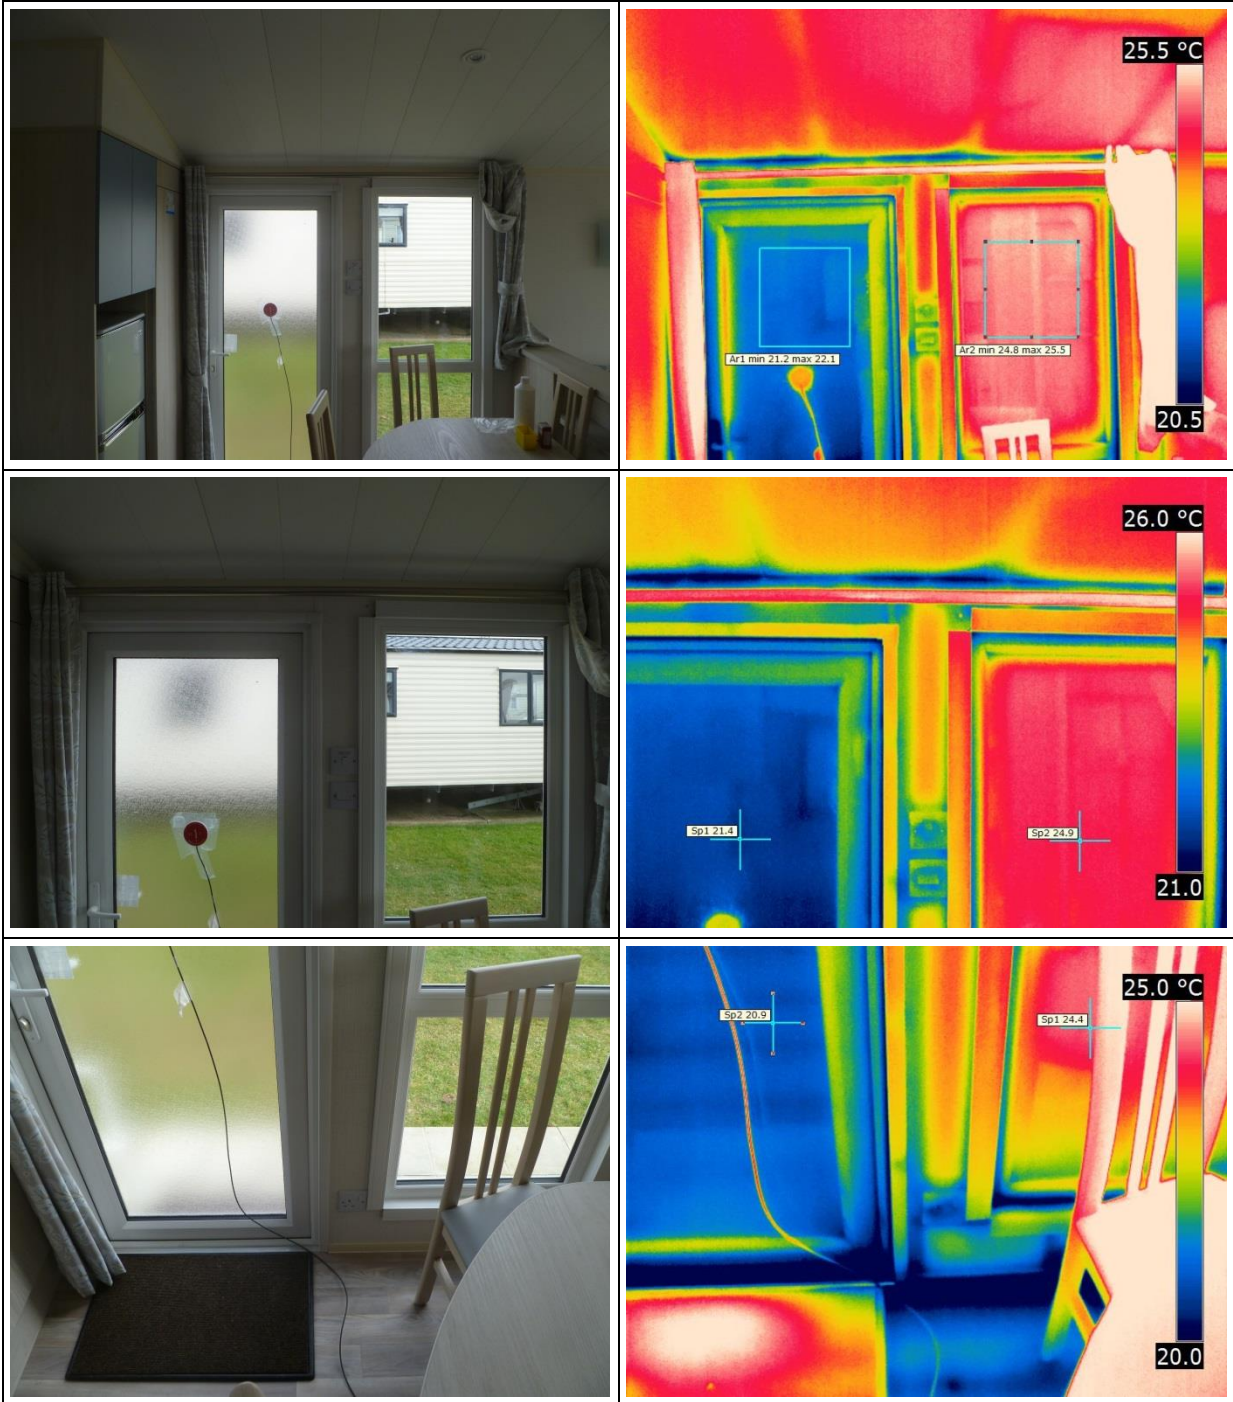
Direct comparison of the original door and a replacement window in C05:
