Johnston, D and Farmer, D and Miles-Shenton, D (2016) Bourne Leisure Ltd. Thermal Performance Measurement Report. Project Report. Centre for the Built Environment (CeBE) Group, Leeds Sustainability Institute, Leeds Beckett University., Leeds, UK.

## **Bourne Leisure Ltd. Thermal Performance Measurement Report**

May 2016

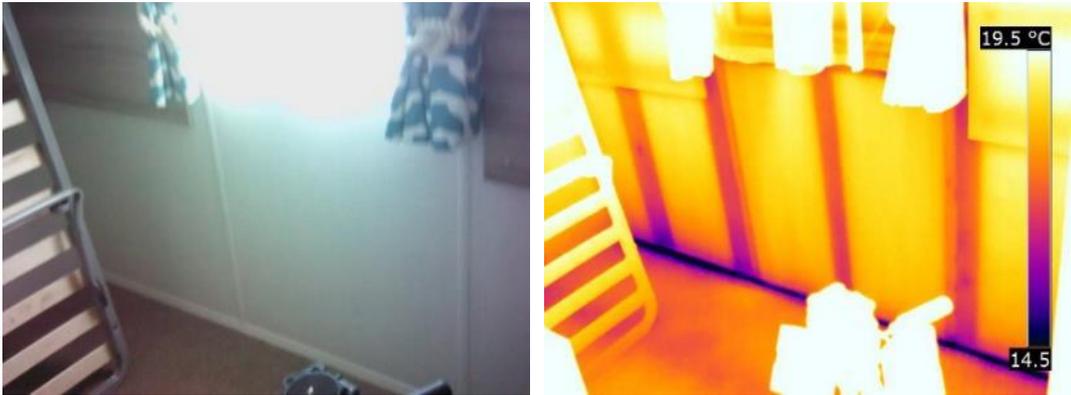
- At the vertical and horizontal studs used to construct the framing for the external wall where they penetrated through the insulation layer (see Figure 30). It is interesting to note that there are no horizontal farming members used in the construction of the external walls in caravan E (see Figure 31).

Figure 31 Lack of horizontal members in the external wall of caravan E.

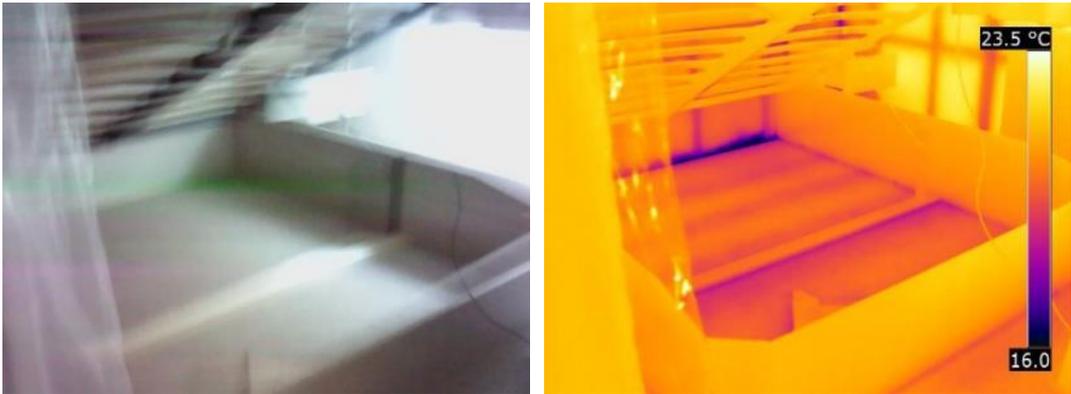
- At the external wall/floor junction in the master bedroom of caravan A (see Figure 38).
- Below the kitchen/living area window in caravan E (see Figure 39).
- Close to the ridge on the master bedroom end wall of caravan A (see Figure 40).
- At the sloping section of the kitchen/living area end wall in caravan A (see Figure 41).

Figure 38 Thermal bridge at the external wall/floor junction in the master bedroom of caravan A.

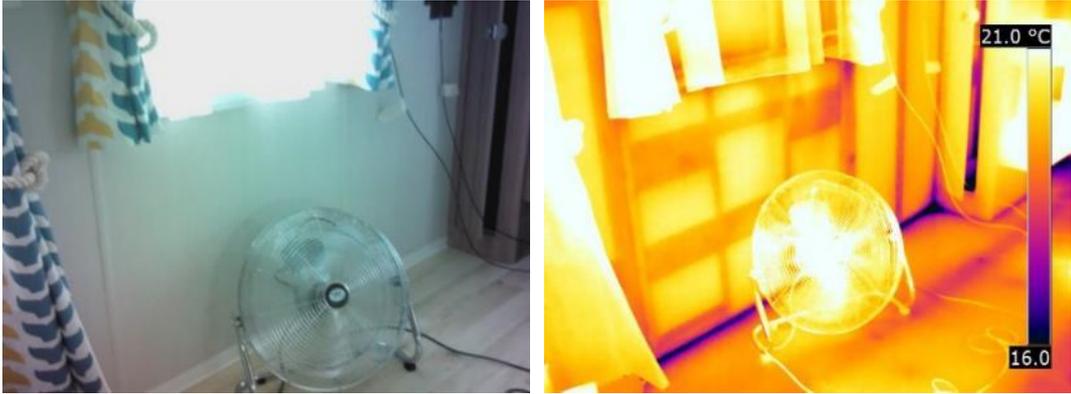
Figure 39 Thermal bridging below the kitchen/living area window in caravan E.

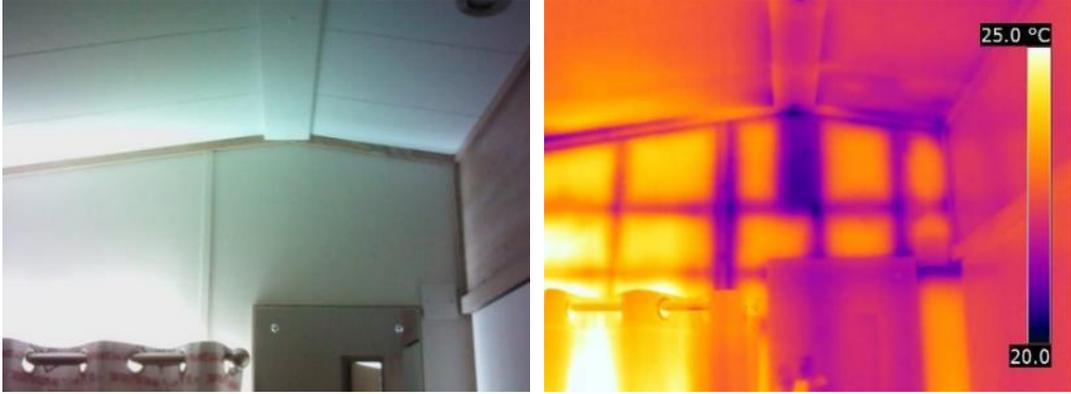
Figure 40 Thermal bridge close to the ridge on the end wall of caravan A.

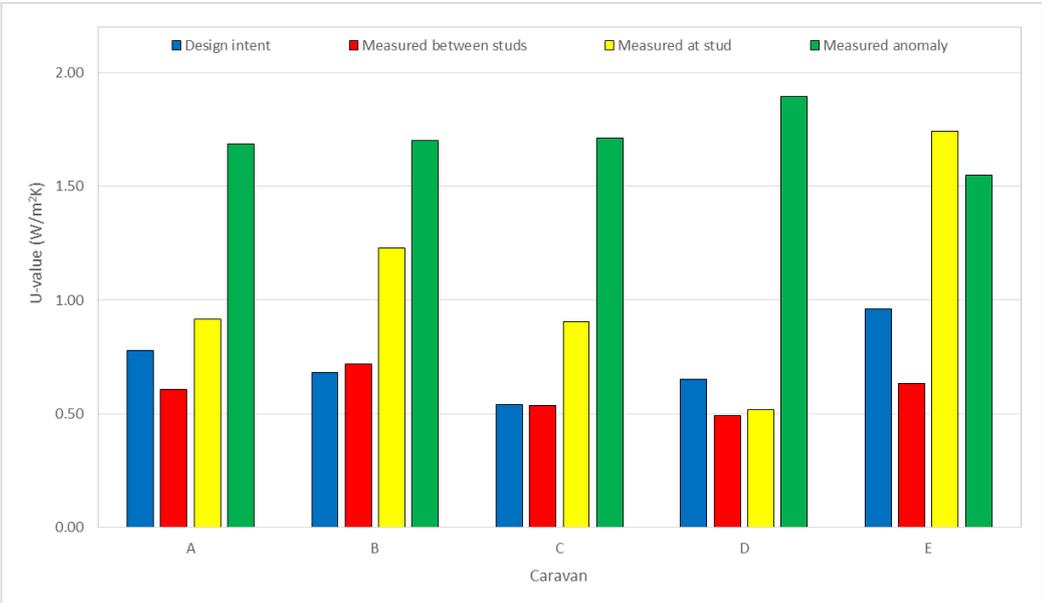
- 46 It is also clear from Figure 46 and Figure 48 that the *in situ* U-values measured at the external wall and roof anomalies are significantly higher than the design intent steady-state U-values. This can be attributed to the excessive thermal bridging that was observed at these locations. In the case of the external wall anomaly, the thermal bridging was caused by the insertion of additional timber at this location to enable the mounting of an external aerial. With respect to the ceiling anomaly, removal of the ceiling extract grille revealed either a lack of, or the omission of insulation surrounding the extract grille (see Figure 51).

Figure 46 Average *in situ* external wall U-value for each test caravan.

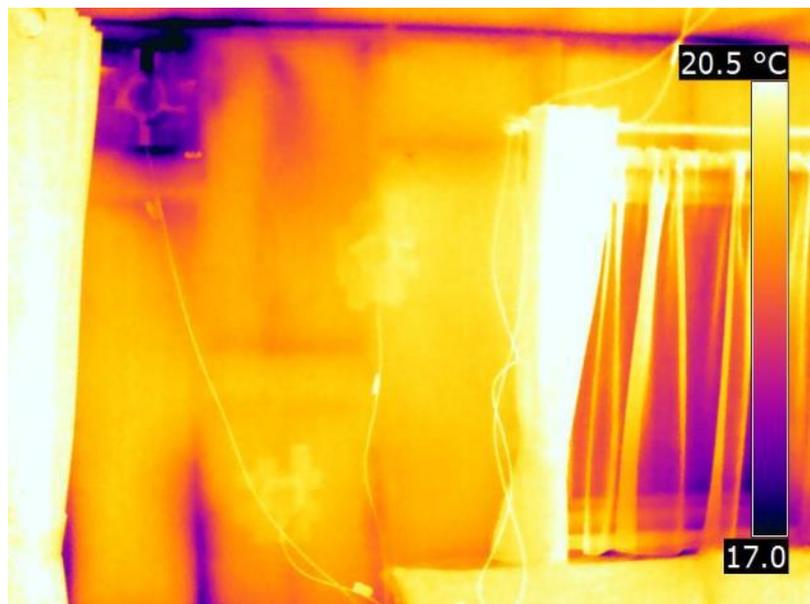
- 45 In terms of the measurements undertaken at the studs and joists, the analysis reveals that in the majority of cases the measured *in situ* U-values are considerably higher than the design intent steady-state U-values. This is to be expected, as the timber studs and joists represent a thermal bridge through the fabric of the test caravans. However, in the external wall of test caravan D, the measured *in situ* U-values at the stud were lower than the design intent steady-state U-values and only marginally higher than the value obtained between the studs. This suggests that this HFP was not accurately positioned directly across the stud within this caravan. An analysis of the thermal image undertaken once the HFPs were installed within test caravan D reveals that this HFP was positioned slightly off-centre to the stud (see Figure 50).

Figure 50 Location of HFP 2 in test caravan D.

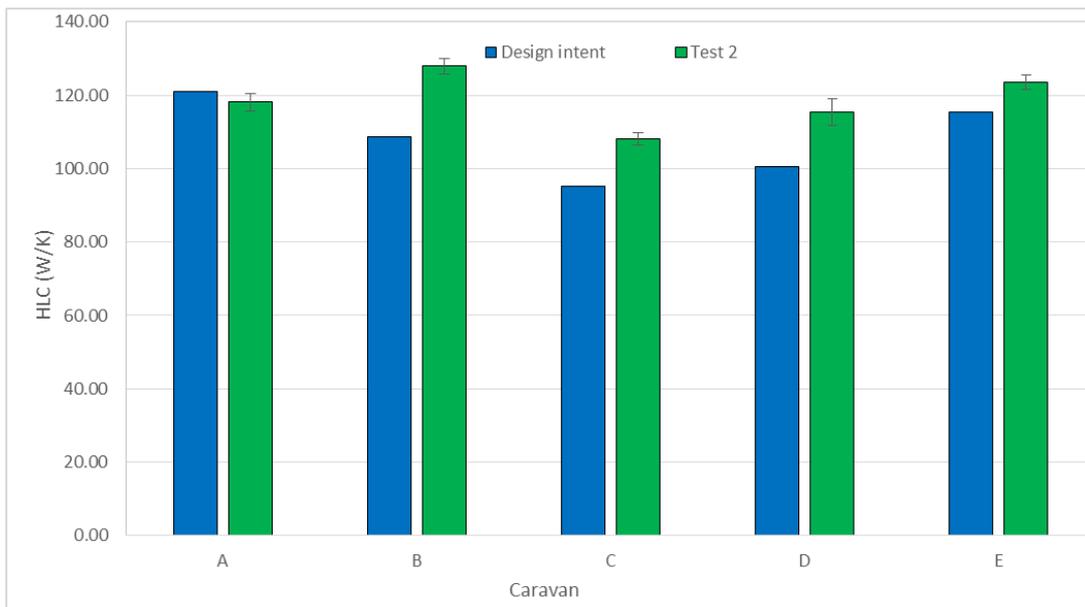
- 52 As can be seen from Figure 56, in the majority of cases, the measured HLC obtained from Test 2 is greater than the design intent HLC, indicating a building fabric performance gap. The only instance where this is not the case is in caravan A, where the measured HLC is comparable to the design intent HLC. However, such a comparison can be misleading, as the design intent HLC figure incorporates background ventilation heat losses which have been calculated based upon the air permeability figures incorporated with the NCC calculator. In all of the tested caravans, a difference was observed between the air permeability figures measured and those inserted into the NCC calculator and, in some cases, this difference was considerable.

**Figure 56** Comparison of the electric coheating test results with the design intent HLCs.

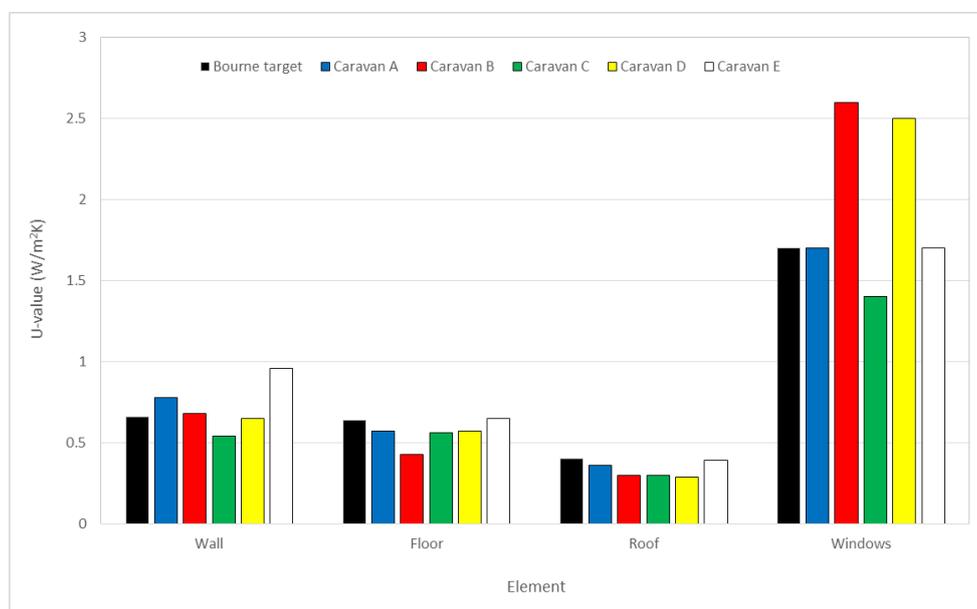
Figure 60 Comparison between the design intent U-values and the Bourne specification.

57 As can be seen from Figure 60, four of the five caravans failed to meet one or more elements of the U-value specification, resulting in only the caravan meeting all of the U-value specifications (caravan C). The caravans that failed to meet the greatest number of elements of the specification were caravans B & E, which failed to meet 50% of the U-value specification. In terms of the individual fabric elements, although all of caravans met the roof U-value specification, caravans A,

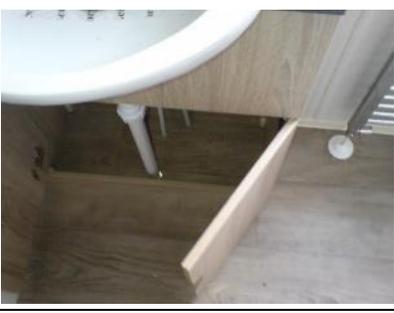
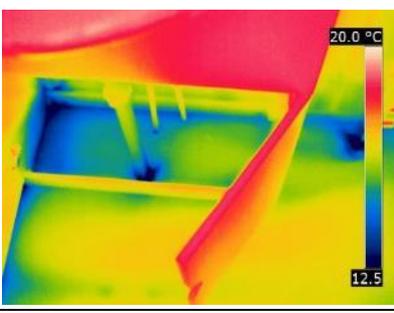
<p>Room – Bathroom Span – 7.5 °C Daylight visible through a gap at the waste pipe penetration – a photo of this detail from beneath is shown at the end of this section.</p>

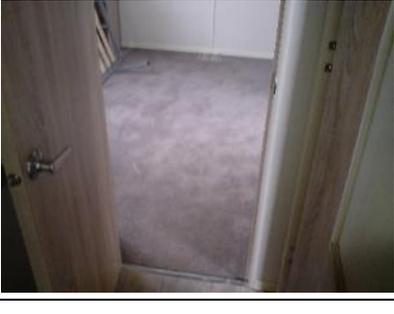
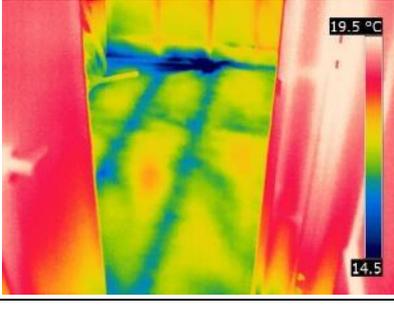
<p>Room – End Bedroom Span – 5 °C Under depressurisation, at higher pressures, the carpet in this room was seen ballooning upwards; air can be seen moving beneath the carpet in the thermal images.</p>

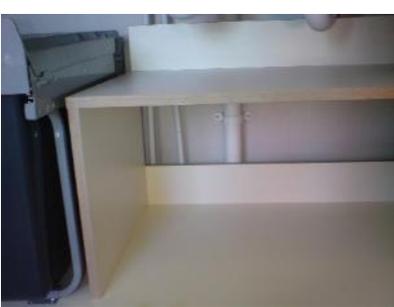
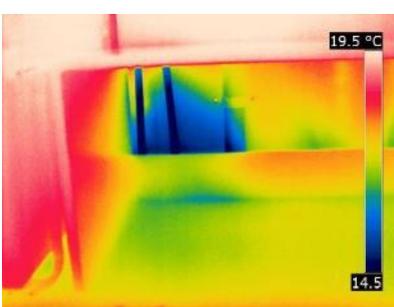
<p>Room – Lounge/Kitchen Span – 5 °C</p>

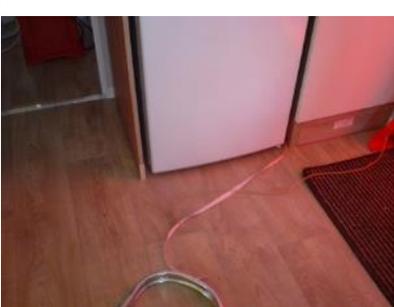
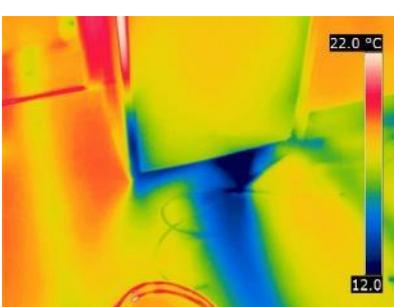
<p>Room – Lounge/Kitchen Span – 10 °C Excessive air leakage observed from under the fridge.</p>

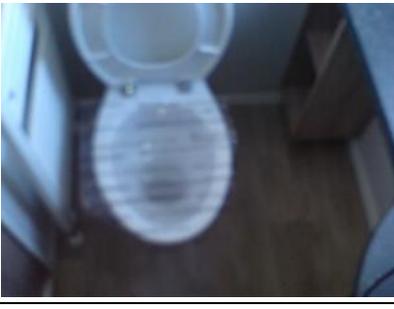
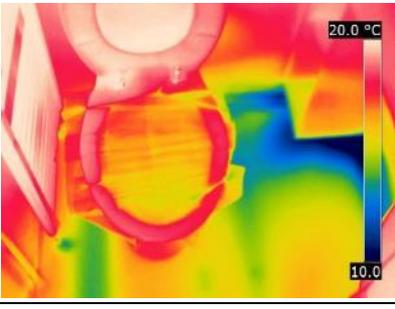
<p>Room – Bathroom Span – 10 °C</p>

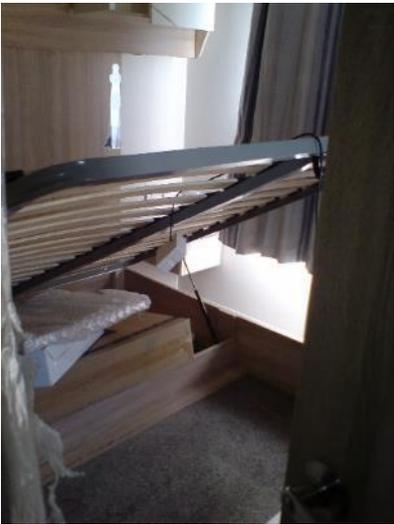
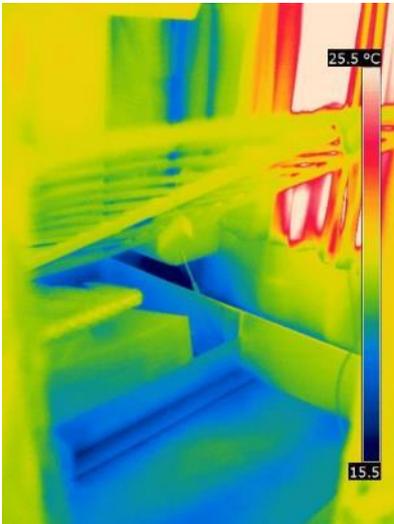
Room – End Bedroom Span – 10 °C Higher span in the thermal images in this room is due to direct sunlight creating warmer internal surface temperatures rather than cooler air emerging.

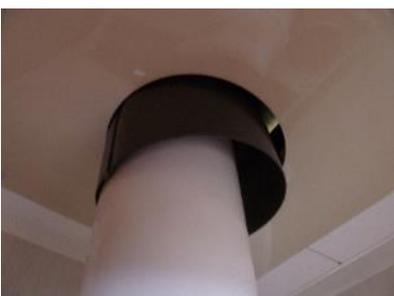
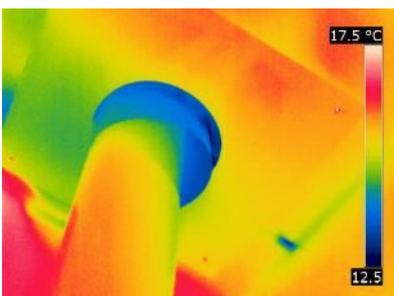
Room – Boiler Span – 5 °C Daylight visible around the penetration for the boiler flue.

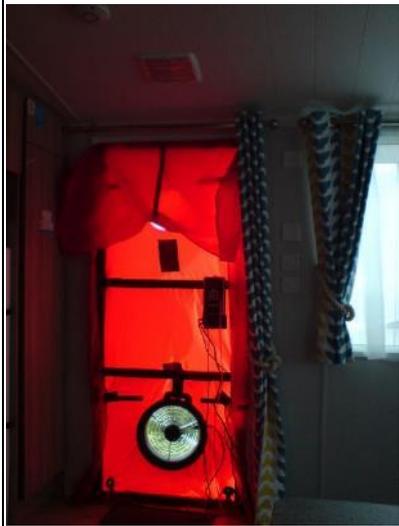
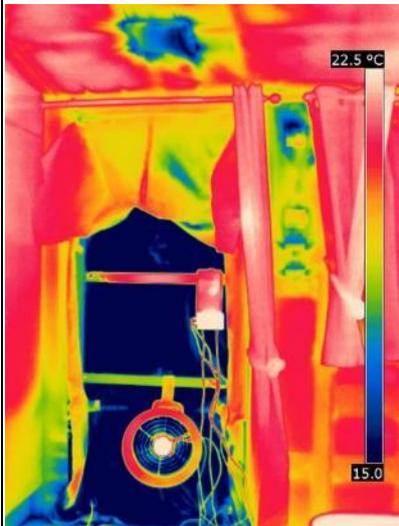
Room – Lounge/Kitchen  
Span – 7.5 °C
