Taylor Wimpey – Thermal Imaging Project

Site: Newton Farm
Cambuslang
G72 8QF

Visit Date: 13th November 2017

Plot(s): 268
267

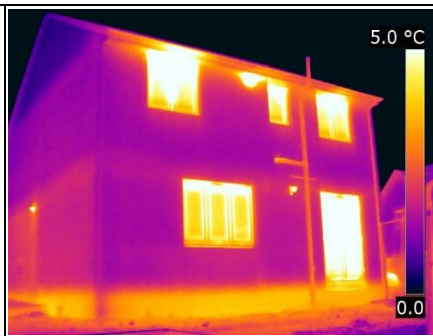
A warmer strip was visible on both gable walls around the intermediate floor void, where the floor joists run normal to the walls, but less so on the front and rear façades where the joists run parallel to the external walls. The difference in elevations suggests that may be due to difference in floor perimeter detailing, but is complicated by heating pipes running through the floor void:

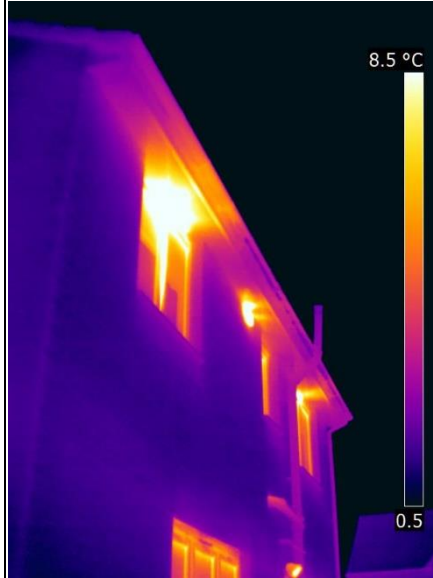
The ground floor perimeter was much warmer than the rest of the external wall. It was unclear whether this was expected or unintended heat loss at ground floor perimeter. Additional heat loss was observed at the patio door threshold which was not completely finished.

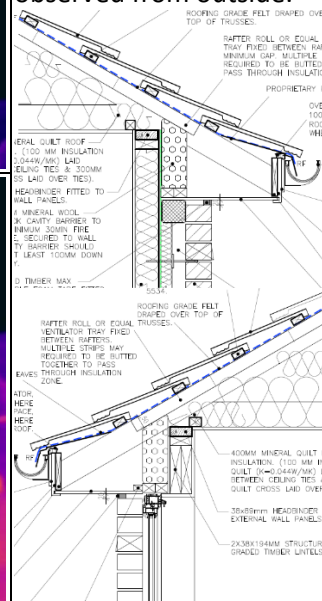
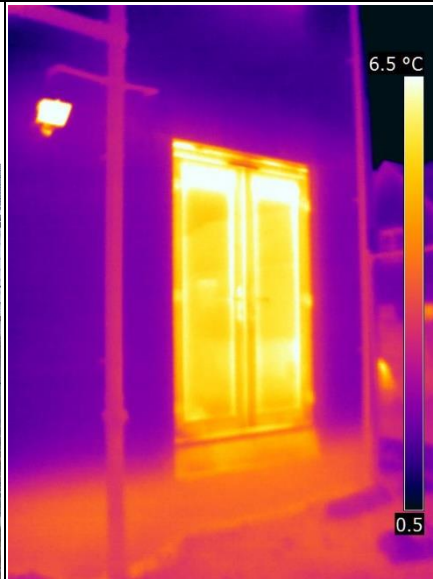
As the trickle vents had been left open it was difficult to see if the warmer sections of boxed eaves were due to thermal anomalies or due to warm air venting out. As such, any potential difference between the thermal performance of the solid timber above the windows and the insulated panels between them could not be observed from outside:

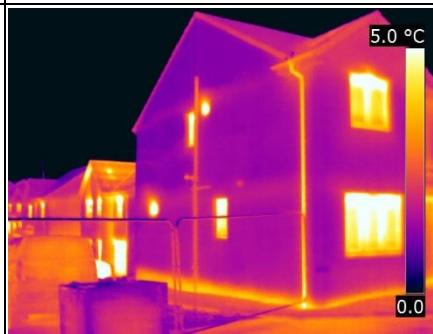
Similarly, the gable windows on the front elevation appeared to show different levels of thermal performance from outside, particularly at the window heads and gable above. However, on internal inspection it appears most probably due to the trickle vents being left open in Bedroom 2 (above the garage) and closed in Bedroom 1 prior to the thermal survey being undertaken.

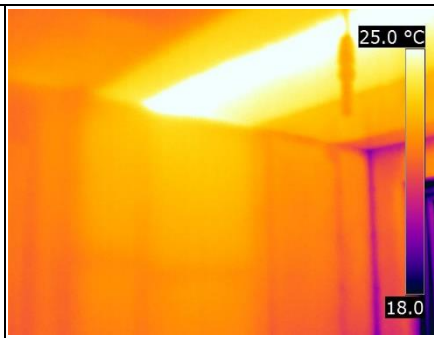
Where the internal wall with the hall becomes external wall there is a sharp drop in surface temperature, particularly at patches just above the base of the wall panel.

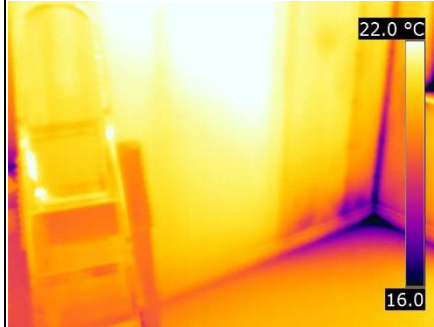
Even under natural pressures some infiltration could be observed around the window, particularly beneath the sill board edges.

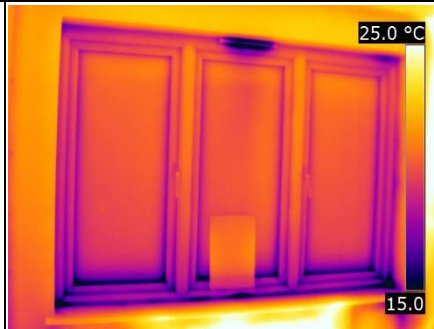
The cooler vertical members of the timber frame were clear on the thermal images, with warmer insulated sections between. Cooler horizontal timbers at the ground floor and intermediate floor coincided with warmer areas viewed from outside.

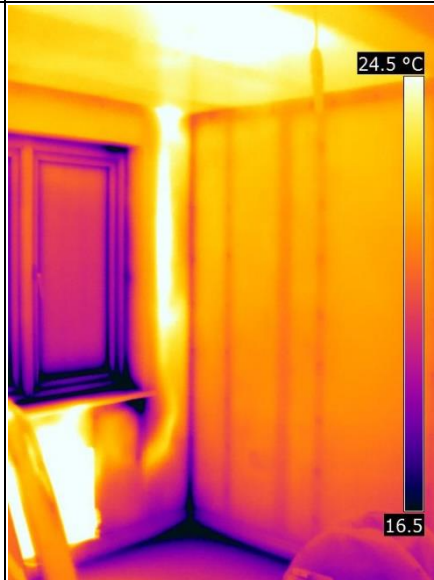
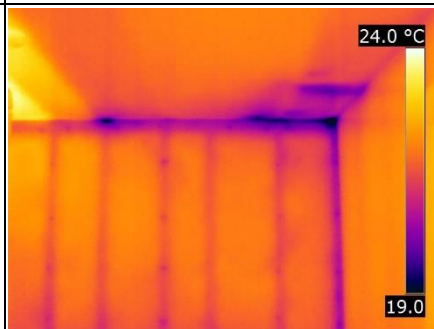
Stratification of the voids between the joists in the intermediate floor appeared to be driven by the positioning of the heating system pipework.

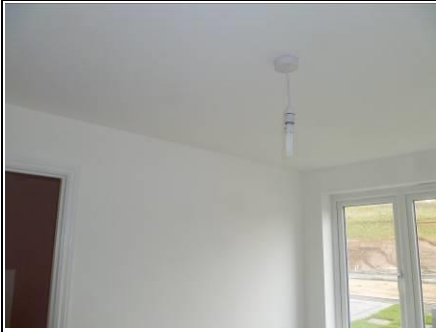
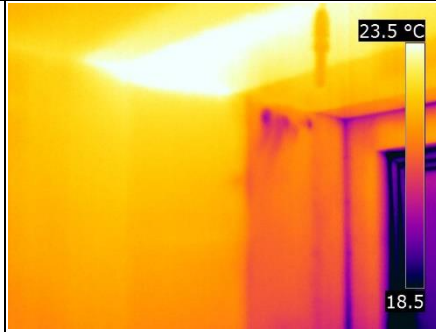
The differences in surface temperature of the hall/external sections of the same wall appeared to increase under depressurisation, with a number of points at the top and bottom of the external wall section indicating air movement into the wall panels.

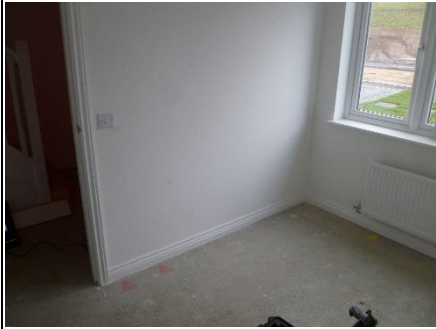
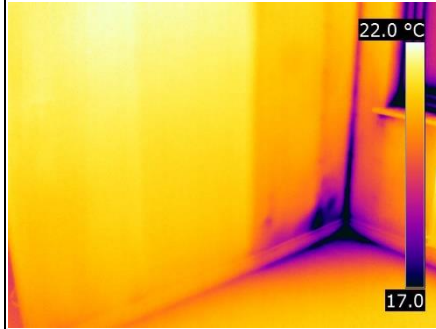
Although the window seals appeared to work well, infiltration between the window frame and opening was apparent, particularly around the sill board.

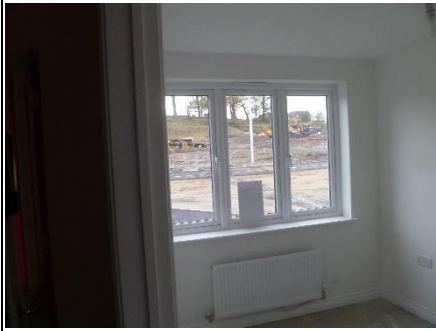
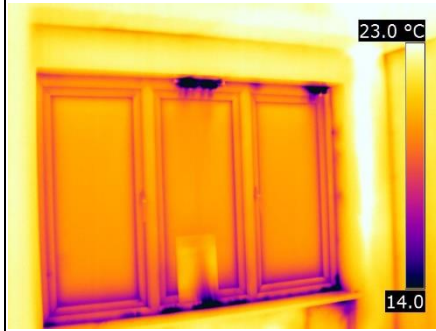
The stratification of the intermediate floor void and cooler sections at the floor junctions did not seem to change much under depressurisation for their appearances under natural pressures, suggesting these were due to thermal issues rather than air movement.

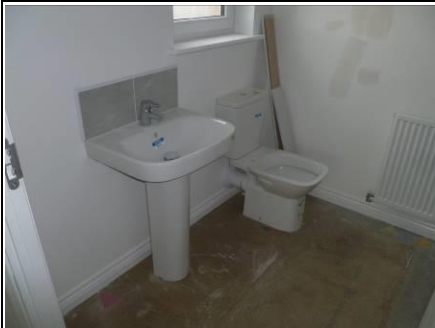
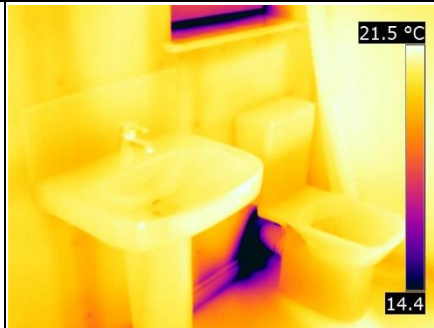
En-Suite – Under natural conditions

Colder areas are visible around the wall penetration to the external soil pipe from the toilet and on the ceiling where the loft insulation might not be in direct contact with the ceiling plasterboard.

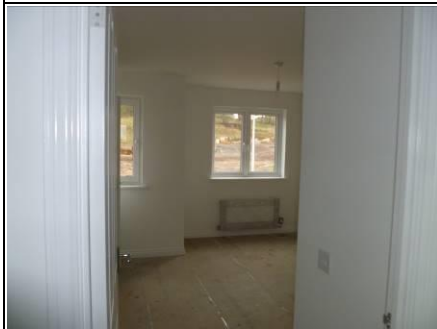
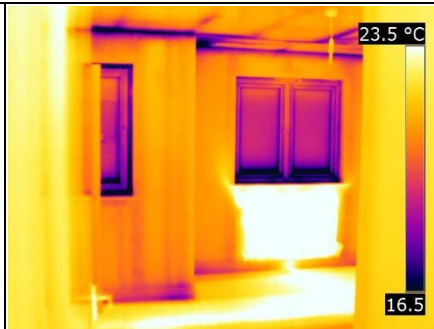
Bedroom 1 – Under natural conditions

The ceiling at the eaves junction is very cold in places suggesting that there is a lack of insulation in places, with additional roof timbers present to support the gable roof this may have presented difficulty in installing the loft insulation adequately. The result is a 6° difference between surface

temperatures at the centre and sides of the ceiling directly in front of the window:

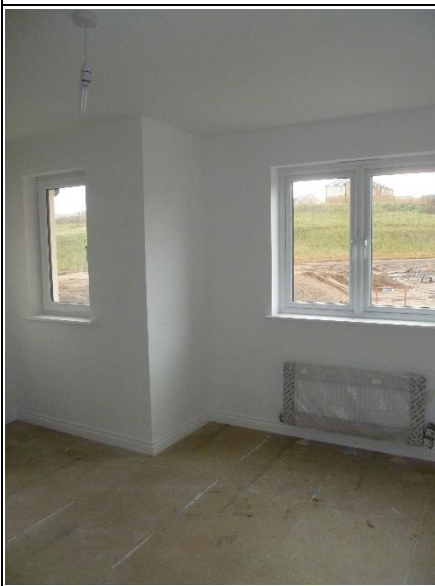
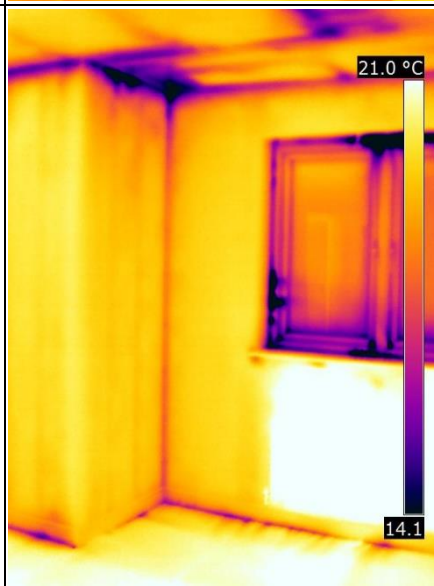
Under depressurisation cold air could be observed spreading out from the previously identified colder areas and being drawn down the external wall panels.

Air infiltration was detected again around the window and at the intermediate floor junctions with the external walls

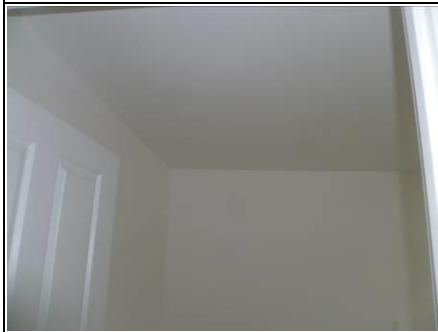
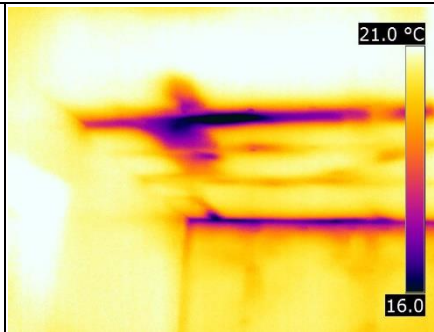
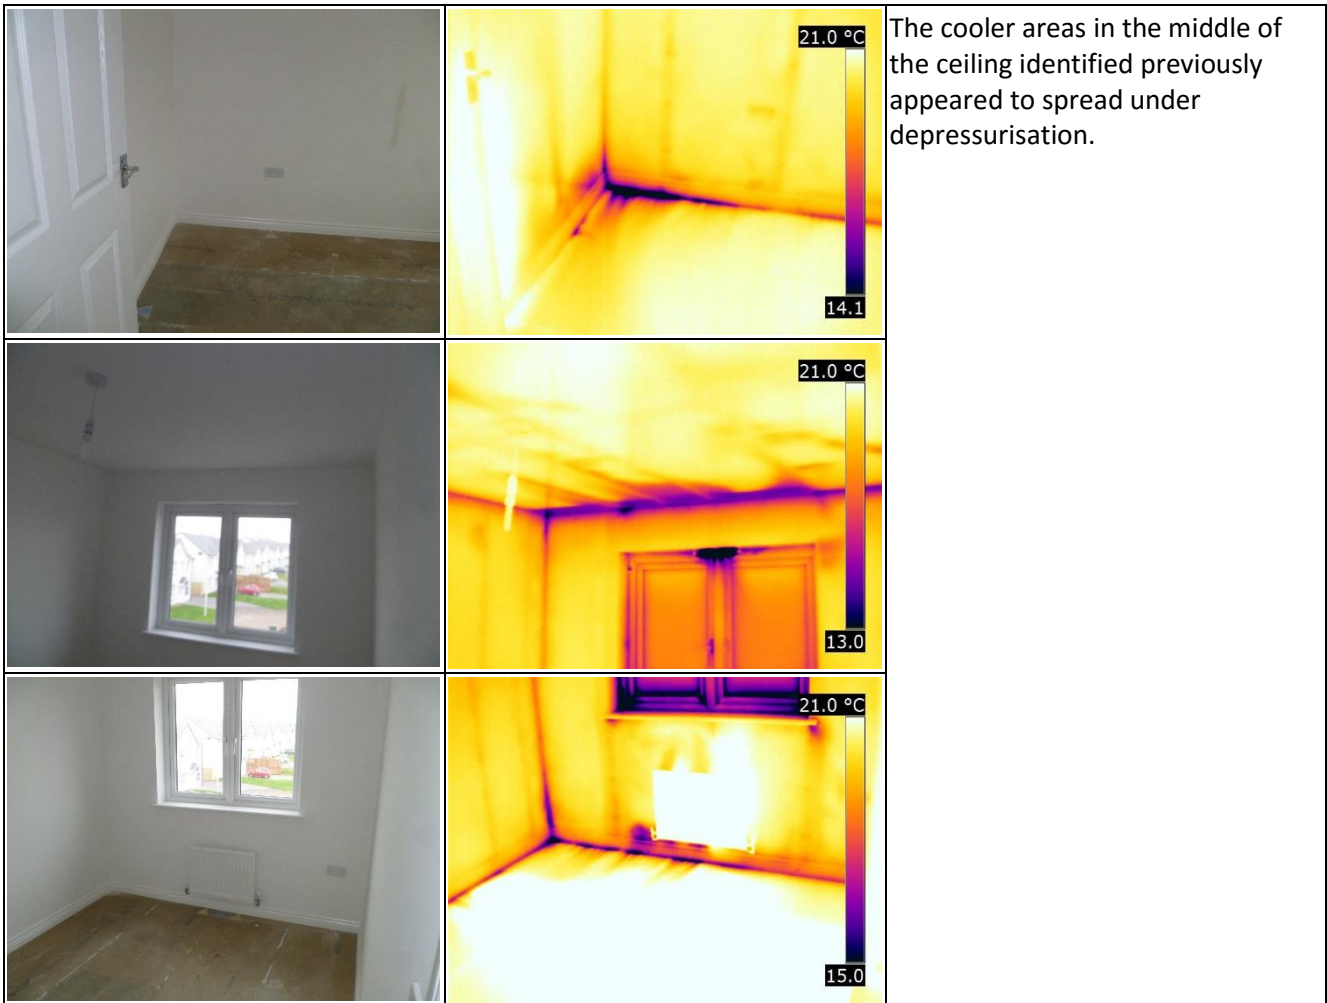
Bedroom 4 – Under depressurisation

Most of the observations made under natural conditions were exacerbated under depressurisation.

Air infiltration was again detected around the window and intermediate floor perimeter.

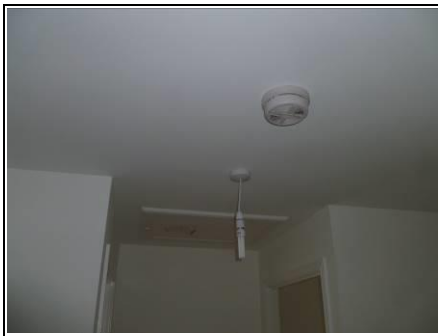
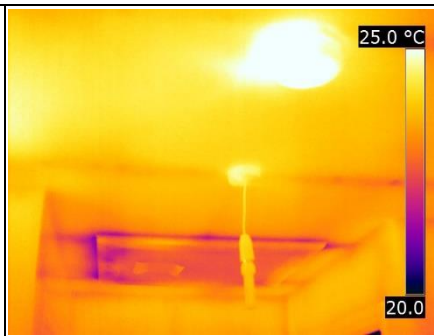
Some colder areas are visible where the loft insulation appears to not be in direct contact with the ceiling plasterboard.

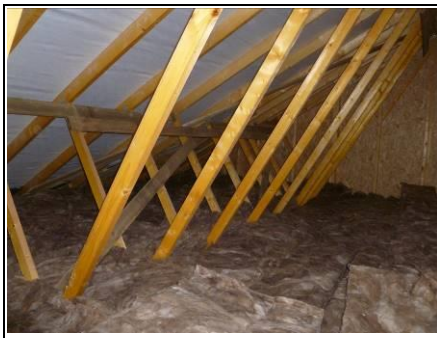
Looking towards the gable wall above garage hot spots can be seen around the angled junctions of the trussed rafters and between gaps in the uppermost layer of loft insulation between the rolls.

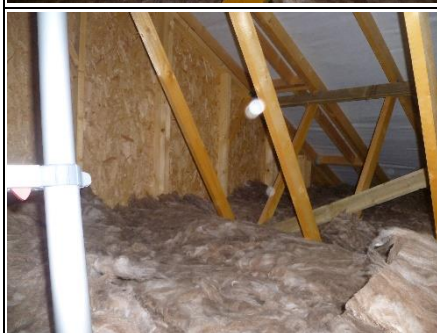
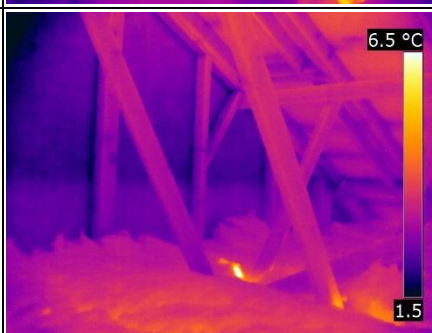
Looking towards the opposing gable wall similar observations are made.

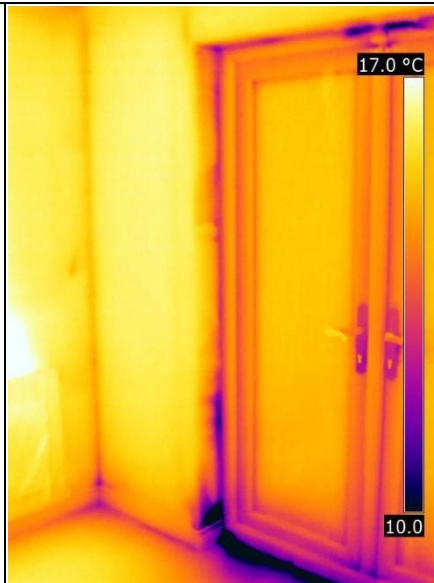
Dining – Under depressurisation

The patio doors themselves appeared to prevent air movement through them very well, with just a small amount coming through at the top and bottom of the doors; however there was more significant air movement around the frame and up into the walls on either side of the infilled section between the floor slab and door frame.

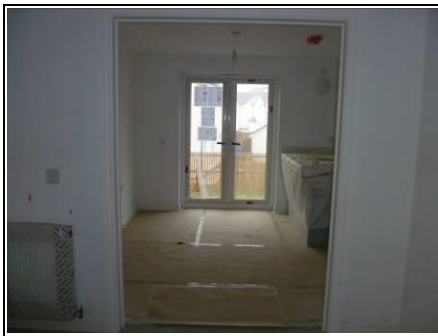
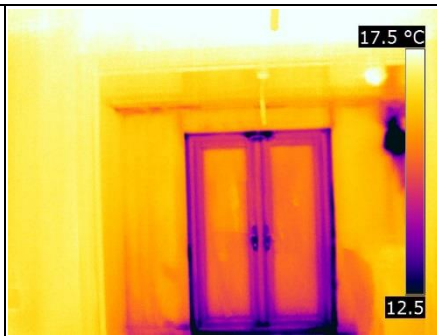
Family / Kitchen – Under depressurisation

Under depressurisation the previously observed infiltration paths worsened and air leakage around and below the windows were now apparent.

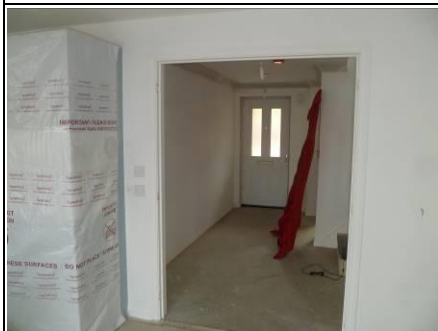
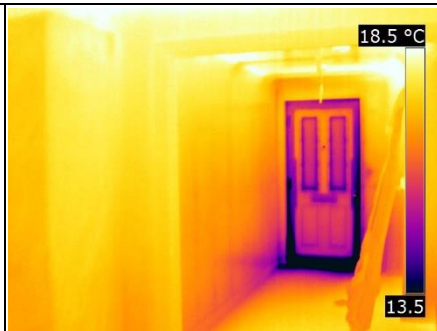
Hall – Under natural conditions

The garage wall appeared to have a similar surface temperature to the other internal walls.

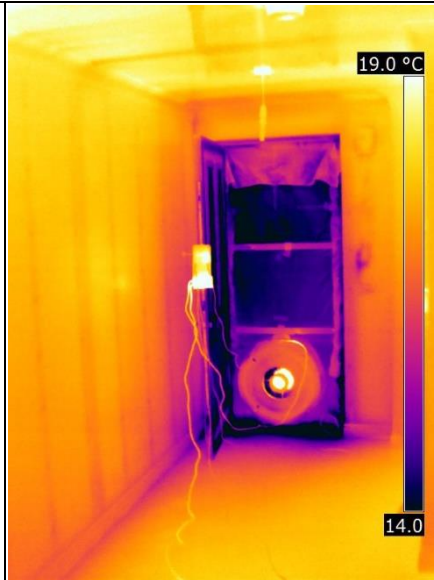
Hall – Under depressurisation

The ground floor and the water in the heating/DHW system appeared to have retained their heat more than the rest of the dwelling, with the floor and the section of intermediate floor containing the pipework remaining the warmest areas in the images opposite.

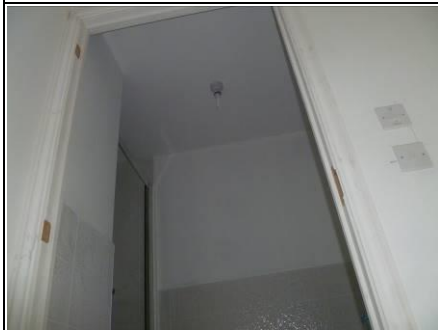
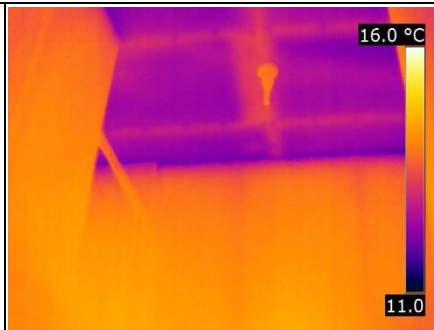
En-Suite – Under natural conditions

No significant issues with the thermal imaging on a 5° span and the loft un-insulated. However, the crossed timbers seen through the ceiling plasterboard may explain why some of the cooler patches of ceiling were observed in plot 268; as these would likely allow air gaps between the ceiling plasterboard and insulation, impairing the performance of the insulation

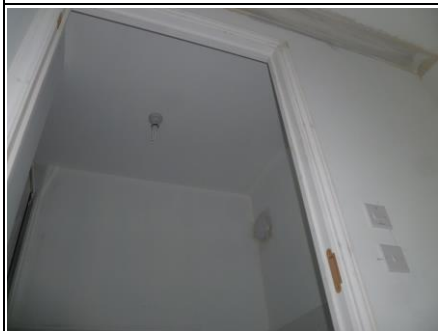
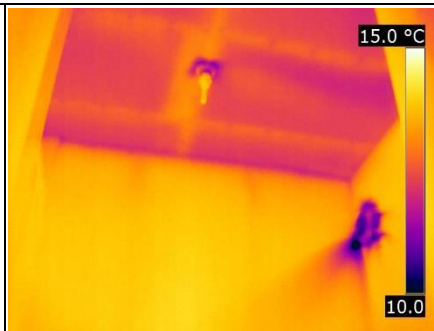
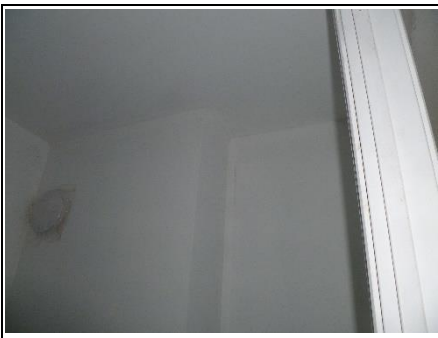
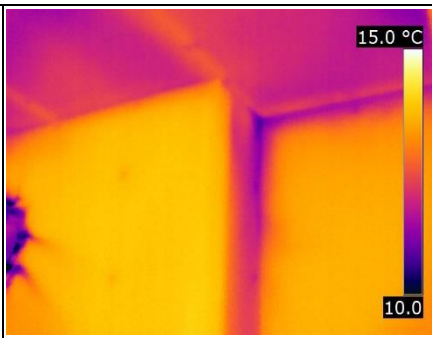
En-Suite – Under depressurisation

As above, but with cooler air entering around the temporarily sealed extract fan and perhaps down the partition walls and boxed-in services.

Without loft insulation the air being drawn in from the loft is not that much cooler than the room

temperature so is difficult to determine with certainty, air infiltration from outside is still clearly visible.

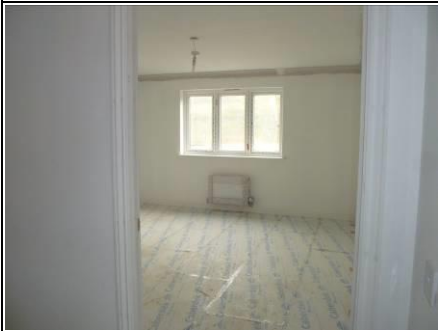
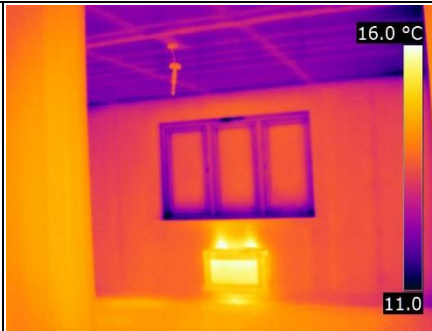
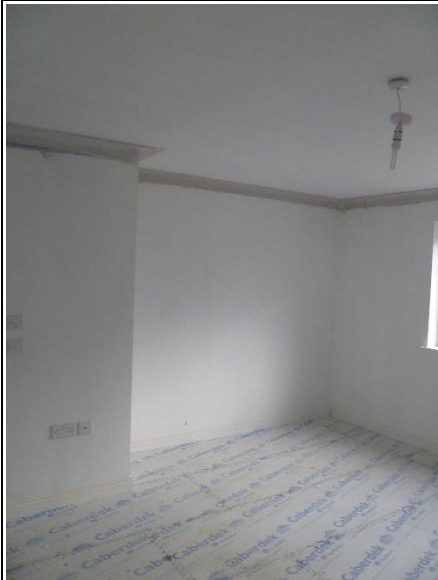
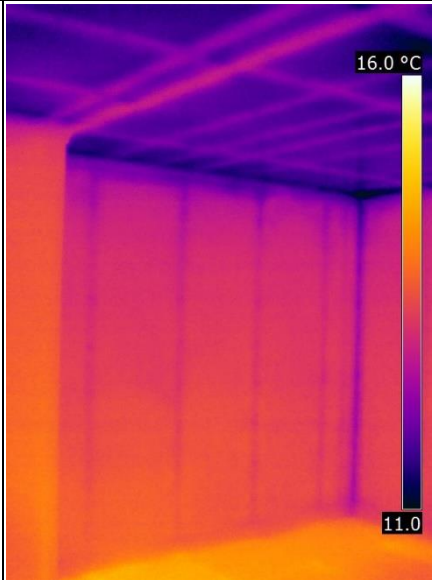
Bedroom 1 – Under natural conditions

No significant issues with the thermal imaging on a 5° span.

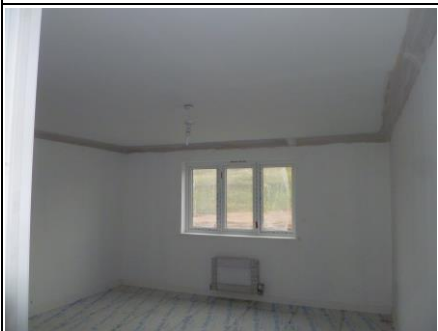
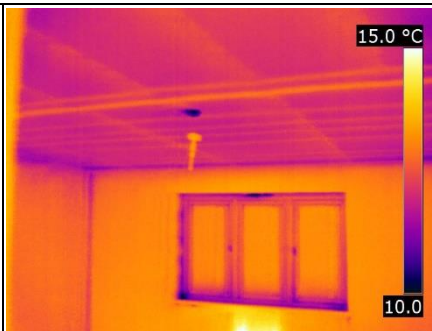
Bedroom 1 – Under depressurisation

Infiltration at the ceiling penetration, window jamb were now perceptible.

Air could also be seen being drawn into the wall panel at the side of the gable window where issues had been seen in plot 268.

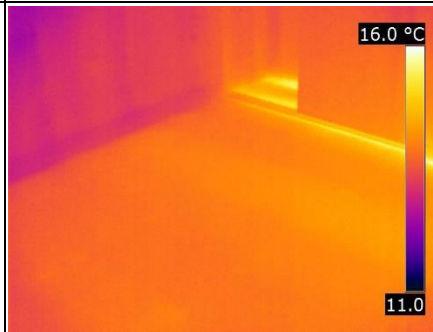
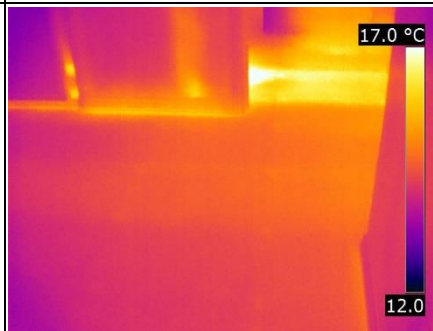
As seen in previous bedrooms.
The pipework from the boiler to the cylinder cupboard retained heat much better than the rest of the upstairs without loft insulation installed.

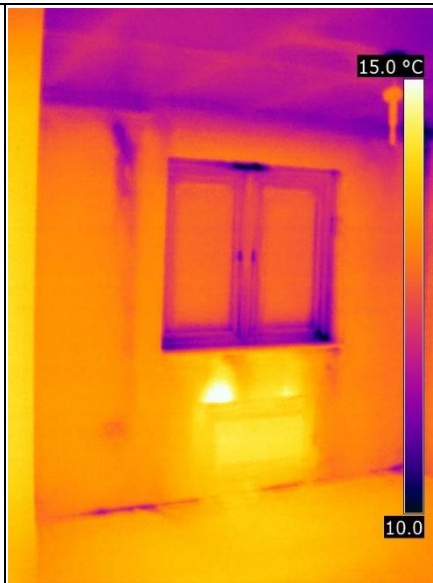
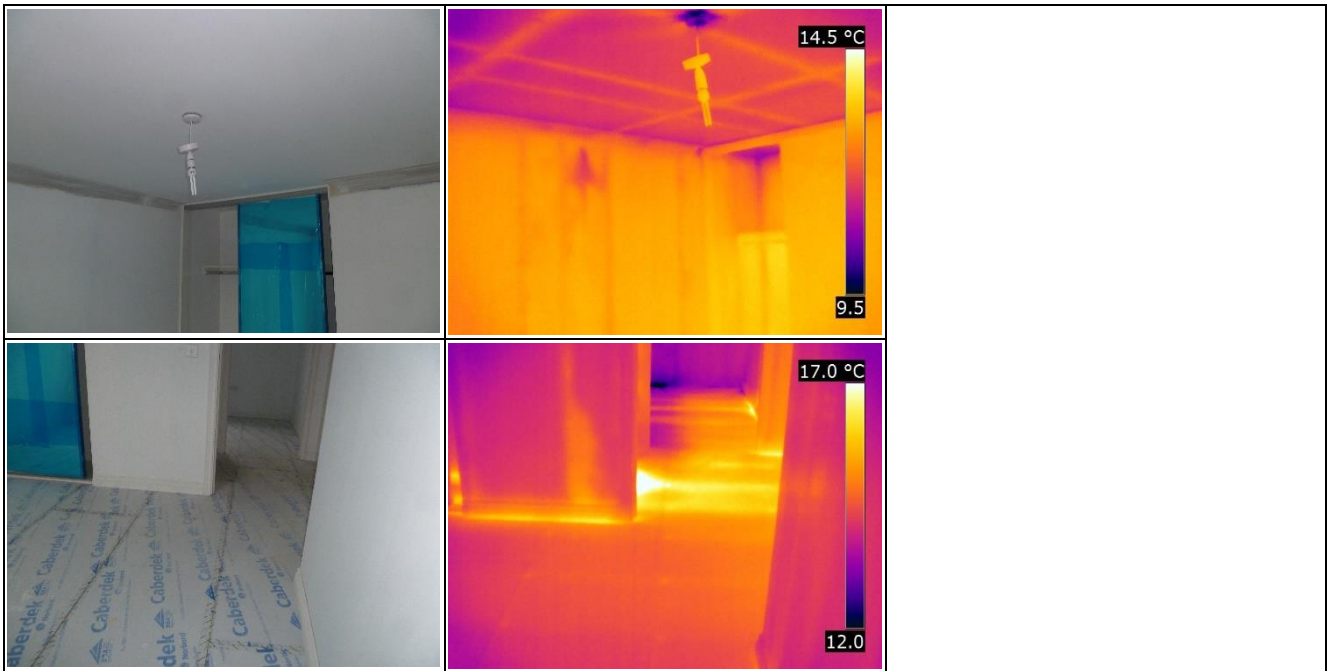
Bedroom 4 – Under depressurisation

As in Bedroom 1, cooler air was seen tracking down the wall the external wall along the cabling route for an electrical socket.
Cooler air could be seen infiltrating around the window and at the intermediate floor perimeter.

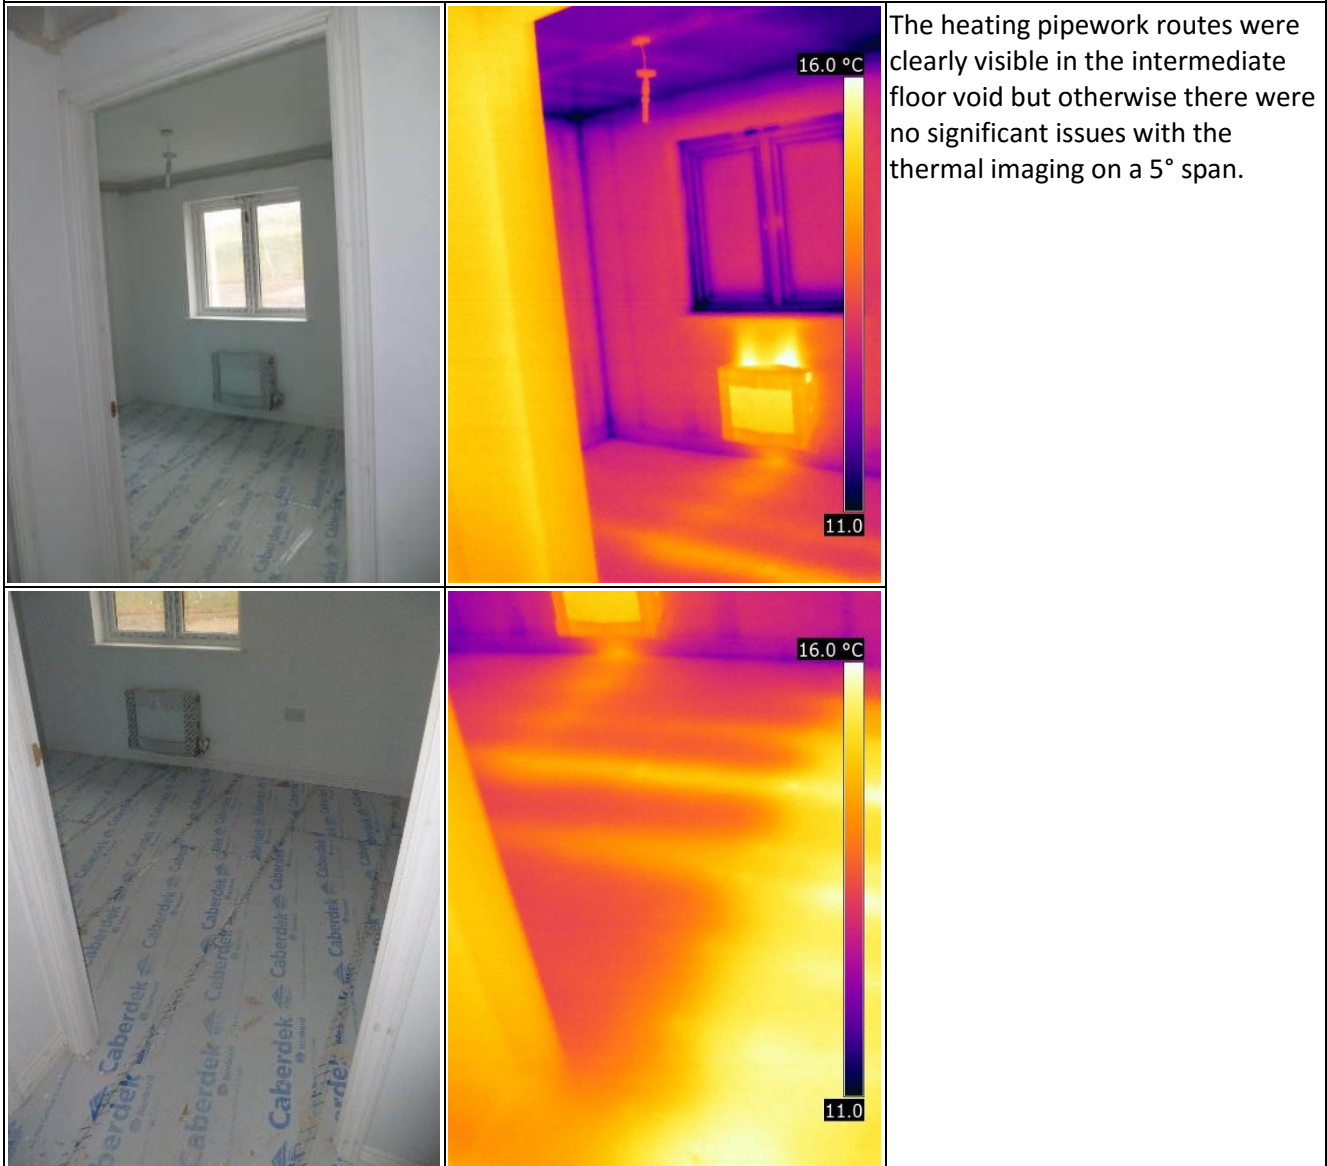
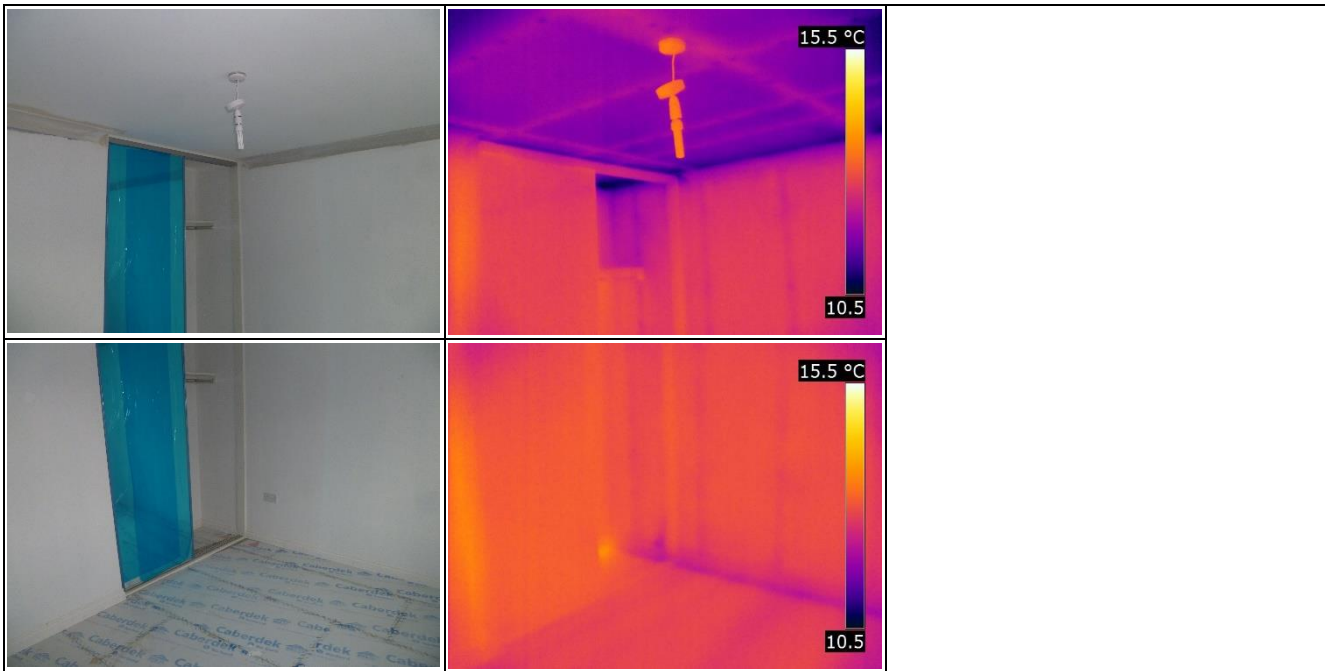
Bedroom 2 – Under natural conditions

The heating pipework routes were clearly visible in the intermediate floor void but otherwise there were no significant issues with the thermal imaging on a 5° span.

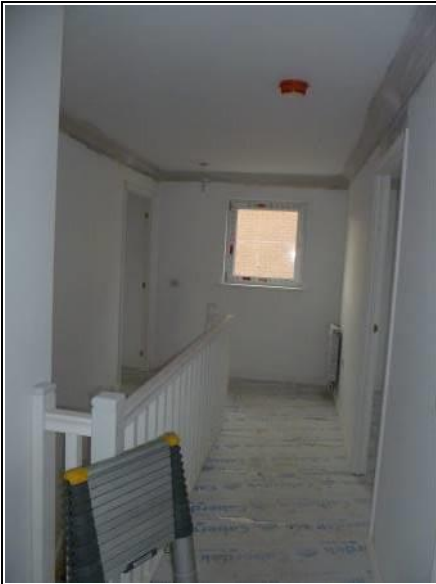
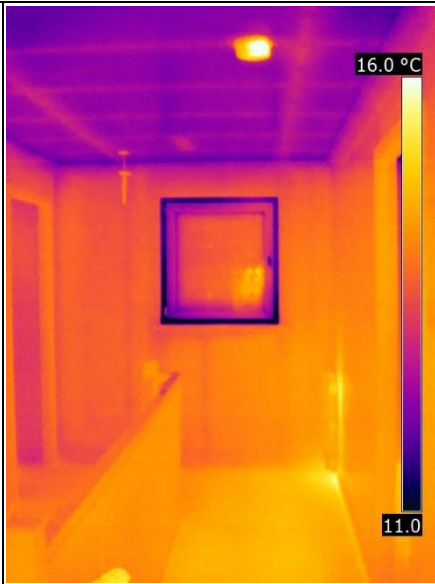
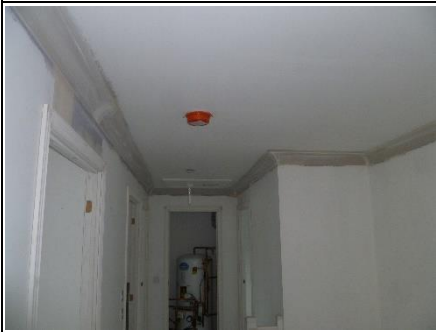
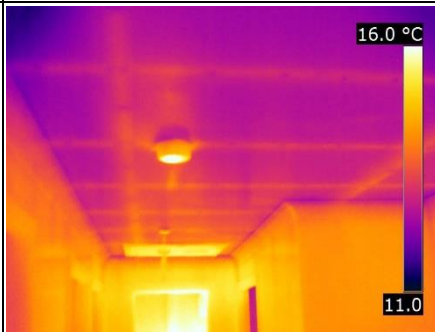
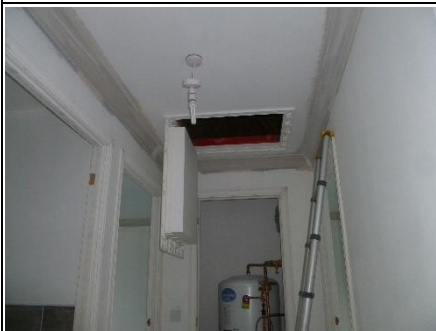
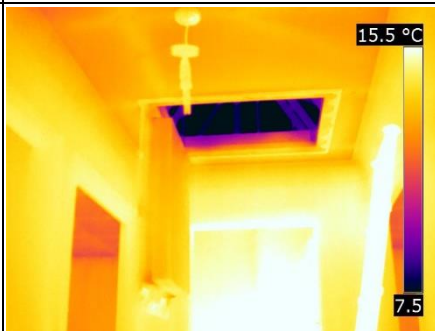
Landing – Under natural conditions

No significant issues with the thermal imaging on a 5° span.

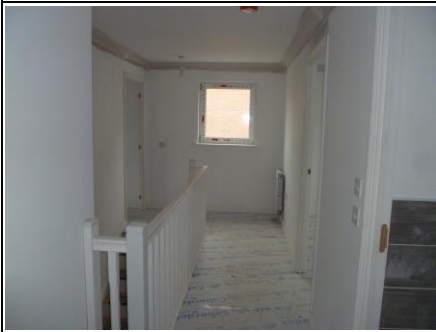
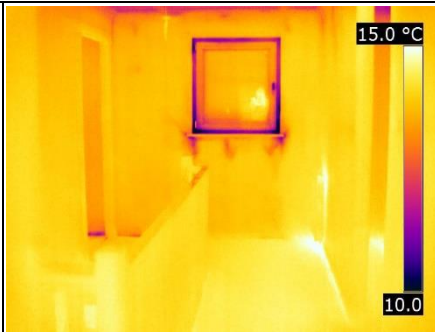
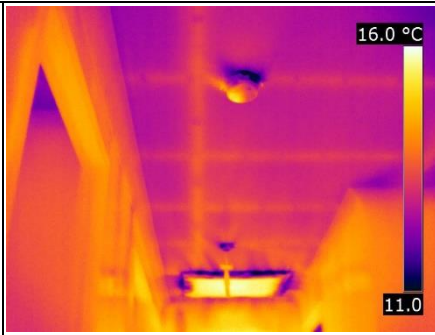
Landing – Under depressurisation

Under depressurisation the usual issues at the window and around ceiling penetrations became apparent

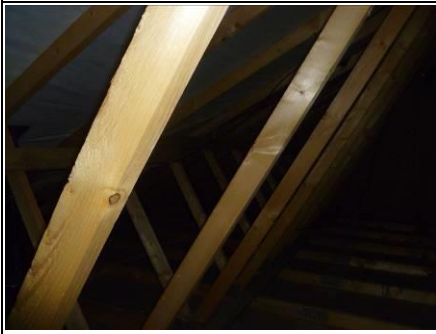
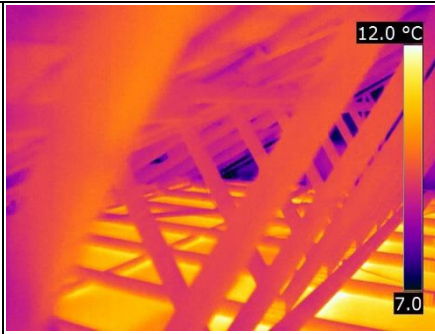
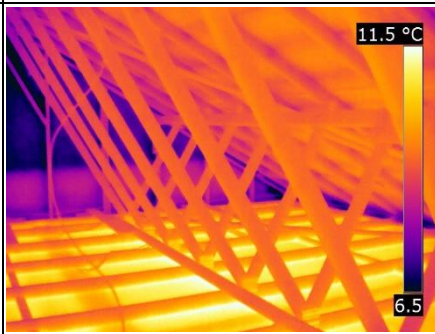
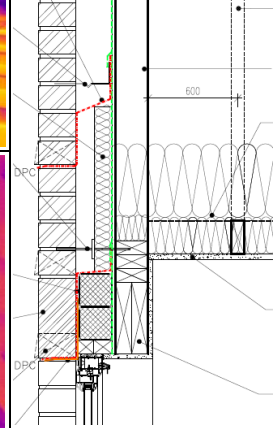
Loft – Under natural conditions

Looking towards the gable wall above garage the additional rigid board insulation on the outside of the timber frame is easily discernible:

Without insulation the loft itself is around 9~10°C, compared to ~4°C in plot 268.

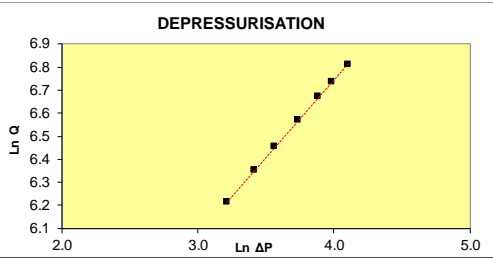
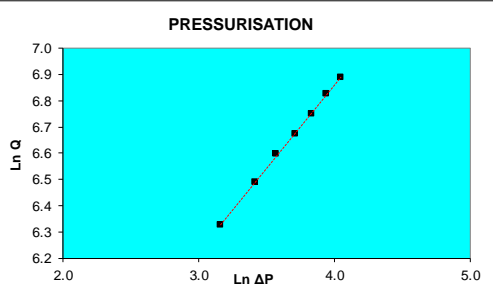
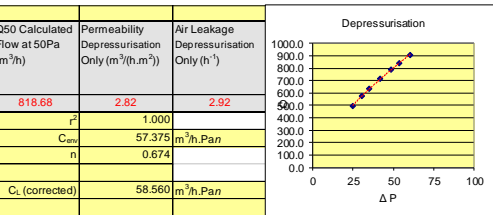
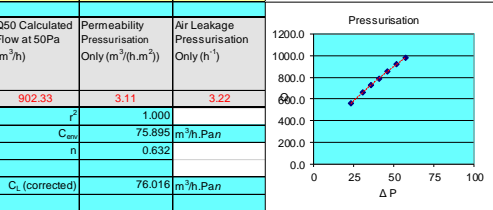
Pressure Test Spreadsheet: 268

RESULTS:			
Q50 Mean Flow at 50Pa =	860.51 m ³ /h		
Mean Air Leakage at 50Pa =	3.07 h ⁻¹		
Mean Air Permeability at 50 Pa =	2.98 m ³ /h or m ³ /h.m ²		
Equivalent Leakage Area =	0.034 m ² at	10 Pa

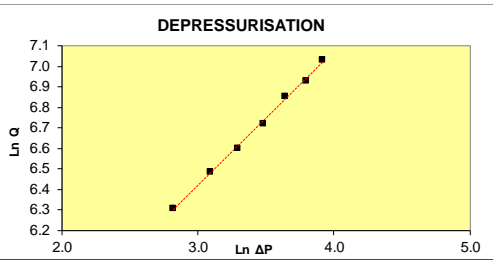
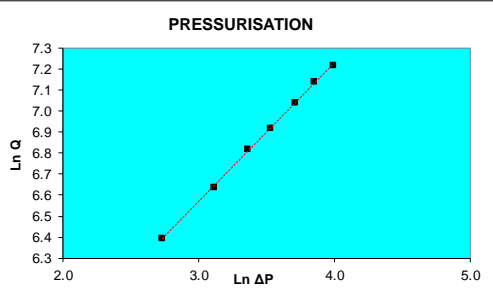
Pressure Test Spreadsheet: 267

RESULTS:	Q50 Mean Flow at 50Pa = 1222.74 m ³ /h		Mean Air Leakage at 50Pa = 3.61 h ⁻¹		Mean Air Permeability at 50 Pa = 3.66 m ³ /h or m ³ /h.m ²		Equivalent Leakage Area = 0.048 m ² at 10 Pa				
DEPRESSURISATION	RING - O.A.B.C.D.E for BD3 or 0.1,2,3 for DuctBB	MEASURED FAN PRESSURE (Pa) Max 90 Pa	MEASURED FLOW (m ³ /h)	ADJUSTED FLOW (m ³ /h)	FLOW RANGE OK FOR SELECTED RING?	Adjusted Pressure (Pa)	Ln delta P	Ln Q	Q50 Calculated Flow at 50Pa (m ³ /h)	Permeability Depressurisation Only (m ³ /h.m ²)	Air Leakage Depressurisation Only (h ⁻¹)
Approx 65 Pa	b	50.3	1195	1133.0	OK	50.3	3.918	7.033	1139.54	3.41	3.37
Approx 57 Pa	b	44.5	1075	1019.2	OK	44.5	3.795	6.927	r ²	0.998	
Approx 49 Pa	b	38.3	999	947.2	OK	38.3	3.645	6.853	C _{eq}	85.241	m ³ /h.Pan
Approx 41 Pa	b	32.5	874	828.7	OK	32.5	3.481	6.720	n	0.657	
Approx 33 Pa	b	27	776	735.7	OK	27	3.296	6.601			
Approx 25 Pa	b	22	689	653.3	OK	22	3.091	6.482	C _L (corrected)	87.171	m ³ /h.Pan
