Taylor Wimpey – Thermal Imaging Project

Site: Pipers Green
 Crigglestone
 WF4 3HY

Plot(s): 288

House Type: PA48 – Shelford
 Full-fill Masonry, 2-Storey, 4-Bed Detached

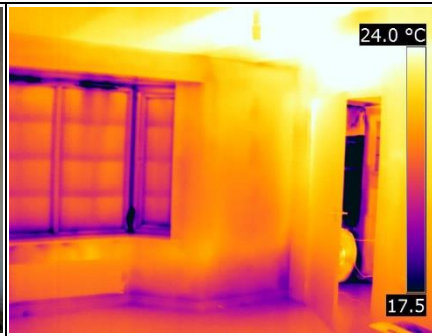
Lounge – Under depressurisation

Under depressurisation cooler air could be observed infiltration around the windows, with air entering through and around the closed trickle vents, at junctions between the lights and around the sill board.

The thermal anomalies on the bay appear to worsen under depressurisation, where air movement is forced from cold external air to inside the structure, with a much clearer cold strip at the junction with the external wall above. This would indicate that gaps at interfaces play a part at this detail, whereas at the floor/wall junction the difference in IR images between natural and depressurised conditions is marginal suggesting that the increased heat loss at this junction is more likely due to conductive heat loss with discontinuities or disruptions of the insulation layer.

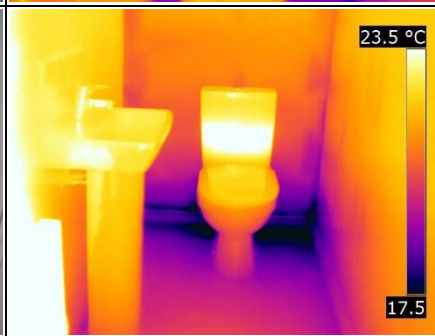
Some air movement behind the plasterboard dry lining observed, it is unclear of the source and direction of movement but tends to look as if the air is coming from the adjacent study.

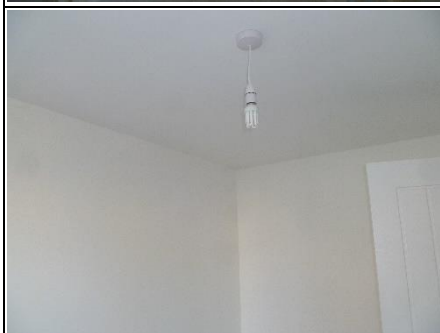
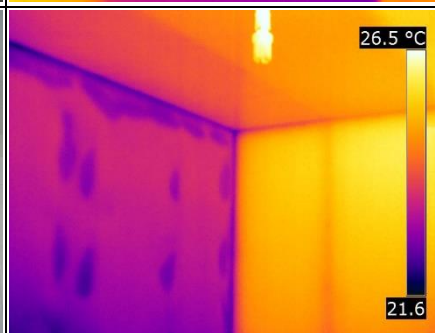
Plasterboard adhesive dabs appear coolest where the utilities meter boxes are situated on the external walls. Some temperature stratification across the intermediate floor void can be observed, but it is unclear whether this is heat from the heating system pipework spreading toward the outside or cooler air from the gable wall junctions spreading inside.

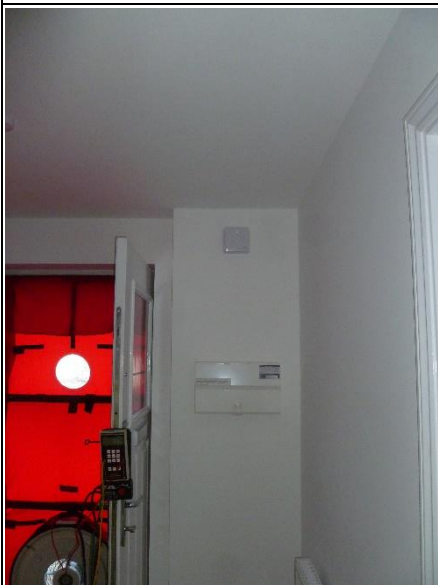
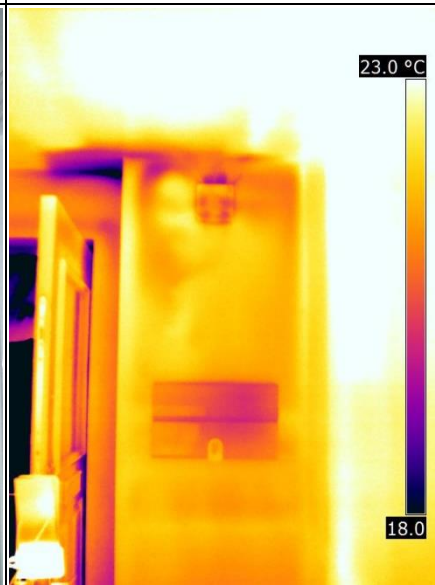
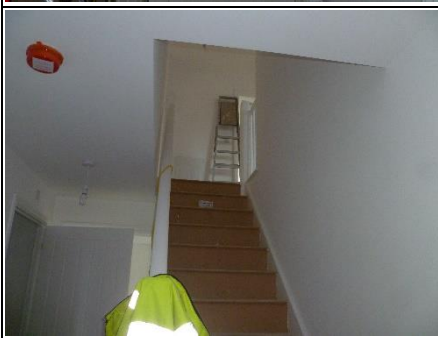
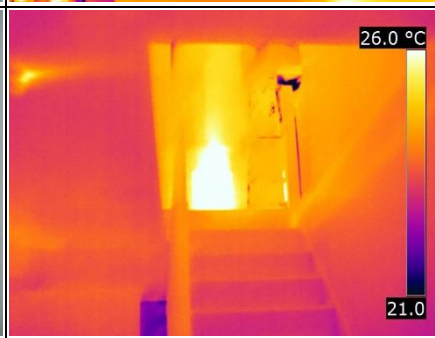
Depressurised

The indirect infiltration by the external wall junction with the lounge wall appears to be due to the penetration for the outside light.
The colder area at the junction of the external wall with the intermediate floor and boxed void appeared to worsen under depressurisation, this is deemed due to increased air movement which can be seen extending down the service void.

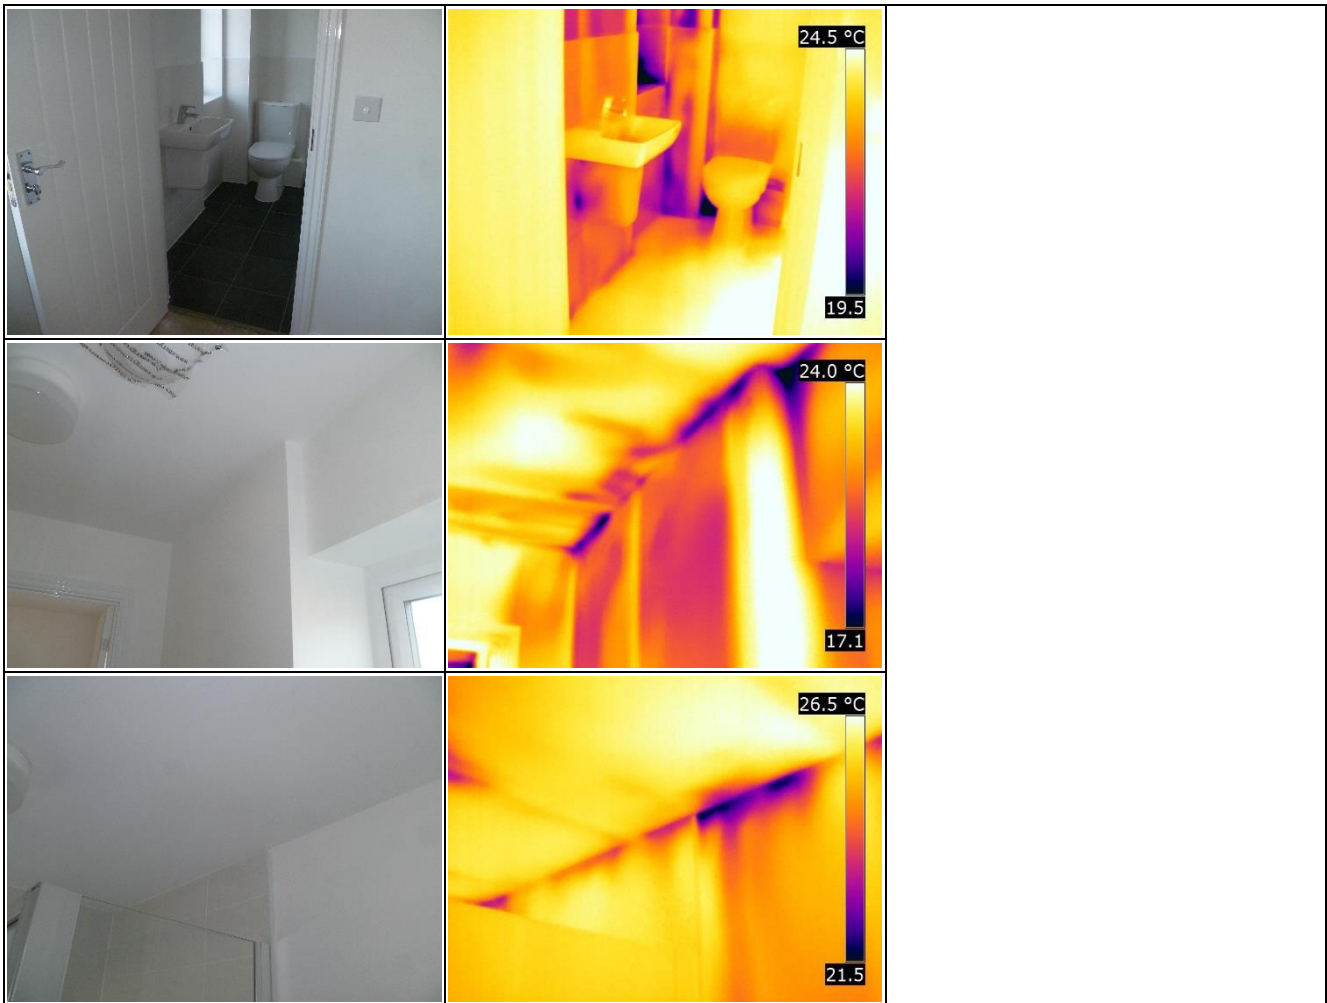
En-Suite – Under depressurisation

Air being drawn in from the loft space was observed into the service voids, around ceiling penetrations and into the internal partition wall by the shower cubicle.

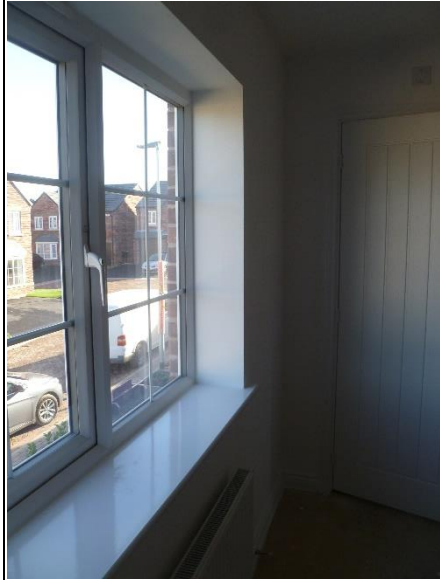
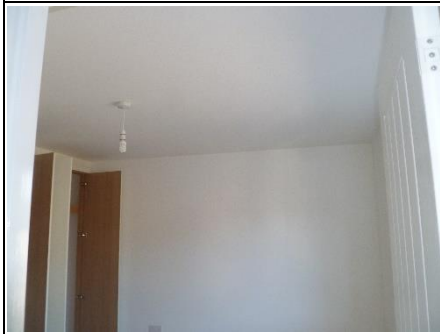
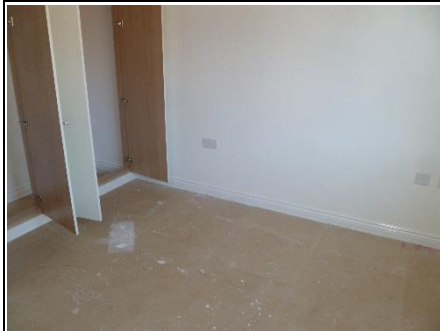
from direct contact with the ceiling are not excessive.

The stratification of temperatures of the intermediate floor void visible from below is also clear from above.

Thermal bridging at jambs/head/sill is also apparent but not excessive.

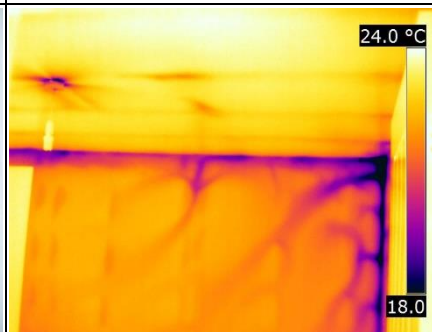
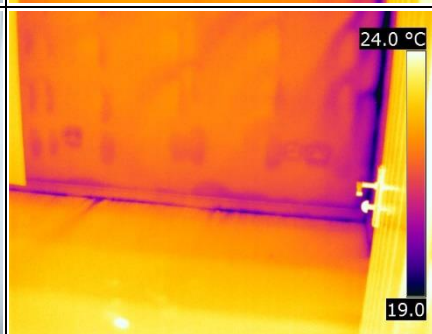
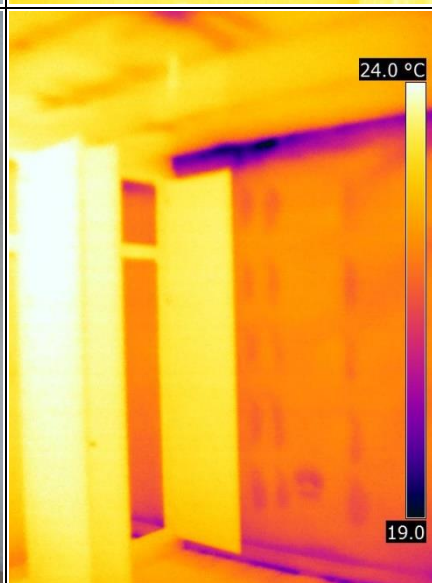
Bedroom 1 – Under depressurisation

Under depressurisation colder air can be seen being drawn in from the loft through ceiling penetrations, into the void behind the plasterboard dry lining and into some partition wall voids and emerging at places at the intermediate floor perimeter. The external wall at the ceiling perimeter, in particular, looks significantly colder than under natural conditions due to the change in air movement direction suggesting that air movement has a greater effect here than any thermal bridging or insulation discontinuity issues.

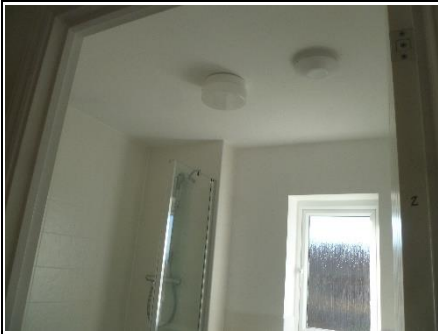
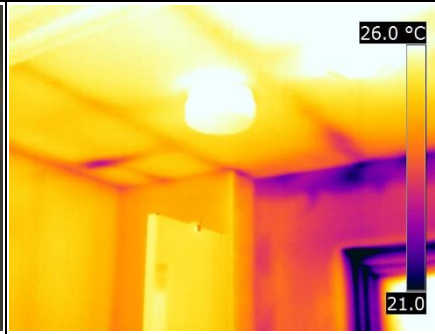
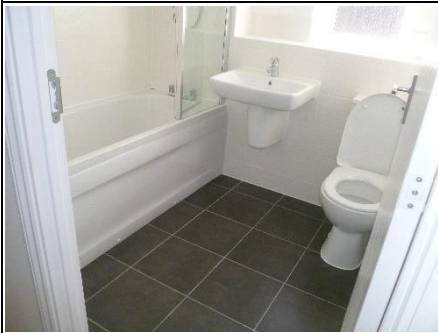
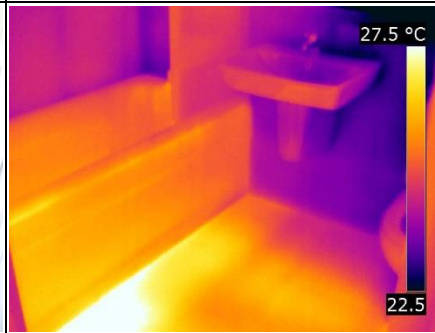
Bathroom – Under natural conditions

As previously observed in the bedroom, with the cold strip at the wall plate more obvious in comparison to the boxed-in service void next to it.

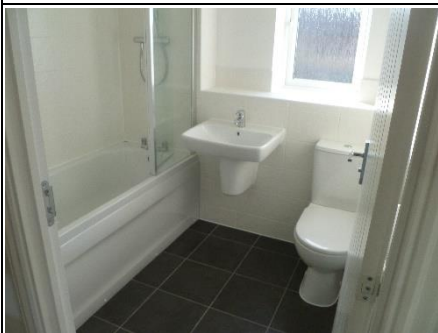
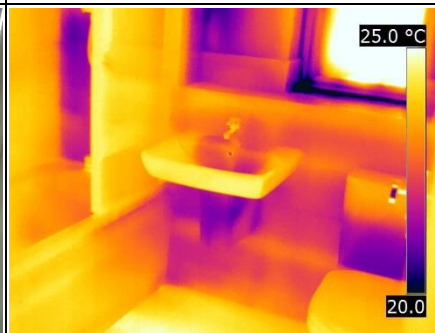
Bathroom – Under depressurisation

As in the En-suite, cold air is drawn in around ceiling penetration, into the void behind the dry lining and into the boxed-in void.

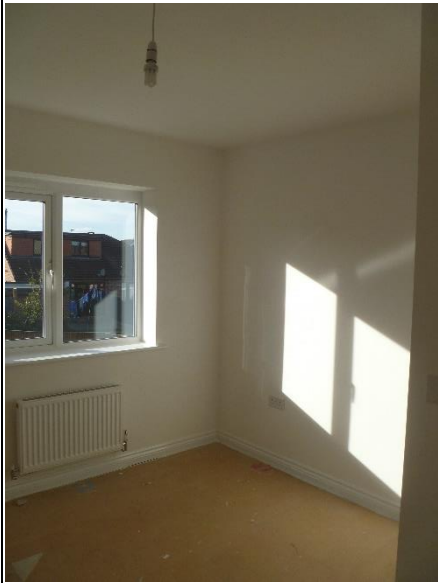
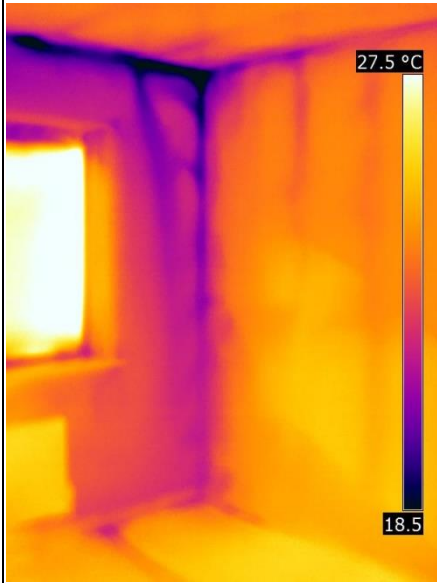
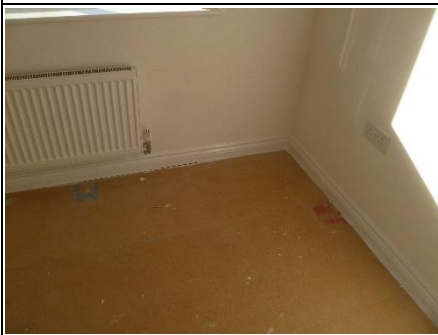
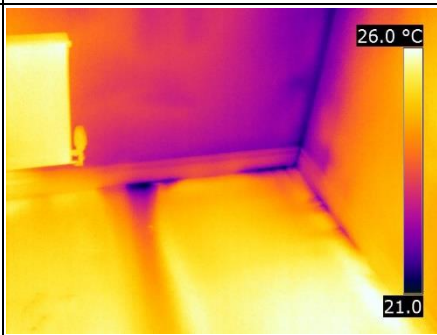
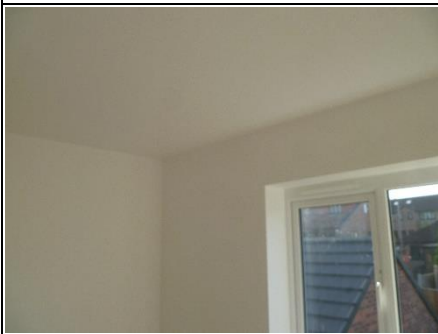
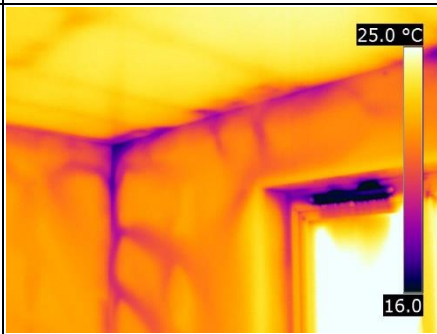
Bedroom 3 – Under depressurisation

As previous bedrooms.

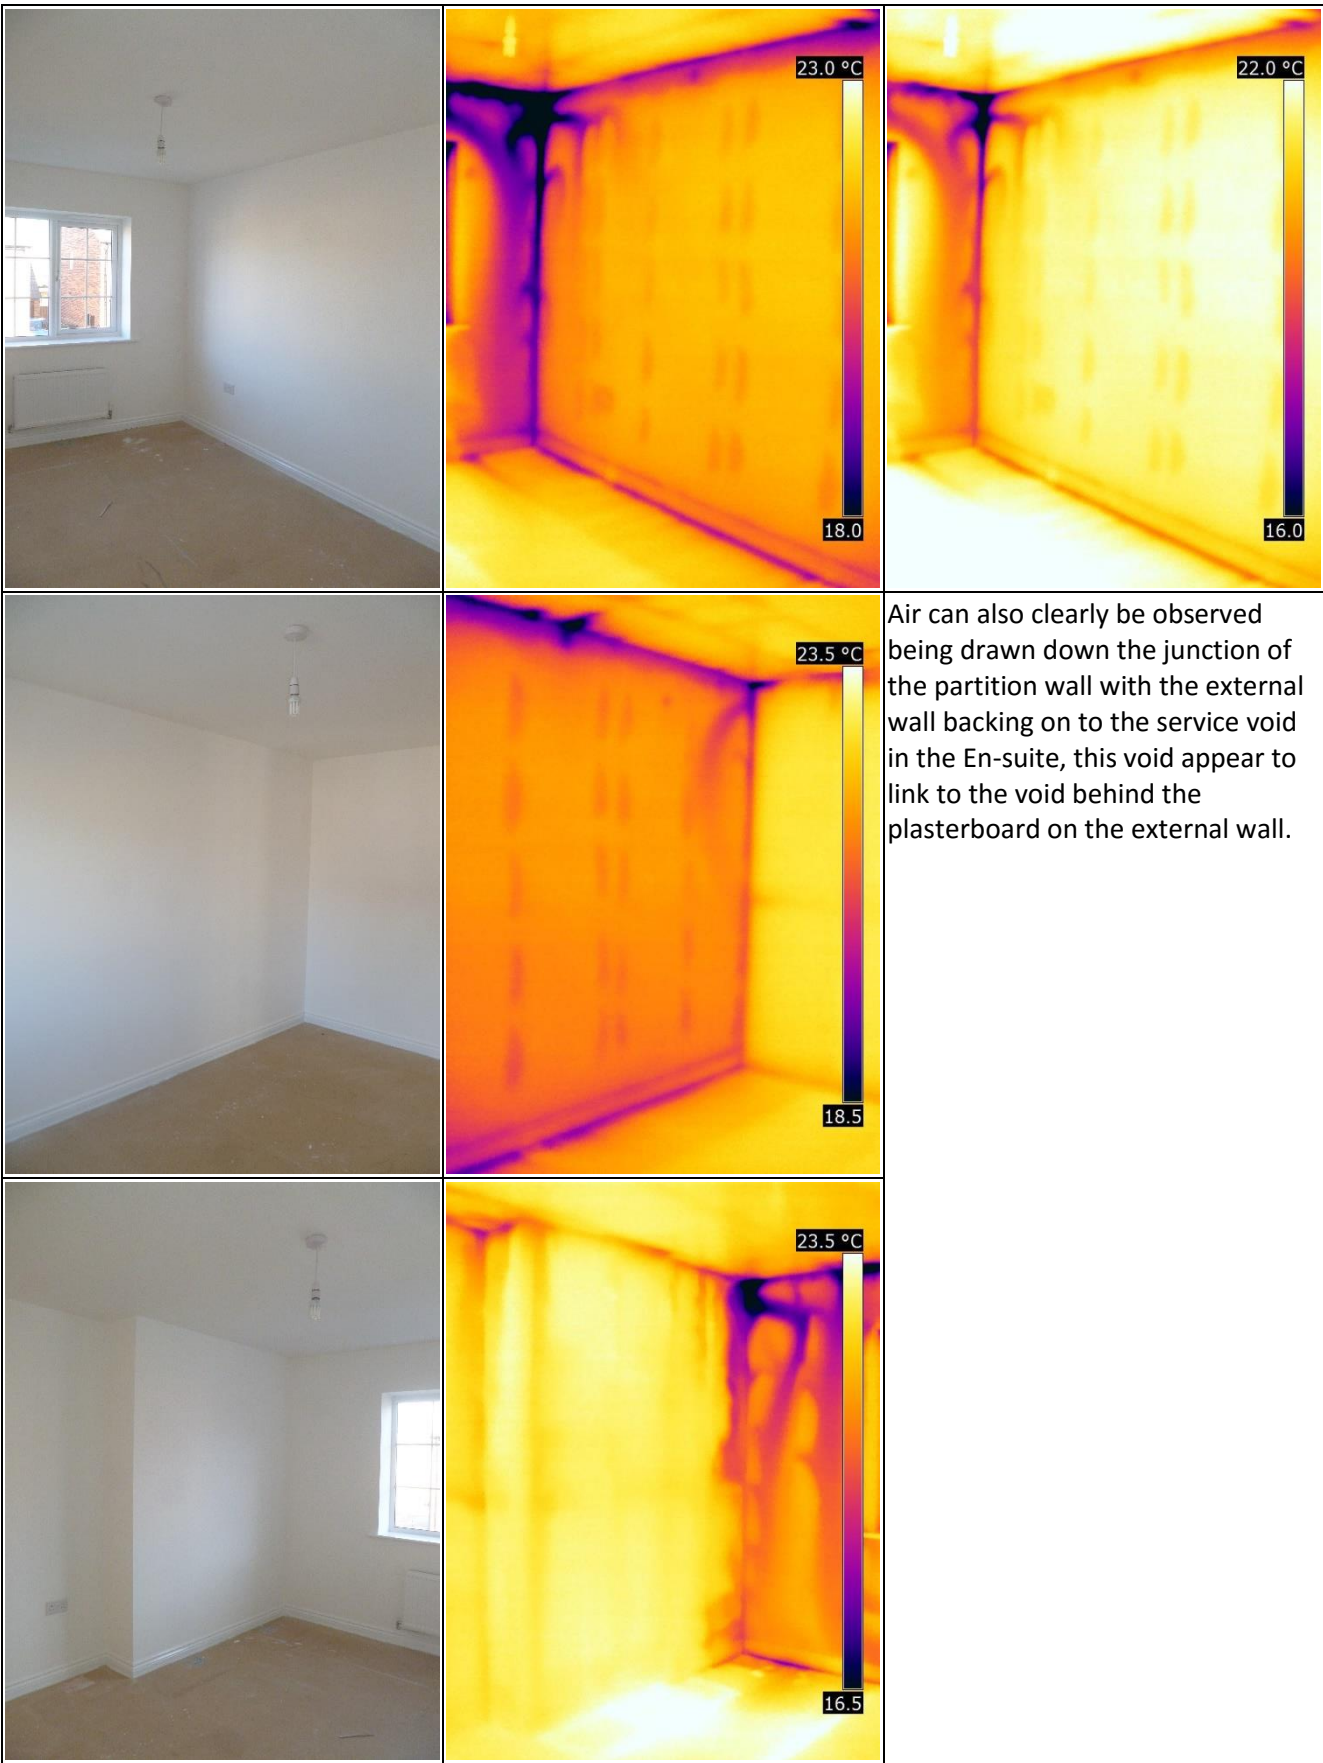
Bedroom 2 – Under depressurisation

As previously observed in other bedrooms.

Air can also clearly be observed being drawn down the junction of the partition wall with the external wall backing on to the service void in the En-suite, this void appear to link to the void behind the plasterboard on the external wall.

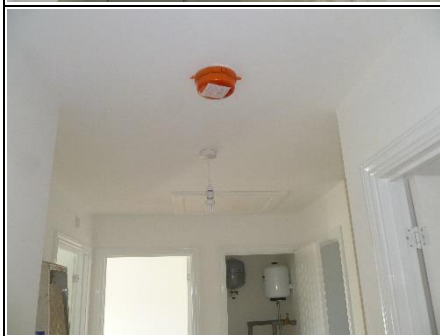
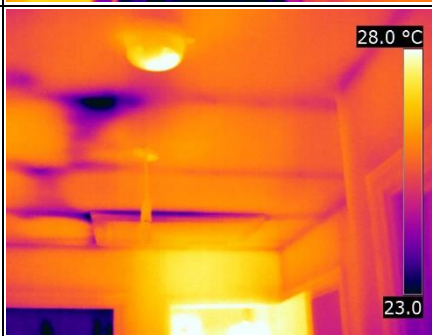
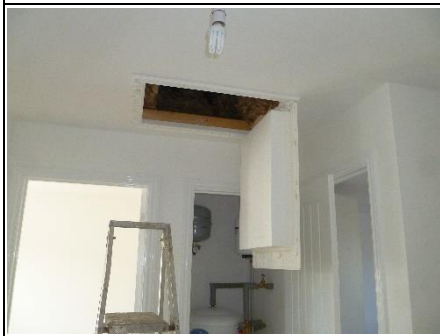
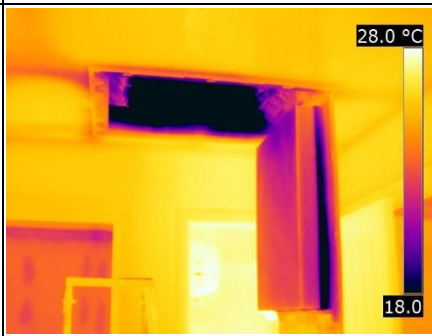
Landing – Under natural conditions

Some areas of dislodged loft insulation appear, the level and span of the thermal image makes some of these appear worse than they are (e.g. the minimum temperature of 22.7 °C in the adjacent image) due to the nearby hot water cylinder.

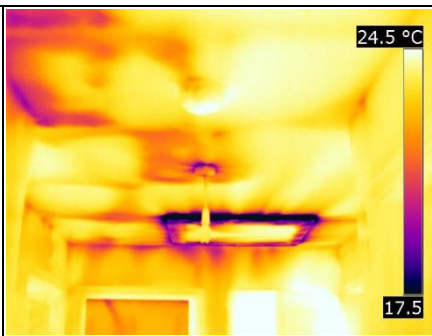
Landing – Under depressurisation

Under depressurisation air could be seen infiltrating directly around ceiling penetrations, most significantly around the loft hatch door. Air could also be seen entering the internal partition wall voids.

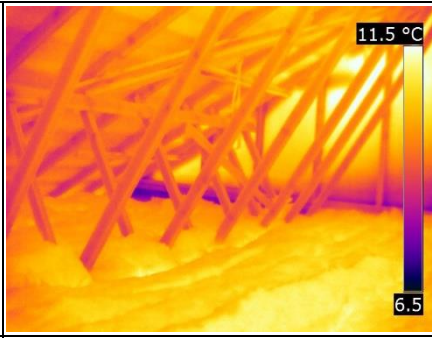
Loft – Under natural conditions

Direct solar on the SE gable hampered thermal imaging, but again no excessive thermal bridging beneath the spandrel panel was observed.

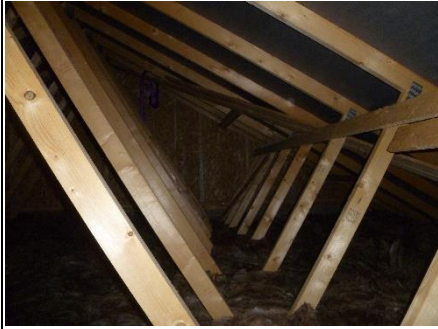
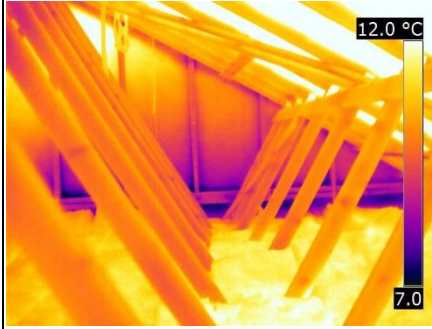
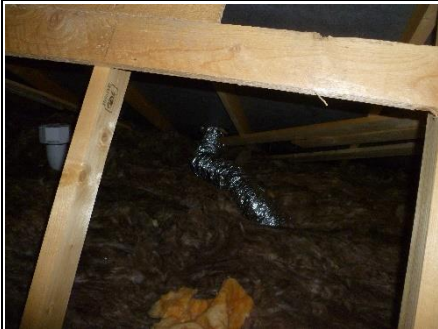
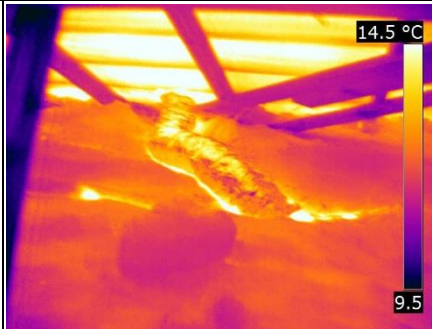
The loft insulation itself appeared from above to be laid particularly diligently; many commonly observed errors had been avoided, with insulation inserted into the small gaps and well placed around awkward truss angles and penetrations.
