Miles-Shenton, D (2018) Small Scale Forensic Thermal Imaging Study. Technical Report. Knauf Insulation.

# Taylor Wimpey – Thermal Imaging Project

Site: Hele Park  
 Newton Abbot  
 TQ12 6JN

Plot(s): 294 & 297

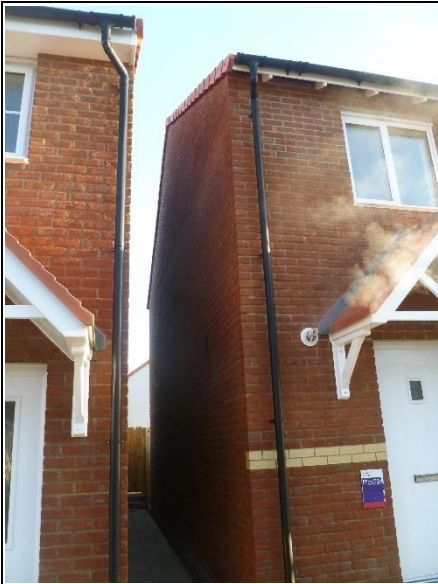
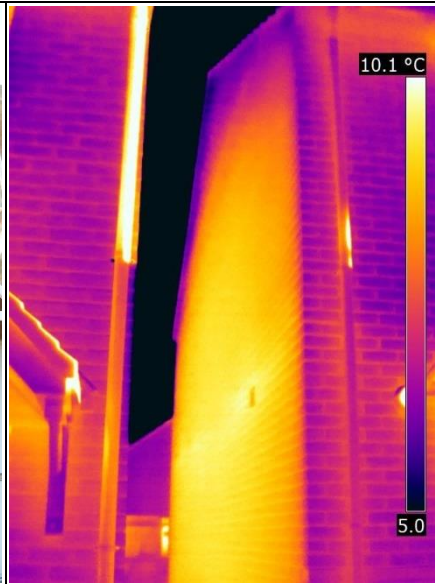
The North West facing gable wall was not exposed to solar, but is reflecting the adjacent heated property's gable wall rather than the clear sky so appears warmer in the thermal image.

Warmer strips are again visible at the ground floor perimeter and also at the intermediate floor level adjacent to the staircase.

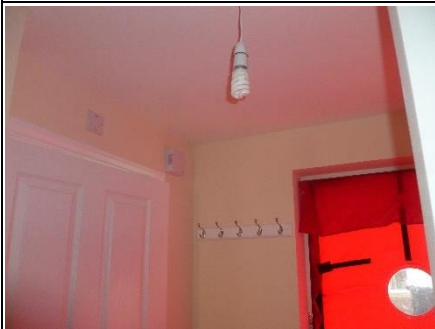
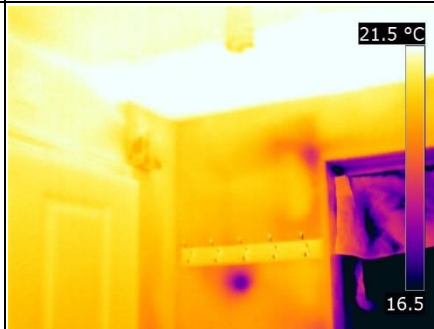
The penetrations through the inner leaf blockwork observed previously are now more obvious as the internal/external pressure difference is held at around -50 Pascal. Cooler air can also be seen moving into the void behind the dry lining plasterboard around the door head and at the base of the door jamb.

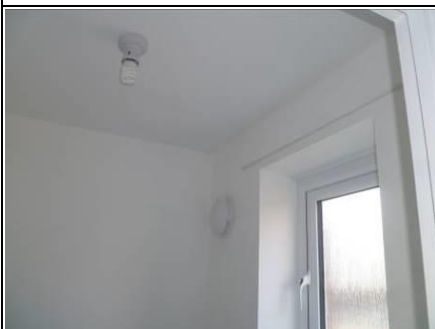
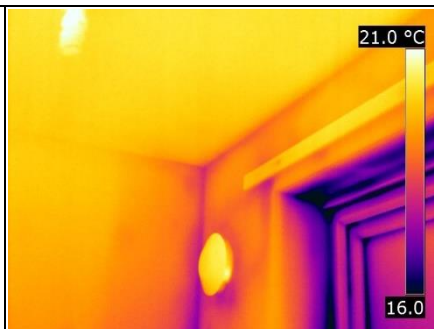
Ground Floor WC – Under natural conditions

The window reveals varied between jamb and head, with the thermal bridge at the head continuing further than that at the jamb. Possibly there is just plasterboard and no insulation beneath the base plate of the lintel?

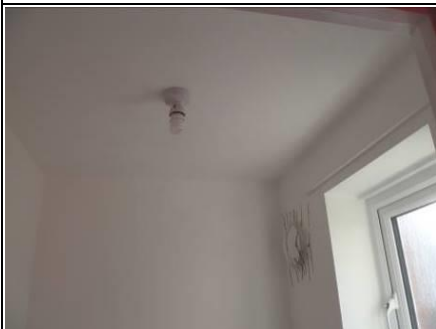
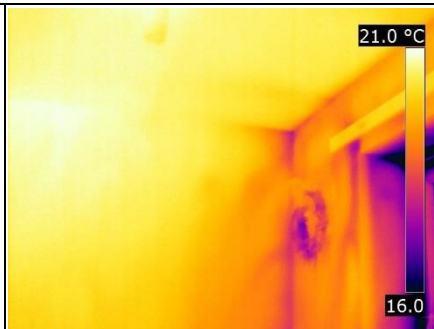
Ground Floor WC – Under depressurisation

Under depressurisation air can be seen entering the void behind the dry lining and moving around the external wall and into the adjacent void on the party wall. The main points of entry appear to be around the window opening and particularly around the sill board.

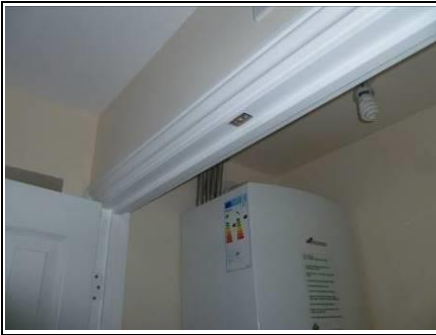
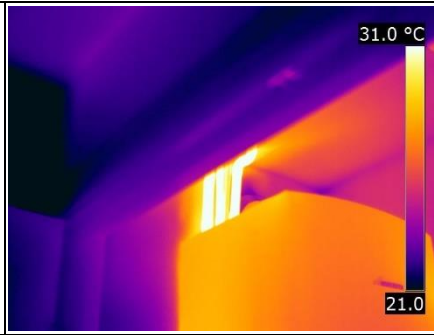
Ground Floor Store – Under natural conditions

As the boiler had not long been switched off it was still very warm and difficult to see anything around it thermally; however it was very cold in the corner beneath the worktop by the penetrations for the condensate pipe and washing machine outlet.

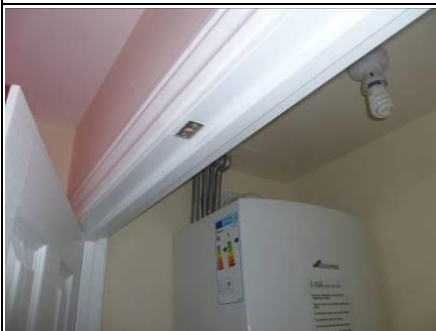
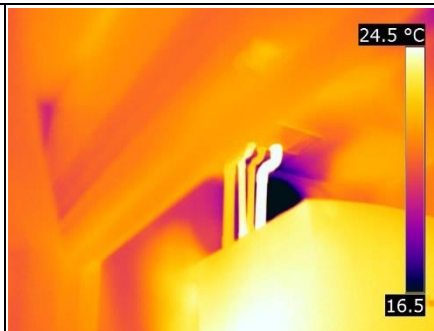
Ground Floor Store – Under depressurisation

Under depressurisation cold external air could be seen entering around the boiler flue and other external wall penetrations and again moving around through the void behind the dry lining. The cold area in the external corner did drop in temperature under depressurisation, indicating that

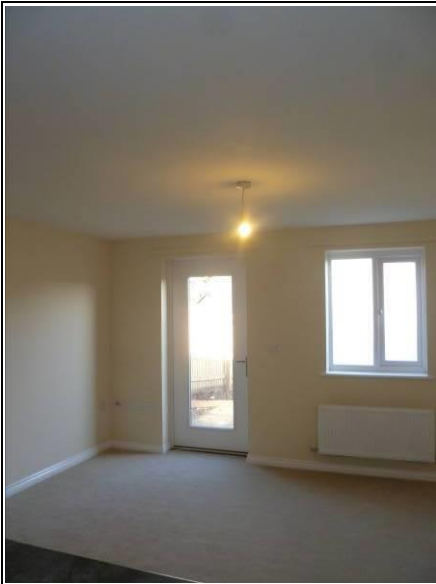
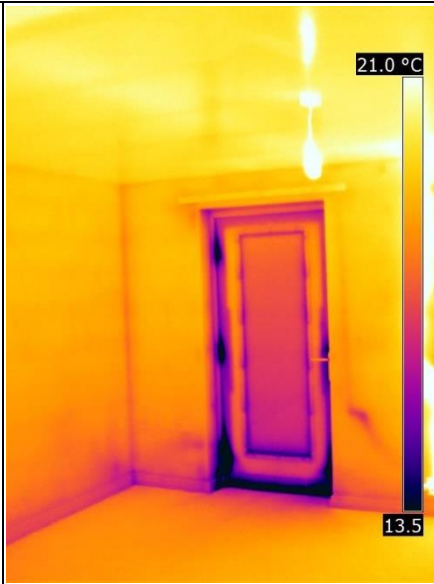
Under natural conditions there is a slight cooler area at the ground floor perimeter, a cold spot on the rear wall where the outside tap is sited, indications of air leakage around the back door (particularly around the 3 door hinges) and a very cold threshold.

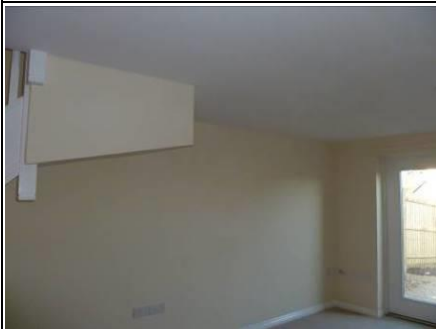
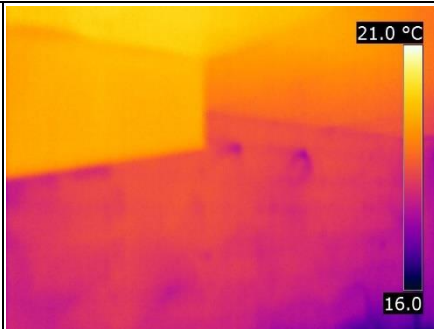
Dining/Lounge/Kitchen – Under depressurisation

Under depressurisation there again appear to be cooler spots appearing in the gable wall with no apparent reason visible externally, this could again be due to gaps in the perpend and bedding layers of the inner leaf blockwork allowing air to enter the void behind the dry lining

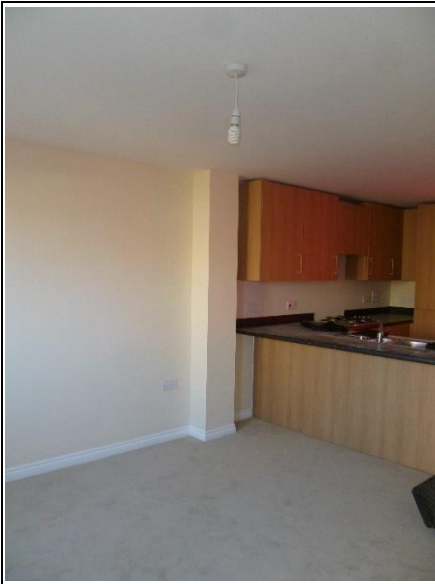
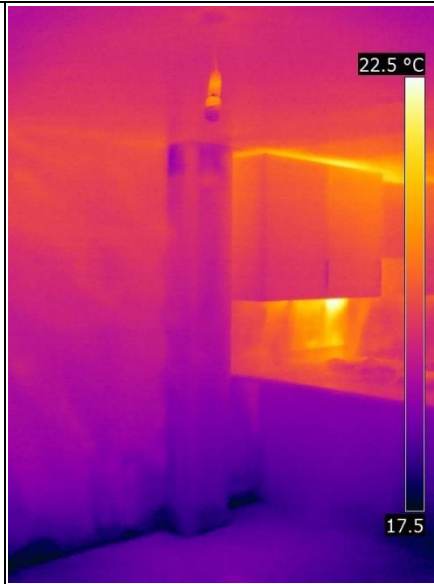
lifting of the lounge carpet under depressurisation, with air appearing to enter at the back door threshold.

The service riser at the edge of the kitchen units appeared cooler under depressurisation, the direction of airflow through it was not obvious.

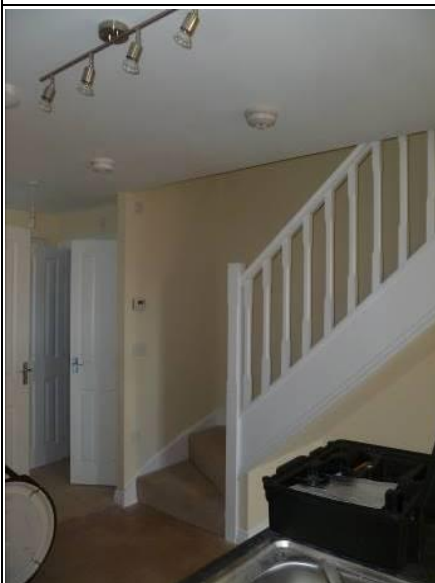
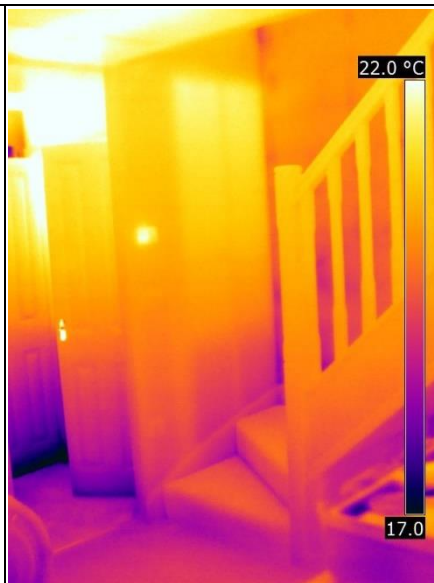
Stairs & Landing – Under natural conditions

The boiler in the store could be seen to make the internal partition wall to the stairs much warmer, as is to be expected.

The pattern of the inner leaf blockwork was clearly visible along the gable wall, but there was nothing that coincided with the warmer strip at intermediate floor level observed from outside.

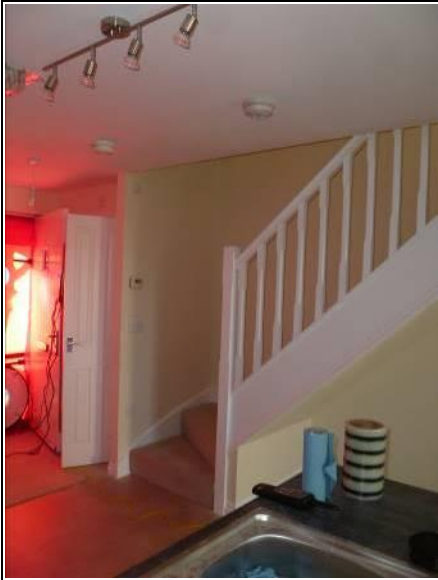
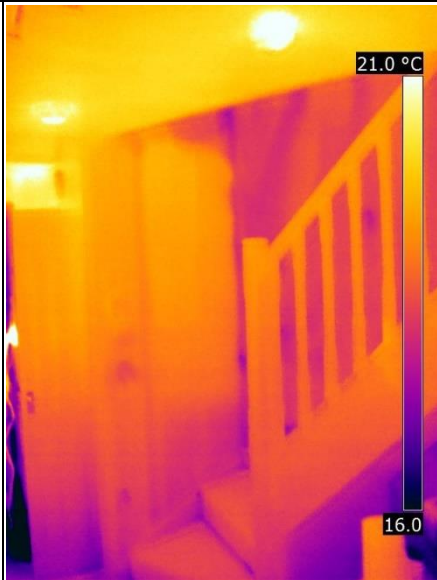
Stairs & Landing – Under depressurisation

Under depressurisation cold air from the loft was observed being drawn down behind the dry lining on the gable wall, around the plasterboard adhesive dabs. Although nothing appeared to be being drawn down the internal partition voids.

Significant air leakage could now be seen around the loft hatch, both between the door and surround and between the surround and the ceiling.

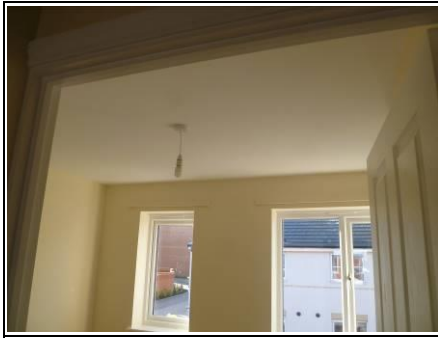
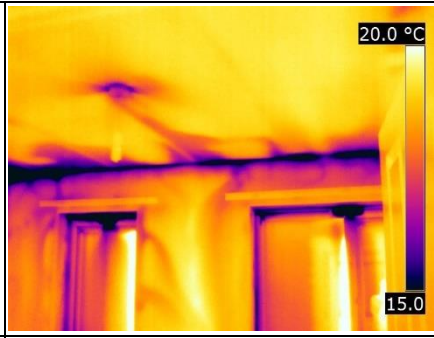
Under depressurisation there was extensive indirect infiltration into the dry lining void from around the windows, with lesser direct infiltration into the habitable space at the intermediate floor junction and around the central light fitting.

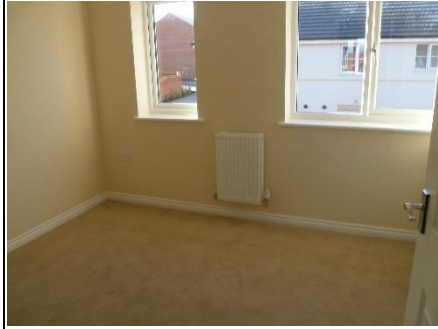
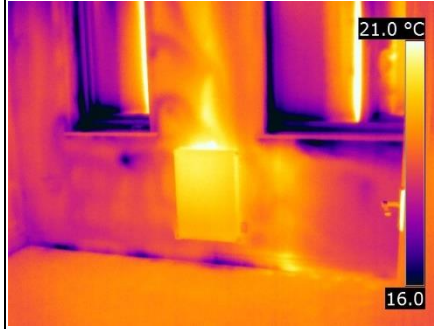
Cold air was also seen being drawn down from the loft space on both the external and party walls.

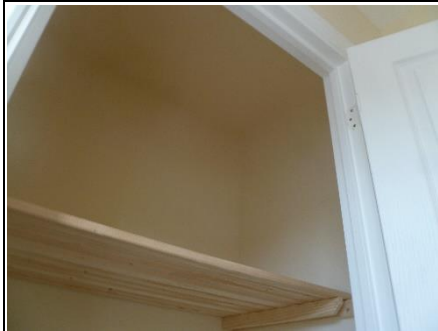
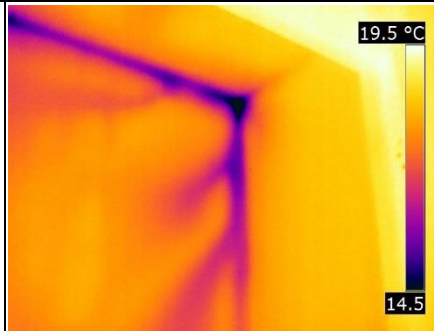
The ceiling in the airing cupboard was again the coolest surface (apart from where external air was entering around the trickle vents) and highlights the need to keep this cupboard heated.

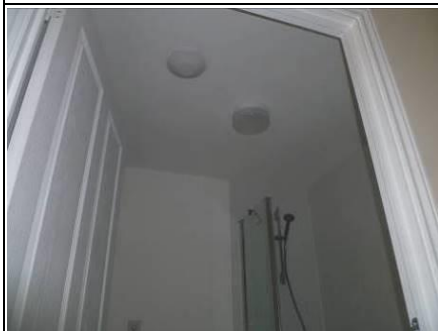
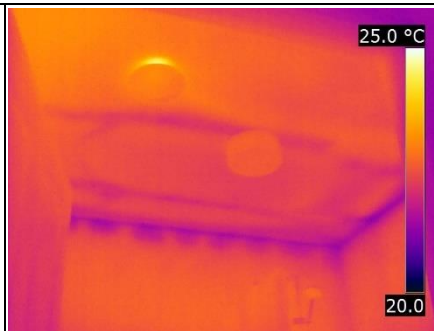
Bathroom – Under natural conditions

Much like the party wall in bedroom 2, the bathroom was pretty much isothermal throughout under natural conditions.

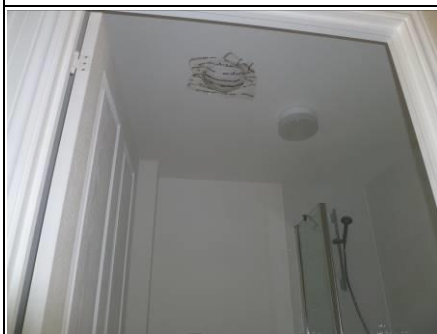
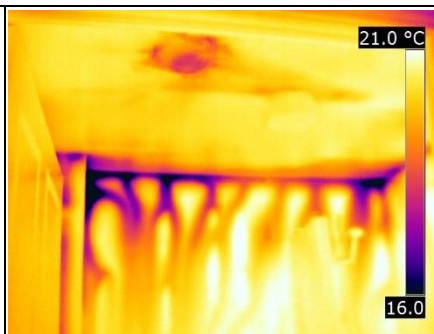
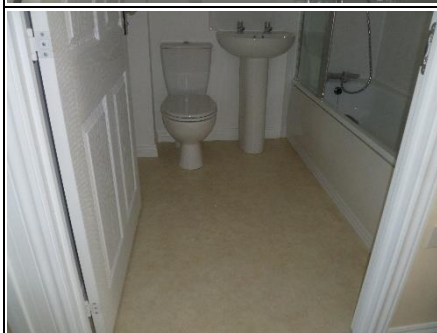
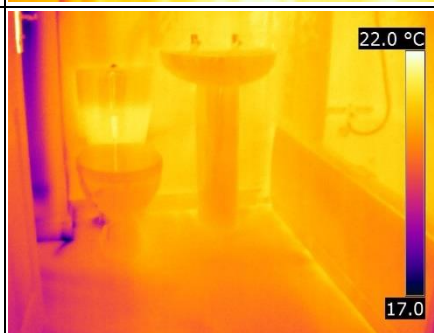
Bathroom – Under depressurisation

Under depressurisation the bathroom looked very different thermally, with cold air being drawn down from the loft space down the void behind the dry lining on the party wall and down the service riser.

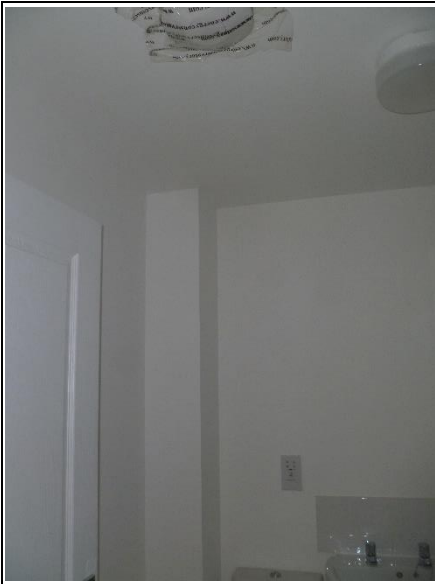
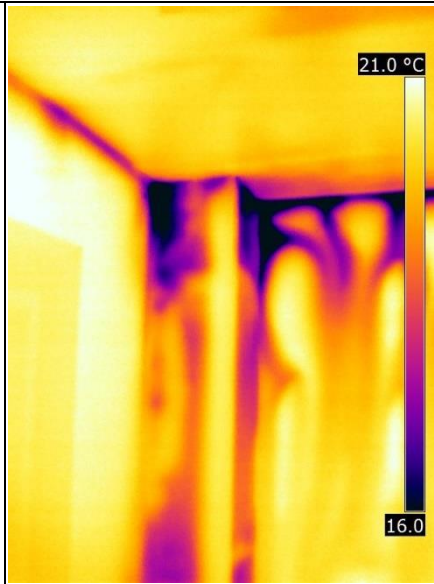
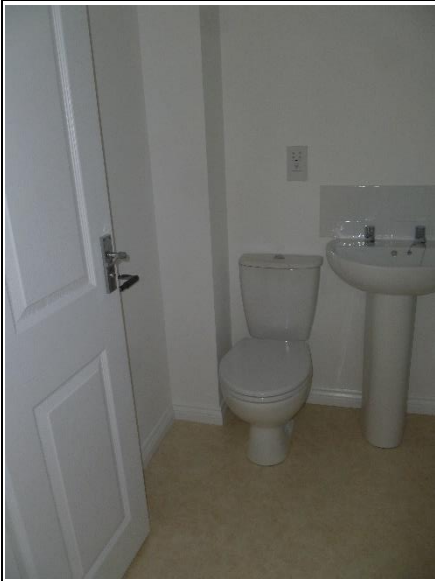
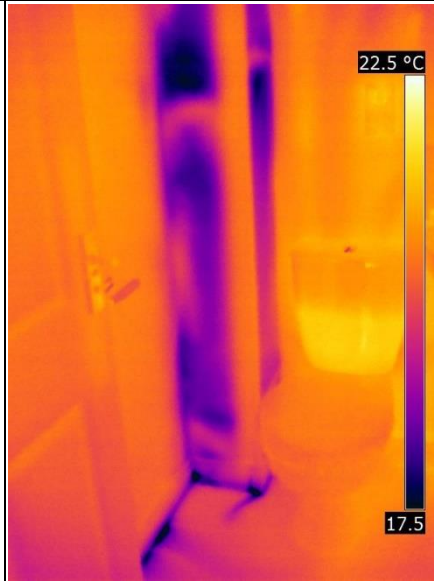
There was some air emerging at the floor wall junction backing on to bedroom 1, possibly tracking along from the stack.

Service penetrations for the bathroom furniture appeared to perform very well.

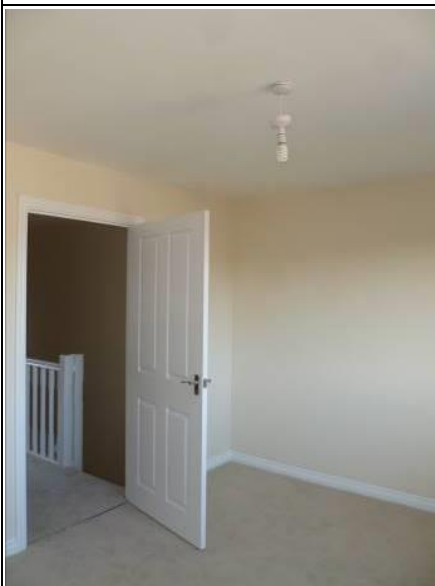
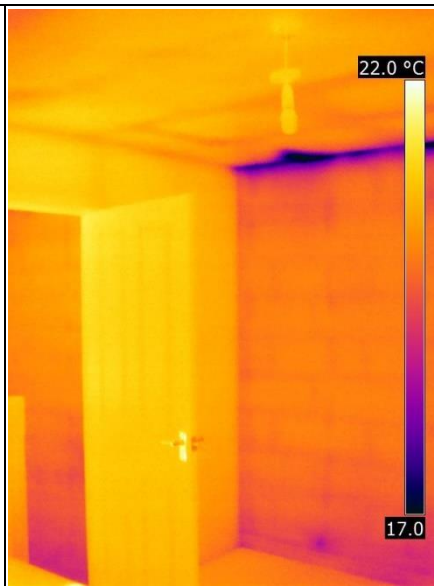
Bedroom 1 – Under natural conditions

As observed in bedroom 2.

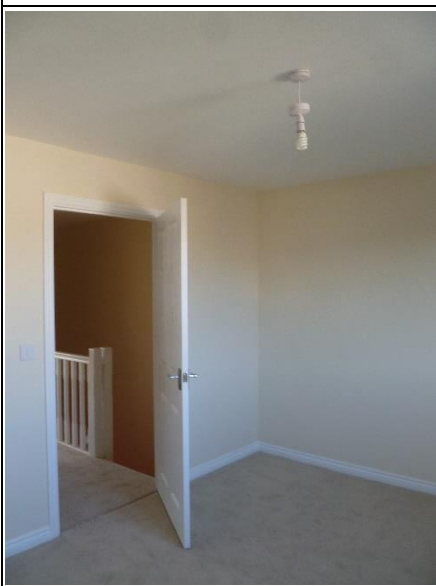
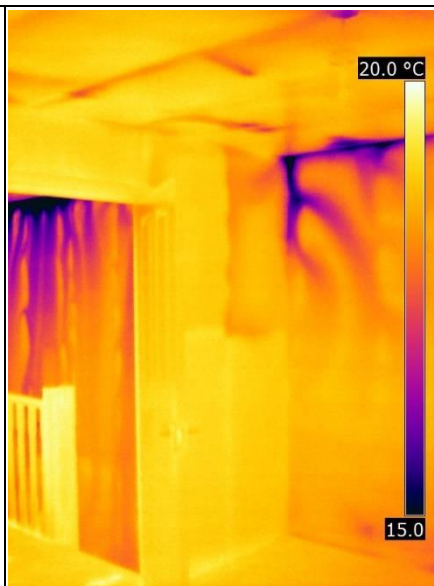
Bedroom 1 – Under depressurisation

Under depressurisation air could be seen being drawn in from the loft space on both external walls and on the party wall.

On the gable wall, cooler air could also be seen entering the internal partition wall adjacent to the stairs/landing.

On the party wall, cooler air could also be seen entering the internal partition wall adjacent to the bathroom there the soil stack was positioned.

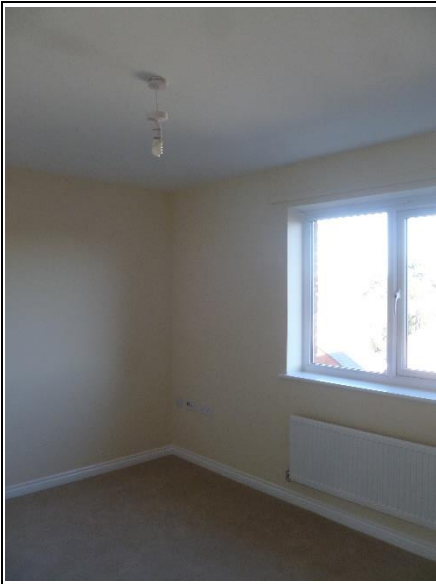
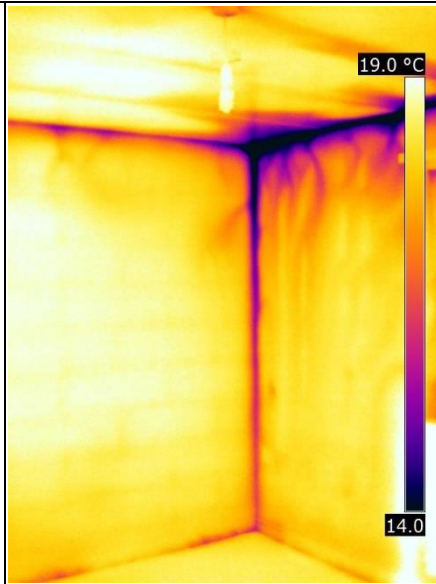
The external corner junction with the ceiling was again very cold, as seen in the airing cupboard in bedroom 2.

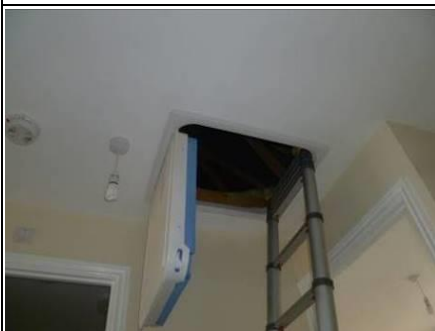
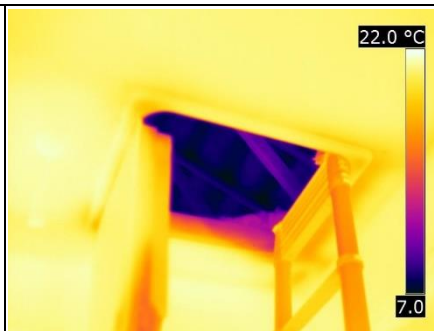
Loft – Under natural conditions

Around the loft hatch the insulation was not completely continuous, which may account for some of the observations made from the landing.

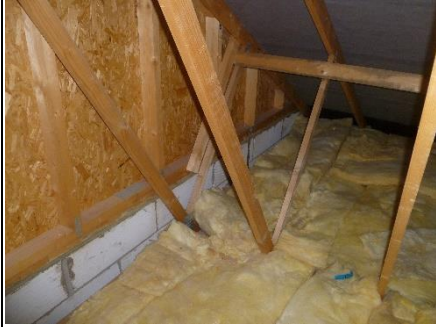
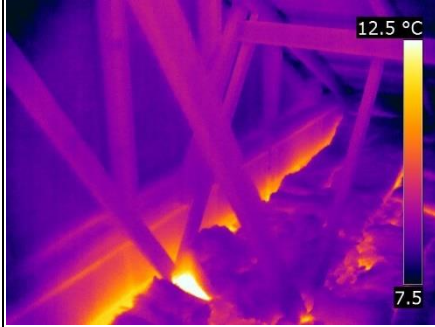
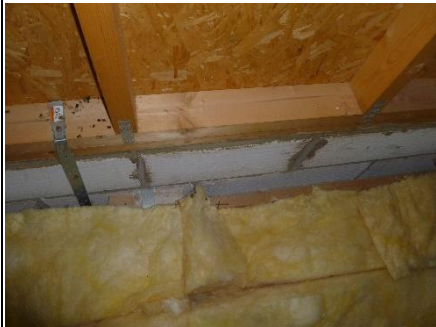
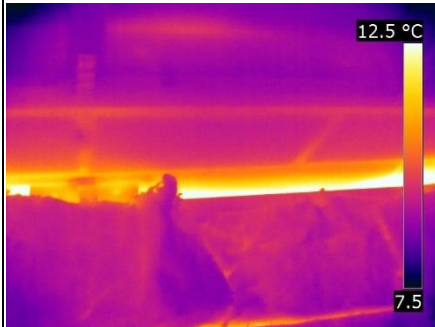
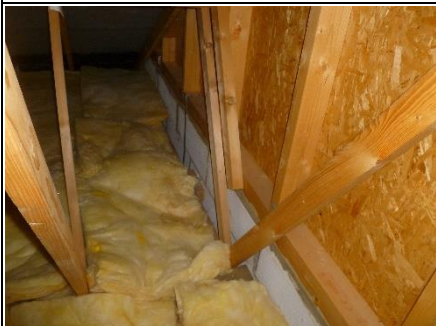
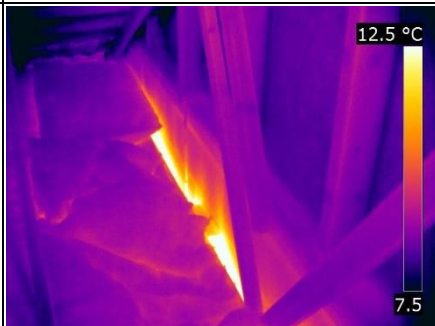
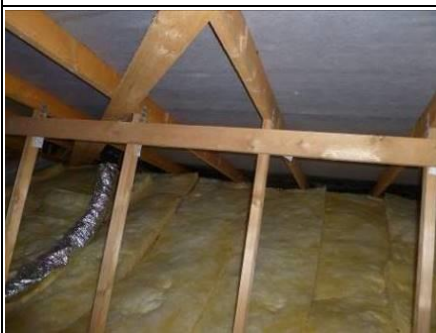
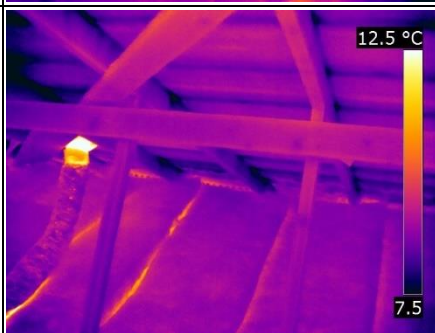
The North West facing gable wall showed a similar pattern of heat loss to the party wall. Here it was possible to see that there was no insulation between the end trussed rafter and the wall, with the non-continuous ribbon of plasterboard adhesive dabs clearly visible from above.

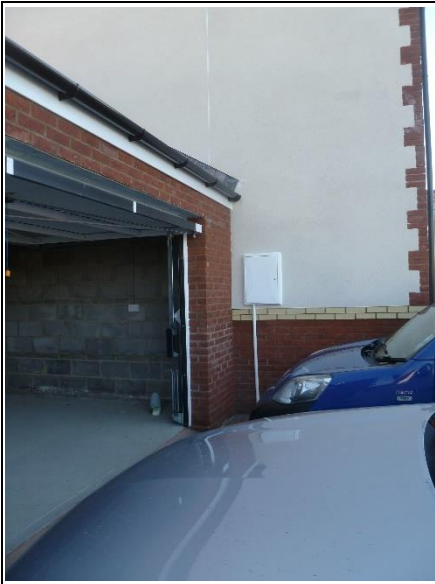
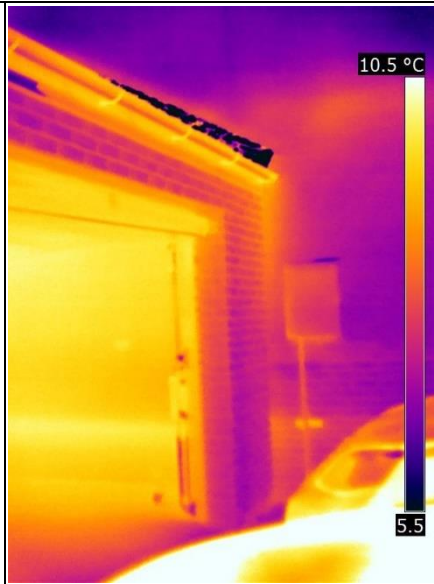
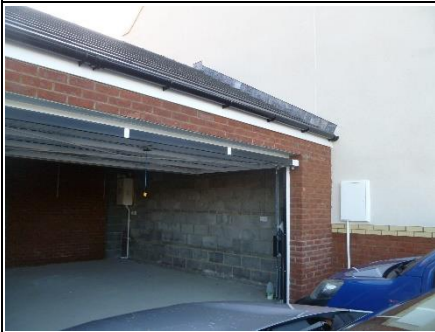
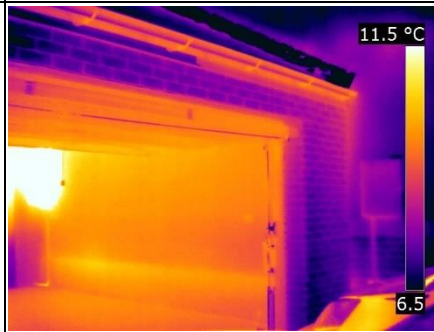
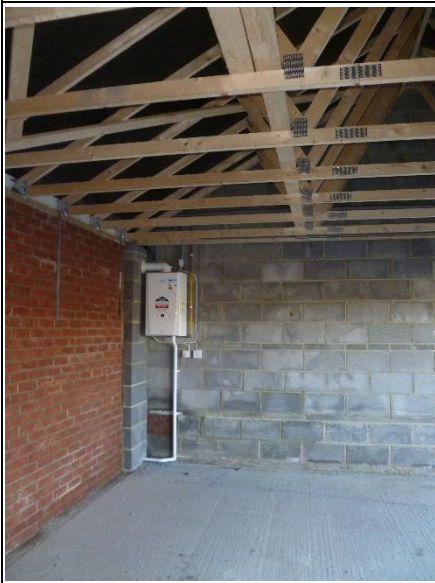
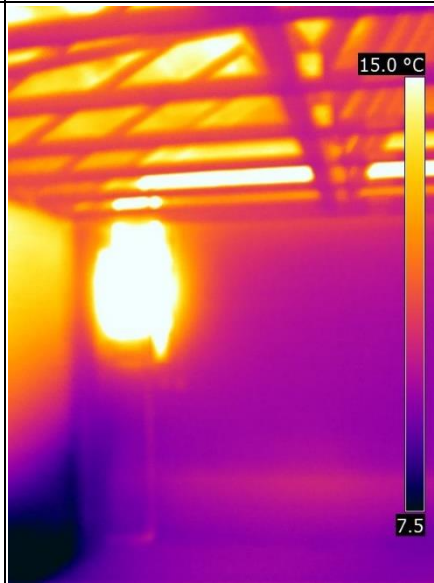
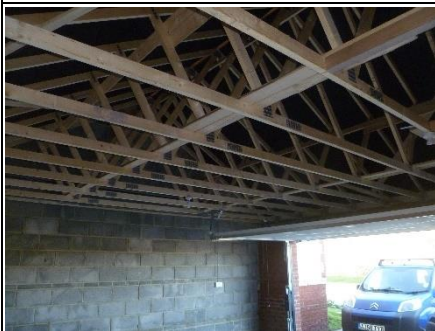
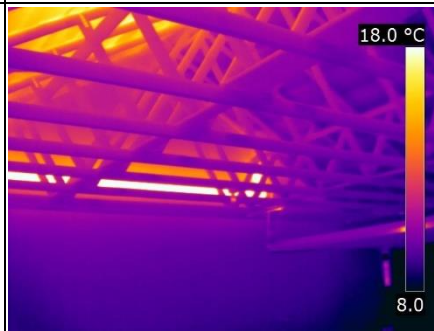
External - Under natural conditions		
 	 	<p>The South West facing gable wall had been exposed to direct solar radiation for over an hour prior to the survey, but the North West facing front façade had not.</p> <p>The gable wall still showed warmer strips at intermediate floor levels, although this was compromised by the direct solar.</p>
 	 	<p>The eaves junction looks warmer but with the same caveats as with plot 294, and the ground floor perimeter looks slightly warmer than the rest of the external façade.</p>

<p>Neither the front façade nor North East gable wall had been exposed to direct solar. Here the warmer strips at intermediate floor levels are more apparent, as is a warmer section at the ridge.</p>

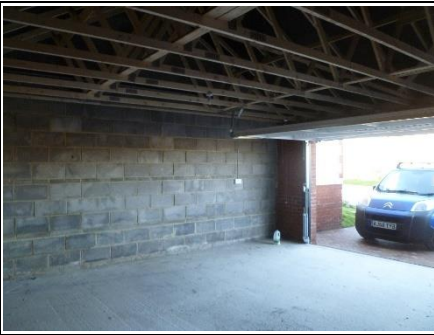
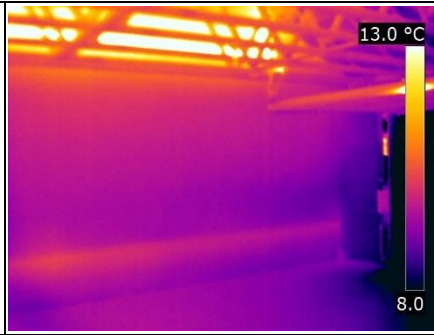
The attached garage on the North East gable wall sheltered most of the ground floor and some of the 1<sup>st</sup> floor. The boiler itself was providing heat to the garage, as was the insulated pipework. Even so, the warmer strip at the ground floor perimeter was still visible from within the garage.

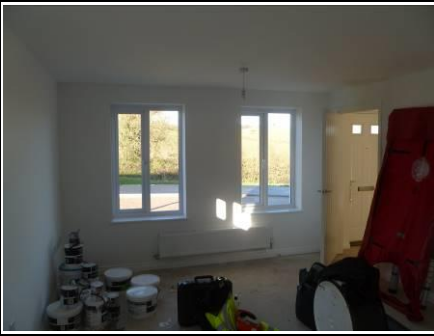
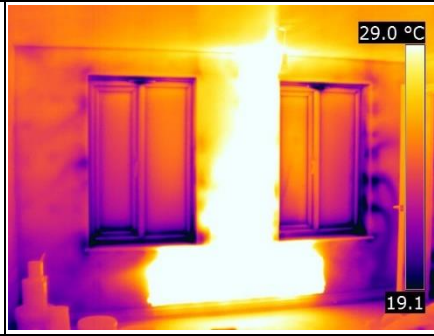
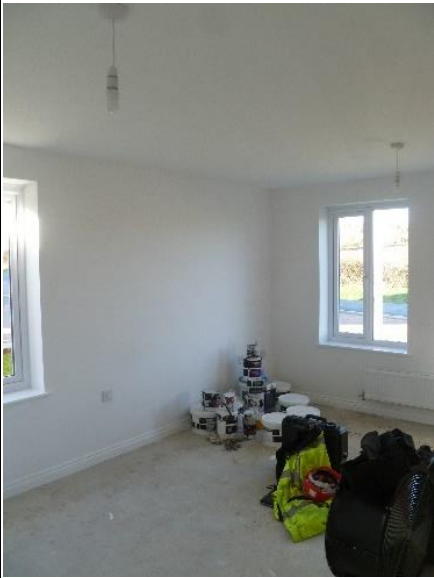
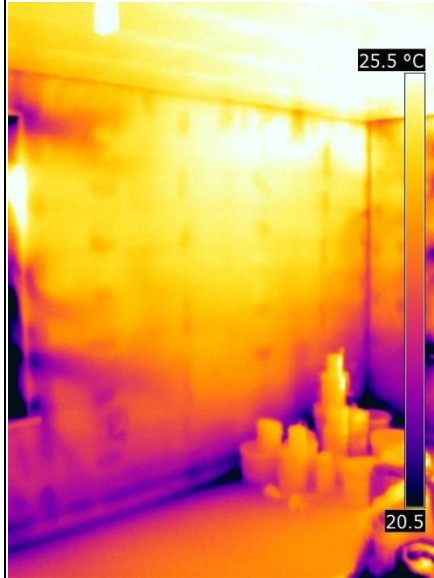
Lounge – Under natural conditions

With the wind blowing directly on to the front façade of the property the combined wind-driven effects and natural stack made the rooms on the ground floor at the front of the house significant infiltration zones even under natural conditions. Infiltrations cooler air could be seen entering the void behind the dry lining without any induces negative pressure.

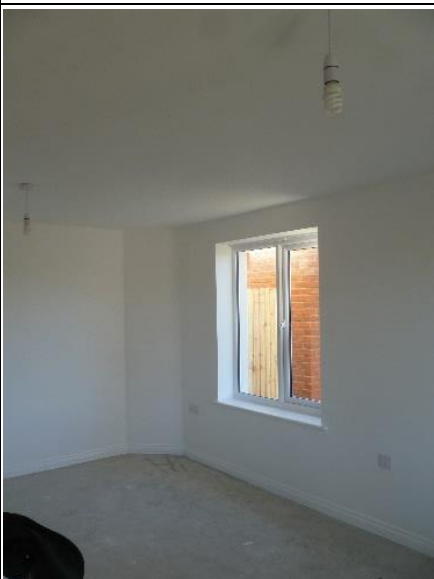
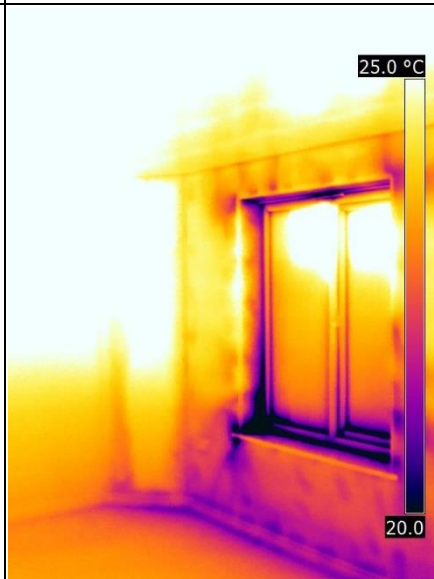
The ground floor perimeter did appear markedly cooler than the walls above, more so than would be expected due to just natural internal temperature stratification.

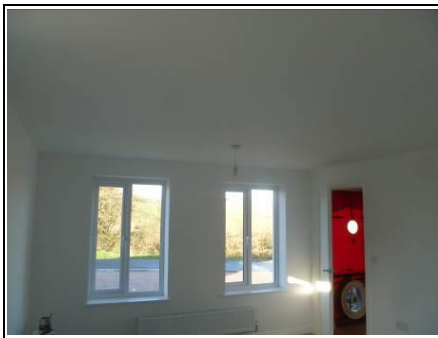
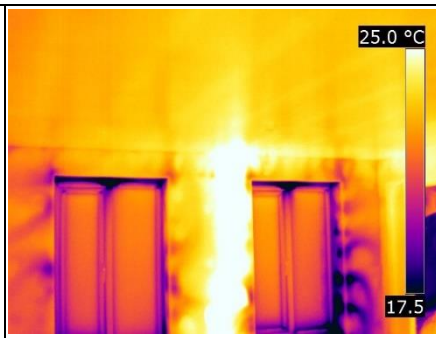
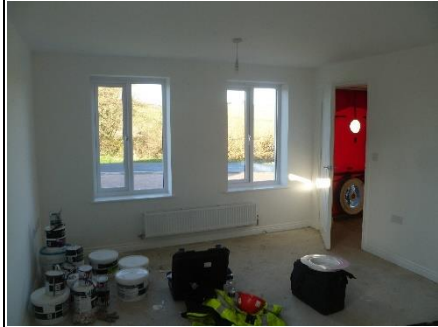
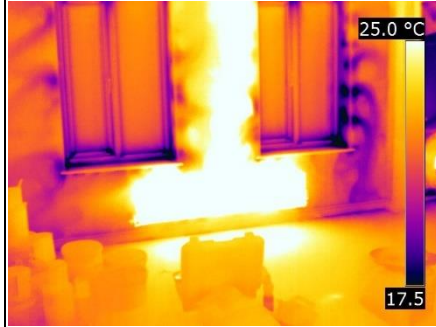
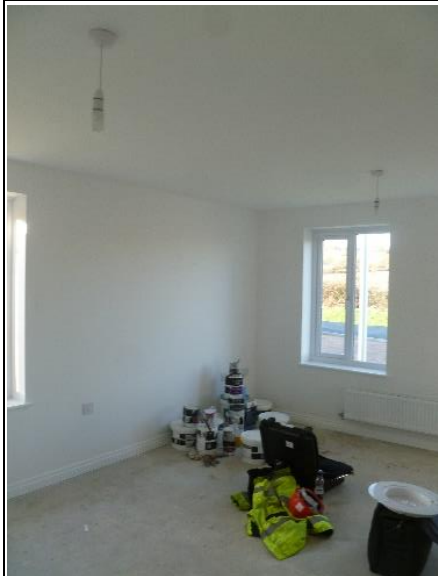
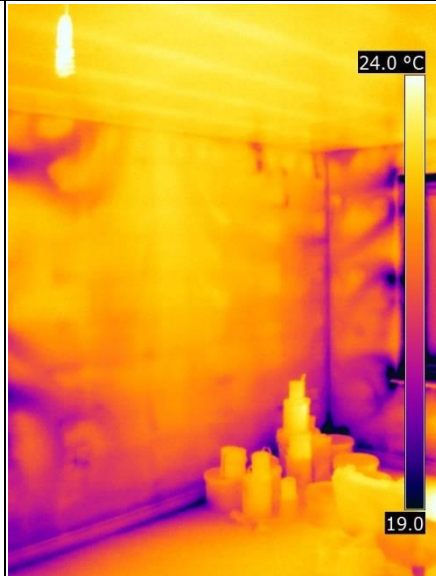
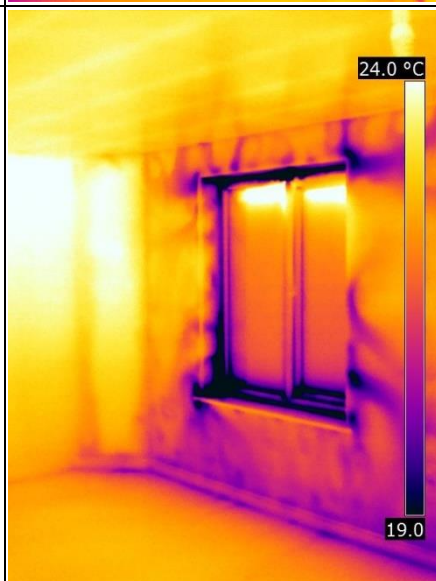
Lounge – Under depressurisation

The infiltration observed under natural conditions was exacerbated under depressurisation on both the front elevation and on the South West facing gable wall.

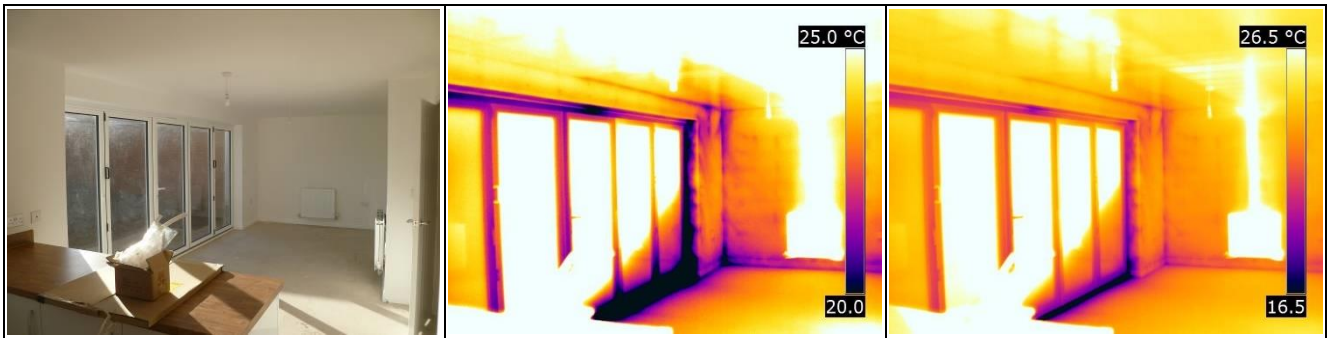
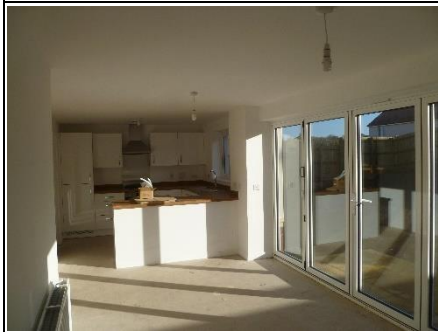
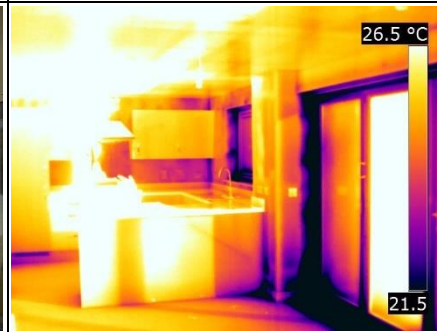
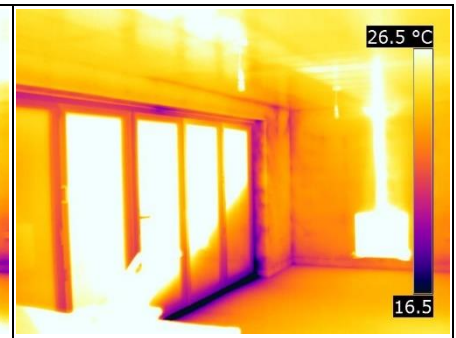
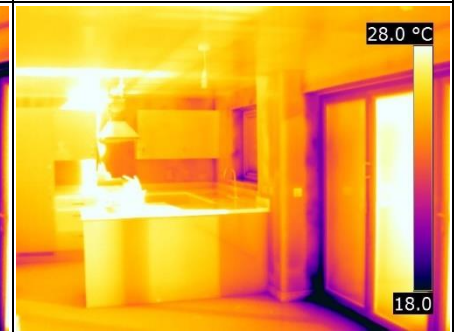
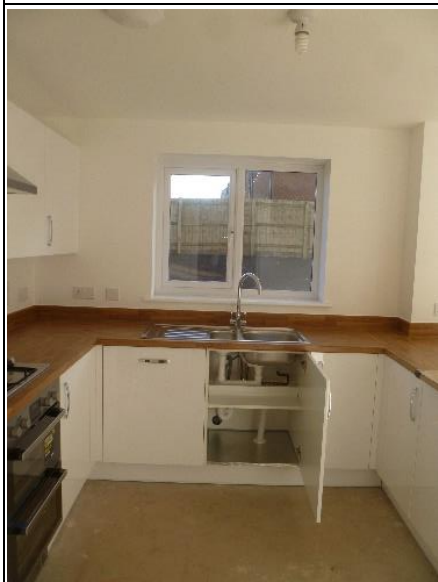
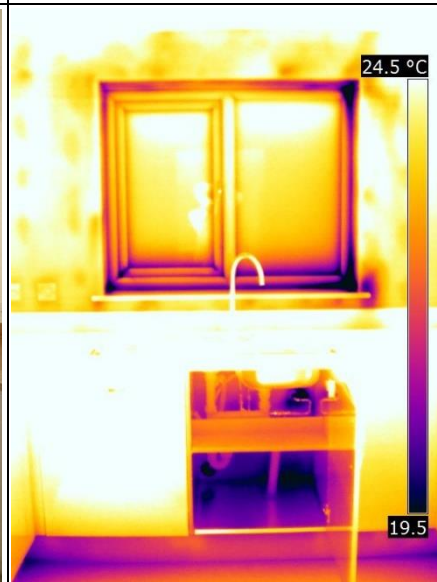
Dining/Kitchen – Under natural conditions

The Dining/Kitchen extended across the entire rear elevation at the ground floor; unlike the Lounge and Study this was on the leeward side of the dwelling and infiltration around the windows under natural conditions was much reduced. However the patio door jambs and threshold appeared particularly cool. The jamb adjacent to the kitchen was even colder than the window head, but this was partially due to shading by the frame. The threshold also appeared very cool.

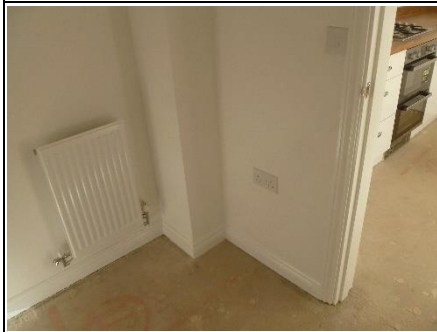
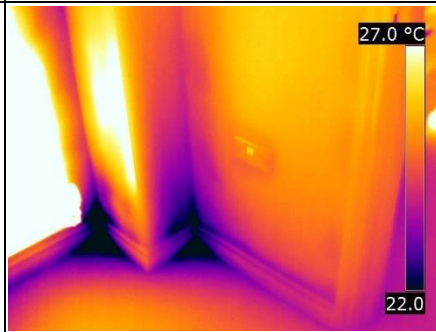
The floor wall junction backing on to the garage looked cooler, but as this room was warmer than the rest of the house it was hard to tell if this was significant.

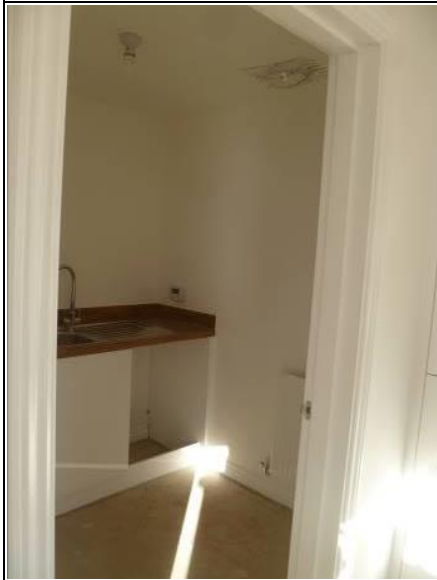
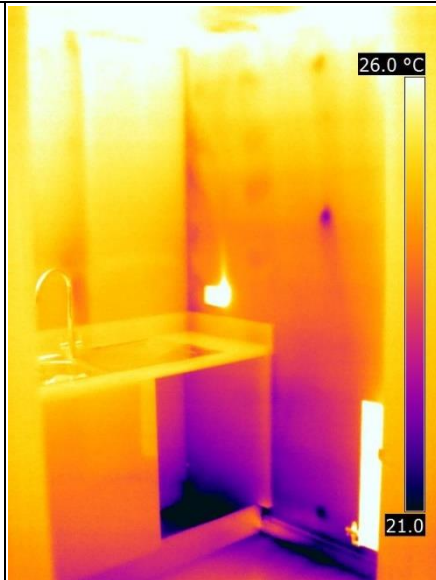
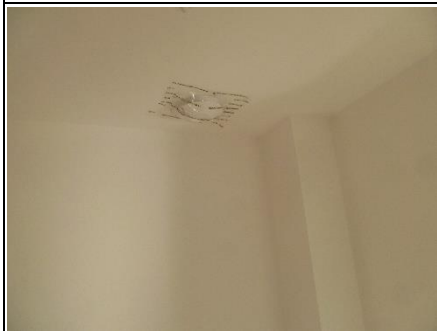
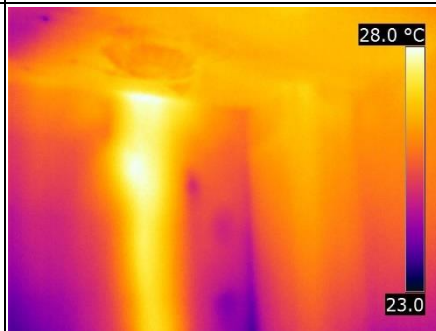
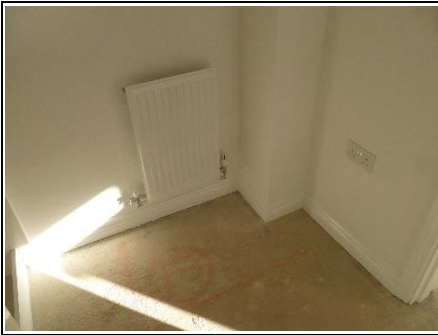
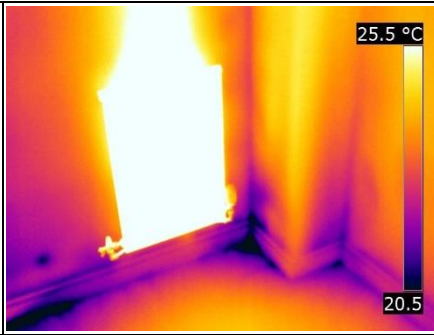
Utility – Under depressurisation

Cold spots on the external wall again suggest (as in the previous plot) that there may be gaps in the inner leaf blockwork that allow air to infiltrated directly from the external wall cavity into the void behind the dry lining.

The service riser looks a little cooler nearer the base, but it is still fairly warm.

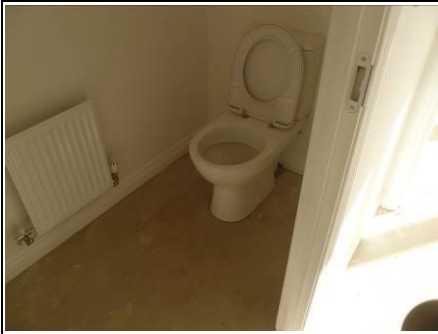
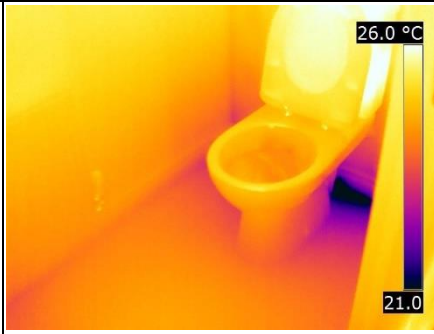
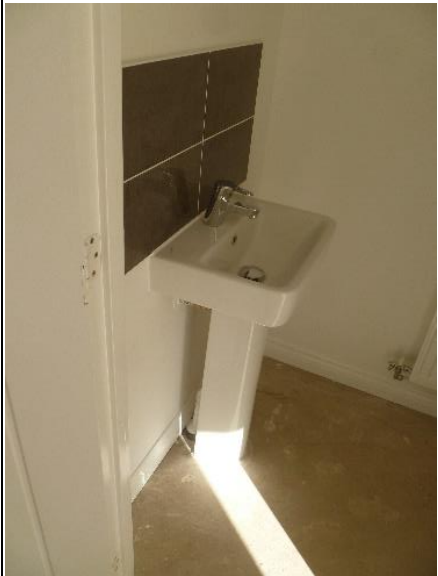
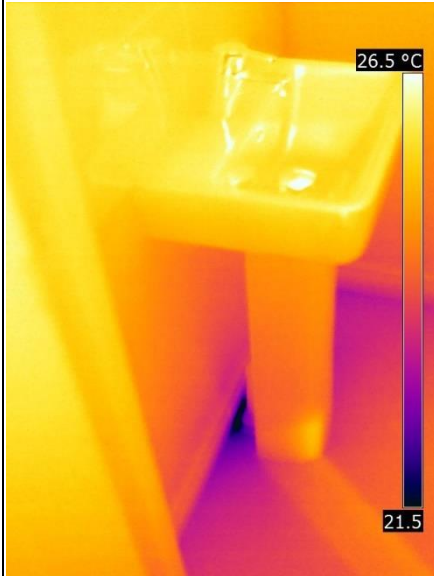
Ground Floor WC – Under natural conditions

The ground floor WC has no external walls so it would be unlikely to exhibit any strange behaviour, cooler patches around the service penetrations through the floor can be explained by the different filling materials around the penetrations.

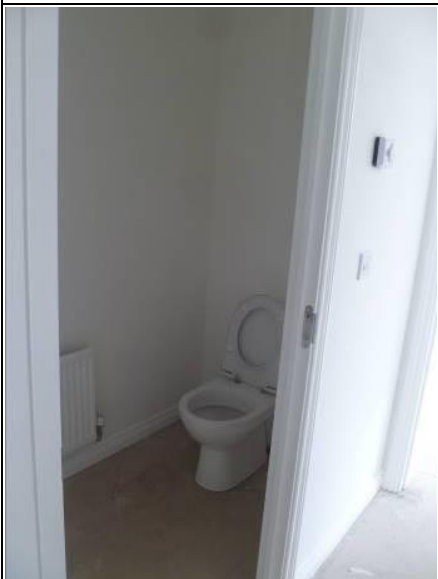
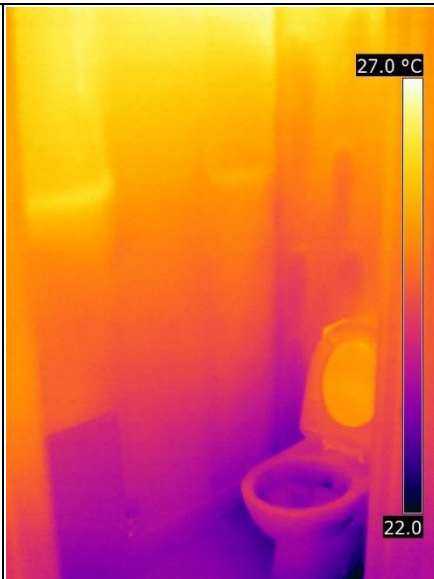
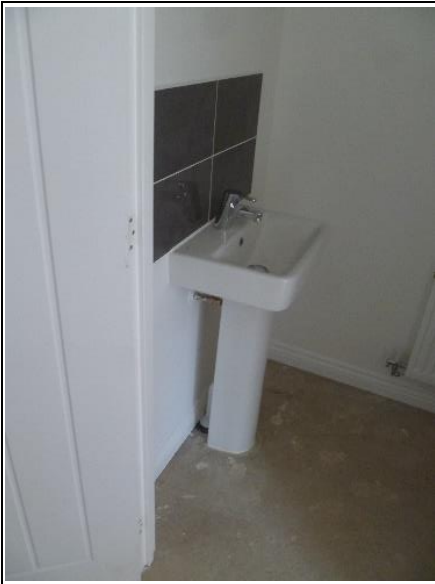
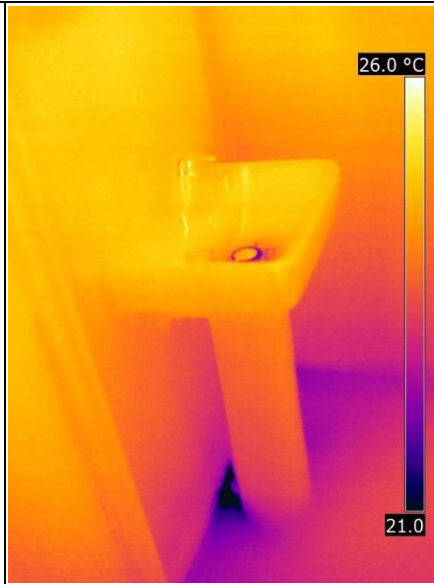
Ground Floor WC – Under depressurisation

Under depressurisation air can be seen moving upwards through the partition wall adjacent to the utility.

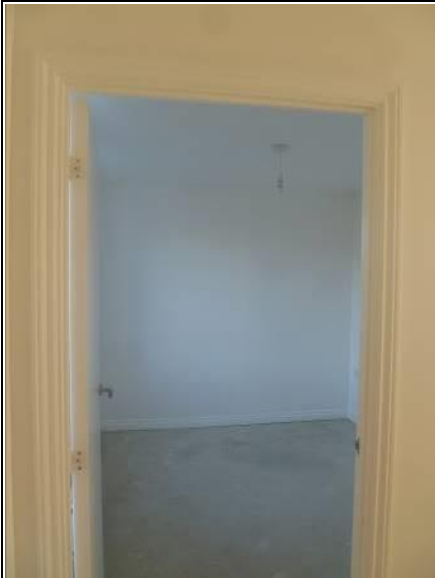
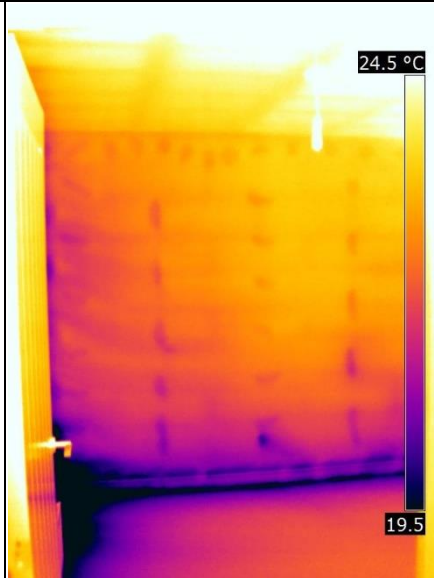
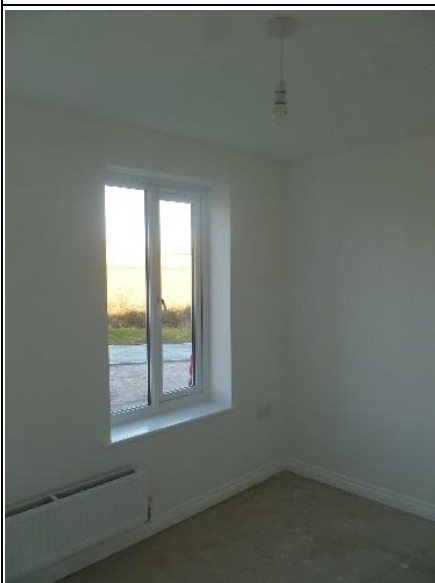
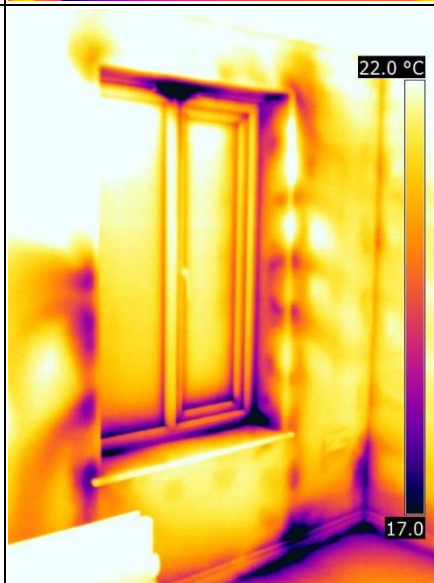
Study – Under natural conditions

The gable wall was partly covered by the garage and contained the electricity meter box, but neither of these were obvious under natural conditions. The ground floor perimeter was again cooler and the pattern of the blockwork visible through the dry lining.

As in the Lounge, the front-facing windows were on the windward side of the house making it an infiltration zone. There appears to be infiltration below the window adjacent to where the gas meter box is positioned.
