Miles-Shenton, D (2018) Small Scale Forensic Thermal Imaging Study. Technical Report. Knauf Insulation.

# Taylor Wimpey – Thermal Imaging Project

Site: Hele Park  
 Newton Abbot  
 TQ12 6JN

Plot(s): 294 & 297

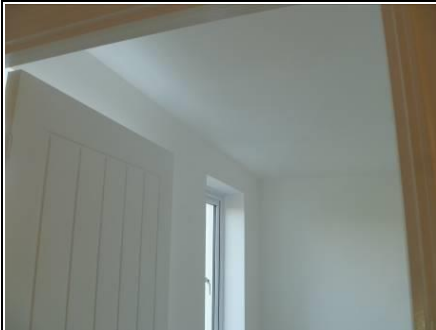
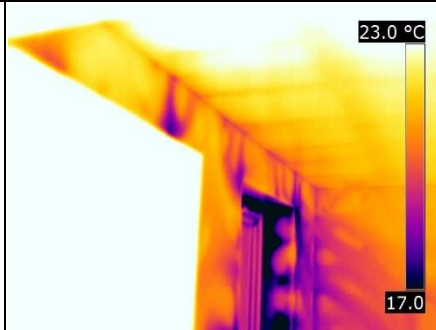
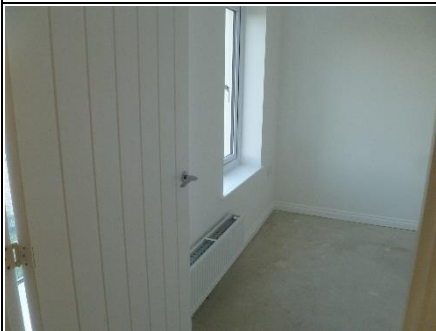
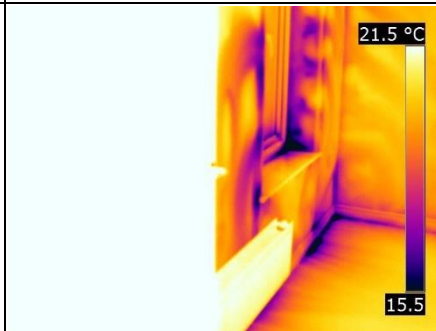
Study – Under depressurisation

Again, under depressurisation the infiltration paths appear significantly worse, with infiltrating air entering the dry lining void all around the windows.

Adjacent to the gas meter box more air is entering, some of which appears to emerge below the skirting.

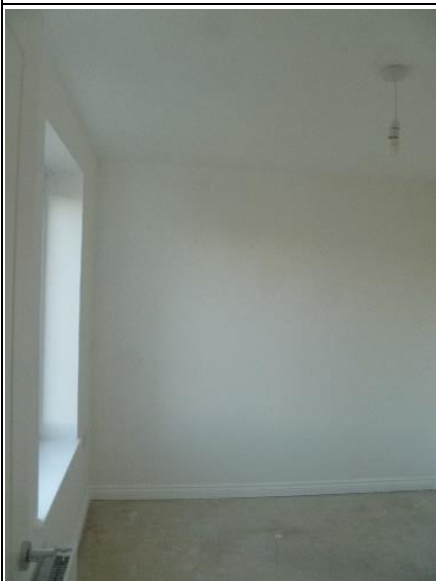
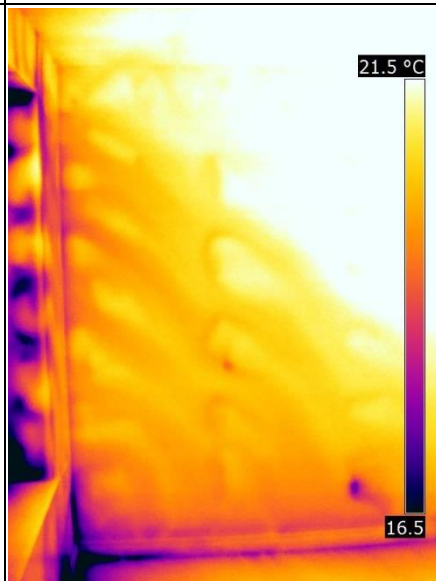
On the gable wall there are a couple of spots that again appear to line up with the inner leaf mortar courses. However, the position of the electricity meter box is not visible internally under pressurisation, unlike what was observed with fully filled walls behind meter boxes.

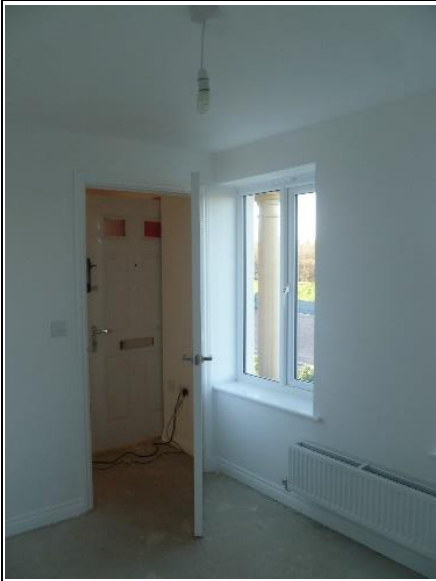
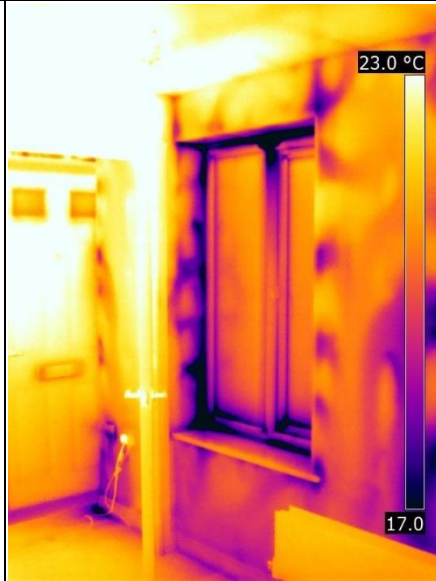
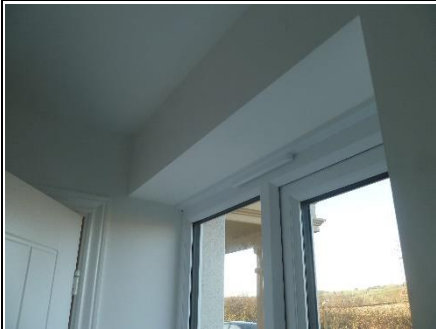
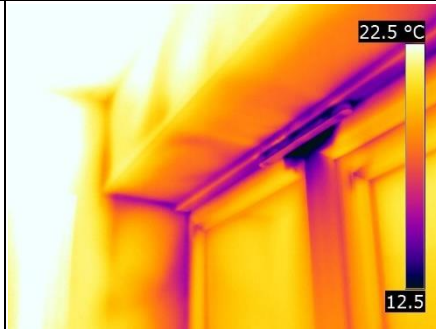
As with most windows and trickle vents observed on this site; the windows function well but allow significant air exchange between the void behind the dry lining and the external wall cavity, and the trickle vents close effectively but are not actually sealed to the window frames.

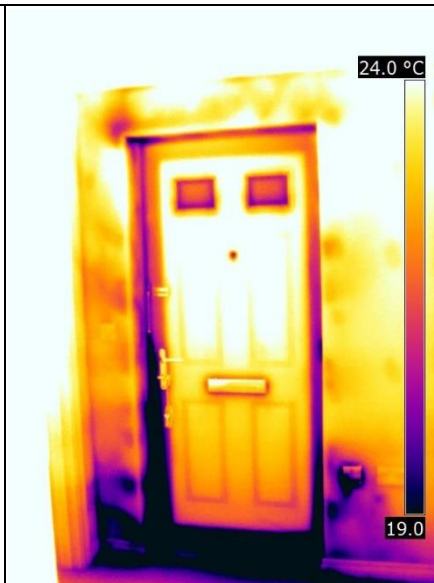
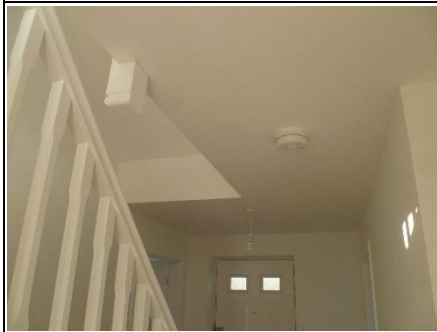
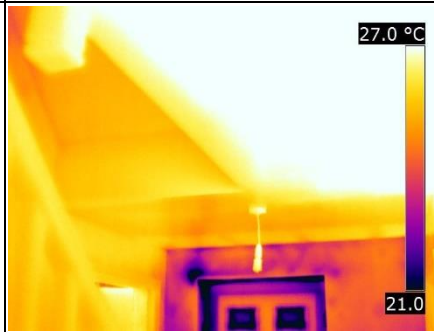
Hall & Stairs – Under natural conditions

The door perimeter is again significantly cooler than the centre of the door, as seen in plot 294.

The threshold is also very cold, although the door having been opened a number of times may have made this look worse.

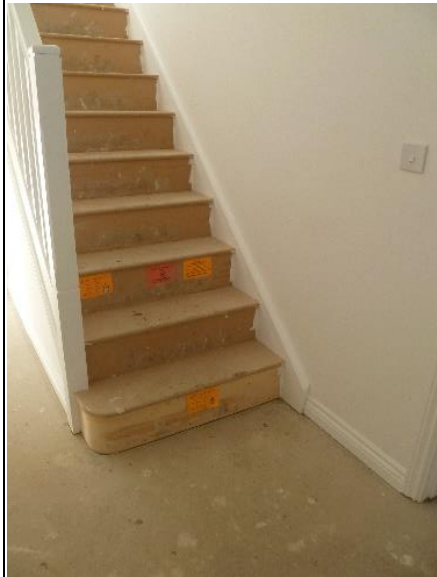
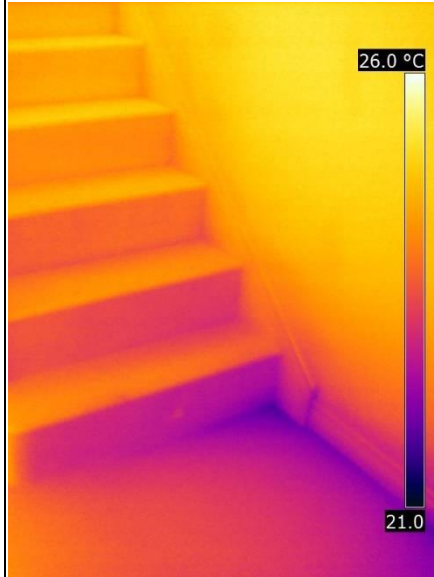
The external wall in the hall showed numerous cooler spots and air leakage paths, but this did not appear to affect the intermediate floor void directly above.

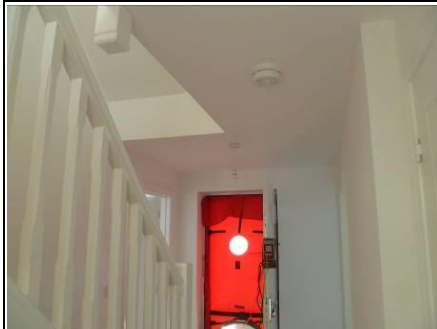
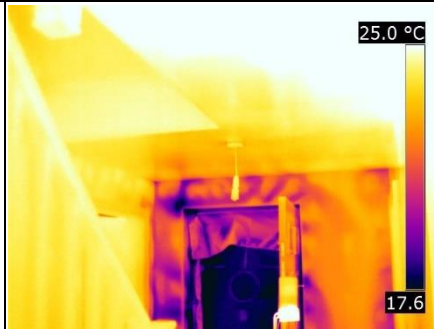
Hall & Stairs – Under depressurisation

Again, under depressurisation the observations made under natural conditions were the same, just more extreme.

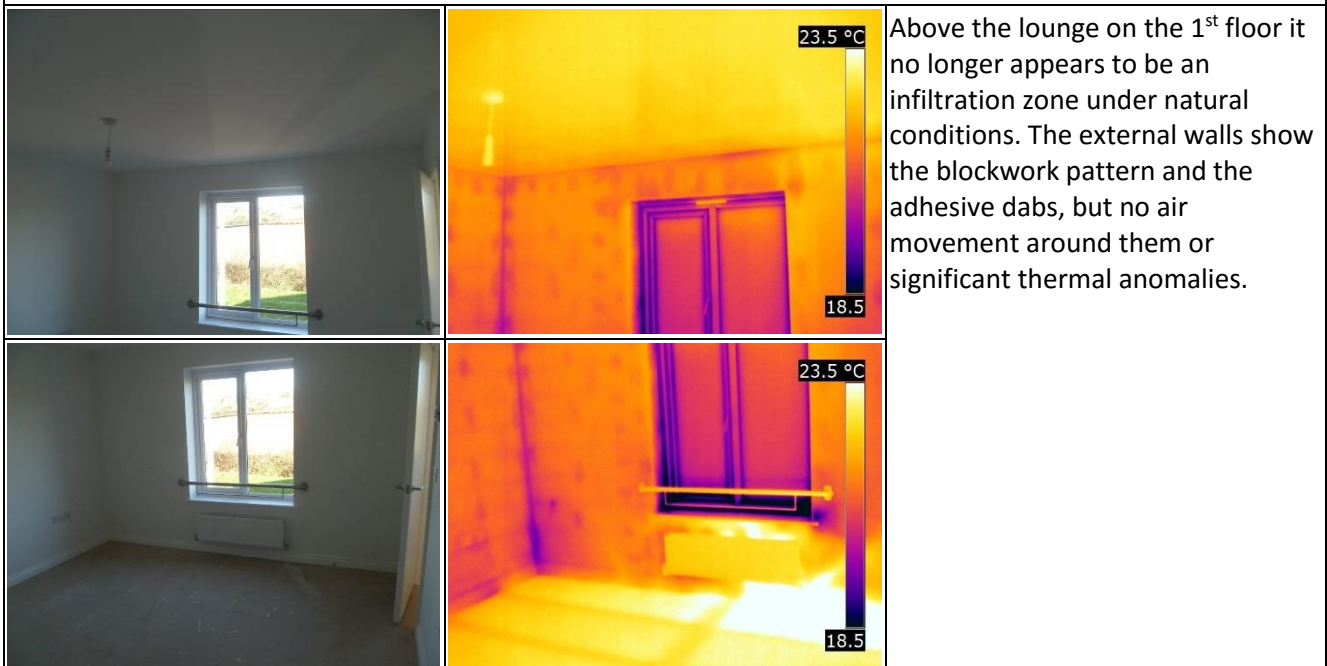
Bedroom 1 – Under natural conditions

Above the lounge on the 1<sup>st</sup> floor it no longer appears to be an infiltration zone under natural conditions. The external walls show the blockwork pattern and the adhesive dabs, but no air movement around them or significant thermal anomalies.

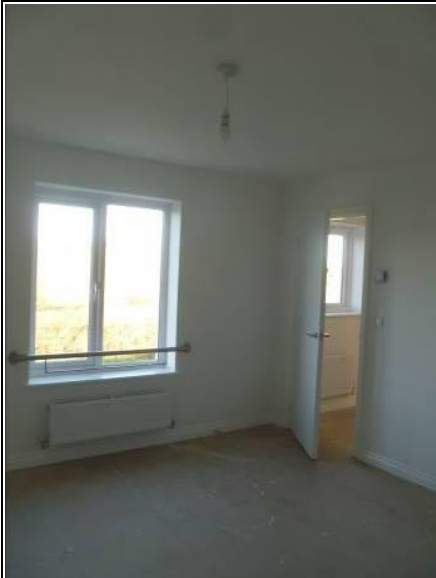
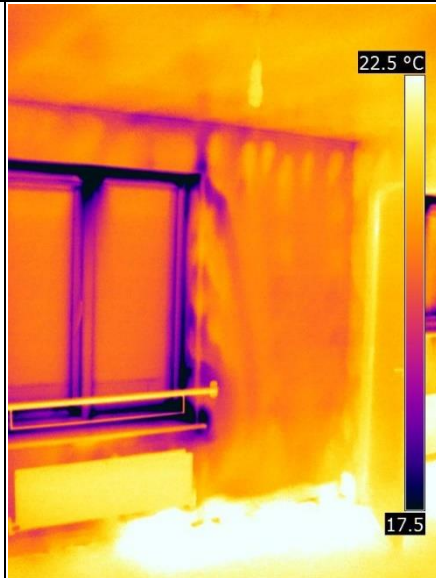
Bedroom 1 – Under depressurisation

Under depressurisation air is again drawn into the dry lining void from around the windows, and also downwards from the eaves more so than from the gable. The gable wall appears to show air moving across through this void rather than downwards.

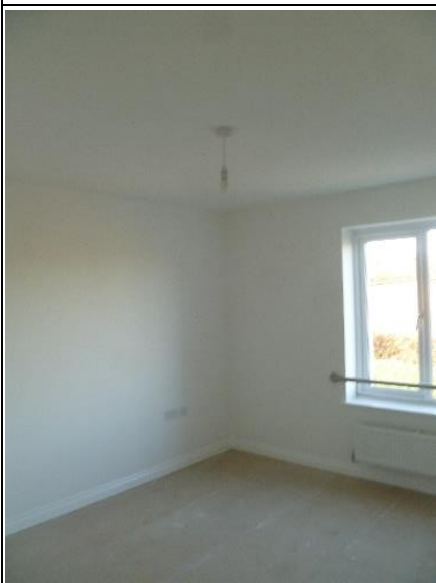
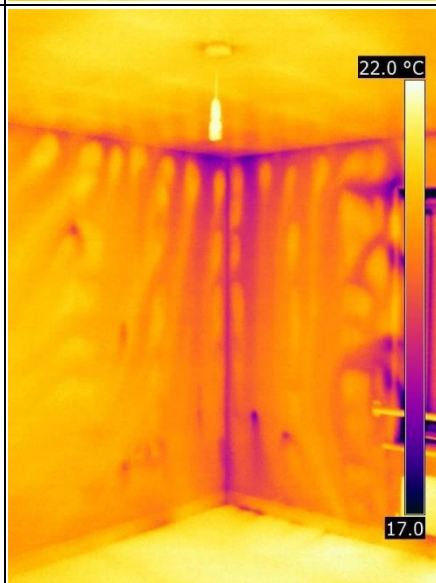
Again cold spots are seen where air appears to be coming through the blockwork.

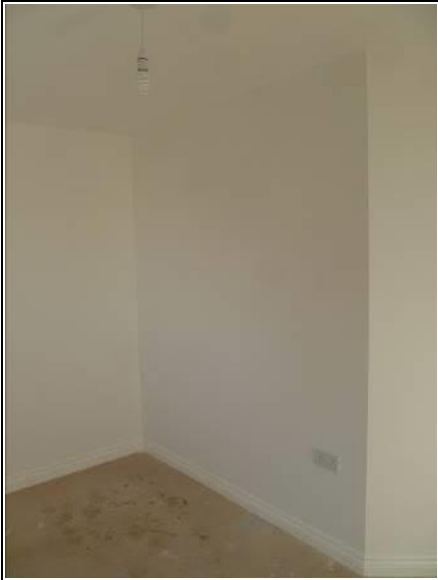
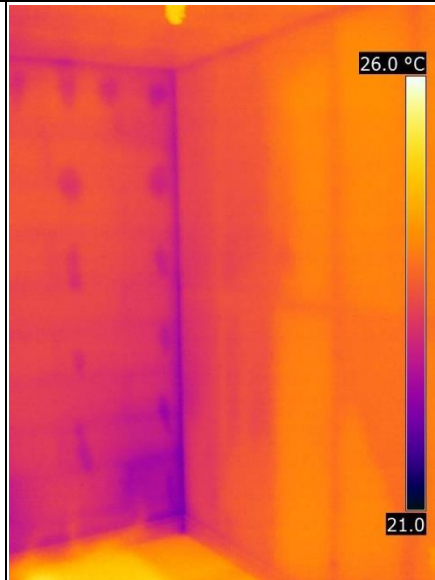
Bedroom 4 – Under natural conditions

The internal partition walls backing onto the en-suite shower and service void in the bathroom look slightly cooler than the rest of the partition walls, but otherwise the room appears very similar to the observations made for bedroom 1.

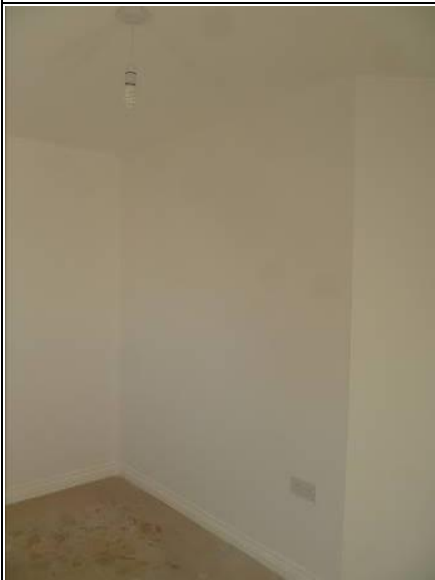
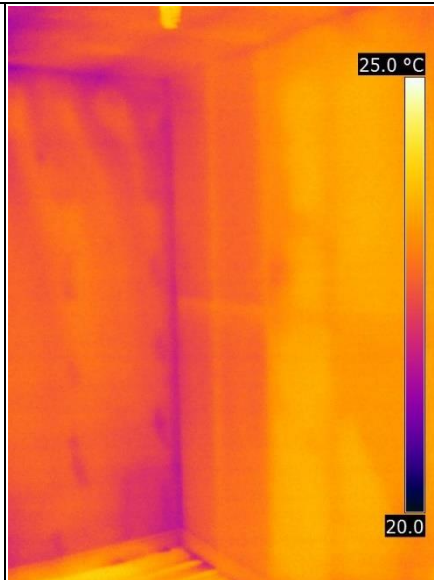
Bedroom 4 – Under depressurisation

The partition wall backing onto the en-suite looks the same under depressurisation as it did under natural conditions so does not appear to be affected by air movement, the same cannot be said of the one backing onto the service void in the bathroom.

As in bedroom 1 the gable wall appears to be less affected by air movement than the other external wall under depressurisation.

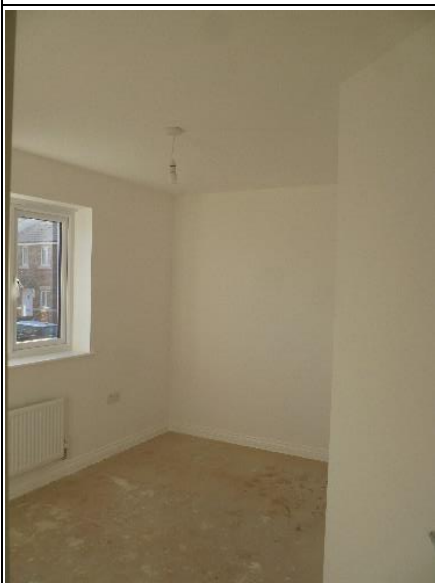
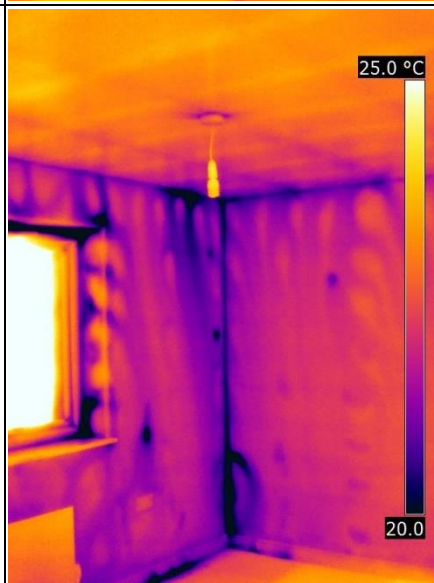
Again cold spots appear under depressurisation which coincide with mortar joints in the inner leaf blockwork.

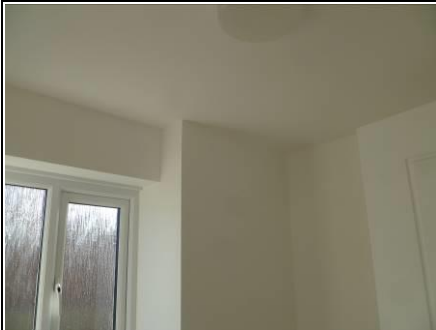
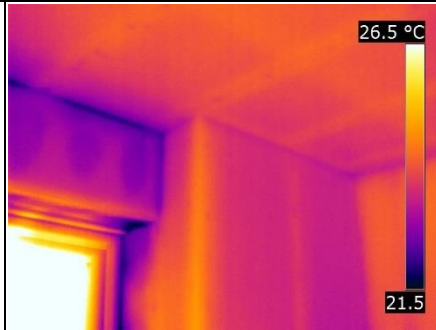
Bathroom – Under natural conditions

The external wall is unsurprisingly cooler than the boxed in voids, but otherwise there's not much happening in the bathroom under natural conditions.

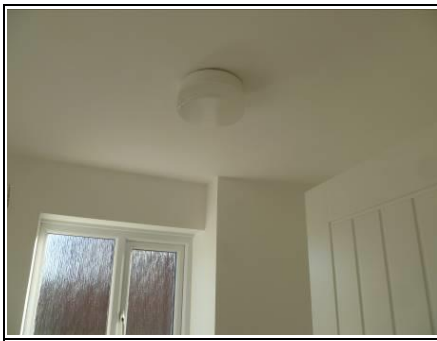
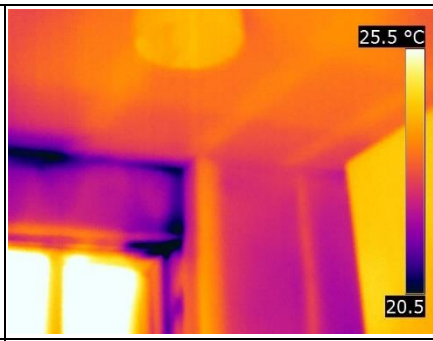
Bathroom – Under depressurisation

Under depressurisation the boxed in void adjacent to bedroom 4 appears cooler at the top, implying that air is being drawn down from above into the void.

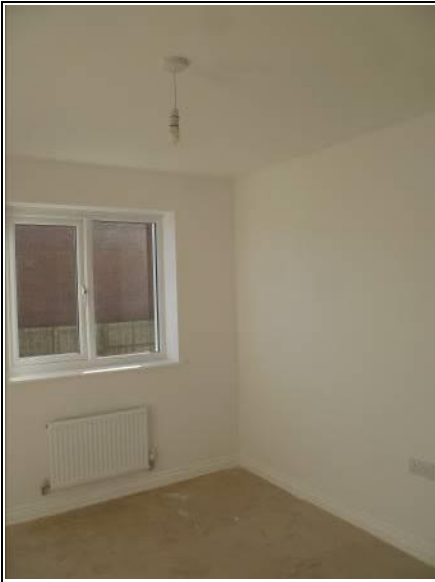
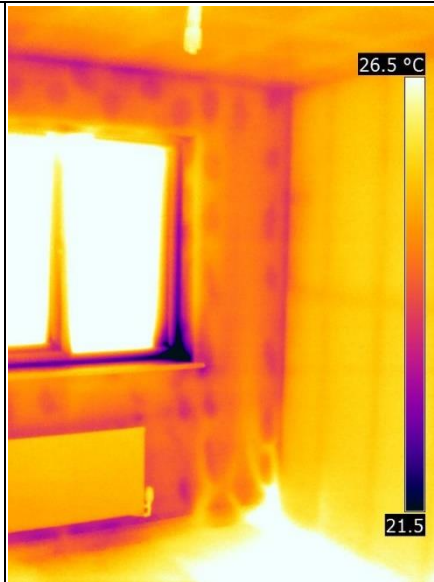
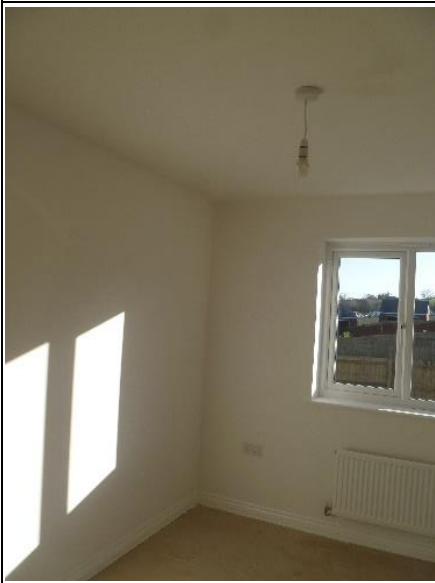
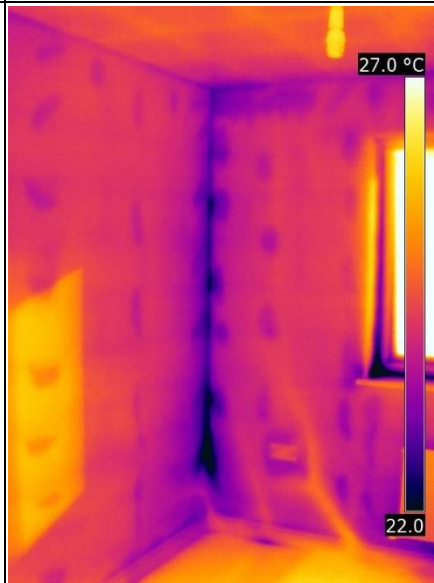
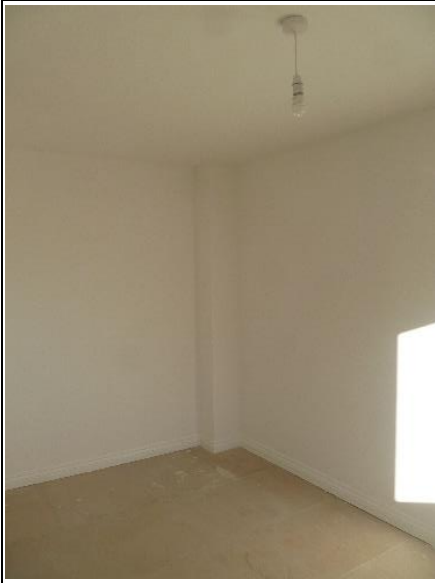
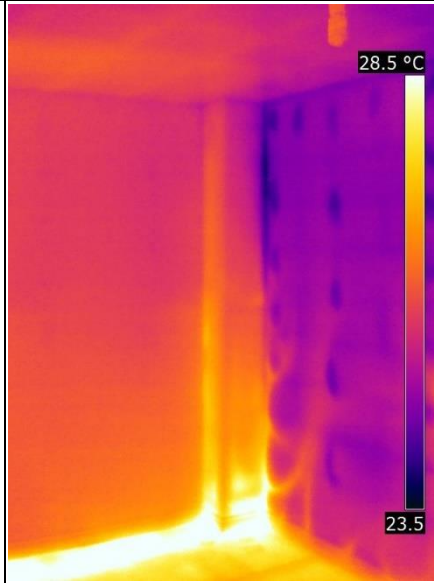
Bedroom 3 – Under natural conditions

Warm air can be seen being drawn up from the intermediate floor void into the dry lining void under natural conditions on both external walls above the kitchen and utility.

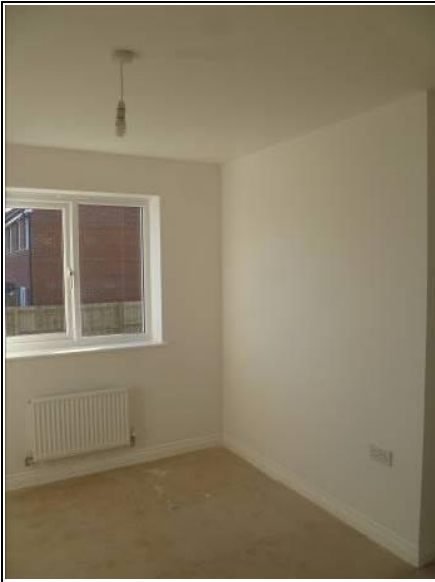
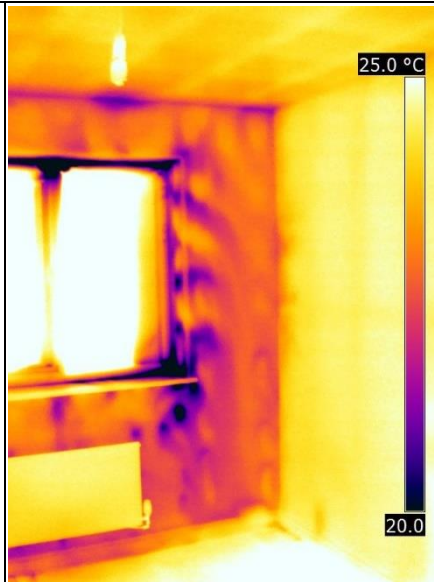
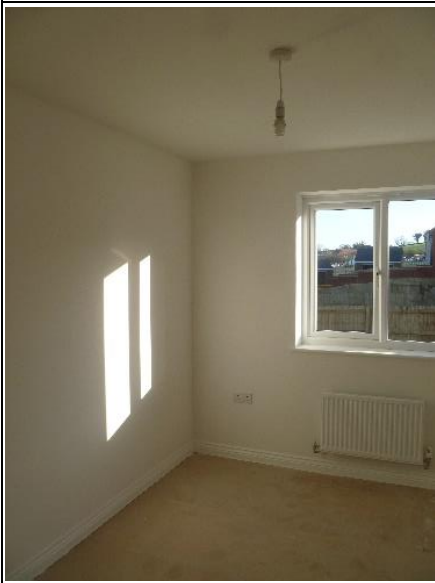
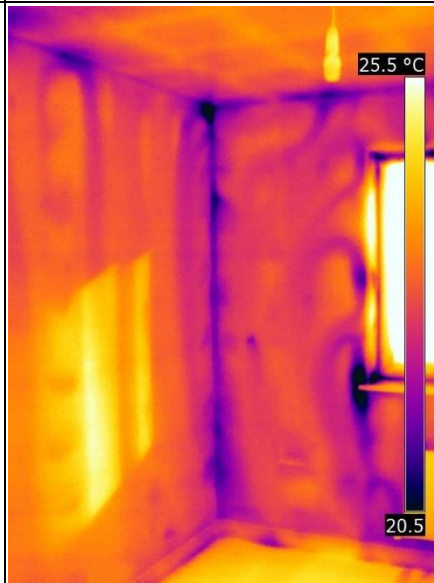
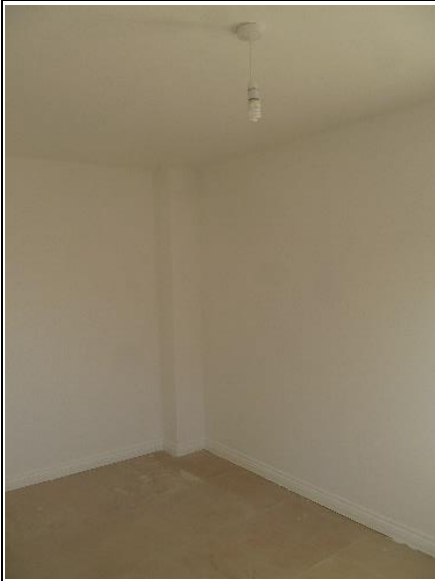
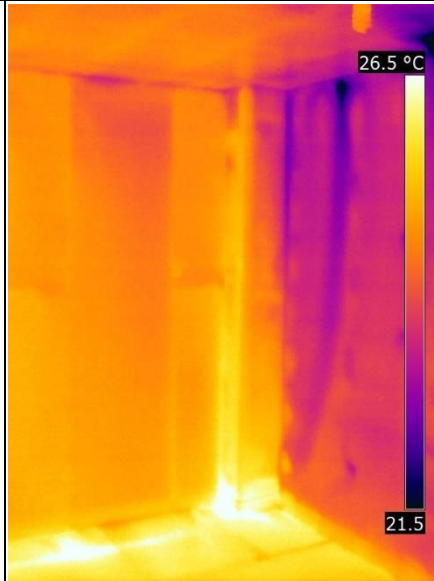
Bedroom 3 – Under depressurisation

Under depressurisation the warm air moving up the wall void has been replaced by colder air entering from around the window on the rear elevation and being drawn down from above on the gable wall.

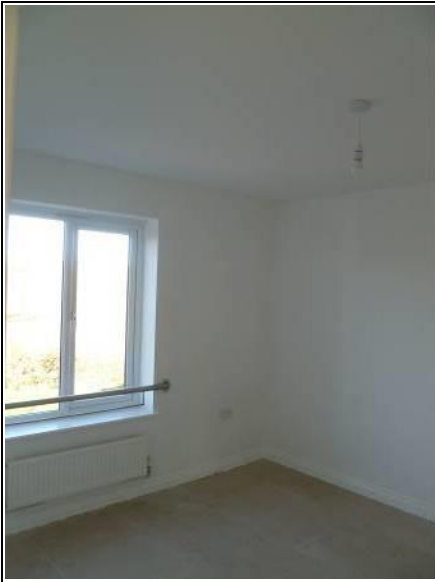
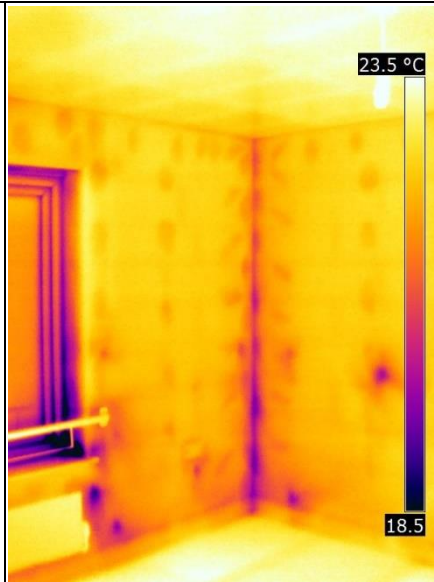
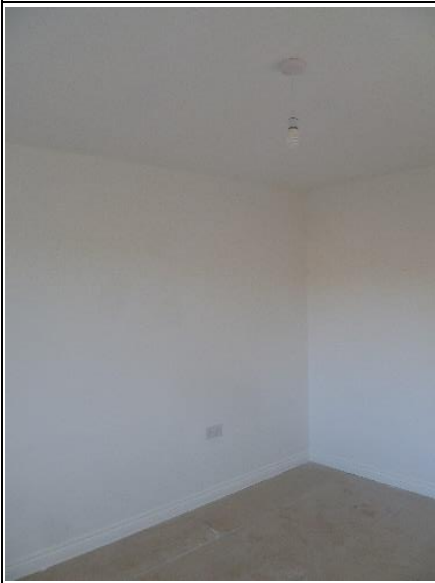
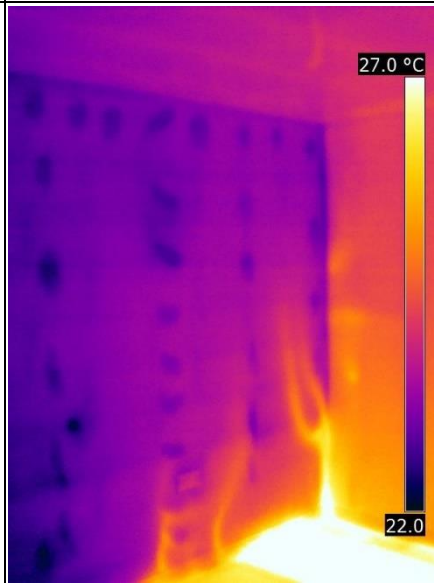
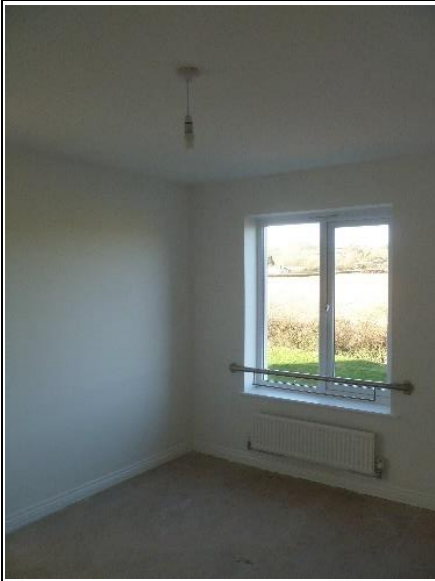
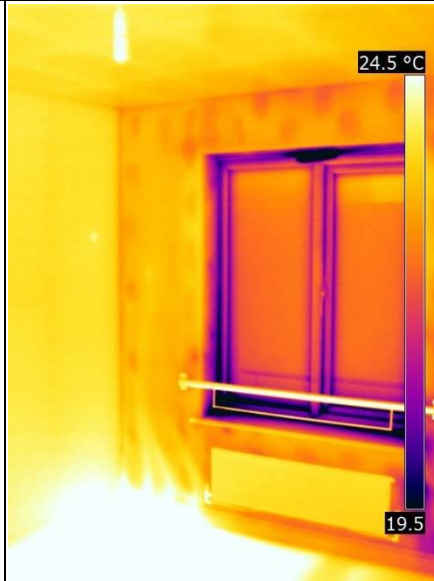
Bedroom 5 – Under natural conditions

The cooler North corner shows some cold spots possibly due to gaps in the inner leaf blockwork.

As in bedroom 3 warm air can be seen being drawn up from the intermediate floor void into the dry lining void under natural conditions on both external walls above

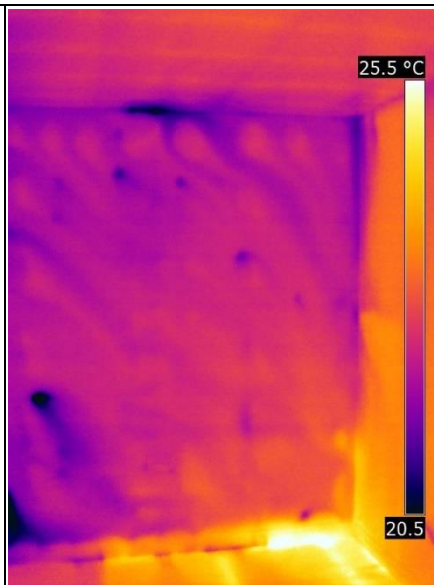
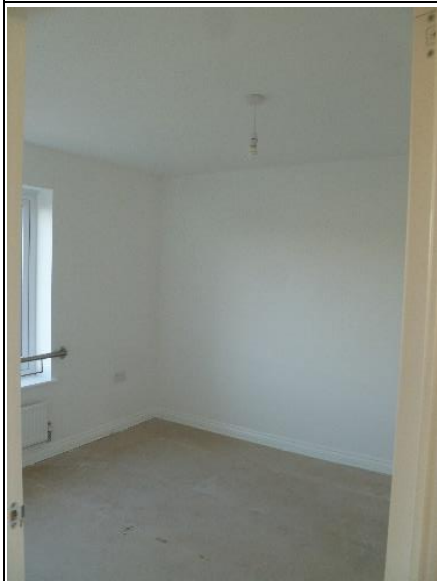
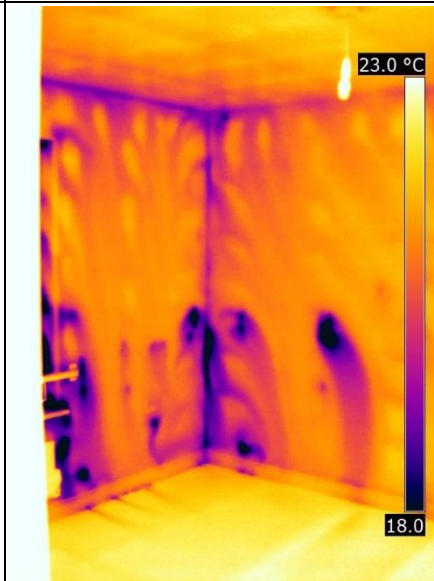
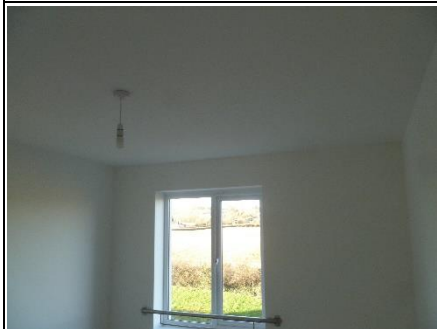
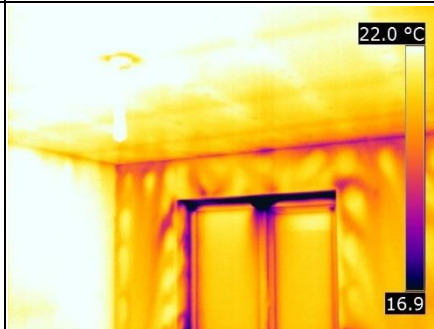
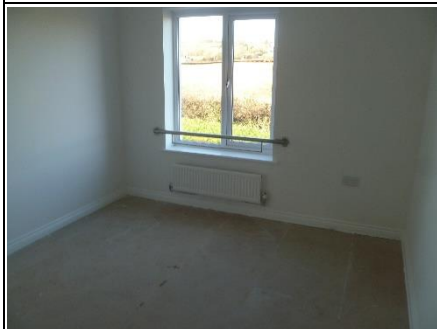
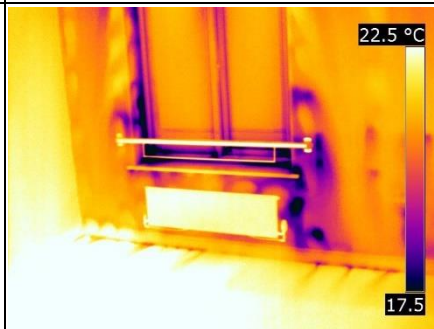
Bedroom 5 – Under depressurisation

As in bedroom 3 the warm air moving up the wall voids under natural conditions has been replaced by colder air entering from around the window on the front elevation and being drawn down from above on the gable wall.

The cold spots on the wall presumably due to leaky blockwork are more extreme under depressurisation, with some infiltrating air emerging at the floor perimeter.

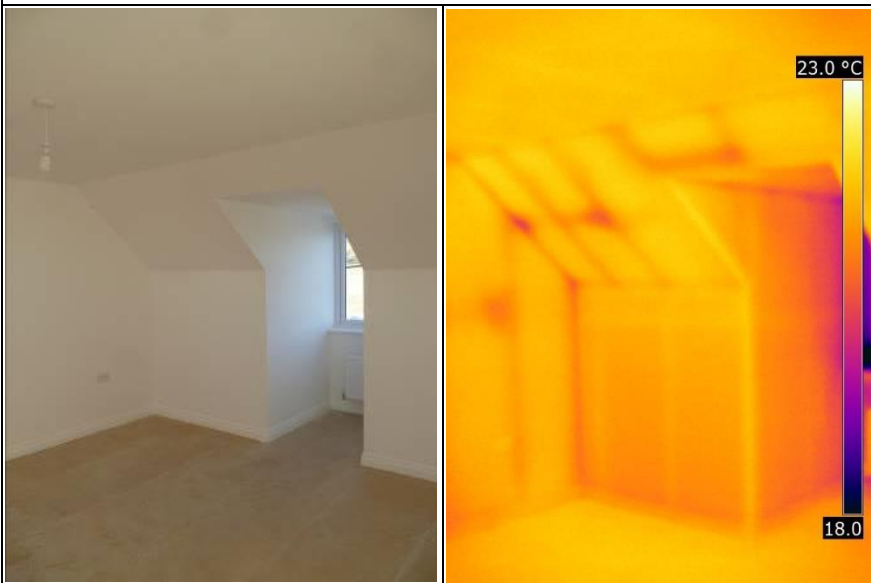
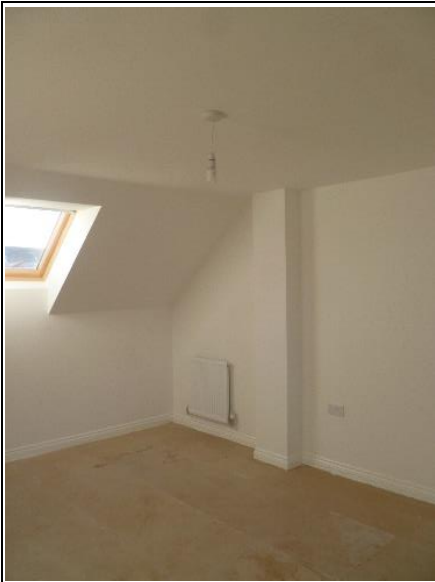
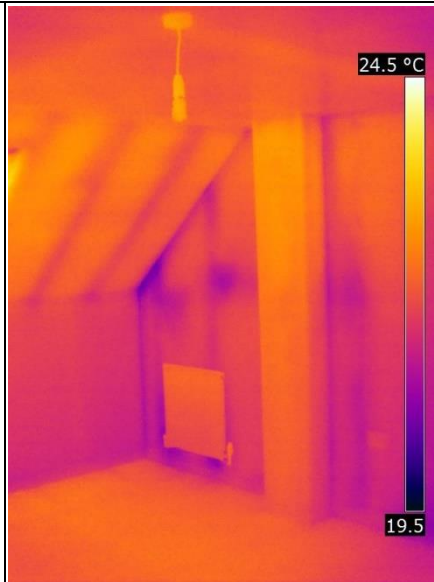
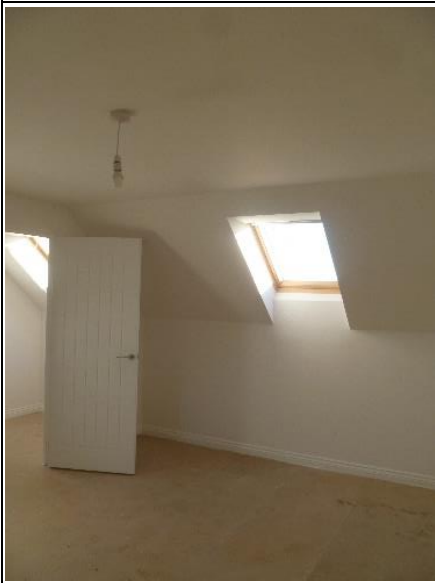
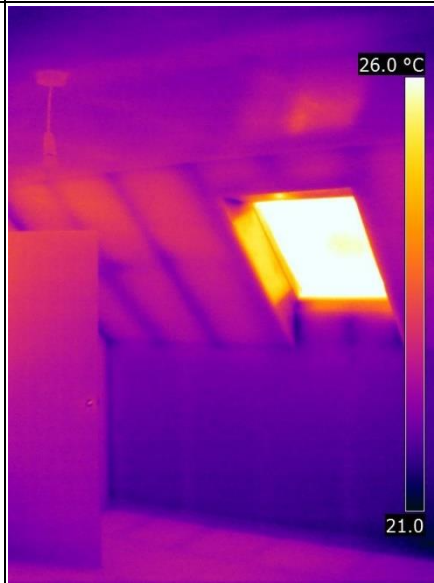
Bedroom 6 – Under natural conditions

Under natural conditions there is not much variation in surface temperatures as the 2<sup>nd</sup> floor is an exfiltration zone and warmer air is more likely to be escaping the house.

The cooler timber and warmer insulated areas of the sloping sections and spandrel show areas without voids behind, the areas with voids behind show warmer timbers and cooler uninsulated sections.

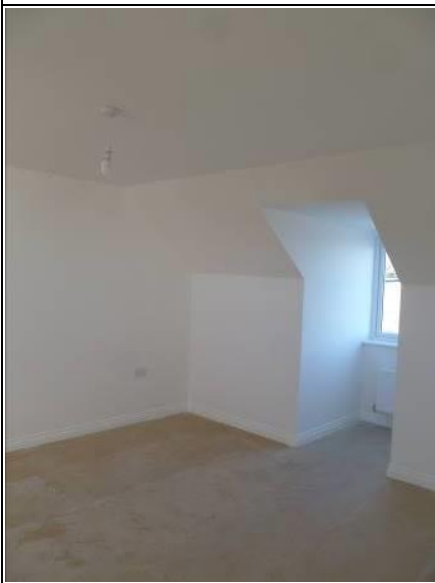
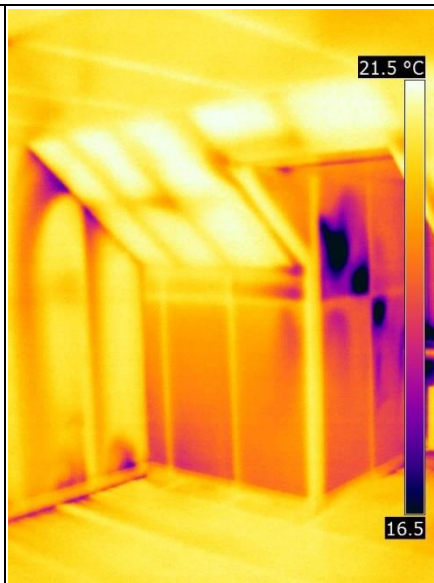
Bedroom 6 – Under depressurisation

The areas with voids behind have become much cooler as cold air is drawn into those voids under depressurisation. This cooler air can be seen being drawn down the gable wall and emerging at the floor/wall junction.

The dormer cheeks appear to be an issue when the direction of air movement is reversed. Cold air appears to be bypassing any insulation in the cheeks.

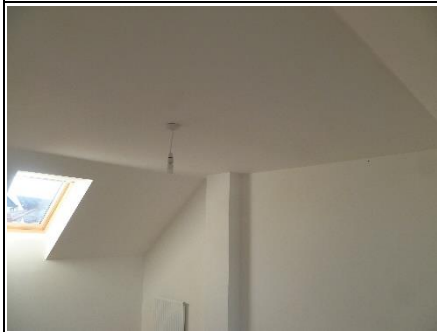
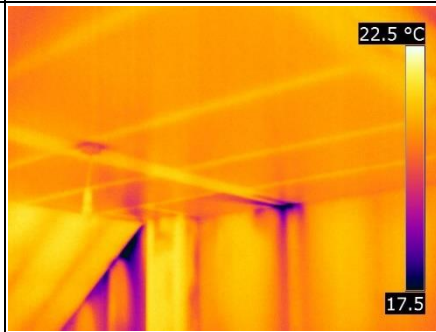
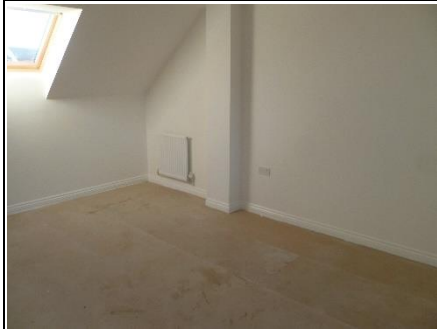
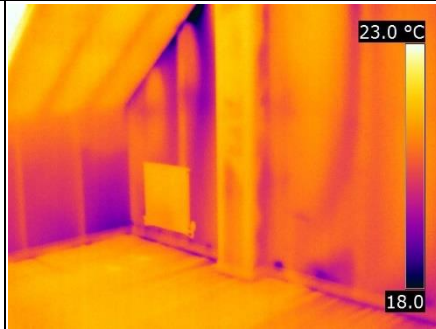
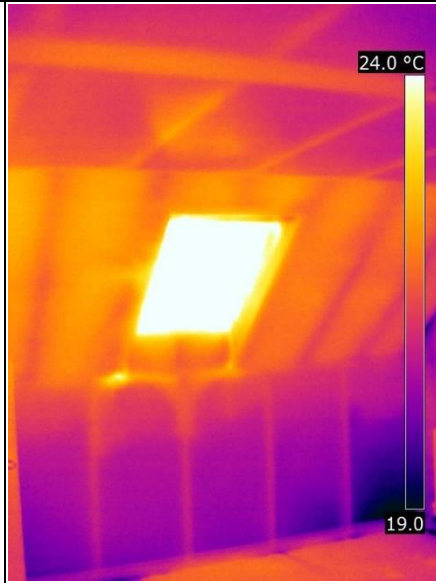
Air infiltrations around the dormer window appears to still be of

concern; the roof-light however appeared to perform very well.

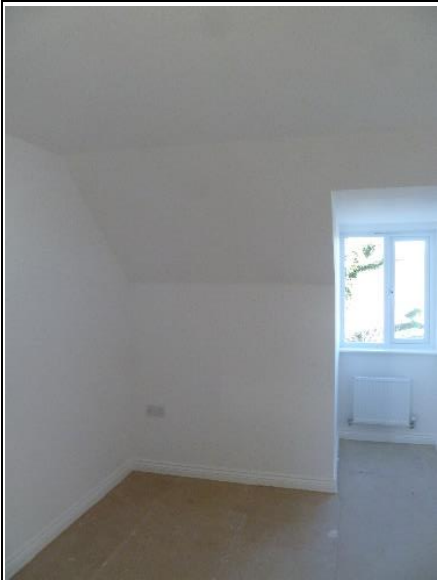
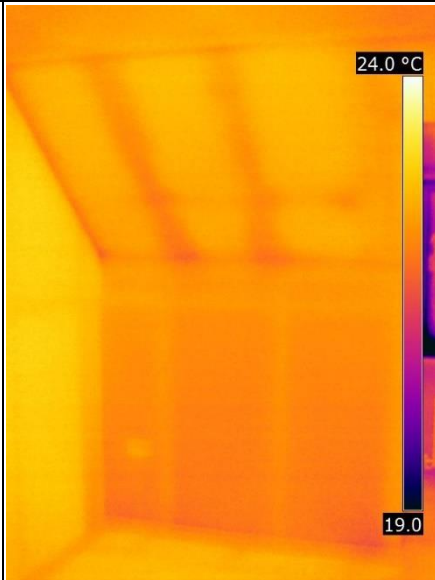
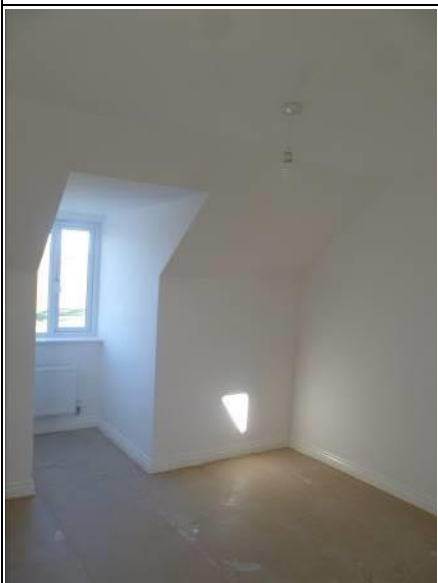
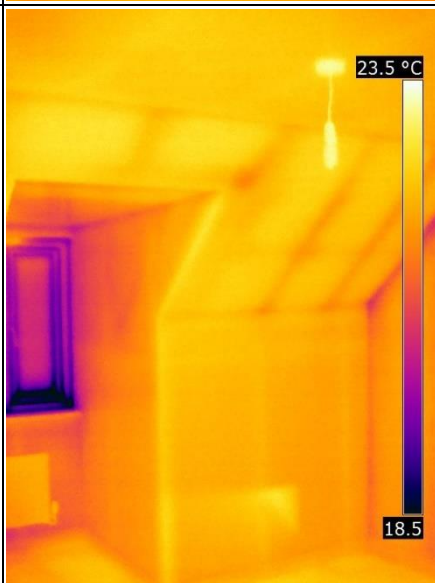
Bedroom 2 – Under natural conditions

Observations as bedroom 6.

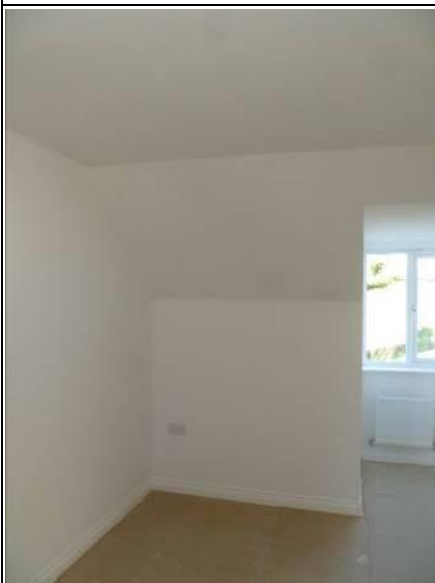
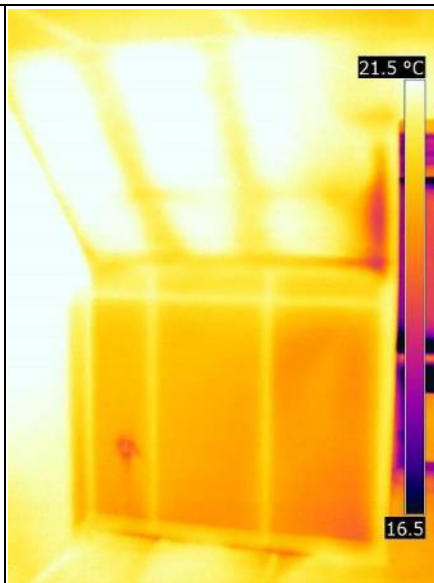
Bedroom 2 – Under depressurisation

Under depressurisation similar observations were made as bedroom 6 only slightly more severe.

Air leakage was also detected around electrical services into the eaves void, and significant infiltration was observed at the floor wall junction on the gable wall.

Also on the gable wall, the service riser adjacent to the en-suite showed cooler air being drawn down from above.

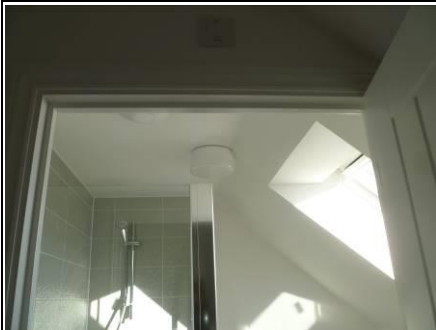
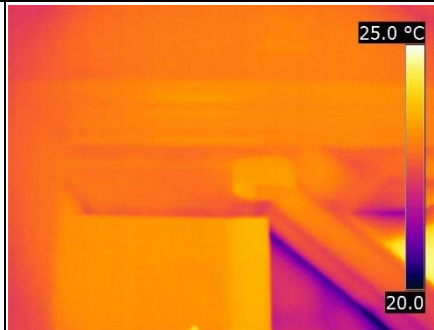
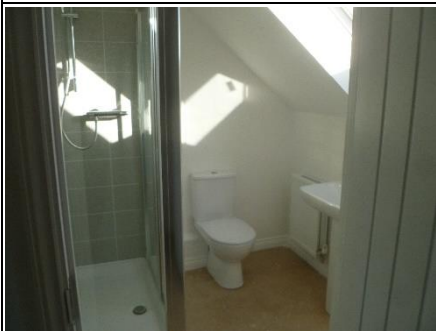
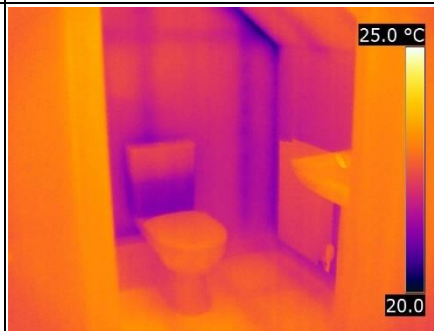
2<sup>nd</sup> Floor En-Suite – Under natural conditions

The gable wall looks slightly cooler, but with all the direct sunlight and reflection it's difficult to assess.

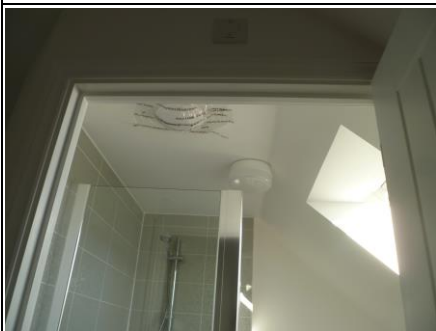
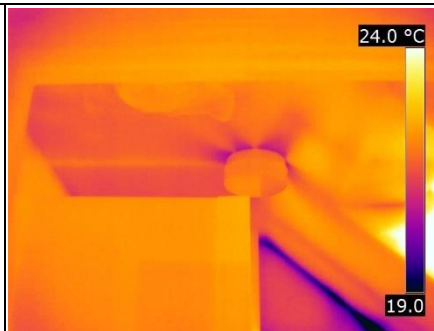
2<sup>nd</sup> Floor En-Suite – Under depressurisation

Under depressurisation air can be seen drawn in from above around the central light, and at the floor/wall junctions on both external facades. Again, there was too much direct solar to view most of the room.

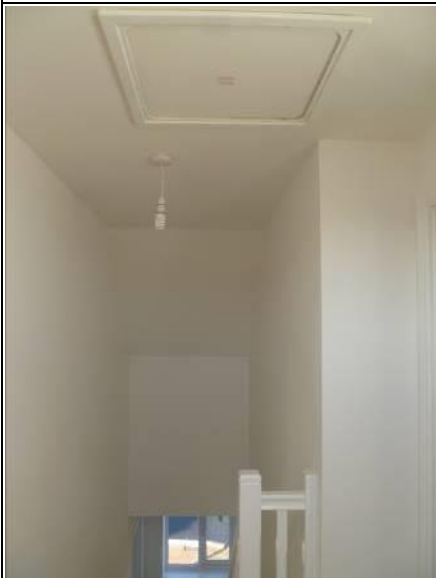
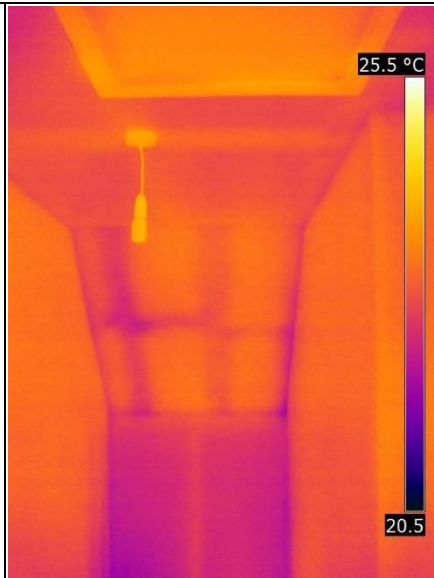
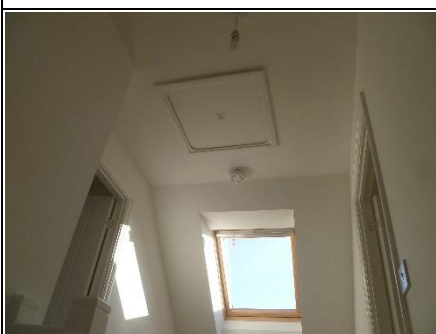
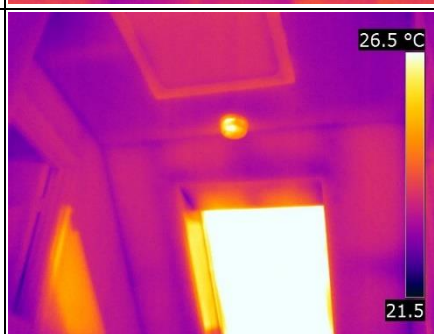
2<sup>nd</sup> Floor Landing – Under natural conditions

As in bedrooms 6 & 2, the panels backing onto voids appeared cooler than those backing directly on to panels.

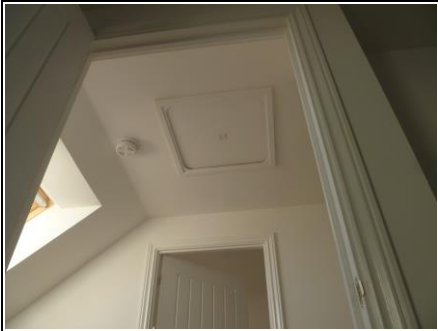
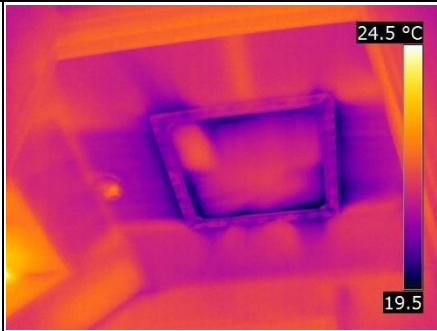
2<sup>nd</sup> Floor Landing – Under depressurisation

Under depressurisation air leakage was detected around the loft hatch.

Again the areas backing onto voids appeared to cool more under depressurisation than those backing directly onto panels.

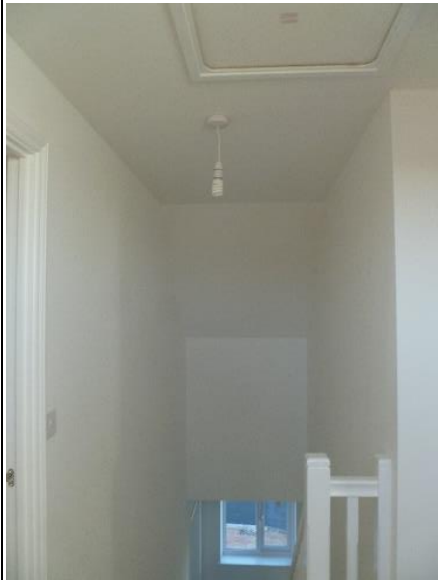
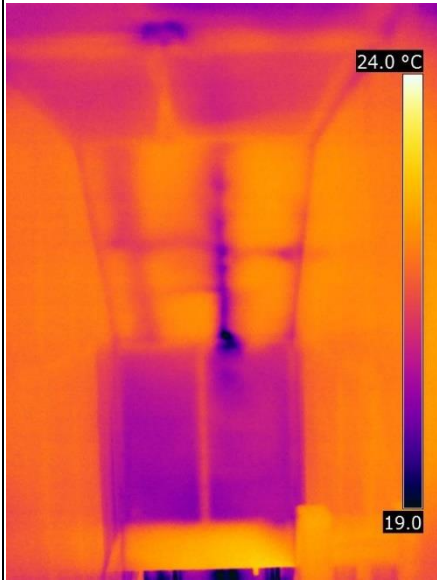
The cold strip along the sloping ceiling section towards the front of the house may indicate the type of place where the cooler air is getting into these voids.

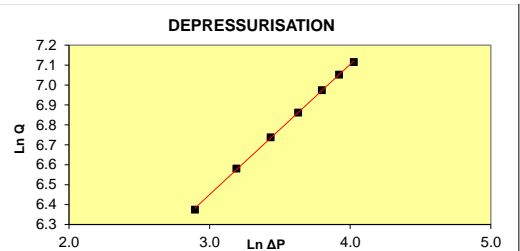
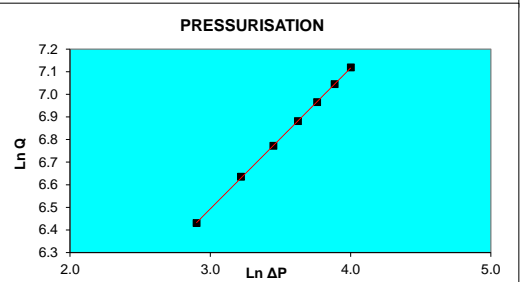
Pressure Test Spreadsheet: 294

RESULTS:											
Q50 Mean Flow at 50Pa =	1169.51	m <sup>3</sup> /h									
Mean Air Leakage at 50Pa =	7.50	h <sup>-1</sup>									
Mean Air Permeability at 50 Pa =	6.48	m <sup>3</sup> /h/m <sup>2</sup>									
Equivalent Leakage Area =	0.047	m <sup>2</sup> at 10 Pa									
DEPRESSURISATION	RING - O,A,B,C,D,E for BD3 0,1,2,3 for DuctBB	MEASURED FAN PRESSURE (Pa) Max. 90 Pa	MEASURED FLOW (m <sup>3</sup> /h)	ADJUSTED FLOW (m <sup>3</sup> /h)	FLOW RANGE OK FOR SELECTED RING?	Adjusted Pressure (Pa)	Ln delta P	Ln Q	Q50 Calculated Flow at 50Pa (m <sup>3</sup> /h)	Permeability Depressurisation Only (m <sup>3</sup> /(h.m <sup>2</sup> ))	Air Leakage Depressurisation Only (h <sup>-1</sup> )
Approx 65 Pa	b	56	1287	1230.6	OK	56	4.025	7.115	1169.79	6.48	7.50
Approx 57 Pa	b	50.4	1208	1155.1	OK	50.4	3.920	7.052		1.000	
Approx 49 Pa	b	44.6	1118	1069.0	OK	44.6	3.798	6.975	C <sub>env</sub>	88.927	m <sup>3</sup> /h.Pan

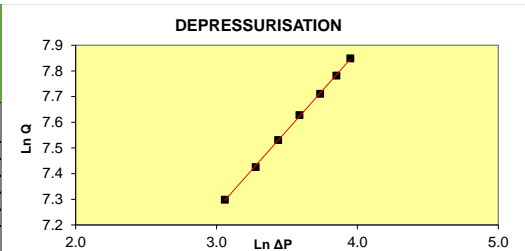
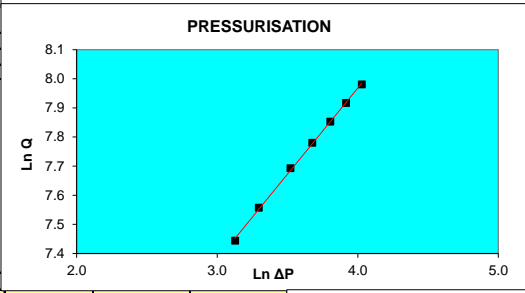
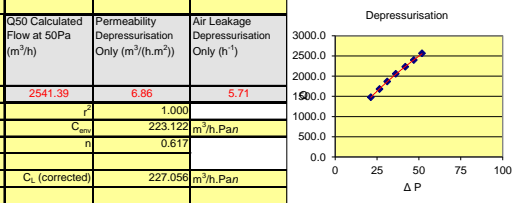
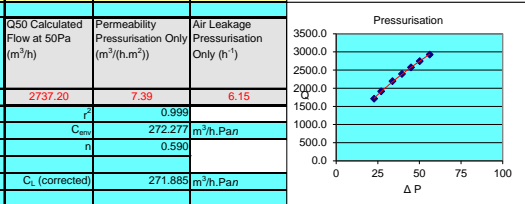
Pressure Test Spreadsheet: 297

Q50 Mean Flow at 50Pa =	2639.29 m <sup>3</sup> /h
Mean Air Leakage at 50Pa =	5.93 h <sup>-1</sup>
Mean Air Permeability at 50 Pa =	7.13 m <sup>3</sup> /h/m <sup>2</sup>
Equivalent Leakage Area =	0.113 m <sup>2</sup> at 10 Pa
