# Taylor Wimpey – Thermal Imaging Project

Site: Kingsbrook Place  
 Elmstree, Bury St Edmunds  
 IP30 9HA

Visit Date: 15<sup>th</sup> November 2017

Plot(s): 8 & 9

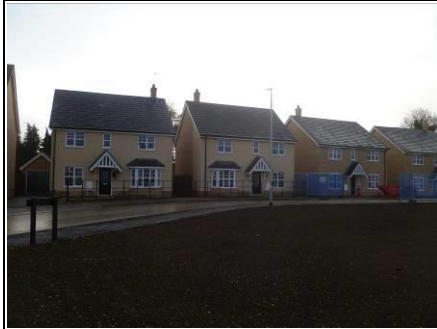
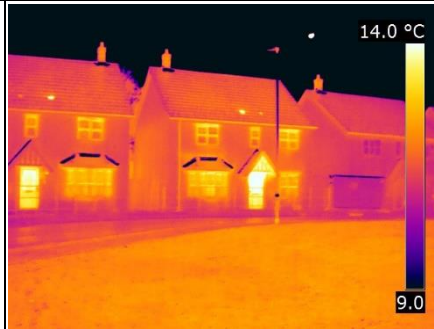
Plot 9 External - Under natural conditions

No significant thermal anomalies were seen from outside the property; slightly warmer areas were again observed adjacent to the bedroom radiators, the meter boxes showed no reasons for concern.

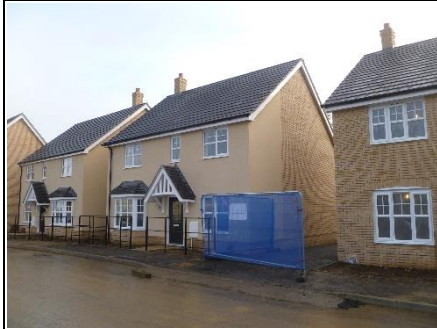
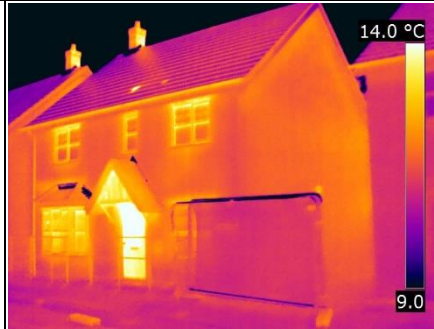
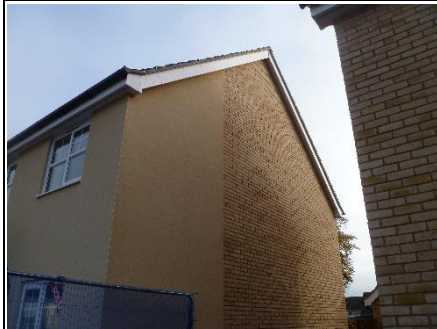
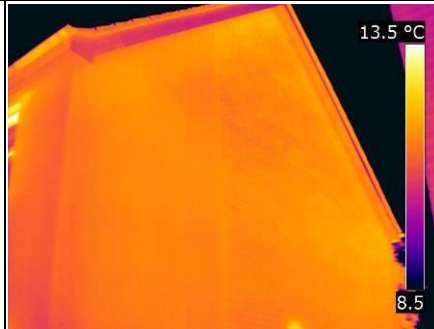
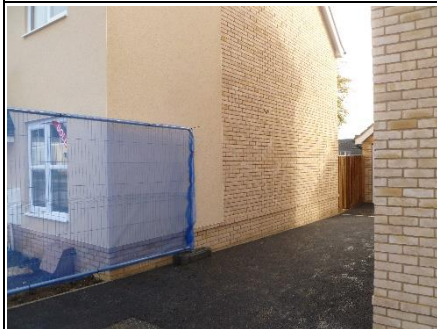
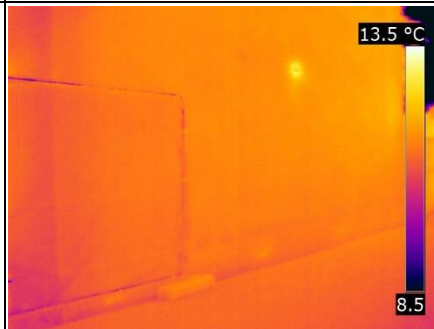
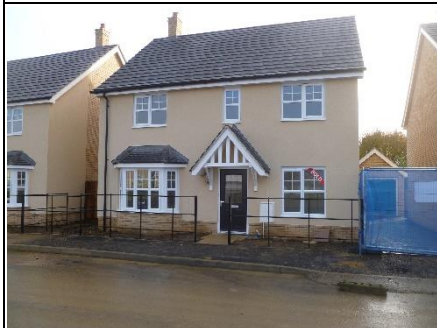
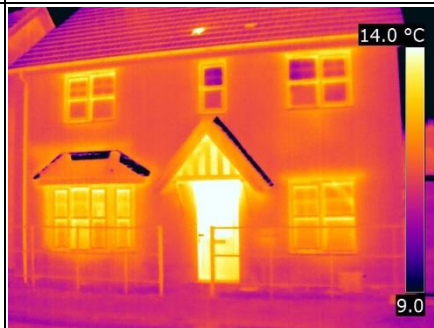
Warmer areas were observed on the external wall at window openings, particularly heads, and above the bay roof but these only appeared significant when manipulating the thermal image span to 2.5° to accentuate any differences:

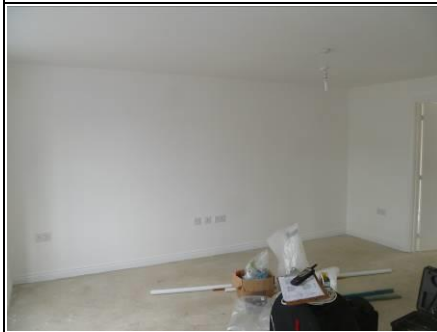
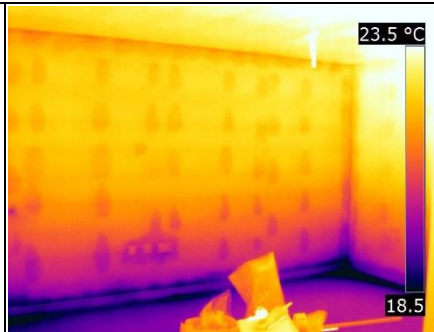
Plot 9 Lounge – Under natural conditions

Again, the external wall appeared marginally cooler at the bottom than was expected from just the natural temperature stratification in the room and the fact that the top part of the wall reflected the warm ceiling and the bottom part reflected the colder floor.

The bay roof again showed minor cooler spots along the lines of the external wall above. There was also some noticeable cold air infiltration at the bay window without any induced negative pressure.

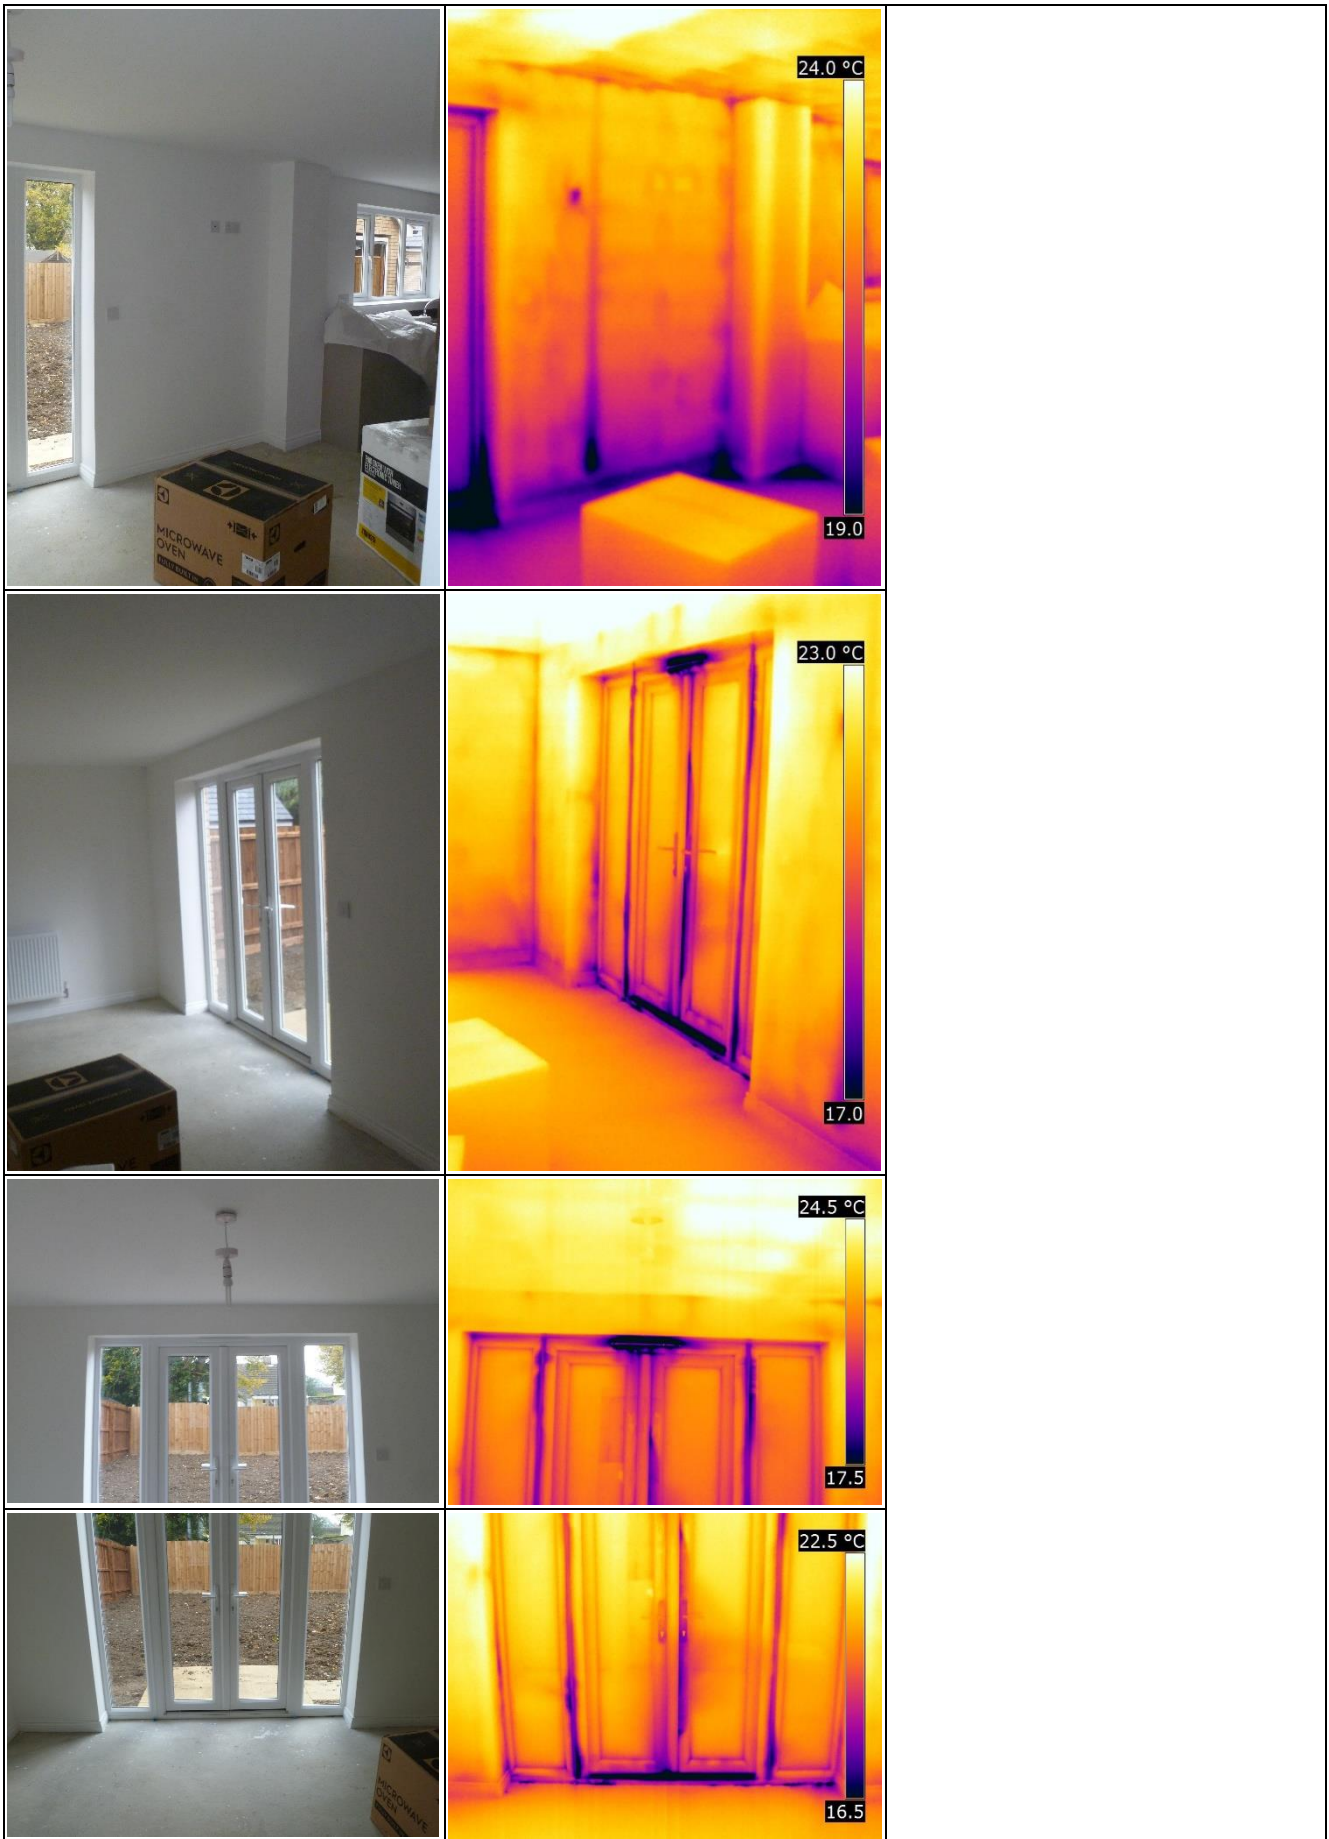
Plot 9 Dining / Kitchen – Under depressurisation

<p>Cold air infiltration was detected around some electrical service penetrations into the void behind the dry lining, including the outside light by the patio doors, and at the floor/ceiling junction by the boxed-in SVP.</p>
		<p>The patio doors appeared to allow a greater amount of air movement between the doors, between the doors and side lights and through/around the trickle vent.</p>

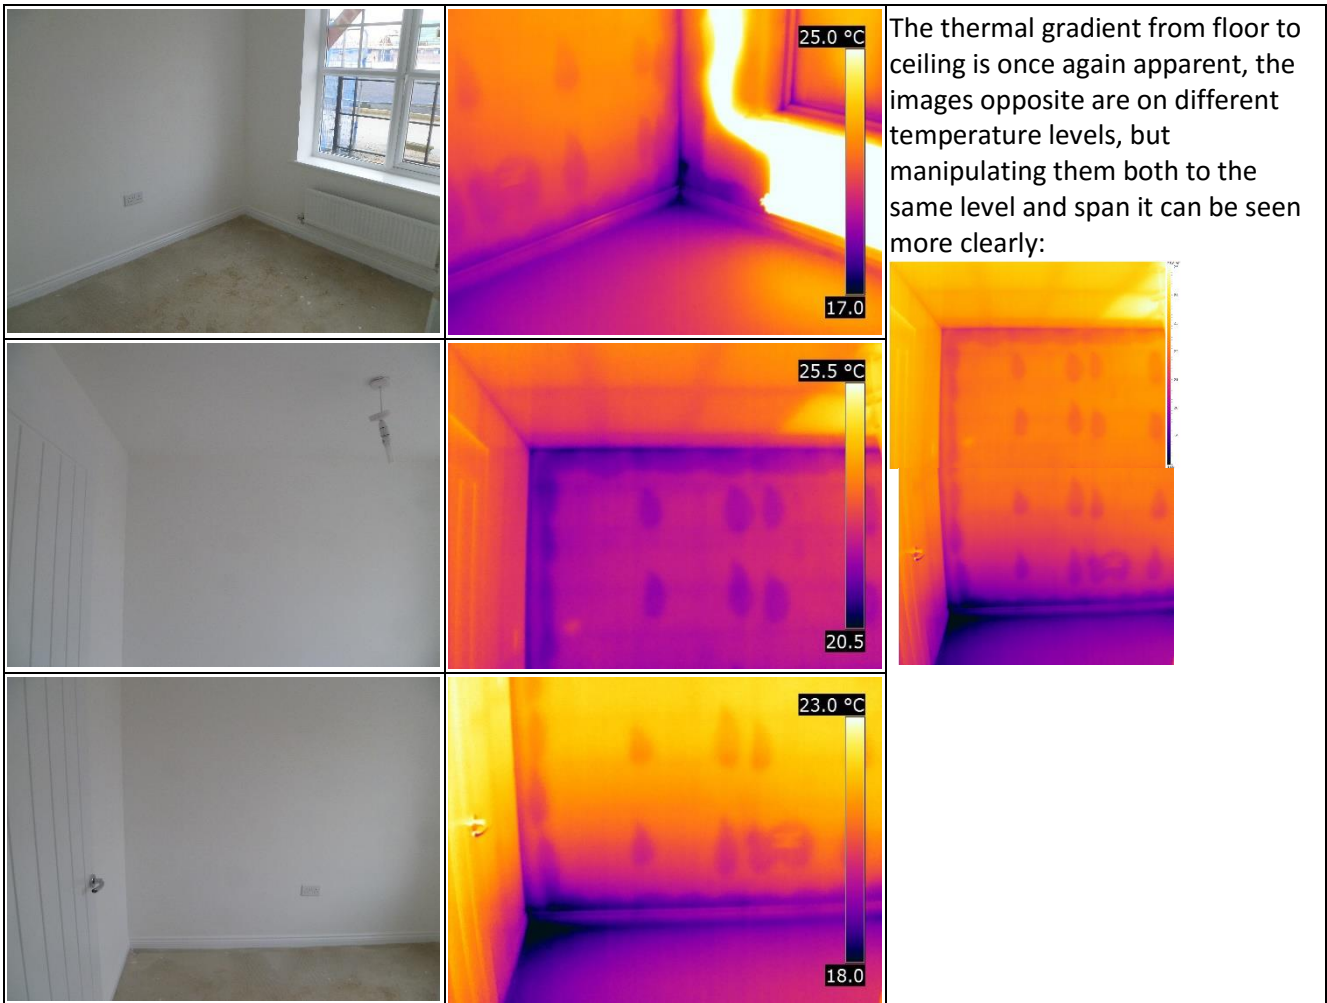
Plot 9 Study – Under natural conditions

The thermal gradient from floor to ceiling is once again apparent, the images opposite are on different temperature levels, but manipulating them both to the same level and span it can be seen more clearly:

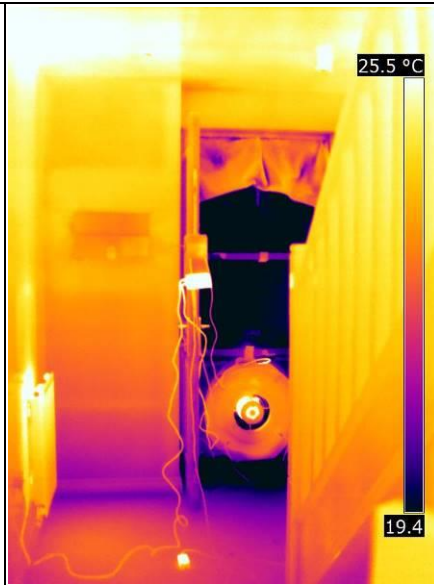
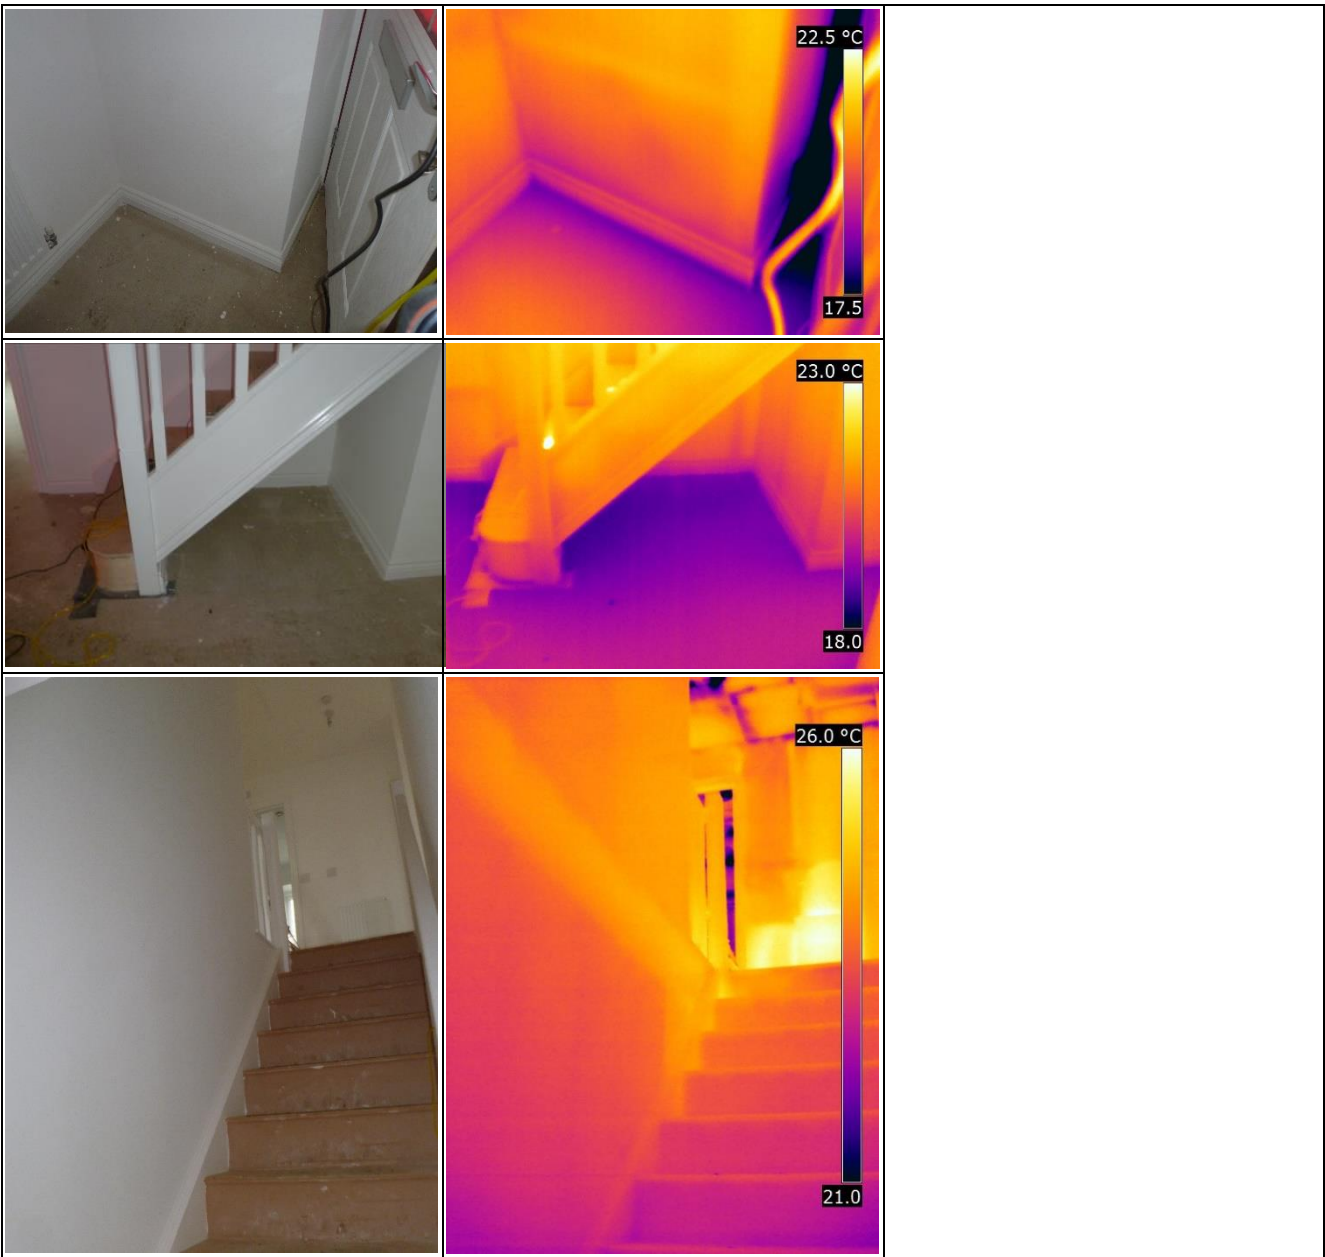
Plot 9 Hall – Under depressurisation

Under depressurisation it appears that colder air is being drawn into the boxed-in service void, as differing wall temperatures can be seen below the consumer unit.

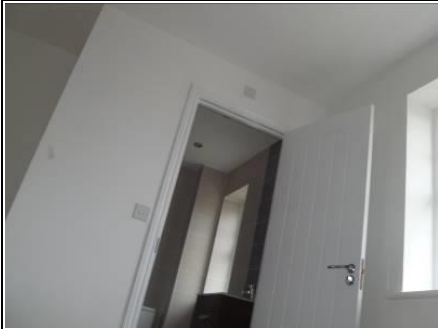
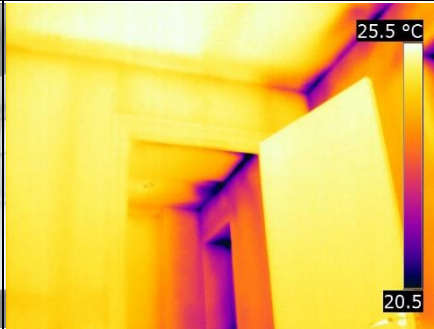
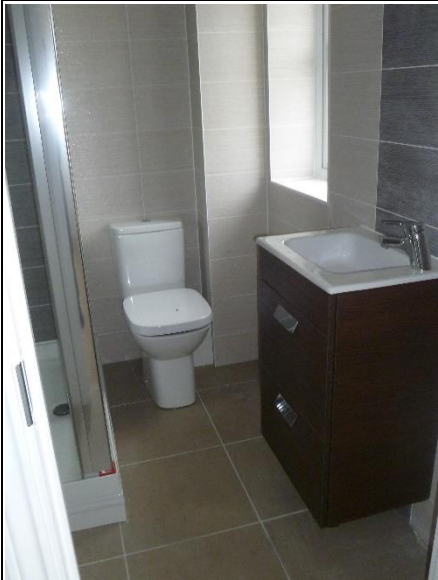
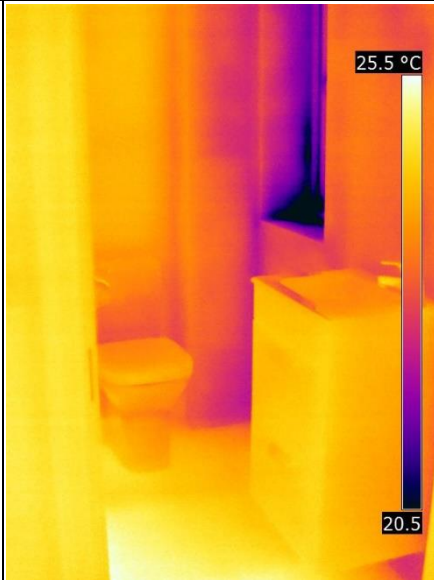
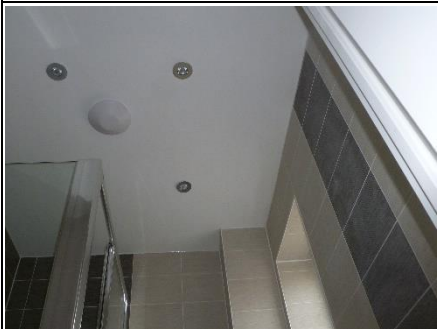
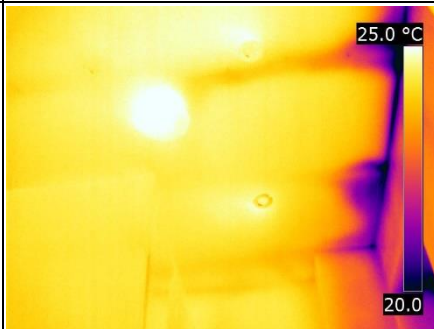
Plot 9 En-Suite – Under natural conditions

As in plot 8, the cold section of ceiling at the external wall junction suggests that the loft insulation does not extend fully to meet up with the wall insulation. The boxed-in SVP also appears to be cooler.

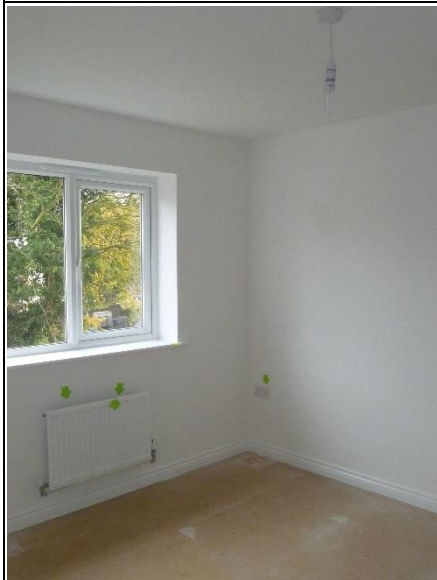
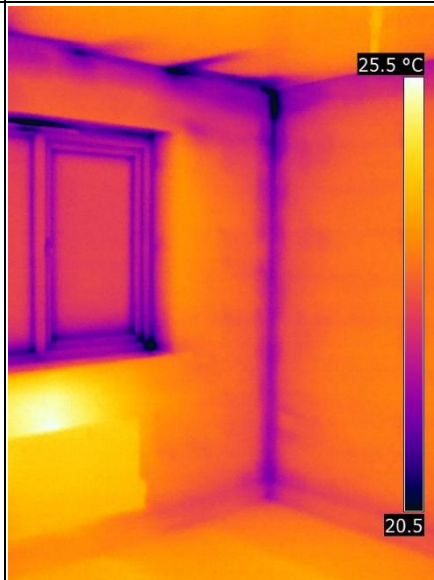
Plot 8 Bedroom 4 – Under natural conditions

The issues at the eaves observed in Bedroom 1 appear more pronounced at the rear of the dwelling. The window head reveal appears slightly cooler than the jamb reveal.

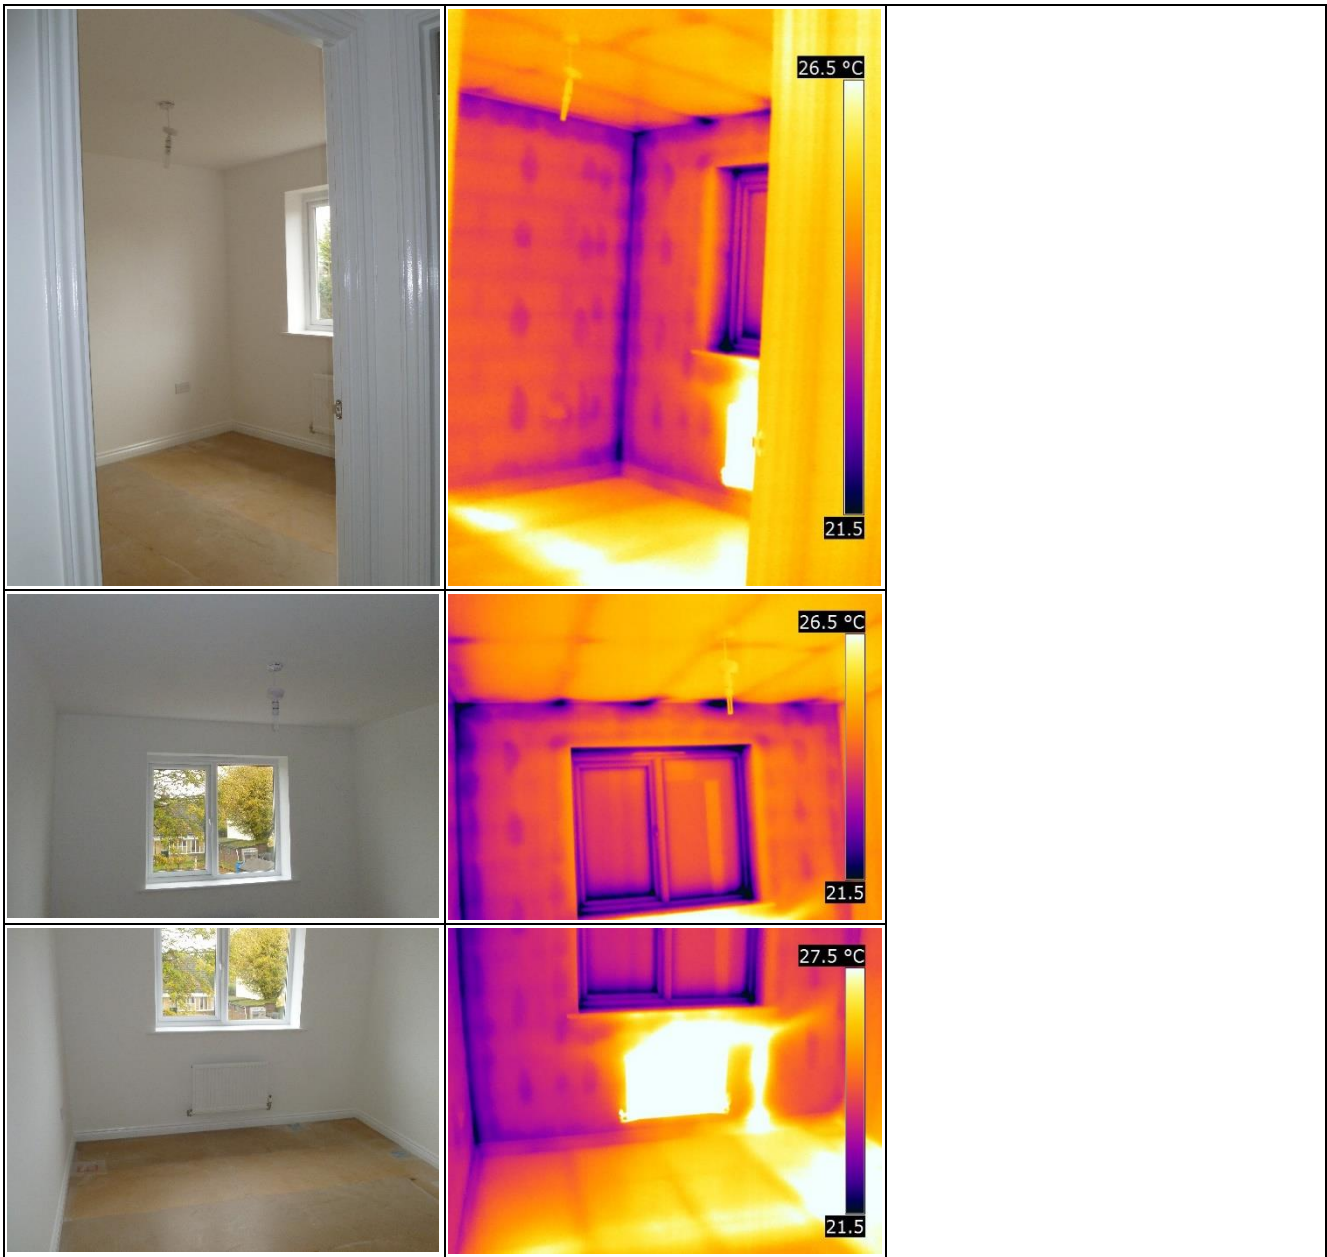
Plot 9 Bedroom 4 – Under natural conditions

As observed in plot 8.

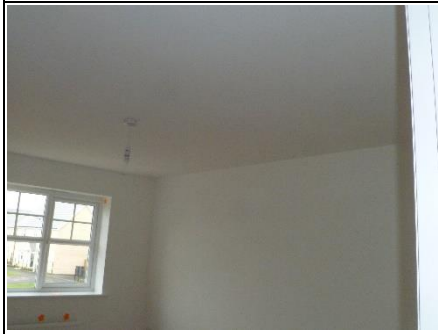
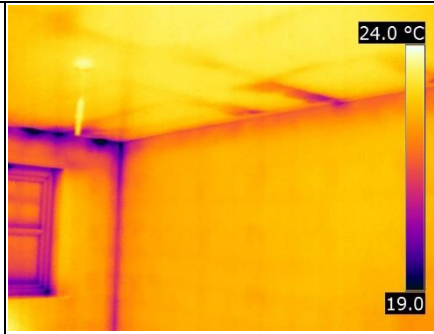
Plot 8 Bedroom 2 – Under natural conditions

As observed in previous bedrooms, with the section of partition wall adjacent to the service void in the En-suite clearly visible in the thermal image.

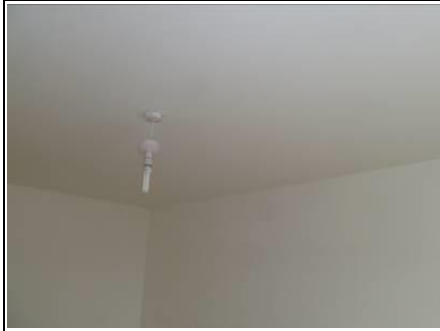
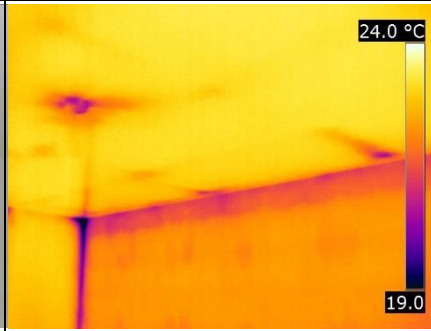
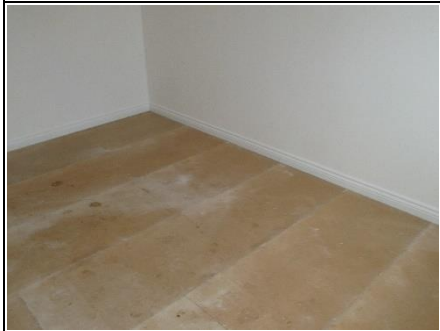
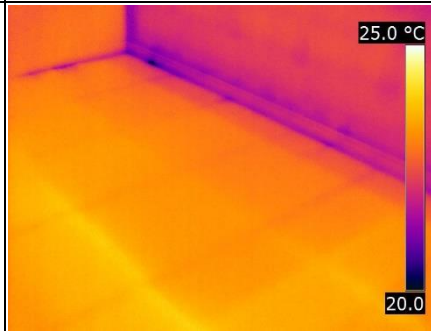
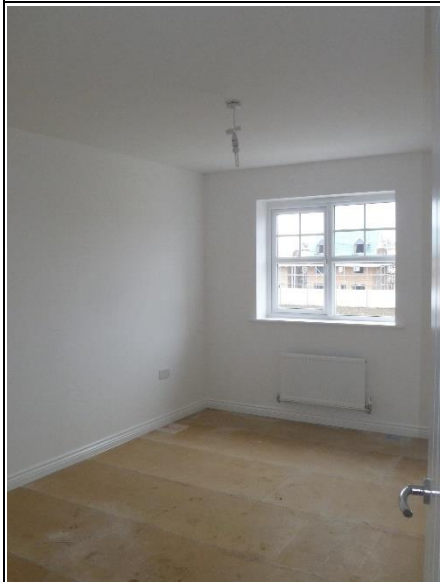
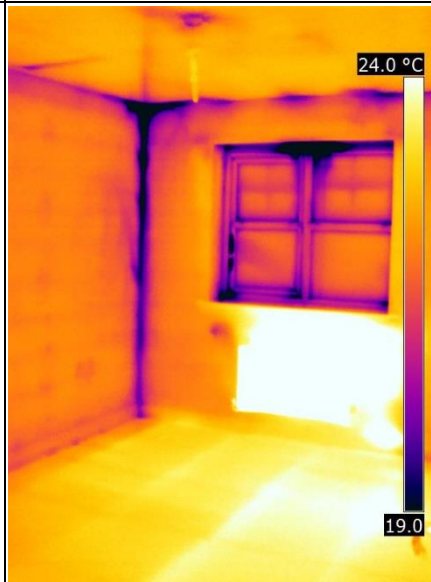
Plot 9 Bedroom 2 – Under depressurisation

As seen in Bedroom 4 air was drawn in from the loft under depressurisation with the greatest area of concern being the junction of the internal and external walls backing on to the service void in the En-suite.
