## **Condensation Risk – Impact of Improvements to Part L and Robust Details on Part C**

## **Interim report number 7: Final report on project fieldwork**

**Malcolm Bell, Melanie Smith & Dominic Miles-Shenton**  
Buildings and Sustainability Research Group  
Leeds Metropolitan University

## Interim report to ODPM Building Regulations Division under the Building Operational Performance Framework

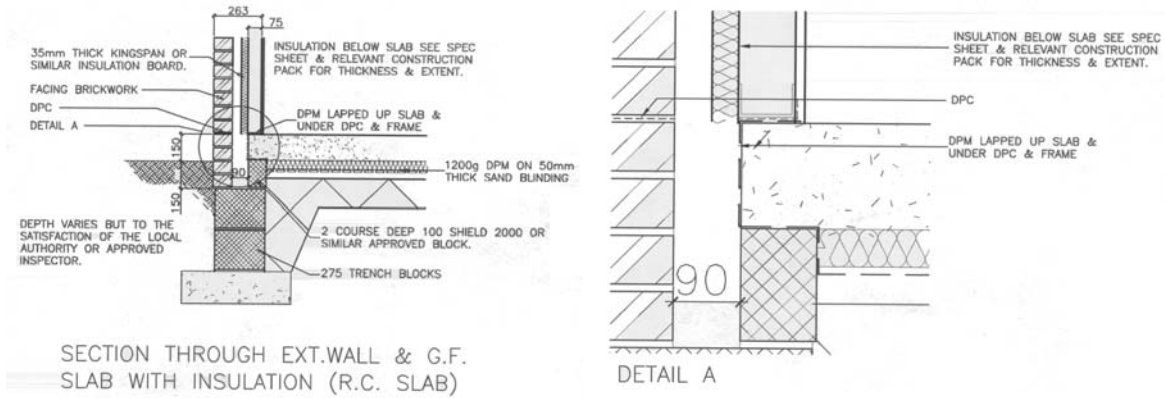
41. An example of this is illustrated on two sites. The drawing information is included in figures 3.01 and 3.02. Here different trades were supplied with a ground floor/foundation/external wall detail. For two trades (Groundworks detail 01 and Bricklayer detail 01) the position of the bottom of the cavity wall insulation was vague, shown positively from dpc/top of slab level, with accompanying text sending the reader to a further design sheet for information as to where to start the cavity wall insulation (figure 3.01). A third trade detail drawing (Joiner detail 01) showed the cavity wall insulation correctly starting at the base of the ground floor slab insulation (figure 3.02). Site observations revealed an inconsistency in construction, with some in accordance with the drawn information on the ground-work and bricklayer detail, resulting in thermal bridging, and some following the more robust joiner version.

Figure 3.01 Extracts from working drawings, showing details for groundworks and bricklayer.

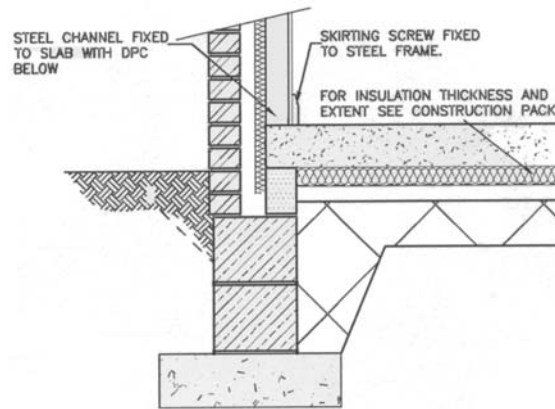
Figure 3.02 Extract from working drawings, showing details for joiner.

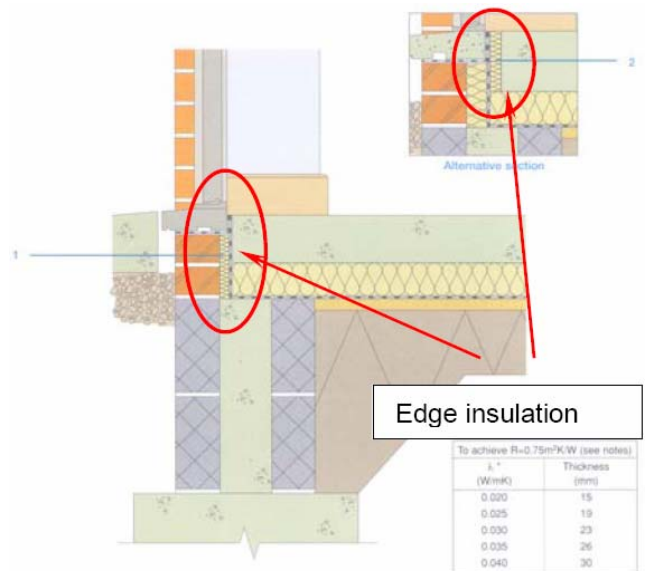
Figure 3.13 Ground floor with perimeter insulation in place.

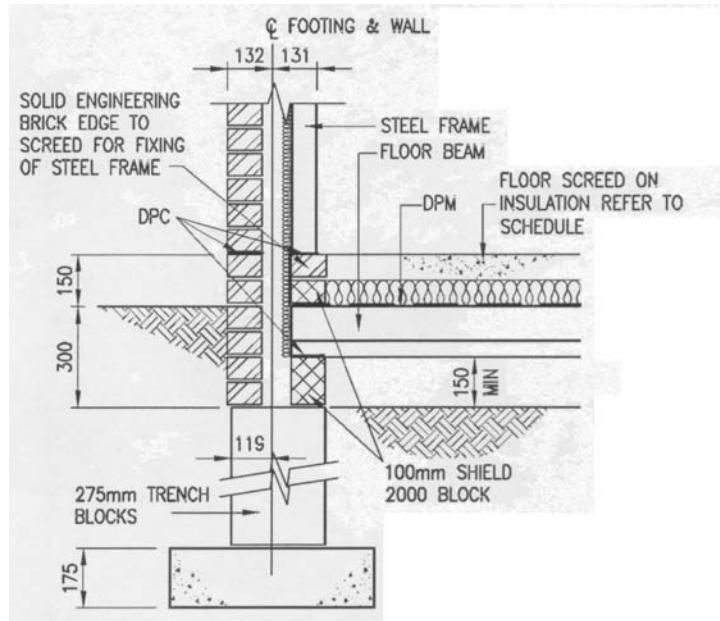
50. All ground floor/wall junction details in the Robust Details document relating to steel frame construction (details 7.07 to 7.11) rely on the continuation of the cavity insulation below floor level and this is the approach used in the designs adopted on the sites studied (see figure 3.17) However, the effectiveness of the insulation is dependant, to some extent on its closeness of fit and the avoidance of discontinuities. In order to achieve a good fit it is important that the frame lines up with the outside edge of the slab or kerb (as indicated in figure 3.17). On one of the steel frame sites visited this was not achieved. Figure 3.18 shows a mismatch between the plan shape of the base and that of the frame. This meant that, on at least one elevation, the base of the frame was not in alignment with the edge of the base resulting in a set back from the edge of around 50mm at one end of a wall section narrowing to almost zero at the other<sup>2</sup>.

<sup>2</sup> In the case observed there would not appear to be any structural implications of the misalignment since the frame channel was fully supported, but it may not have been within the range of normal tolerances and deviations in BS 5606, Accuracy in Building.

Figure 3.17 Ground floor detail in steel frame construction.

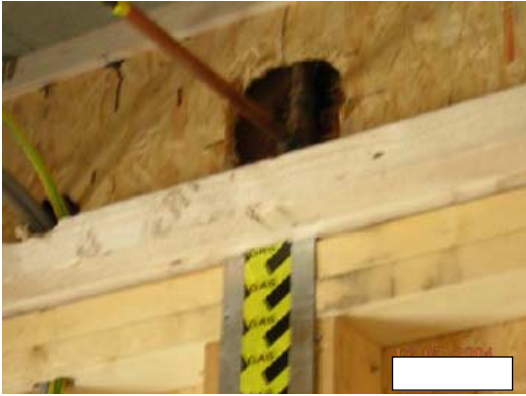
55. Despite the perimeter insulation shown in design drawings, site observations revealed little evidence that it was actually placed. Figure 3.25 shows external walls with wall insulation and vapour control layers in place but no perimeter insulation at intermediate floor level. Although it is possible that insulation would be placed at a later date, this was considered unlikely as it would have required a second visit by the insulation gang. In any case the proliferation of services runs (figure 3.25) would make placement difficult as would the narrow space between the multiple joist and the wall. On some sites there seems to have been an assumption that the timber I-beam floor cassettes would have perimeter insulation fitted at the factory. In one case the site team had an opportunity to check this assumption through a hole in the perimeter space, which was cut for a gas pipe. As shown in figure 3.26 no insulation was evident. Evidence from another timber frame site where access to the floor edge<sup>1</sup> was available provided another example of an uninsulated void (see figure 3.27). The lack of perimeter insulation would seem to be a general problem since in none of the timber frame sites visited was the placement of perimeter insulation observed.

Figure 3.26 Holes made in double I-beams reveal lack of perimeter insulation.

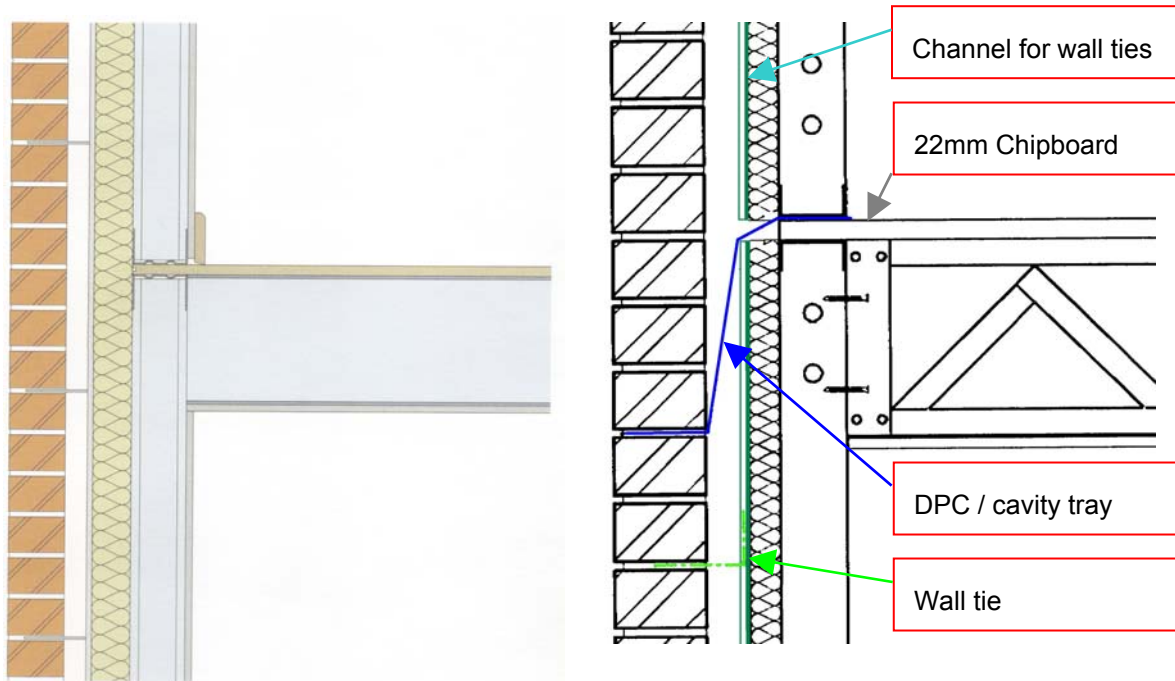
56. As already indicated, warm frame steel frame design relies heavily on the integrity of the external insulation to avoid moisture and thermal degradation problems. In warm steel frame, the primary air barrier is provided by the insulation layer. Thus, gaps in the continuity of this layer will result in coincident air leaks and thermal bridges. Moreover, as our observations establish, there is a tendency for defects in the insulation layer to occur close to framing members – where local thermal conductivities are highest. The coincidence of gaps in insulation, leakage paths and framing members maximises the impact of such defects. In general, on both sites included in the research, the close butting and taping of insulation boards was done with reasonable care. However, as indicated in the ground floor section above, this was not always possible. Figure 3.28 shows the relevant Robust Detail (RD 7.13) for the intermediate floor junction compared with the detail as designed and constructed. The designer thought it necessary to introduce a cavity tray<sup>1</sup>, the fitting of which meant that a gap of some 22 mm (the thickness of the floor boarding, which is sandwiched between the upper and lower frame sections) in the insulation layer. Given a perfect fit and a good seal between the frame and the floor covering this may not be particularly significant but site observations indicated that the gap in the insulation could be almost 40 mm and the joint between tray and insulation remained unsealed, providing a potential air leakage path. Air pressure tests carried out on the same site for a related project (see figure 3.29 reproduced from Johnston et al 2004) identified considerable leakage at this junction.

Figure 3.28 Robust Detail 7.13 and typical design detail of an intermediate floor for lightweight steel frame construction.

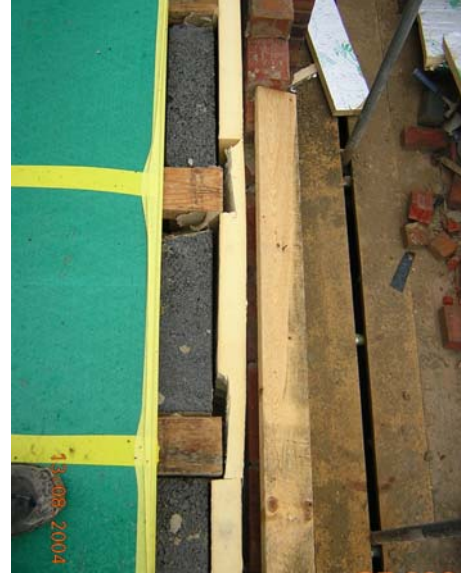
an illustration of the difficulties of insulating across the joist ends. In figure 3.31 the joist ends protrude into the partially filled cavity but instead of trimming the joists to a tight fit the insulation has been cut back, not only reducing the insulation thickness but also leaving room for air flow which bypasses the insulation. This is, perhaps, something of a curio in this project and the problem is not particularly severe but it is conceivable that in extreme cases, even greater thicknesses of insulation could be removed.

Figure 3.31 Partial-fill insulation in masonry construction, cut around joist ends.

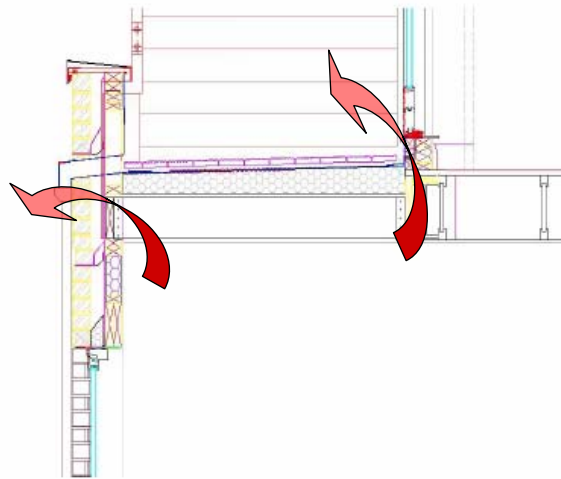
60. Figure 3.32 shows one example of design where the lack of perimeter insulation below the parapet wall results in a thermal bridge through the timber frame. In addition, the area around the steel beam below the balcony door shows a lack of consideration of insulation requirements; RSJs are further also discussed later.

Figure 3.32 Example of balcony drawing detail, with potential thermal bridges indicated (arrows).

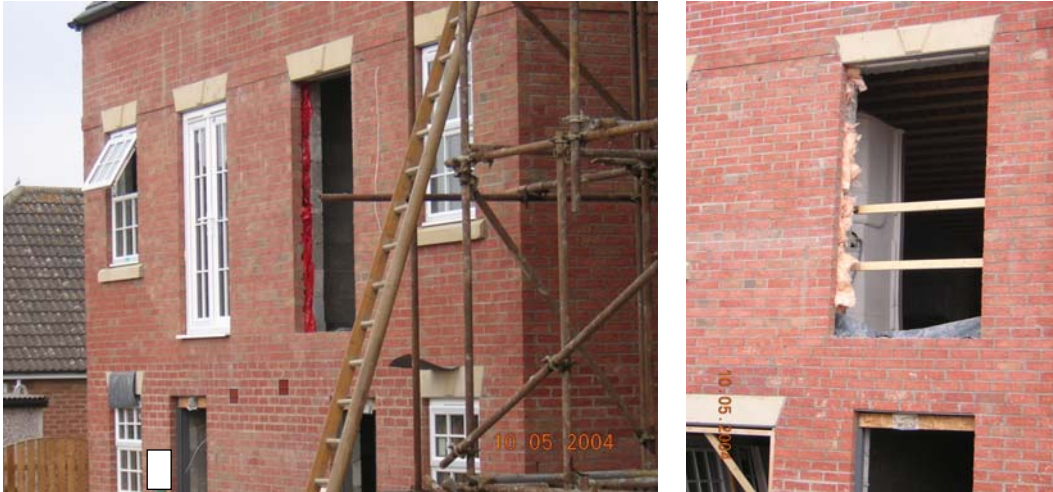
65. Not all sites adopted the propriety closure, some sites using glass or mineral fibre bats wedged into the jamb cavity to be held in place by the window frame as illustrated in figures 3.37 and 3.38 – although from time to time the result was not very pretty. On one site an apparently idiosyncratic mixture of propriety cavity closer and return block was used in the same construction. This is shown in figure 3.39. In this case a well insulated closer was used for the window reveals (a point we discuss below) but in the case of the connected door opening a return block with a rather thin (about 10mm) and ill fitting insulated vertical dpc was used. The impact of the return block is to bypass the partial-fill insulation, resulting in a thermal bridge, the insulated dpc not withstanding.

Figures 3.37 and 3.38 Alternatives to proprietary cavity closers.

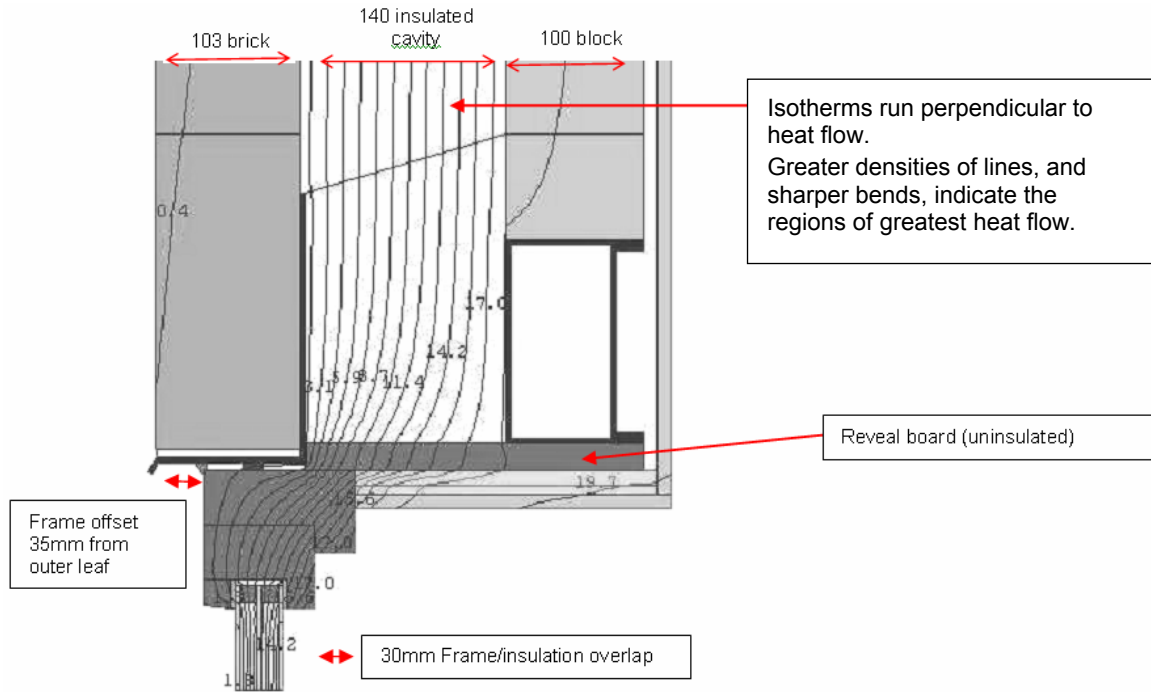
69. The location of the frame with respect to an insulation layer is an important determinant of the extent of thermal bridging, even in otherwise well designed, bridge-minimised, reveals. This point is well illustrated by an analysis of frame location (Roberts, 2004) in the context of a low energy housing scheme (Lowe and Bell, 2002). Figure 3.45 shows the thermal analysis of a head detail produced for one of the house types in the scheme. In its original form the detail adopted the practice advocated by Robust Details (e.g. RD 3.12 figure 3.46) of ensuring a minimum of a 30mm overlap between frame and closer layer. The construction was; 105mm brick – 150mm fully filled (mineral fibre) cavity – 100mm medium density block; separate lintels are used and insulation taken to the back of a liner board so that bridging at the reveal is minimised and the frame set to give a 35mm offset from the front face of the external brick work<sup>1</sup>. Given a frame depth of 100mm this resulted in the minimum 30mm overlap required by Robust Details.

Figure 3.45 Head detail with a frame offset of 35mm from the outside surface of the outer leaf – detail drawing 031. (source Roberts, 2004)

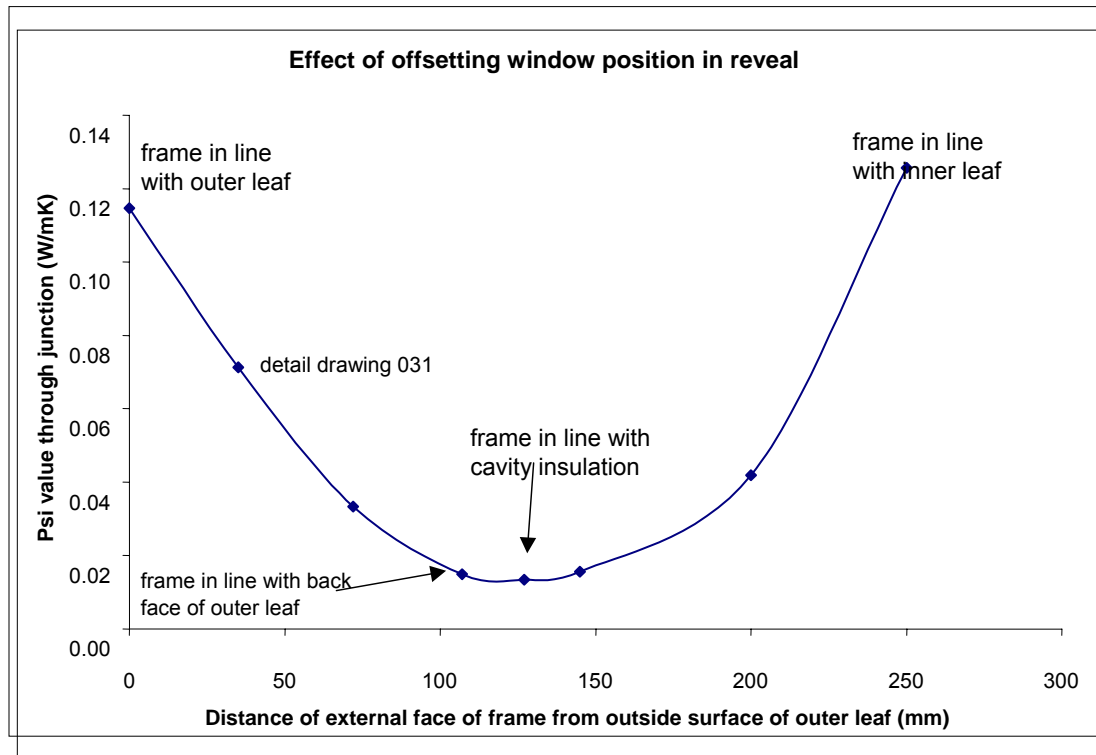
70. Figure 3.47 demonstrates the impact on the linear thermal transmittance ( $\Psi$  value<sup>1</sup>) of different locations of the frame in this detail. The distinct U shape illustrates clearly the impact of shifting the window into line with the insulation. Increasing the overlap to the full thickness of the frame (100mm) results in a significant fall in the  $\Psi$  value of the detail. If applied to all openings in the particular house type analysed, the effect of shifting the

window frame was an improvement in overall wall U value (including thermal bridging) of about 13% (from 0.3 W/m<sup>2</sup>K to 0.26 W/m<sup>2</sup>K).

Figure 3.47 Effect of offsetting window position in reveal on  $\Psi$ (psi) value of head junction. (source Roberts, 2004)

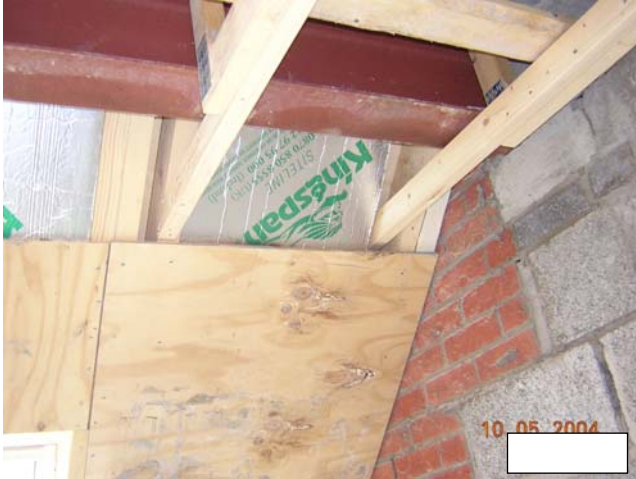
Figure 3.51 Ventilated rafter void all insulation between rafters.

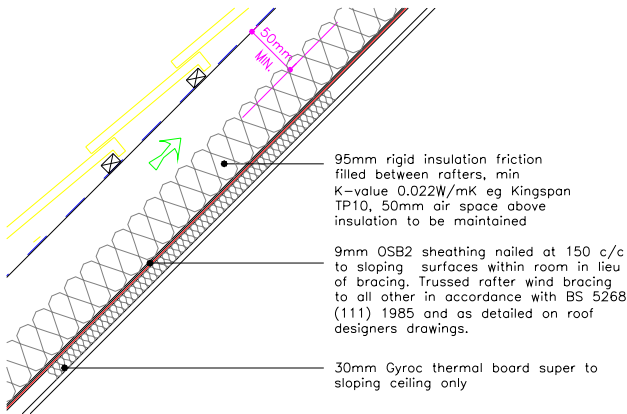
77. An alternative ventilated rafter construction is illustrated in figures 3.54 and 3.55. In this case the construction is a little more forgiving in that the insulated lining will reduce bridging through the timbers and any associated gaps (although on this site the fitting of insulation boards was of very high quality). The lack of an air barrier may remain a problem but with racking ply in place (if used instead of alternative bracing) and taped joints a reasonable air and vapour barrier could be achieved. No taping of joints of roof insulation was observed on any site.

Figure 3.54 Ventilated rafter void with insulation between and under rafters.

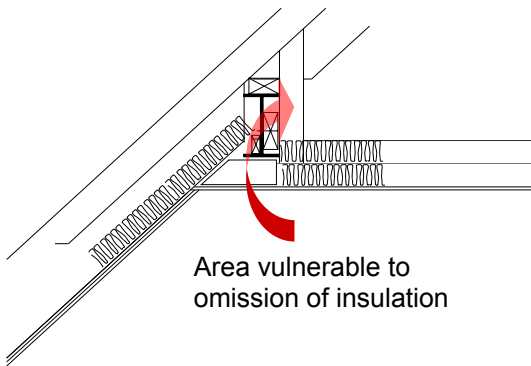
78. In the room-in-the-roof structures encountered, steel purlins were a common feature used as part of a composite type construction with rafters at the lower level and trusses above to complete the roof pitch. Given the high conductivity of steel, insulation detailing around the purlins is critical. This arrangement can be seen in figure 3.51. Figure 3.56 illustrates the key features of the apparent design of the purlin and surrounding construction. In the design illustrated the ceiling level provided the space for the area under the purlin to be reasonably well insulated but if the insulation was installed from above, as would be the case with the main loft, it would be very difficult to place. It could be placed from below, as the plasterboard ceiling is installed, but the general observations during site visits would suggest that such small areas of insulation are often overlooked. Unfortunately no direct observations were made of either ceiling erection or of loft insulating so it is not possible to be certain of the final state in the dwellings surveyed but the detail remains vulnerable. In another case however, it is clear that if constructed as designed (see figure 3.57) a very real condensation risk would exist<sup>1</sup>.

Figure 3.56 Steel purlin design - vulnerable to poor insulation placement and potential condensation risk<sup>2</sup>.

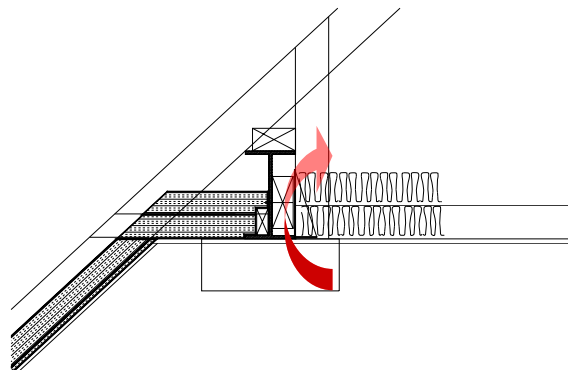
Figure 3.57 Steel purlin design – significant thermal bridge and high condensation risk<sup>3</sup>.

<sup>1</sup> In passing, this particular thermal bridge appears to be the largest, in terms of contribution to fabric heat loss, to be featured in this report. A rough calculation suggests that the additional heat loss is of a similar order to the heat loss through the fenestration, and effectively doubles the heat loss through the roof.

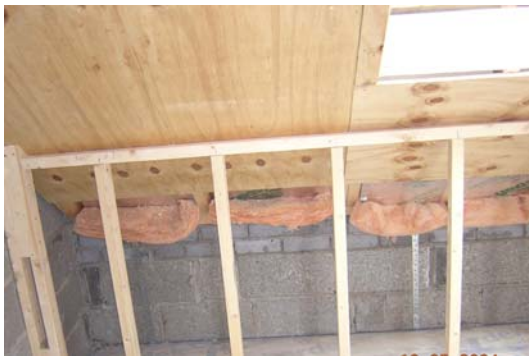
79. Maintaining the continuity of insulation at eaves was achieved in a reasonable number of cases where observation was possible. Figure 3.58 is typical of the arrangement in cavity masonry sites and figure 3.55 shows the care taken to fill small gaps at the eaves junction on one of the timber frame sites. However, concerns remain about the level of detailing in relation to airtightness since eaves junctions had little provision for air sealing. The arrangement shown in figure 3.58 is likely to be particularly leaky since the roof wall junction is likely to remain unfinished as the eaves area forms a void useable for loft type storage only. This is not the case in the timber frame example shown in figure 3.55 and as far as can be established this detail follows the recommended robust eaves detail for this type of roof (RD 6.03). However airtightness remains a problem.

Figure 3.58 Cavity wall – roof junction.

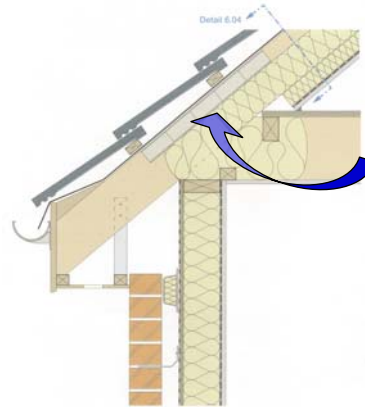
80. The robust detail is reproduced in Figure 3.59. The only resistance to air flow within and through the inter-floor space is the mineral wool packing. This raises two key problems; first, this space is very difficult to inspect and vulnerable to insulation being omitted<sup>1</sup> and second, if insulation was placed, achieving a significant resistance to air flow is fraught with difficulties even if it could be shown that tight packing is able to achieve the air flow resistance required. The configuration in the case of a ventilated rafter void is particularly prone to the inducement of air flow, not only through the rafter void, as intended, but also through the floor void from eaves to eaves. The likely condensation risk at eaves may be increased as moist internal air and vapour travelling through the floor void condenses on the underside of the roofing felt or the proprietary roof vent with consequent wetting of any insulation, the top of the timber frame and rafter or joist ends.

Figure 3.59 Robust Detail 6.03 – timber frame wall – roof junction.

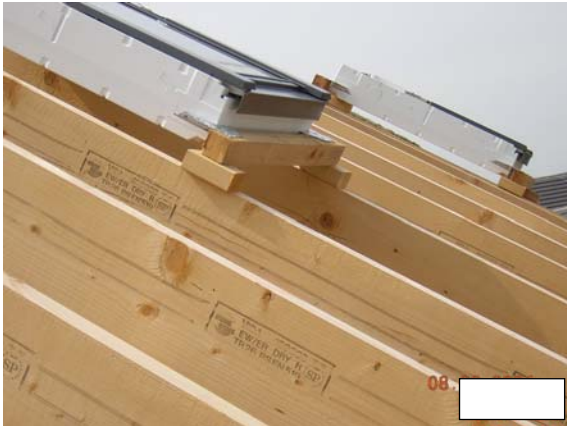
Figure 3.60 Rooflight fixed above external insulation to rafters.

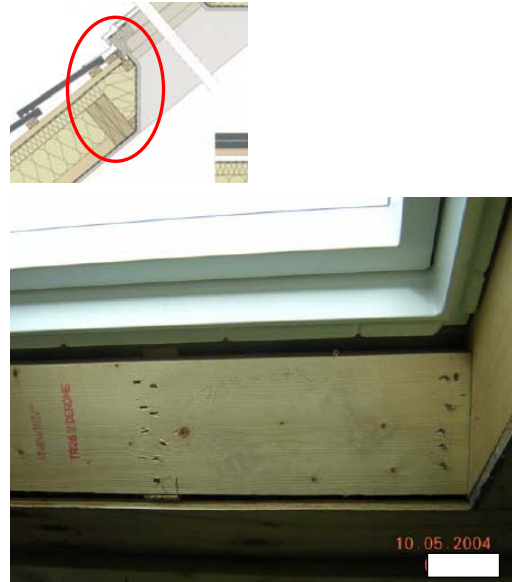
Figure 3.63 Lower lining section, uninsulated

rooflight.

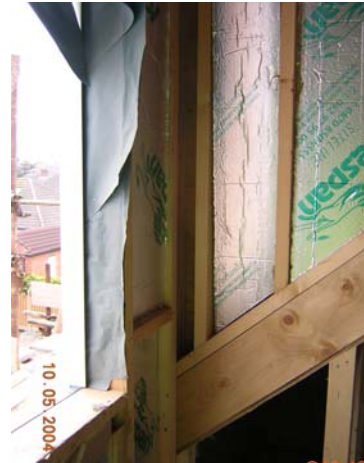
84. As in other cases the main problems related to the fitting of the insulation board. Figures 3.65 and 3.66 illustrate typical fitting problems with gaps around boards and missing insulation in small sections, sections that can be very small indeed requiring considerable attention to detail (see figure 3.64). The missing insulation in the corner section (figure 3.66) is of particular concern since this is one of the most exposed areas of the external envelope.

Figure 3.66 Omission of insulation at small strip in the corner.

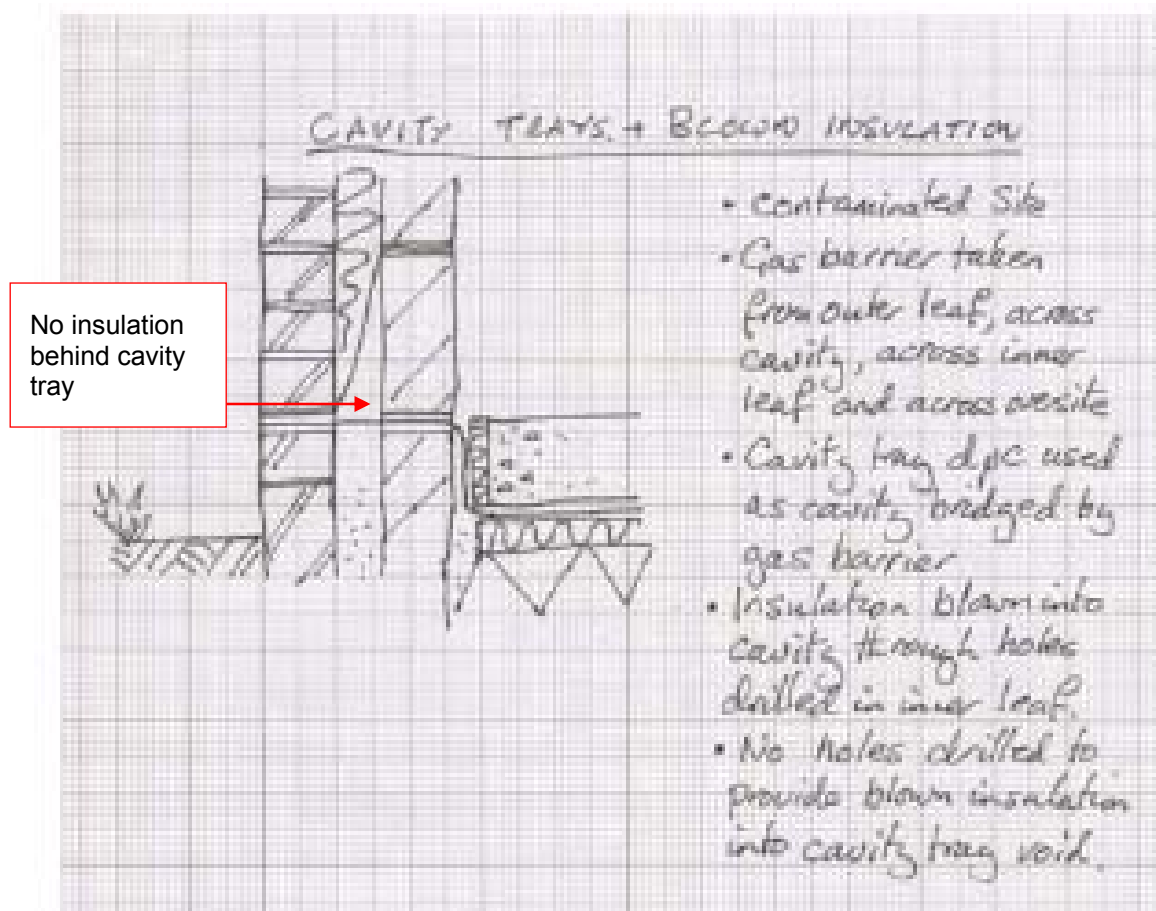
Figure 3.67 Gas barrier and cavity tray at ground floor/external wall junction.

87. The site sketch in Figure 3.67 illustrates the arrangement on one of the full-fill masonry sites. Given that cavity insulation was to be injected from the inside upon completion of the wall, filling this area would be very difficult and, in practice almost certainly omitted. In this case it would be more appropriate to ensure that insulation was placed at the same time as the cavity tray was fitted. Figure 3.68 shows clearly that this was not done, as well as illustrating the age-old problem of keeping the cavity clean. Similar difficulties arise with the placement of partial-fill insulation (see figure 3.69) since if not well fitted below the tray its performance is reduced considerably, almost to the point where it may as well not be placed at all. The effect in both the cases illustrated would be to increase the potential for localised temperature variation, the more so since, as we have discussed above, cavity insulation is often omitted at ground floor slab level. Of course, once the gas barrier is in place the lack of insulation below is hidden from view.

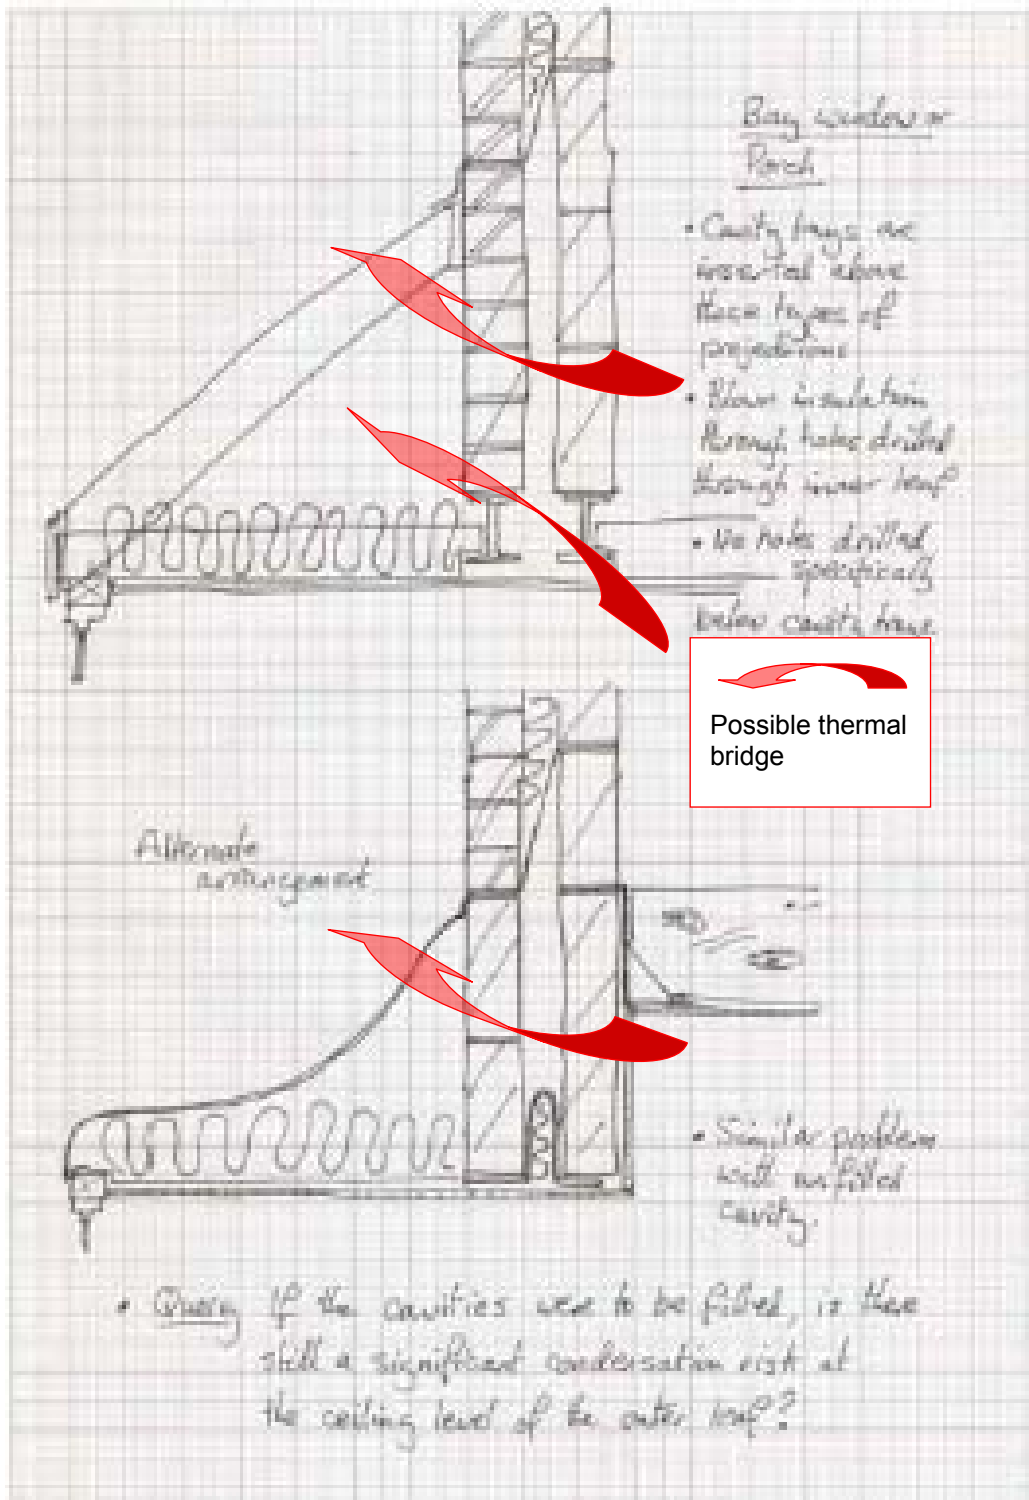
88. The site sketch in figure 3.70 shows a typical arrangement of lintel and cavity tray at bay windows and other projections. In the case of injected full-fill cavity insulation, filling the space below the can be difficult, particularly if there are restrictions such as floor joists. As in the case of cavity trays at gas barriers, placing insulation below the tray as the wall is built would be the only way of reliably avoiding this problem but there was little evidence on full-fill masonry sites that this approach was adopted. Similarly, observations of fill holes indicated that, in a number of cases injection had not taken place below trays. The problem can also manifest itself in partial-fill cavity masonry if access to the space below the tray is restricted; however in this type of construction the problem is more likely to be one of quality of fit rather than omission.

Figure 3.70 Cavity tray arrangements at projections.

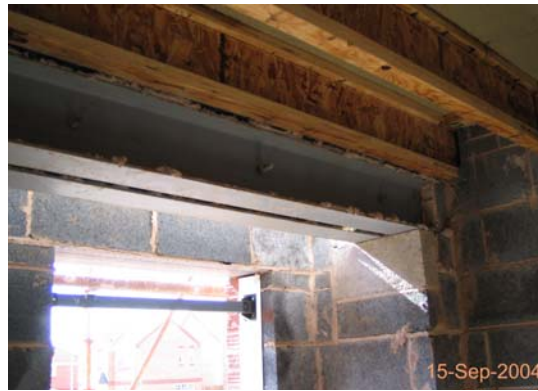
89. Where loads are high, the steel work required is often substantial and insulated lintels are not suitable (top sketch in Figure 3.70). Although there are concerns that insulated combination lintels are either unsuitable or ineffective<sup>1</sup>, of greater concern is the detailing around larger steel sections. Some of these concerns were raised in the context of room-in-the-roof constructions. The Robust Details document gives no guidance on detailing around structural steel and the analysis of design and construction would suggest that the design issues are not well understood. Unless additional insulation were provided at ceiling level across the flanges of the steel beams, the arrangement of the steel work in the top sketch in figure 3.70 and the would give rise to increased condensation risk even if cavity insulation was in place. Similarly, detailing around the steel work in the photograph in figure 3.71 presents a considerable detail design challenge<sup>2</sup>.

Figure 3.71 Steel work at large openings.

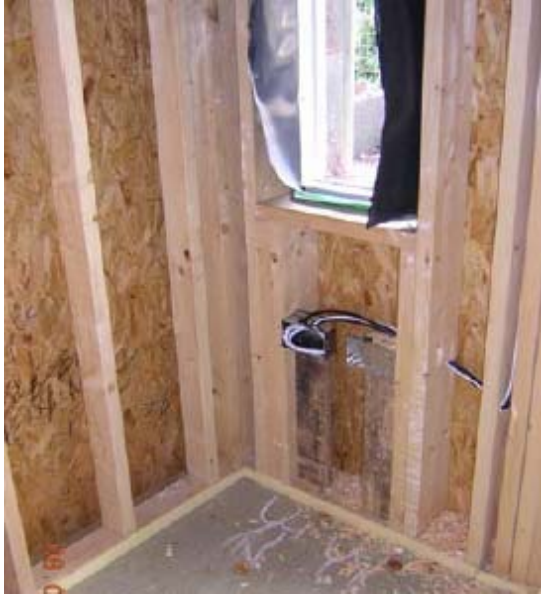
Figure 3.79 Small gap between studs (also, note high timber concentration at corner).

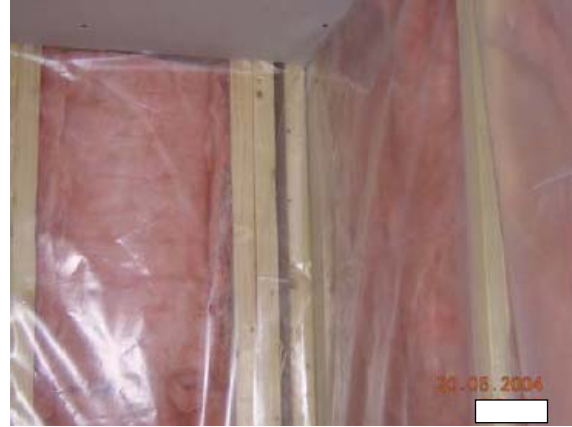
Figure 3.80 Unfilled gap between studs.

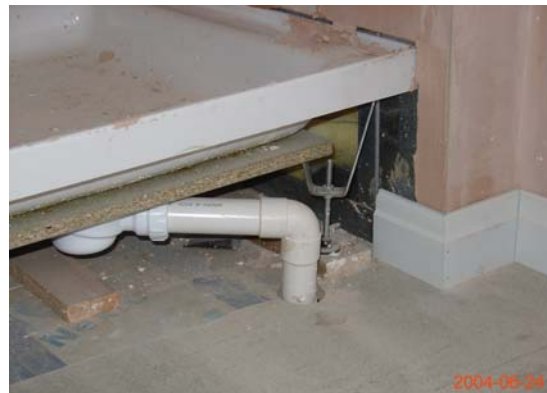
97. The sealing of the junction between wall and floor behind shower trays, baths and kitchen units is rarely done with the same degree of care as in other locations. This can be seen in Figures 3.82 and 3.83 where the internal plasterboard finish is stopped short of the floor (figure 3.82) or cut away to accommodate the fitting (figure 3.83). An air/vapour path is created which can be directly connected to the structural space. In timber frame constructions a polythene membrane is used which is lapped and stapled to the frame but where there is no plasterboard to hold the polythene air barrier tight back to the timber frame, an adequate seal is not achieved at floor level. The fact that these problems occur mainly out of sight behind the fittings in kitchens and bathrooms is of particular concern since these are areas of intermittently high vapour pressure. In warm steel frame construction, it could be argued that air movement, moist or otherwise, in the frame space is of little consequence since the condensation risk is small and a high level of airtightness is maintained as long as the external insulation layer is well fitted and all joints securely taped. This is, of course, a very reasonable position but it places considerable reliance on the integrity of the external layer. Although, on the two steel frame sites, considerable attention was given to insulation and sealing, as indicated in the ground and intermediate floor sections above, this can be compromised at junctions.

Figure 3.83 Plasterboard finish cut away to enable the shower tray to be inset, giving access to the structural space.

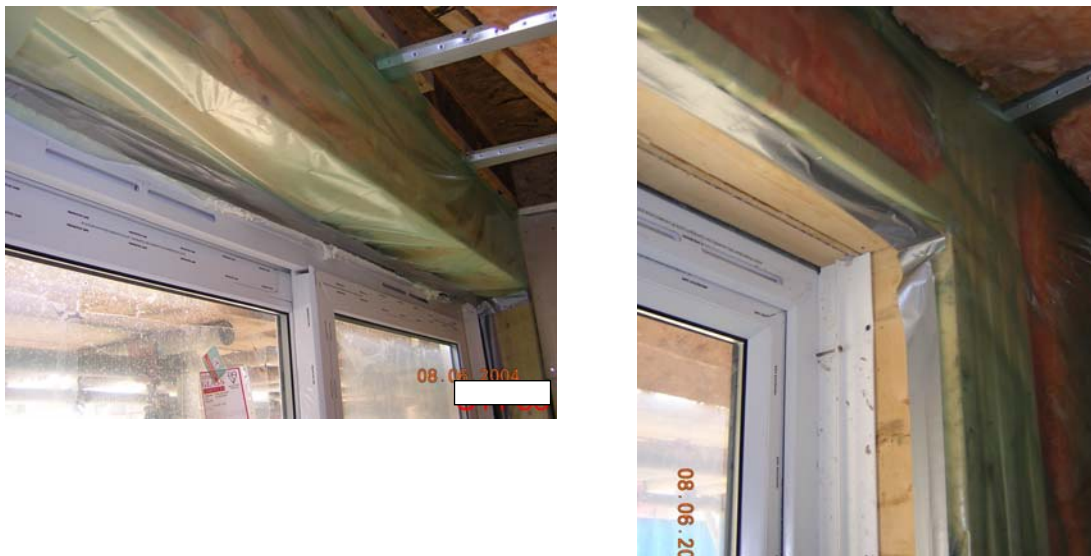
99. In order to ensure continuity of air/vapour control layers in timber frame and hybrid steel frame constructions, section 8 of the Robust Details document recommends that sheet barriers be well lapped, returned into reveals at openings and sealed with the DPC at ground floor level. In general the lapping of sheets was done with care but no lapping with the DPC was observed on any site (figure 3.87 is typical) and sealing into reveals was not dealt with consistently. The arrangement at window and door openings was generally more consistent as in most cases membranes were wrapped into reveals, sills and heads and either stapled or taped (Figure 3.88).

Figure 3.88 Vapour control layer returned in to reveals and window/door heads.

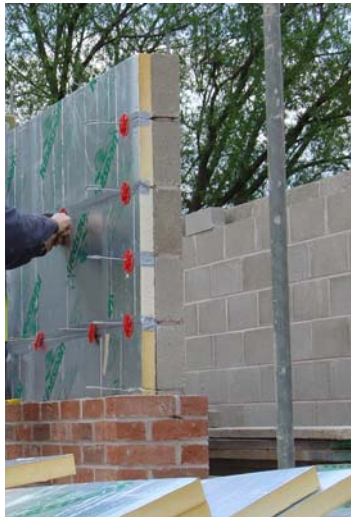
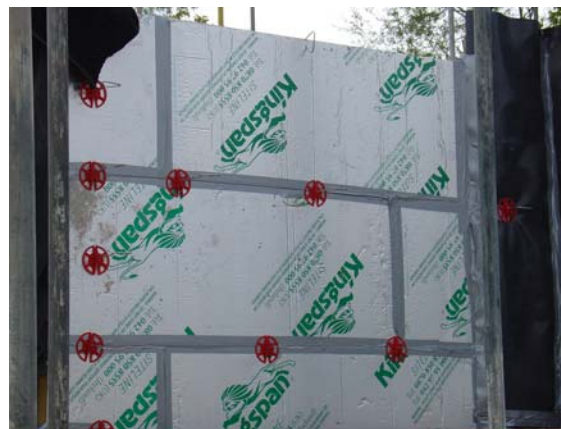
101. An example of good practice in the use of the external insulation layer in partial fill masonry as an airtight layer is provided from observations made on one site where insulation was tightly fitted, clipped in place and all joints sealed with tape (figure 3.90), a practice that is likely to produce a reasonable level of airtight construction by using the insulation layer as an air control layer. However, as with steel frame construction this must be maintained at junctions if it is to be fully effective.

Figure 3.90 Fixing and sealing of partial cavity wall insulation in masonry construction.

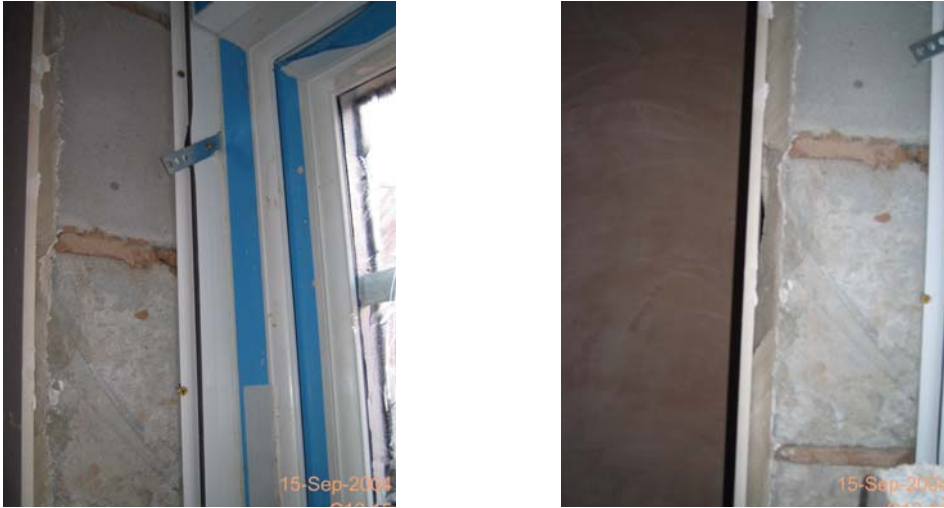
102. Although masonry construction is relatively robust from the point of view of interstitial condensation, as any moisture vapour is able to diffuse through the structure with little adverse effect, the practice of using plasterboard finishes results in relatively poor airtightness, with a consequent impact on thermal performance. It is possible also that moisture laden air within the construction may increase the risk of condensation problems around such things as steel lintels, particularly if insulation is poorly placed. The standard solution to minimising airtightness problems when using plasterboard linings has been to require that the air void behind the lining is isolated with a continuous ribbon of plaster adhesive around each exposed edge. This is the method recommended in section 8 of the RSD document<sup>1</sup>. The evidence that such an approach is not generally applied has been mounting for some time and many believe that, in practice, it is almost impossible to achieve a reliable seal. Of the 10 masonry sites visited only one site had examples that appeared to have achieved a continuous ribbon. Figure 3.91 shows a typical arrangement at an opening, with the adhesive applied as dabs rather than a continuous ribbon and leaving an air void that can be as much as 20mm thick. The one case site that proved to be the exception is illustrated in figure 3.92.

Figure 3.92 Continuity of plaster adhesive - an unusual case.

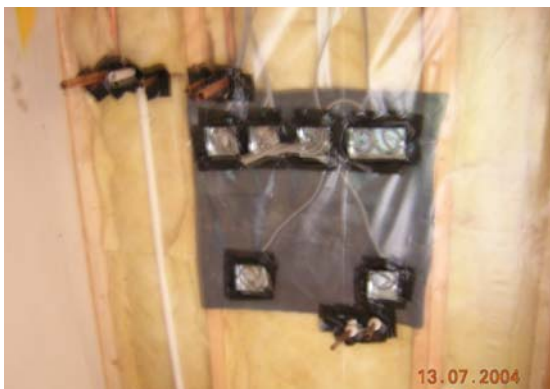
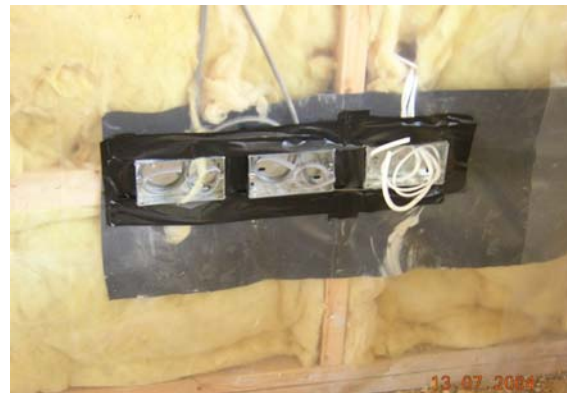
104. It is tempting in a project of this nature to emphasise the negative aspects of detailed construction, however a number of examples of attempts at a more careful approach have also been observed. Figure 3.96 shows a reasonable attempt to seal the services passing through the air/vapour barrier within timber framed construction. In this case a polythene backing membrane has been inserted behind the cable boxes, the polythene air barrier carefully cut for electrical boxes and pipes and the services generously taped to the main polythene air/vapour control layer. Although it would be more robust to have included a services void (as discussed below) this is, probably, the most practical solution in the circumstances although not very robust in the long term. The only air paths that have not been fully sealed is the cable entry into back-boxes and some leakage around the boxes themselves, the backing membrane not withstanding. This is an interesting example of how the principles in Robust Details, such as those expressed in section 8 of the Robust Details document, are being interpreted.

Figure 3.96 Sealing and taping of services entries in timber frame construction.
