Ogunmakinde, O and Egbelakin, T and Omotayo, T and Sojobi, A (2023) Seismic vulnerability and inventory of at-risk elements in the wine industry: Auckland region case study. Structures, 58. pp. 1-14. ISSN 2352-0124 DOI: <https://doi.org/10.1016/j.istruc.2023.105346>

Seismic vulnerability and inventory of at-risk elements in the wine industry: Auckland region case study

Olabode E. Ogunmakinde^a, Temitope Egbelakin^b, Temitope Omotayo^{c,*}, Adebayo Sojobi^d

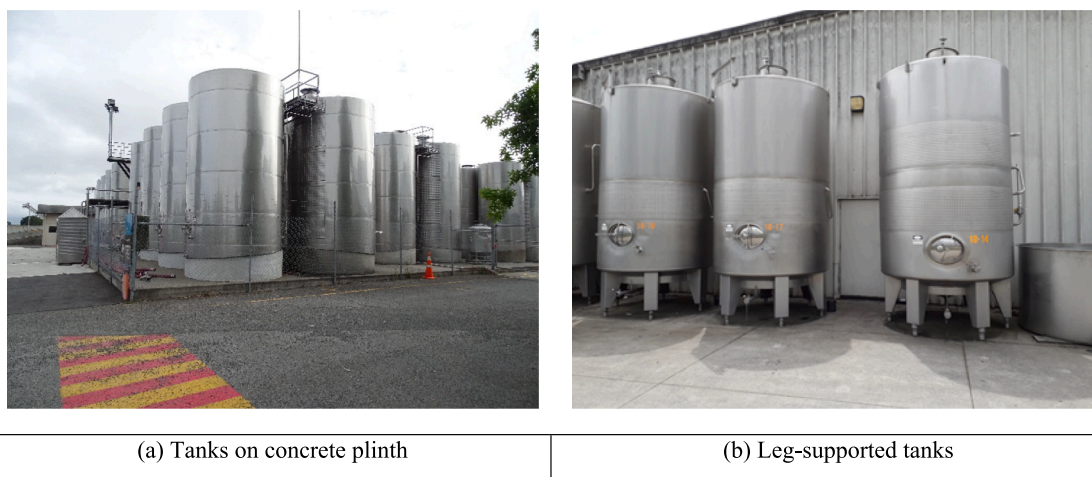
Compared to other winery structures, storage tanks typically experience higher levels of failure during earthquakes [11]). While steel tanks are preferred in the wine industry, they are more prone to earthquakes than concrete tanks [20]. Plinth-mounted and legged tanks are two types of tanks with different methods of failure [16,33]. The type and capacity of the tank are important factors when determining vulnerability. Sometimes the tank's design is a 'weak link' in the failure of the wine tanks [11]. Plinth-mounted tanks (see Fig. 1a) with 60,00–300,000 L capacities are installed on a concrete base [24]. Plinth tanks suffer damage to anchorage systems, walls, skirts, and connection points, while the most common damage to the plinth tanks is anchor failure. Leg-mounted tanks (see Fig. 1. b) typically have a capacity of 5,000–60,000 L and are generally supported by a frame system [24]. The performance of the leg-supported tanks showed that these tanks sustained damage to the legs, tank skirt, bracing, roof and storage systems. According to Dizhur et al. [11], the extent of damage sustained in storage tanks depends on the size and design of the tank.

Fig. 1. Two different tank types.

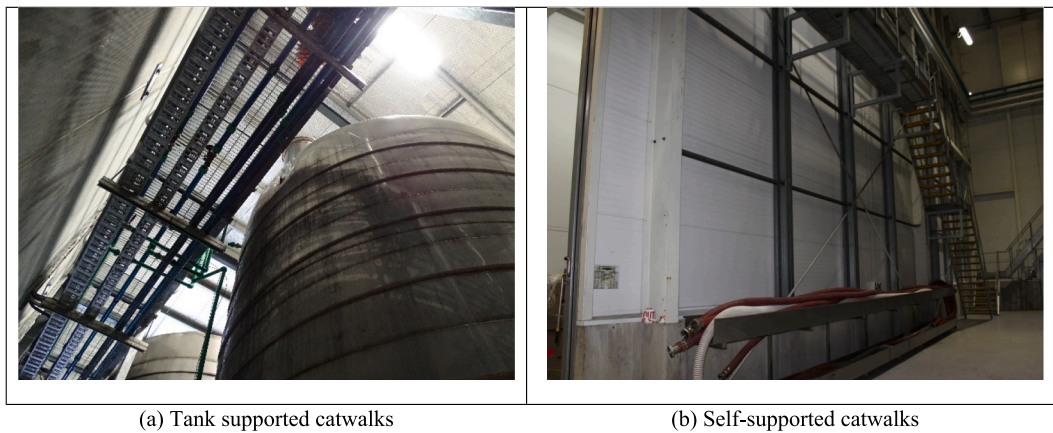
Catwalks (Fig. 2) are access systems easily damaged by their connection to the storage tanks [24]. Determining the vulnerability and level of damage depends on whether the tank supports the catwalks (see Fig. 2a) or self-supported (see Fig. 2b) [11]. Self-supported catwalks showed almost no signs of damage, only minor denting during the past earthquakes [33]. On the other hand, Tank-supported catwalks showed large amounts of damage, especially in systems where no movement was made between the connection points of the tank and the catwalk [33]. Catwalks are directly linked to storage tanks, and damage to one of these elements usually damages the other [11]. As catwalks are expected to be designed by an engineer and have the approval to build, it is unlikely they will be used in smaller wineries.

Fig. 2. Catwalk types commonly used in the wineries.

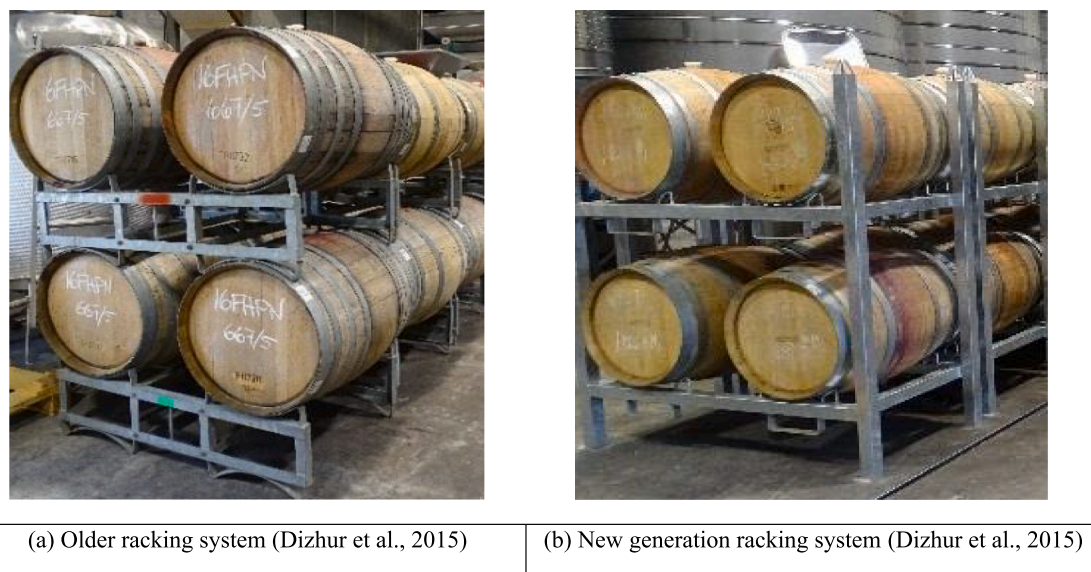
South Napa earthquake [17]. Occasionally, wooden rails are used to store barrels and perform the same function as the old steel rack, as described by Dizhur et al. [11], which implies that wooden and old steel rack systems have limited seismic resilience. New structural design standards for barrel racks have recently been introduced in New Zealand, resulting in a more robust rack design [11]. The performance of the old and new storage rack design was observed in the Kaikoura earthquake of 2016, where the older design system (see Fig. 3a) experienced failure. In contrast, the newer rack system, a kind of seismic reinforced design (Fig. 3b), experienced only limited movement [11].

Fig. 3. Two generation of racking system.
