Glew, DW and Smith, M and Miles-Shenton, D and Gorse, C (2017) Assessing the quality of retrofits in solid wall dwellings. International Journal of Building Pathology and Adaptation. ISSN 2398-4708  
DOI: <https://doi.org/10.1108/IJBPA-05-2017-0022>

**Assessing the quality of retrofits in solid wall dwellings**

The purpose of the paper is to provide a detailed appraisal of the quality of domestic retrofits.

This paper presents the results of technical surveys on 51 retrofits undertaken before, during and after the retrofits.

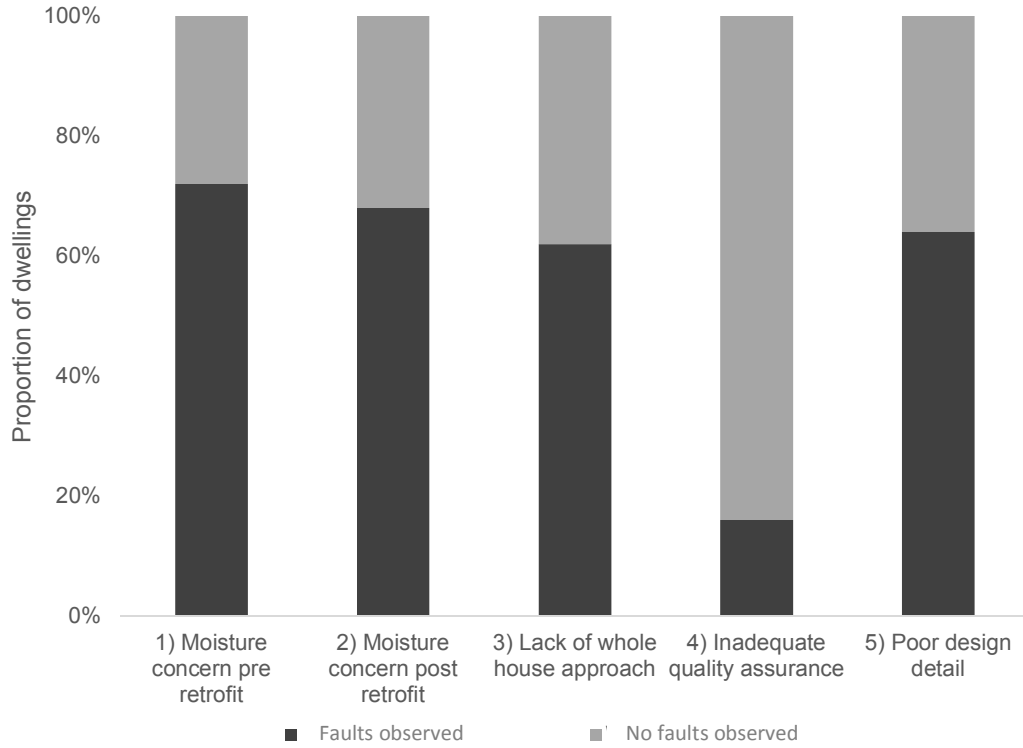
Figure 1 Proportion of dwellings with observed faults

From this process five retrofit failure categories emerged which characterised the vast majority of all the observations; 1) Moisture issues pre retrofit, 2) Moisture risk post retrofit, 3) Lack of whole house approach, 4) Inadequate quality assurance, 5) Insufficient design detail. Figure 1 shows the proportion of homes exhibiting each of the 5 issues; the majority exhibited multiple failure types. The following sections describes each category in turn.
