Taylor Wimpey – Thermal Imaging Project

Site: Newton Farm
 Cambuslang
 G72 8QF

Visit Date: 13th November 2017

Plot(s): 268
 267

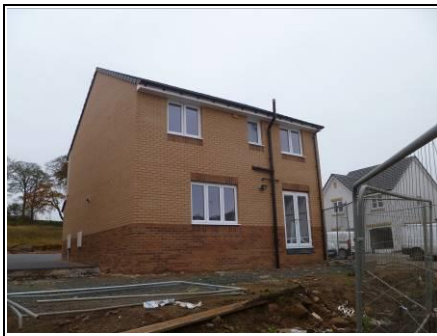
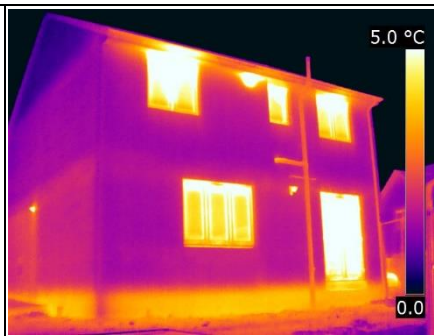
<p>As expected the house appears cooler at loft level on the gables, not so expected was that the gable wall would be warmer than the external surface of the rest of the house. This appeared due to the boiler placement in the garage and the much lower thermal resistance of the external wall at the garage:</p>
		<p>A warmer strip was visible on both gable walls around the intermediate floor void, where the floor joists run normal to the walls, but less so on the front and rear façades where the joists run parallel to the external walls. The difference in elevations suggests that may be due to difference in floor perimeter detailing, but is complicated by heating pipes running through the floor void:</p>

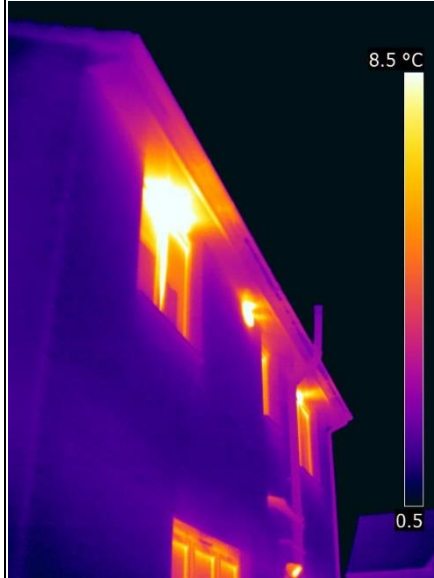
The ground floor perimeter was much warmer than the rest of the external wall. It was unclear whether this was expected or unintended heat loss at ground floor perimeter. Additional heat loss was observed at the patio door threshold which was not completely finished.

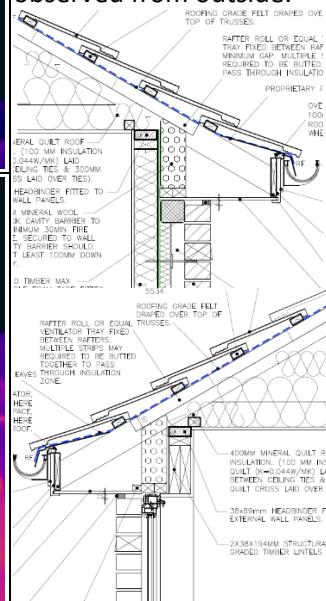
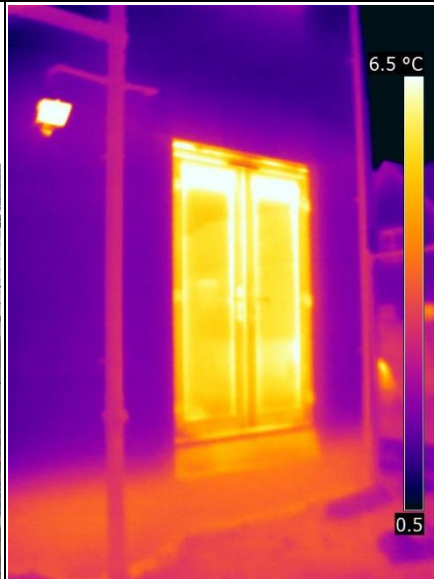
As the trickle vents had been left open it was difficult to see if the warmer sections of boxed eaves were due to thermal anomalies or due to warm air venting out. As such, any potential difference between the thermal performance of the solid timber above the windows and the insulated panels between them could not be observed from outside:

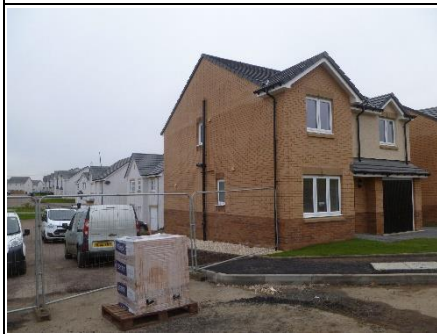
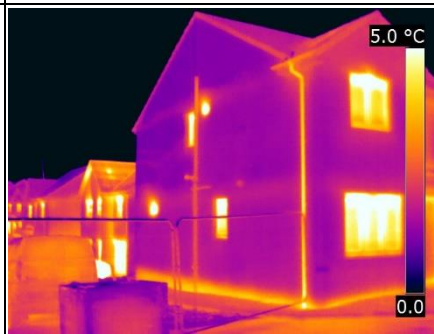
Similarly, the gable windows on the front elevation appeared to show different levels of thermal performance from outside, particularly at the window heads and gable above. However, on internal inspection it appears most probably due to the trickle vents being left open in Bedroom 2 (above the garage) and closed in Bedroom 1 prior to the thermal survey being undertaken.

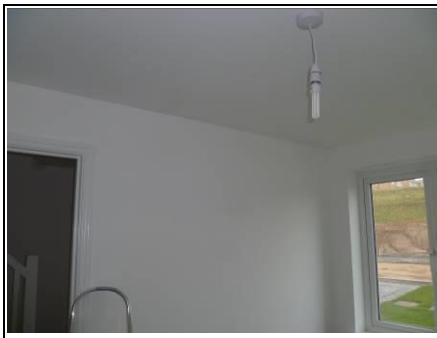
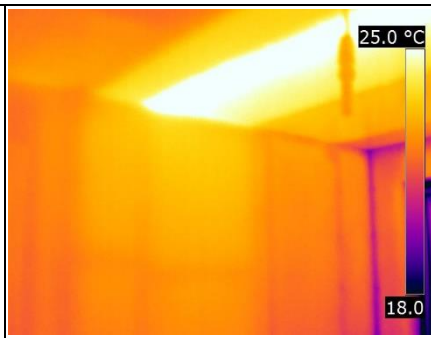
Where the internal wall with the hall becomes external wall there is a sharp drop in surface temperature, particularly at patches just above the base of the wall panel.

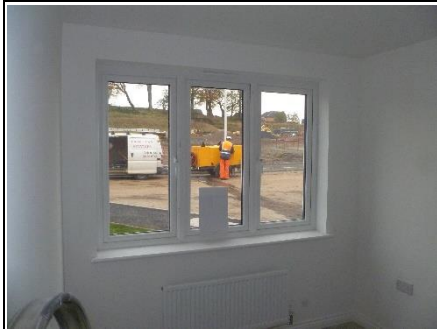
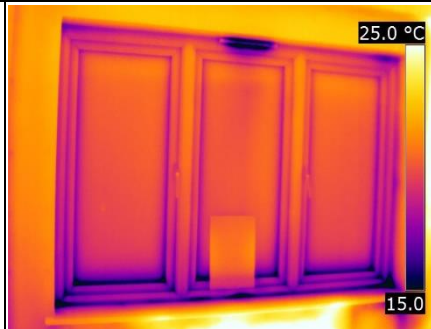
The cooler vertical members of the timber frame were clear on the thermal images, with warmer insulated sections between. Cooler horizontal timbers at the ground floor and intermediate floor coincided with warmer areas viewed from outside.

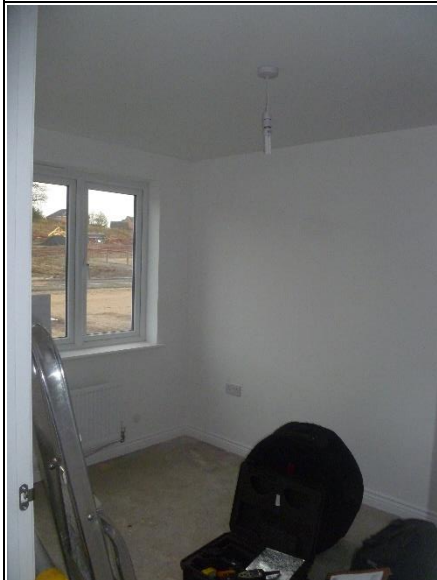
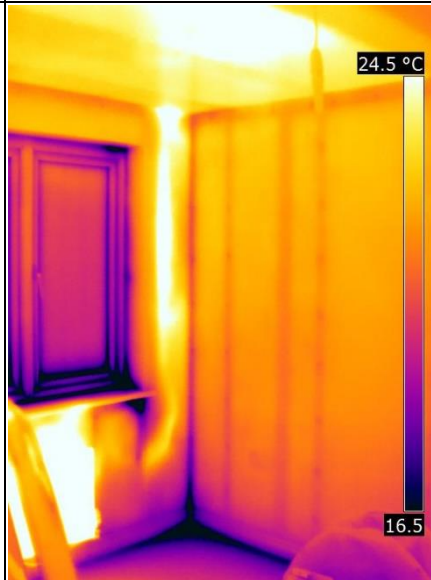
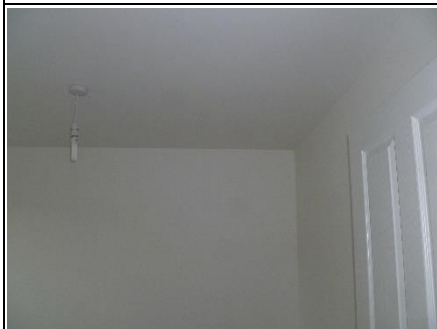
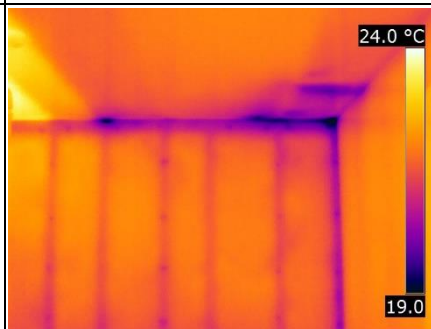
Stratification of the voids between the joists in the intermediate floor appeared to be driven by the positioning of the heating system pipework.

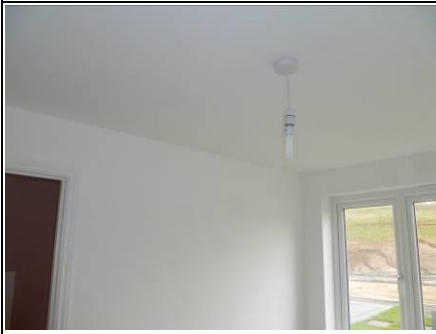
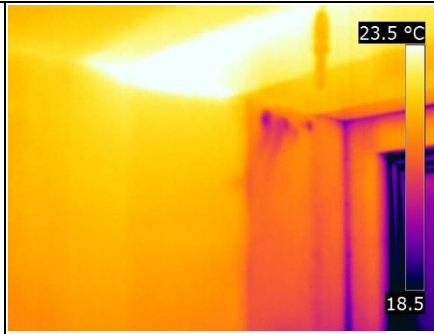
The differences in surface temperature of the hall/external sections of the same wall appeared to increase under depressurisation, with a number of points at the top and bottom of the external wall section indicating air movement into the wall panels.

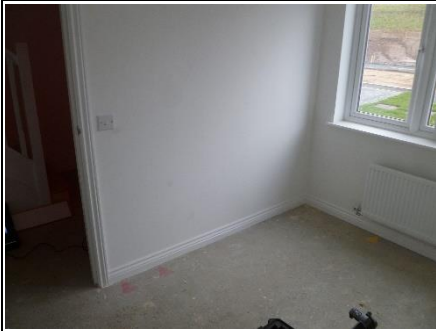
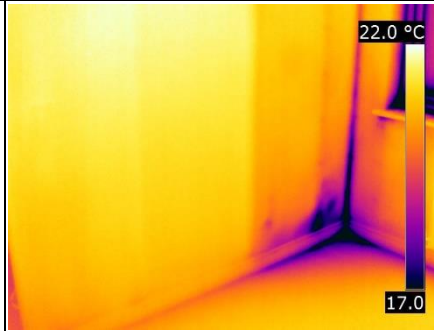
Although the window seals appeared to work well, infiltration between the window frame and opening was apparent, particularly around the sill board.

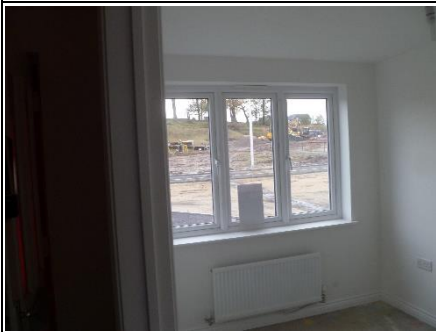
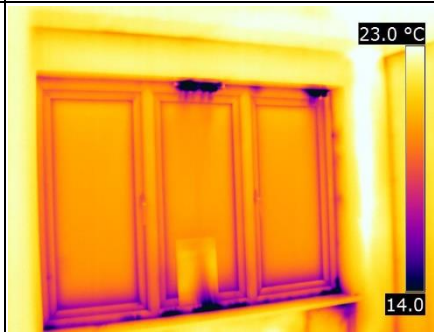
The stratification of the intermediate floor void and cooler sections at the floor junctions did not seem to change much under depressurisation for their appearances under natural pressures, suggesting these were due to thermal issues rather than air movement.

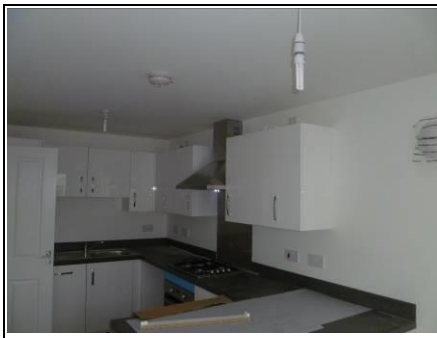
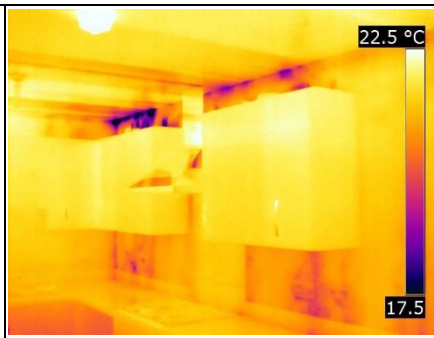
Under depressurisation air infiltration was detected emerging around a number of service penetrations; above the kitchen units this air appeared to be drawn from the intermediate floor perimeter as this was where it looked coolest, below the kitchen units the emerging air appeared to be spreading up from the ground floor.

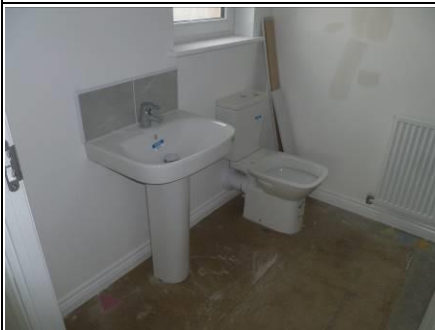
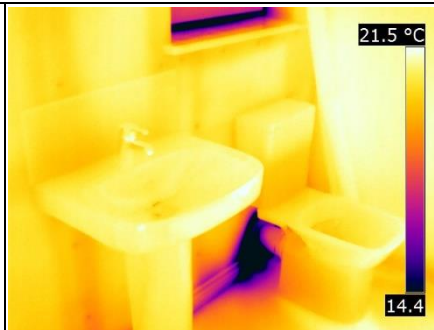
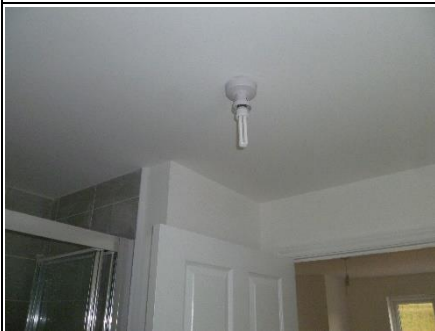
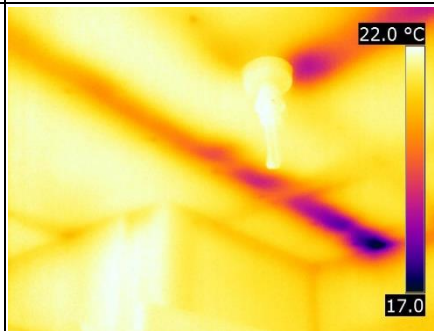
En-Suite – Under natural conditions

Colder areas are visible around the wall penetration to the external soil pipe from the toilet and on the ceiling where the loft insulation might not be in direct contact with the ceiling plasterboard.

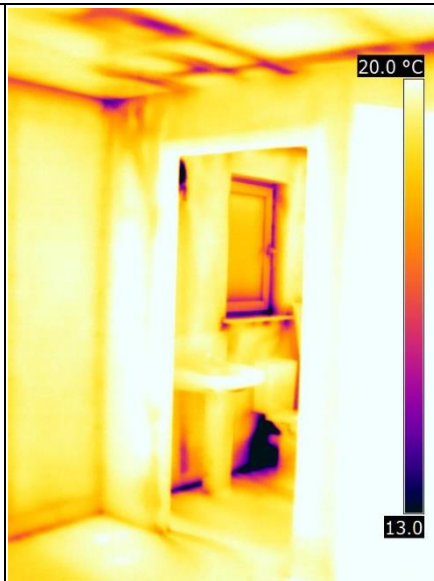
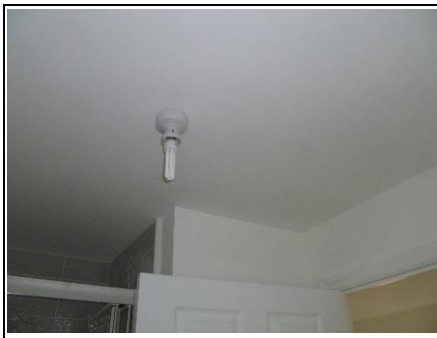
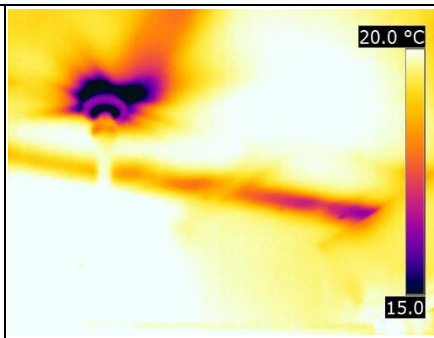
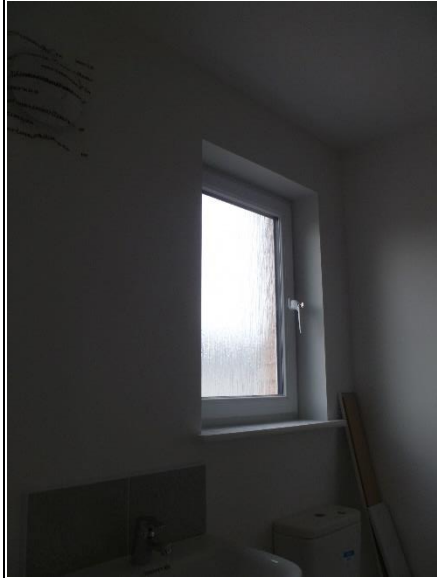
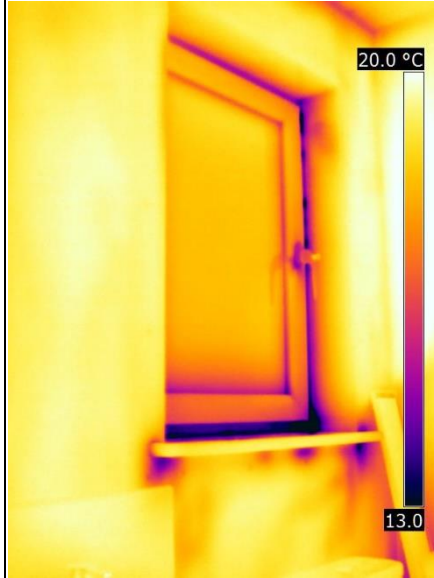
En-Suite – Under depressurisation

Under depressurisation the usual issues are apparent around the window as seen elsewhere throughout the house.

Air infiltration around the soil pipe penetration appears significantly worse, as does the air flow from the loft being drawn in around the central light fixing.

Air is also detected entering at the intermediate floor junction with the external wall, it is unclear whether this is entering around the soil pipe penetration and tracking across

behind the skirting and there is a only a very slight increase in emerging air temperature moving away from the penetration.

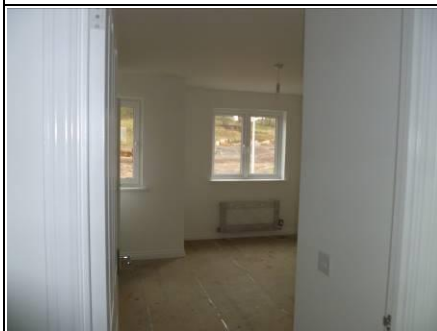
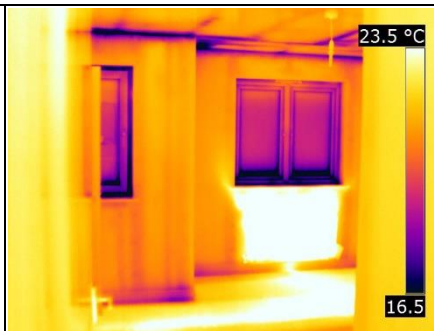
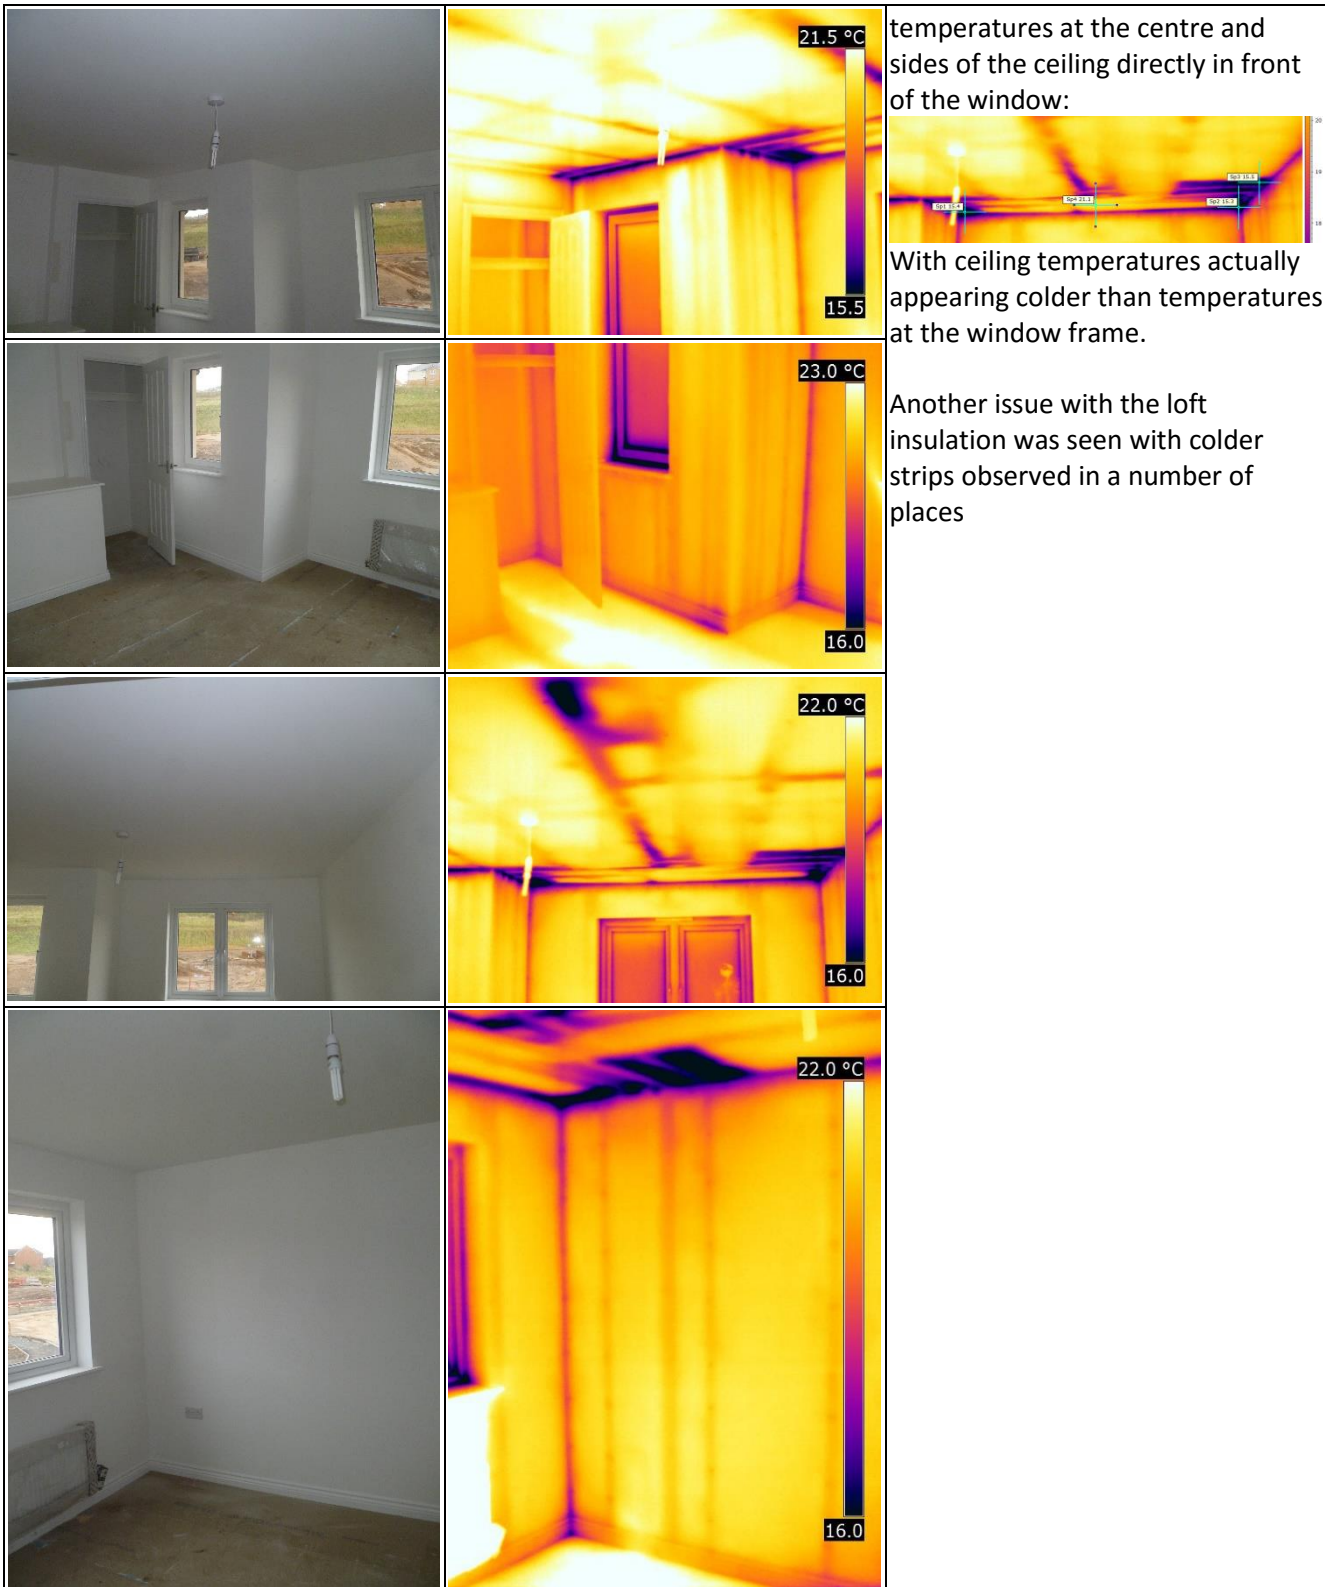
Bedroom 1 – Under natural conditions

The ceiling at the eaves junction is very cold in places suggesting that there is a lack of insulation in places, with additional roof timbers present to support the gable roof this may have presented difficulty in installing the loft insulation adequately. The result is a 6° difference between surface

temperatures at the centre and sides of the ceiling directly in front of the window:

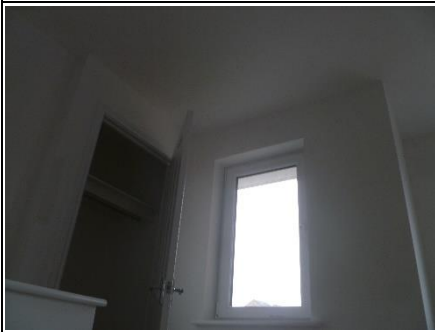
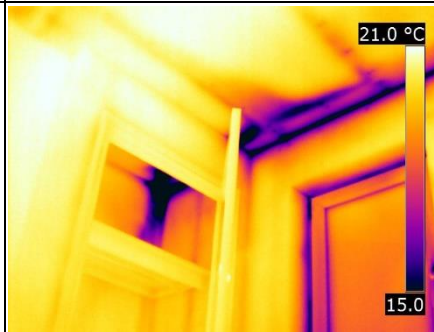
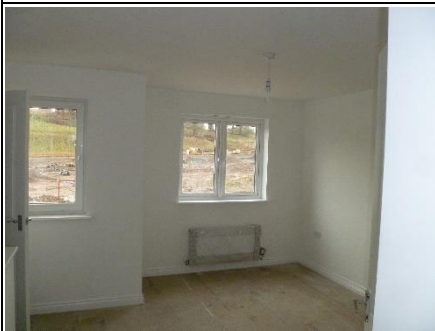
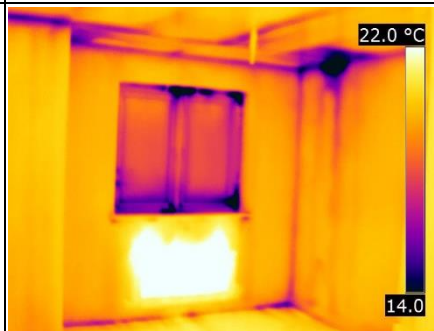
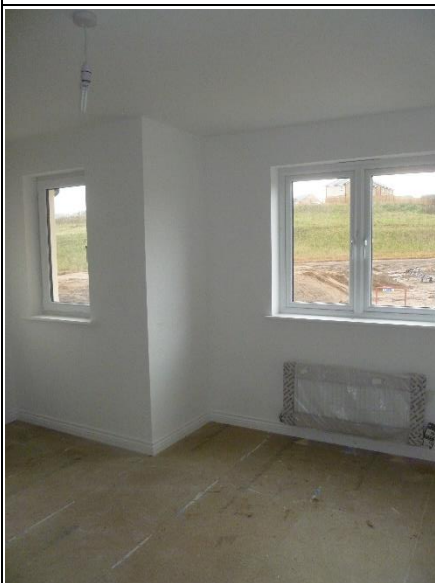
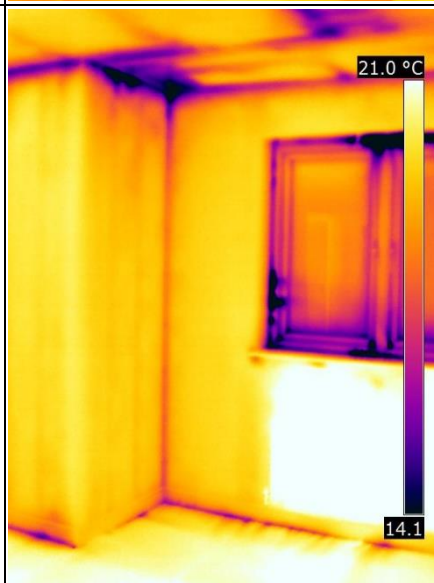
Under depressurisation cold air could be observed spreading out from the previously identified colder areas and being drawn down the external wall panels.

Air infiltration was detected again around the window and at the intermediate floor junctions with the external walls

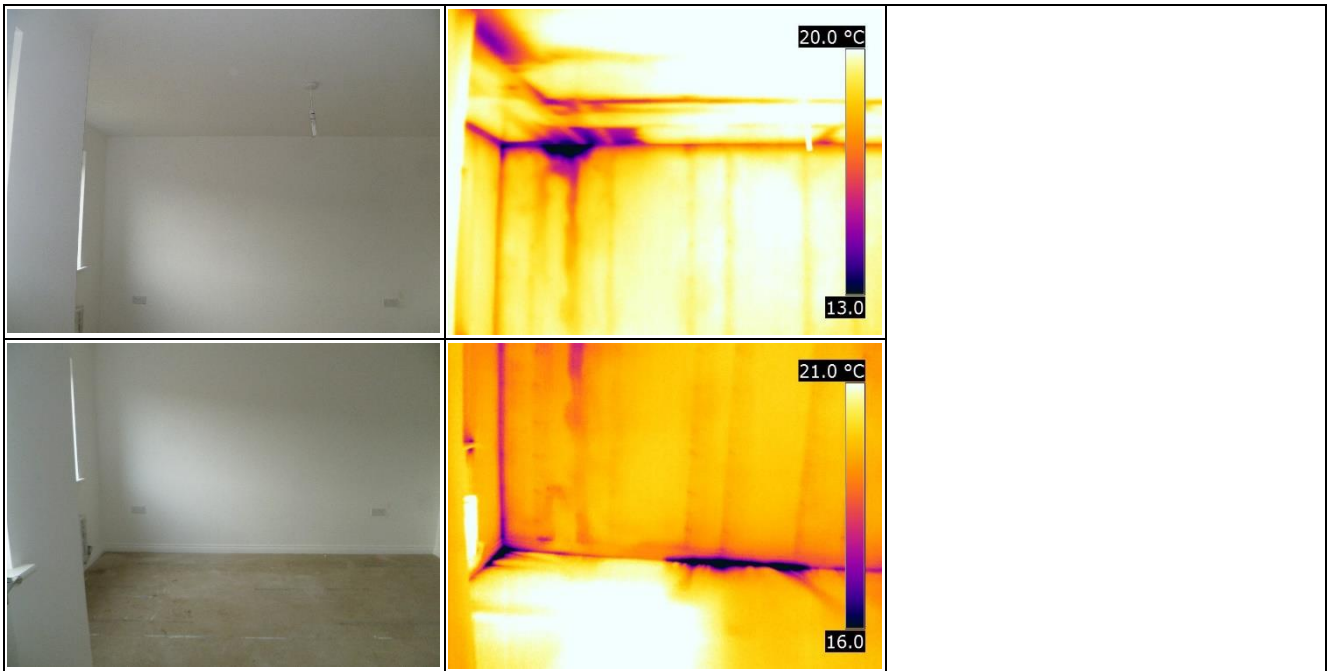
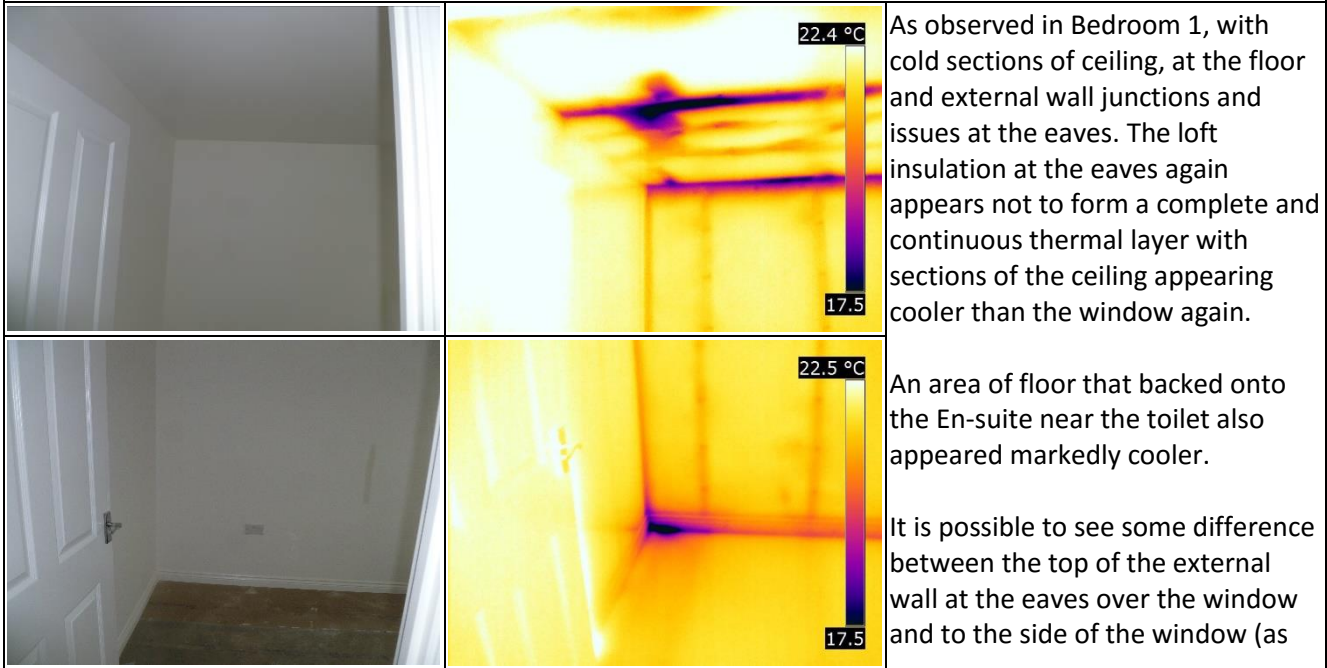
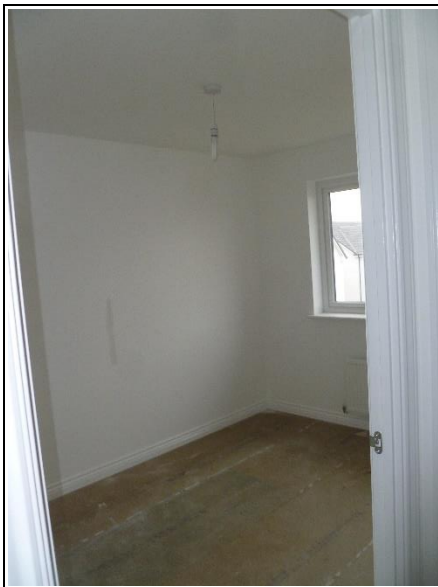
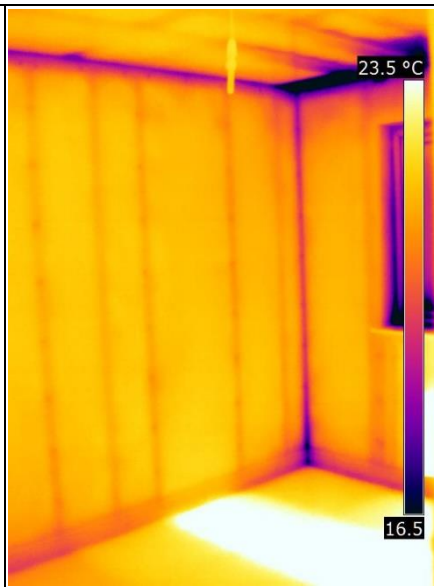
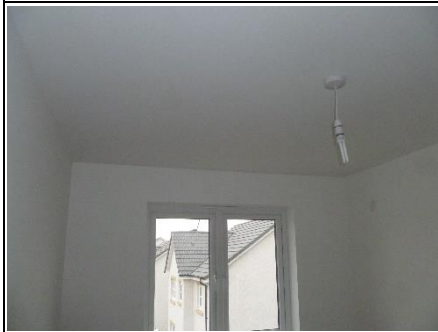
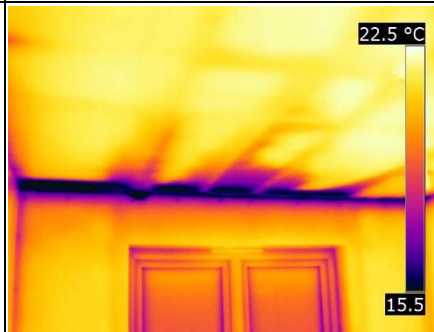
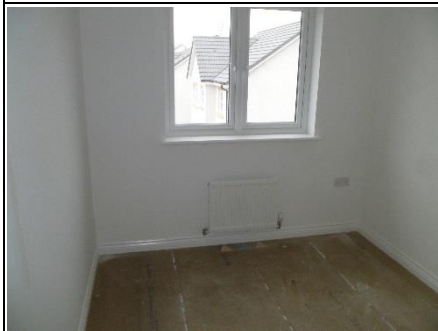
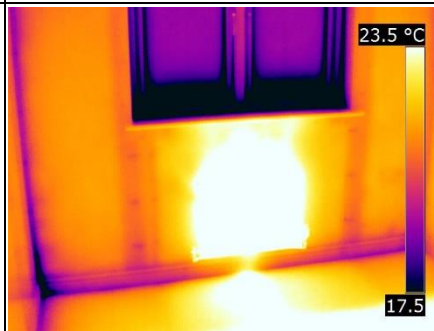
Bedroom 4 – Under natural conditions

noted on page 4) but this is only slight.

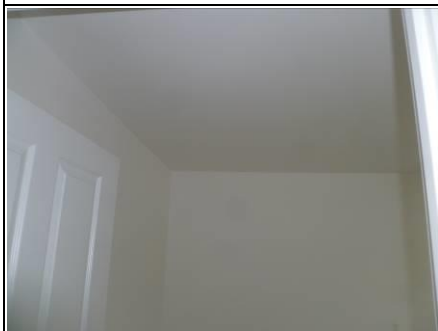
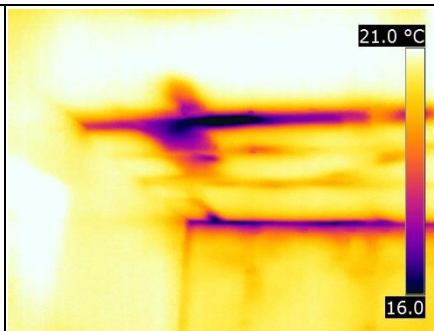
Bedroom 4 – Under depressurisation

Most of the observations made under natural conditions were exacerbated under depressurisation.

Air infiltration was again detected around the window and intermediate floor perimeter.

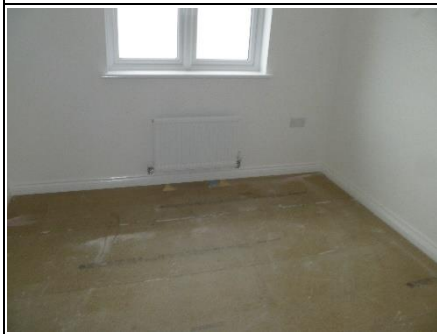
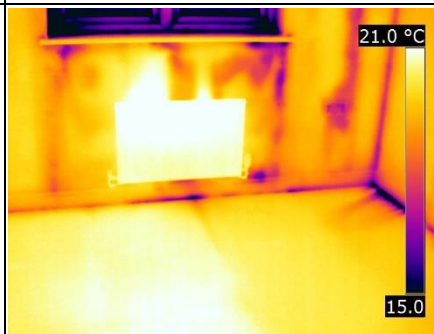
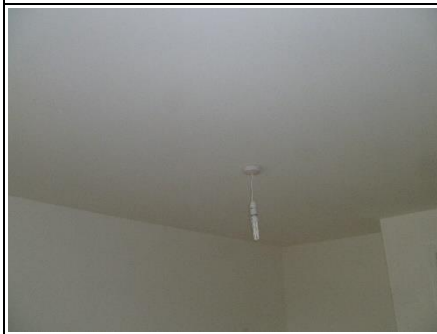
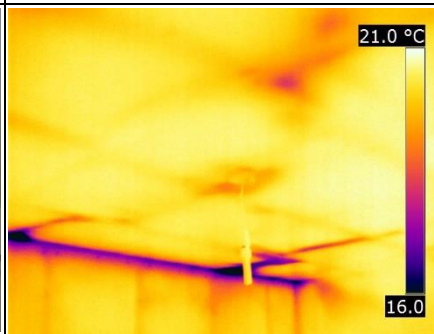
Some air leakage was also detected at the intermediate floor junctions with the external walls and at the internal wall backing on to the built-in wardrobe in Bedroom 2 above the garage.

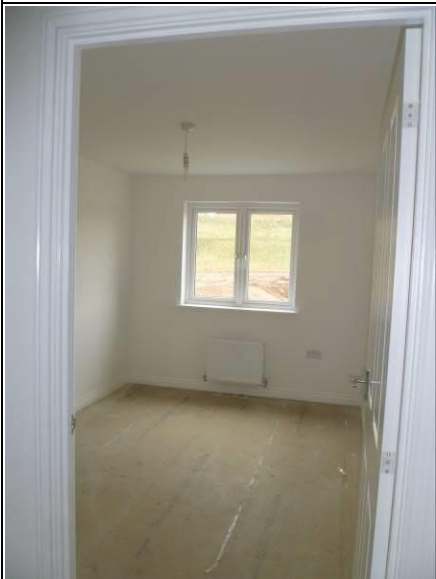
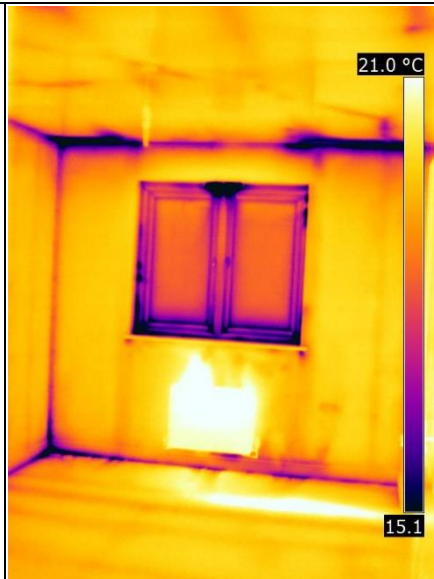
Bedroom 2 – Under depressurisation

Repeating what was seen in the other bedrooms; however, with increased infiltrations observed around the intermediate floor perimeter, particularly at the built-in wardrobe.

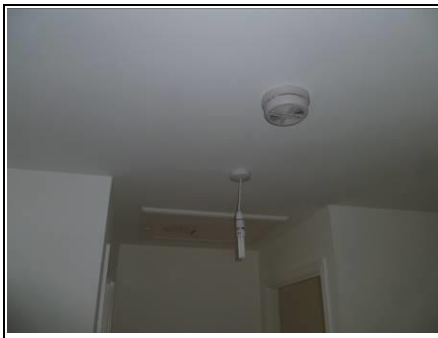
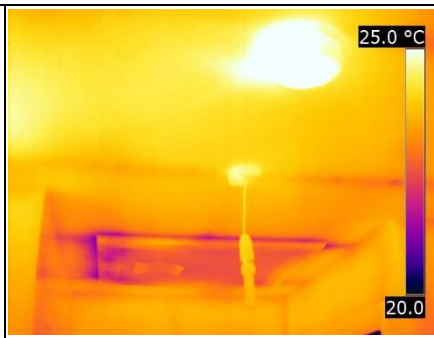
Some colder areas are visible where the loft insulation appears to not be in direct contact with the ceiling plasterboard.

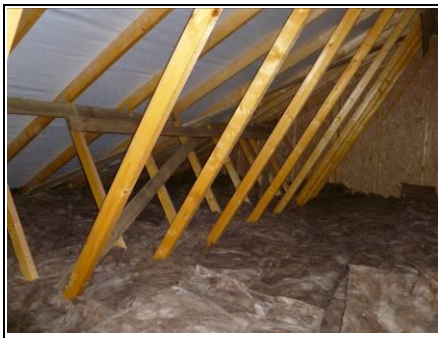
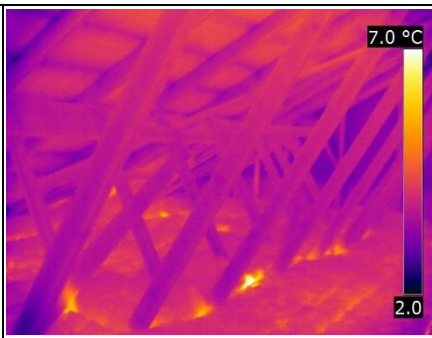
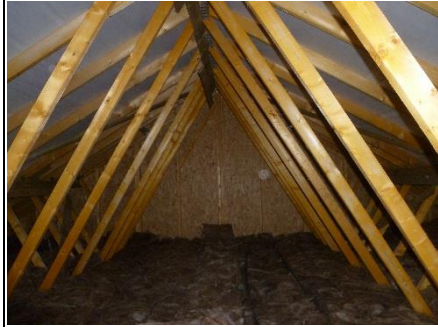
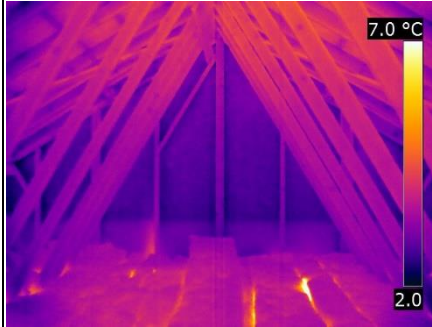
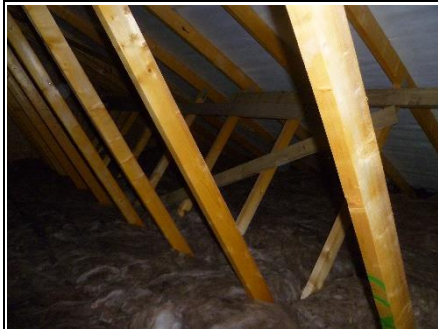
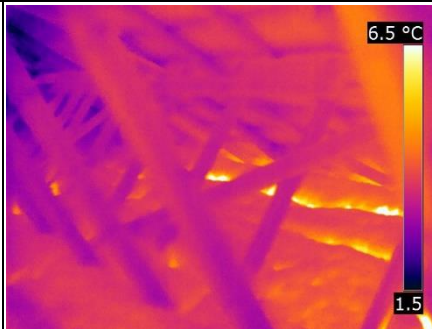
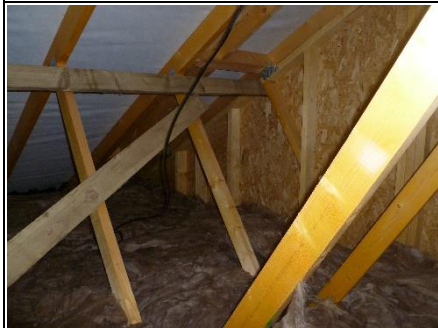
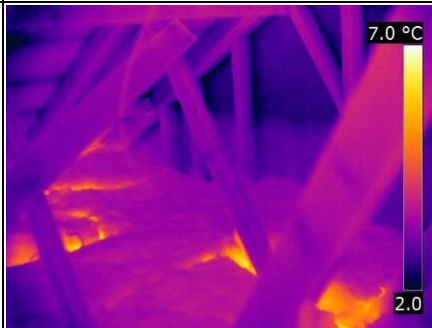
Landing – Under depressurisation

Looking towards the gable wall above garage hot spots can be seen around the angled junctions of the trussed rafters and between gaps in the uppermost layer of loft insulation between the rolls.

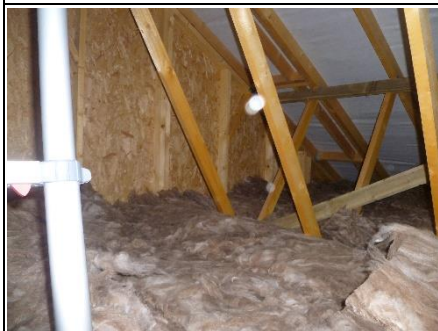
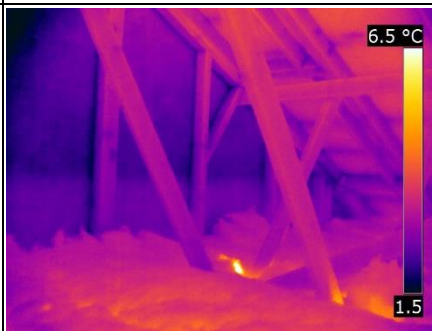
Looking towards the opposing gable wall similar observations are made.

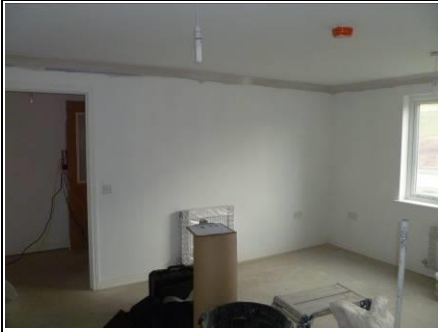
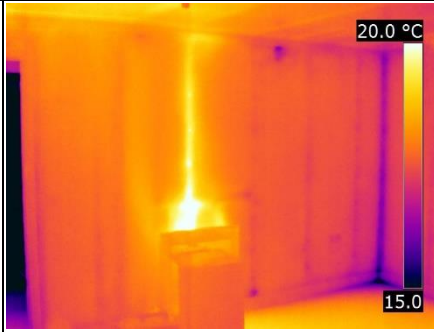
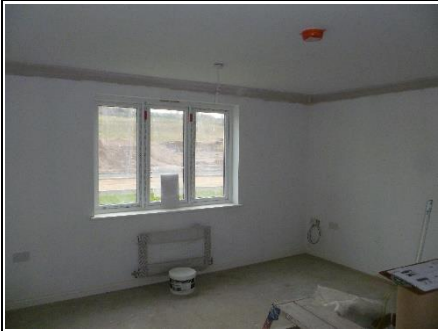
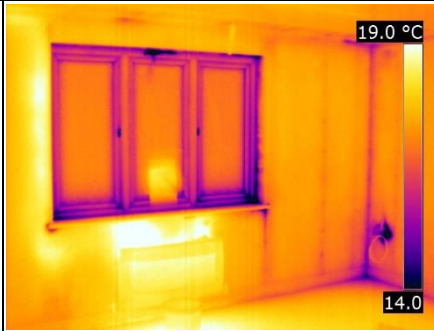
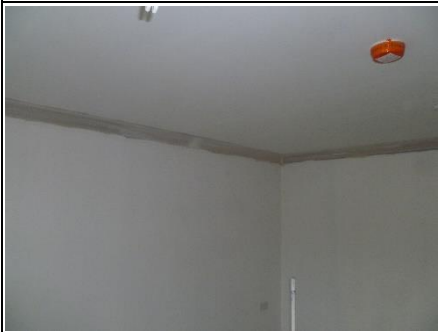
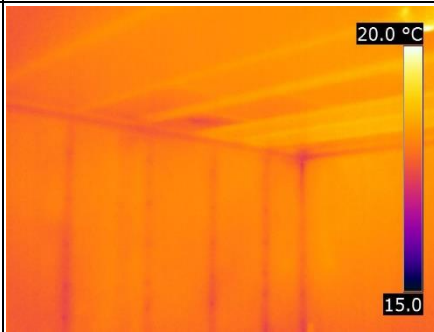
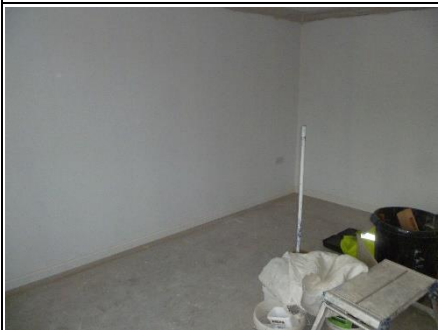
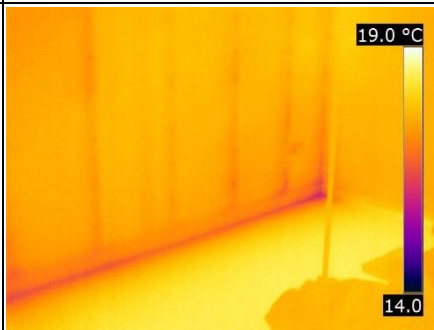
Lounge – Under depressurisation

Under depressurisation the previously observed infiltration paths understandably worsened, as in plot 268 there were noticeable air paths around the sill board.

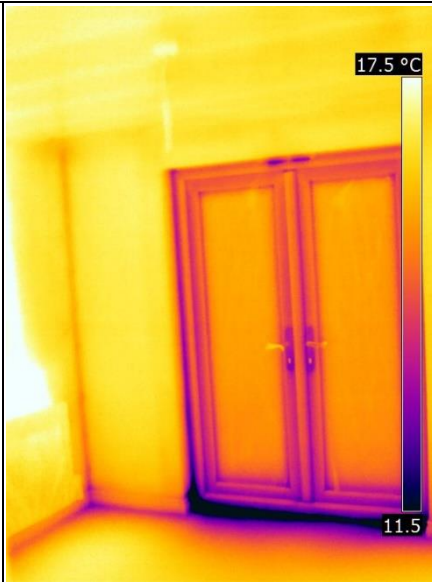
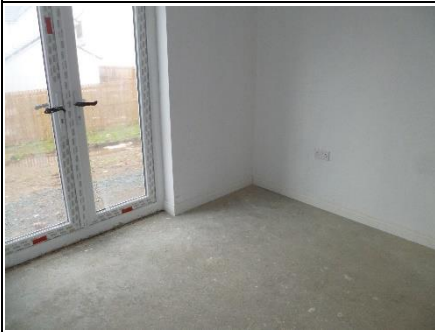
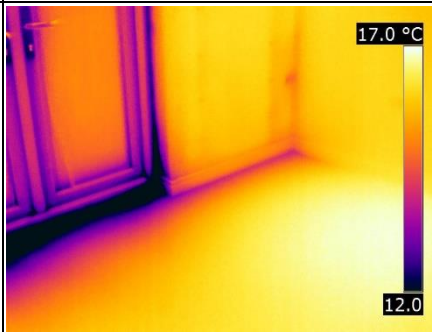
Dining – Under natural conditions

The patio doors appeared much like those in the Family/Breakfast Room in plot 268, with a very cold section at the infilled section at the threshold.

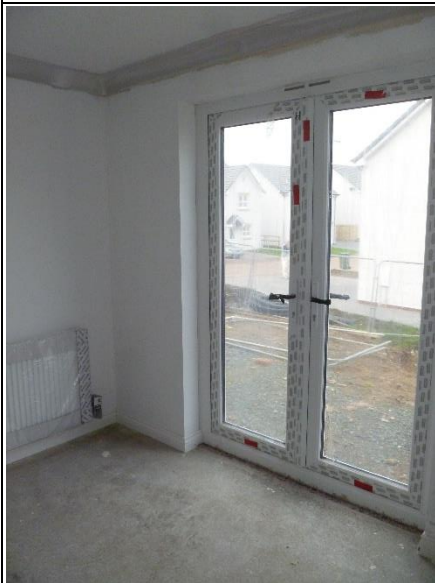
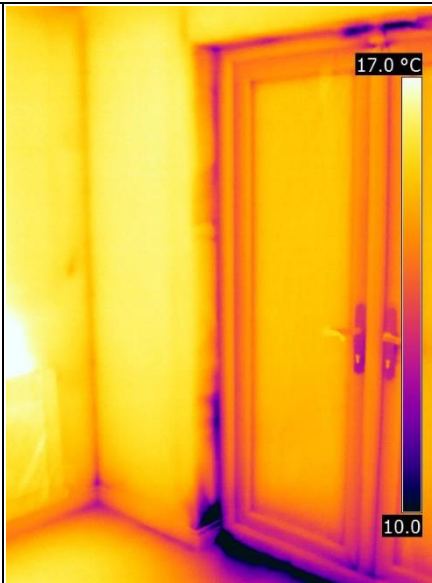
Dining – Under depressurisation

The patio doors themselves appeared to prevent air movement through them very well, with just a small amount coming through at the top and bottom of the doors; however there was more significant air movement around the frame and up into the walls on either side of the infilled section between the floor slab and door frame.

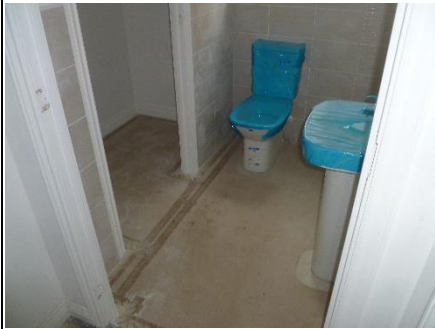
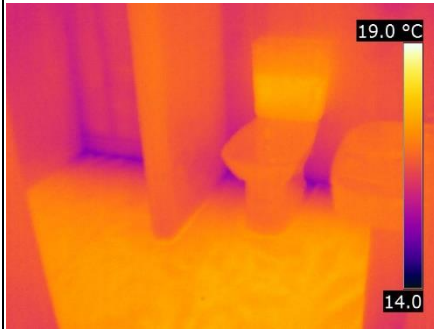
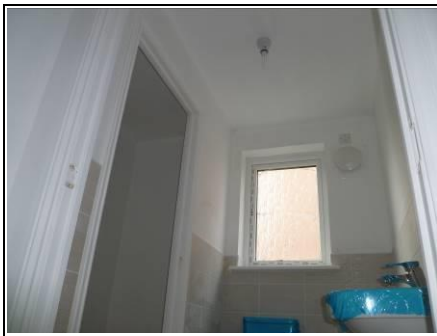
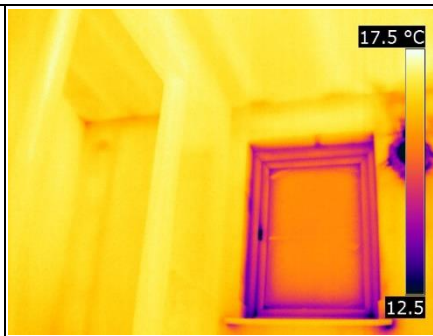
Ground Floor WC – Under depressurisation

Again, there were no major issues detected on a 5° span, there may be some air infiltration into the wall around the penetration for the extract fan but nothing significant.

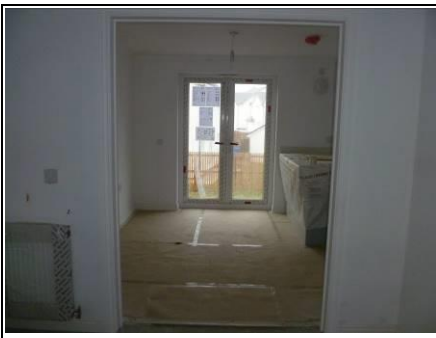
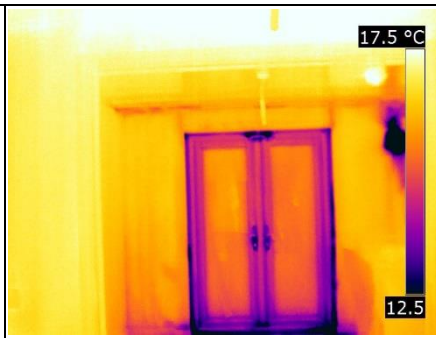
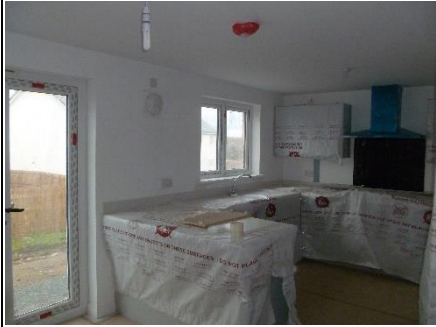
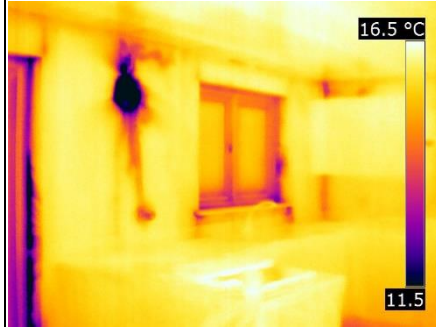
Family / Kitchen – Under depressurisation

Under depressurisation the previously observed infiltration paths worsened and air leakage around and below the windows were now apparent.

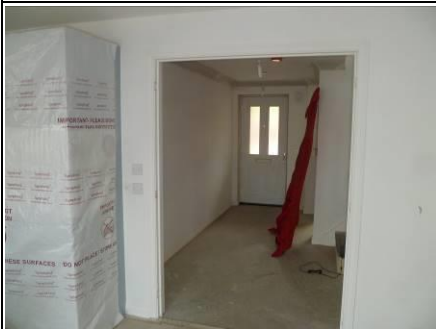
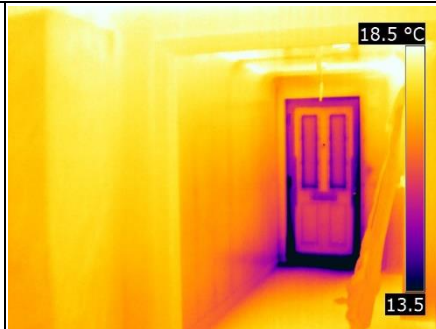
Hall – Under natural conditions

The garage wall appeared to have a similar surface temperature to the other internal walls.

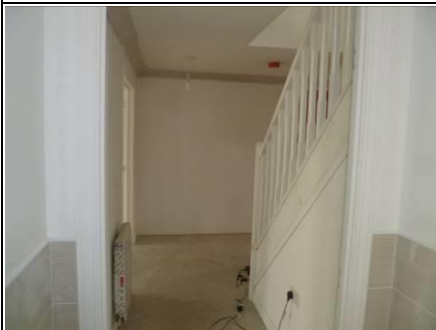
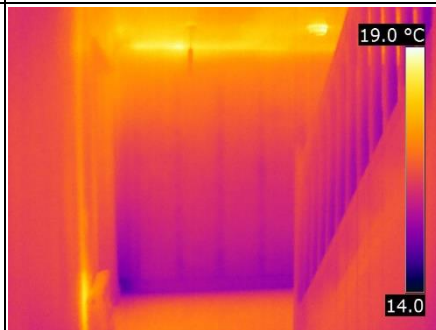
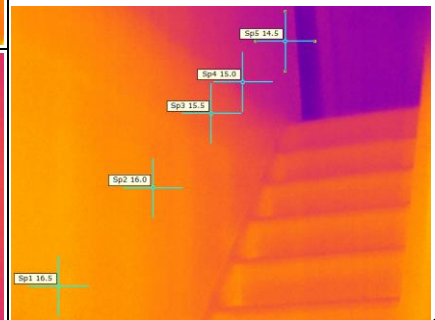
Without loft insulation the temperature of the wall surface backing onto the Lounge going up the stairs:

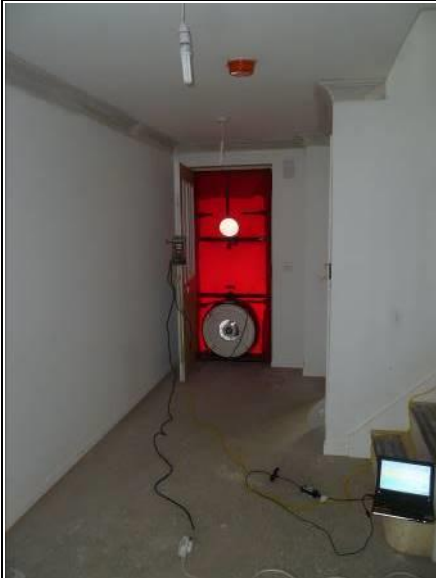
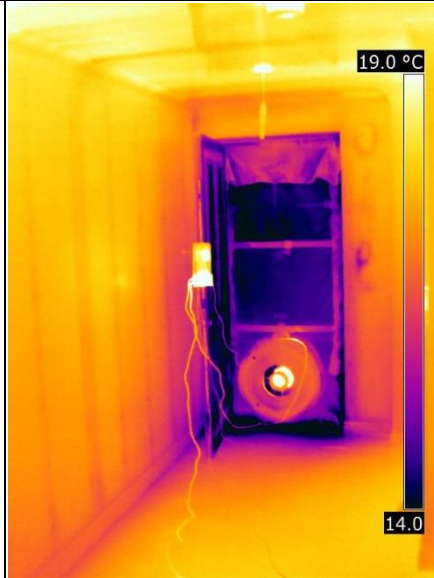
Hall – Under depressurisation

The ground floor and the water in the heating/DHW system appeared to have retained their heat more than the rest of the dwelling, with the floor and the section of intermediate floor containing the pipework remaining the warmest areas in the images opposite.

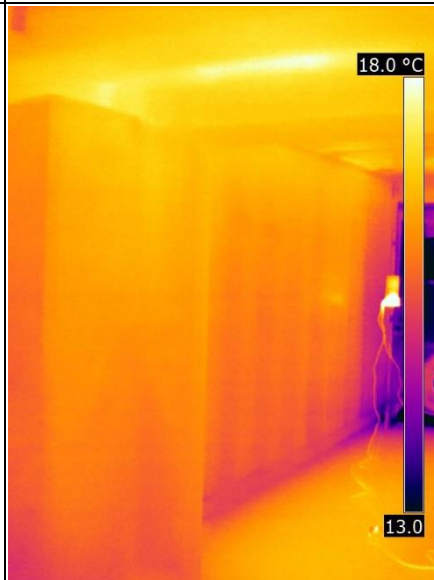
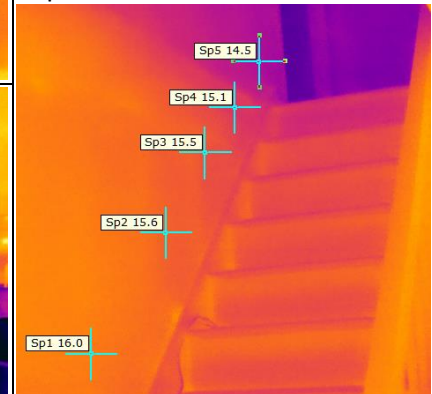
The internal walls did not lose much additional heat over the 40 minutes between the thermal survey under natural conditions and under depressurisation:

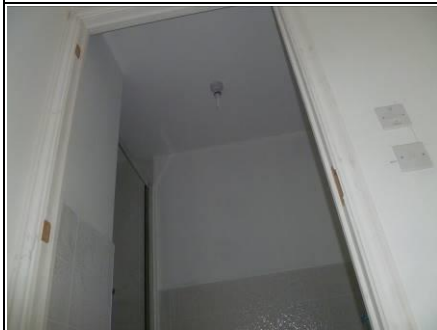
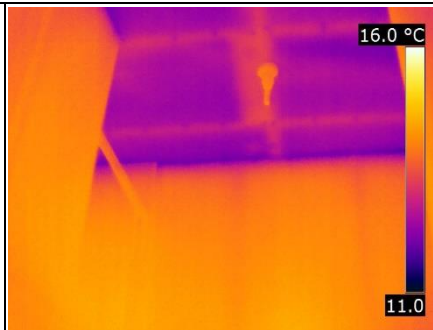
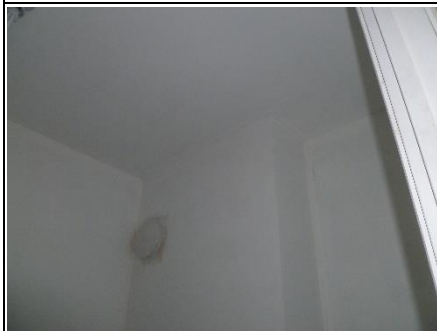
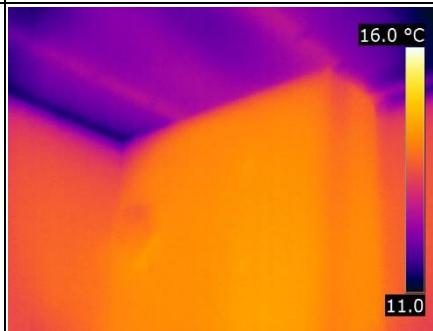
En-Suite – Under natural conditions

No significant issues with the thermal imaging on a 5° span and the loft un-insulated. However, the crossed timbers seen through the ceiling plasterboard may explain why some of the cooler patches of ceiling were observed in plot 268; as these would likely allow air gaps between the ceiling plasterboard and insulation, impairing the performance of the insulation
