Taylor Wimpey – Thermal Imaging Project

Site: Newton Farm
 Cambuslang
 G72 8QF

Visit Date: 13th November 2017

Plot(s): 268
 267

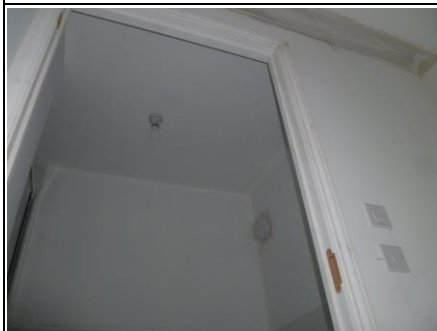
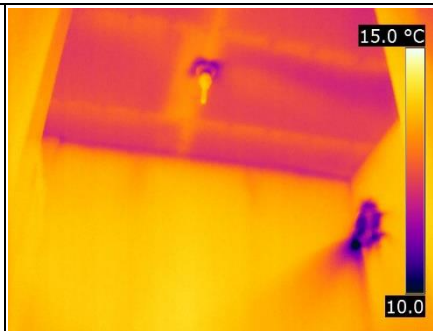
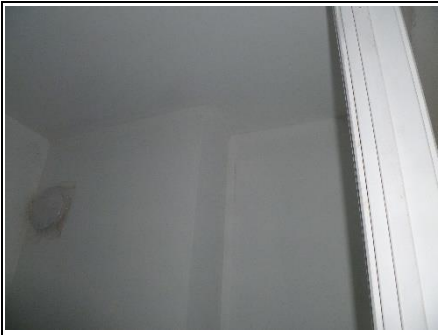
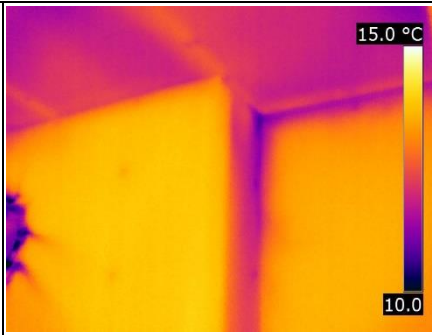
En-Suite – Under depressurisation

As above, but with cooler air entering around the temporarily sealed extract fan and perhaps down the partition walls and boxed-in services.

Without loft insulation the air being drawn in from the loft is not that much cooler than the room

temperature so is difficult to determine with certainty, air infiltration from outside is still clearly visible.

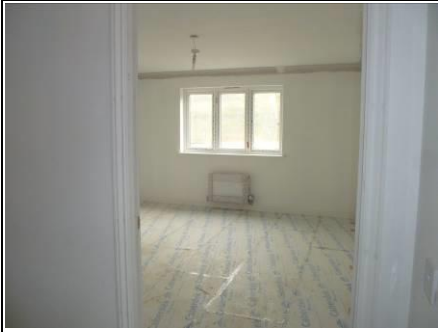
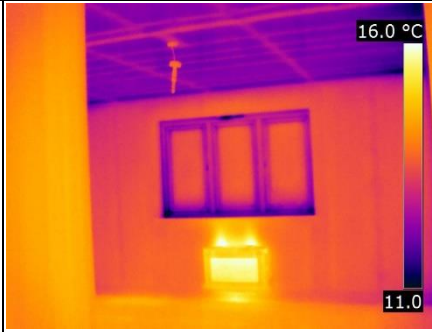
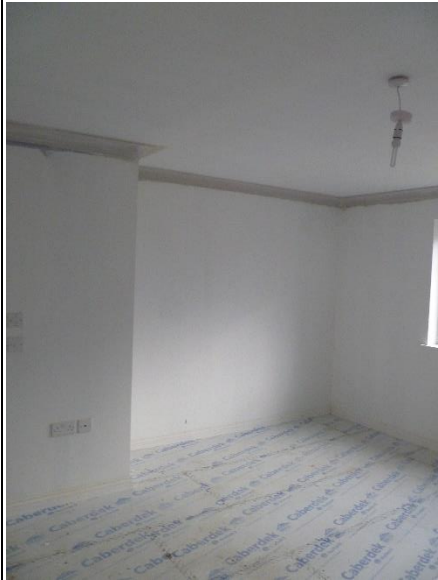
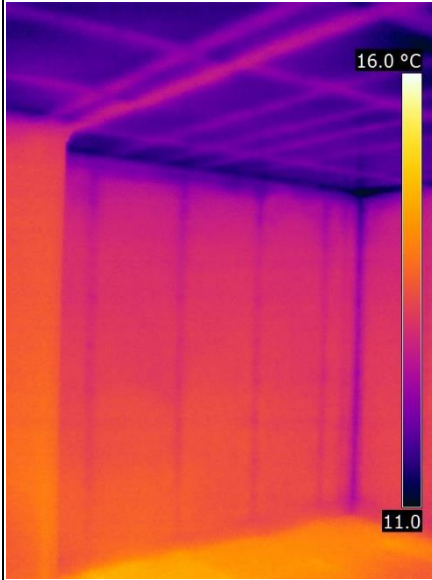
Bedroom 1 – Under natural conditions

No significant issues with the thermal imaging on a 5° span.

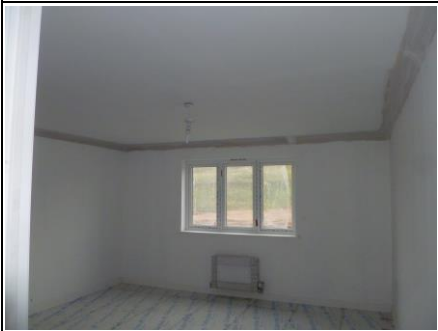
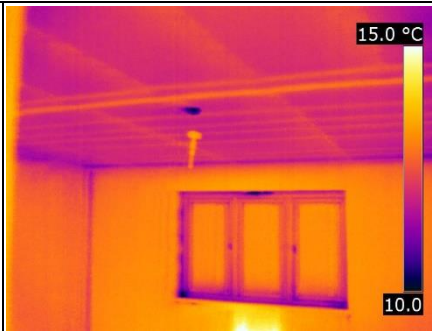
Bedroom 1 – Under depressurisation

Infiltration at the ceiling penetration, window jamb were now perceptible.

Air could also be seen being drawn into the wall panel at the side of the gable window where issues had been seen in plot 268.

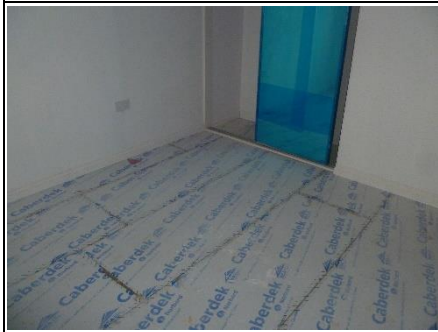
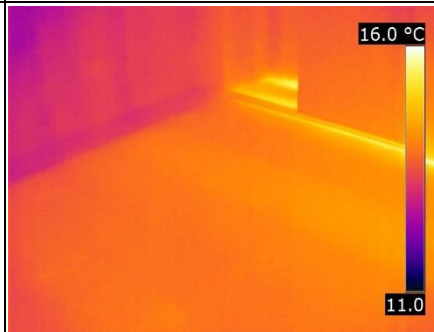
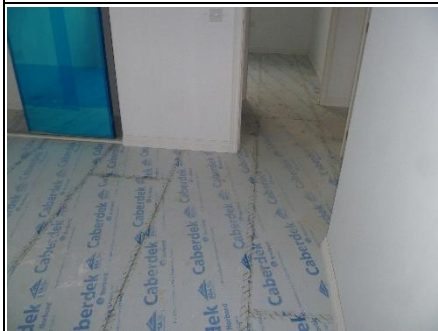
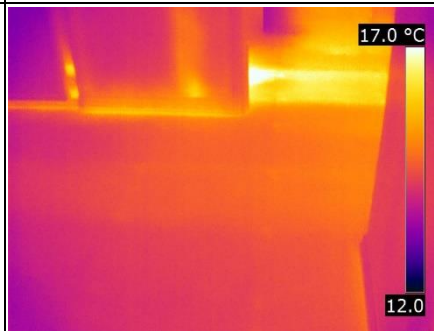
As seen in previous bedrooms.

The pipework from the boiler to the cylinder cupboard retained heat much better than the rest of the upstairs without loft insulation installed.

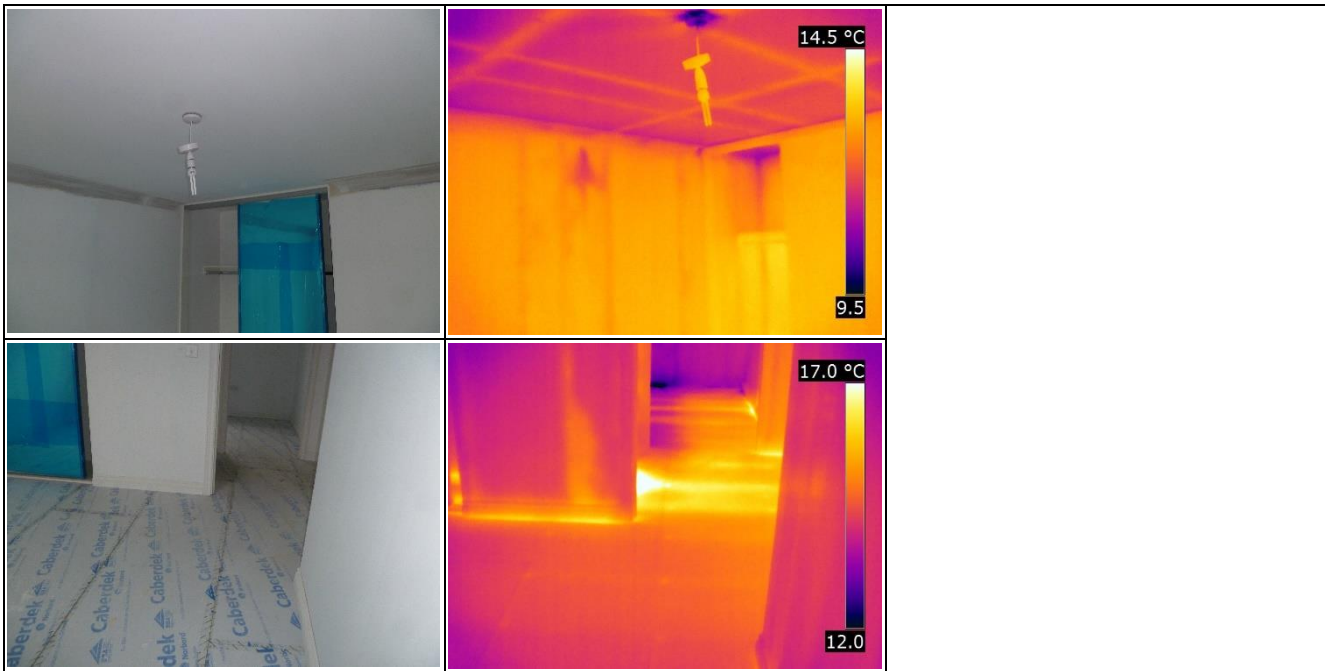
As in Bedroom 1, cooler air was seen tracking down the wall the external wall along the cabling route for an electrical socket.

Cooler air could be seen infiltrating around the window and at the intermediate floor perimeter.

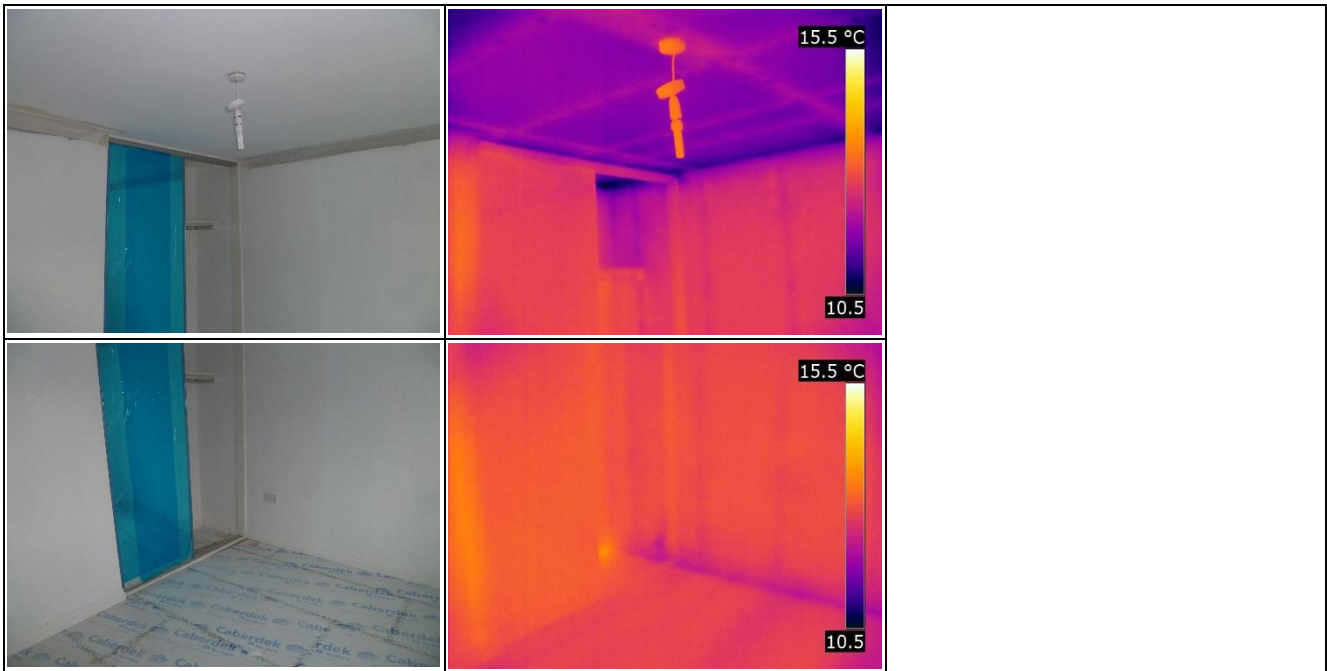
The heating pipework routes were clearly visible in the intermediate floor void but otherwise there were no significant issues with the thermal imaging on a 5° span.

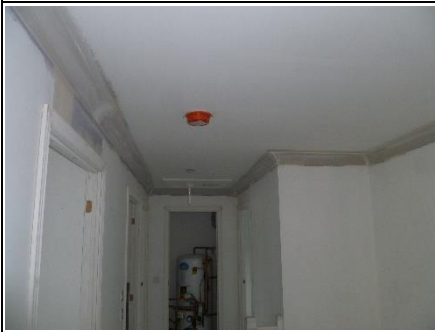
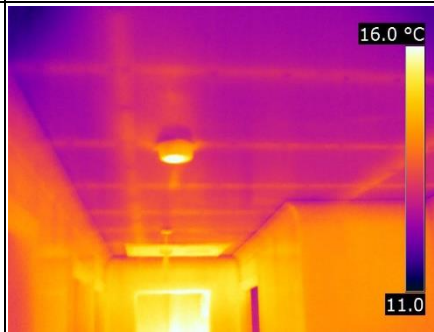
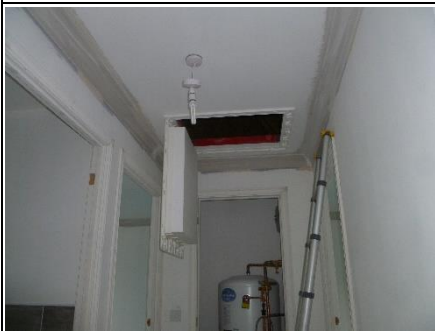
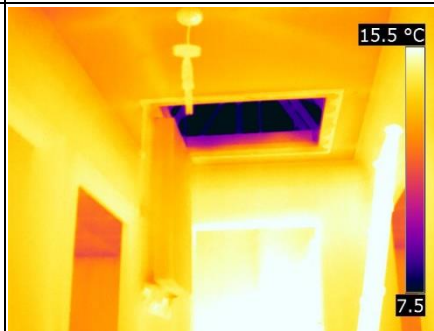
No significant issues with the thermal imaging on a 5° span.

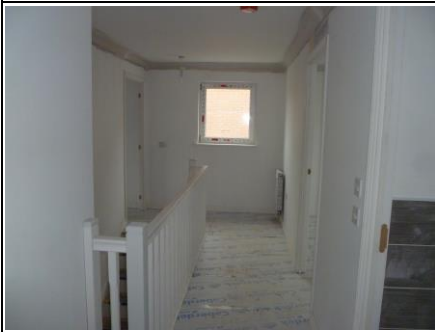
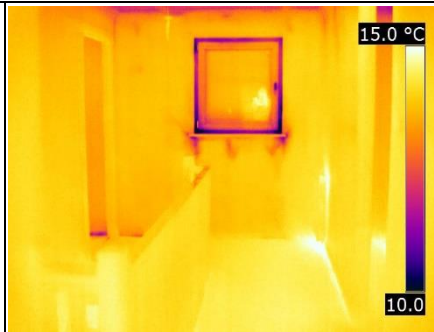
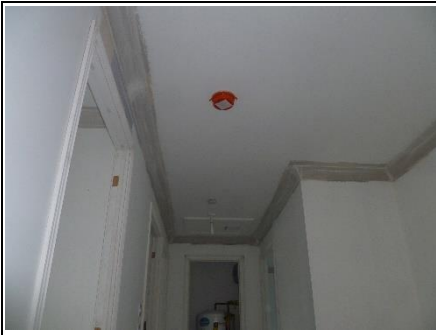
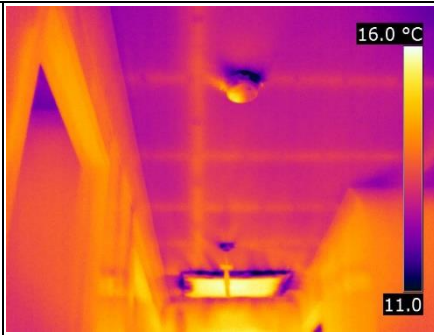
Landing – Under depressurisation

Under depressurisation the usual issues at the window and around ceiling penetrations became apparent

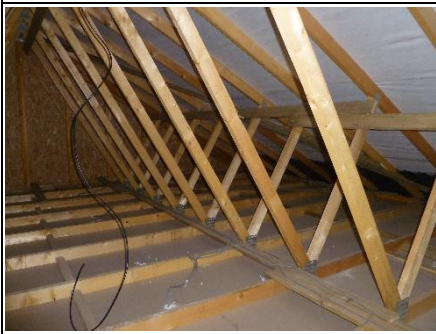
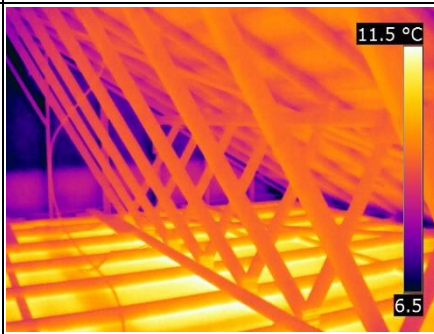
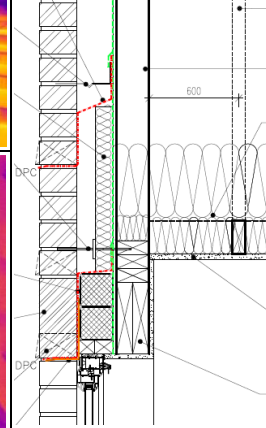
Looking towards the gable wall above garage the additional rigid board insulation on the outside of the timber frame is easily discernible:

Without insulation the loft itself is around 9~10°C, compared to ~4°C in plot 268.

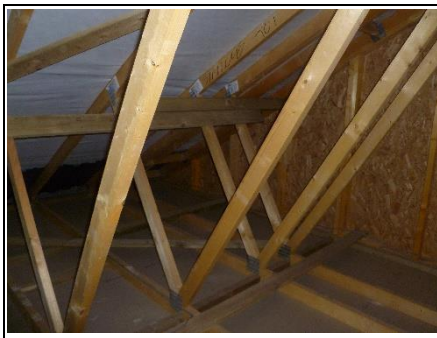
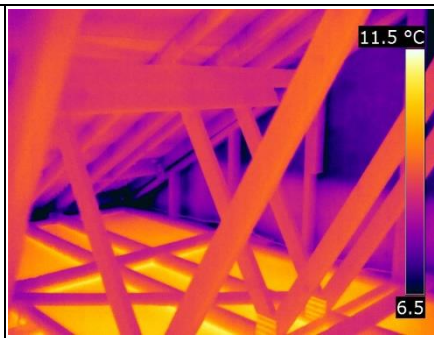
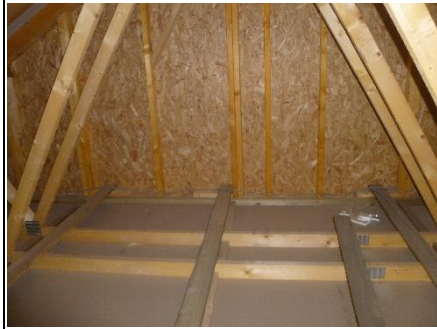
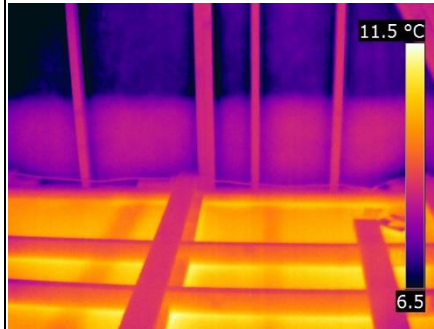
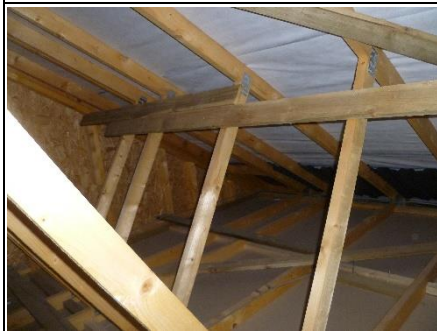
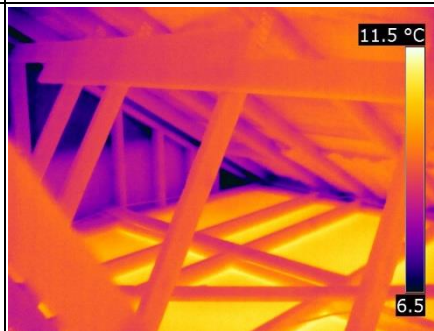
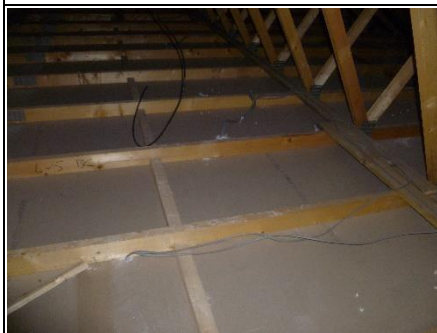
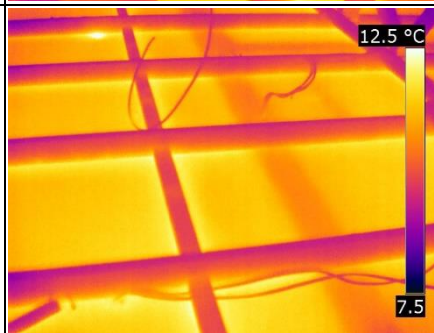
Loft – Under natural conditions

Looking towards the opposing gable wall it is quite easy to see how some of the cold areas of ceiling observed in plot 268 came about. With so many nogs, braces and additional timbers, as well as electrical cabling, it is understandable that gaps between loft insulation and the ceiling will result, compromising the performance of the loft insulation.
