Taylor Wimpey – Thermal Imaging Project

Site: Pipers Green
 Crigglestone
 WF4 3HY

Plot(s): 288

House Type: PA48 – Shelford
 Full-fill Masonry, 2-Storey, 4-Bed Detached

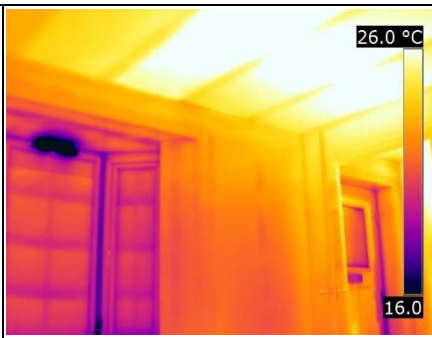
account for the significantly cooler surface temperatures at the base of the external walls. The temperature difference between the wall surface on and off the plasterboard adhesive dabs appears to reduce near the base of the wall.

The internal surface of the bay roof appears cooler than the external elements around it, but due to cold air ingress at the trickle vents and reflection of the cooler windows it is difficult to analyse.

The bay window jambs appear to show no significant issues, an area where problems are commonplace.

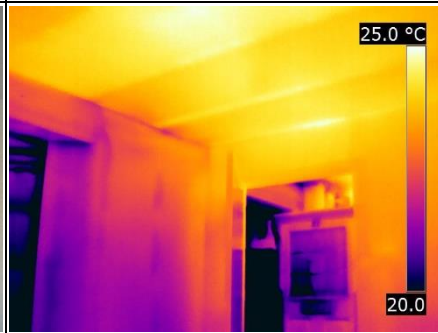
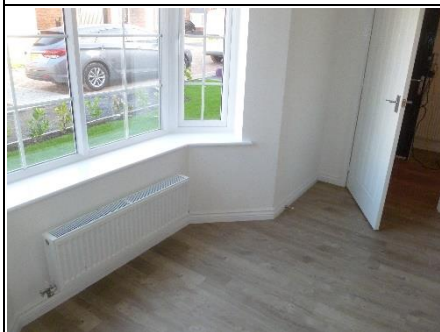
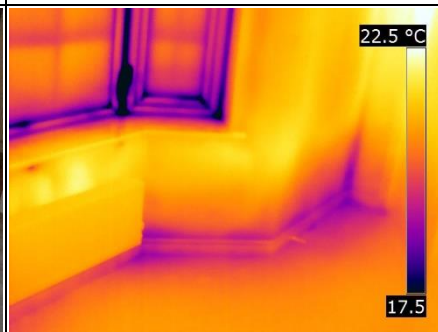
Lounge – Under depressurisation

Under depressurisation cooler air could be observed infiltration around the windows, with air entering through and around the closed trickle vents, at junctions between the lights and around the sill board. The thermal anomalies on the bay appear to worsen under depressurisation, where air movement is forced from cold external air to inside the structure, with a much clearer cold strip at the junction with the external wall above. This would indicate that gaps at interfaces play a part at this detail, whereas at the floor/wall junction the difference in IR images between natural and depressurised conditions is marginal suggesting that the increased heat loss at this junction is more likely due to conductive heat loss with discontinuities or disruptions of the insulation layer.

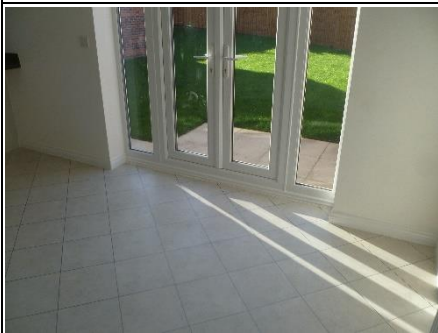
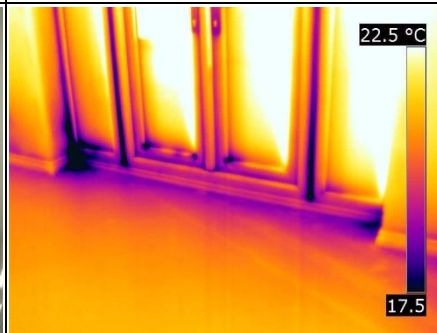
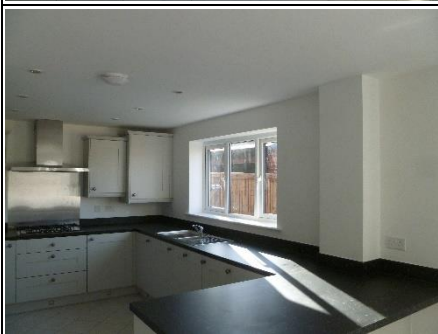
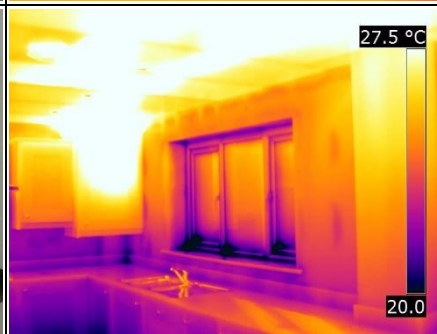
Dining / Kitchen – Under natural conditions

The previously observed phenomena at the floor/wall junction was again apparent. Where the patio doors are positioned further out in the external wall the floor surface appears to get noticeably cooler, possibly due to greater thermal bridging.

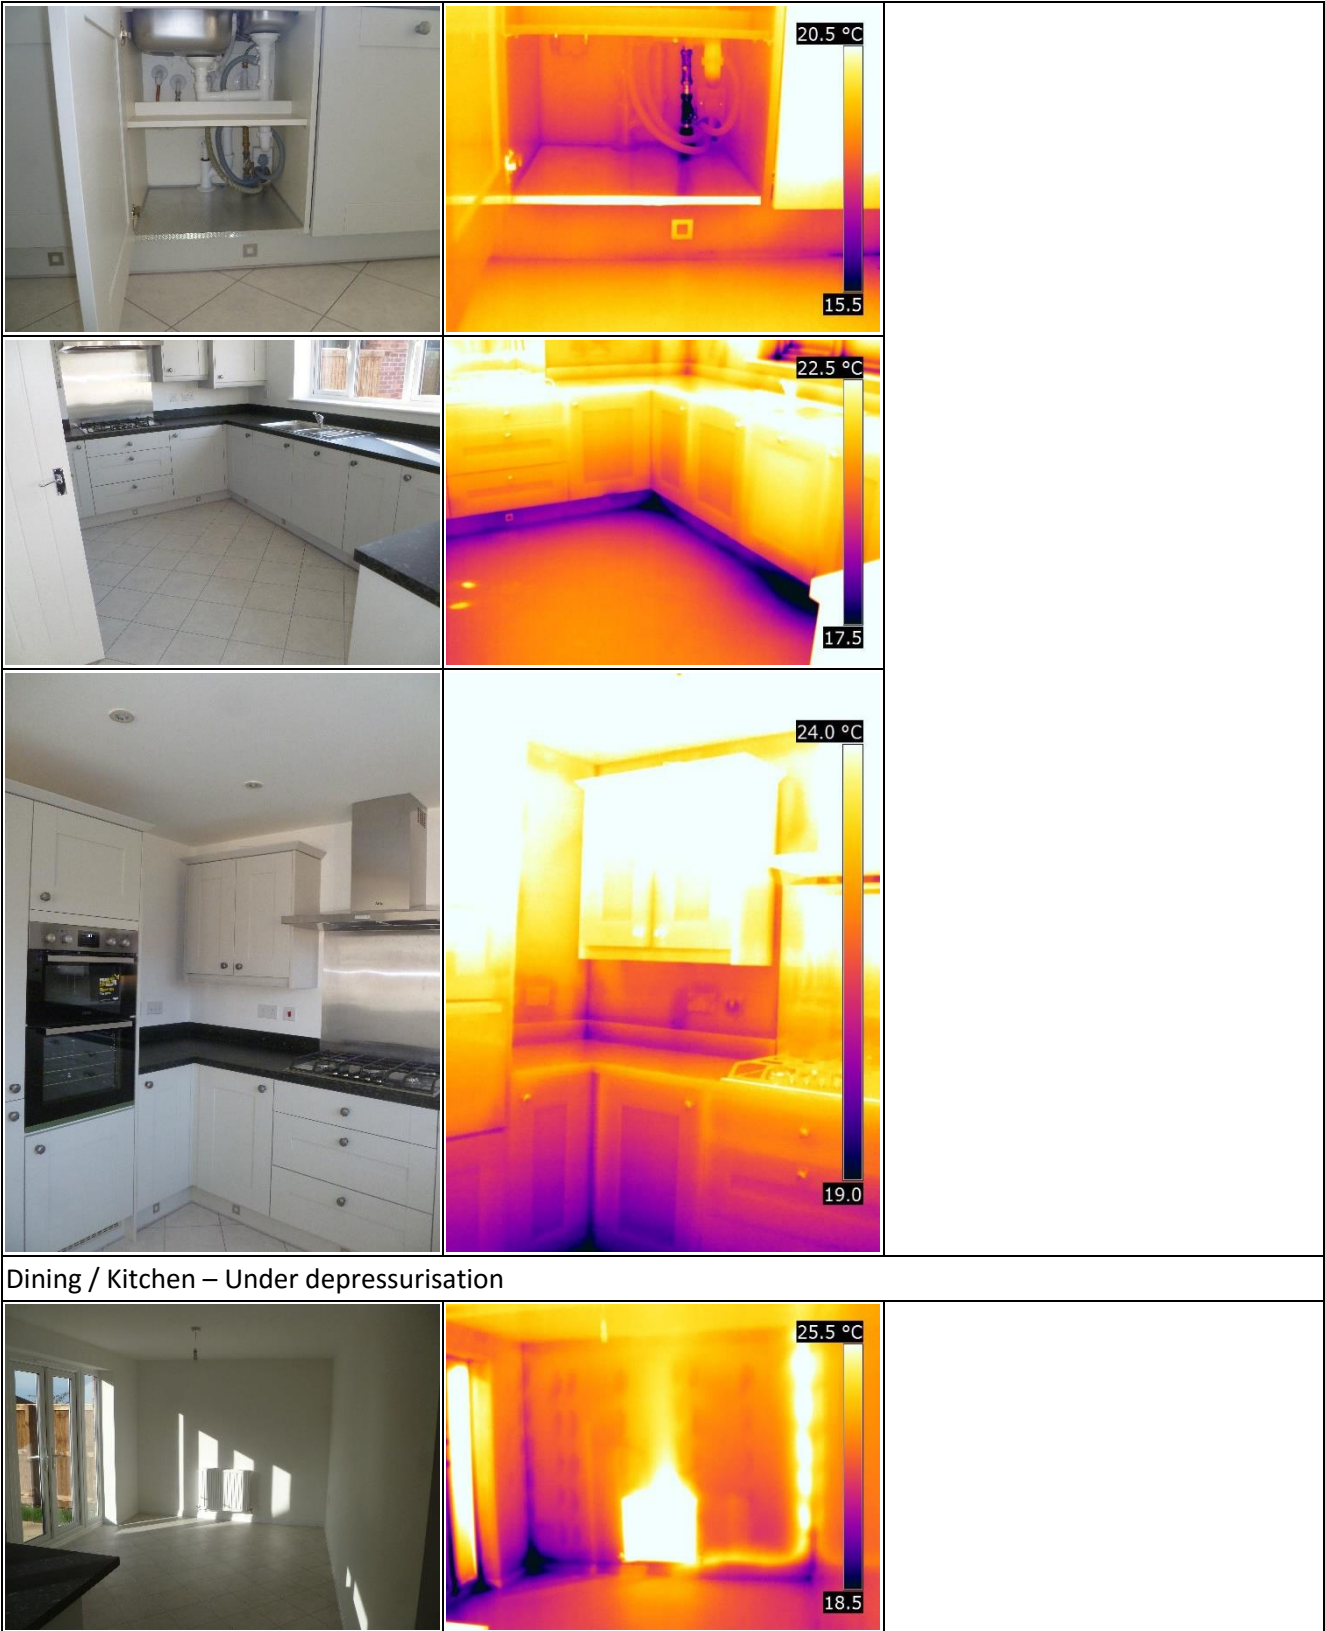
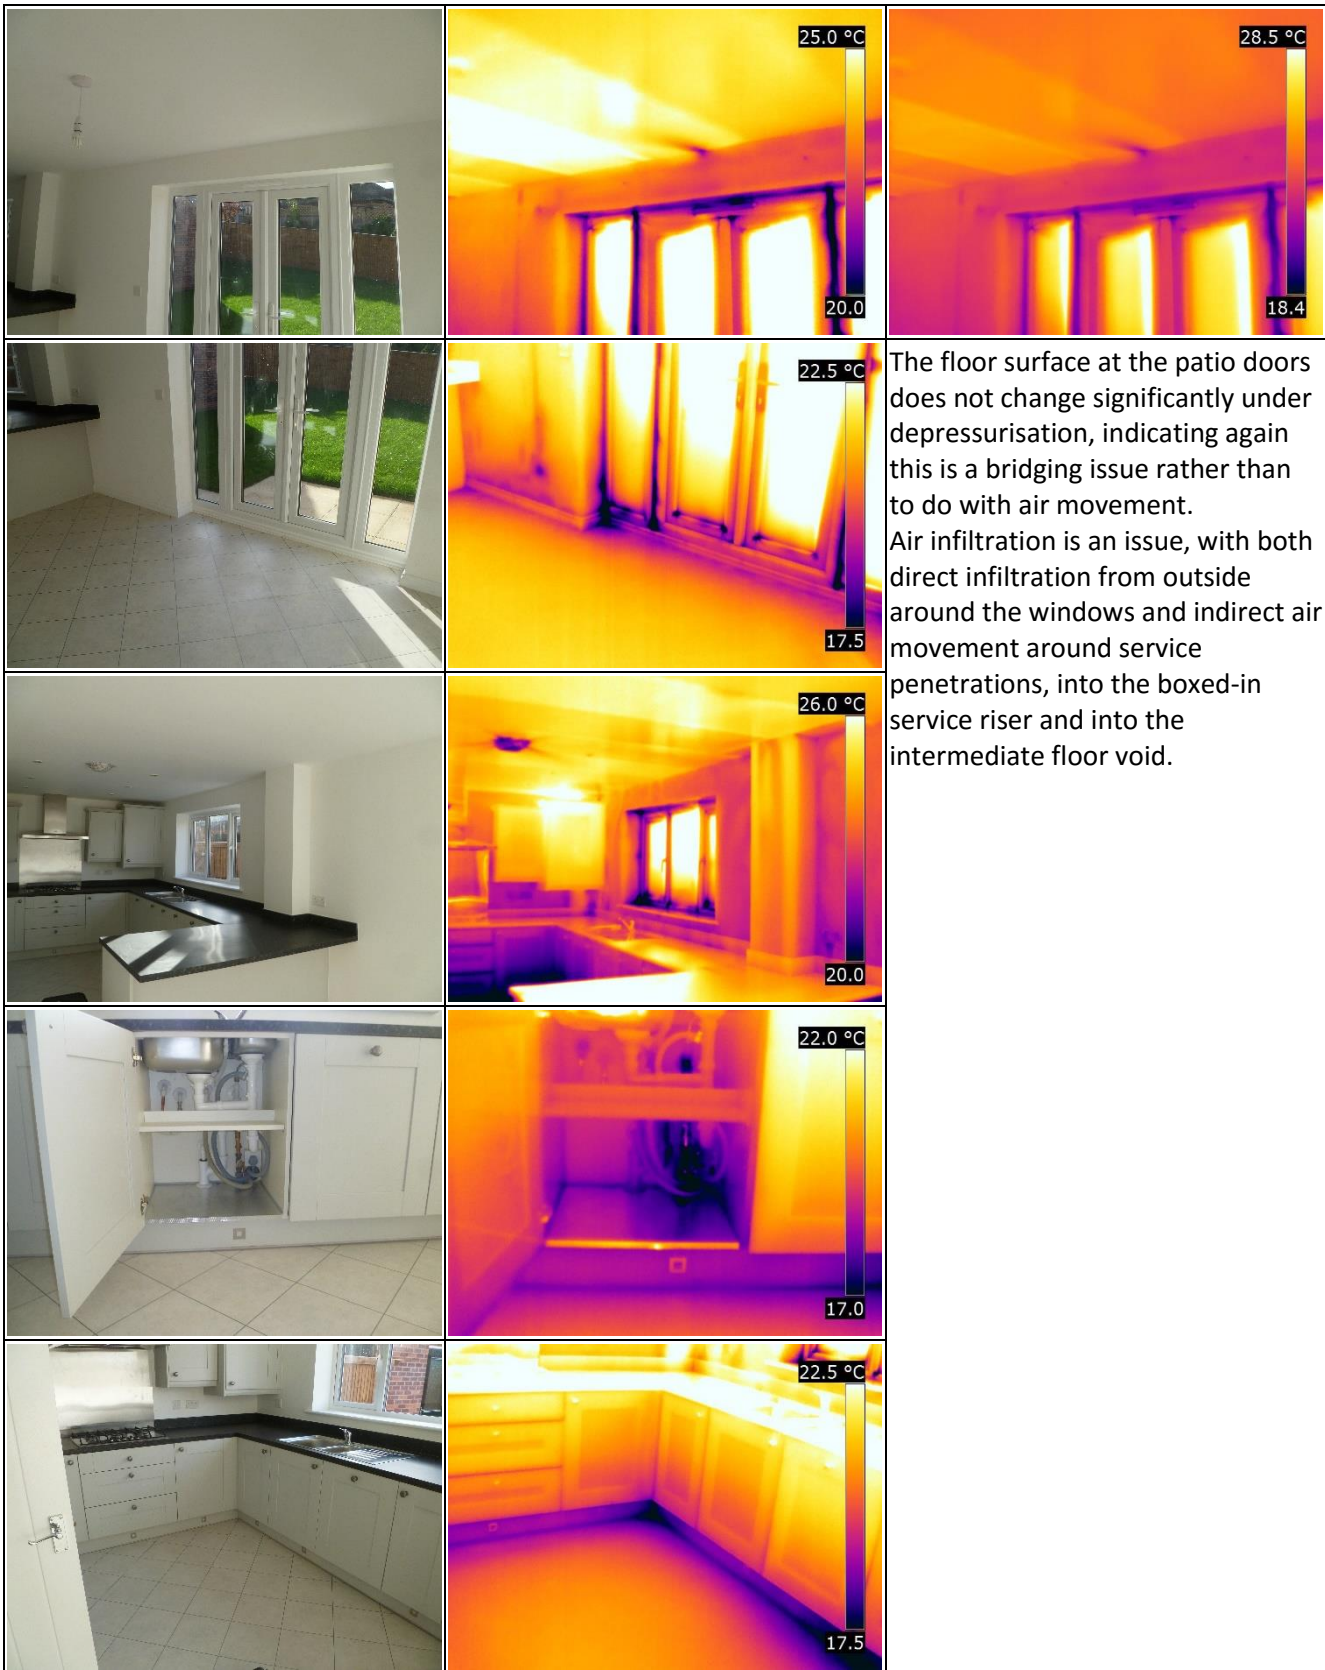
The floor surface at the patio doors does not change significantly under depressurisation, indicating again this is a bridging issue rather than to do with air movement. Air infiltration is an issue, with both direct infiltration from outside around the windows and indirect air movement around service penetrations, into the boxed-in service riser and into the intermediate floor void.

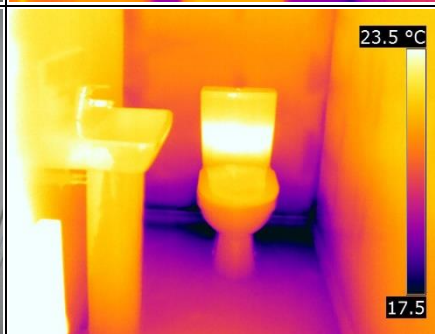
Ground Floor WC – Under depressurisation

Some air movement behind the plasterboard dry lining observed, it is unclear of the source and direction of movement but tends to look as if the air is coming from the adjacent study.

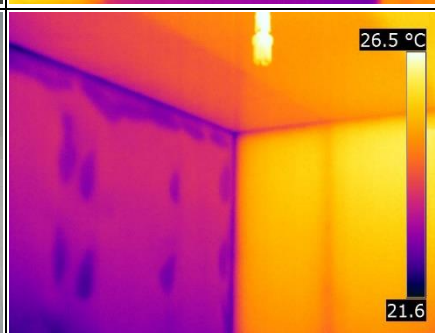
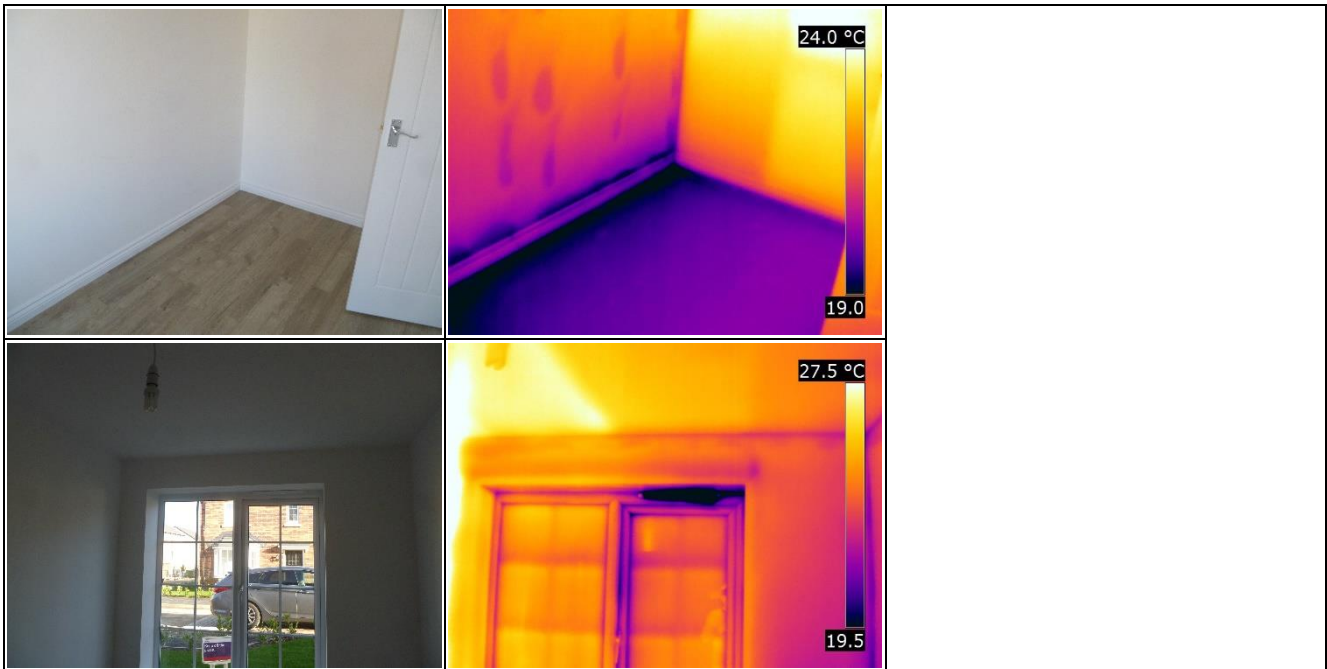
Study – Under natural conditions

Plasterboard adhesive dabs appear coolest where the utilities meter boxes are situated on the external walls. Some temperature stratification across the intermediate floor void can be observed, but it is unclear whether this is heat from the heating system pipework spreading toward the outside or cooler air from the gable wall junctions spreading inside.

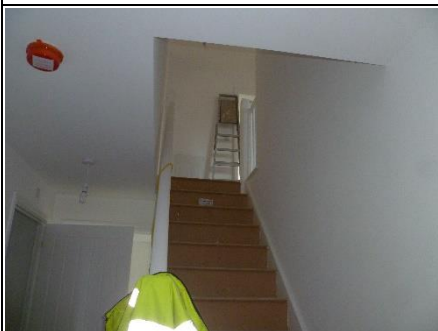
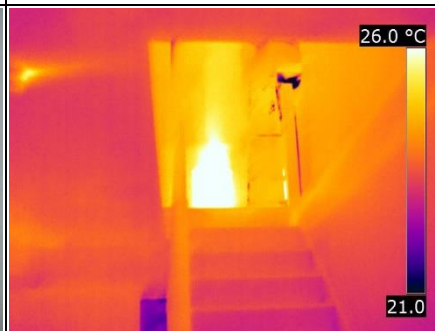
Hall – Under depressurisation

The indirect infiltration by the external wall junction with the lounge wall appears to be due to the penetration for the outside light.
 The colder area at the junction of the external wall with the intermediate floor and boxed void appeared to worsen under depressurisation, this is deemed due to increased air movement which can be seen extending down the service void.

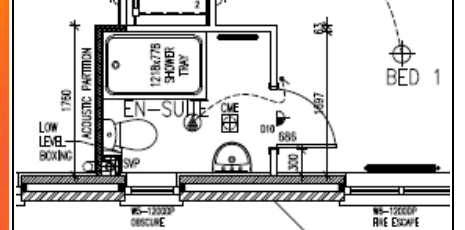
Colder areas are visible at the junction of the ceiling and external wall, extending down the service void to the right of the window. The service void to the left of the window show warmer timbers than the air voids behind but no distinct thermal gradient beyond the natural temperature stratification in the room. This void was not present on the drawings supplies:

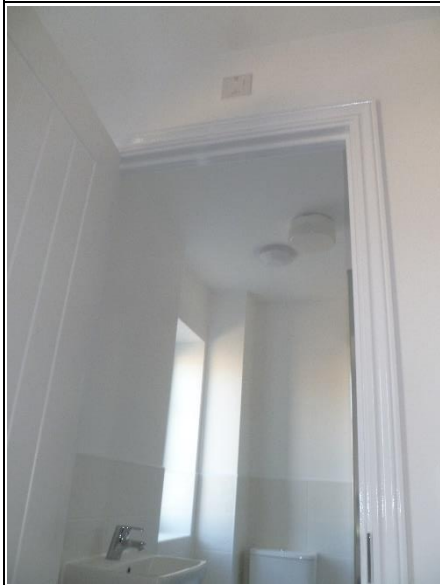
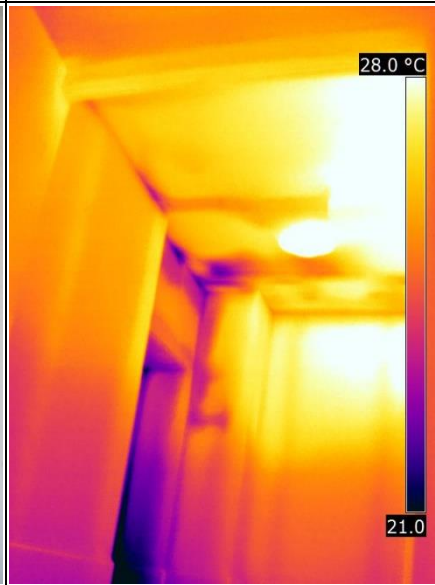
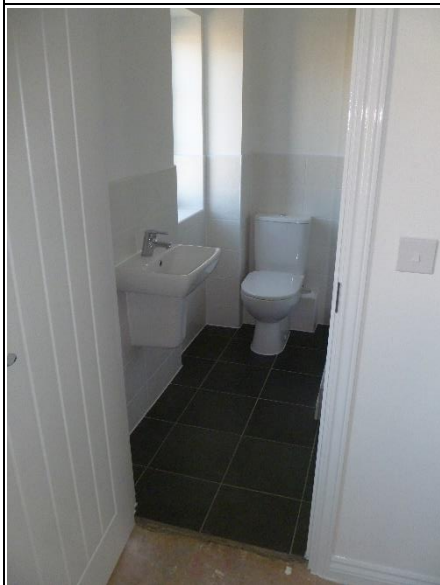
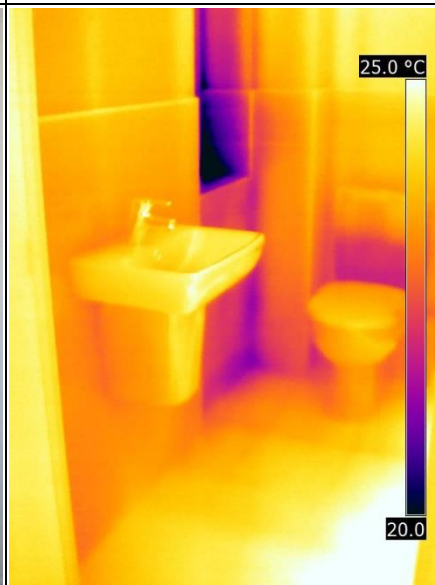
En-Suite – Under natural conditions

Additionally, there appears to be some dislocation of the loft insulation around ceiling penetrations.

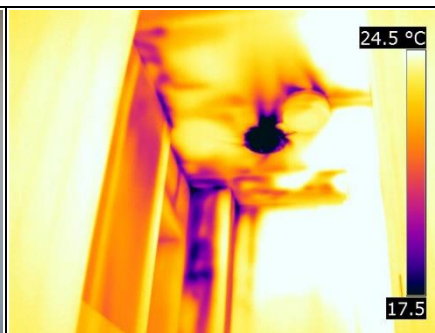
En-Suite – Under depressurisation

Air being drawn in from the loft space was observed into the service voids, around ceiling penetrations and into the internal partition wall by the shower cubicle.

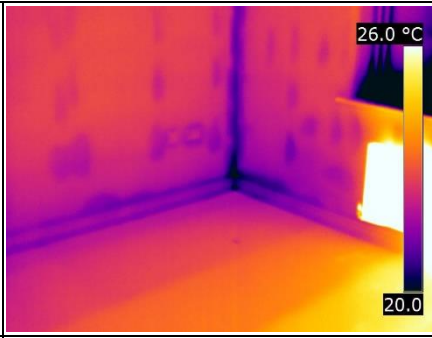
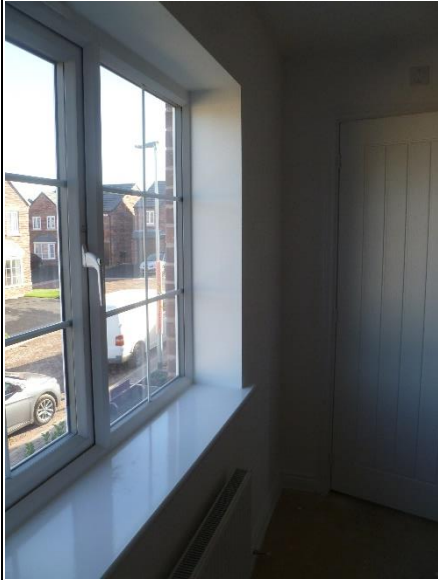
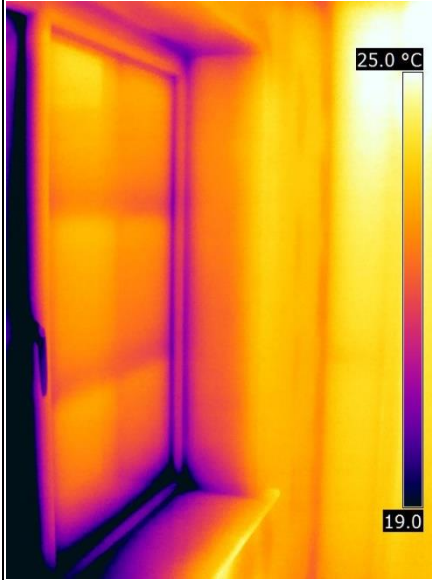
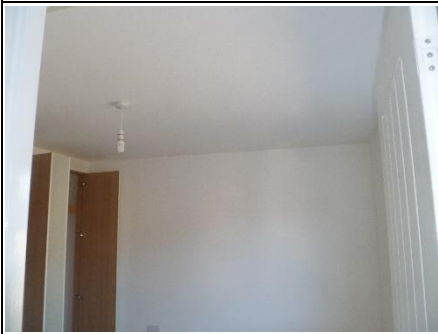
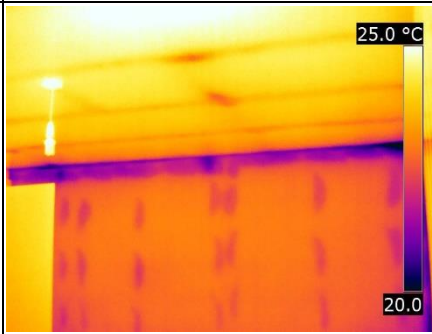
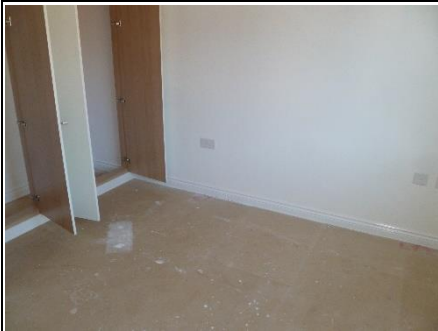
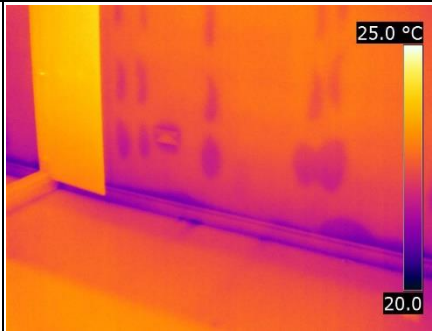
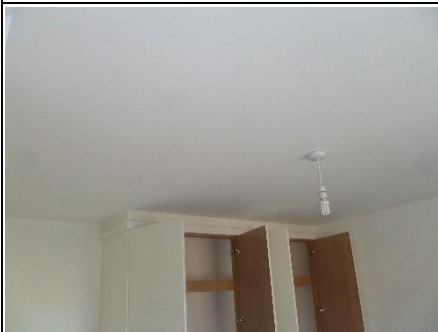
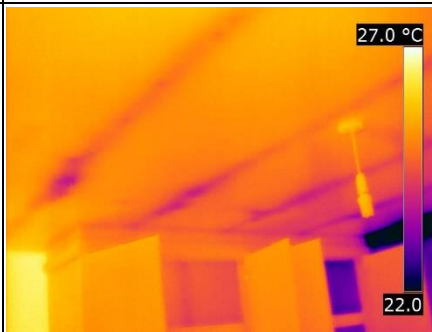
Bedroom 1 – Under natural conditions

from direct contact with the ceiling are not excessive.

The stratification of temperatures of the intermediate floor void visible from below is also clear from above.

Thermal bridging at jambs/head/sill is also apparent but not excessive.

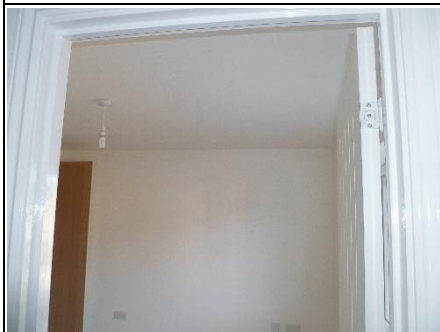
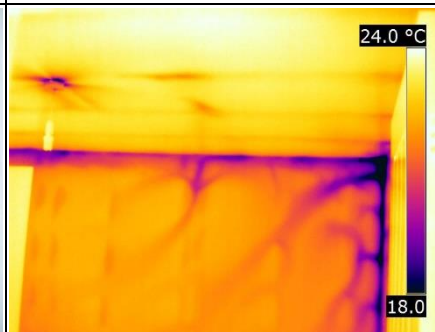
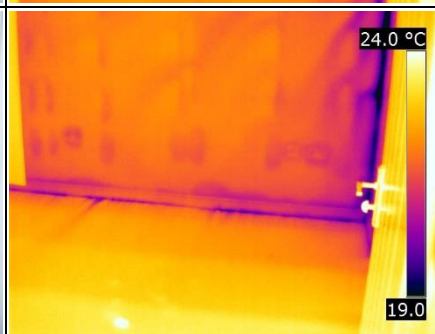
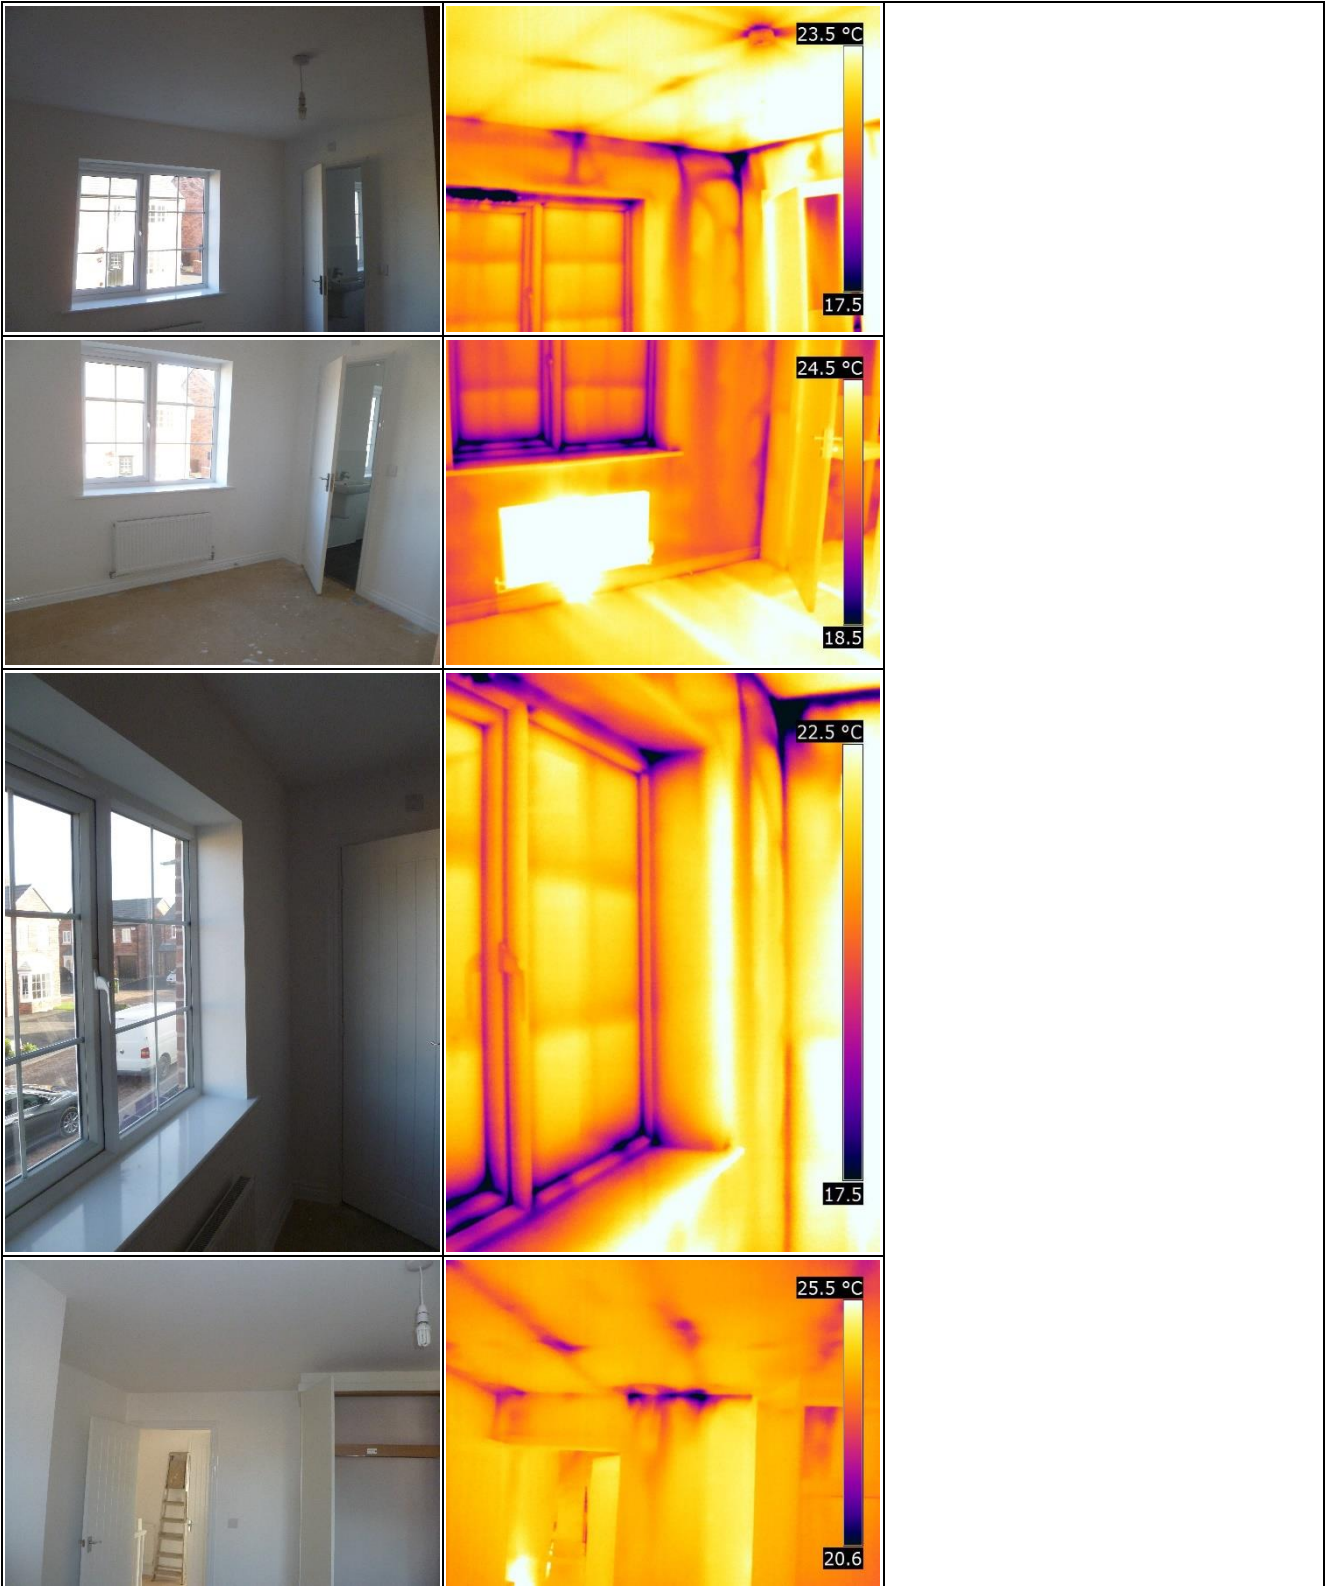
Bedroom 1 – Under depressurisation

Under depressurisation colder air can be seen being drawn in from the loft through ceiling penetrations, into the void behind the plasterboard dry lining and into some partition wall voids and emerging at places at the intermediate floor perimeter. The external wall at the ceiling perimeter, in particular, looks significantly colder than under natural conditions due to the change in air movement direction suggesting that air movement has a greater effect here than any thermal bridging or insulation discontinuity issues.

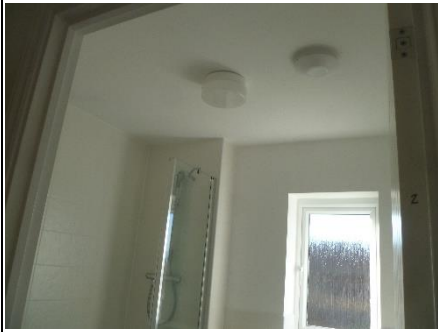
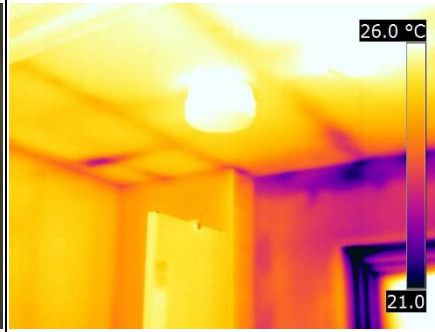
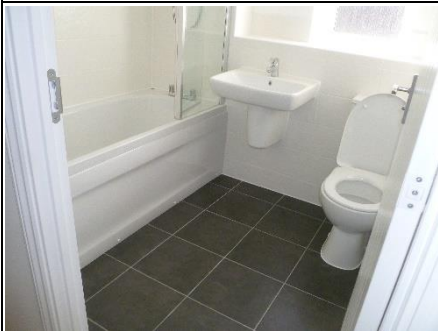
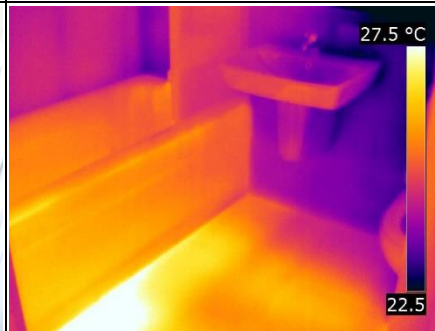
Bathroom – Under natural conditions

As previously observed in the bedroom, with the cold strip at the wall plate more obvious in comparison to the boxed-in service void next to it.

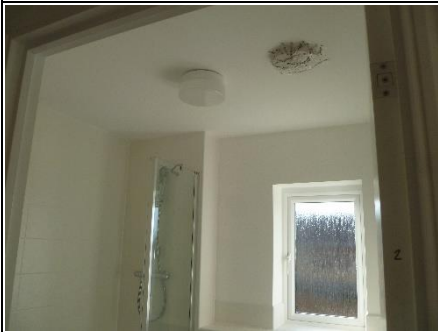
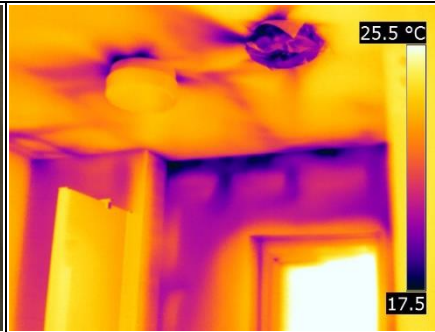
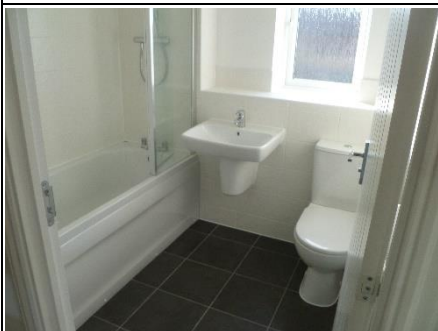
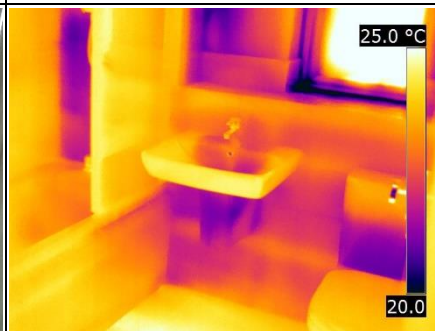
Bathroom – Under depressurisation

As in the En-suite, cold air is drawn in around ceiling penetration, into the void behind the dry lining and into the boxed-in void.

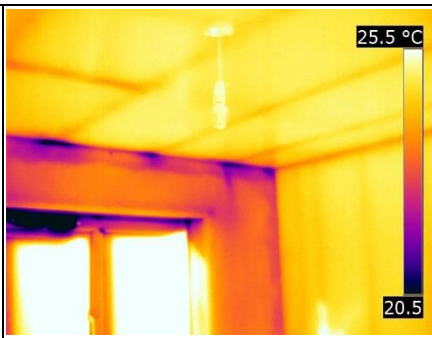
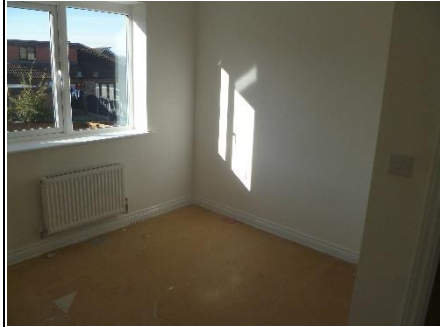
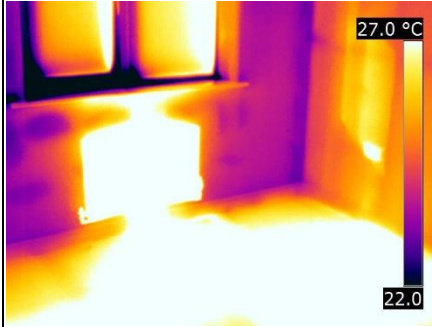
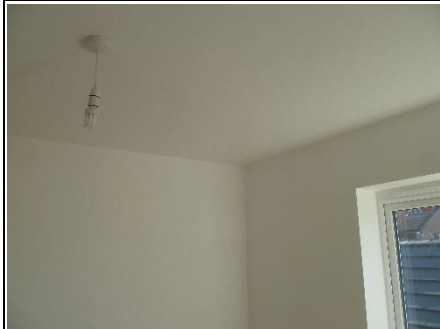
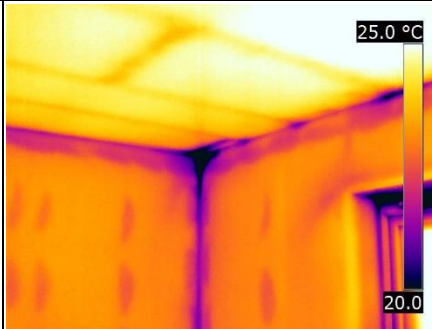
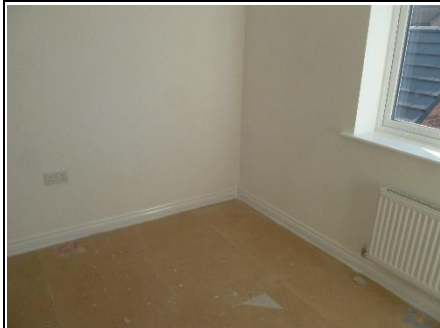
Bedroom 3 – Under natural conditions

As previous bedrooms.

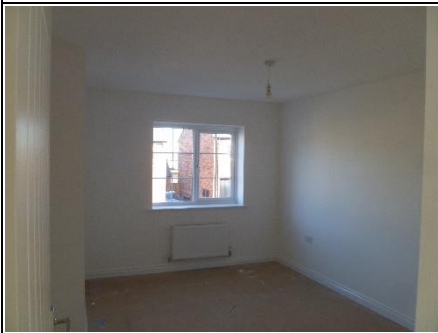
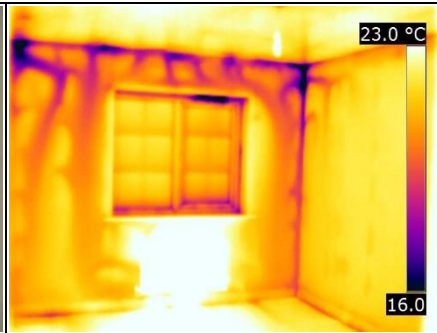
Bedroom 2 – Under depressurisation

As previously observed in other bedrooms.

Air can also clearly be observed being drawn down the junction of the partition wall with the external wall backing on to the service void in the En-suite, this void appear to link to the void behind the plasterboard on the external wall.

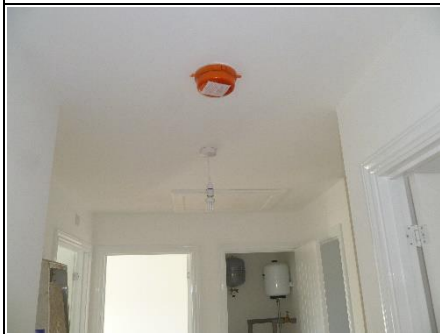
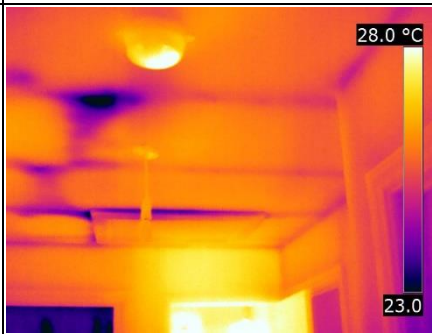
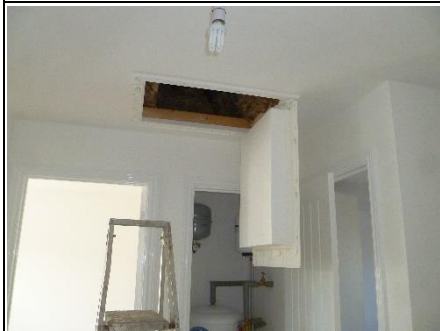
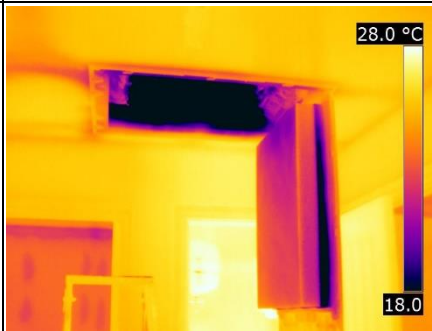
Landing – Under natural conditions

Some areas of dislodged loft insulation appear, the level and span of the thermal image makes some of these appear worse than they are (e.g. the minimum temperature of 22.7 °C in the adjacent image) due to the nearby hot water cylinder.

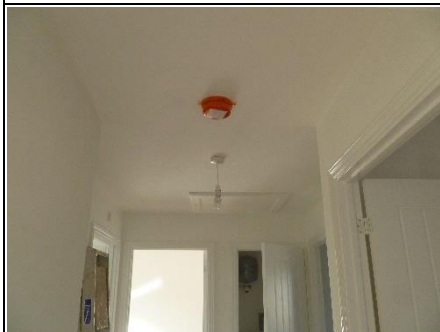
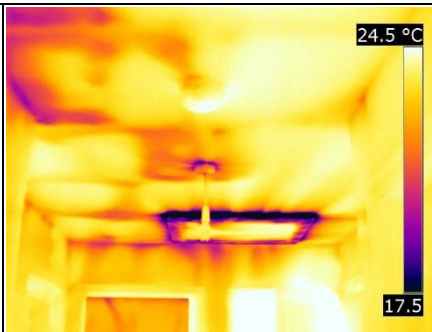
Landing – Under depressurisation

Under depressurisation air could be seen infiltrating directly around ceiling penetrations, most significantly around the loft hatch door. Air could also be seen entering the internal partition wall voids.
