Miles-Shenton, D (2018) Small Scale Forensic Thermal Imaging Study. Technical Report. Knauf Insulation.

Taylor Wimpey – Thermal Imaging Project

Site: Hele Park
 Newton Abbot
 TQ12 6JN

Plot(s): 294 & 297

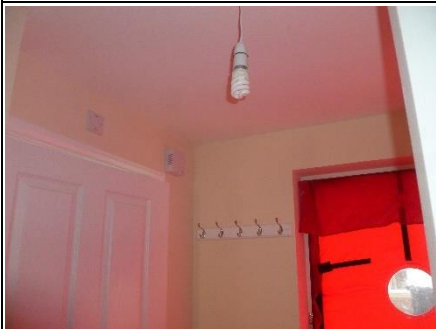
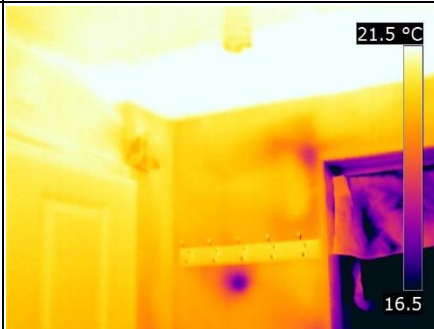
The penetrations through the inner leaf blockwork observed previously are now more obvious as the internal/external pressure difference is held at around -50 Pascal. Cooler air can also be seen moving into the void behind the dry lining plasterboard around the door head and at the base of the door jamb.

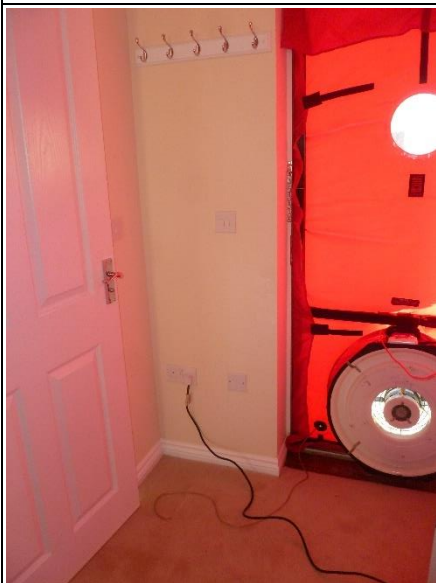
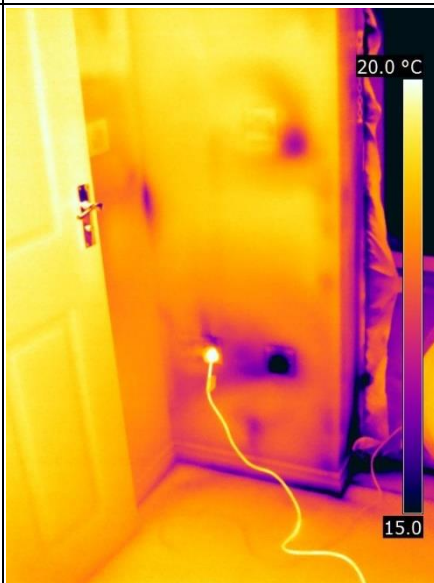
Under depressurisation air was also getting beneath the hall carpet and lifting it slightly, although it was not clear where this air was entering it seemed to be from around the door jamb junctions with the threshold.

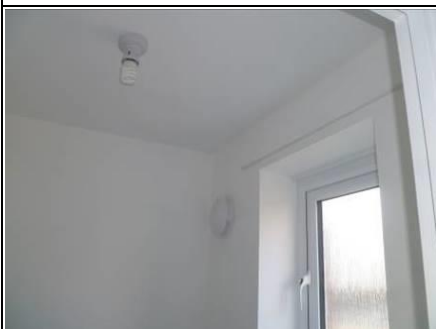
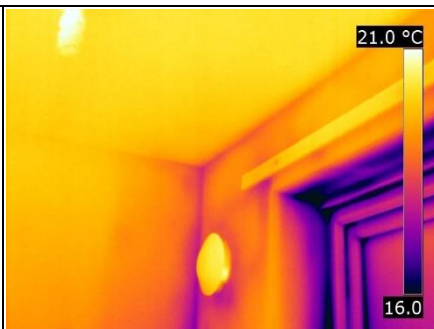
Ground Floor WC – Under natural conditions

The window reveals varied between jamb and head, with the thermal bridge at the head continuing further than that at the jamb. Possibly there is just plasterboard and no insulation beneath the base plate of the lintel?

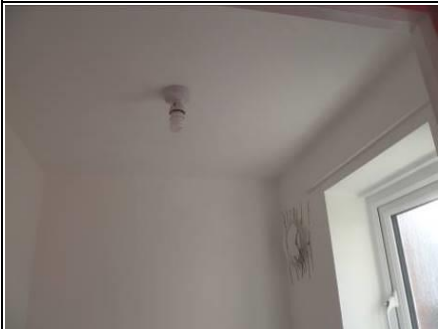
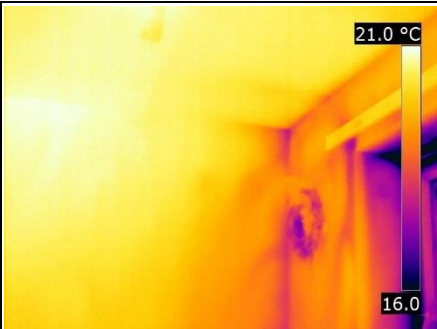
Ground Floor WC – Under depressurisation

Under depressurisation air can be seen entering the void behind the dry lining and moving around the external wall and into the adjacent void on the party wall. The main points of entry appear to be around the window opening and particularly around the sill board.

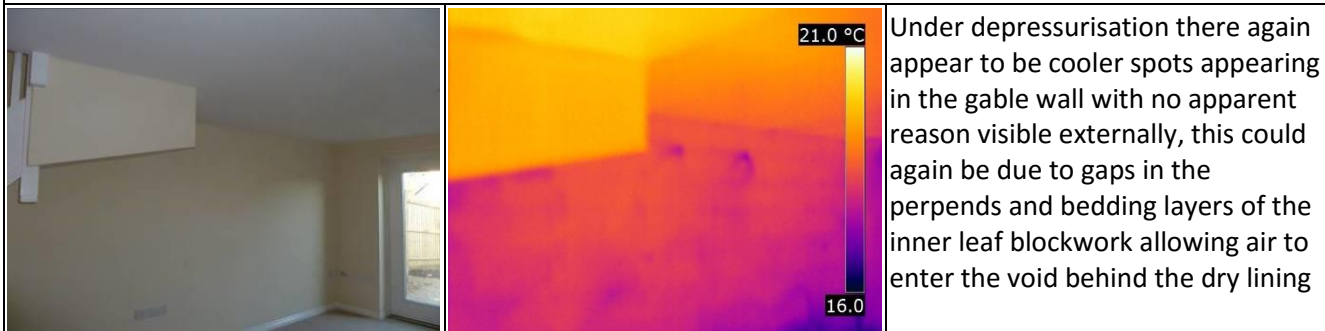
Dining/Lounge/Kitchen – Under depressurisation

Under depressurisation there again appear to be cooler spots appearing in the gable wall with no apparent reason visible externally, this could again be due to gaps in the perpend and bedding layers of the inner leaf blockwork allowing air to enter the void behind the dry lining

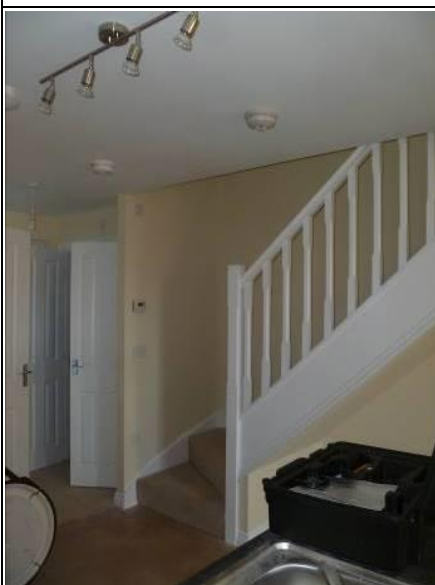
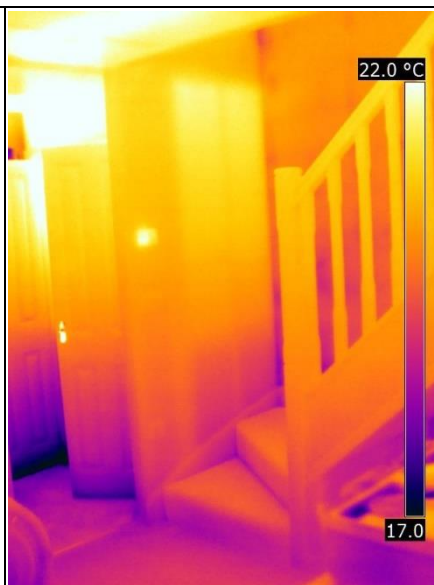
Stairs & Landing – Under natural conditions

The boiler in the store could be seen to make the internal partition wall to the stairs much warmer, as is to be expected.

The pattern of the inner leaf blockwork was clearly visible along the gable wall, but there was nothing that coincided with the warmer strip at intermediate floor level observed from outside.

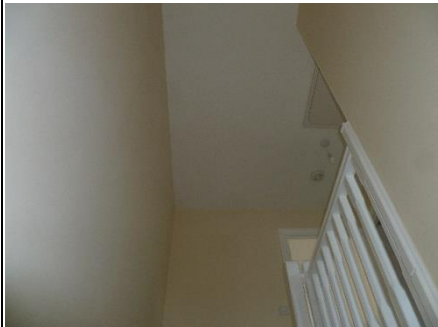
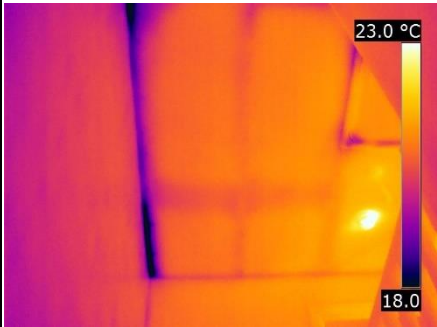
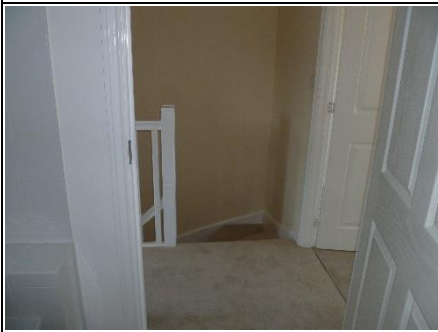
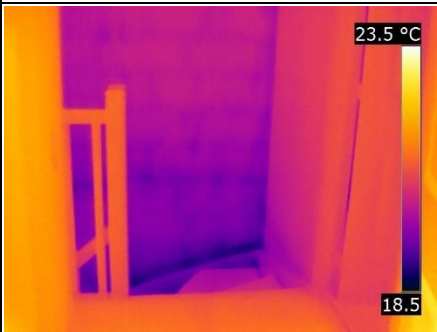
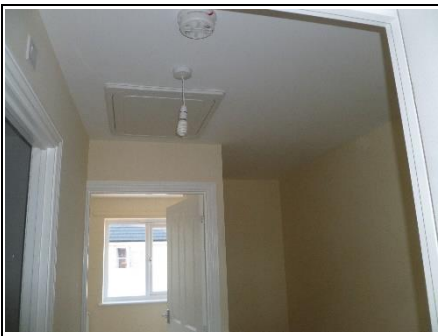
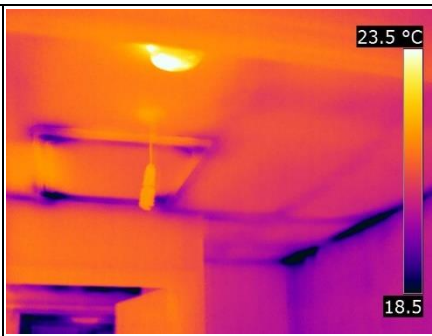
between the gable wall and end trussed rafter.

Cooler spots could be seen around the loft hatch, this is quite unusual under natural conditions as this is an exfiltration zone, with warmer air leaving the property.

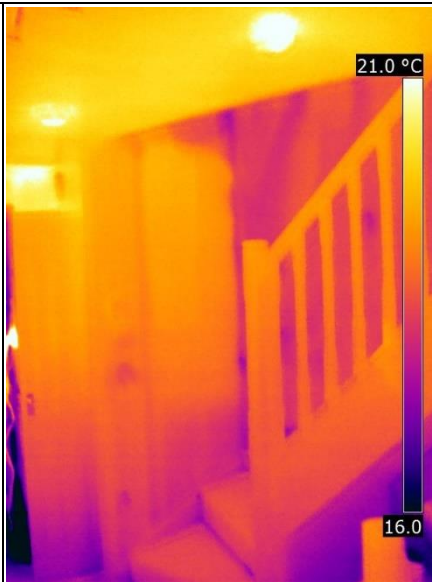
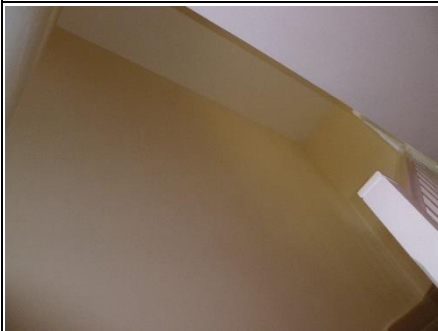
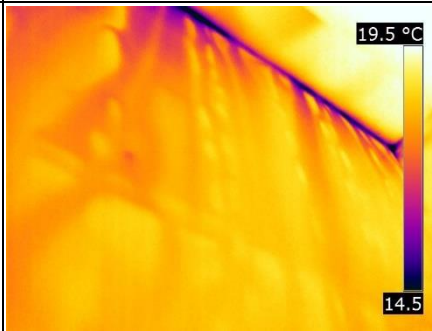
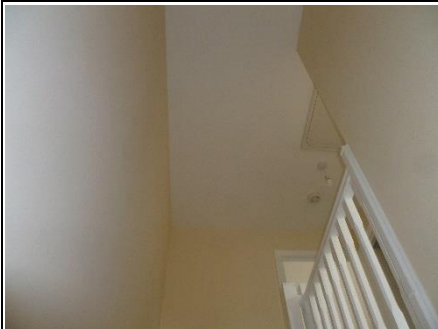
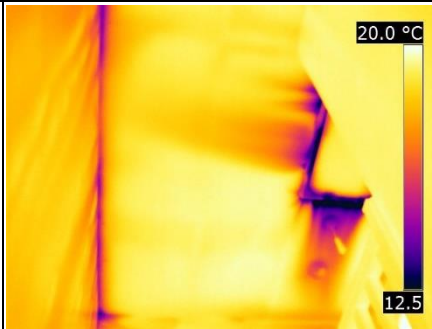
Stairs & Landing – Under depressurisation

Under depressurisation cold air from the loft was observed being drawn down behind the dry lining on the gable wall, around the plasterboard adhesive dabs. Although nothing appeared to be being drawn down the internal partition voids.

Significant air leakage could now be seen around the loft hatch, both between the door and surround and between the surround and the ceiling.

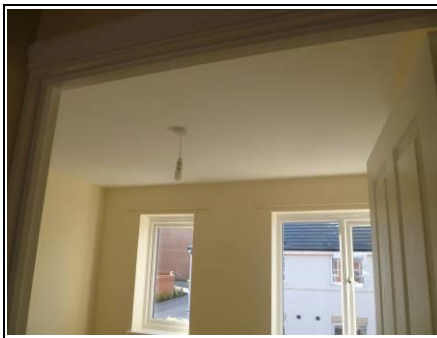
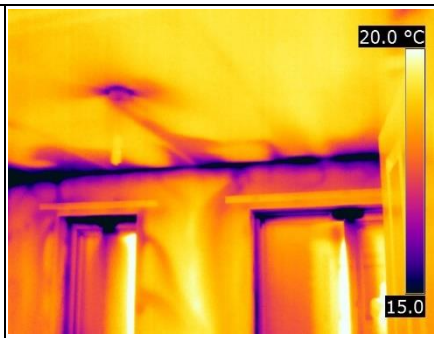
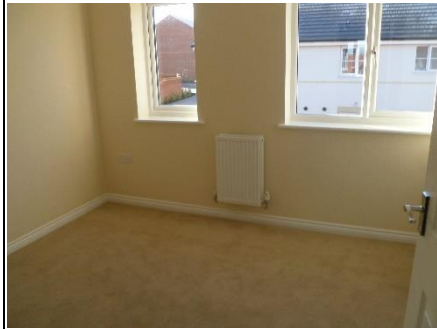
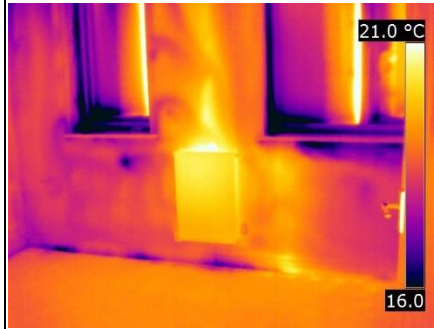
Under depressurisation there was extensive indirect infiltration into the dry lining void from around the windows, with lesser direct infiltration into the habitable space at the intermediate floor junction and around the central light fitting.

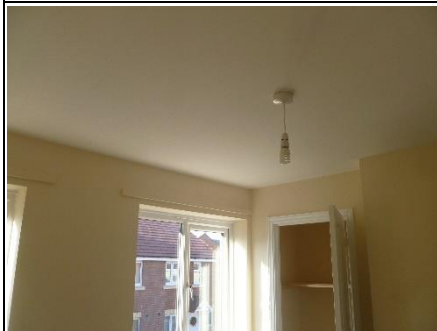
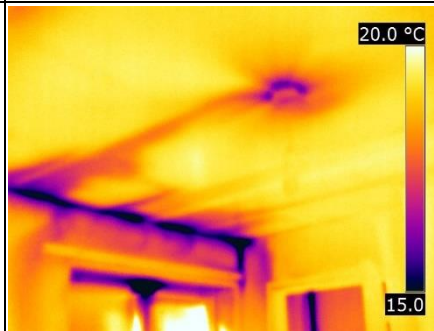
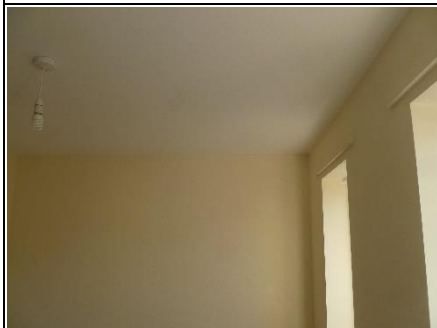
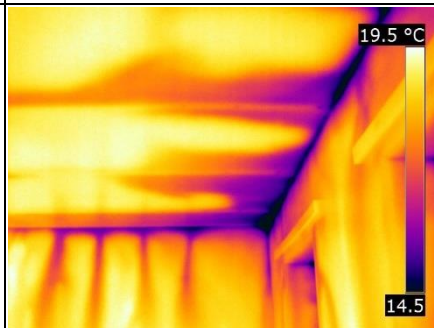
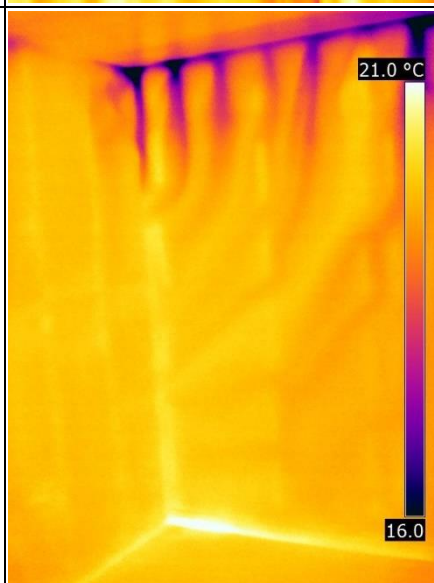
Cold air was also seen being drawn down from the loft space on both the external and party walls.

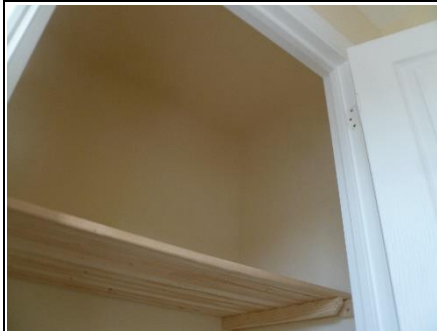
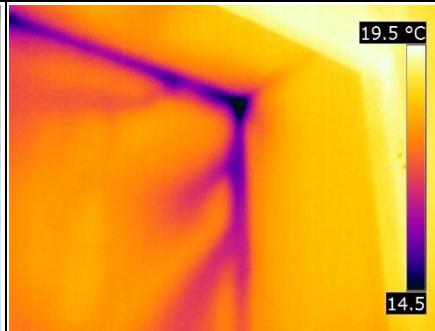
The ceiling in the airing cupboard was again the coolest surface (apart from where external air was entering around the trickle vents) and highlights the need to keep this cupboard heated.

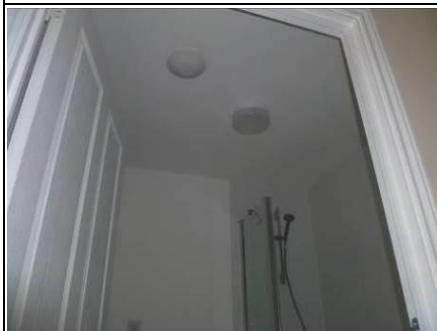
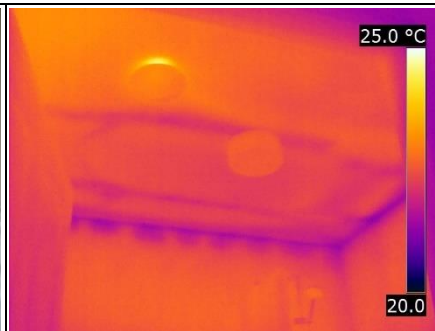
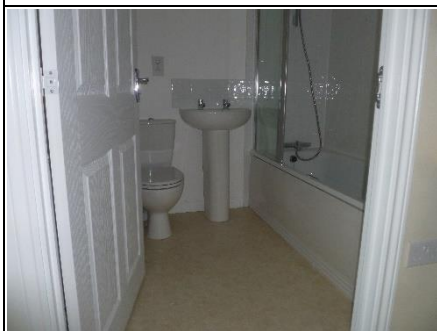
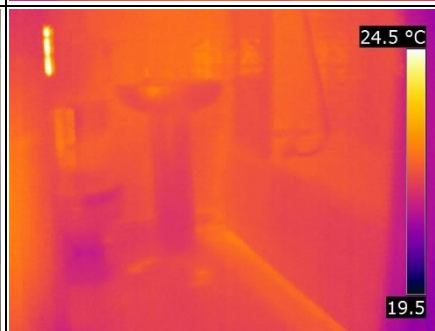
Bathroom – Under natural conditions

Much like the party wall in bedroom 2, the bathroom was pretty much isothermal throughout under natural conditions.

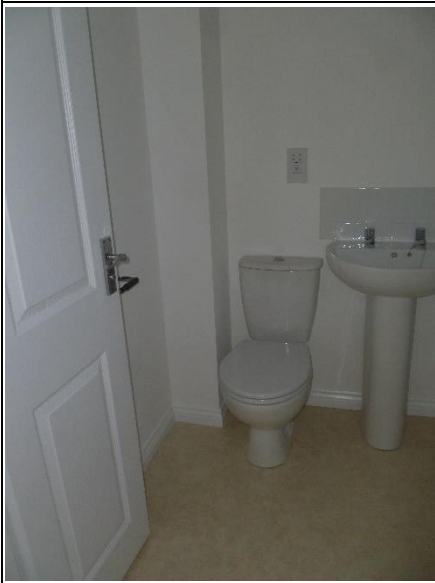
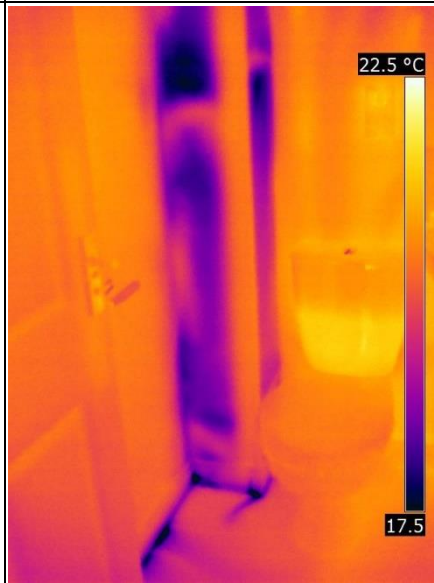
There was some air emerging at the floor wall junction backing on to bedroom 1, possibly tracking along from the stack.

Service penetrations for the bathroom furniture appeared to perform very well.

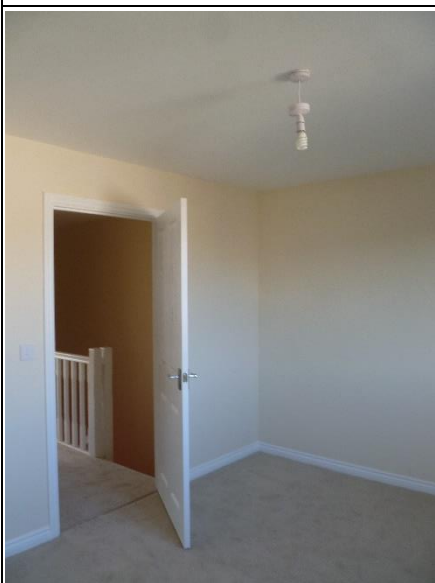
Bedroom 1 – Under depressurisation

Under depressurisation air could be seen being drawn in from the loft space on both external walls and on the party wall.

On the gable wall, cooler air could also be seen entering the internal partition wall adjacent to the stairs/landing.

On the party wall, cooler air could also be seen entering the internal partition wall adjacent to the bathroom there the soil stack was positioned.

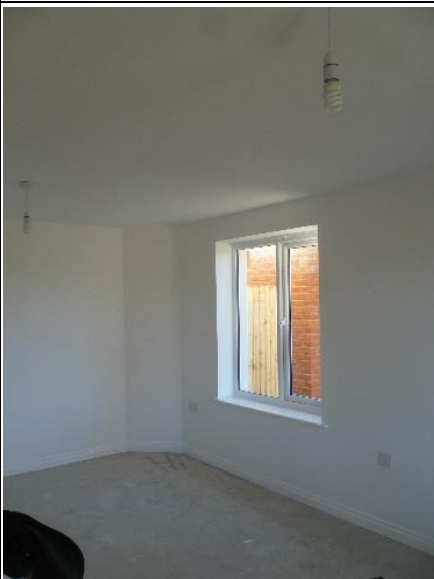
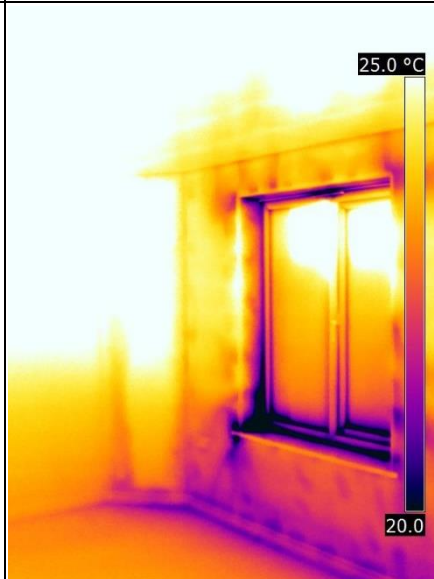
Lounge – Under natural conditions

With the wind blowing directly on to the front façade of the property the combined wind-driven effects and natural stack made the rooms on the ground floor at the front of the house significant infiltration zones even under natural conditions. Infiltrations cooler air could be seen entering the void behind the dry lining without any induces negative pressure.

The ground floor perimeter did appear markedly cooler than the walls above, more so than would be expected due to just natural internal temperature stratification.

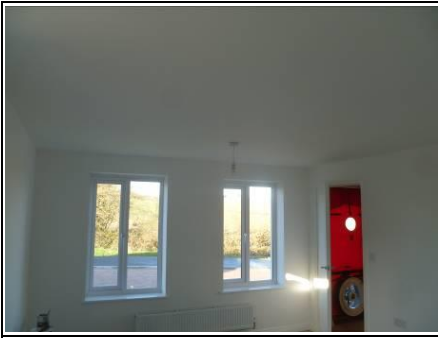
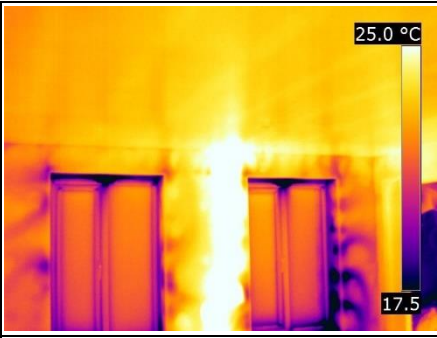
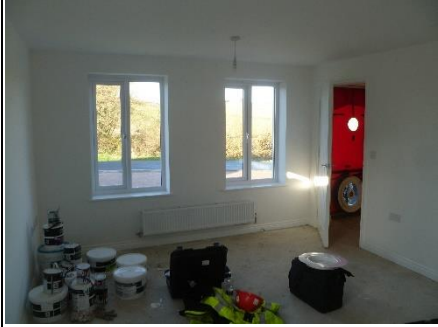
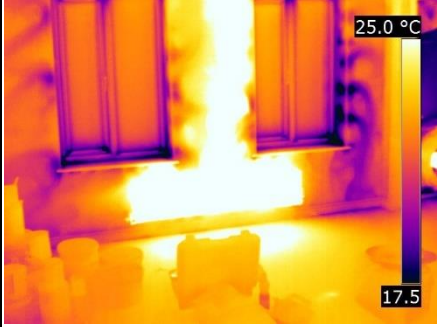
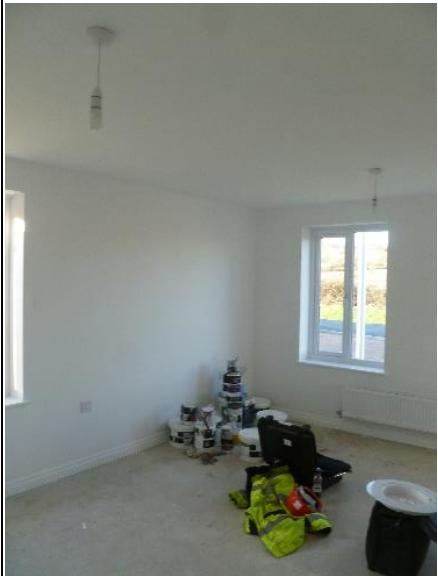
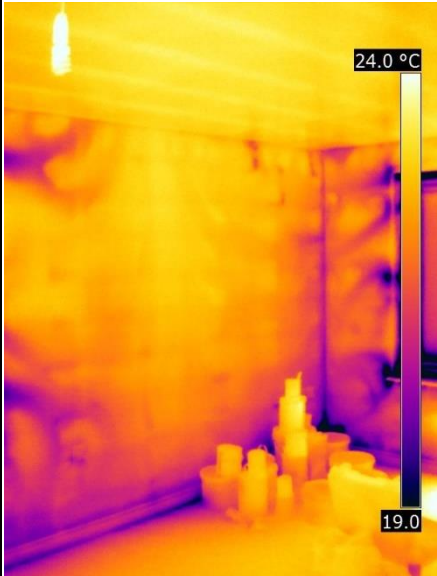
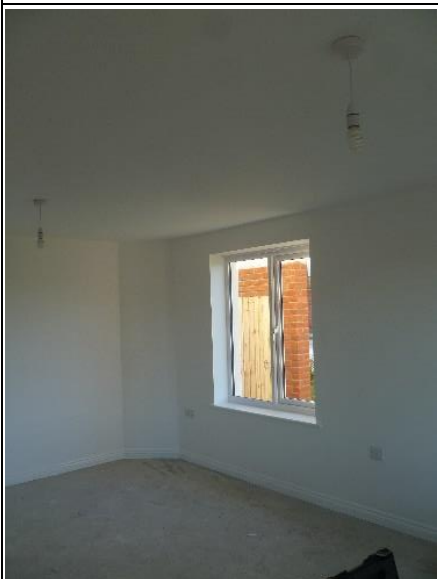
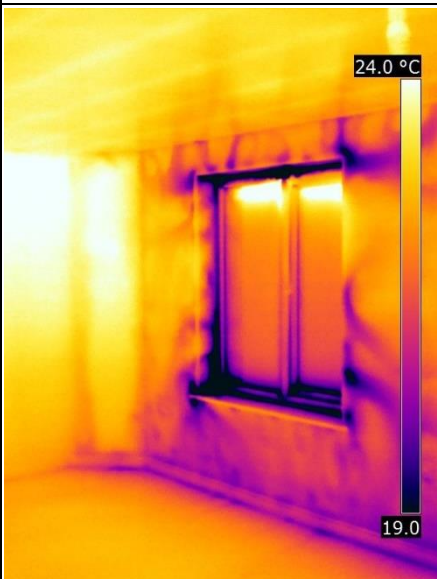
Lounge – Under depressurisation

The infiltration observed under natural conditions was exacerbated under depressurisation on both the front elevation and on the South West facing gable wall.

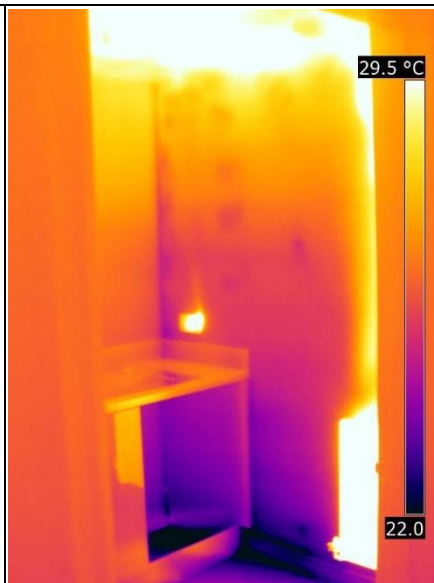
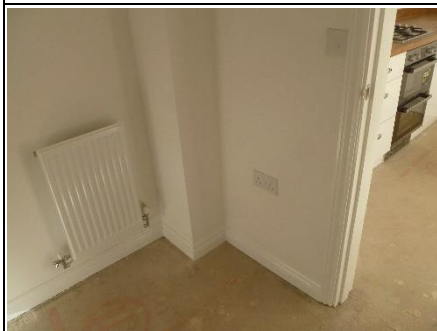
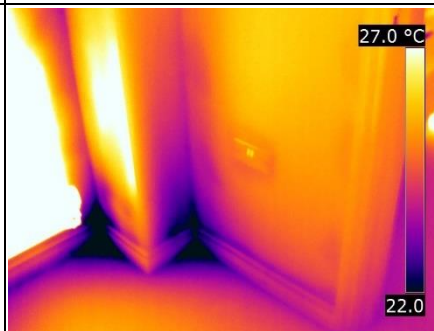
Utility – Under natural conditions

The floor wall junction backing on to the garage looked cooler, but as this room was warmer than the rest of the house it was hard to tell if this was significant.

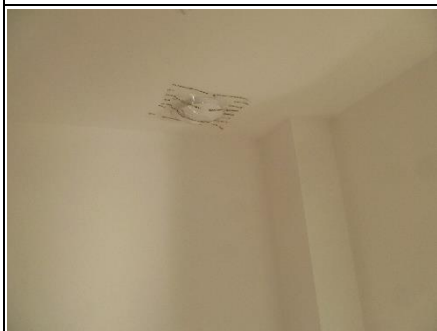
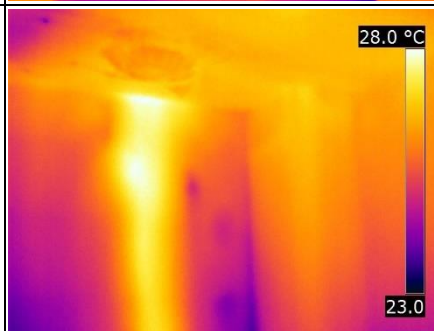
Utility – Under depressurisation

Cold spots on the external wall again suggest (as in the previous plot) that there may be gaps in the inner leaf blockwork that allow air to infiltrated directly from the external wall cavity into the void behind the dry lining.

The service riser looks a little cooler nearer the base, but it is still fairly warm.

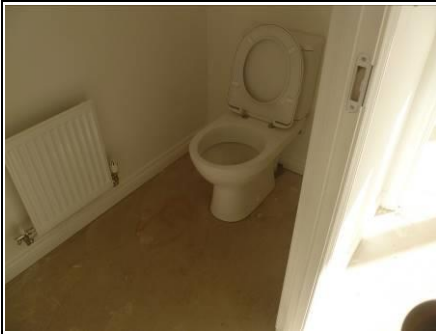
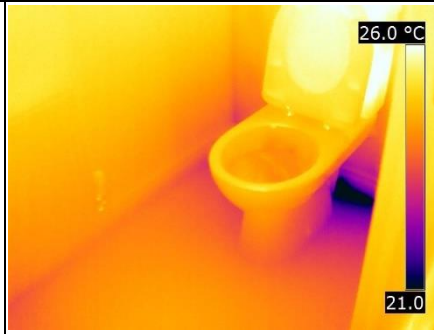
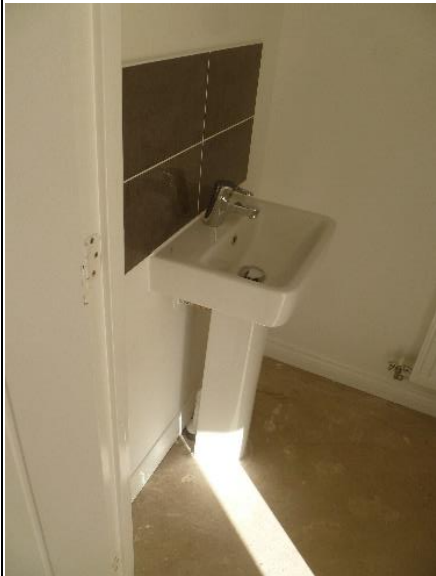
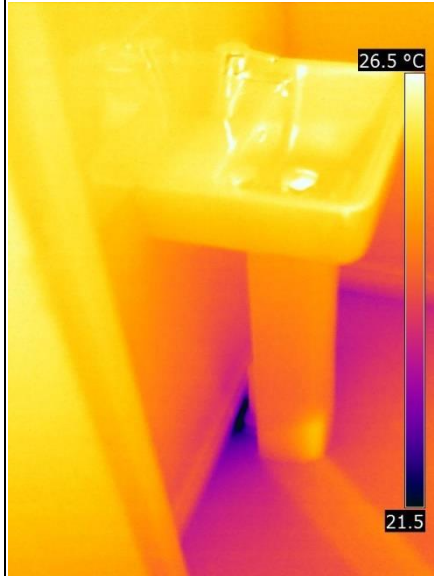
Ground Floor WC – Under natural conditions

The ground floor WC has no external walls so it would be unlikely to exhibit any strange behaviour, cooler patches around the service penetrations through the floor can be explained by the different filling materials around the penetrations.

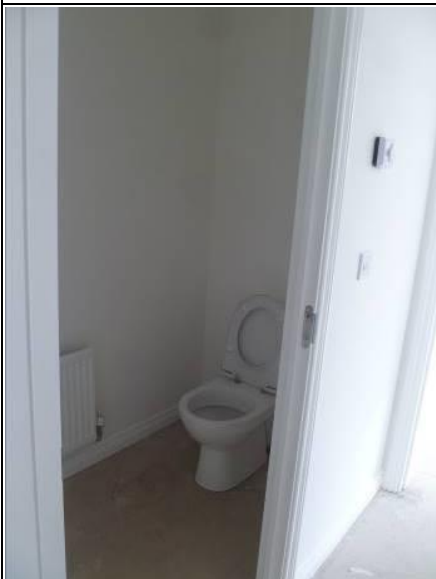
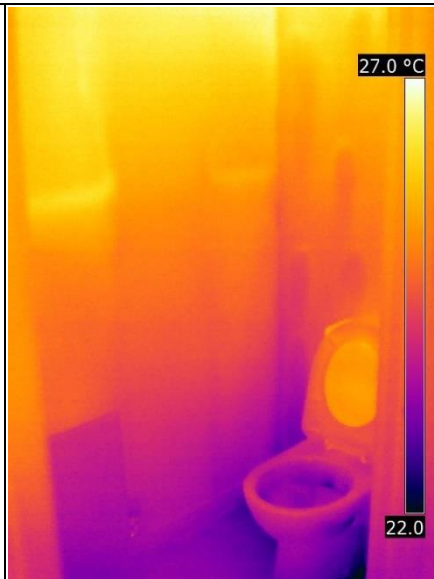
Ground Floor WC – Under depressurisation

Under depressurisation air can be seen moving upwards through the partition wall adjacent to the utility.

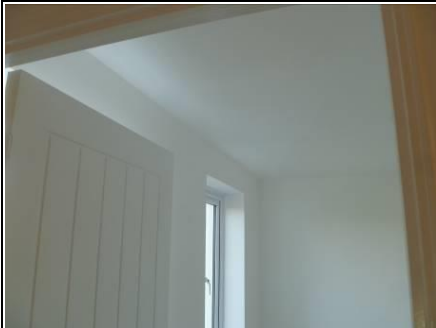
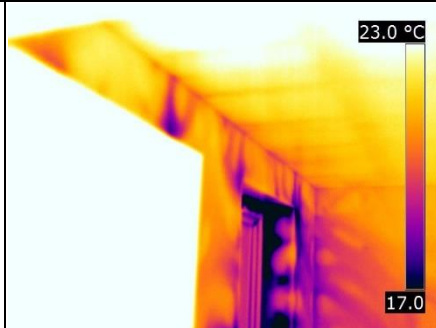
Study – Under depressurisation

Again, under depressurisation the infiltration paths appear significantly worse, with infiltrating air entering the dry lining void all around the windows.

Adjacent to the gas meter box more air is entering, some of which appears to emerge below the skirting.

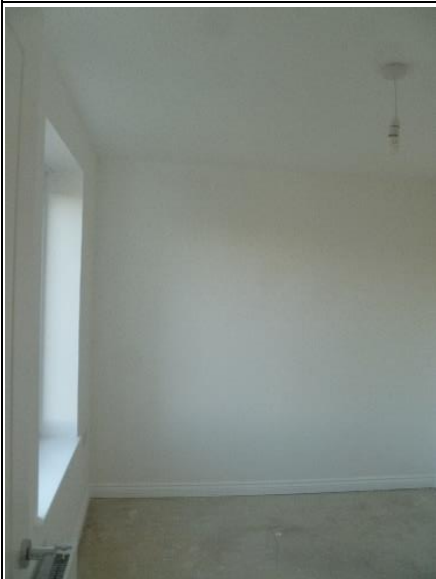
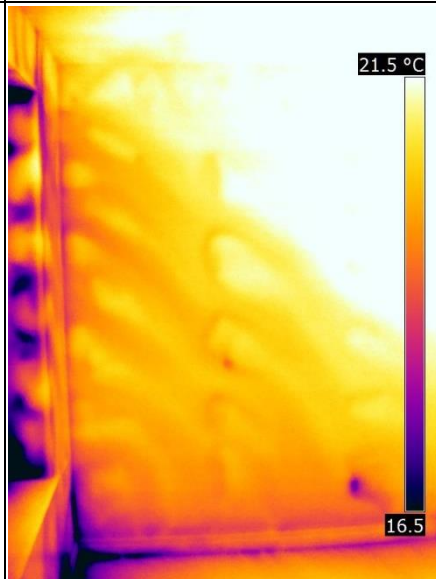
On the gable wall there are a couple of spots that again appear to line up with the inner leaf mortar courses. However, the position of the electricity meter box is not visible internally under pressurisation, unlike what was observed with fully filled walls behind meter boxes.

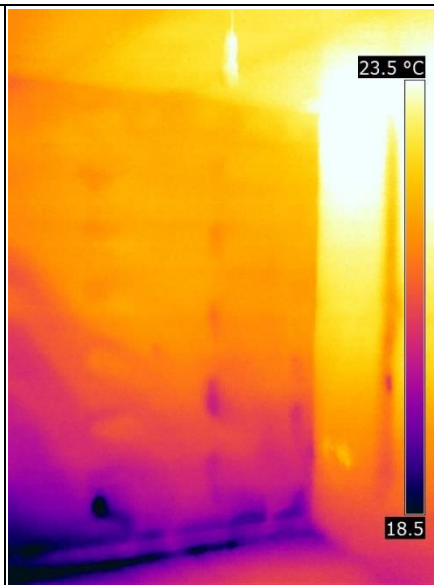
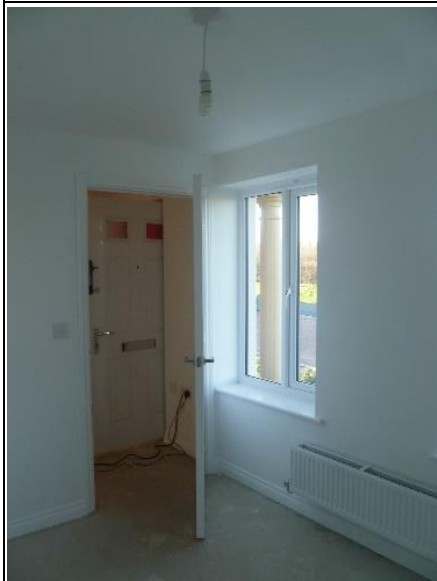
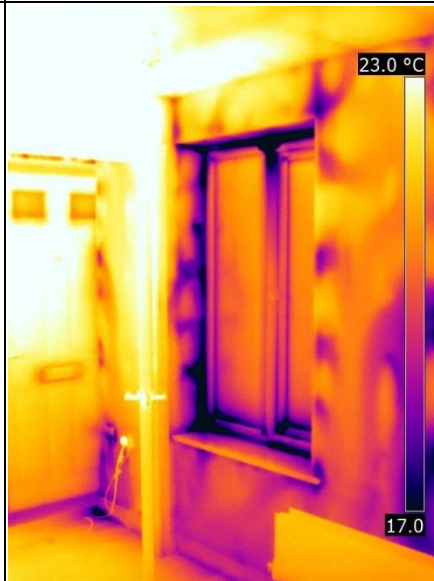
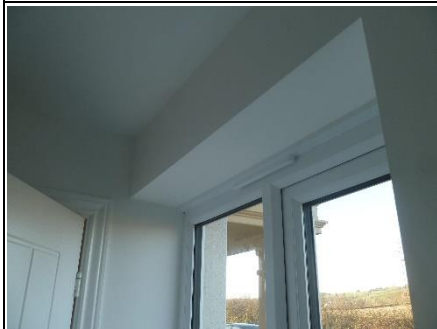
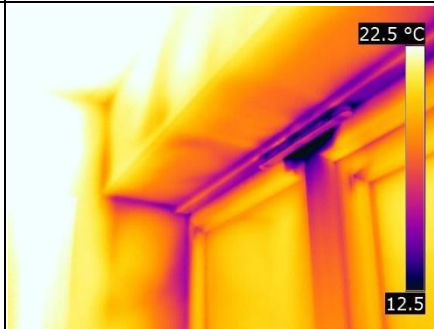
As with most windows and trickle vents observed on this site; the windows function well but allow significant air exchange between the void behind the dry lining and the external wall cavity, and the trickle vents close effectively but are not actually sealed to the window frames.

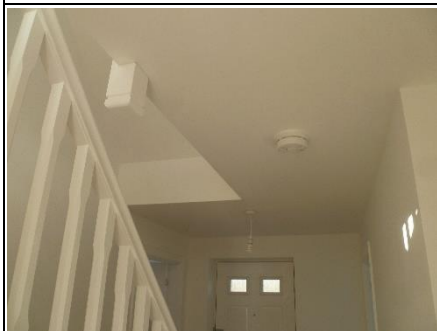
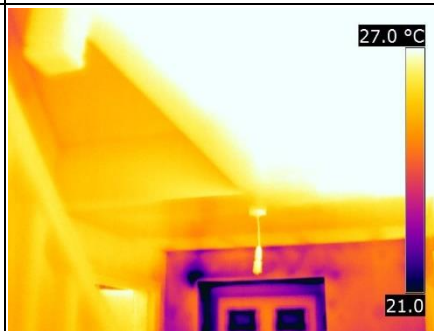
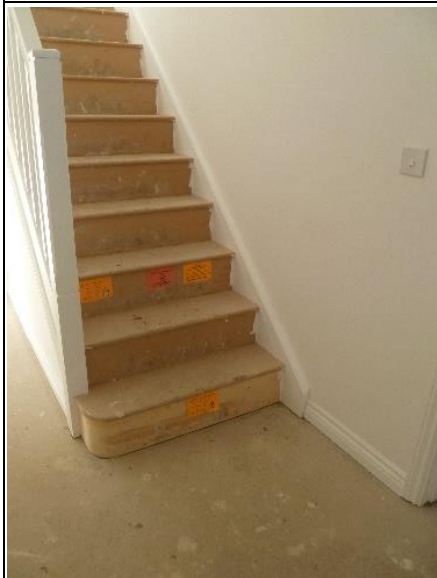
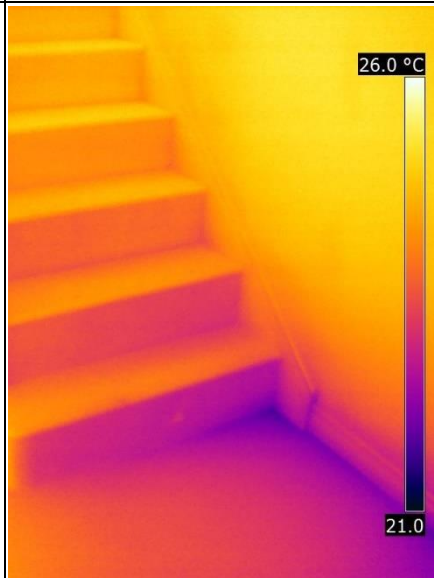
Hall & Stairs – Under natural conditions

The door perimeter is again significantly cooler than the centre of the door, as seen in plot 294.

The threshold is also very cold, although the door having been opened a number of times may have made this look worse.

The external wall in the hall showed numerous cooler spots and air leakage paths, but this did not appear to affect the intermediate floor void directly above.

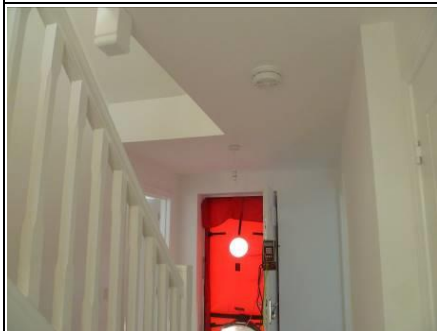
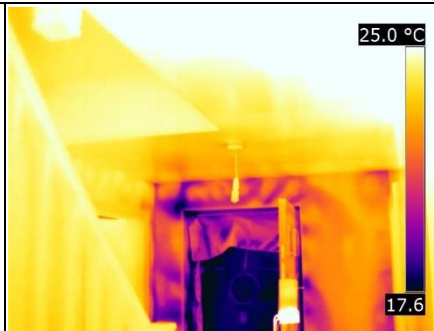
Hall & Stairs – Under depressurisation

Again, under depressurisation the observations made under natural conditions were the same, just more extreme.

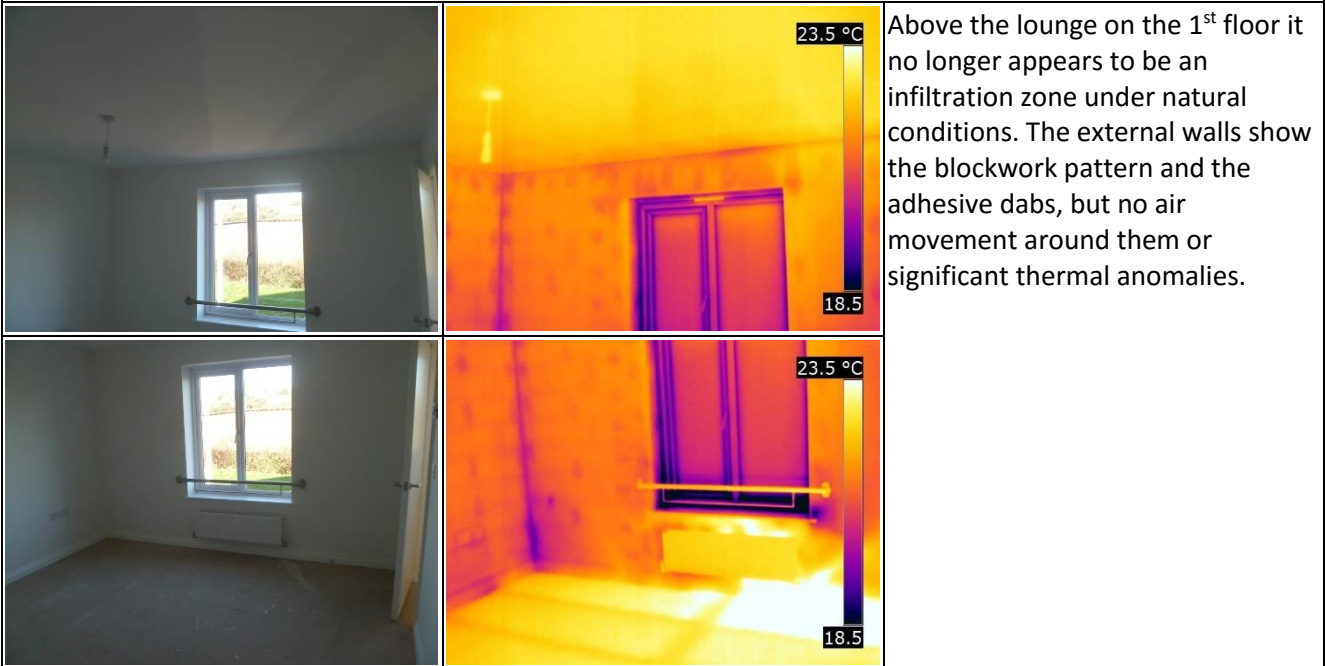
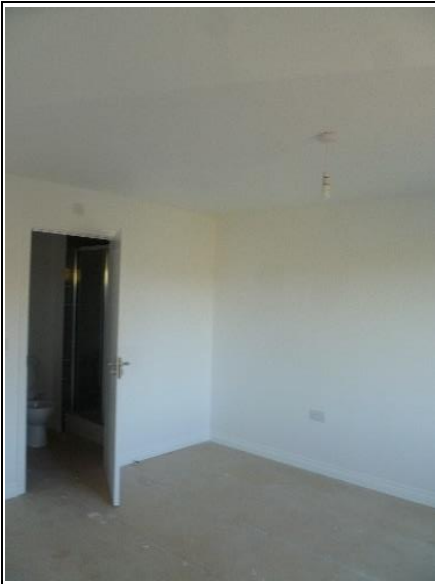
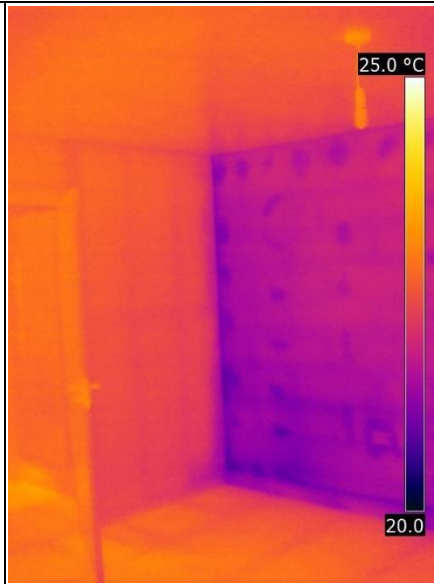
Bedroom 1 – Under natural conditions

Above the lounge on the 1st floor it no longer appears to be an infiltration zone under natural conditions. The external walls show the blockwork pattern and the adhesive dabs, but no air movement around them or significant thermal anomalies.

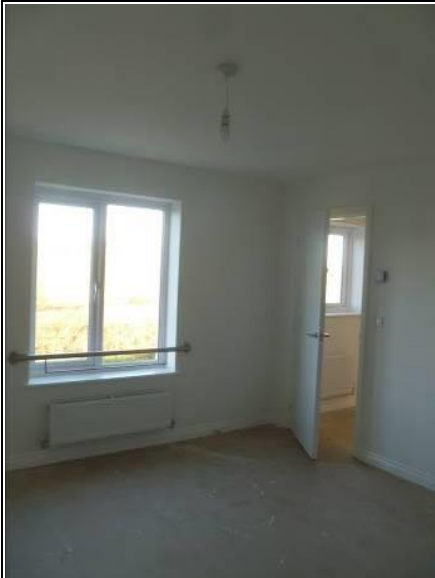
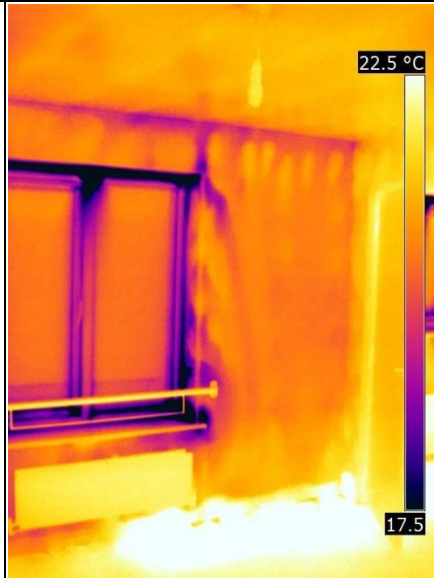
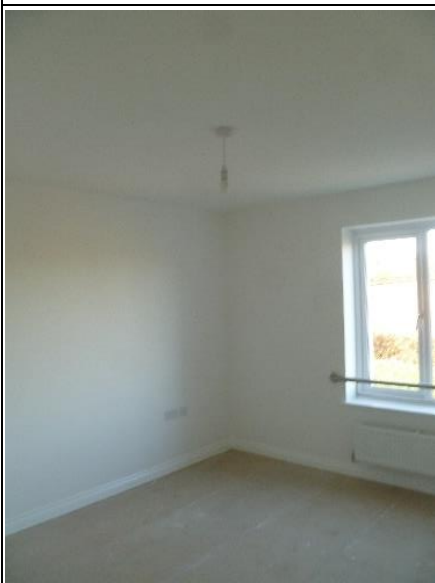
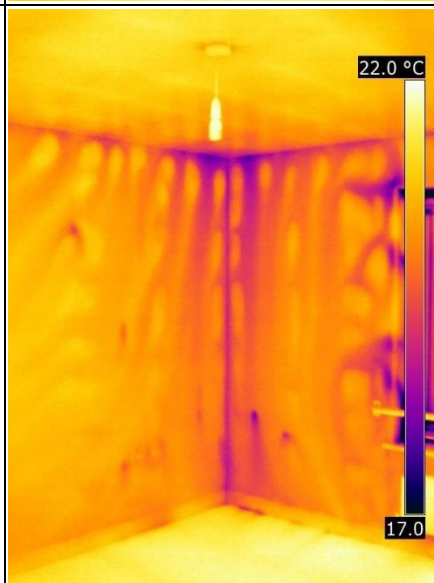
Bedroom 1 – Under depressurisation

Under depressurisation air is again drawn into the dry lining void from around the windows, and also downwards from the eaves more so than from the gable. The gable wall appears to show air moving across through this void rather than downwards.

Again cold spots are seen where air appears to be coming through the blockwork.

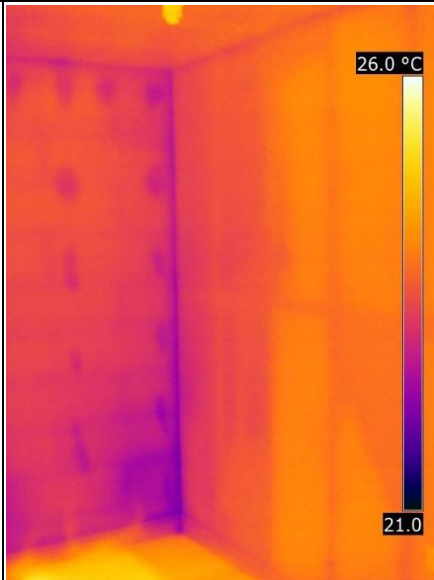
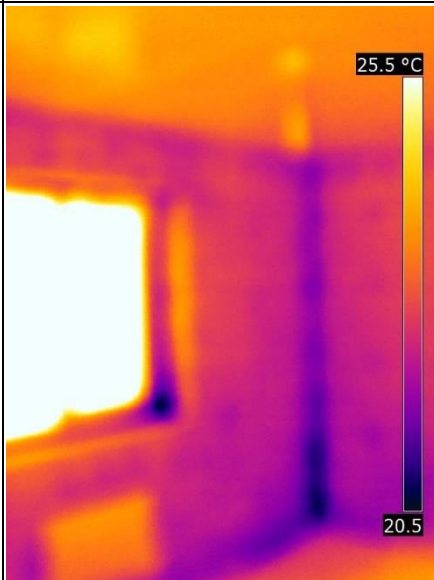
Bedroom 4 – Under natural conditions

The internal partition walls backing onto the en-suite shower and service void in the bathroom look slightly cooler than the rest of the partition walls, but otherwise the room appears very similar to the observations made for bedroom 1.

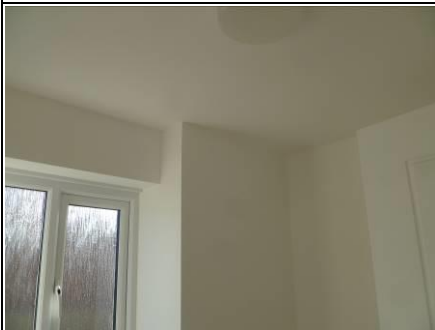
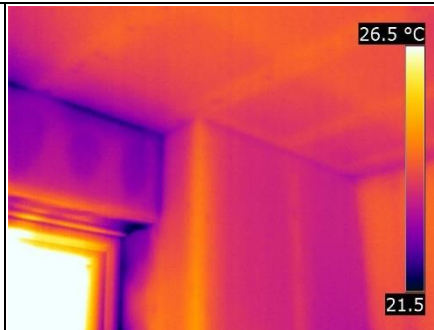
Bathroom – Under natural conditions

The external wall is unsurprisingly cooler than the boxed in voids, but otherwise there's not much happening in the bathroom under natural conditions.

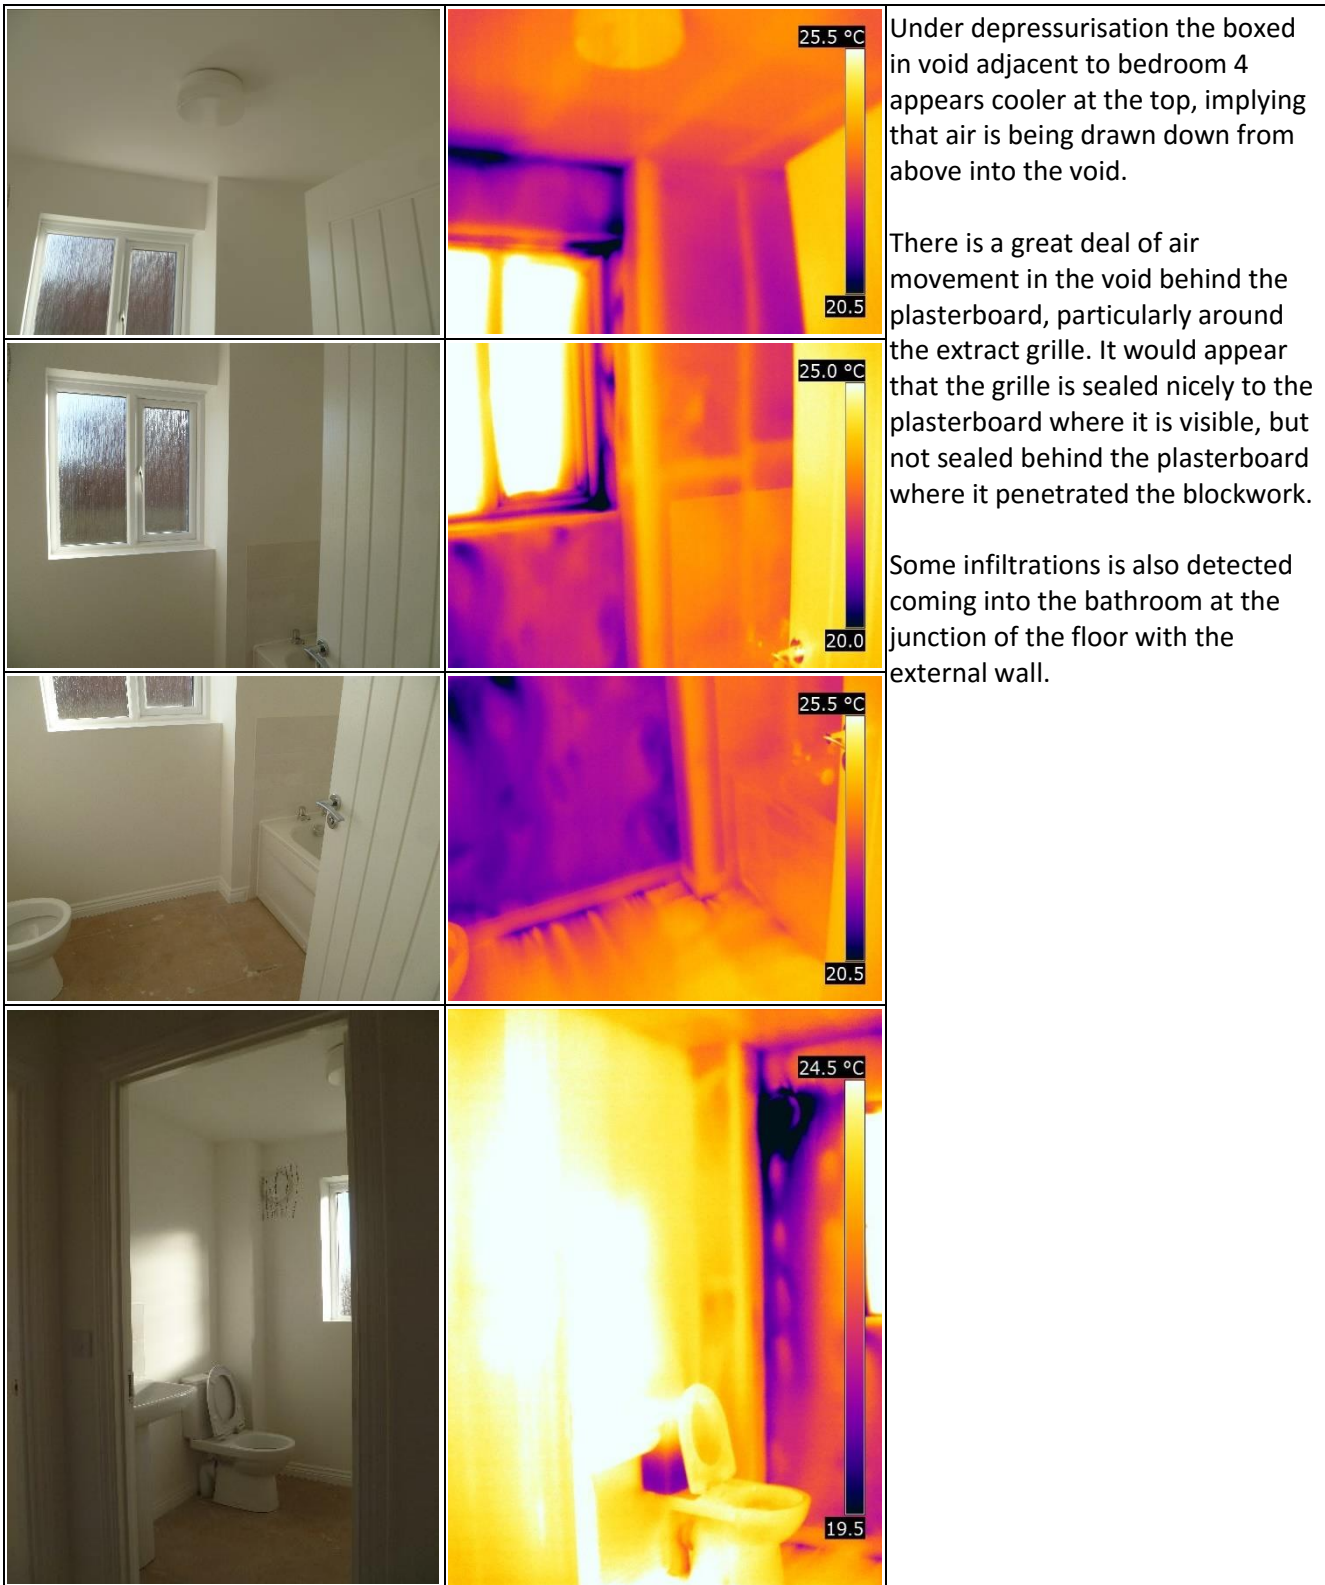
Bathroom – Under depressurisation

Under depressurisation the boxed in void adjacent to bedroom 4 appears cooler at the top, implying that air is being drawn down from above into the void.

There is a great deal of air movement in the void behind the plasterboard, particularly around the extract grille. It would appear that the grille is sealed nicely to the plasterboard where it is visible, but not sealed behind the plasterboard where it penetrated the blockwork.

Some infiltrations is also detected coming into the bathroom at the junction of the floor with the external wall.

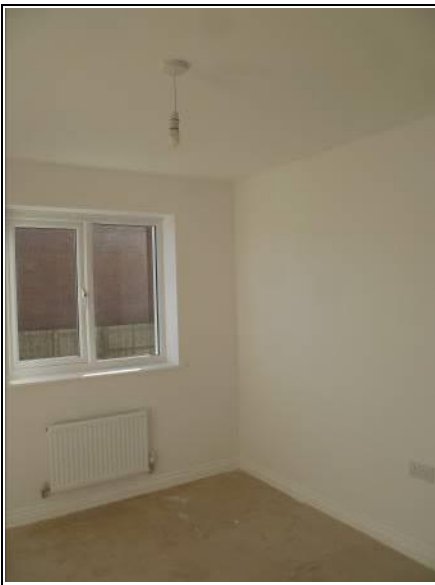
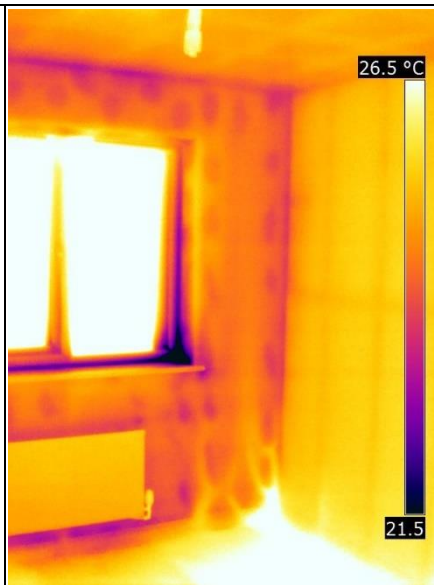
Bedroom 3 – Under natural conditions

Warm air can be seen being drawn up from the intermediate floor void into the dry lining void under natural conditions on both external walls above the kitchen and utility.

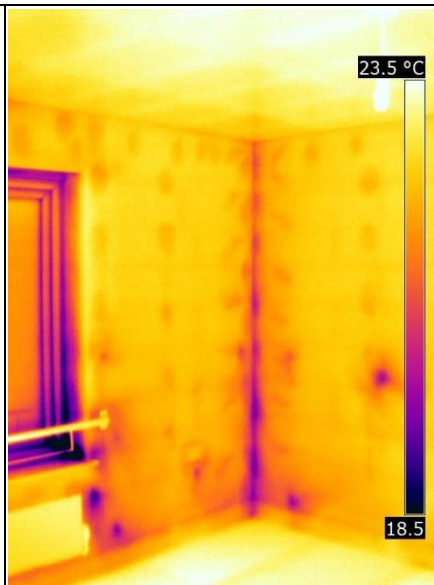
Bedroom 5 – Under natural conditions

The cooler North corner shows some cold spots possibly due to gaps in the inner leaf blockwork.

As in bedroom 3 warm air can be seen being drawn up from the intermediate floor void into the dry lining void under natural conditions on both external walls above
