Miles-Shenton, D (2018) Small Scale Forensic Thermal Imaging Study. Technical Report. Knauf Insulation.

Taylor Wimpey – Thermal Imaging Project

Site: Hele Park
 Newton Abbot
 TQ12 6JN

Plot(s): 294 & 297

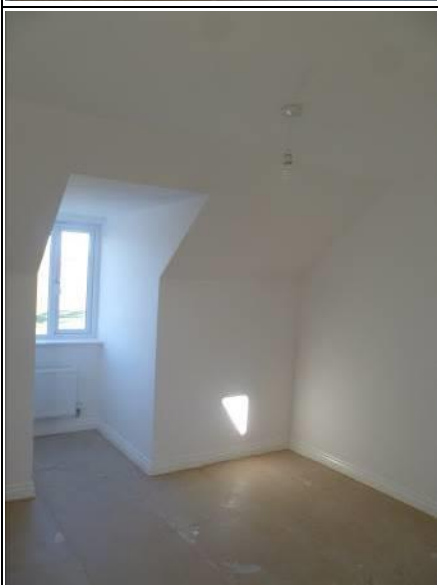
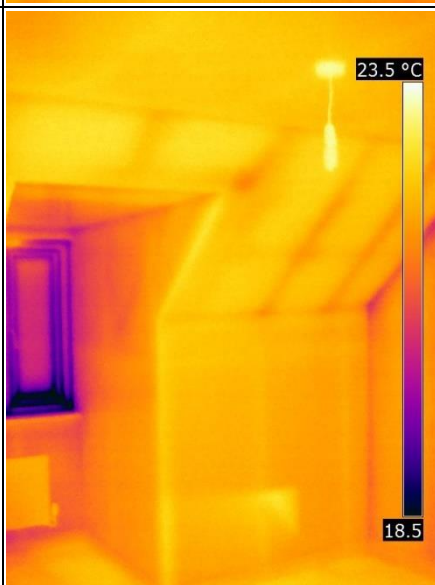
Bedroom 2 – Under natural conditions

Observations as bedroom 6.
