Miles-Shenton, D (2018) Small Scale Forensic Thermal Imaging Study. Technical Report. Knauf Insulation.

Taylor Wimpey – Thermal Imaging Project

Site: Kingsbrook Place

Visit Date: 15th November 2017

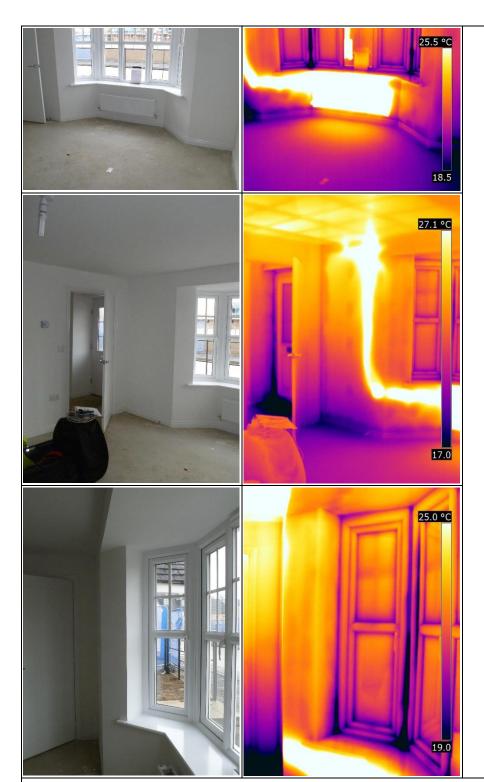
Again, the external wall appeared marginally cooler at the bottom than was expected from just the natural temperature stratification in the room and the fact that the top part of the wall reflected the warm ceiling and the bottom part reflected the colder floor. The bay roof again showed minor cooler spots along the lines of the external wall above. There was also some noticeable cold air infiltration at the bay window without any

induced negative pressure.

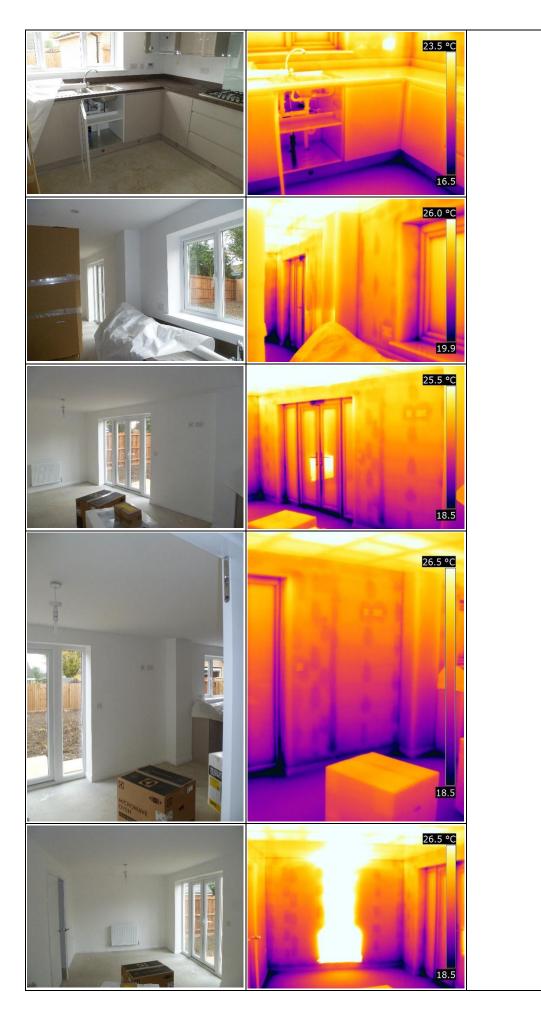
This was much as in Plot 8, but the floor to ceiling thermal gradient was more like that observed in the lounges.

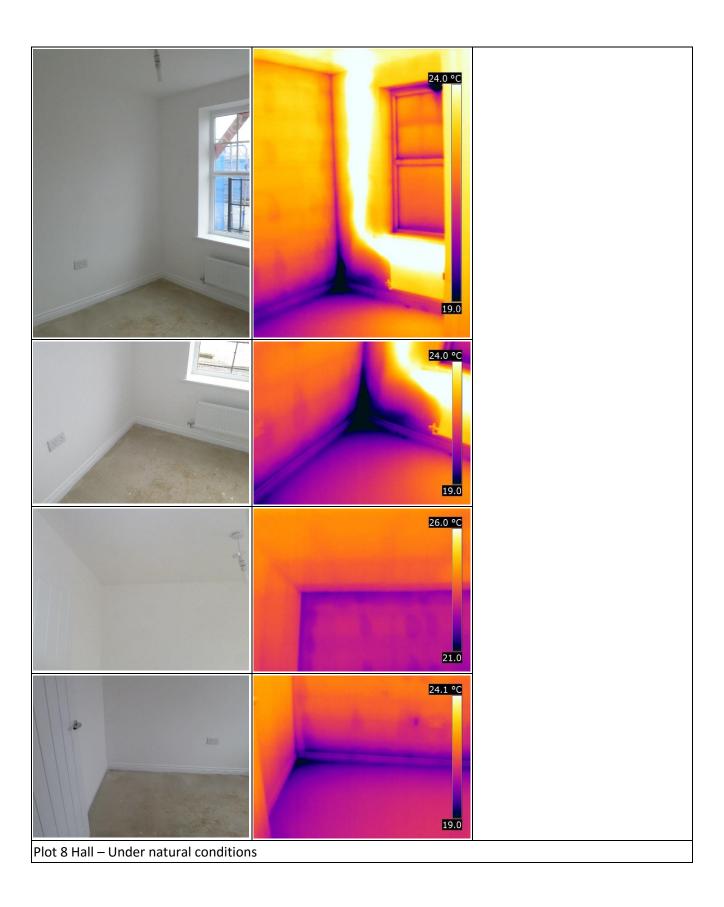
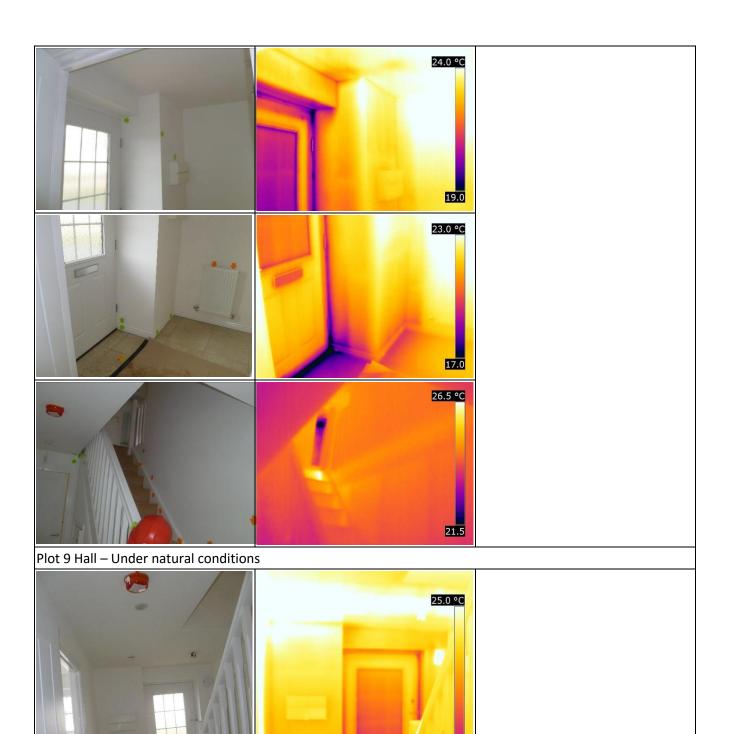
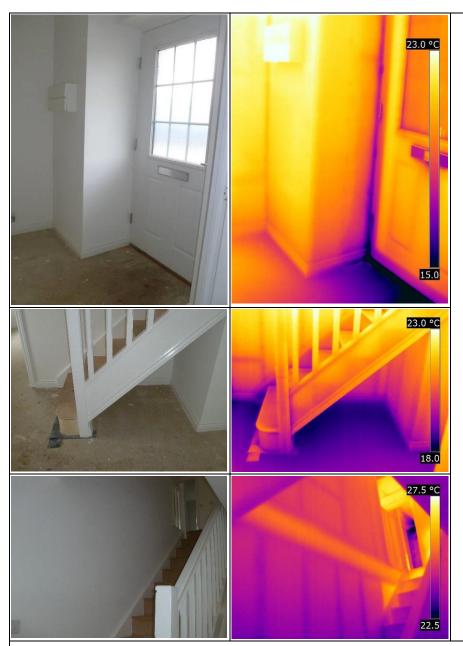
The internal wall adjacent to the boxed-in services in the hall for the electric box and consumer unit appears even more distinct, possible due to air infiltration into this void under depressurisation; with a clear stratification along the study/hall partition from the external wall to where the hall radiator pipework remains visible. The gas meter box also remain welldefined, without air infiltration spreading out from it, indicating that the cooler patch here is due to it being less well insulated than the surrounding area rather than cold air entering through inner leaf wall penetrations.

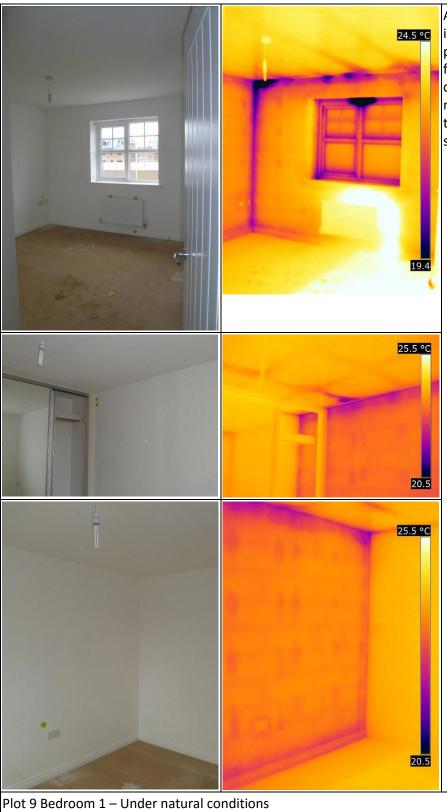
Cooler air is detected drawn in from the loft around recessed ceiling lights, into the internal partition walls, into the void behind the plasterboard on the external walls, into the bowed-in SVP riser and around some of the beading of the glazing panels.

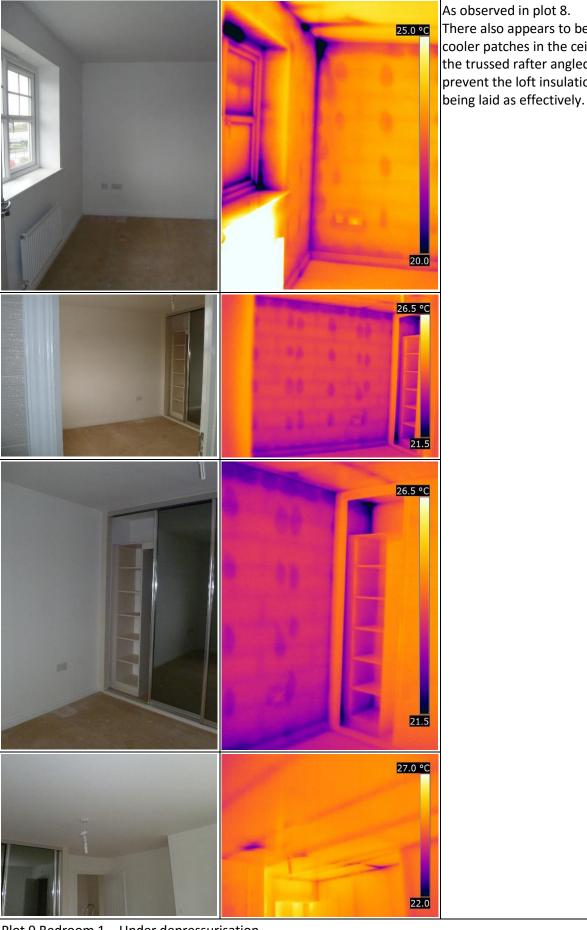
As in the En-suite there are some issues at the eaves but not as pronounced. The thermal gradient from floor to ceiling observed downstairs on the external walls is not present on the first floor where the floor and ceiling appear to be similar temperatures.

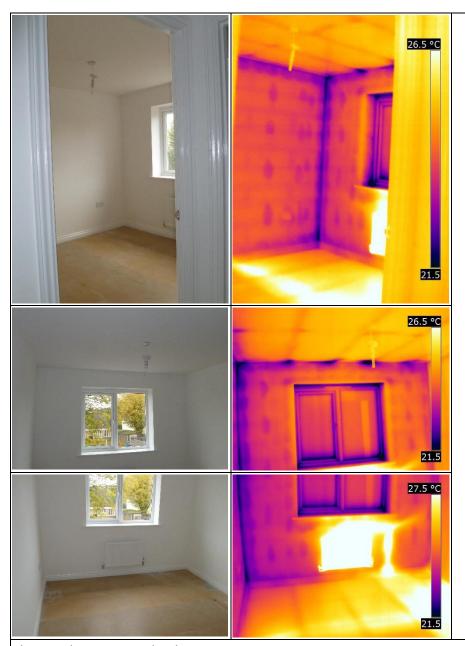
Plot 9 Bedroom 4 – Under natural conditions

As observed in plot 8.

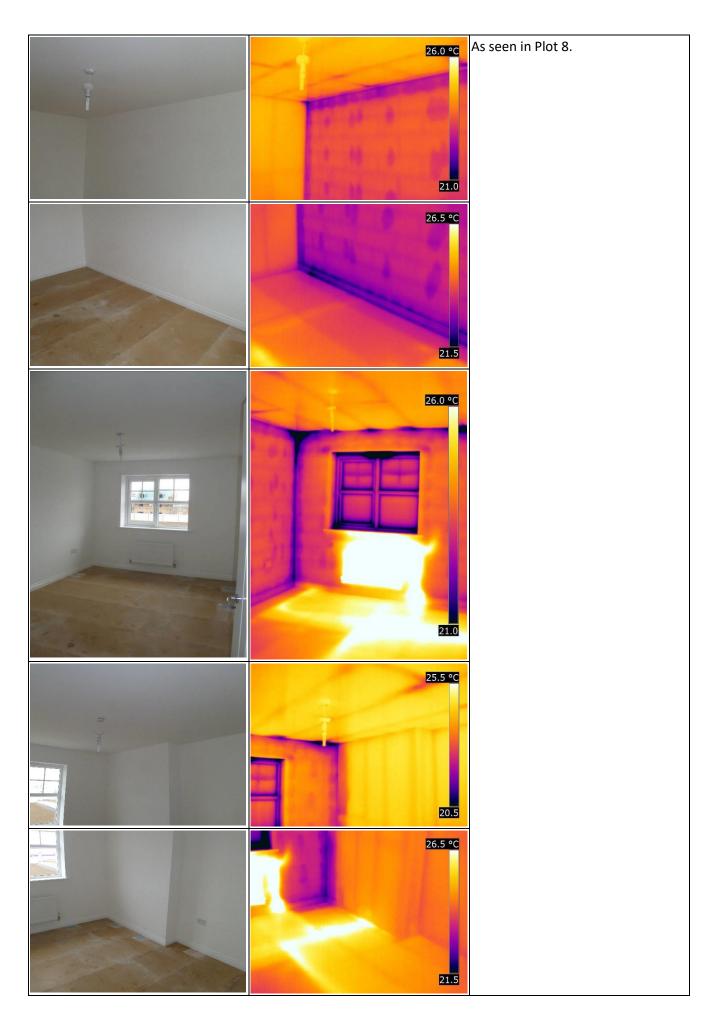
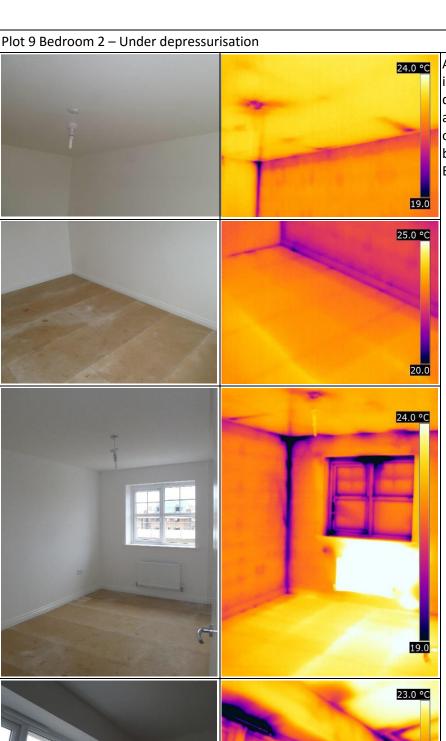
As seen in Bedroom 4 air was drawn in from the loft under depressurisation with the greatest area of concern being the junction of the internal and external walls backing on to the service void in the En-suite.

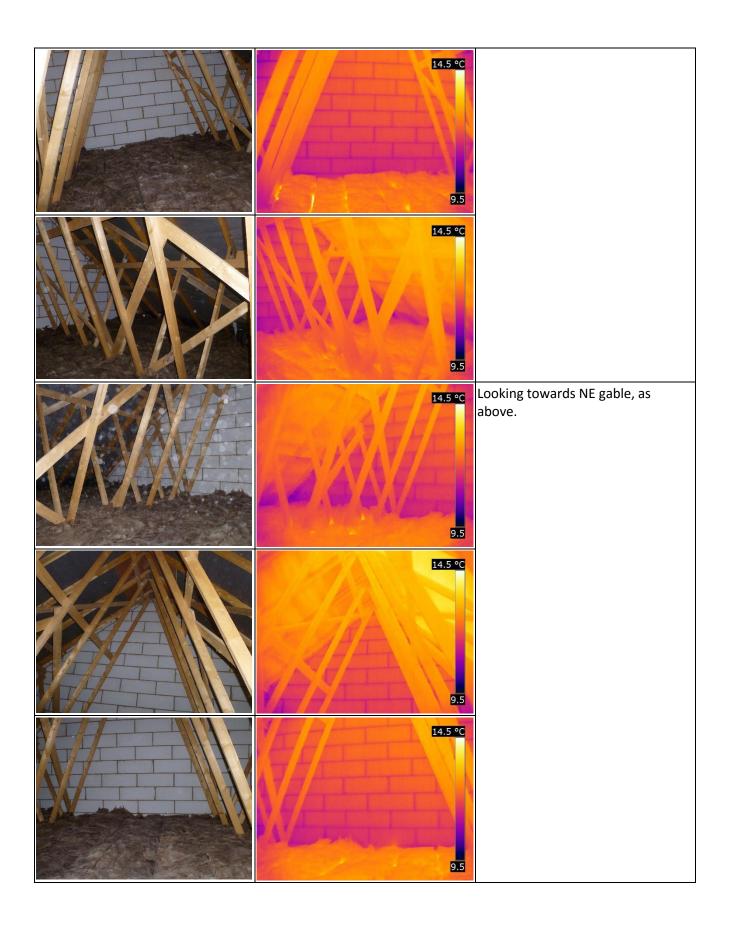
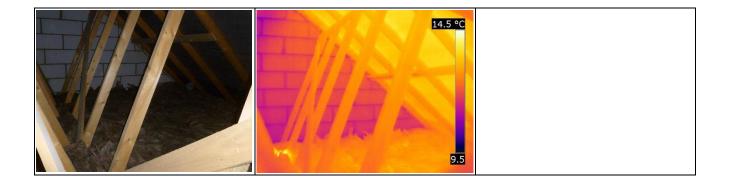
Looking toward the SE Gable the loft insulation appeared to be laid reasonably well, right up to the gable wall and without gaps.
At some of the truss rafter angled junctions additional heat loss could be detected, as could be seen from cooler areas below.

It was not possible to see the insulation at the eaves junctions, no attempt was made to lift the insulation to view services running beneath it.
