Taylor Wimpey – Thermal Imaging Project

Site: Kingsbrook Place
 Elmstree, Bury St Edmunds
 IP30 9HA

Visit Date: 15th November 2017

Plot(s): 8 & 9

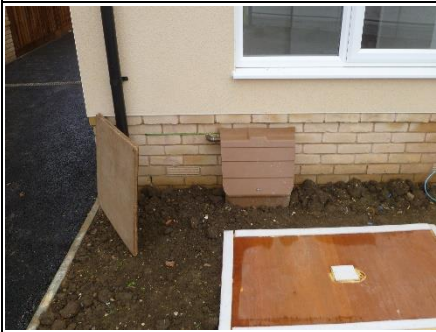
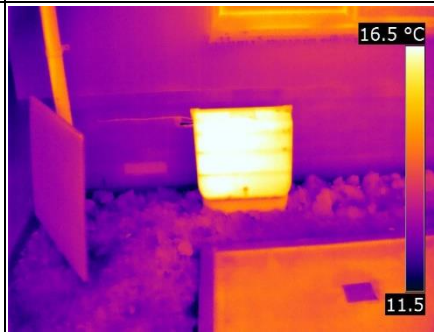
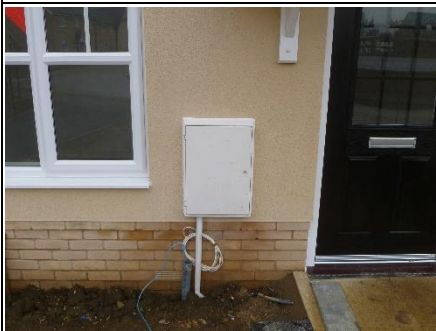
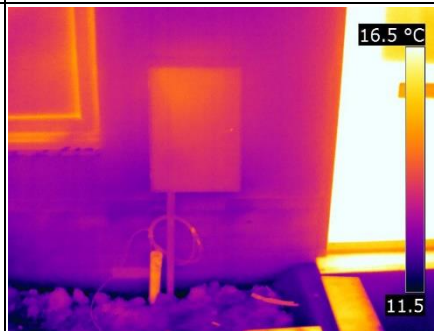
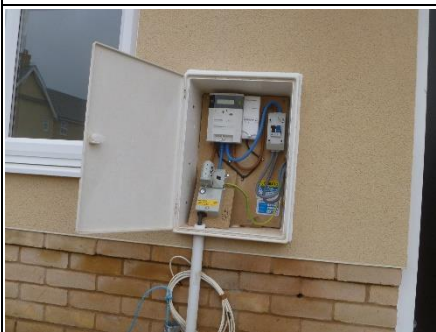
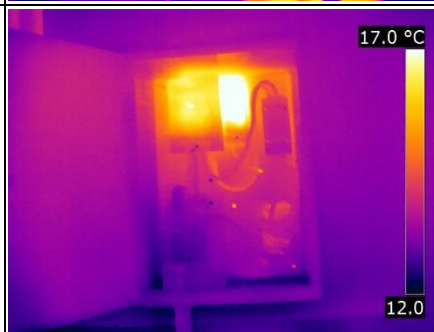
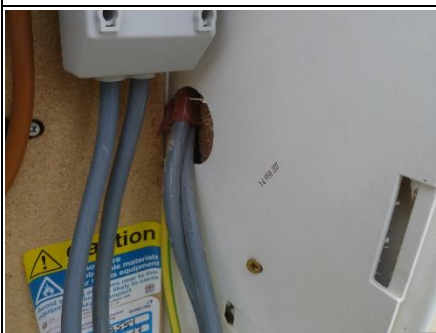
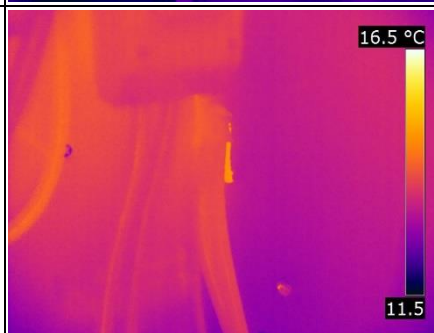
Plot 8 External - Under natural conditions

<p>There had been recent direct solar and drizzle prior to the external thermal survey for this property, affecting apparent surface temperatures. Even reducing the thermal image span to 2.5° to intensify any surface temperature differences little extra can be observed besides warmer areas of walls where radiators are positioned internally:</p>

<p>The heat loss observed in the previous survey of this house type at the ground floor perimeter (Pipers Green, 08-Nov-2017) was not apparent on this site.</p>

Issues around meter boxes had been observed on this house type in a previous survey (Pipers Green), although then both utility boxes were positioned on the gable wall adjacent to the study rather than on the front façade; no significant issues were observed here.

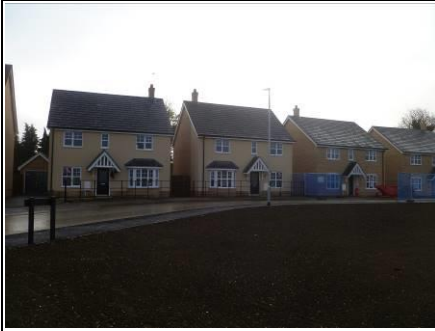
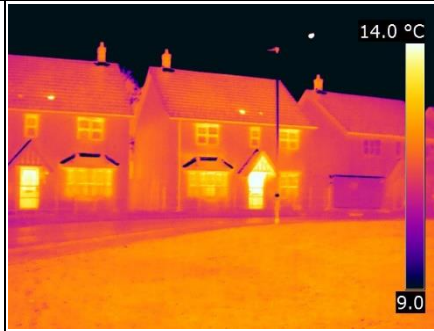
Plot 9 External - Under natural conditions

No significant thermal anomalies were seen from outside the property; slightly warmer areas were again observed adjacent to the bedroom radiators, the meter boxes showed no reasons for concern.

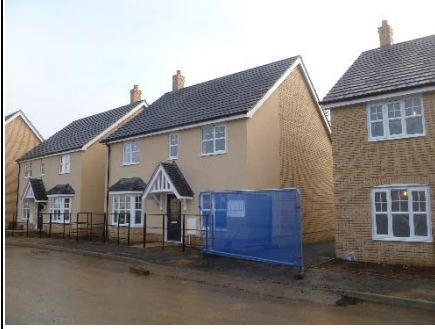
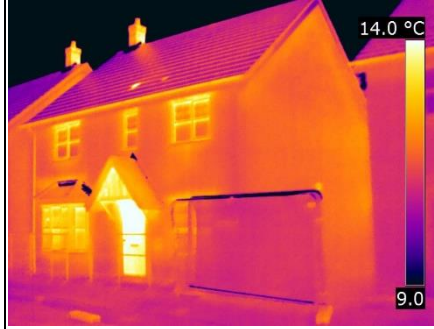
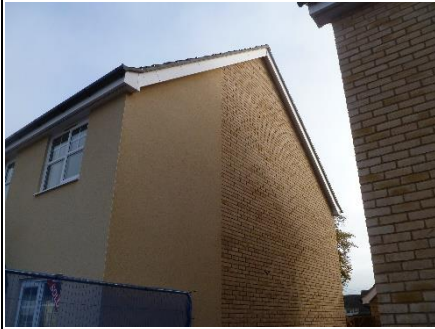
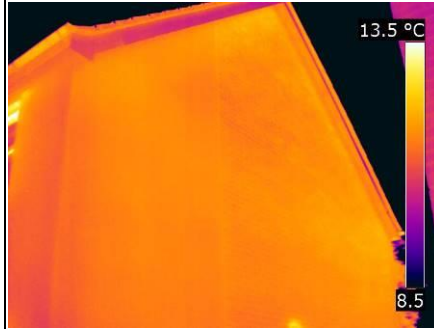
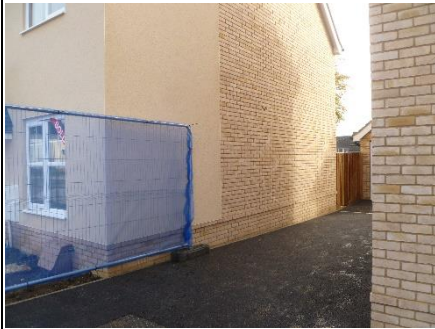
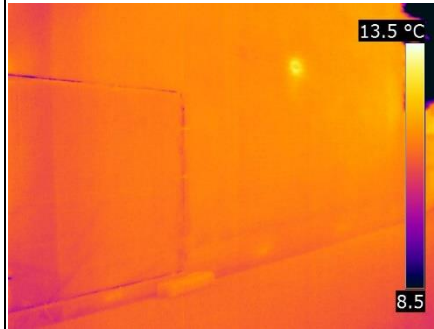
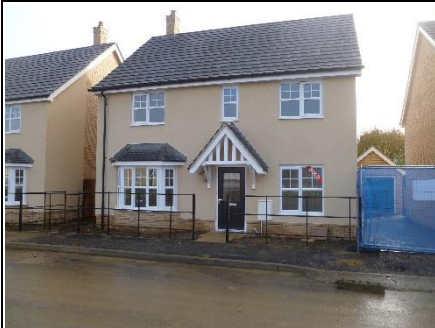
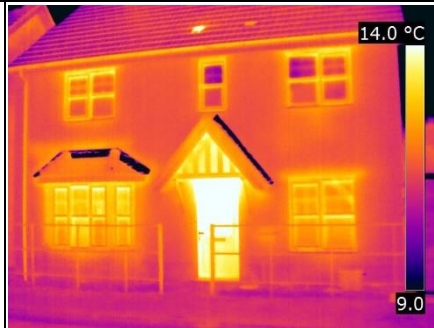
Warmer areas were observed on the external wall at window openings, particularly heads, and above the bay roof but these only appeared significant when manipulating the thermal image span to 2.5° to accentuate any differences:

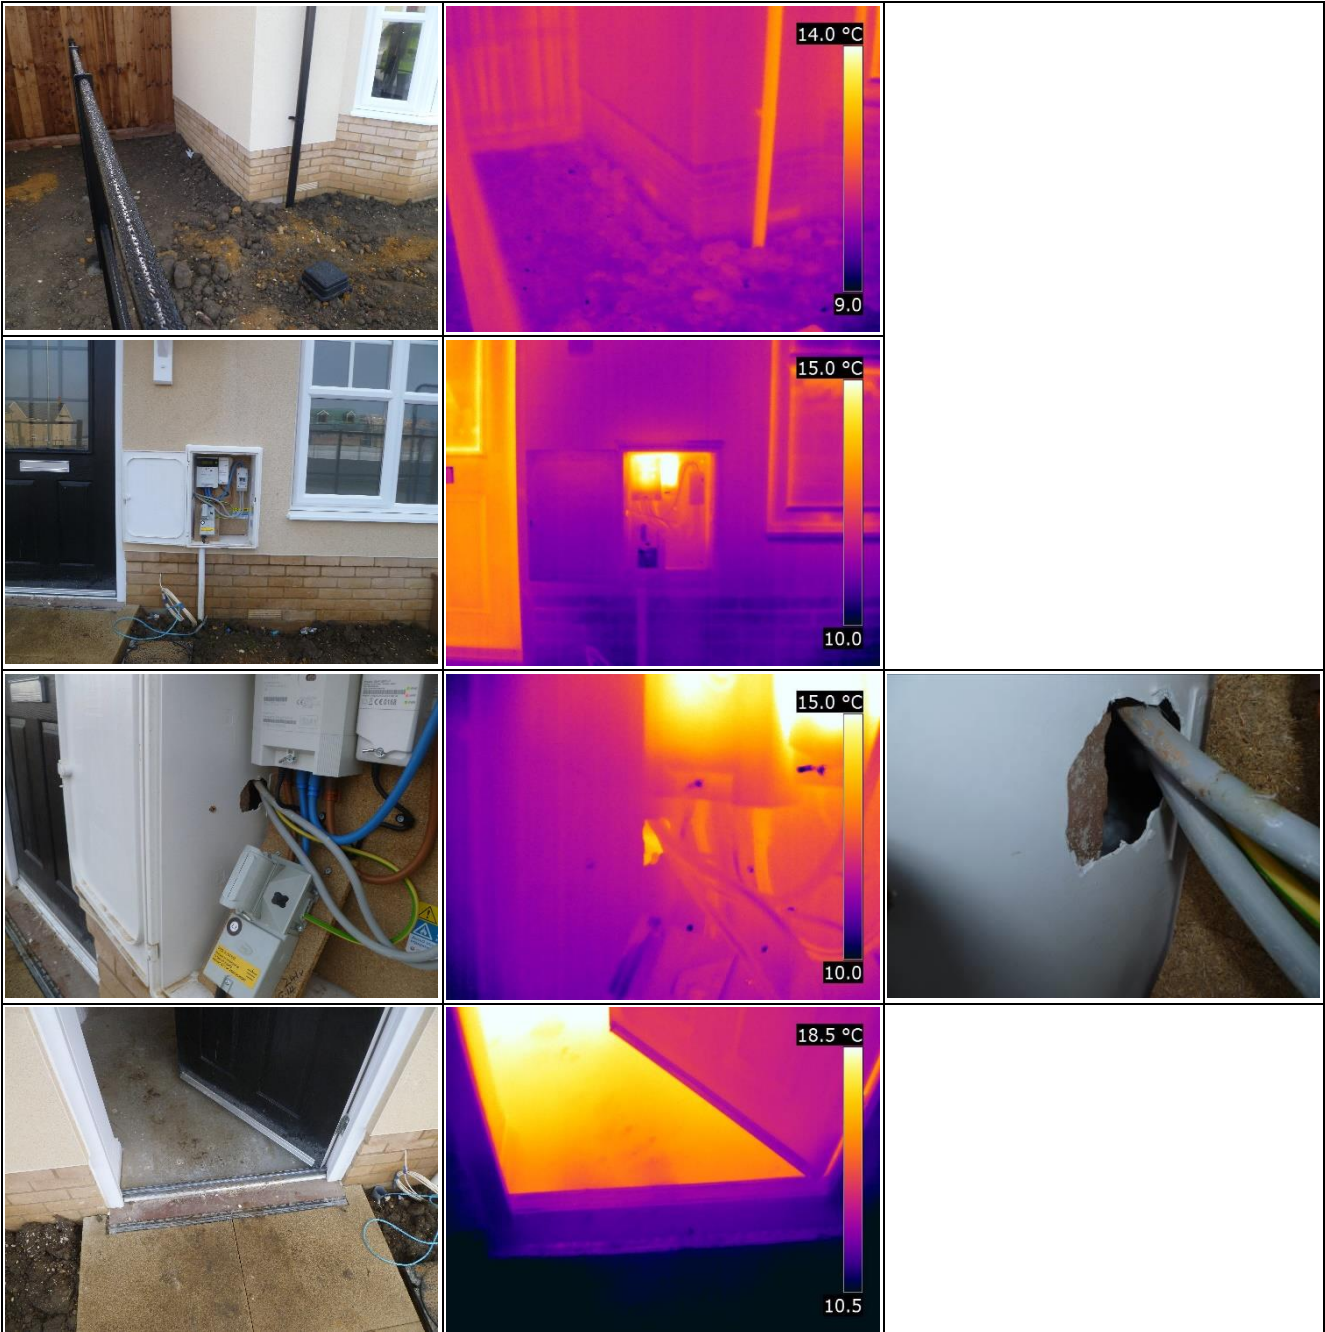
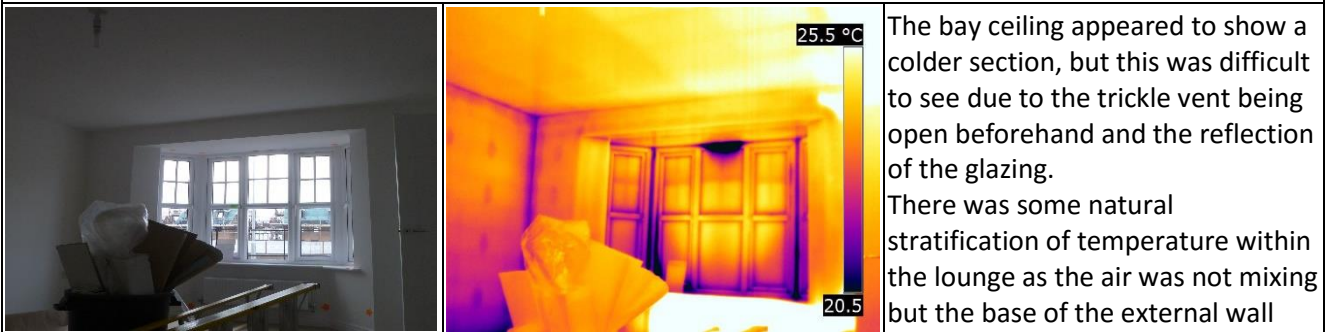
Plot 8 Lounge – Under natural conditions

still appeared slightly cooler than expected, although this was not reflected in the external images.

There was also colder vertical strip which was not observed from outside due to the fence between the dwellings.

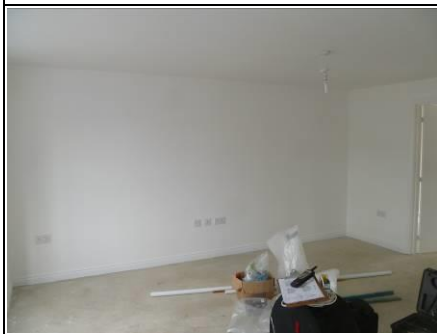
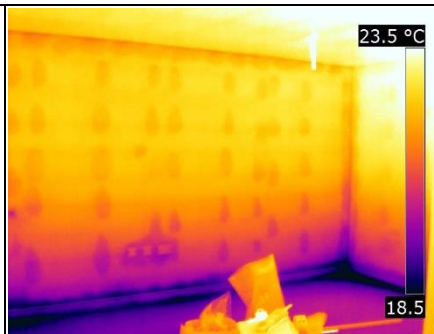
Plot 9 Lounge – Under natural conditions

Again, the external wall appeared marginally cooler at the bottom than was expected from just the natural temperature stratification in the room and the fact that the top part of the wall reflected the warm ceiling and the bottom part reflected the colder floor.

The bay roof again showed minor cooler spots along the lines of the external wall above. There was also some noticeable cold air infiltration at the bay window without any induced negative pressure.

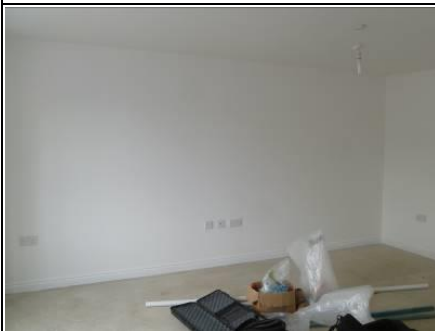
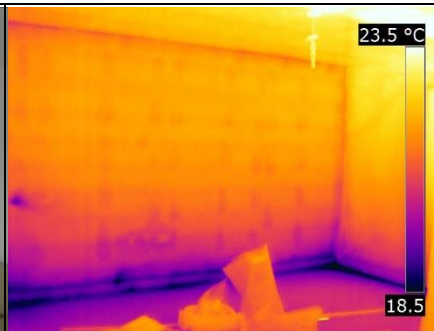
Plot 9 Lounge – Under depressurisation

There appear to be some spots on the external wall where air is being drawn into the void behind the plasterboard directly from the external wall cavity, most probably due to gaps in the mortar in the inner leaf blockwork. This air from the cavity appears to have cooled the void behind the plasterboard

enough to reduce the temperature differential between areas of dry lining directly over and away from the adhesive dabs.

The line of the external wall is more distinct on the bay ceiling, as is air infiltration around the window and through/around the closed trickle vent.

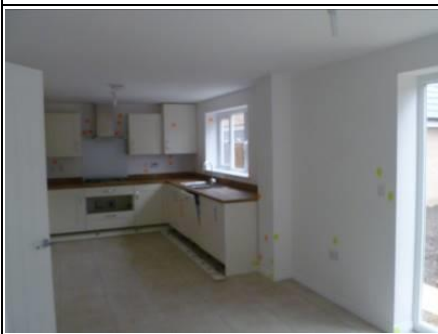
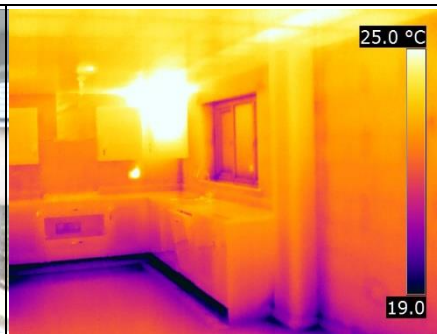
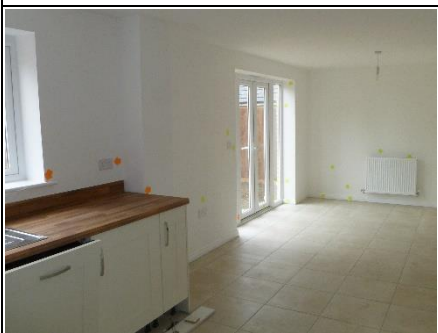
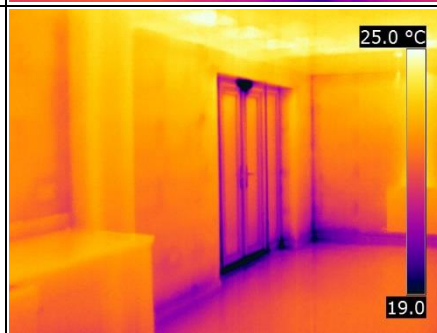
Plot 8 Dining / Kitchen – Under natural conditions

Some additional thermal bridging around the patio doors was observed, in comparison to the kitchen window, where the patio doors were positioned further out into the external wall than the window, but nothing substantial. The external walls appeared to show a slightly decreased temperature gradient to those in the lounge.

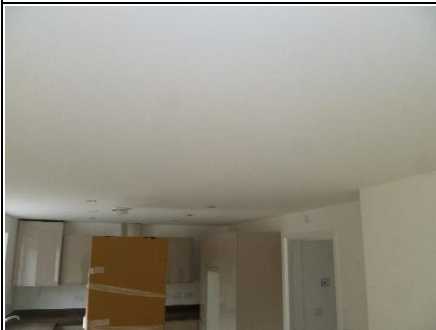
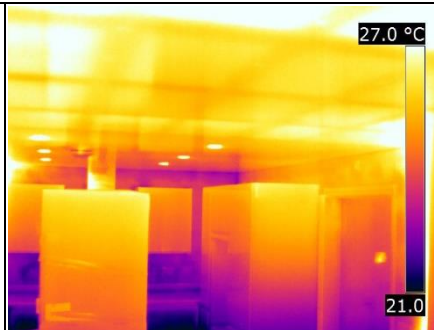
Plot 9 Dining / Kitchen – Under natural conditions

This was much as in Plot 8, but the floor to ceiling thermal gradient was more like that observed in the lounges.
Another unexplained cold vertical strip, as seen in the lounge in plot 8 was visible to the right of the patio doors

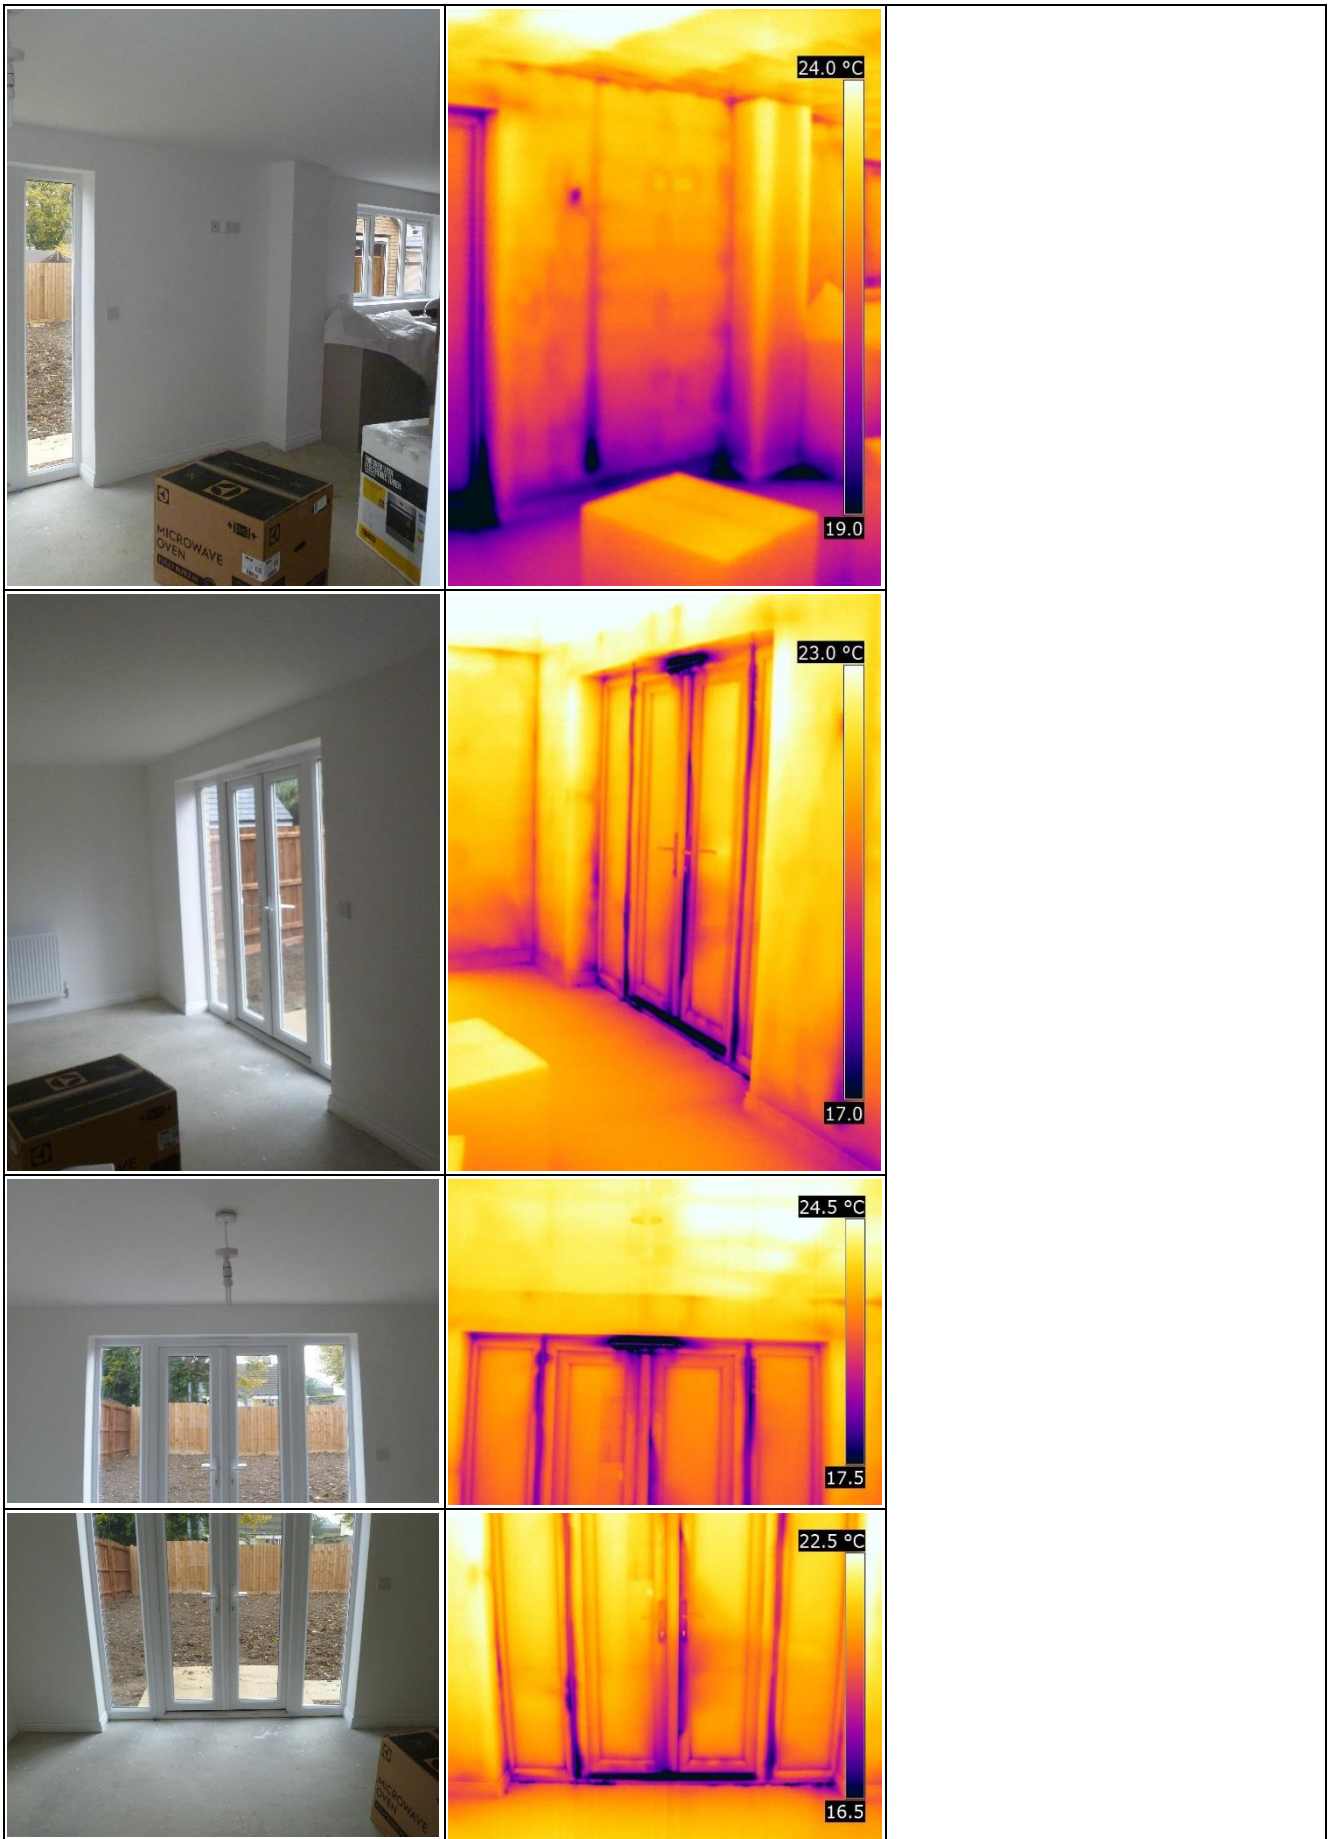
Plot 9 Dining / Kitchen – Under depressurisation

<p>Cold air infiltration was detected around some electrical service penetrations into the void behind the dry lining, including the outside light by the patio doors, and at the floor/ceiling junction by the boxed-in SVP.</p>
		<p>The patio doors appeared to allow a greater amount of air movement between the doors, between the doors and side lights and through/around the trickle vent.</p>

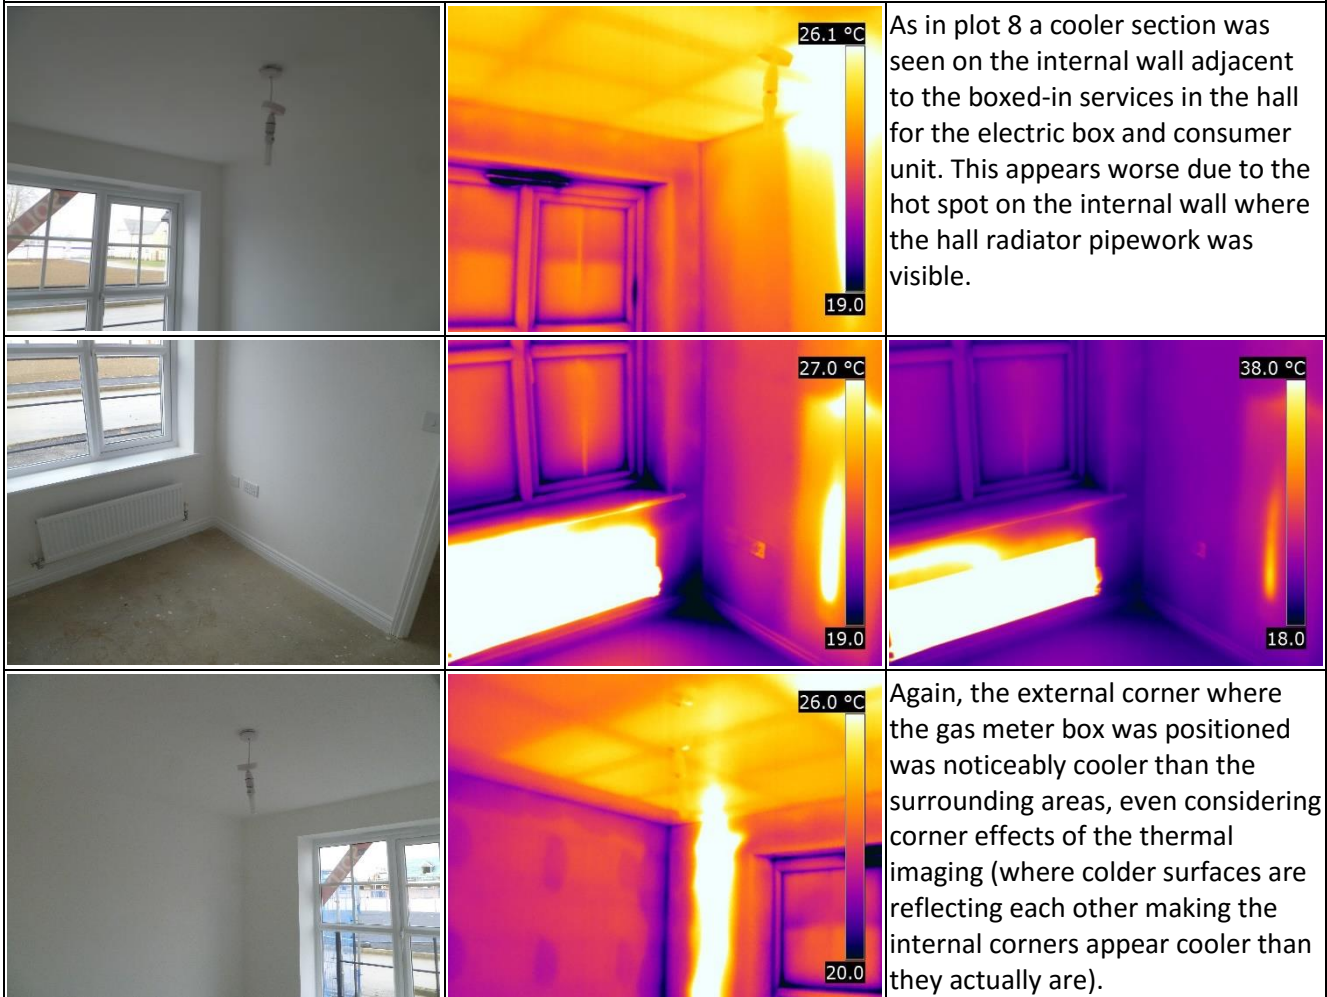
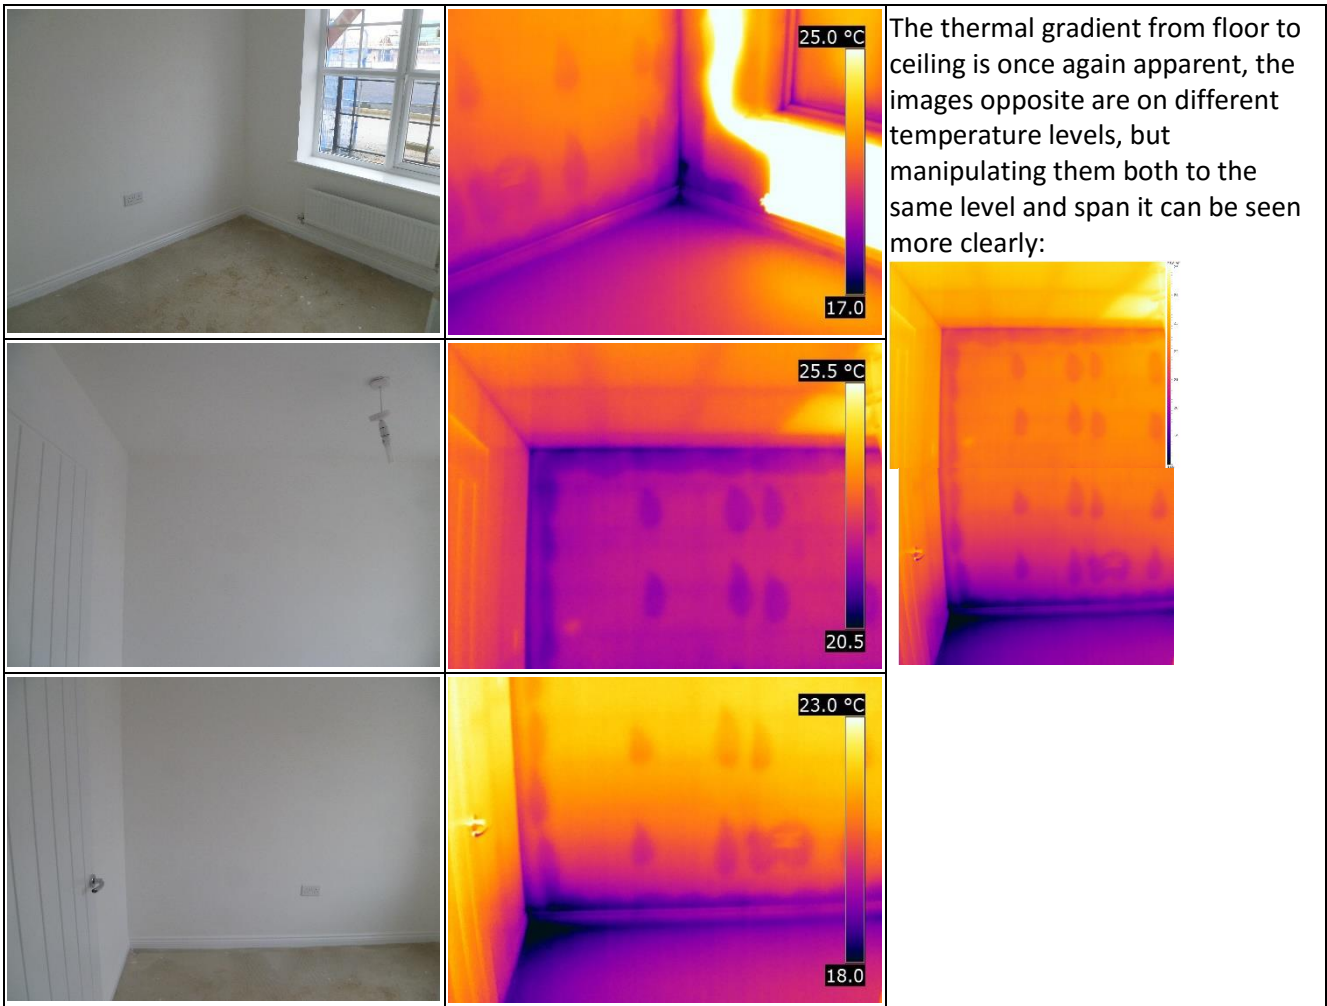
Plot 9 Study – Under natural conditions

The thermal gradient from floor to ceiling is once again apparent, the images opposite are on different temperature levels, but manipulating them both to the same level and span it can be seen more clearly:

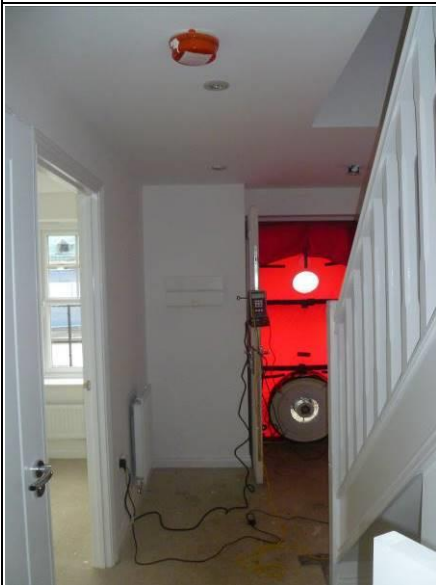
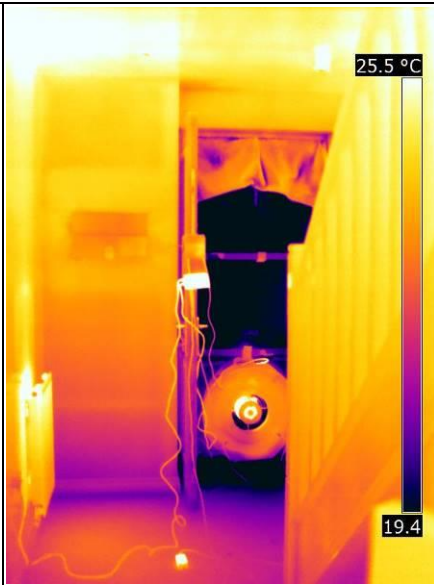
Plot 9 Hall – Under depressurisation

Under depressurisation it appears that colder air is being drawn into the boxed-in service void, as differing wall temperatures can be seen below the consumer unit.

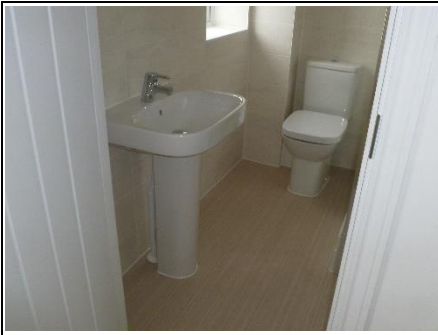
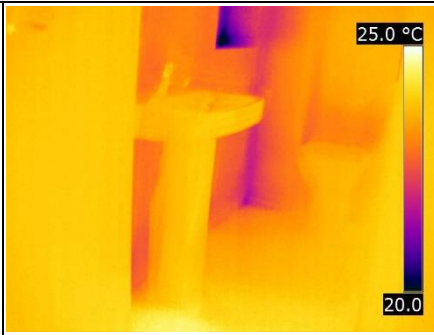
Plot 8 En-Suite – Under natural conditions

The cold section of ceiling at the eaves suggests that the loft insulation does not extend fully to meet up with the wall insulation. Whether this also accounts for the seemingly cooler section at the top of the wall is unclear.

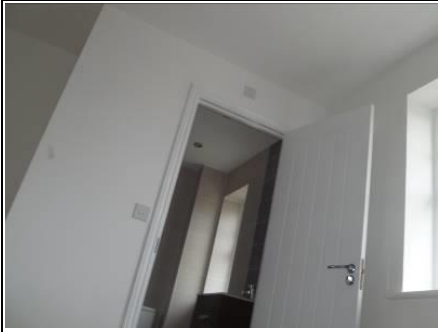
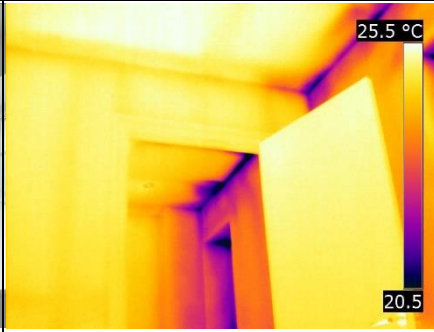
Plot 9 En-Suite – Under natural conditions

As in plot 8, the cold section of ceiling at the external wall junction suggests that the loft insulation does not extend fully to meet up with the wall insulation. The boxed-in SVP also appears to be cooler.

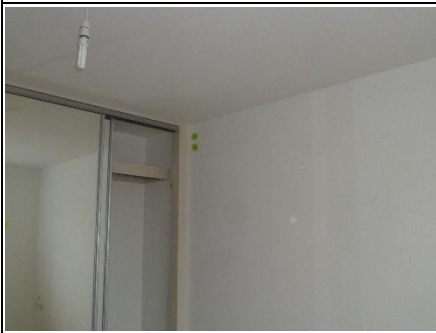
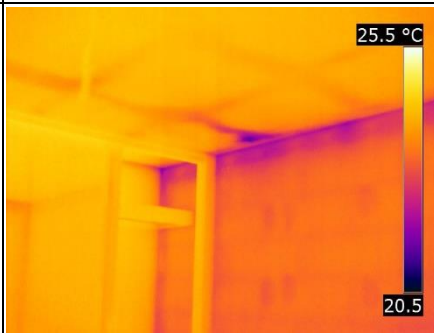
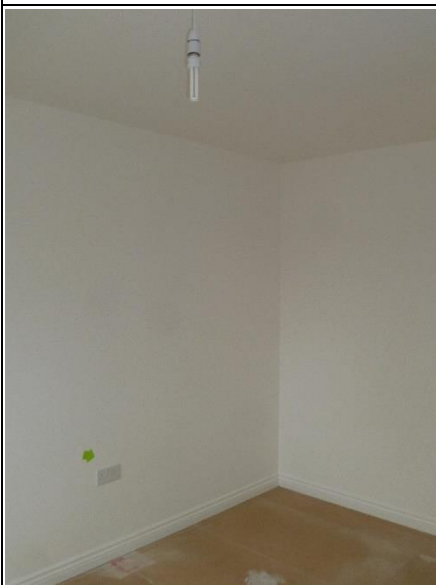
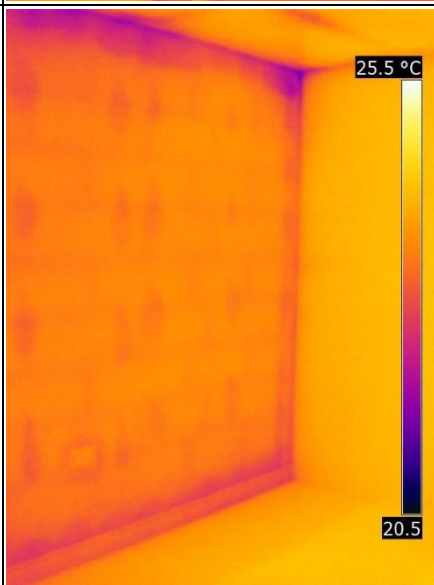
Plot 8 Bedroom 1 – Under natural conditions

As in the En-suite there are some issues at the eaves but not as pronounced. The thermal gradient from floor to ceiling observed downstairs on the external walls is not present on the first floor where the floor and ceiling appear to be similar temperatures.

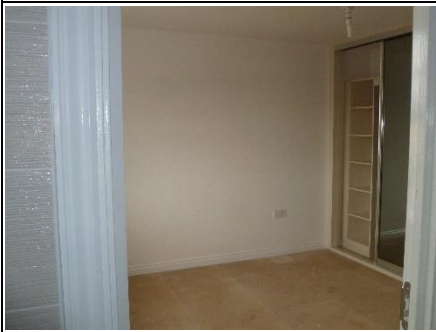
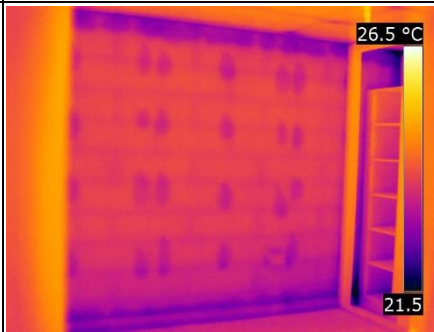
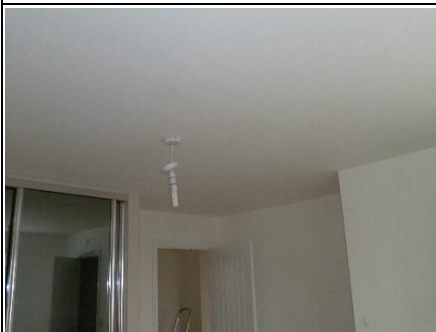
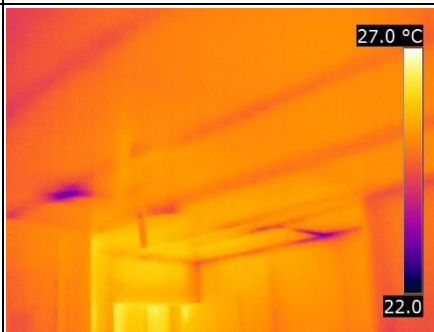
Plot 9 Bedroom 1 – Under natural conditions

As observed in plot 8.
There also appears to be additional cooler patches in the ceiling where the trussed rafter angled junctions prevent the loft insulation from being laid as effectively.

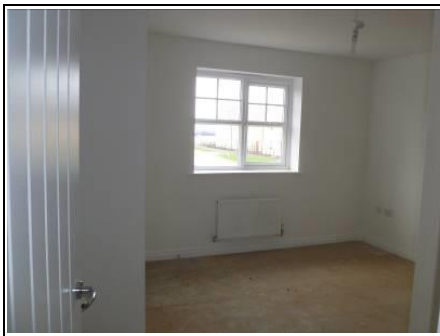
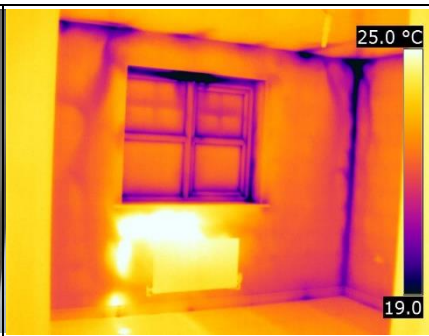
Plot 9 Bedroom 1 – Under depressurisation

Under depressurisation colder air can be seen being drawn down the dry lining voids on the external wall through gaps in the adhesive ribbons.
Cold air in the loft can also be seen tracking the cabling for the central ceiling light, emerging at the rose fitting.

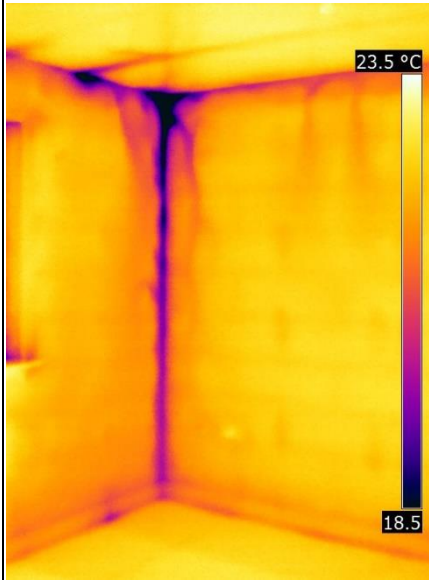
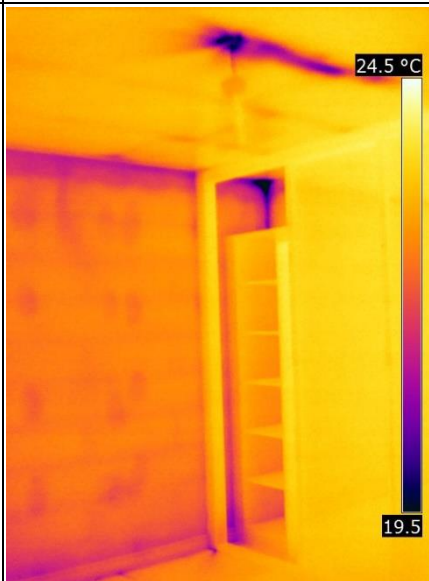
There is some stratification between joists of the intermediate floor which was not observed from beneath.

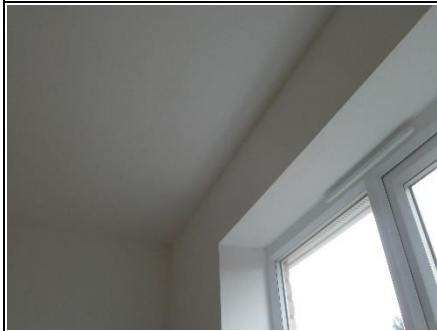
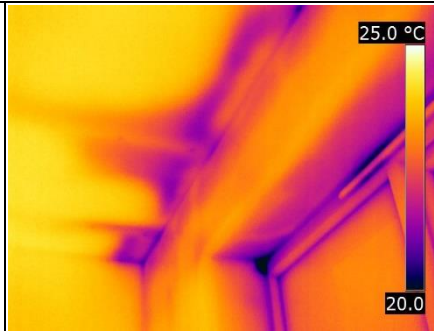
Plot 8 Bedroom 4 – Under natural conditions

The issues at the eaves observed in Bedroom 1 appear more pronounced at the rear of the dwelling. The window head reveal appears slightly cooler than the jamb reveal.

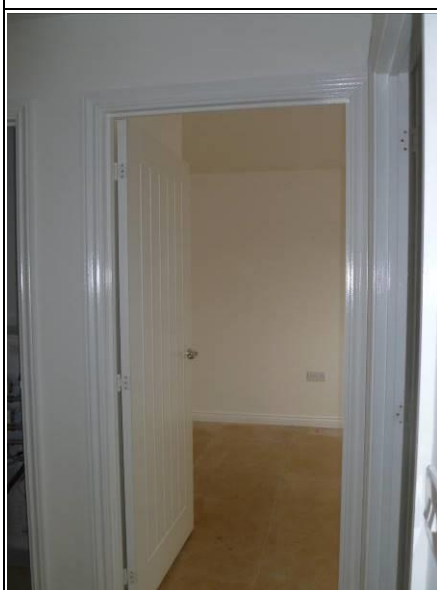
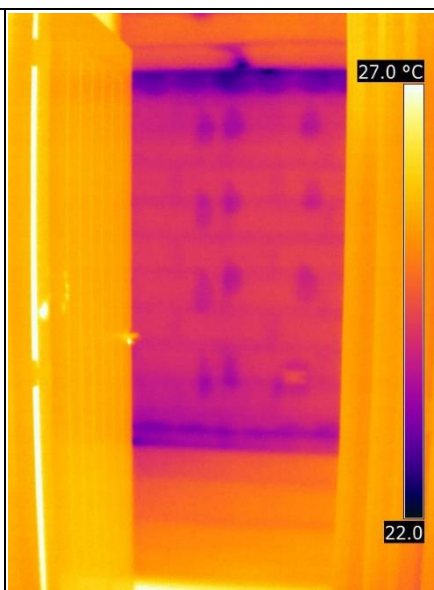
Plot 9 Bedroom 4 – Under natural conditions

As observed in plot 8.

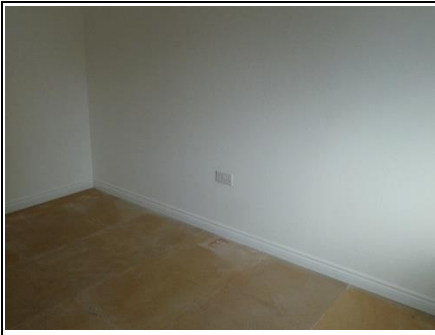
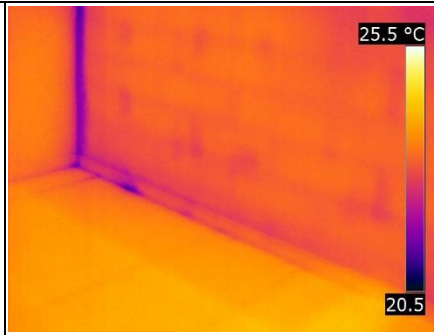
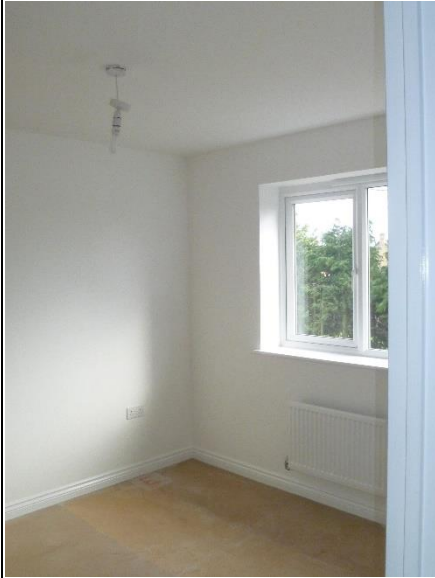
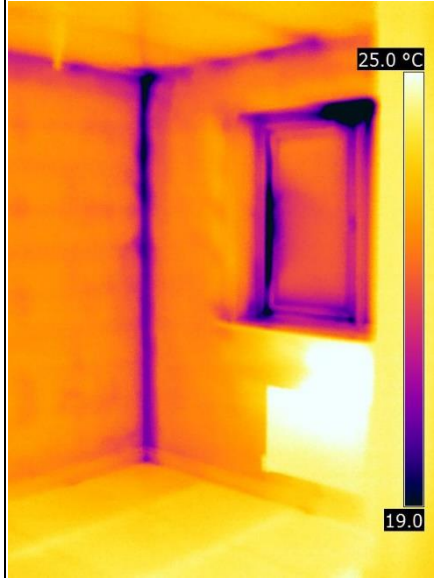
Plot 9 Bedroom 4 – Under depressurisation

Air was again observed being drawn in from the loft into the dry lining void, although to a lesser extent than seen in Bedroom 1 along the gable wall. The internal partition wall that backs onto the service void in the bathroom was cooler than the rest of the wall, and allowed colder air

to enter the dry lining void along its full height and air to emerge around the floor/wall junction at the bottom.
Direct air infiltration at the window was also clear.

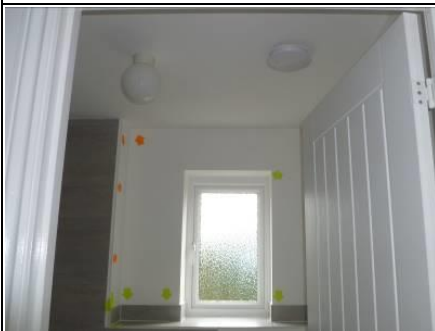
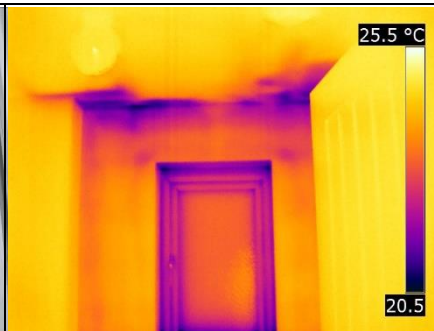
Plot 8 Bathroom – Under natural conditions

As seen previously there are colder patches at the eaves junction; these appear cooler than the window frame, and if condensation forms in the bathroom it will form on the coldest surfaces first, so may cause future issues.

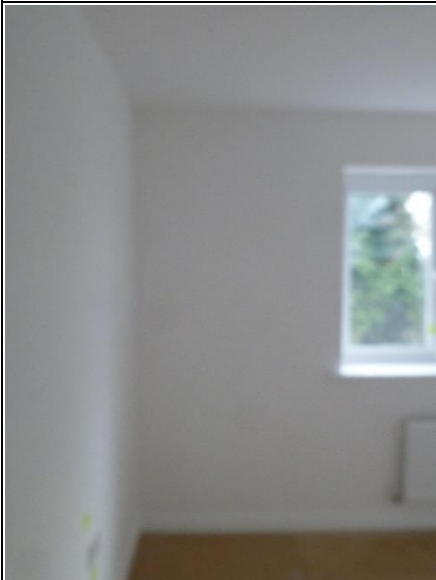
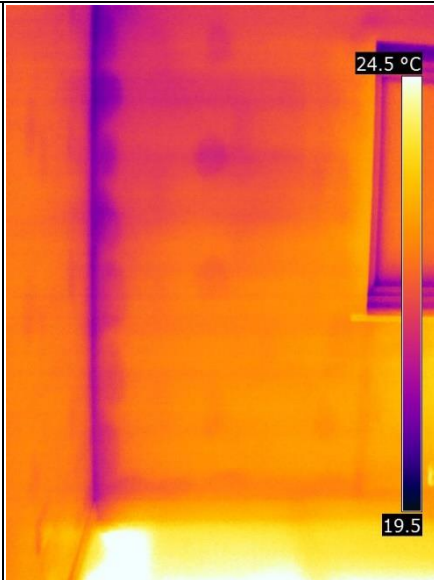
Plot 8 Bedroom 3 – Under natural conditions

As observed in previous bedrooms.

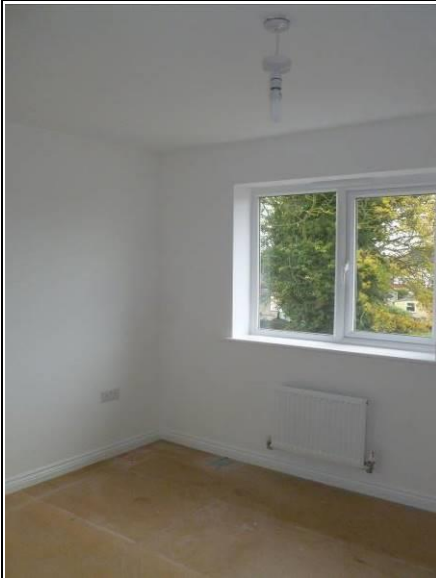
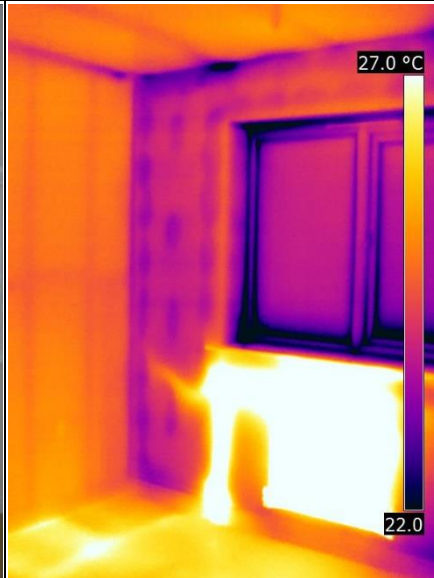
Plot 9 Bedroom 3 – Under natural conditions

As observed in previous bedrooms.

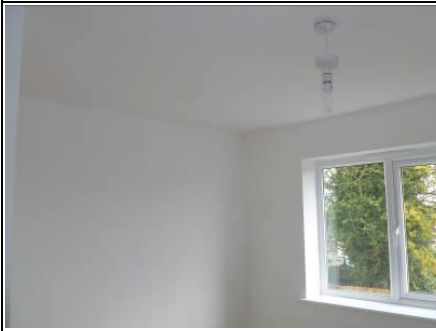
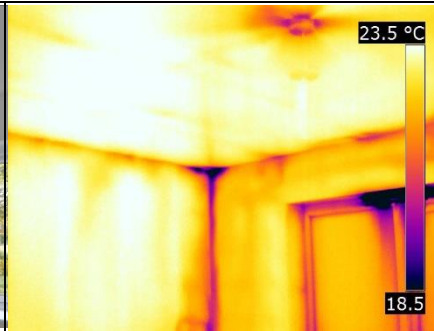
Plot 9 Bedroom 3 – Under depressurisation

As observed in Bedroom 4; here the partition wall backing onto a service void in the bathroom was even cooler with cooler air appearing to spread into the intermediate floor void.

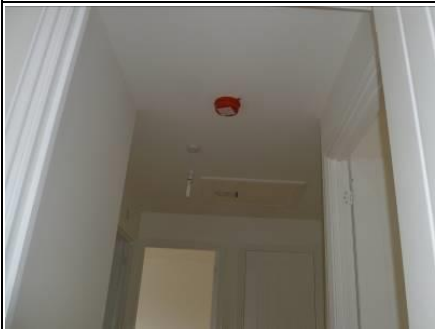
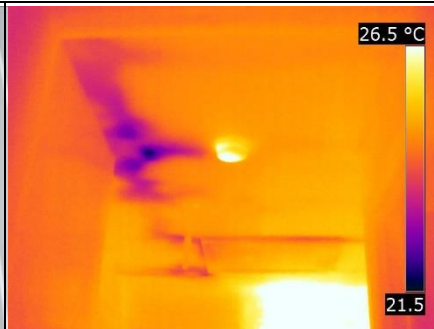
Plot 8 Landing – Under natural conditions

Some colder areas where the loft insulation appears to not be in full contact with the ceiling plasterboard.

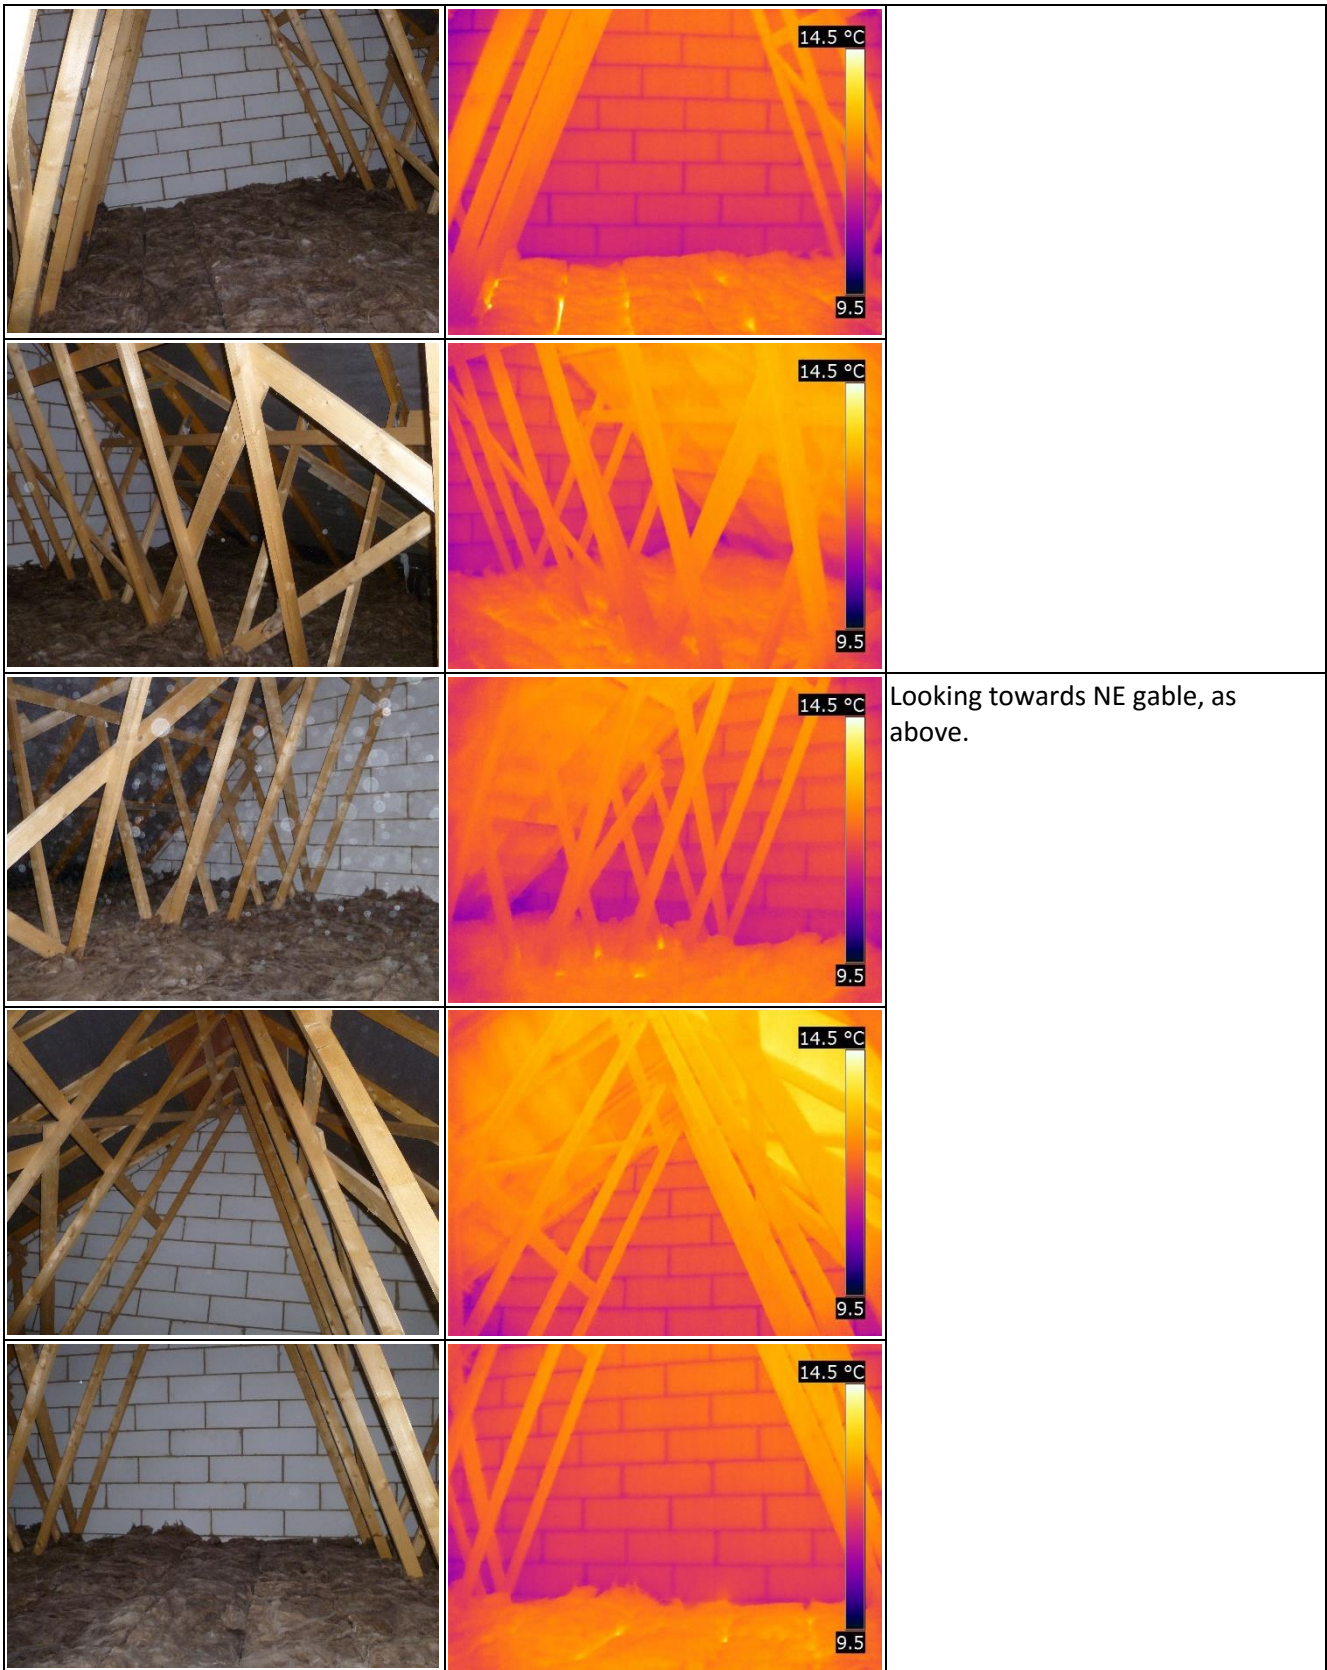
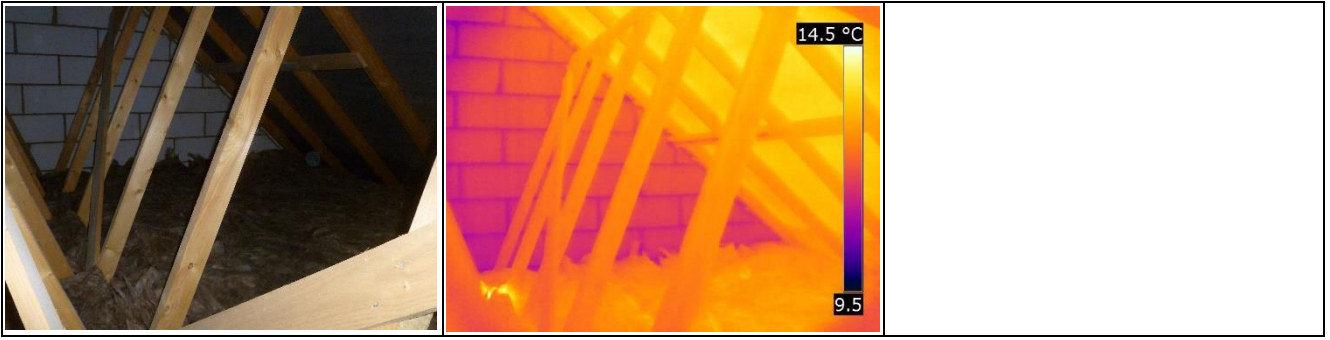
Plot 9 Loft – Under natural conditions

Looking toward the SE Gable the loft insulation appeared to be laid reasonably well, right up to the gable wall and without gaps. At some of the truss rafter angled junctions additional heat loss could be detected, as could be seen from cooler areas below. It was not possible to see the insulation at the eaves junctions, no attempt was made to lift the insulation to view services running beneath it.
