## **Condensation Risk – Impact of Improvements to Part L and Robust Details on Part C**

Project Reference Number: CI 71/6/1 BD2414

## **Interim report number 7: Final report on project fieldwork**

## Interim report to ODPM Building Regulations Division under the Building Operational Performance Framework

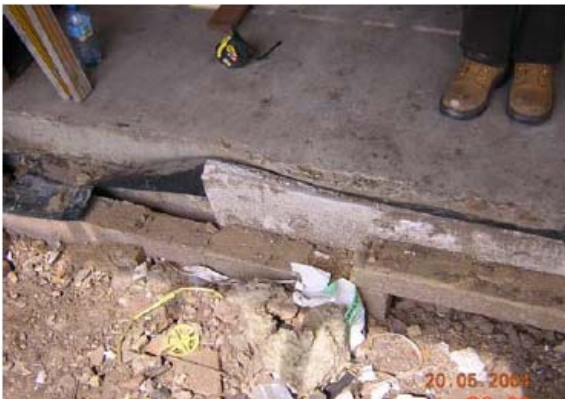
47. In the eight non-standard cases, the placement of edge insulation in the cavity and the use of a suitable lightweight block below the slab are important if thermal bridging is to be minimised. However site observations indicated that in many cases the required edge insulation extending below dpc level was not installed. This is illustrated in figures 3.08 and 3.09 where partial-fill insulation rests on a wall tie at dpc level but no edge insulation exists below this level<sup>1</sup>. On some sites, edge insulation was in place, partly to act as a former for casting the slab but then either completely or partially removed, leaving a gap in this edge insulation (see figure 3.10). Similar problems were also evident on sites using pre-cast suspended concrete beam and block floors where edge insulation in the cavity, in addition to insulation at the edges of a floor screed, would be required, as shown in figure 3.11, this was often missing. The omission of edge insulation at level thresholds to patio and entrance doors was another common problem irrespective of construction. Figure 3.12 shows a typical arrangement together with the relevant Robust Detail (RD 8.06). There were examples of well constructed details (see figure 3.13) but these tended to be in the minority.

Figure 3.10 Gap in slab edge insulation in timber frame construction.

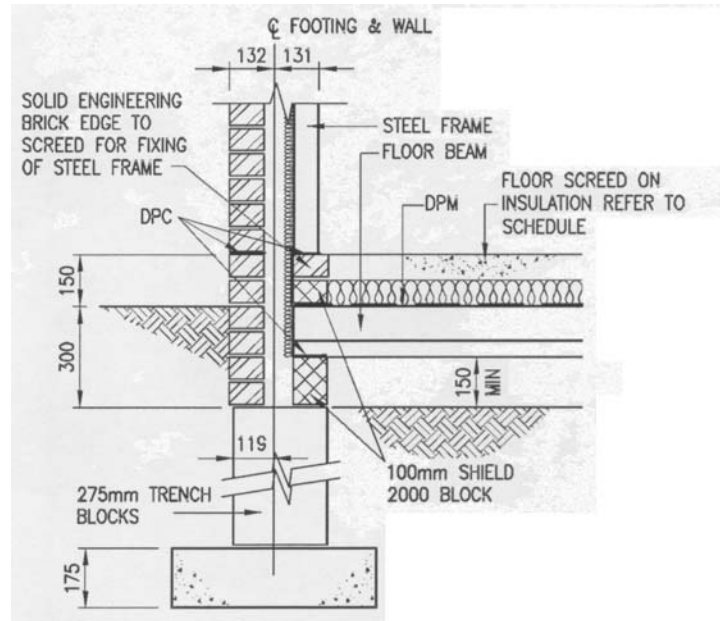
50. All ground floor/wall junction details in the Robust Details document relating to steel frame construction (details 7.07 to 7.11) rely on the continuation of the cavity insulation below floor level and this is the approach used in the designs adopted on the sites studied (see figure 3.17) However, the effectiveness of the insulation is dependant, to some extent on its closeness of fit and the avoidance of discontinuities. In order to achieve a good fit it is important that the frame lines up with the outside edge of the slab or kerb (as indicated in figure 3.17). On one of the steel frame sites visited this was not achieved. Figure 3.18 shows a mismatch between the plan shape of the base and that of the frame. This meant that, on at least one elevation, the base of the frame was not in alignment with the edge of the base resulting in a set back from the edge of around 50mm at one end of a wall section narrowing to almost zero at the other<sup>2</sup>.

Figure 3.17 Ground floor detail in steel frame construction.

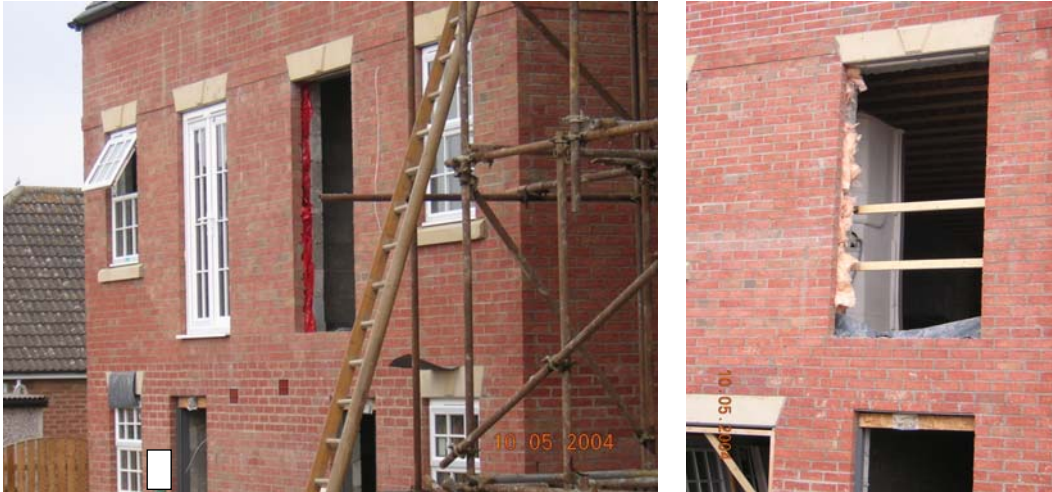
65. Not all sites adopted the propriety closure, some sites using glass or mineral fibre bats wedged into the jamb cavity to be held in place by the window frame as illustrated in figures 3.37 and 3.38 – although from time to time the result was not very pretty. On one site an apparently idiosyncratic mixture of propriety cavity closer and return block was used in the same construction. This is shown in figure 3.39. In this case a well insulated closer was used for the window reveals (a point we discuss below) but in the case of the connected door opening a return block with a rather thin (about 10mm) and ill fitting insulated vertical dpc was used. The impact of the return block is to bypass the partial-fill insulation, resulting in a thermal bridge, the insulated dpc not withstanding.

Figures 3.37 and 3.38 Alternatives to proprietary cavity closers.

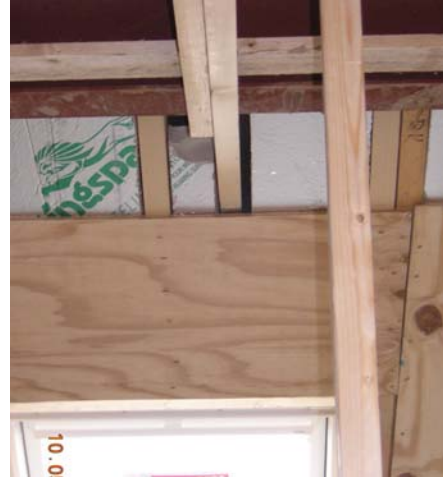
75. The fitting of insulation, particularly when rigid boards were used, was the most common general problem observed, together with the lack of air/vapour control layers in sloping roof sections. Many of the problems were accentuated around roof lights and dormers and the particular difficulties in these areas will be dealt with in those sub sections. The constructions that are most unforgiving if insulation is not tightly fitted tend to be those that adopt a ventilated rafter void with all the insulation fixed between the rafters. Figure 3.51 shows a typical arrangement with 70mm (sometimes as 2 layers of 35mm) polyurethane foam board fixed between rafters, plywood racking board and 12mm plasterboard finish<sup>1</sup>. Problems arise with this form of construction where there is no air barrier, or where the air barrier is discontinuous, particularly since gaps around the insulation boards are common, many of which can be large (see figure 3.52).

Figure 3.52 Gaps around insulation boards between rafters.

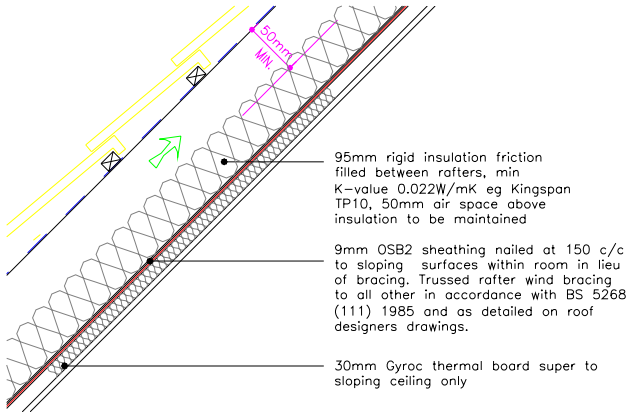
77. An alternative ventilated rafter construction is illustrated in figures 3.54 and 3.55. In this case the construction is a little more forgiving in that the insulated lining will reduce bridging through the timbers and any associated gaps (although on this site the fitting of insulation boards was of very high quality). The lack of an air barrier may remain a problem but with racking ply in place (if used instead of alternative bracing) and taped joints a reasonable air and vapour barrier could be achieved. No taping of joints of roof insulation was observed on any site.

Figure 3.54 Ventilated rafter void with insulation between and under rafters.

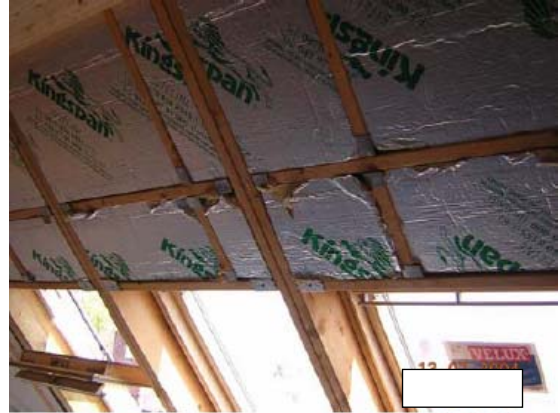
Figure 3.55 Insulation prior to fitting of insulated lining.

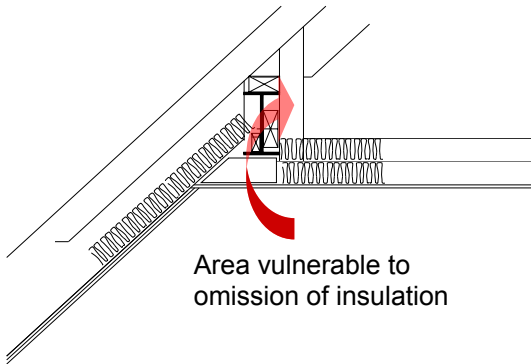
78. In the room-in-the-roof structures encountered, steel purlins were a common feature used as part of a composite type construction with rafters at the lower level and trusses above to complete the roof pitch. Given the high conductivity of steel, insulation detailing around the purlins is critical. This arrangement can be seen in figure 3.51. Figure 3.56 illustrates the key features of the apparent design of the purlin and surrounding construction. In the design illustrated the ceiling level provided the space for the area under the purlin to be reasonably well insulated but if the insulation was installed from above, as would be the case with the main loft, it would be very difficult to place. It could be placed from below, as the plasterboard ceiling is installed, but the general observations during site visits would suggest that such small areas of insulation are often overlooked. Unfortunately no direct observations were made of either ceiling erection or of loft insulating so it is not possible to be certain of the final state in the dwellings surveyed but the detail remains vulnerable. In another case however, it is clear that if constructed as designed (see figure 3.57) a very real condensation risk would exist<sup>1</sup>.

Figure 3.56 Steel purlin design - vulnerable to poor insulation placement and potential condensation risk<sup>2</sup>.

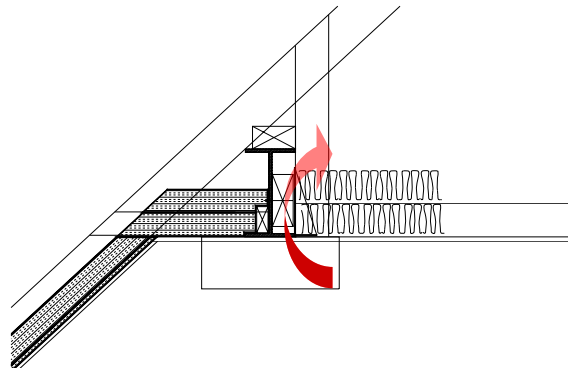
Figure 3.57 Steel purlin design – significant thermal bridge and high condensation risk<sup>3</sup>.

<sup>1</sup> In passing, this particular thermal bridge appears to be the largest, in terms of contribution to fabric heat loss, to be featured in this report. A rough calculation suggests that the additional heat loss is of a similar order to the heat loss through the fenestration, and effectively doubles the heat loss through the roof.

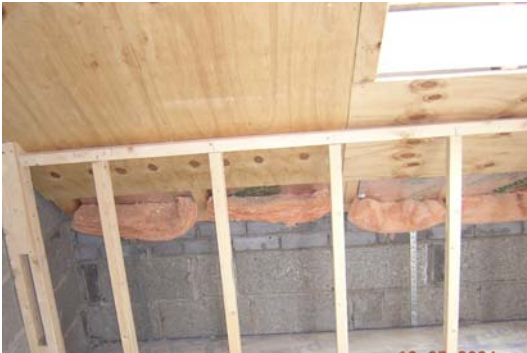
79. Maintaining the continuity of insulation at eaves was achieved in a reasonable number of cases where observation was possible. Figure 3.58 is typical of the arrangement in cavity masonry sites and figure 3.55 shows the care taken to fill small gaps at the eaves junction on one of the timber frame sites. However, concerns remain about the level of detailing in relation to airtightness since eaves junctions had little provision for air sealing. The arrangement shown in figure 3.58 is likely to be particularly leaky since the roof wall junction is likely to remain unfinished as the eaves area forms a void useable for loft type storage only. This is not the case in the timber frame example shown in figure 3.55 and as far as can be established this detail follows the recommended robust eaves detail for this type of roof (RD 6.03). However airtightness remains a problem.

Figure 3.58 Cavity wall – roof junction.

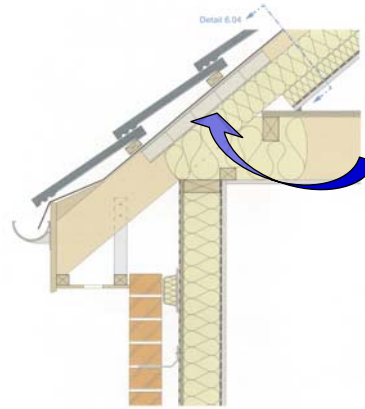
80. The robust detail is reproduced in Figure 3.59. The only resistance to air flow within and through the inter-floor space is the mineral wool packing. This raises two key problems; first, this space is very difficult to inspect and vulnerable to insulation being omitted<sup>1</sup> and second, if insulation was placed, achieving a significant resistance to air flow is fraught with difficulties even if it could be shown that tight packing is able to achieve the air flow resistance required. The configuration in the case of a ventilated rafter void is particularly prone to the inducement of air flow, not only through the rafter void, as intended, but also through the floor void from eaves to eaves. The likely condensation risk at eaves may be increased as moist internal air and vapour travelling through the floor void condenses on the underside of the roofing felt or the proprietary roof vent with consequent wetting of any insulation, the top of the timber frame and rafter or joist ends.

Figure 3.59 Robust Detail 6.03 – timber frame wall – roof junction.

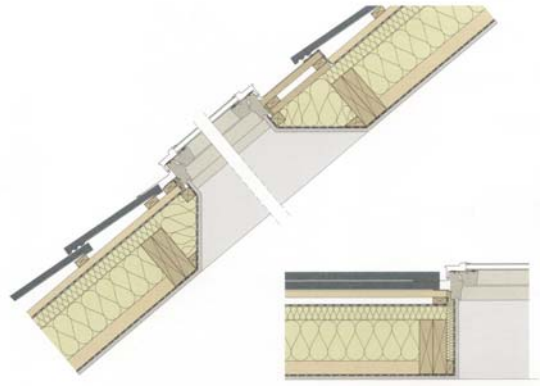
and reduce the risk of surface condensation around the rooflight frame, the fitting of insulation around the structural opening and up to the frame edge requires particular care both in design and construction. Robust Detail 8.03 (see figure 3.61), demonstrates the insulation detailing required.

Figure 3.61 Robust Detail 8.03 – Rooflight detail (ventilated batten void).

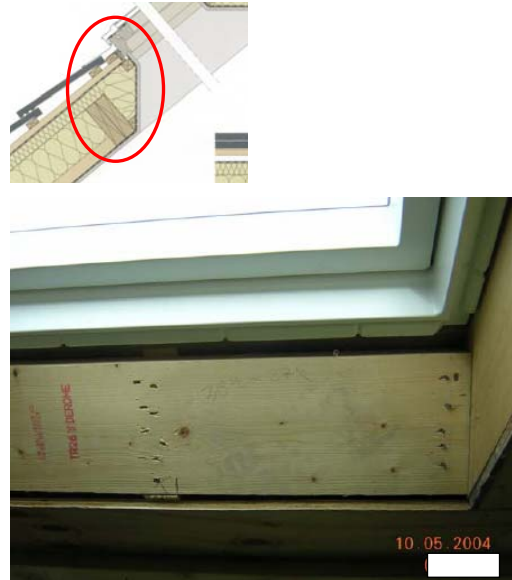
82. Although, as with other site observations, it is hard to know for certain if defects will be identified and rectified by site quality control, the observations made during visits suggested that the insertion of small strips of insulation and the accurate cutting of boards around rooflight openings was not always done with the level of care required. Figure 3.62 shows a typical gap in external insulation and figure 3.63 shows a framing board at the “sill” of the rooflight, which, when investigated proved to have no insulation in the space behind nor evidence of an air/vapour barrier. This would certainly give rise to airtightness problems and poor thermal performance, both of which may lead to increased condensation risk. A number of observations of the space available for lining insulation to the sides of rooflight openings suggested that achieving the required resistance ( $R \geq 0.34 \text{ m}^2\text{K/W}$ ) would be difficult especially if decorative linings were also to be applied. As a general observation missing insulation (particularly when small strips are required) around roof lights was a common occurrence on most sites.

Figure 3.63 Lower lining section, uninsulated

rooflight.

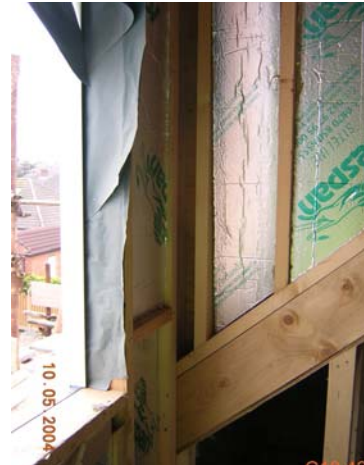
84. As in other cases the main problems related to the fitting of the insulation board. Figures 3.65 and 3.66 illustrate typical fitting problems with gaps around boards and missing insulation in small sections, sections that can be very small indeed requiring considerable attention to detail (see figure 3.64). The missing insulation in the corner section (figure 3.66) is of particular concern since this is one of the most exposed areas of the external envelope.

Figure 3.66 Omission of insulation at small strip in the corner.

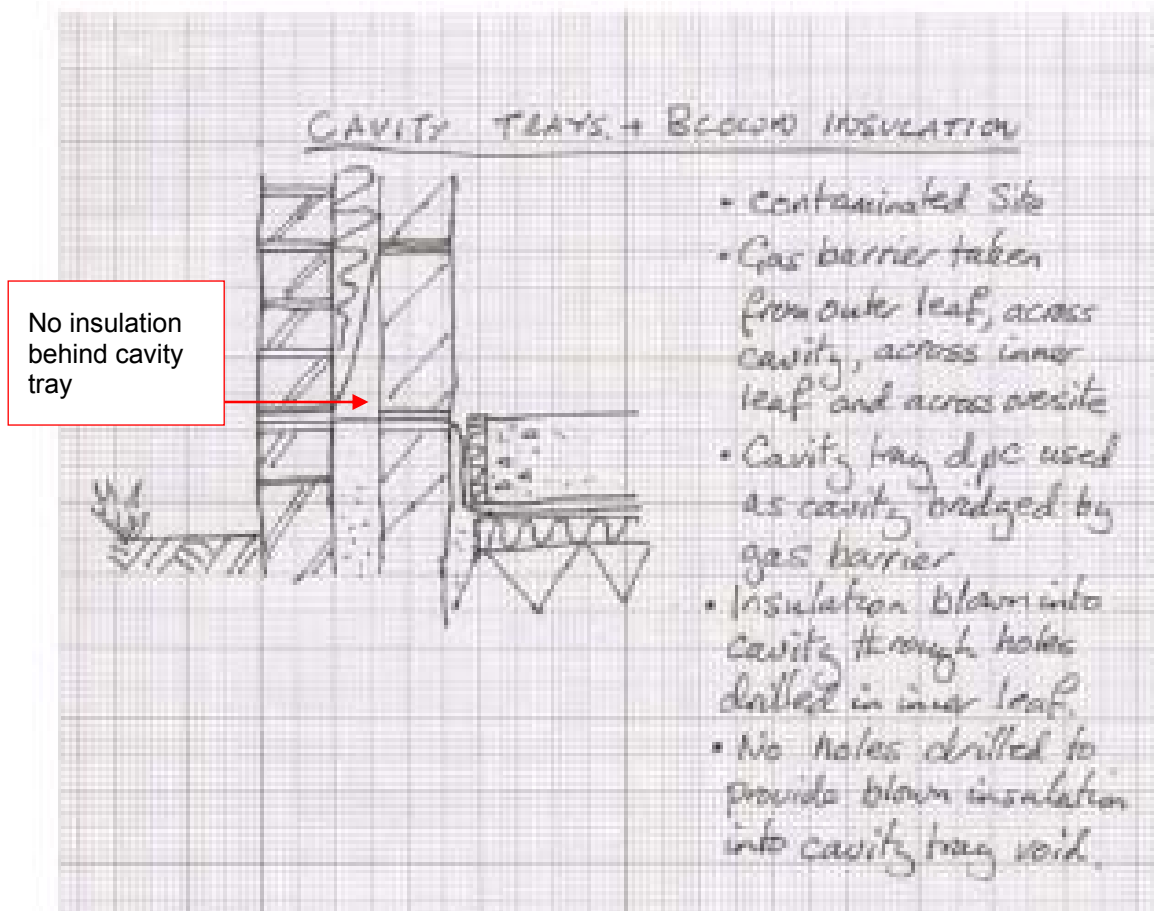
86. Gas barriers across the external wall cavities are common for contaminated sites, and green-field sites that contain naturally occurring gases such as methane or radon. Since such membranes necessarily bridge the cavity, a low level cavity tray is required. In some of the cases studied the detailing problems had been considered at design stage and dealt with reasonably successfully but in others the details were worked out on site (possibly because the need for a gas barrier was not discovered until after construction had begun) with less success. The particular problem in relation to gas barriers is the fact that the cavity tray has to be placed very close to ground level leading to problems of insulating a very small strip of wall.

Figure 3.67 Gas barrier and cavity tray at ground floor/external wall junction.

87. The site sketch in Figure 3.67 illustrates the arrangement on one of the full-fill masonry sites. Given that cavity insulation was to be injected from the inside upon completion of the wall, filling this area would be very difficult and, in practice almost certainly omitted. In this case it would be more appropriate to ensure that insulation was placed at the same time as the cavity tray was fitted. Figure 3.68 shows clearly that this was not done, as well as illustrating the age-old problem of keeping the cavity clean. Similar difficulties arise with the placement of partial-fill insulation (see figure 3.69) since if not well fitted below the tray its performance is reduced considerably, almost to the point where it may as well not be placed at all. The effect in both the cases illustrated would be to increase the potential for localised temperature variation, the more so since, as we have discussed above, cavity insulation is often omitted at ground floor slab level. Of course, once the gas barrier is in place the lack of insulation below is hidden from view.

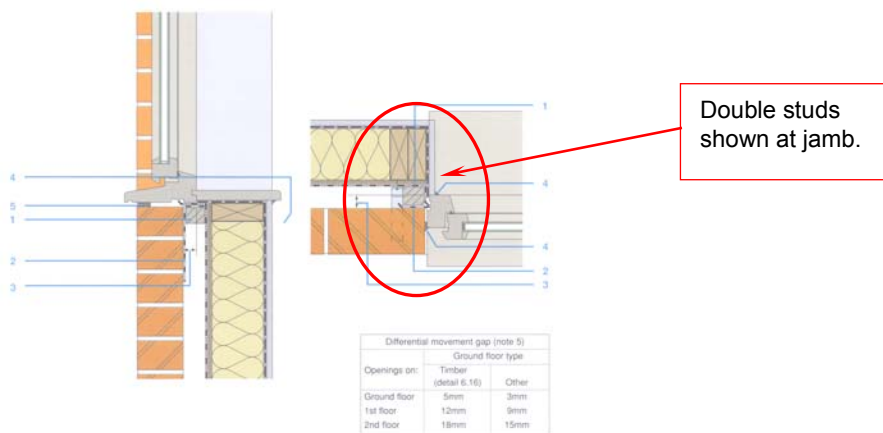
Figure 3.74 Robust Detail 6.10; Jamb and sill details in timber frame construction.

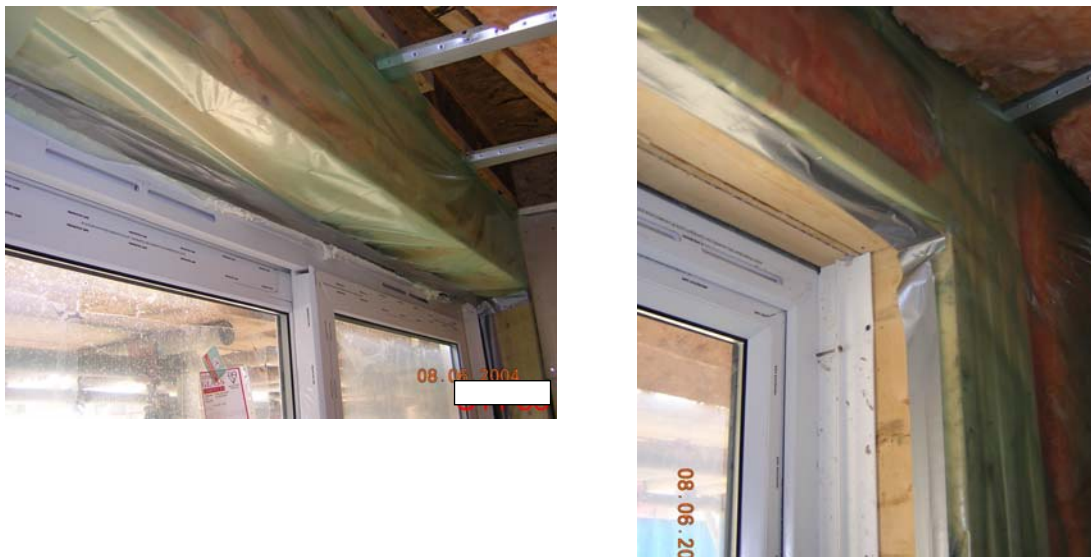
99. In order to ensure continuity of air/vapour control layers in timber frame and hybrid steel frame constructions, section 8 of the Robust Details document recommends that sheet barriers be well lapped, returned into reveals at openings and sealed with the DPC at ground floor level. In general the lapping of sheets was done with care but no lapping with the DPC was observed on any site (figure 3.87 is typical) and sealing into reveals was not dealt with consistently. The arrangement at window and door openings was generally more consistent as in most cases membranes were wrapped into reveals, sills and heads and either stapled or taped (Figure 3.88).

Figure 3.88 Vapour control layer returned in to reveals and window/door heads.

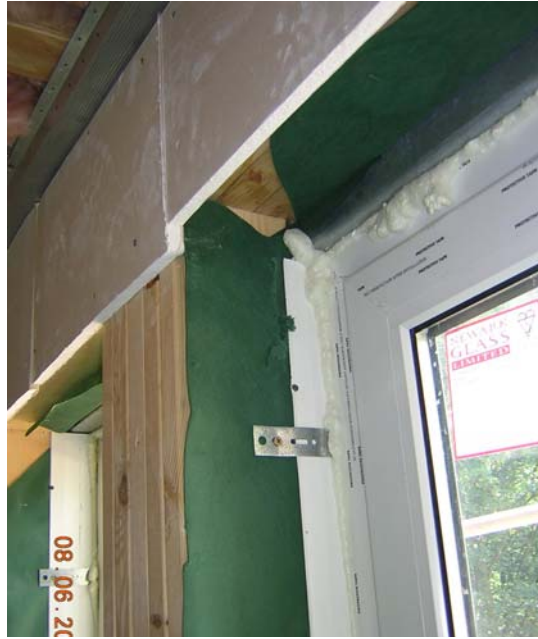
100. Despite that fact that care was taken to ensure that air/vapour control layers in timber frame construction were well sealed there was some apparent uncertainty about parts of the structure that consists of isolated collections of studs or substantial timber lintels. Figure 3.89 presents a typical example, showing 5 studs forming the section between openings and the plaster-boarded window head with no evidence of any air/vapour control. It seems that since there is no adjacent insulation, air and vapour control is thought not to be required.

Figure 3.89 Air/vapour control layer not applied to studs – no evidence of layer across lintels and wrapping into head of opening.

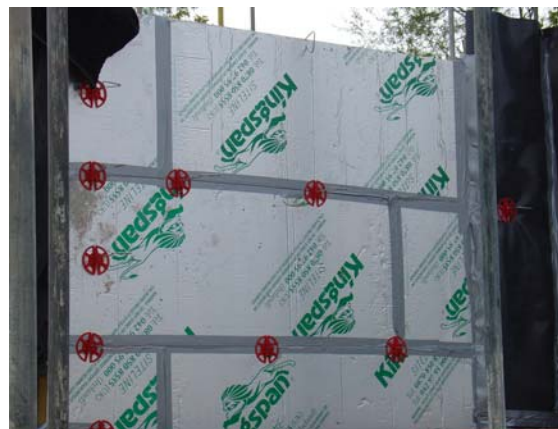
101. An example of good practice in the use of the external insulation layer in partial fill masonry as an airtight layer is provided from observations made on one site where insulation was tightly fitted, clipped in place and all joints sealed with tape (figure 3.90), a practice that is likely to produce a reasonable level of airtight construction by using the insulation layer as an air control layer. However, as with steel frame construction this must be maintained at junctions if it is to be fully effective.

Figure 3.90 Fixing and sealing of partial cavity wall insulation in masonry construction.

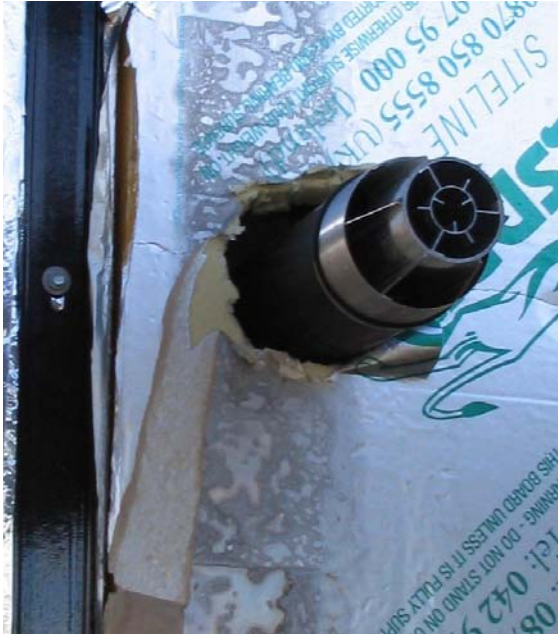
Figure 3.94 Penetration through the insulation/vapour layers in light steel frame construction.

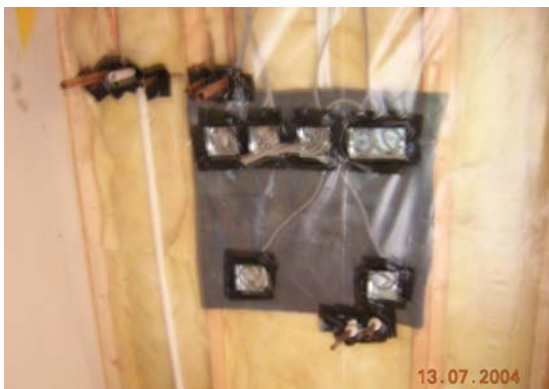
104. It is tempting in a project of this nature to emphasise the negative aspects of detailed construction, however a number of examples of attempts at a more careful approach have also been observed. Figure 3.96 shows a reasonable attempt to seal the services passing through the air/vapour barrier within timber framed construction. In this case a polythene backing membrane has been inserted behind the cable boxes, the polythene air barrier carefully cut for electrical boxes and pipes and the services generously taped to the main polythene air/vapour control layer. Although it would be more robust to have included a services void (as discussed below) this is, probably, the most practical solution in the circumstances although not very robust in the long term. The only air paths that have not been fully sealed is the cable entry into back-boxes and some leakage around the boxes themselves, the backing membrane not withstanding. This is an interesting example of how the principles in Robust Details, such as those expressed in section 8 of the Robust Details document, are being interpreted.

Figure 3.96 Sealing and taping of services entries in timber frame construction.
