Condensation Risk – Impact of Improvements to Part L and Robust Details on Part C

Project Reference Number: CI 71/6/1 BD2414

Interim report number 7: Final report on project fieldwork

Malcolm Bell, Melanie Smith & Dominic Miles-Shenton
Buildings and Sustainability Research Group
Leeds Metropolitan University

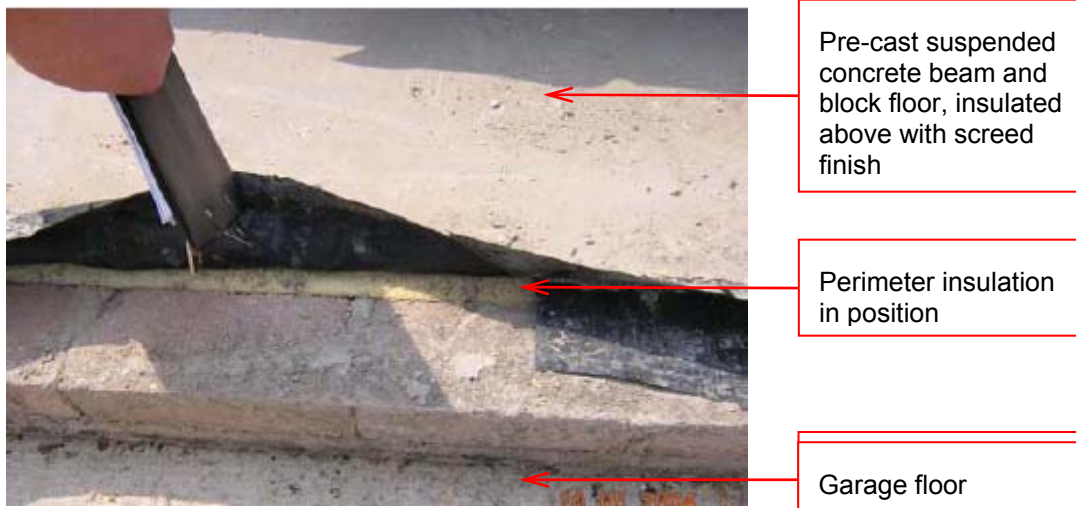
47. In the eight non-standard cases, the placement of edge insulation in the cavity and the use of a suitable lightweight block below the slab are important if thermal bridging is to be minimised. However site observations indicated that in many cases the required edge insulation extending below dpc level was not installed. This is illustrated in figures 3.08 and 3.09 where partial-fill insulation rests on a wall tie at dpc level but no edge insulation exists below this level¹. On some sites, edge insulation was in place, partly to act as a former for casting the slab but then either completely or partially removed, leaving a gap in this edge insulation (see figure 3.10). Similar problems were also evident on sites using pre-cast suspended concrete beam and block floors where edge insulation in the cavity, in addition to insulation at the edges of a floor screed, would be required, as shown in figure 3.11, this was often missing. The omission of edge insulation at level thresholds to patio and entrance doors was another common problem irrespective of construction. Figure 3.12 shows a typical arrangement together with the relevant Robust Detail (RD 8.06). There were examples of well constructed details (see figure 3.13) but these tended to be in the minority.

Figure 3.13 Ground floor with perimeter insulation in place.

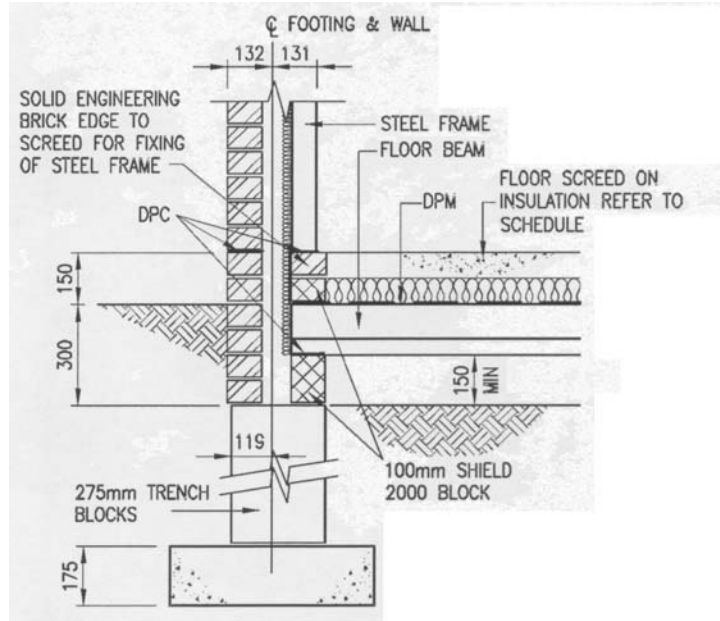
50. All ground floor/wall junction details in the Robust Details document relating to steel frame construction (details 7.07 to 7.11) rely on the continuation of the cavity insulation below floor level and this is the approach used in the designs adopted on the sites studied (see figure 3.17) However, the effectiveness of the insulation is dependant, to some extent on its closeness of fit and the avoidance of discontinuities. In order to achieve a good fit it is important that the frame lines up with the outside edge of the slab or kerb (as indicated in figure 3.17). On one of the steel frame sites visited this was not achieved. Figure 3.18 shows a mismatch between the plan shape of the base and that of the frame. This meant that, on at least one elevation, the base of the frame was not in alignment with the edge of the base resulting in a set back from the edge of around 50mm at one end of a wall section narrowing to almost zero at the other².

Figure 3.17 Ground floor detail in steel frame construction.

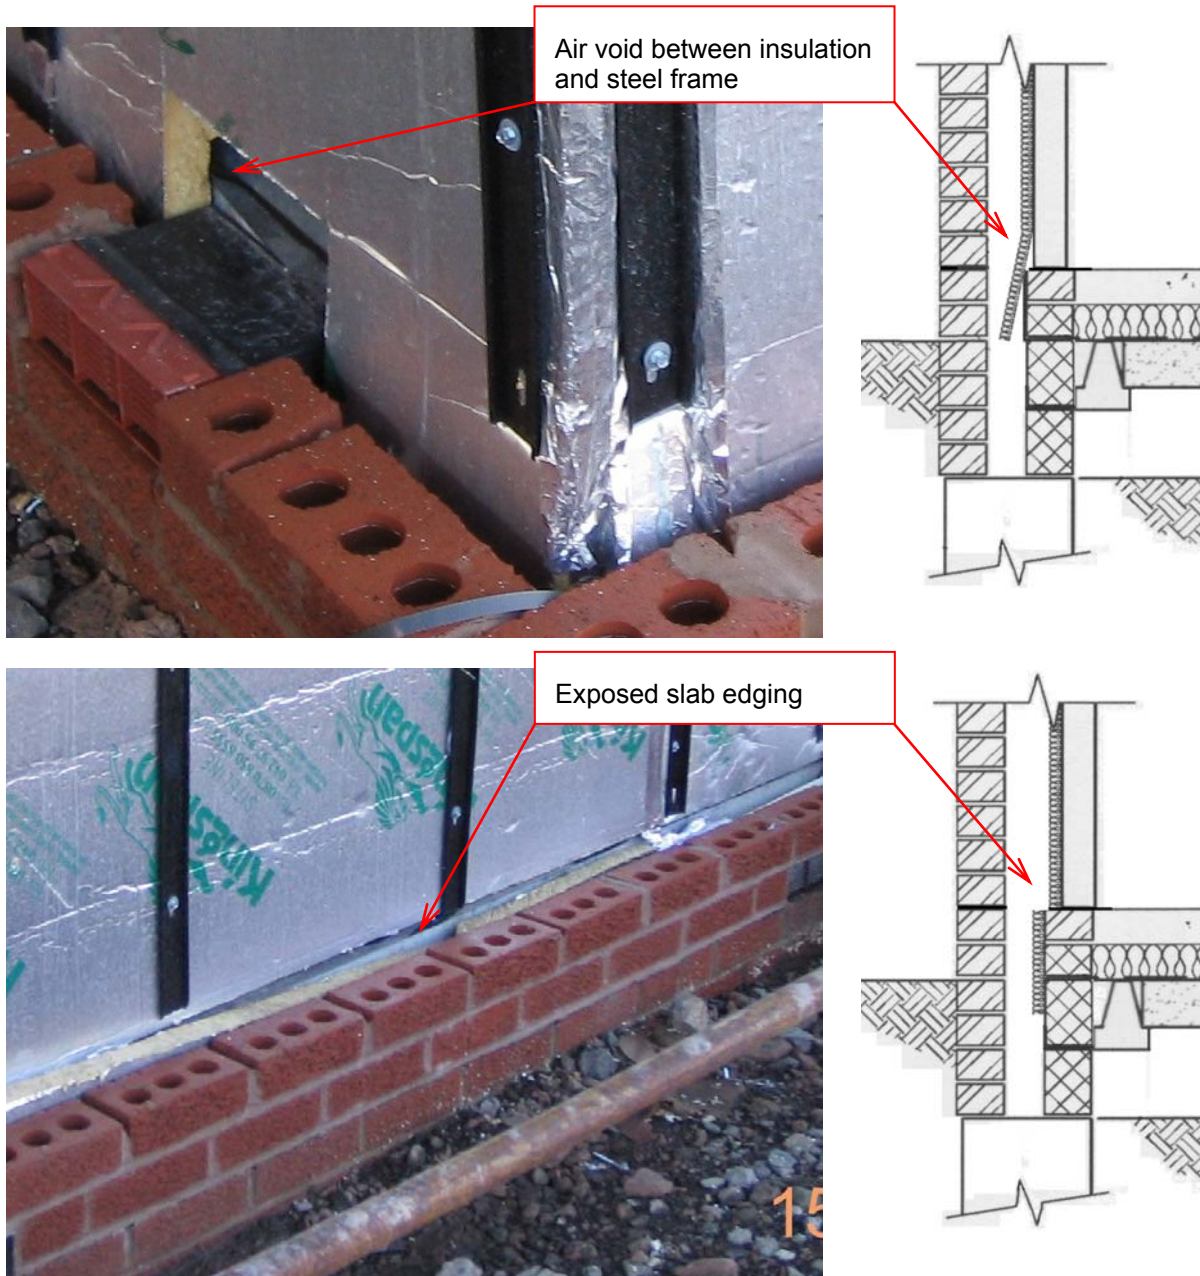
51. Whatever the cause of the misalignment (setting out of the base or manufacturing errors in the steel frame) its effect was to make it very difficult to maintain continuity in the external insulation. The practical response to this problem was two-fold; either the wall insulation was stopped at dpc level and a separate piece of insulation placed in the

cavity, leaving gaps in insulation, or the wall insulation was bent over the protruding slab leaving an air space around the base of the steel frame. The sketches in figures 3.19 and 3.20 illustrate this together with examples of site observations. Although the resulting gaps appear to be small, they have implications for the effectiveness of the insulation around the junction and airtightness. The integrity of the insulation layer is of particular importance in warm steel frame construction since it has an additional function as the prime air and vapour control layer.

Figure 3.19 and 3.20 Placement of cavity wall insulation, above and below slab, in steel frame construction with misalignments of steel frame and slab.

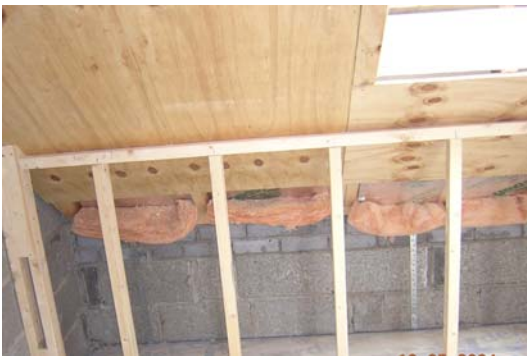
79. Maintaining the continuity of insulation at eaves was achieved in a reasonable number of cases where observation was possible. Figure 3.58 is typical of the arrangement in cavity masonry sites and figure 3.55 shows the care taken to fill small gaps at the eaves junction on one of the timber frame sites. However, concerns remain about the level of detailing in relation to airtightness since eaves junctions had little provision for air sealing. The arrangement shown in figure 3.58 is likely to be particularly leaky since the roof wall junction is likely to remain unfinished as the eaves area forms a void useable for loft type storage only. This is not the case in the timber frame example shown in figure 3.55 and as far as can be established this detail follows the recommended robust eaves detail for this type of roof (RD 6.03). However airtightness remains a problem.

Figure 3.58 Cavity wall – roof junction.

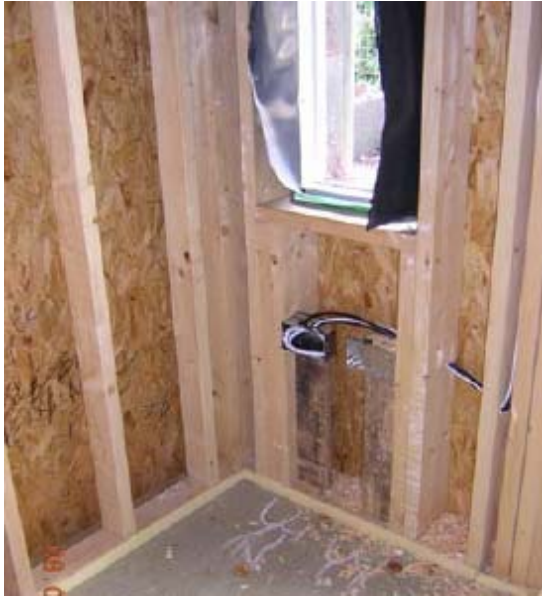
Figure 3.79 Small gap between studs (also, note high timber concentration at corner).

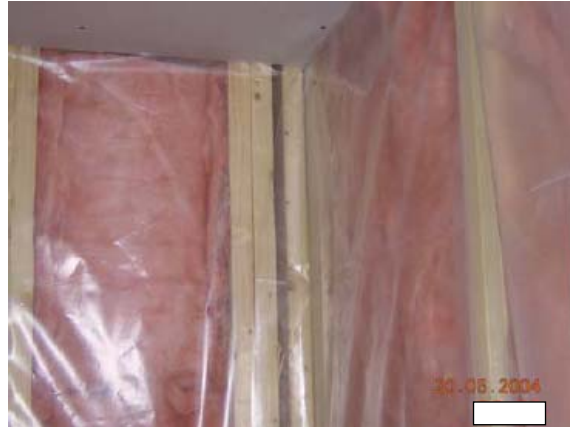
Figure 3.80 Unfilled gap between studs.

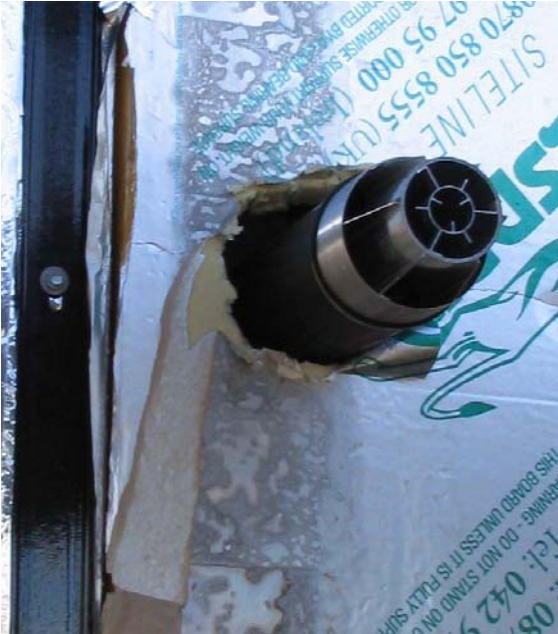
103. Although not likely to have significant condensation implications in all cases the care taken to ensure that service and other penetrations of the air/vapour control layer will have a major impact on the overall airtightness of the dwelling. The holes cut for services are often large and, as pressure tests demonstrate (see for example Johnston et al 2004) are not well sealed. The services penetrations shown in figures 3.93 and 3.94 are typical. Other penetrations such as those made by steel structural elements also need to be adequately sealed. The steel beam in figure 3.95 not only poses an airtightness problem but if not well insulated may pose an additional condensation risk.

Figure 3.94 Penetration through the insulation/vapour layers in light steel frame construction.

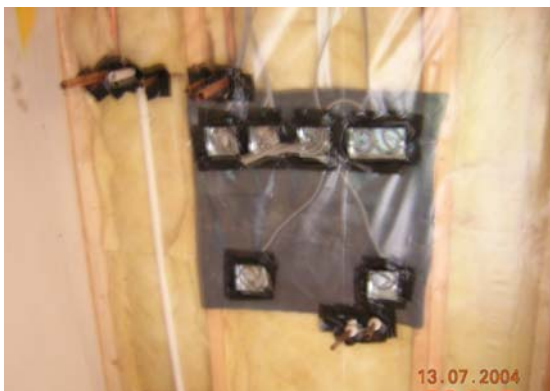
104. It is tempting in a project of this nature to emphasise the negative aspects of detailed construction, however a number of examples of attempts at a more careful approach have also been observed. Figure 3.96 shows a reasonable attempt to seal the services passing through the air/vapour barrier within timber framed construction. In this case a polythene backing membrane has been inserted behind the cable boxes, the polythene air barrier carefully cut for electrical boxes and pipes and the services generously taped to the main polythene air/vapour control layer. Although it would be more robust to have included a services void (as discussed below) this is, probably, the most practical solution in the circumstances although not very robust in the long term. The only air paths that have not been fully sealed is the cable entry into back-boxes and some leakage around the boxes themselves, the backing membrane not withstanding. This is an interesting example of how the principles in Robust Details, such as those expressed in section 8 of the Robust Details document, are being interpreted.

Figure 3.96 Sealing and taping of services entries in timber frame construction.
