Aziz, G and Hardy, A (2023) An investigation into how Energy Performance Certificate variables relate to damp. In: 2nd International Conference on Moisture in Buildings 2023 (ICMB23), 3-4 Jul 2023, London, UK. DOI: <https://doi.org/10.14293/icmb230029>

Gulala Aziz^a, Adam Hardy^a

Excess dampness and mould can lead to poor indoor air quality, building damage, and negative health impacts for occupants. This study investigates several Energy Performance Certificate (EPC) variables such as efficiency rating, building type, and wall types and their relationships to damp issues. An EPC gives a property an energy efficiency rating from A (most efficient) to G (least efficient) and is valid for 10 years. 859 homes in England's housing stock were analysed, and a significant relationship was found between wall types and damp levels. The result of this study will help in the management of damp issues and the prediction of risky homes.

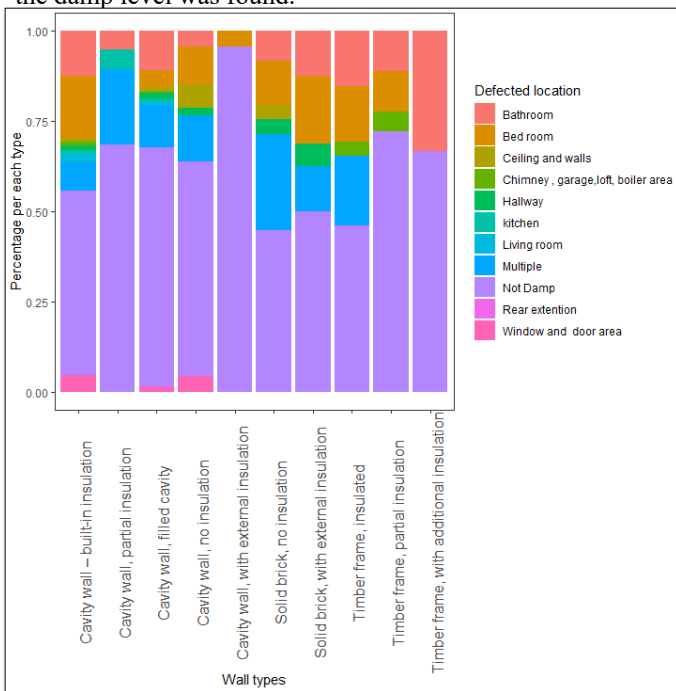
Figure 1. Percentage of defected location per each wall type

Figure 1 shows the percentage of defective locations per each wall type. The most defective locations are the bathroom and kitchen. Furthermore, multiple locations, which are regarded to have more than one defective room, are common. Figure 1 further shows that the worst wall types for dampness are uninsulated solid walls and, surprisingly, as-built insulated cavity and insulated timber walls. It is especially intriguing that the as-built cavity insulation has a stronger correlation with dampness than retro-filled cavity insulation. It is not apparent from the data why this may be. One potential reason is that, because as-built insulated cavities will tend to reflect newer properties, they may also have reduced ventilation compared to the older homes. Figure 2 shows the percentage of possible damp sources in damp homes per each wall type. Condensation is the most common cause, with leakage coming in second. The increased levels of dampness in as-built insulated cavities seem to be driven by condensation dampness. This, therefore, adds further evidence to ventilation is one of the contributors. An alternative explanation could be that flaws in either the EPC assessment process or the EPC software itself, are causing some incorrect identifications of as-built insulated cavities. As researches find that at least 27% of all EPCs lodged between 2008

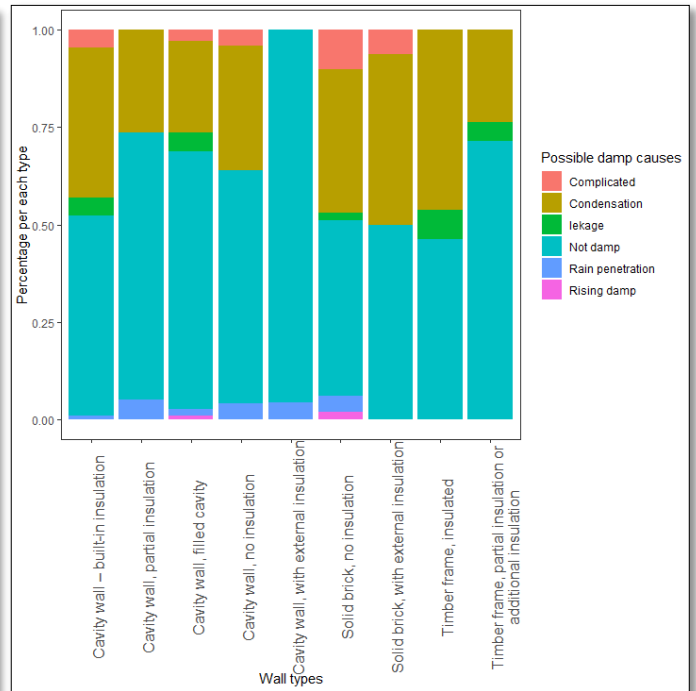
Figure 2. Percentage of damp causes per each wall type
