External walls partially filled with insulation, and the potential to “top-up” the residual cavity.

Literature Review

November 2015

Dominic Miles-Shenton, Chris Gorse and Felix Thomas

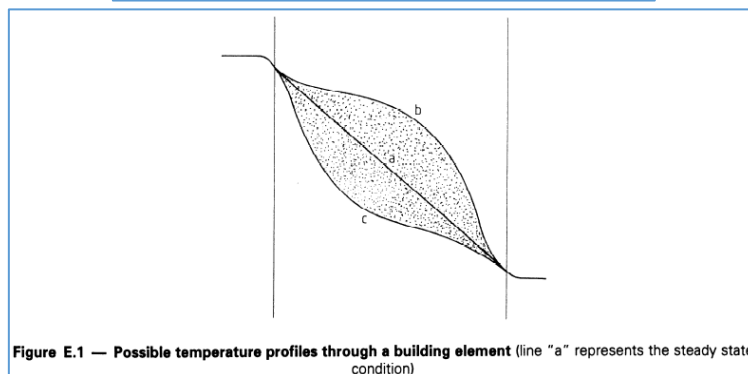
Figure 6 The effect of dynamic thermal mass effects on in-situ U-value calculation (ISO 9869:1994)

That analysis assumes that the temperature profile, at the start and at the end of the test period, corresponds to that for steady state conditions at the internal and external temperature concerned. This is illustrated for a single layer uniform wall in figure E.1, line a. However, since only the internal and external temperatures, not the temperatures within the structure, are measured, the profile could be either b or c. This means that observations of the change in mean internal or external temperatures is not necessarily sufficient in itself to determine the change in heat storage.

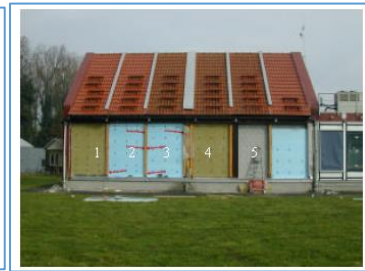
Figure 11 Partially filled test walls displaying lower than expected R-values compared to fully filled test walls (Hens et al., 2006)

Height Cm	Wall 1 S, full fil	Wall 2 S, part. fill	Wall 3 S, part. fill	Wall 4 S, full fill	Wall 5 E, full fill
Calculated	2.90	3.05	3.05	2.90	2.90
Measured					
230 cm	3.19	2.82	2.04	3.19	2.88
160 cm	3.34	2.66	2.67	2.86	3.29
30 cm	2.26	1.61	1.55	2.14	1.68
Weighted average	2.99	2.38	2.20	2.72	2.72
Loss in %	-	22	28	6	6

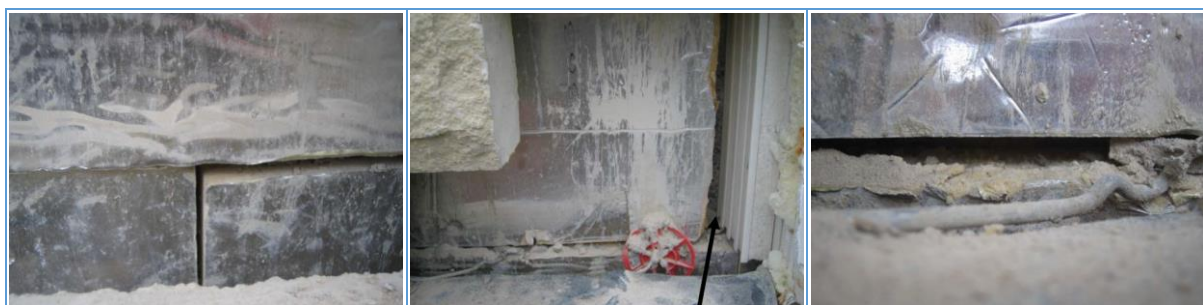
Figure 15 Deconstruction allowing gaps to be seen in the partial-fill insulation, from Wingfield et al., 2009.

Other common examples of gaps around partial-fill insulation boards, as shown in Figure 23 and Figure 24, would prove simpler to quantify the benefits of ‘topping-up’ the residual cavity; where the gaps between the insulation boards and the inner leaf are minimal but areas of the inner leaf are directly exposed to the external wall cavity. In cases such as these, topping up the residual cavity with insulation would have maximum effect. Examples of this type were detected and reported on in Wingfield *et al.* (2009), where the external walls displayed daily mean in-situ U-value of more than double the theoretically obtained design values (Figure 12, Figure 13 and Figure 15).

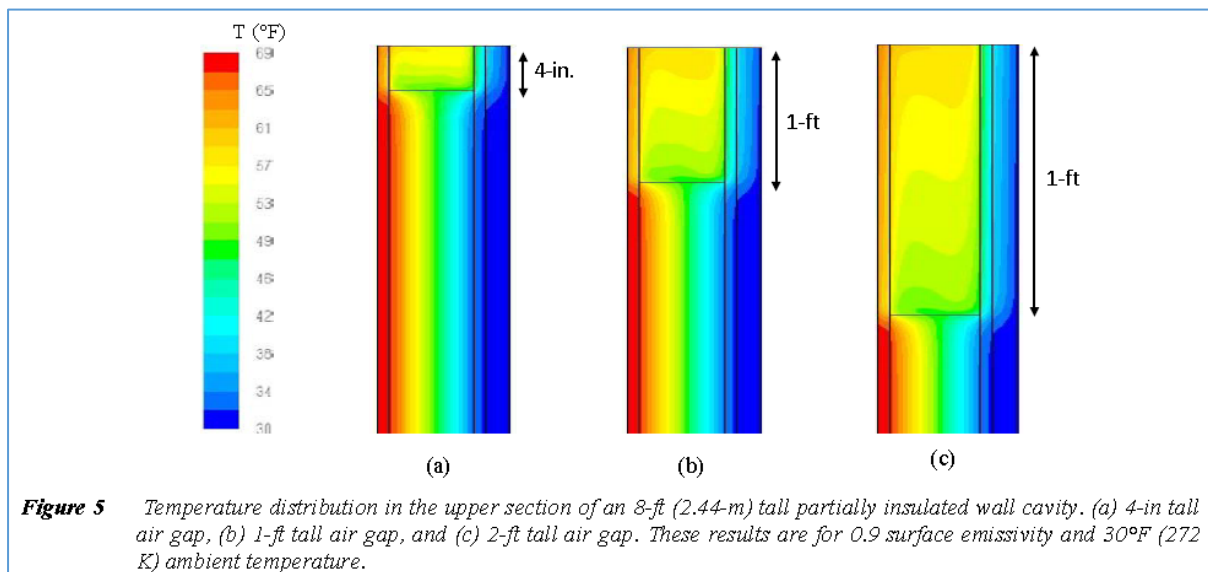
Figure 17 Simulated effect of air gaps at the top of an insulated wall panel (Ridouane & Bianchi, 2011)

surface emissivity, cavity aspect ratios and physical properties of the materials; the findings showed that the most significant factor affecting the thermal resistance was convection in the uninsulated cavity.

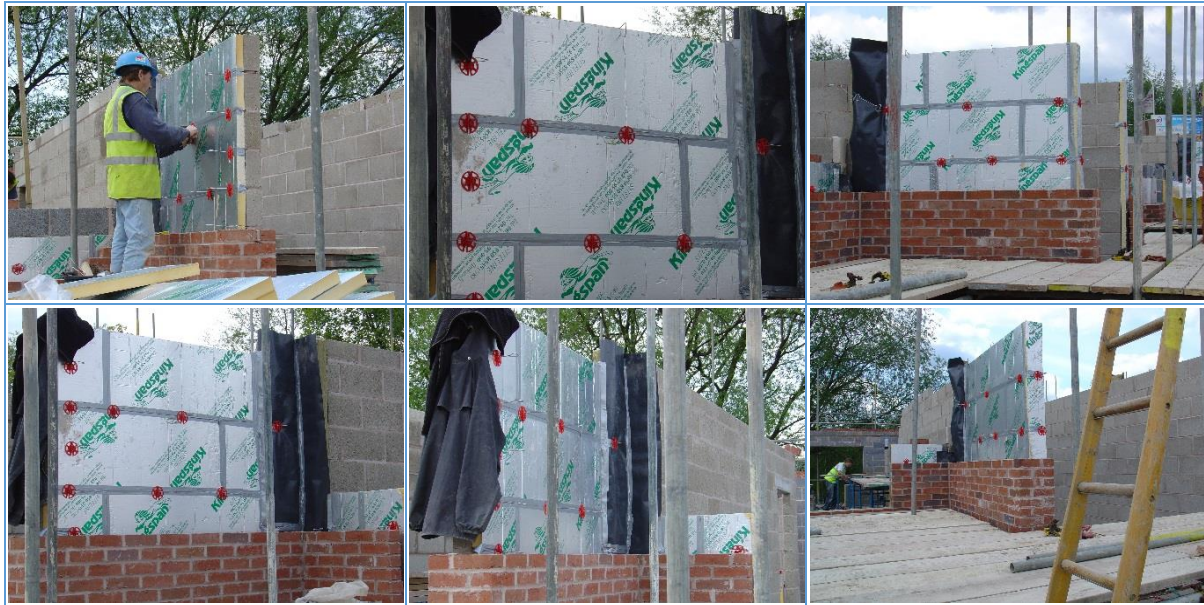
Figure 18 Partial-fill insulation being installed in standard brick-block masonry construction in an apartment block in Sheffield.

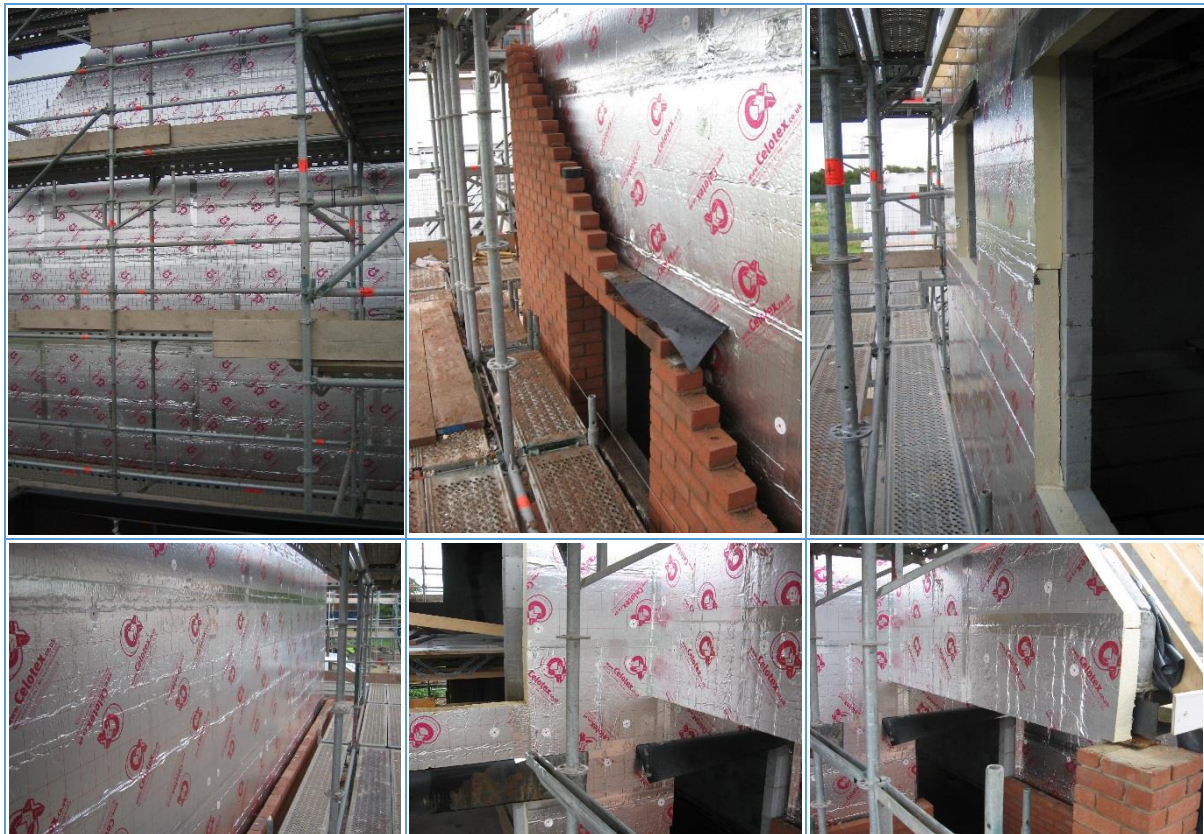
Figure 19 Partial-fill insulation being installed in a thin-joint masonry construction prototype house in York.

However, even with partial-fill rigid board fitted as well as in Figure 19 there can be underperformance. Figure 20 shows a detail on the same building as Figure 19 where even a small gap can cause visible and measurable change in performance. In Figure 20 the in situ U-values measured ranged from 0.18 to 0.27 $\text{W}/\text{m}^2\text{K}$ (compared to a design value of 0.17 $\text{W}/\text{m}^2\text{K}$). The research illustrates that problems still do occur even when there is considerable effort placed on achieving an exemplar building.

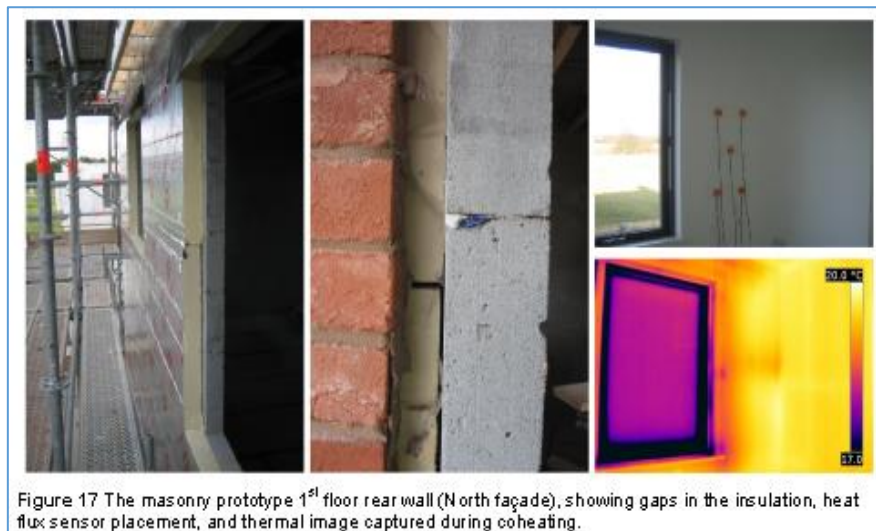
Figure 20 Measured discrepancy in performance due to small issues with partial-fill rigid board insulation (Miles-Shenton et al, 2010)

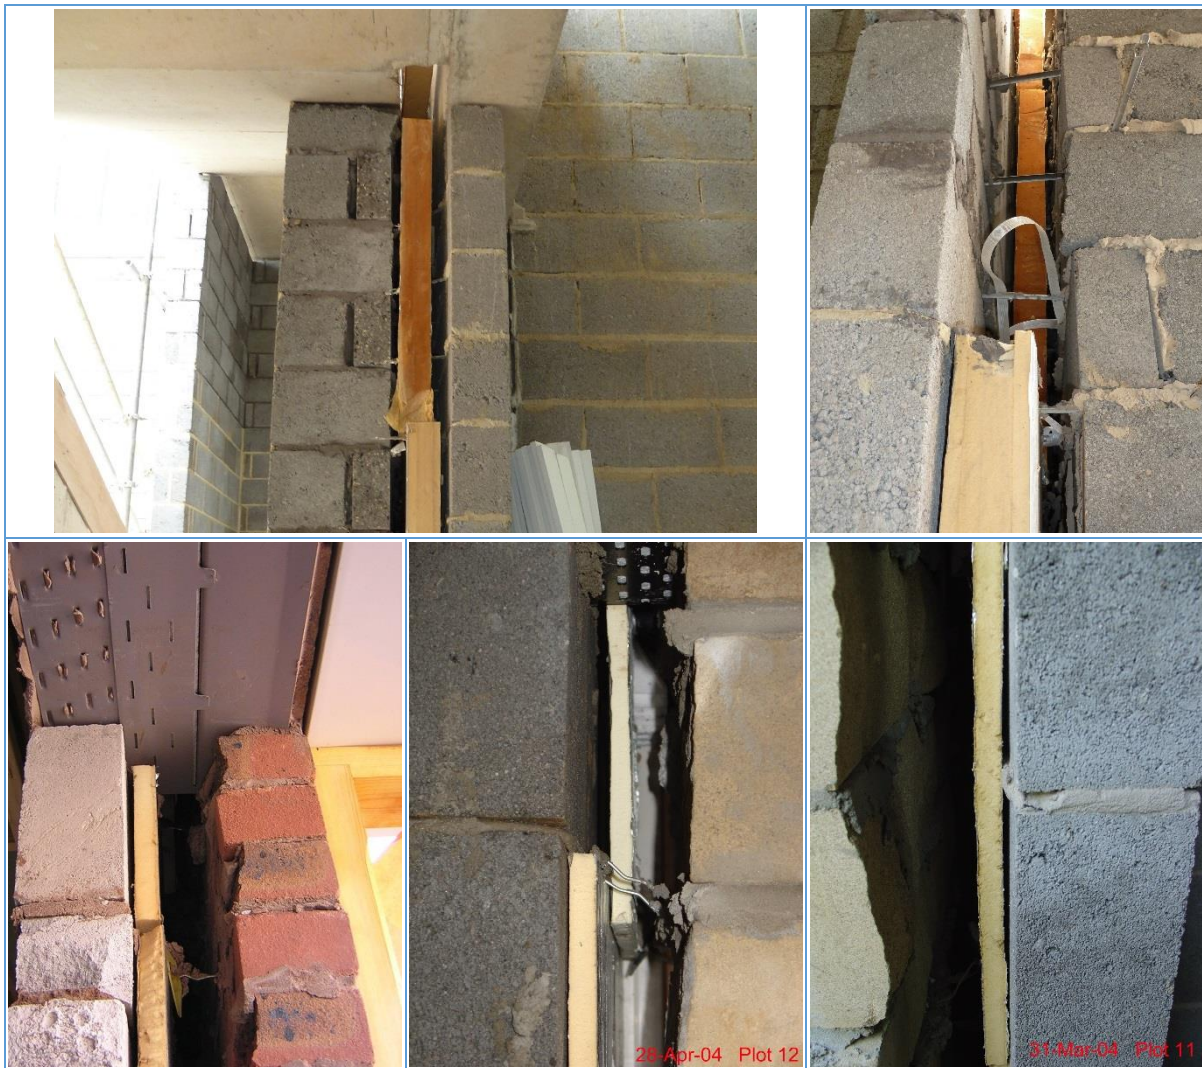
Figure 21 Partial-fill boards are not positioned flush with the inner leaf blockwork

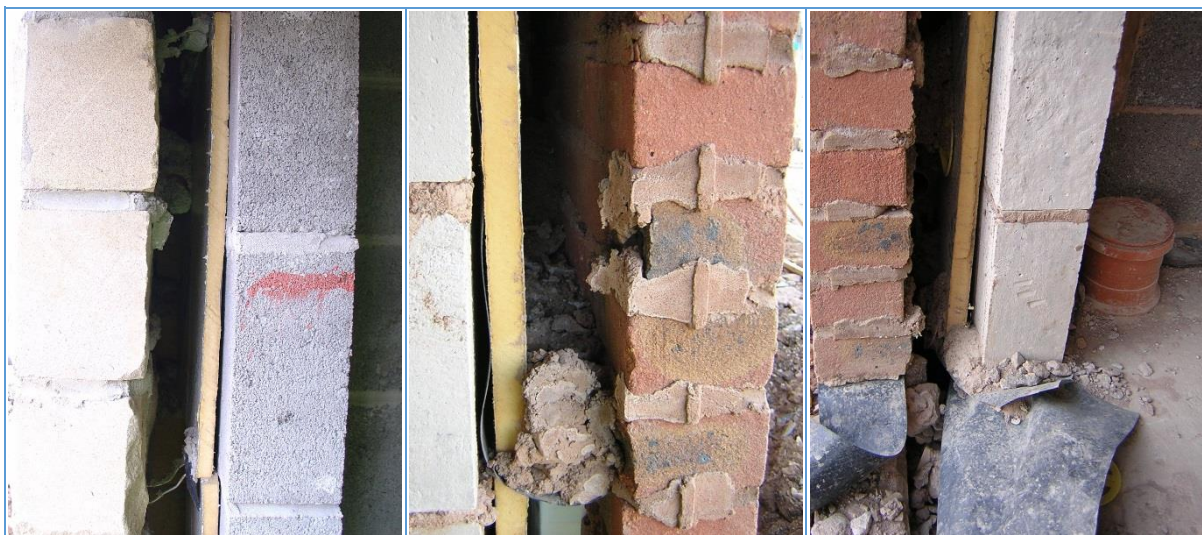
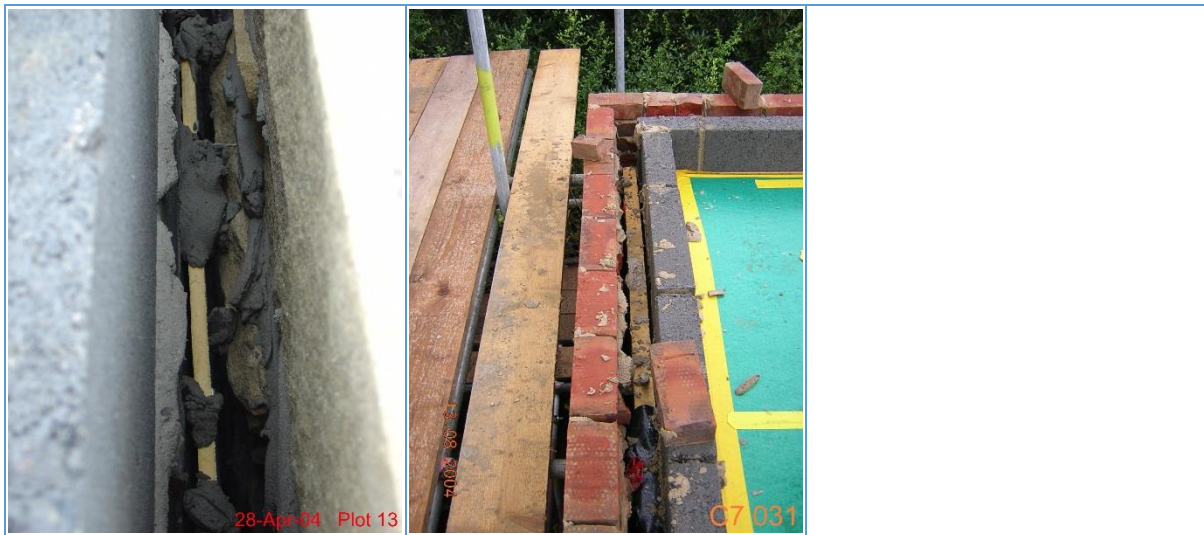
Figure 22 Partial-fill insulation affected by mortar snots

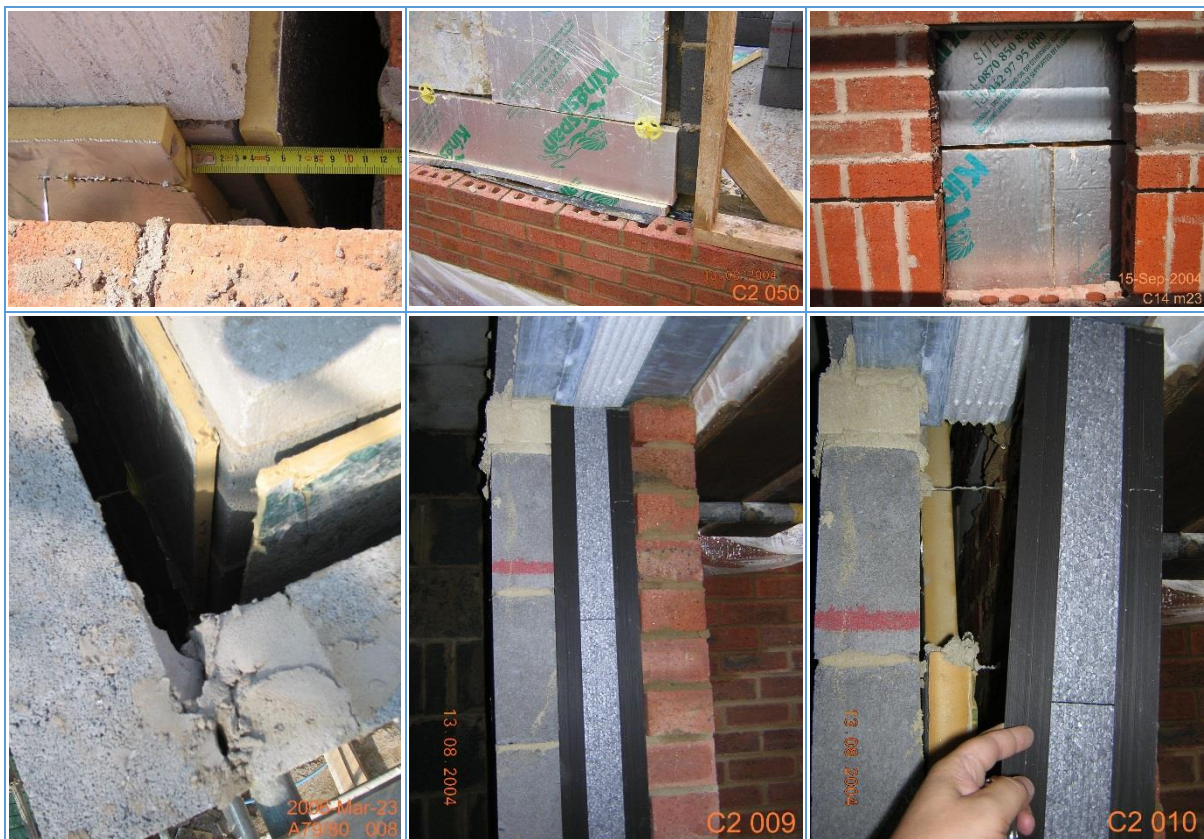
Figure 23 Gaps between and around partial-fill insulation boards

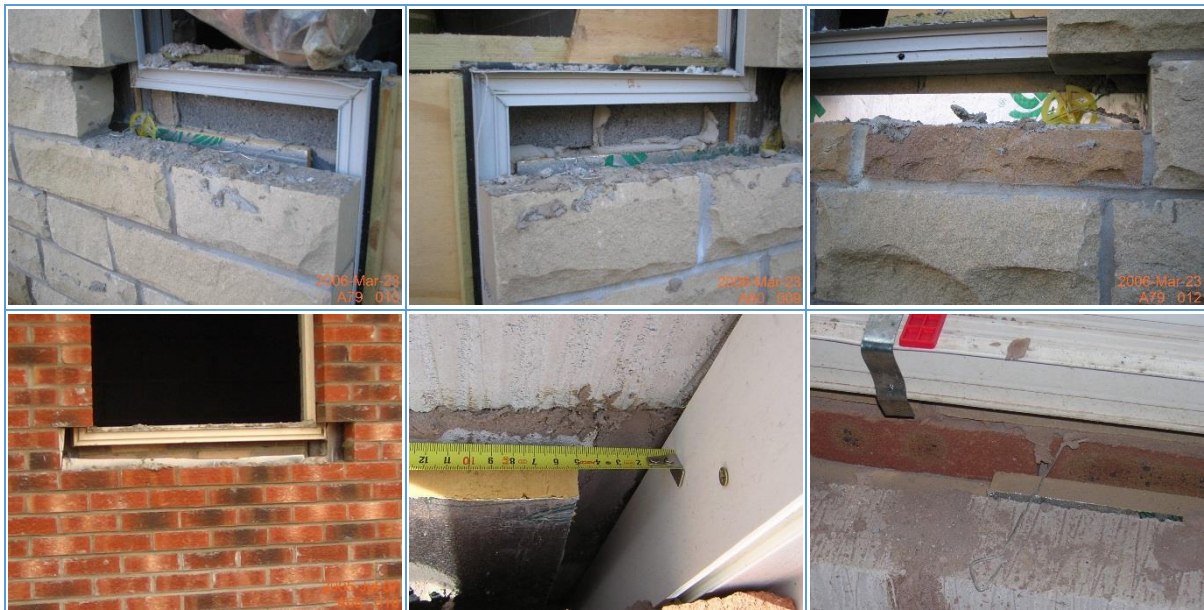
Figure 24 Gaps around partial-fill insulation boards at openings

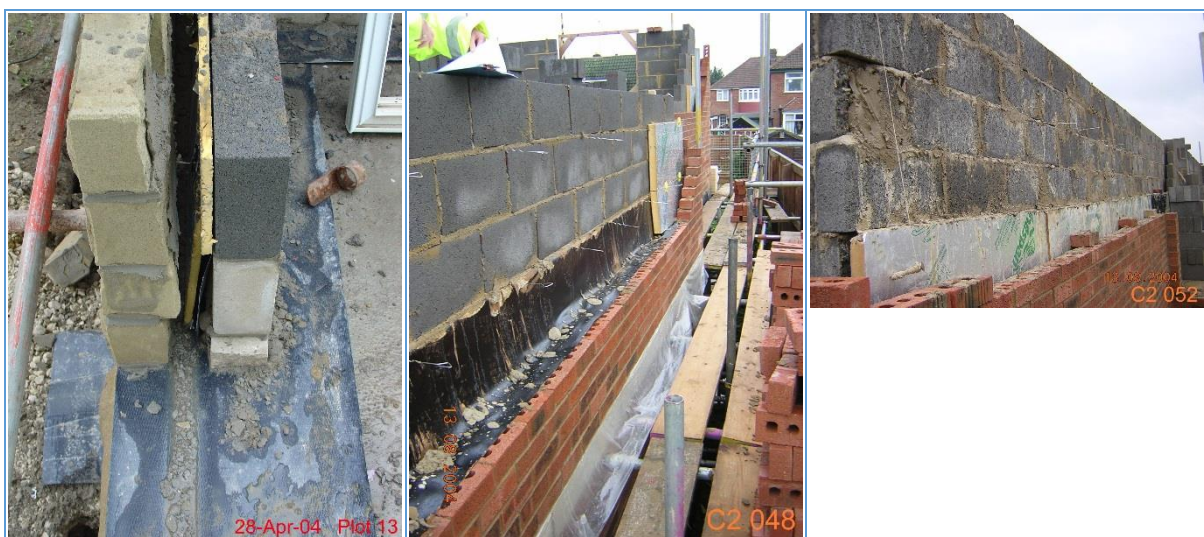
Figure 25 Issues with partial-fill insulation around cavity trays

Figure 25, Figure 26 and Figure 27 show other commonly seen issues with partially-filled external walls where ‘topping-up’ the residual cavity by injecting insulation through the external leaf might not prove to be as successful as desired. Figure 25 shows a common issue with the installation of any insulation, not just partial-fill, where cavity trays prevent the insulation achieving good contact with the inner leaf, filling the residual cavity from the outside will reinforce thermal resistance on the cold side of the existing insulation, but would not solve the issue of air gaps on the warm side. Figure 26 shows another common issue with partial-fill, where the first course of insulation boards or batts only starts at dpc level or sits neatly on the first row of wall ties, rather than extending the prerequisite distance below floor insulation level. In the first case shown in Figure 26 ‘topping-up’ would not address this problem due to the cavity tray closing off the external cavity below floor level; however, for the other two examples filling the residual cavity would also fill the uninsulated cavity below floor level and provide additional thermal resistance around the ground floor perimeter that is missing from the original construction. Figure 27 introduces further issues around cavity tray, those at lintels where insulation is often inadequate and may present problems for ‘topping-up’ close to the eaves junctions.

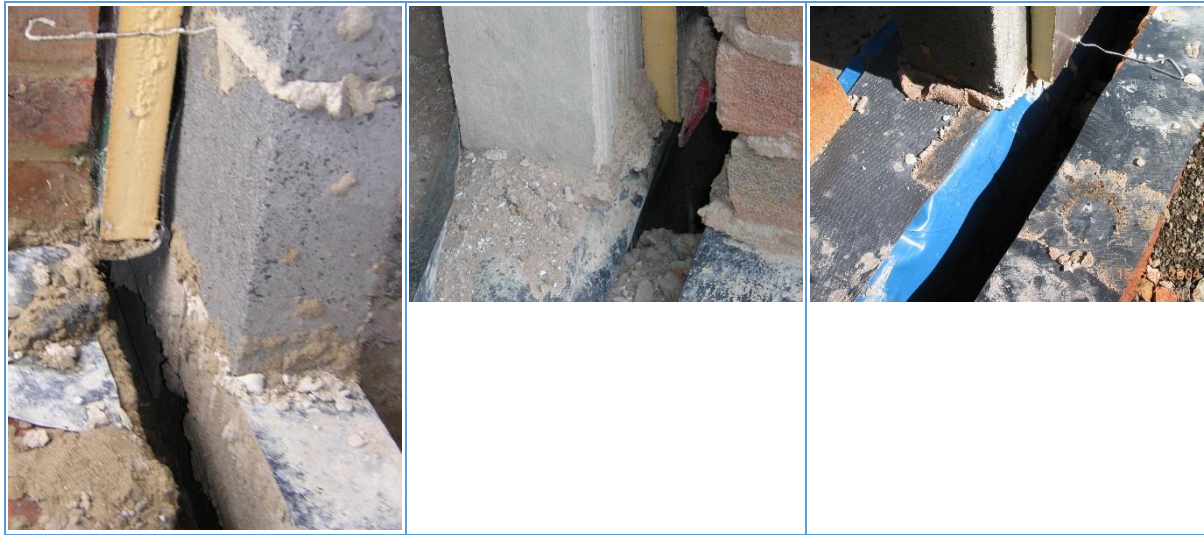
Figure 26 Partial-fill insulation not extending below ground floor level

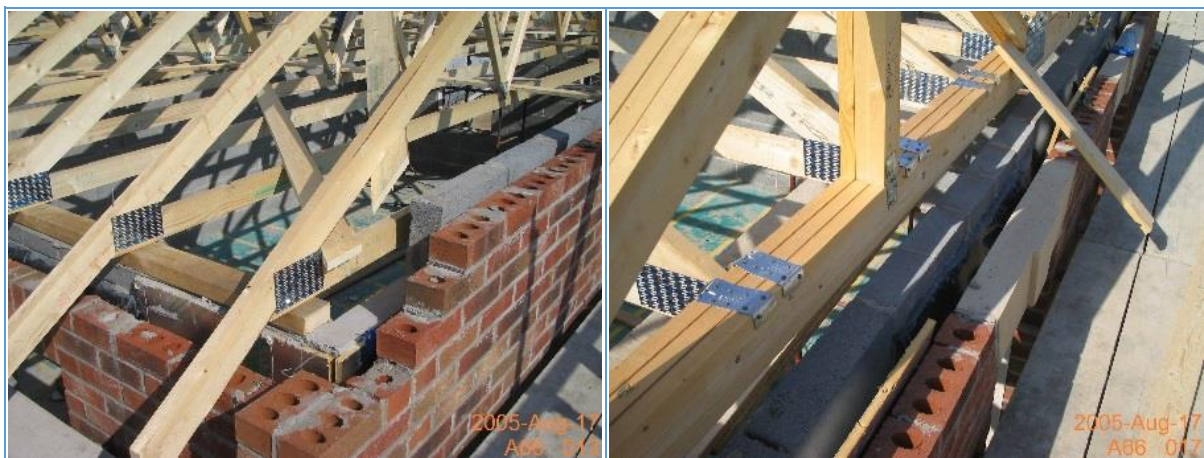
Figure 27 Issues with partial-fill boards at eaves, wall plates and top storey lintels

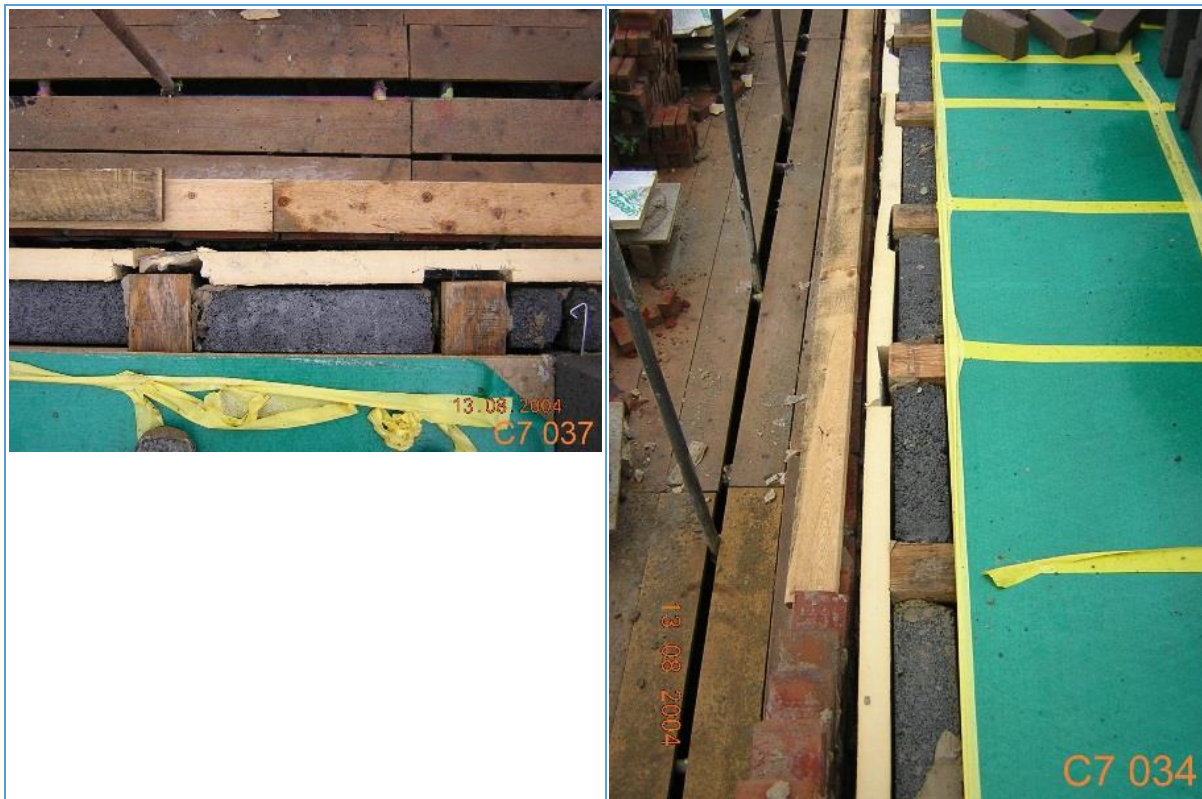
Figure 28 Missing/displaced insulation due to wall protrusions

Figure 28 shows an issue which is less common than many of the other partial-fill issues mentioned previously, and rather than showing a problem illustrates a work-around another issue. In the majority of cases observed the builders would not have cut out sections of insulation to fit the partial-fill boards in close contact with the inner leaf, but instead have left gaps between the inner leaf and insulation boards where protrusions for built-in joists and RSJs extend beyond the plane of the blockwork. In the example shown in Figure 28 'topping-up' the residual cavity could prove highly successful, much more so than if the insulation board had not been adapted to limit the air gaps on the warm side of the insulation.

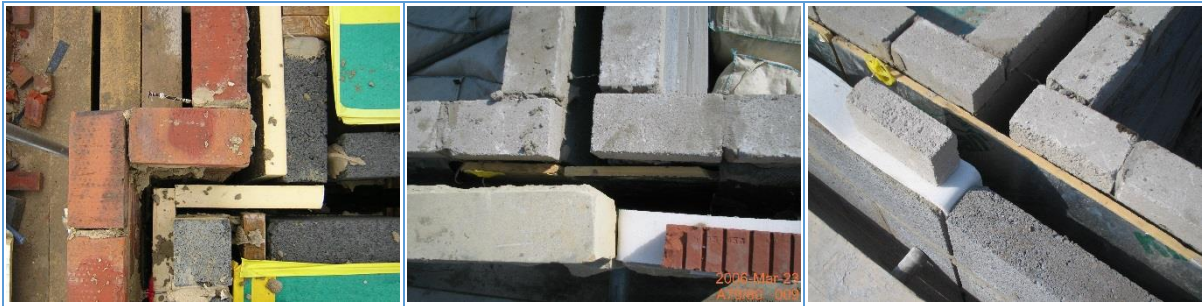
Figure 30 Party wall junctions with external walls

Figure 29 and Figure 30 show junctions of the external wall cavity, with both adjacent external wall cavities and with party wall cavities, and illustrate how issues with the continuity of the partial-fill insulation layer arise. Small staggers in the external wall often result in no wall ties being present in the short sections of wall normal to the main façade, making it impossible to fit retaining clips to ensure contact between the insulation and inner leaf. Party wall junctions can also result in similar issues, although this is usually mitigated by the inclusion of a cavity stop sock. In both cases the 'top-up' insulation introduced to fill the residual external wall cavity would reduce the unplanned additional heat loss at these junction.

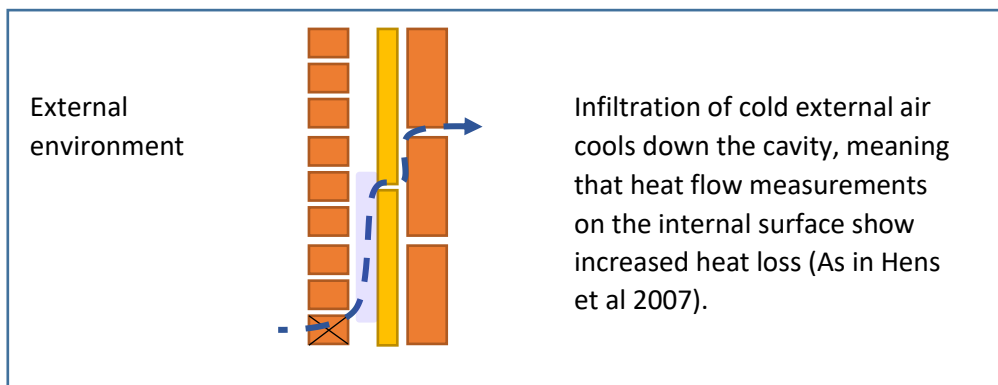
Figure 32 Effect of infiltration and exfiltration on the measurement of conductive heat flow.

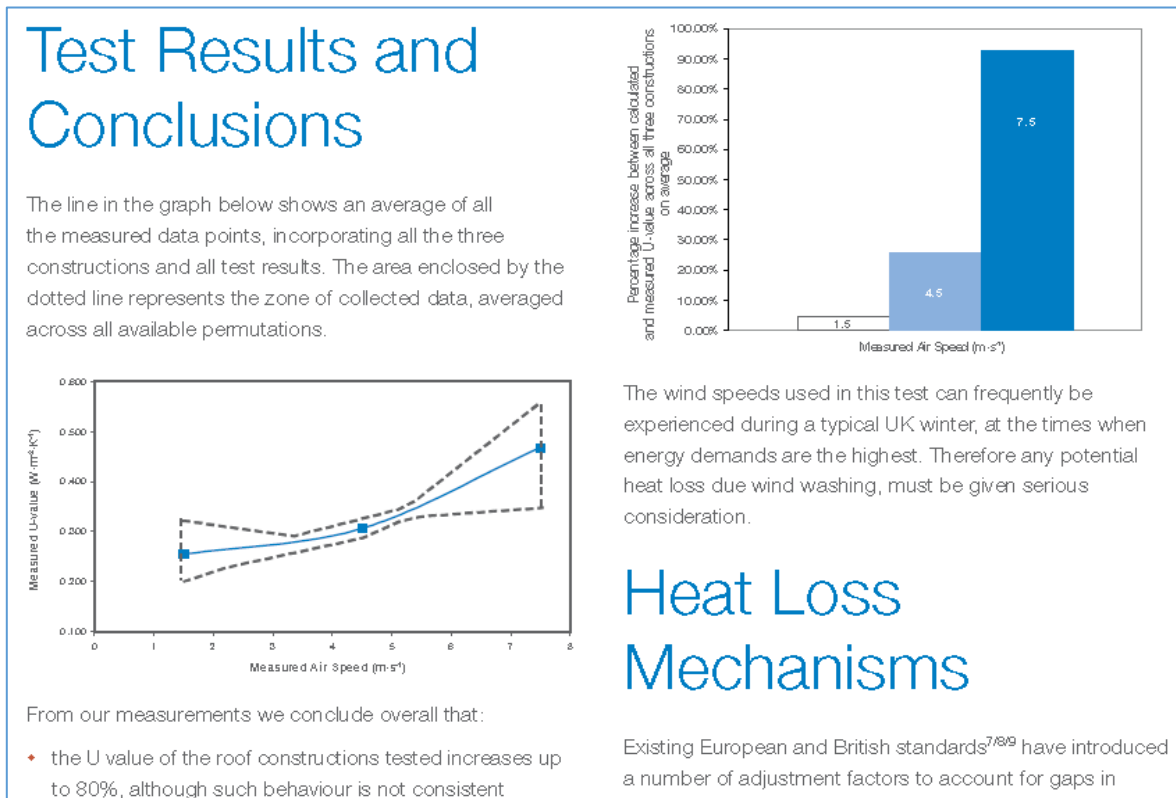
Figure 38 Effect of air movement on measured U-values of roof structures (BBA, 2012)

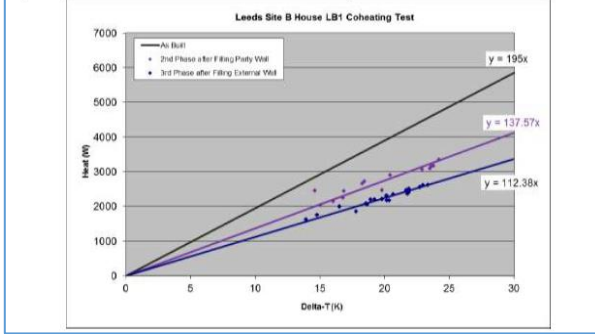
Figure 167 – Leeds Site B House LB1 - Coheating Test Phase1, Phase 2 and Phase 3

Condition of Test House during Coheating Test	Heat Loss Coefficient (W/K)			
	Predicted	Measured	Difference Measured vs. Predicted	Measured Difference after Intervention
Phase 1 - As Built	105.9	195.0	+89.1	n/a
Phase 2 - Party Wall Filled	106.0	137.6	+31.6	-57.4
Phase 3 - External Wall Filled	102.8	112.4	+9.6	-25.2

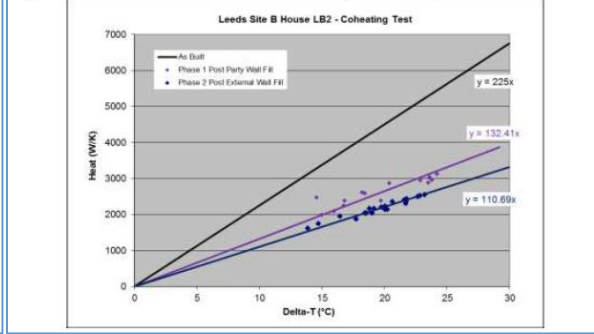
Figure 168 – Leeds Site B House LB2 - Coheating Test Phase1, Phase 2 and Phase 3

Condition of Test House during Coheating Test	Heat Loss Coefficient (W/K)			
	Predicted	Measured	Difference Measured vs. Predicted	Measured Difference after Intervention
Phase 1 - As Built	88.3	225.0	+136.7	n/a
Phase 2 - Party Wall Filled	88.4	132.4	+44.0	-92.6
Phase 3 - External Wall Filled	89.6	110.7	+21.1	-21.7

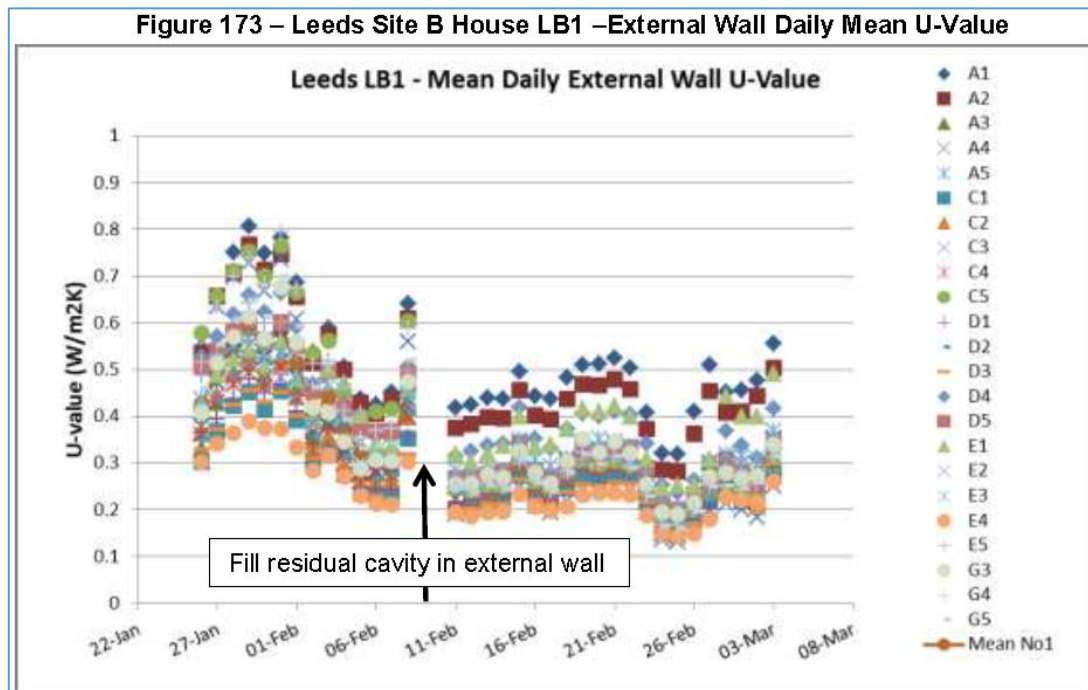
Figure 42 Mean daily in-situ U-values before and after residual cavity top-up (Wingfield et al., 2011)

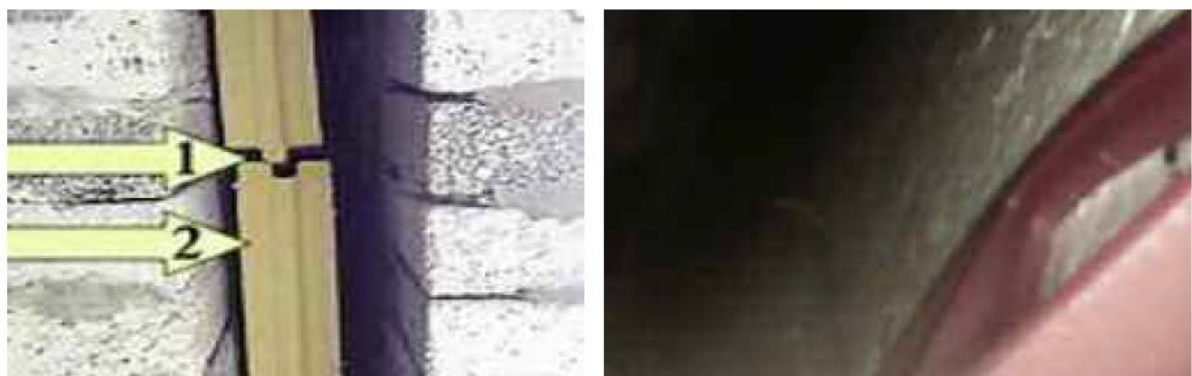
Where the board is poorly fitted (usually by a bricklayer) and gaps are present this allows cold air to circulate around the insulation

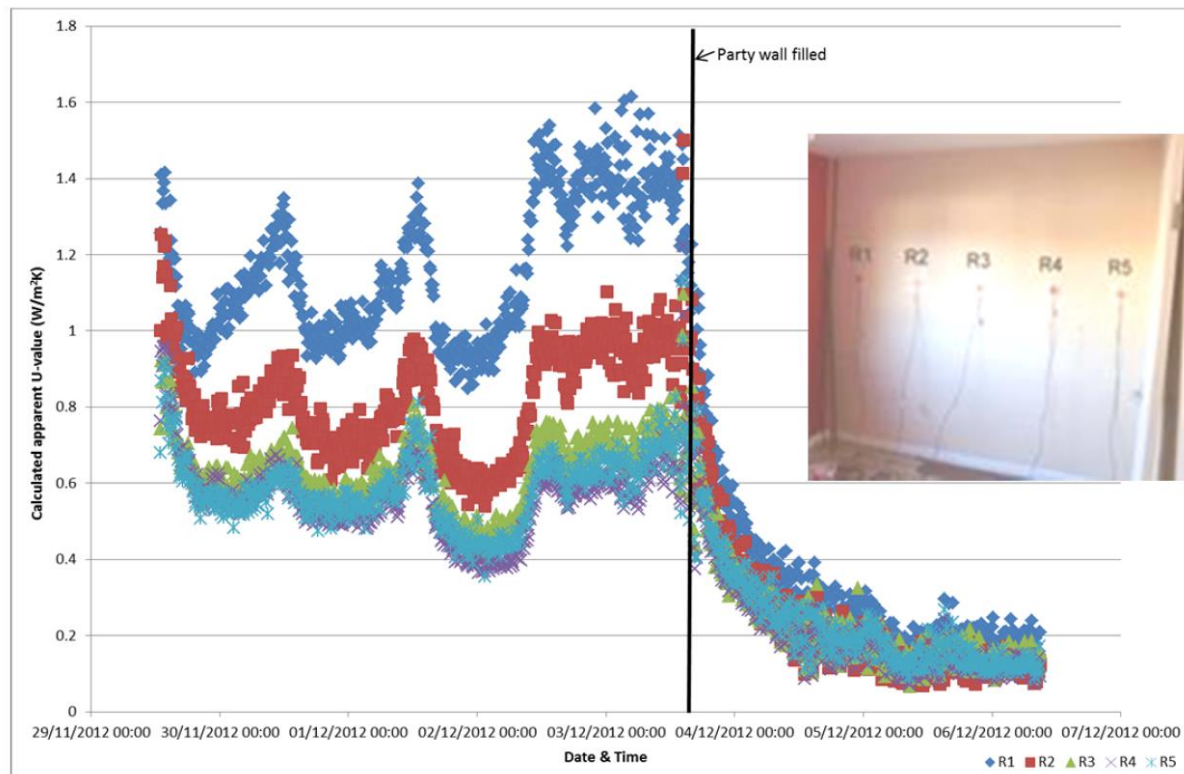
Figure 49 An unfilled cavity party wall exhibiting characteristic signs of thermal bypass and air movement, the full-fill intervention creates a fabric that controls movement and significantly reduces heat loss (Gorse et al., 2014)

wall, which appears to be communicating directly with the external wall cavity. As the external conditions impacting on the wall change, and thus the conditions in the attached external wall cavity change, a large degree of variance in the party wall can be seen. Notably, once the party wall is filled with insulation the thermal resistance is improved for each section of the wall, there is also a greater degree of consistency in thermal performance across the wall and the impact of external conditions on the thermal resistance is significantly reduced.
