Predicting In-situ Heat Pump Performance: An Investigation into a Single Ground-Source Heat Pump system in the context of 10 similar systems.

A. Stafford^{a*} and D. Lilley^b

Abstract

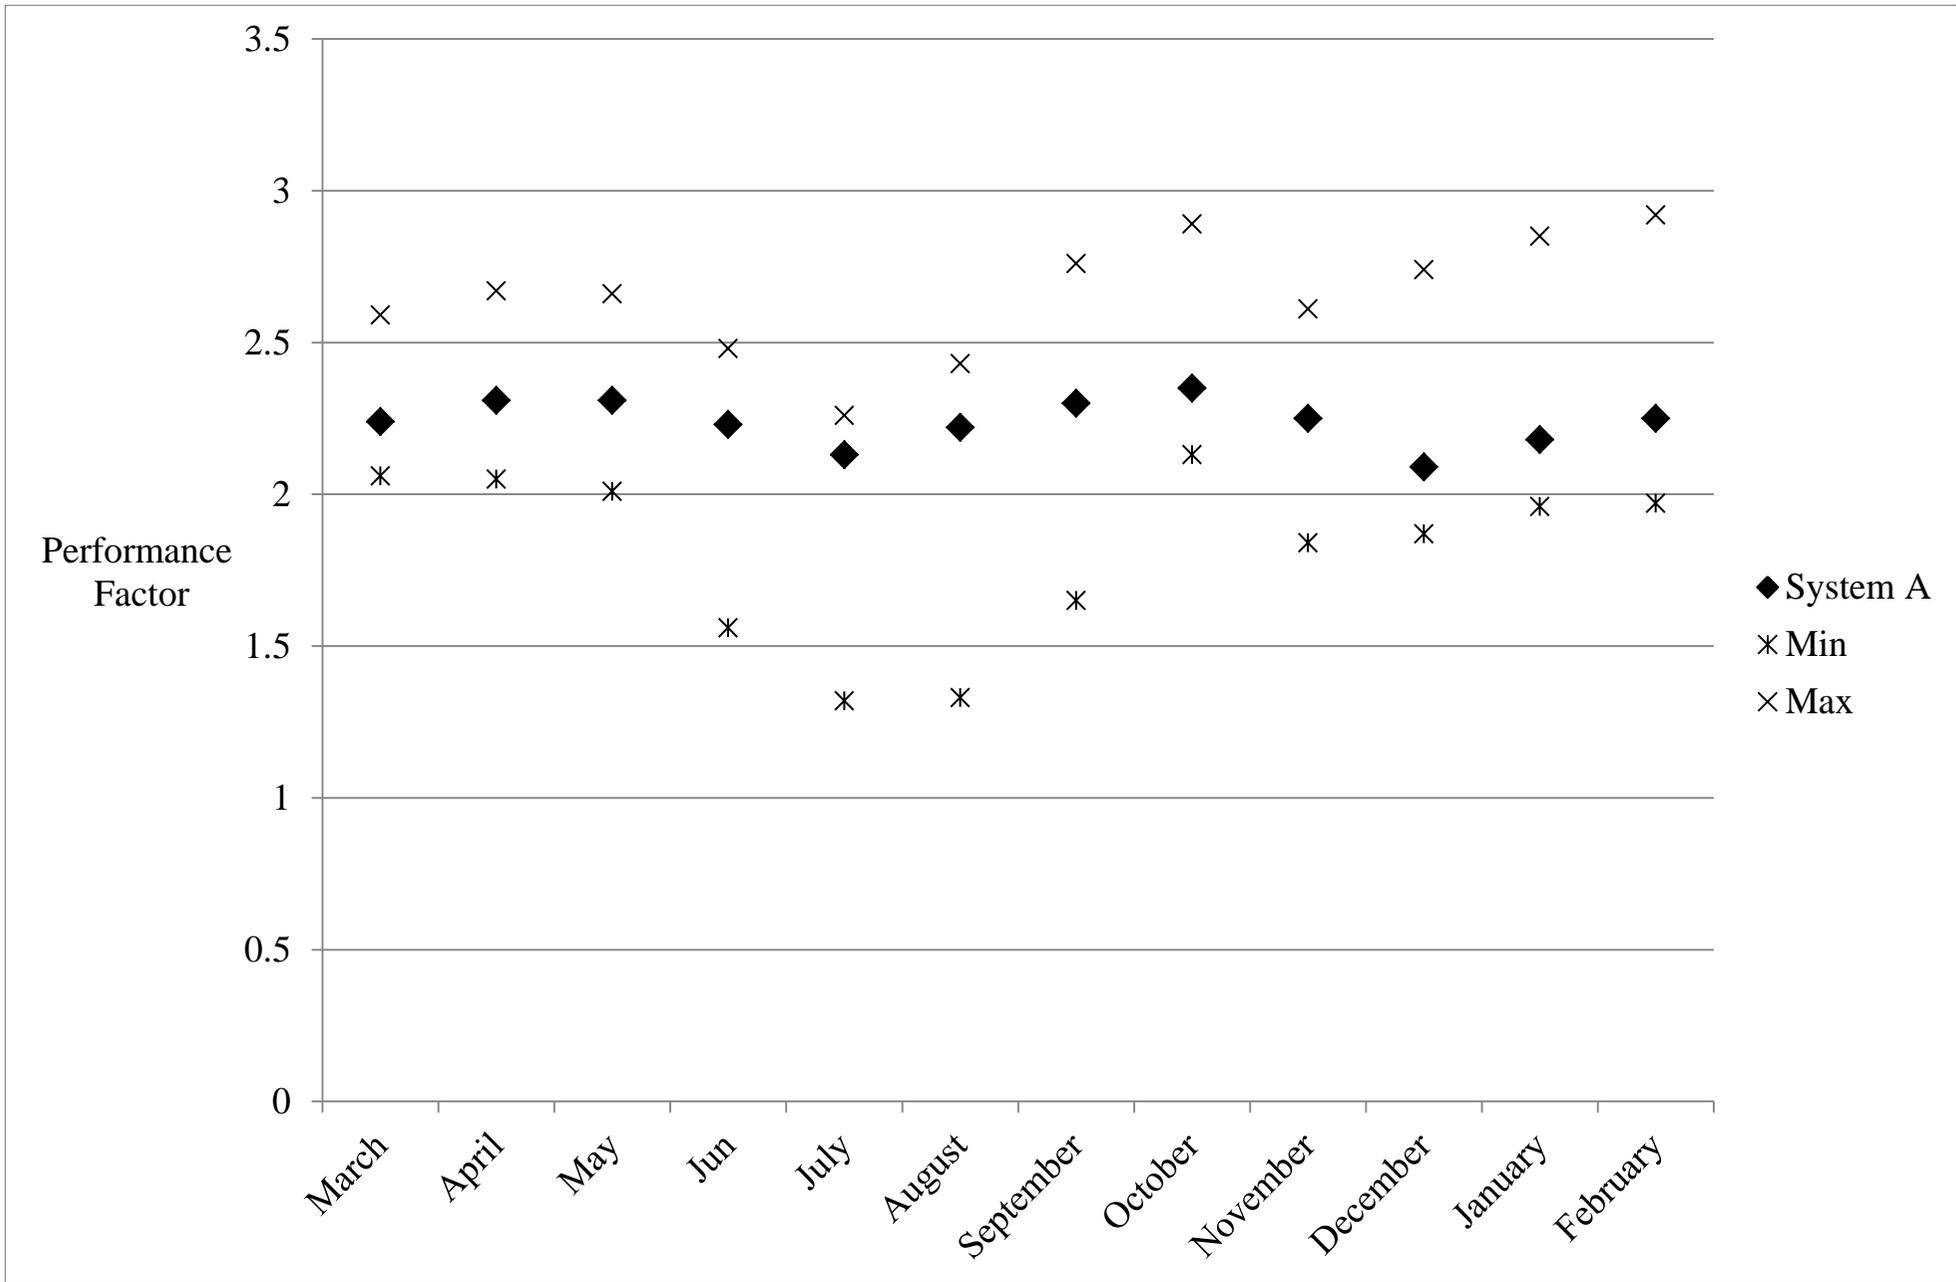
Fig 1: Month by Month Performance Factor of System A, compared with the maximum and minimum performance factors from all 10 systems.

Fig 1 shows the performance factor of system A on a month by month basis, during this year. The spread of values from all 10 systems is also shown in the diagram.

Whilst system A is at no time the best or worst performing system in the group, Fig 1 shows that it is performing relatively well during the summer months, when many of the systems show a significant drop in performance (due to the output being dominated by DHW production). Similarly, the performance in the winter months is relatively poor compared with the other nine systems. In itself this might suggest that this system is producing DHW relatively efficiently, and space heating relatively inefficiently compared with the remainder of the group.

Thus both Fig 1 and Fig 2 suggest that the heat pump system A is performing relatively well with respect to DHW production.

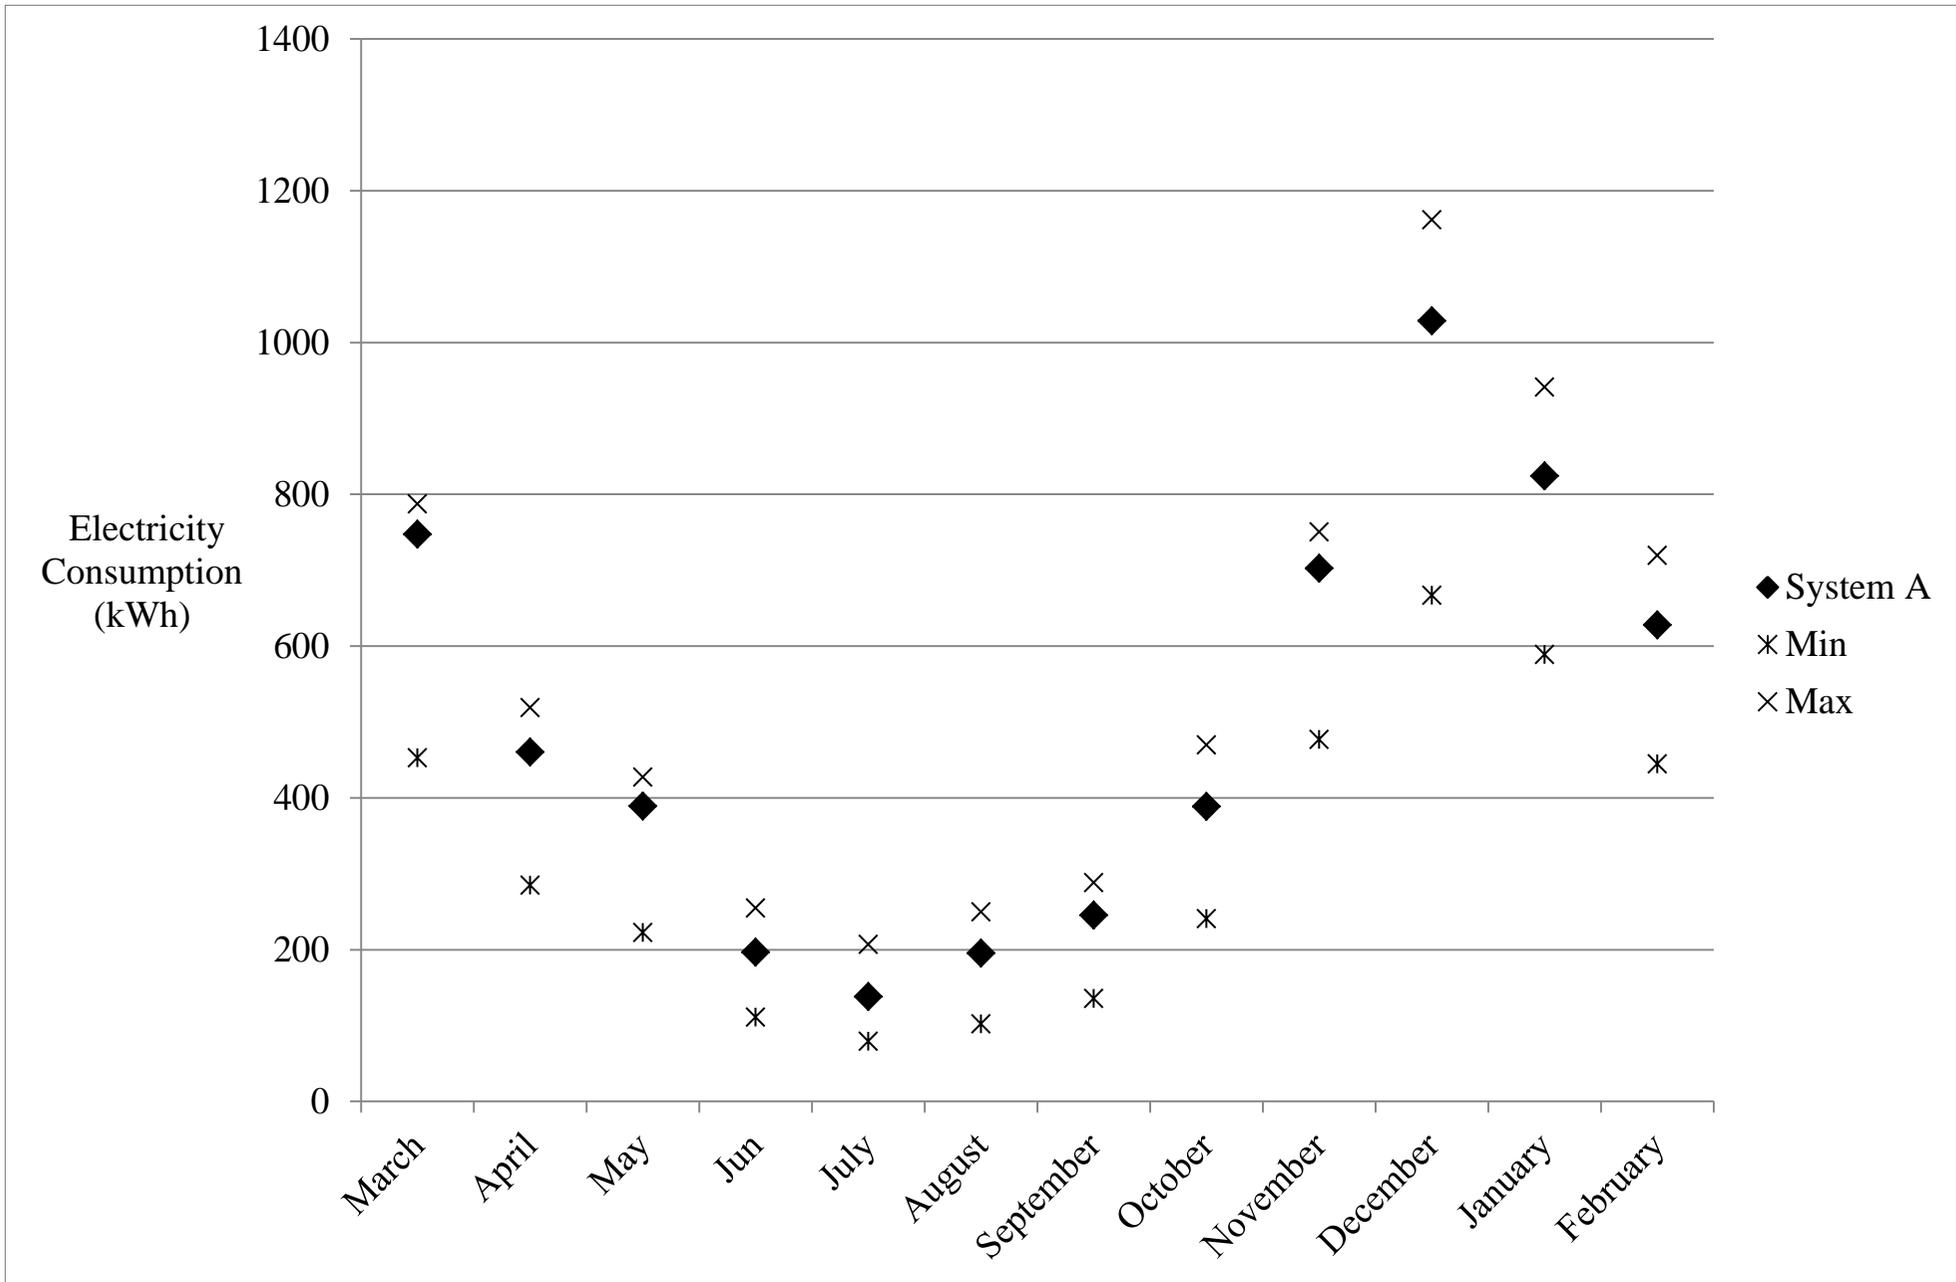
Fig 2: Month by Month Electricity Consumption of System A, compared with the maximum and minimum electricity consumptions from all 10 systems. .

Fig 2 shows a similar plot for the total electrical consumption of the heat pumps on a month by month basis.

Again, system A is at no time the maximum or minimum consumer of electricity within the group of 10 systems, but this time it is clear that during the colder months the consumption tends to be somewhat higher than average. Conversely during the summer months consumption is somewhat below average.

(Note that 4 days of consumption data for system A during October is missing due to a faulty transmitter, so this data point represents a slight underestimate of actual consumption).

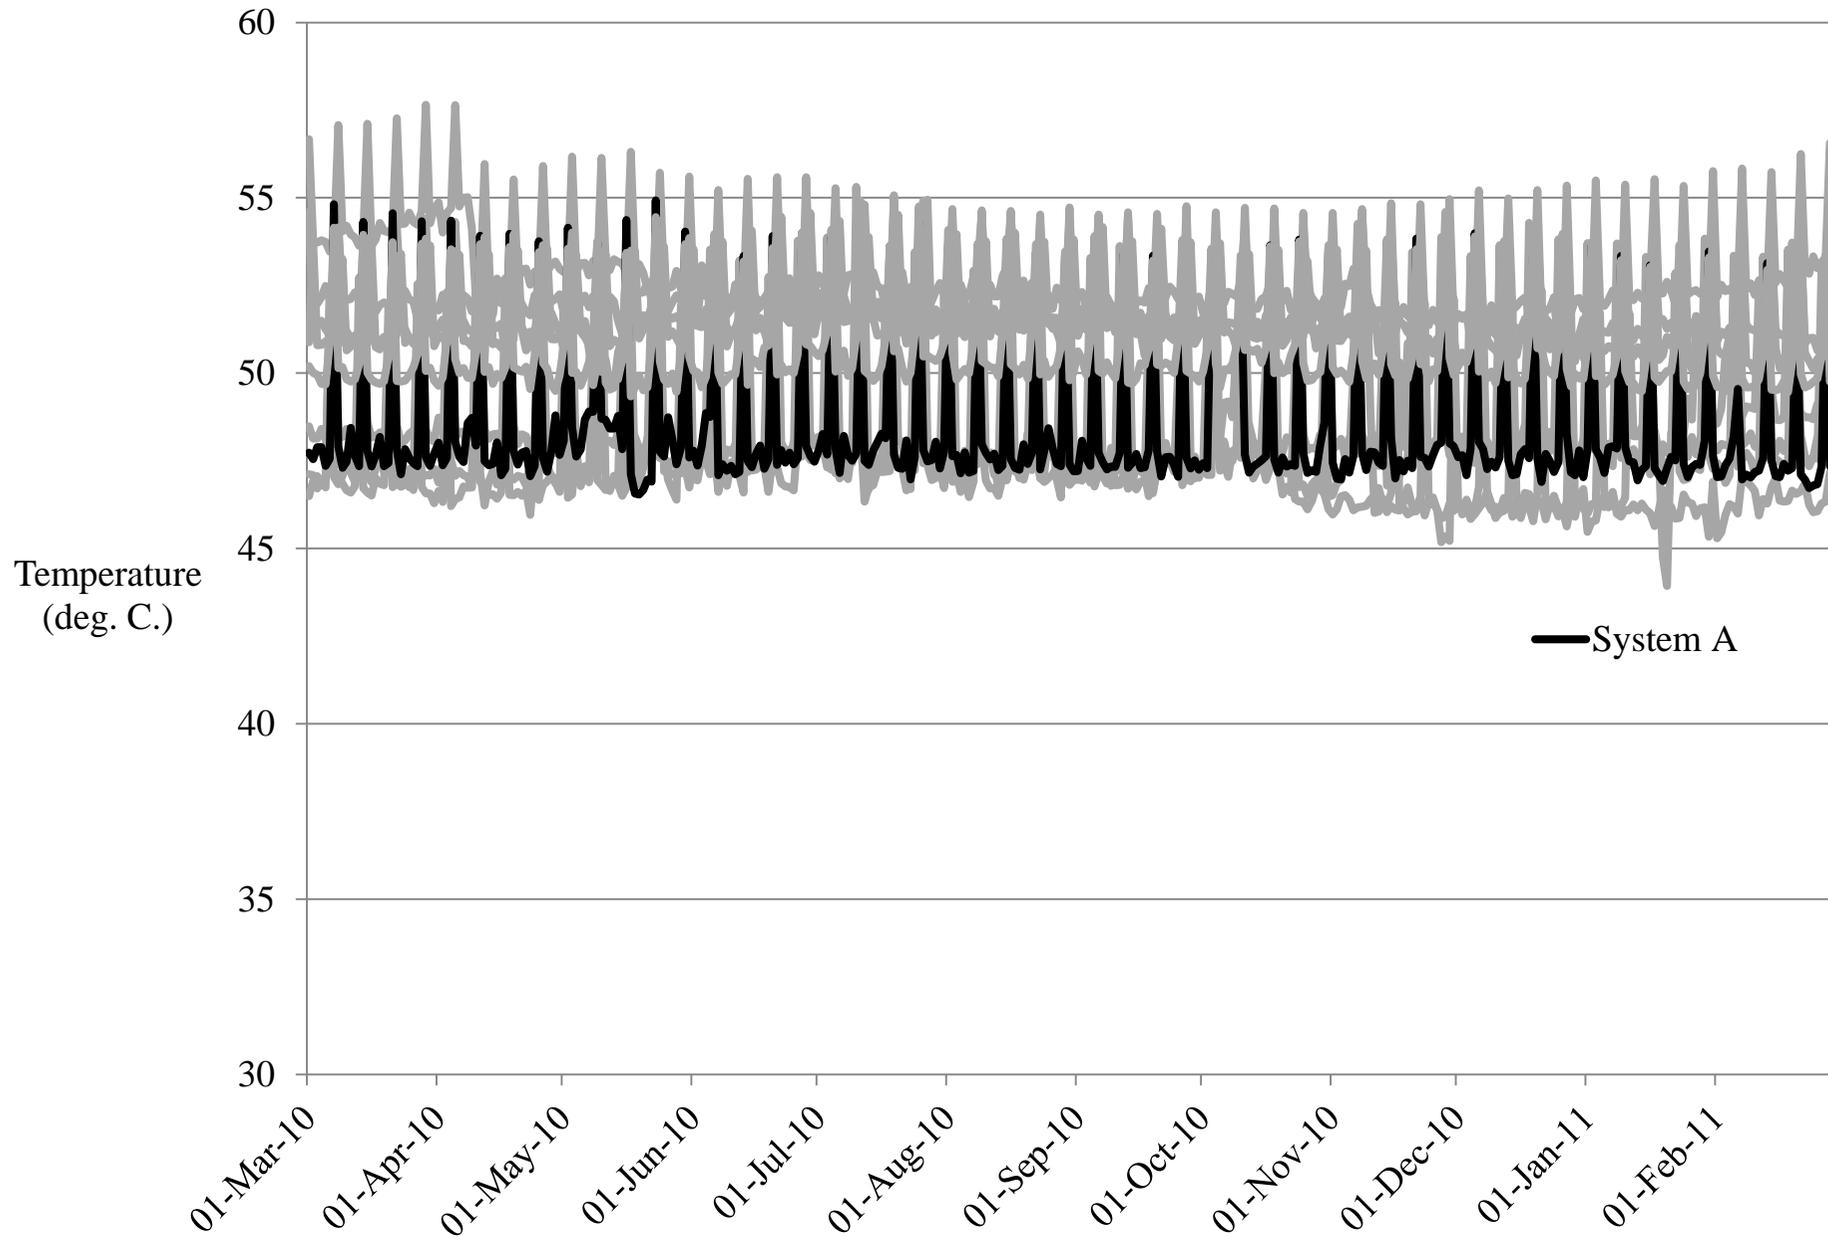
Fig. 3: Surface temperature at top of DHW tank. (Daily average calculated as a mean from data sampled at 10 minute intervals)

From Figs 1 and 2, we might expect that the set-point temperature for DHW in system A is set relatively low (leading to good efficiency and low electricity usage in the summer months). Fig 3 shows the daily average temperature as measured by surface probe at the top of the DHW tank for 9 of the 10 systems including System A. (The tenth system was excluded for reasons relating to system malfunctions). Clearly system A operates at a relatively low baseline DHW tank temperature as expected.

The regular peaks shown by the majority of systems represent weekly pasteurisation cycles where the tank temperature is raised briefly to 60°C to mitigate the risk of legionella growth.

However, since these are daily average values (averaged from data sampled at 10 minute intervals), all temperatures shown on the plot are in fact less than 60°C. There is a loss of pasteurisation cycle for one of the group from October onwards, but this is unrelated to the present discussion.

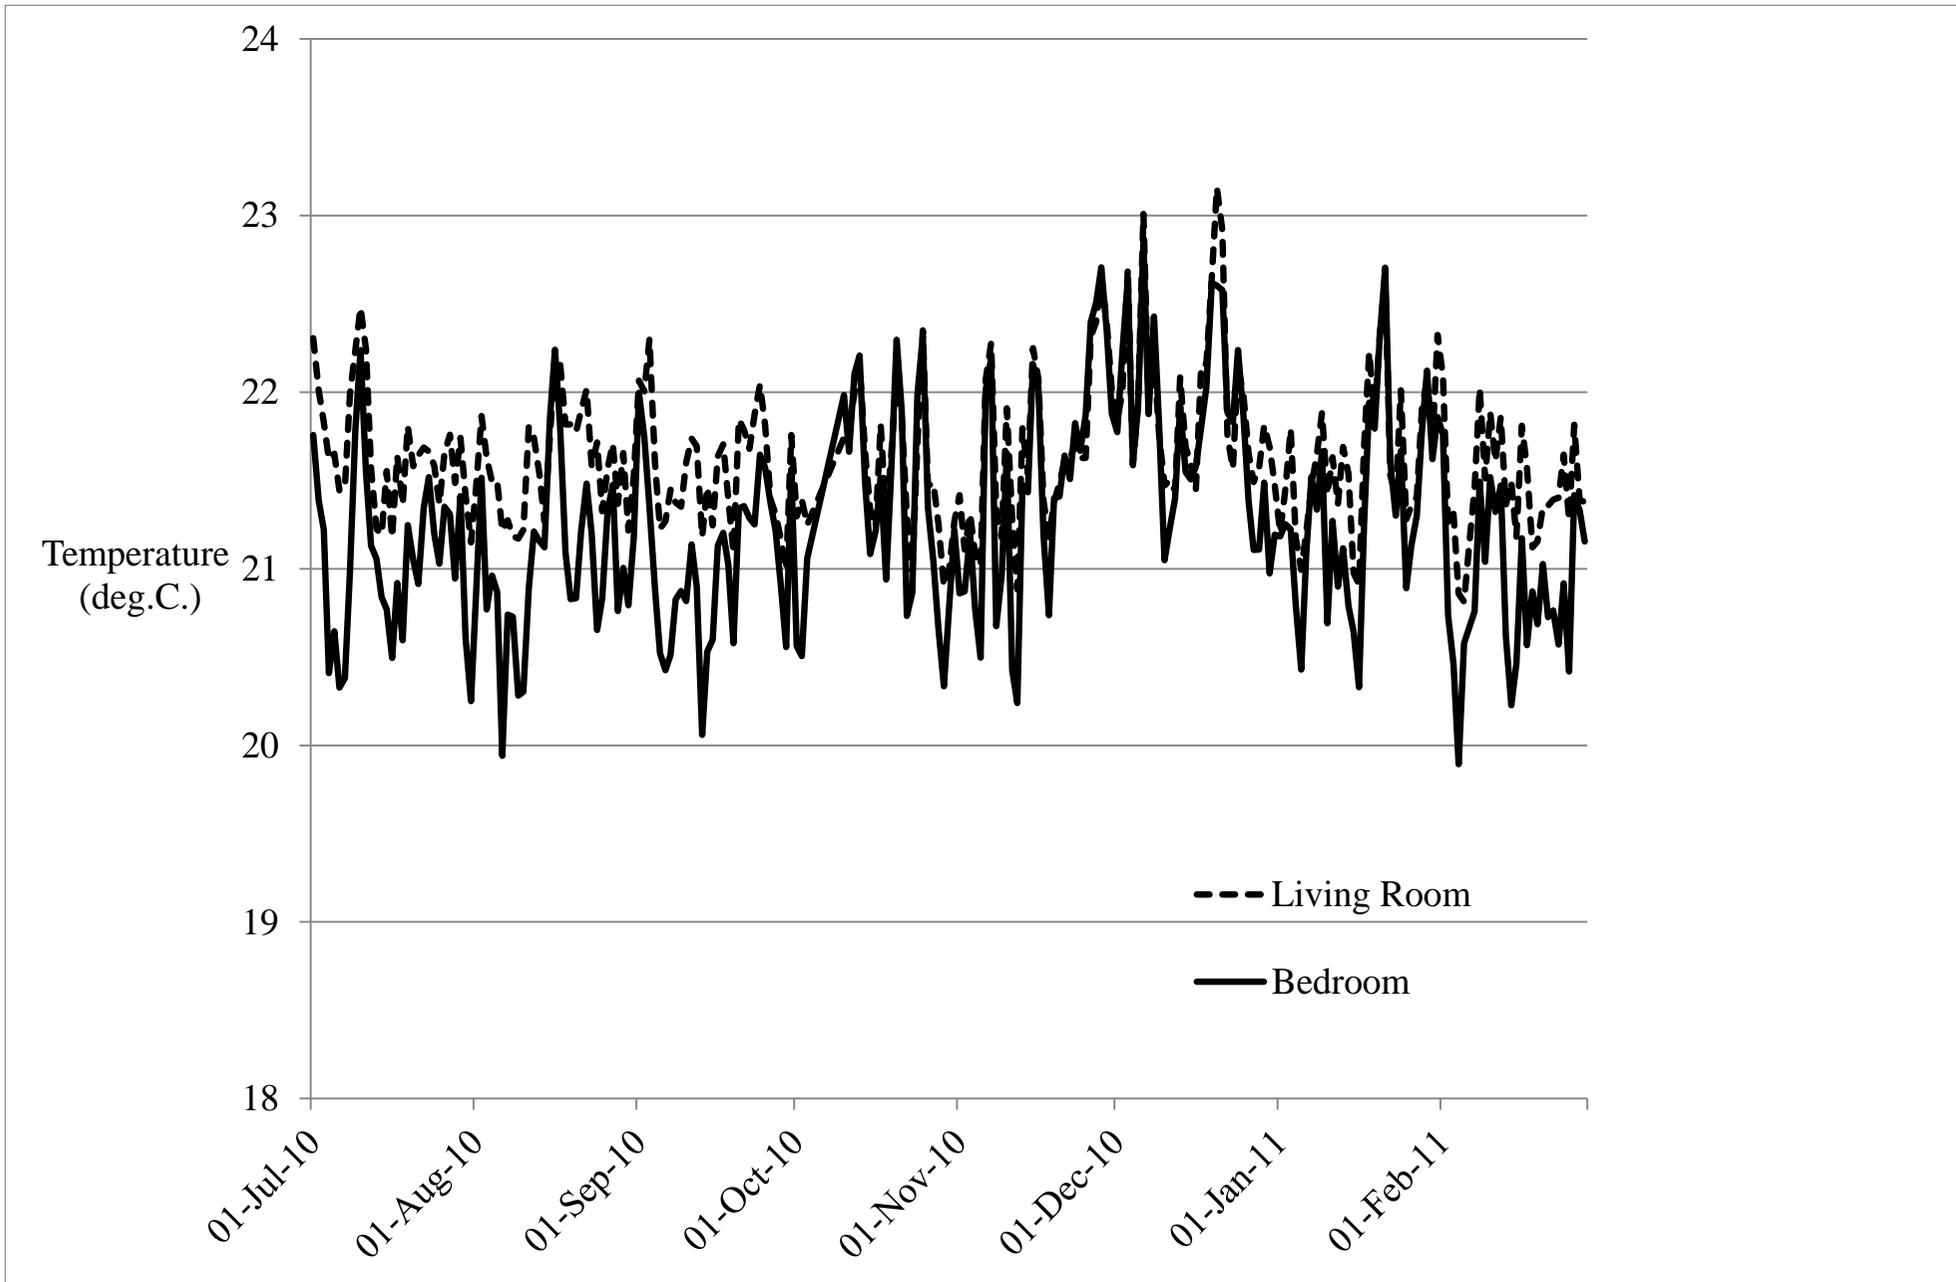
Fig 4: Daily Average Living Room and Bedroom Temperatures for system A (July 10 to February 11). (Daily average calculated as a mean from data sampled at 10 minute intervals).

Taking a simple view we might expect to see either fairly high internal dwelling temperatures, or low ground-loop temperatures, leading to relatively high electricity usage and lower efficiency during the heating season. Internal temperatures in the system A dwelling were measured in four locations (living room, bedroom, kitchen and bathroom) and found to be reasonably consistent and stable throughout the dwelling. Fig 4 shows living room and bedroom temperatures only for the sake of clarity, but kitchen and bathroom temperatures followed the living room temperature closely. The somewhat lower and less stable bedroom temperatures, during all of the year except for the coldest period in late November and December may be explained by the window-opening behaviour discussed in section 2.7.

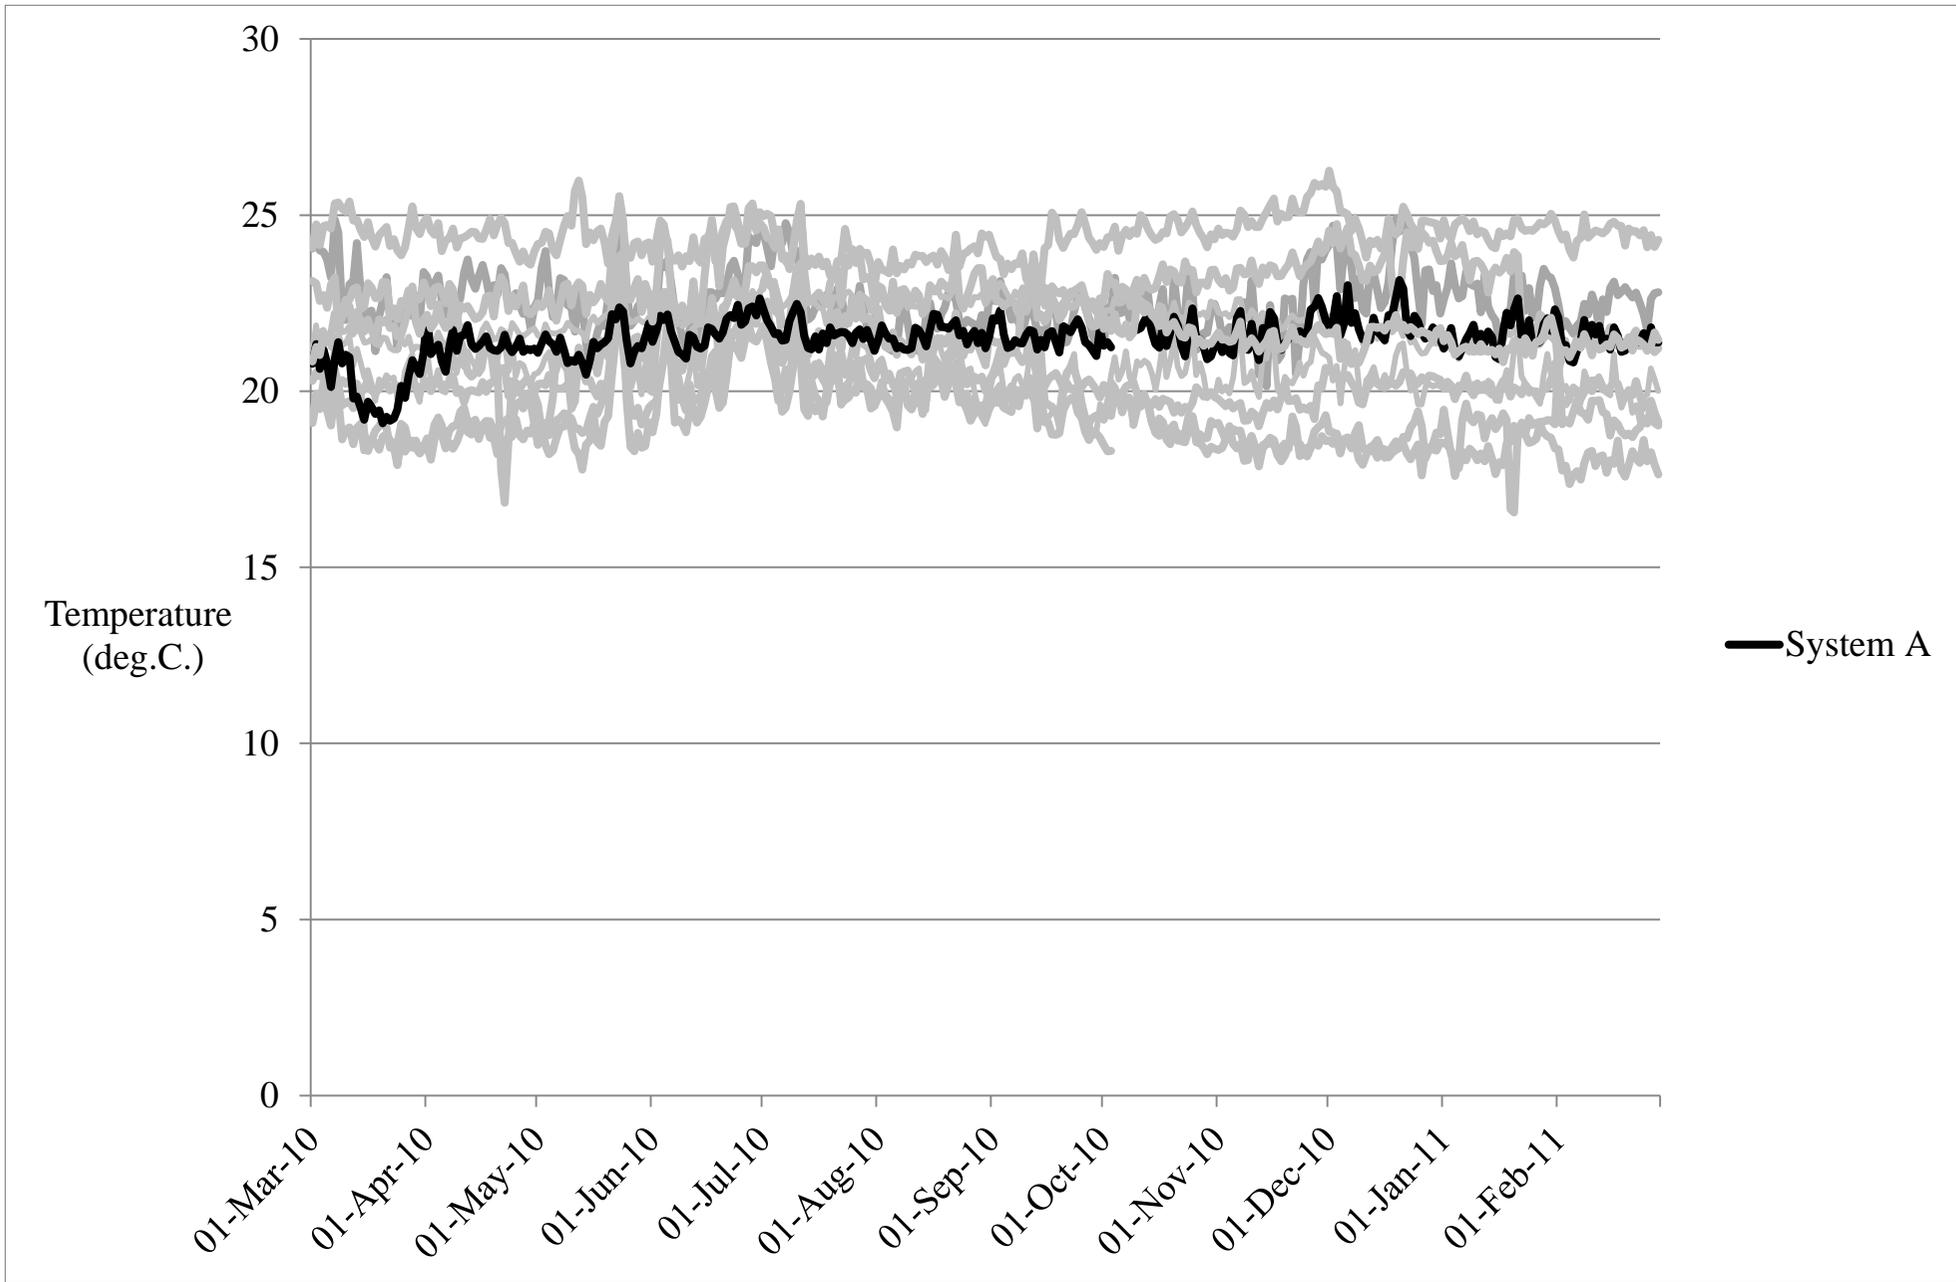
Fig 5: Daily Average living room temperatures – all systems. (Daily average calculated as a mean from data sampled at 10 minute intervals).

Figs 5 and 6 track the living room temperatures and ground-loop fluid temperatures for all the systems. In the case of Fig 6 the plot is restricted to the months of November and December 2010. A full year plot would be misleading since during the warmer months, when the heat

Figs 5 and 6 show that in the context of the other systems, system A is around average for both internal temperature and ground-loop fluid temperature. We might therefore expect to see average performance during the winter months, when the efficiency is dominated by space-heating, but in fact the performance tends to be below average. Factors which may cause this apparent anomaly are discussed in the following sections.

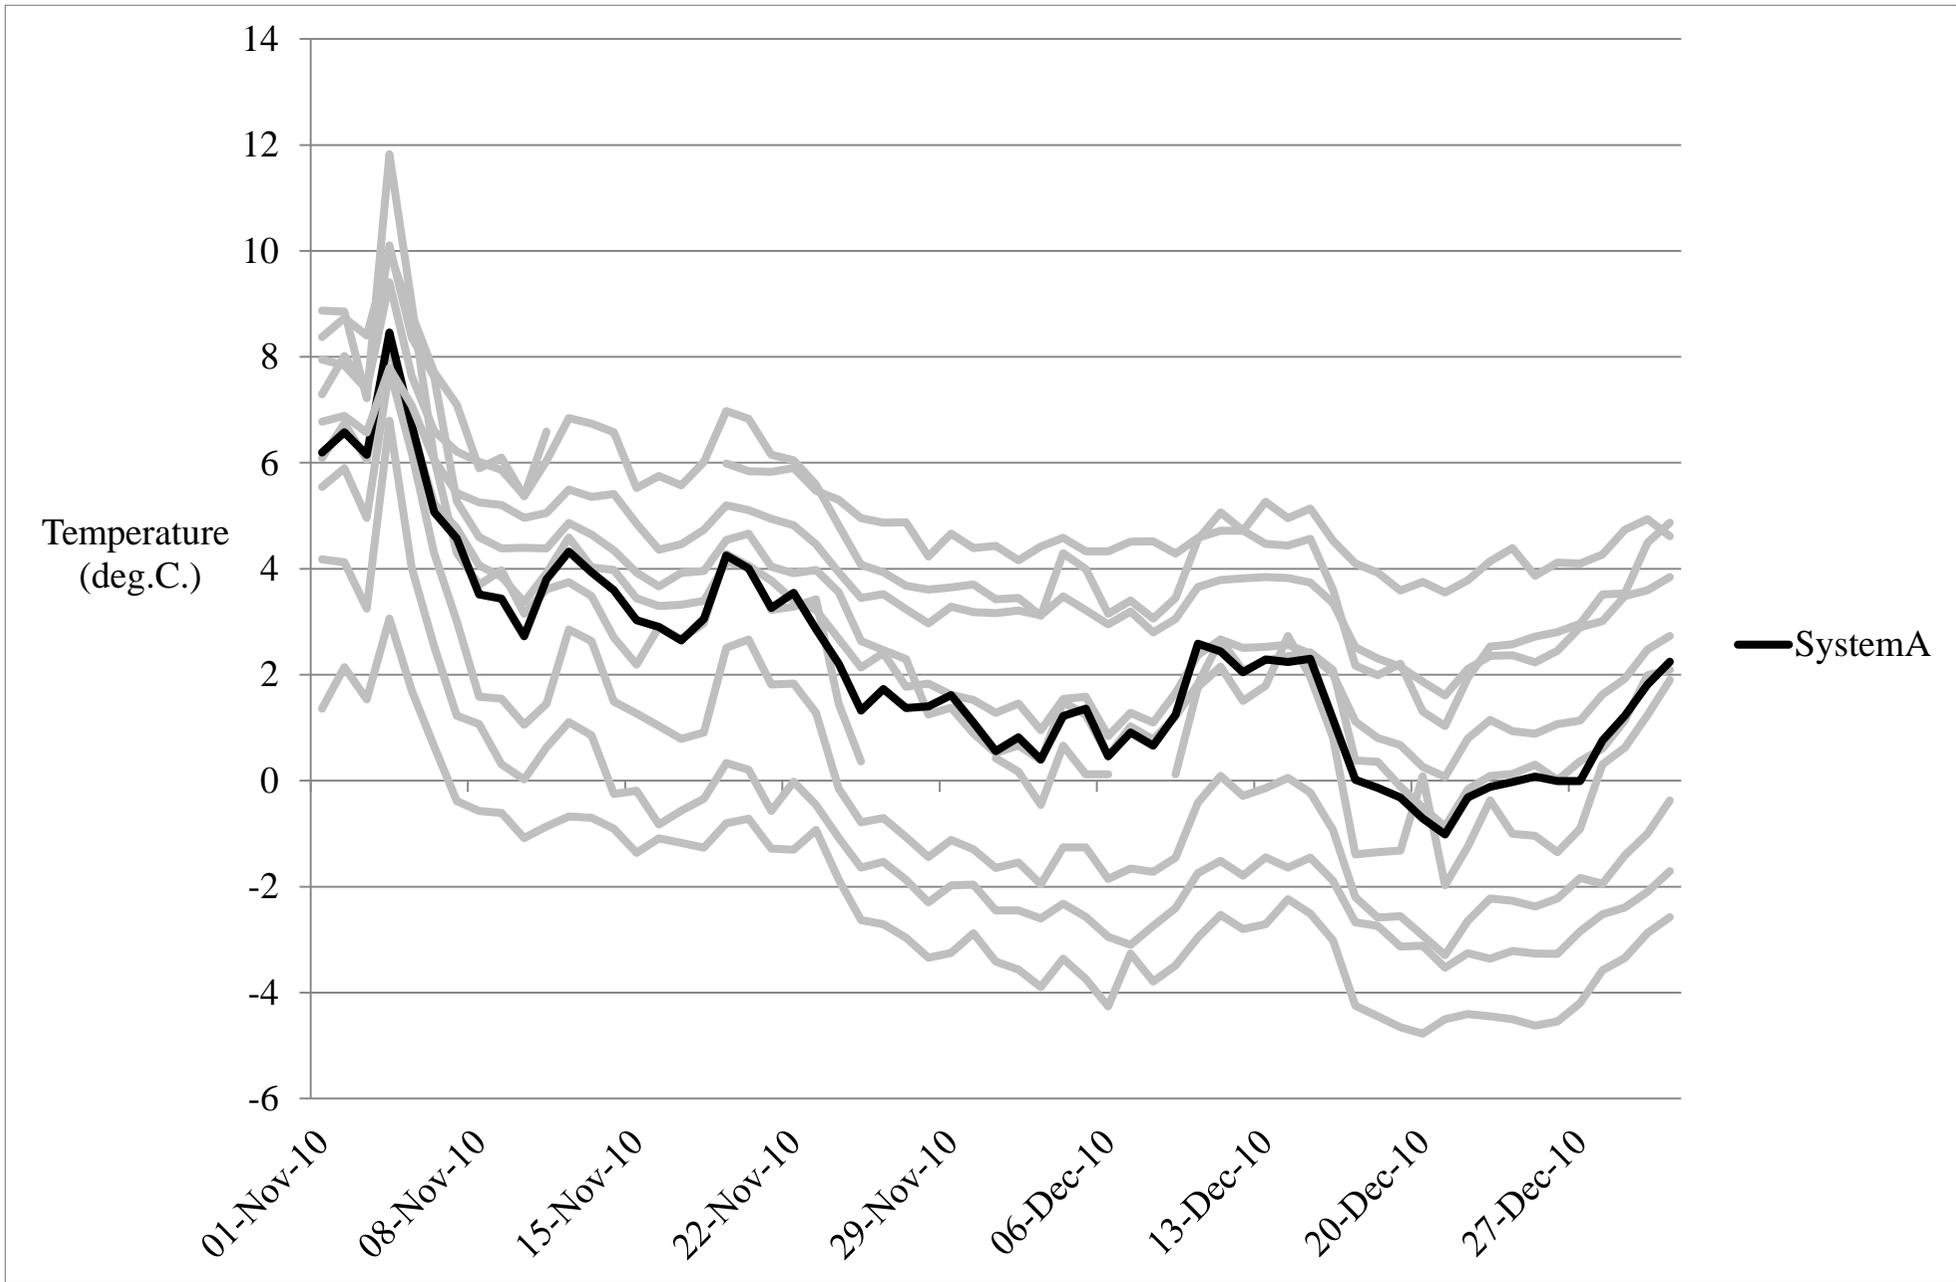
Fig 6: Daily Average Temperature of fluid from Ground Loop for all 10 systems (November/December 2010). (Daily average calculated as a mean from data sampled at 10 minute intervals).

pump is operating intermittently, the temperature measured may represent only that of stagnant fluid in the pipework.

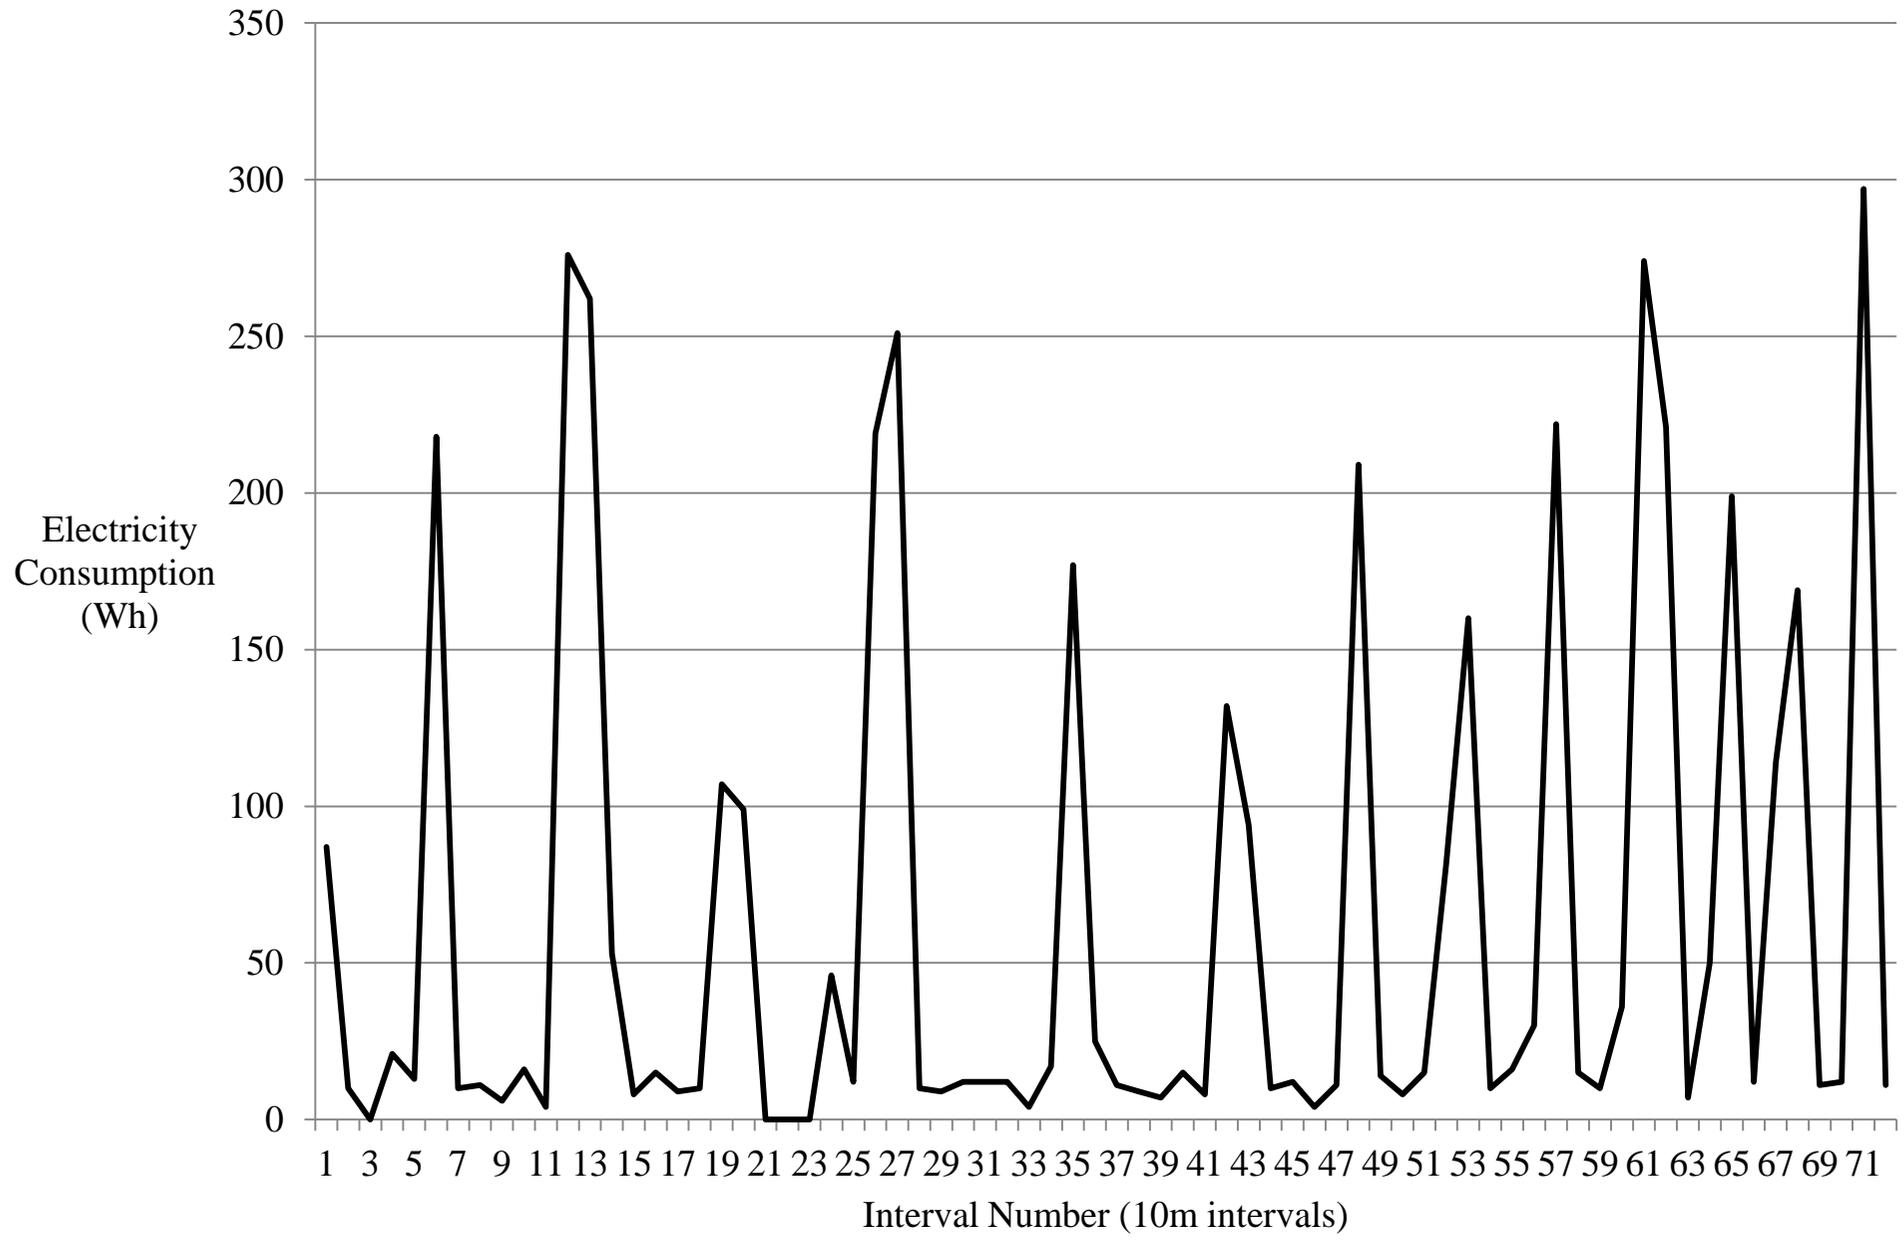
Fig. 7: Compressor cycling in System A.

The compressor cycling behaviour in system A, together with the other 9 systems is illustrated by looking closely at a 2-day period (1st- 2nd October 2010). October was chosen as a period when space heating could be expected to occur, but on the other hand demand was not so constant as to blur the distinction between on and off periods. For each system, the total heat pump electricity consumption was plotted at 10 minute intervals, and the clear peaks simply counted. Fig 7 gives an example of the type of data obtained, showing the period 12 noon – 12 midnight on 1st October for system A.

Whilst an element of human judgement exists in counting peaks in this way, it is nevertheless reasonably clear. Double peaks (i.e. where a shoulder exists on the main peak) are counted as one. It must be remembered however, that some of these peaks may be due to compressor start-up for the purpose of DHW production, and should therefore be discounted. It proved to be possible to separate the two by inspection using the data available in this study, since DHW tank temperature was monitored throughout, and so peaks coinciding with a rise in DHW temperature could be ascribed to DHW production. (DHW demand takes precedence over space-heating demand in these systems).

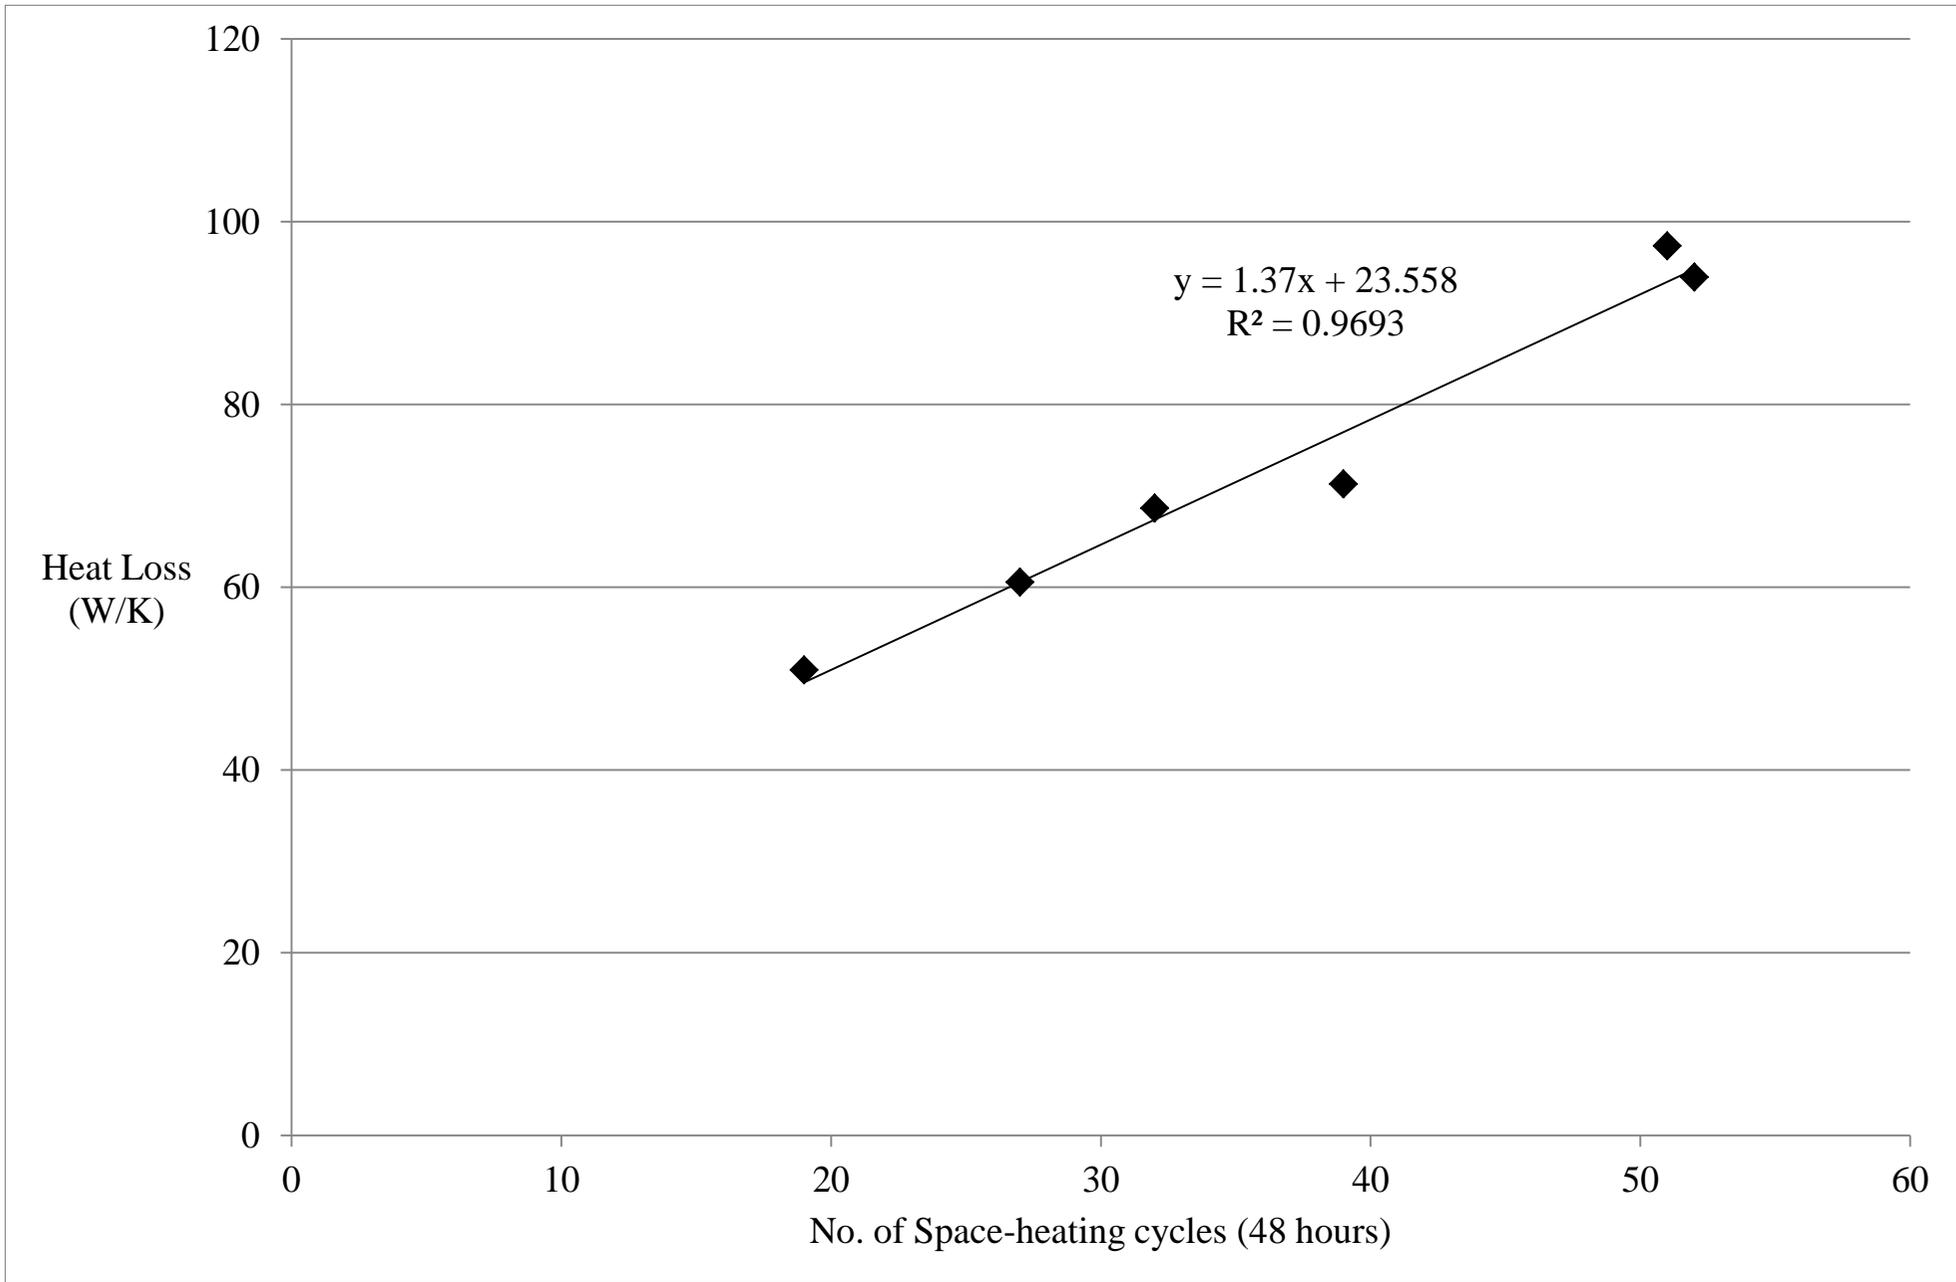
Fig. 8: Correlation of Space-heating Compressor Cycling with Estimated Daily Heat Loss rate (6 co-located systems).

Fig 8 shows a plot of the cycling attributed to space-heating vs the estimated daily heat loss rate in W/K, (average of 1st and 2nd October). The latter was calculated from space-heating heat output and temperature difference as measured by internal and external temperature sensors. This method assumes that the heat production rate of the heat pump (for space-heating) is equivalent to the heat loss rate from the building, which seems a reasonable assumption in view of the observed stability of internal temperatures. Of course it is understood that there will be other contributions to heat input to the building, such as metabolic and appliance gains, so the figures should not be taken as absolute values, but as indicative only.

Fig. 8 demonstrates that space-heating cycling rate can act as a good proxy for heat loss rate for these systems, under the conditions described. This is a potentially useful result since electricity consumption can be monitored more easily than heat output.
