Gorse, CA and Glew, D and Johnston, D and Fylan, F and Miles-Shenton, D and Smith, M and Brooke-Peat, M and Farmer, D and Stafford, A and Fletcher, M and Thomas, F (2017) Core cities Green Deal monitoring project – Leeds. Project Report. Department of Energy and Climate Change.

# Core cities Green Deal monitoring project

Prepared for the Department of Energy and Climate Change

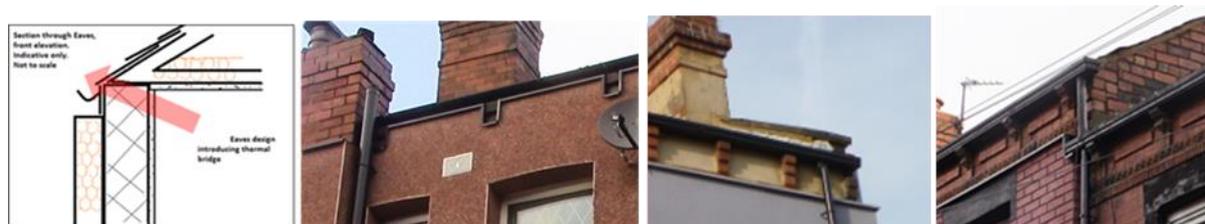
Figure 2-1 Thermal breaks introduced to top floor wall/ceiling junctions: pre-1919 terraces and back-to-backs

In terraces, adjacent properties are sometimes built at different levels so that roof lines are not continuous and party walls become external walls. Where adjacent properties were in the same ownership and both properties had EWI applied, it was found that this part gable external wall was insulated with EWI. Where adjacent properties were not in the same ownership, and were not both insulated, this wall was not insulated as seen in Figure 2-1. If this wall encloses a conditioned space internally, e.g. an attic room, which does not have IWI applied internally, it forms a thermal bridge.

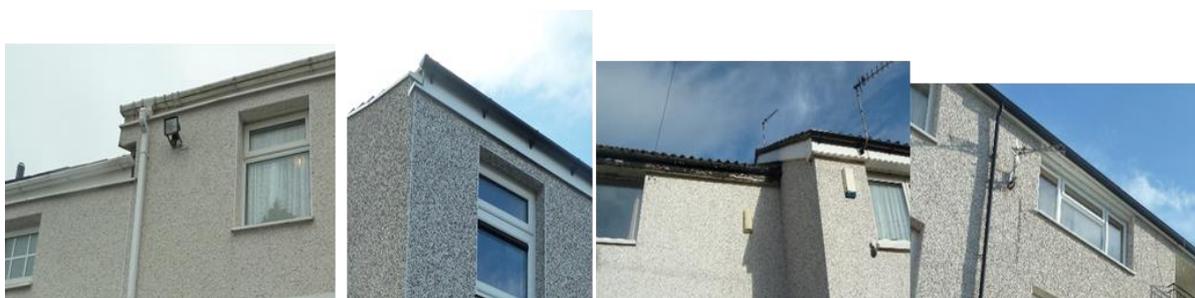
Figure 2-3 Thermal breaks introduced to top floor wall/ceiling junctions: 1945-1970s system built, including flats, terraces and semis. The roof, eaves and sometimes rainwater goods are not amended for the addition of EWI

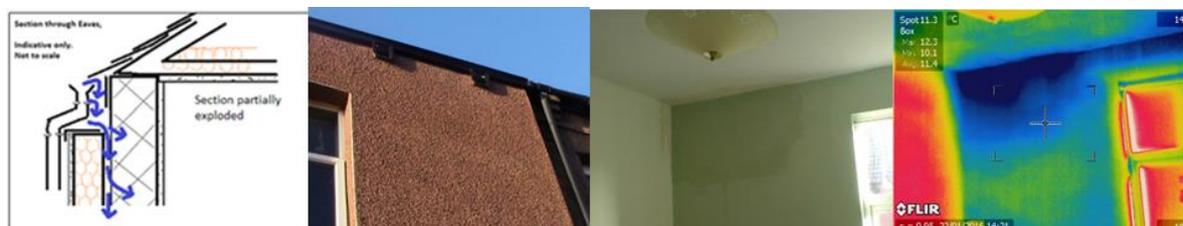
Figure 2-5 Effects of water ingress through an imperfect seal at the top of EWI

It is not unusual for rainwater goods to leak if the fixings become dislodged or blocked for any reason such as wind, build-up of debris/leaves, or even short term issues such as snow. For EWI, if seals between the top capping and the wall is ineffective, water ingress is able to seep between the insulation and original wall. See Figure 2-5 for an indication of the effect of this. The photographs show the rear to one pre-1919 terraced property where there was a leak at the gutter post-intervention and the first floor bedroom wall subsequently suffered from dampness. The flashing at eaves was repaired but the wall was continuing to dry out internally

as the new EWI and render did not permit external drying out. As a rule of thumb, drying out typically takes one month per 25mm wall thickness.

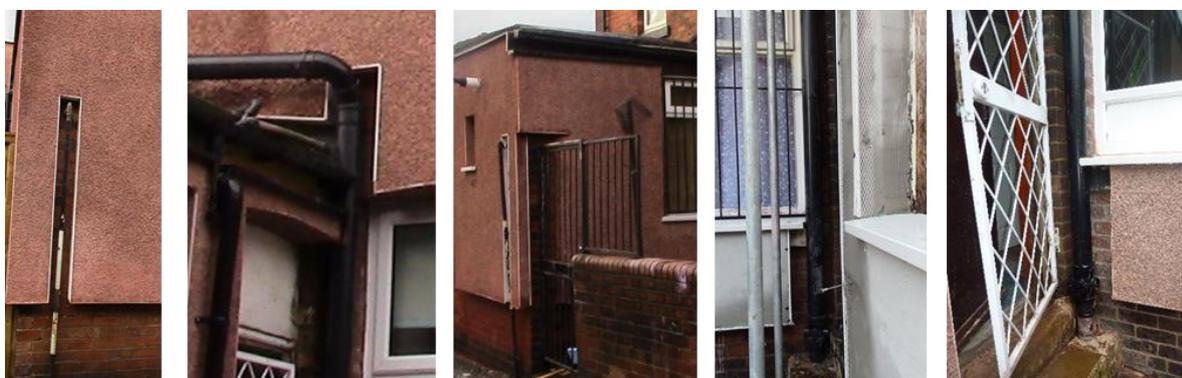
Figure 2-6 Thermal breaks at insulation cut-outs at external pipes, services, walls, doors, gates etc: these are typical for pre-1919 terraces where these services are not being amended in the EWI works

External insulation can also result in decisions to be made regarding moving rainwater and other goods and services positioned on the outside surfaces of walls. In those properties surveyed, generally the services were not moved but cut-outs were provided in the external insulation to accommodate the services. Similarly, garden walls and gates, attached to or butted up to the house wall, were not altered but the insulation cut to accommodate them. See Figure 2-6 and Figure 2-7. These cut-outs represent thermal bridges.

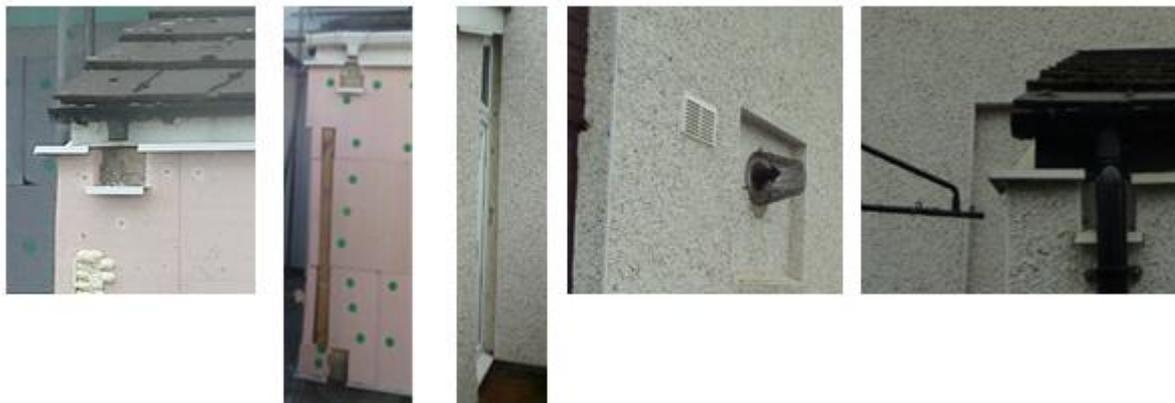
*Figure 2-7 Thermal breaks at insulation cut-outs at external pipes, services, walls, doors etc: these are typical for 1945-1970s system built properties where these services are not being amended in the EWI works*

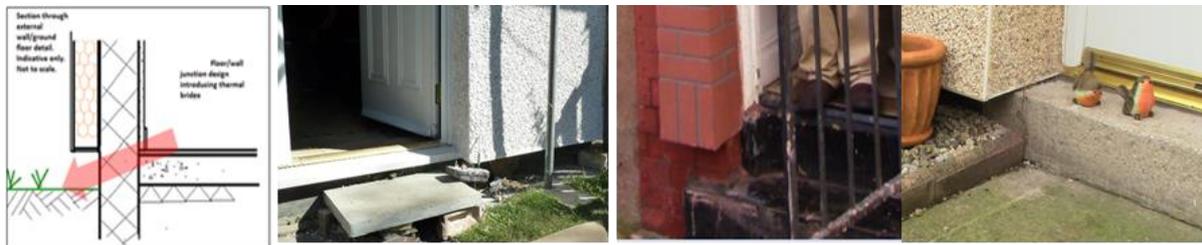
Figure 2-8 Thermal breaks introduced to ground floor/wall junctions where the EWI is stopped around 150mm above ground level. The examples show a 1970 terrace, a pre-1919 terrace and a 1950s semi

There is a requirement under Building Regulation C2 that the walls shall adequately protect the building and the people from the harmful effects of ground moisture and precipitation. A standard way of achieving this is to ensure that applied surfaces to walls, including render and insulation which have the capacity to wick up moisture, are a minimum of 150mm above ground level and do not result in a bridge across a damp proof course (dpc). Dpcs themselves are usually placed at 150mm above ground level. For many properties, the finished internal floor level is at dpc level. This essentially means that there should be a break in externally applied insulation at this point. Some schemes provide for this break incorporating the equivalent of a dpc and then insulation which will not result in rising damp, or moisture penetrating internally, or else bridging of the dpc is applied below the house wall dpc level to ensure continuity of the thermal envelope. Most schemes however do not do this, resulting in a thermal break. See Figure 2-8.

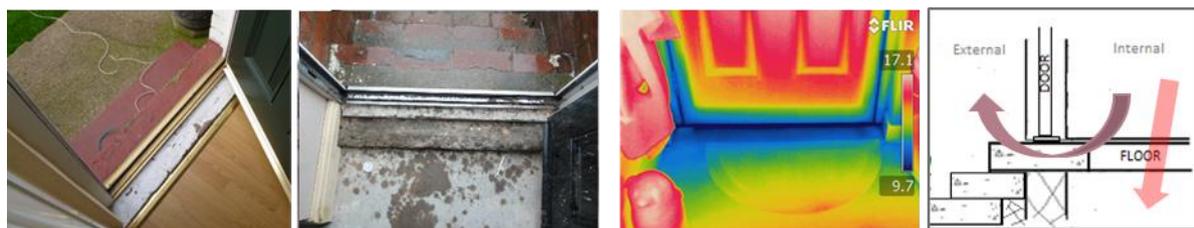
Figure 2-10 Thermal breaks due to lack of insulation to ground floor and single slab door thresholds. These thresholds are found at suspended timber or solid concrete ground level floors

Where a lack of floor insulation is coupled with a thermal break at ground floor/wall junction as described above, the issue might be exacerbated.

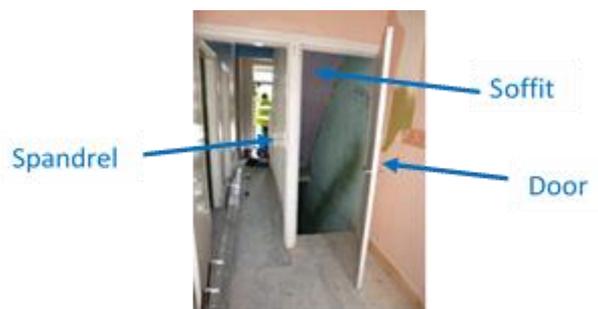
Figure 2-11 Interfaces between the unheated basement and heated ground floor which need to be insulated

These doors, spandrels and soffits form the interface between the unheated, uninsulated basement and the heated, insulated ground floor areas. Without the provision of insulation to these, there is a large thermal bridge between the unheated basement and the ground floor living area.

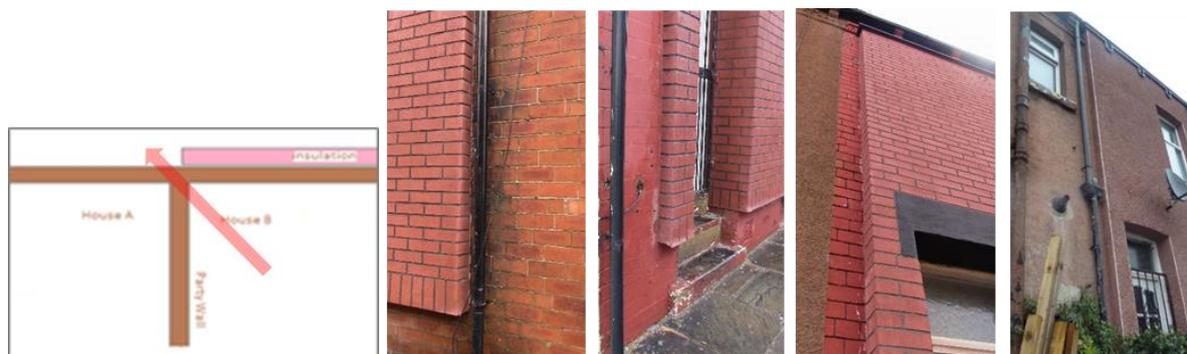
Figure 2-12 Thermal break at party wall/external wall junctions between differently owned terraced properties

For EWI, adjacent properties may not be in the same ownership. The external wall insulation cannot therefore be applied onto the neighbouring property without incurring trespass, party wall issues, etc. To avoid conflicts arising the EWI needs to be kept away from the centre-line of the party wall. This generally results in a thermal break at this area, see Figure 2-12.

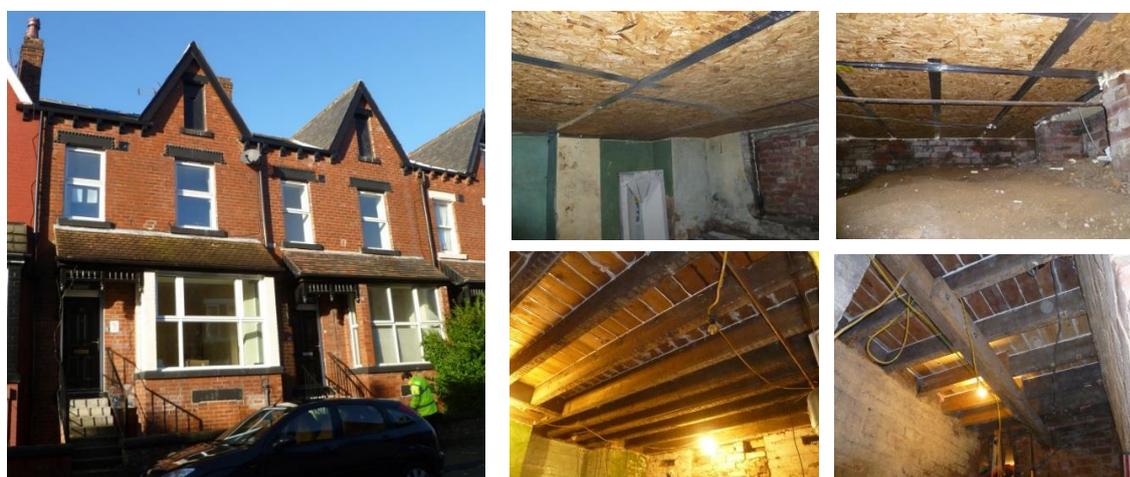
*Figure 3-3 Dwellings I-02 & I-03, and the different treatment of the suspended timber ground floor, views from the cellar; top – contractor retrofit, bottom – local housing charity retrofit prior to insulation installation*

2 dwellings varied considerably. The sub-contractors refurbishing I-02 were highly conscious of time and labour costs, so utilised solutions which minimised these; for the local housing charity refurbishing I-03 the main concern was material costs and developed alternative solutions accordingly. Figure 3-3 illustrates these alternative approaches to the same detail, the suspended timber ground floor above the cellar. The contractors fitted insulation to the floor and a new airtight cellar ceiling, the local housing charity removed the existing cellar ceiling and sealed around the floorboards and joists before installing the floor insulation. The result was that the local housing charity virtually eliminated infiltration through the ground floor and attained a final air permeability result below  $5 \text{ m}^3/(\text{h.m}^2) @ 50\text{Pa}$ , the sub-contractor retrofit left infiltration paths through ground floor around the joists into the “solid” walls and an air permeability of over  $12 \text{ m}^3/(\text{h.m}^2) @ 50\text{Pa}$ .

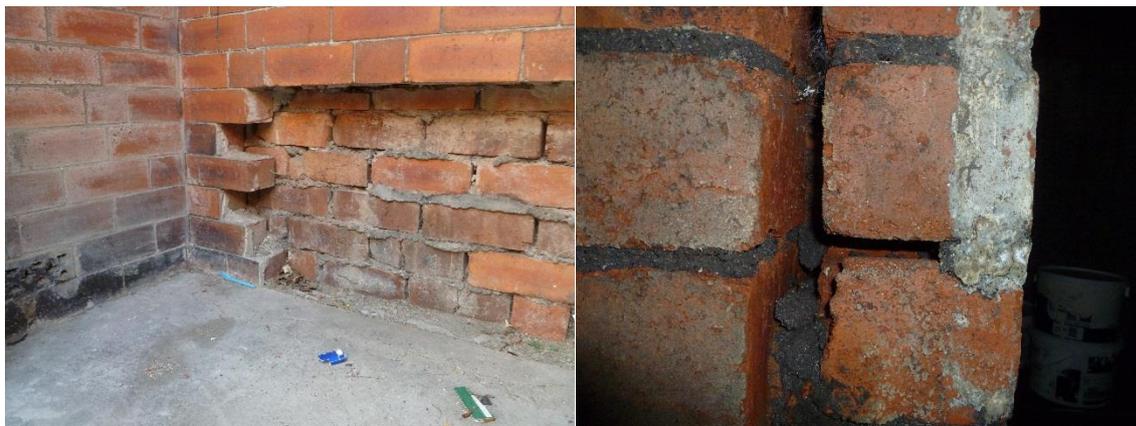
*Figure 3-5 The difference in quality of brickwork between inner and outer leaf of a solid wall and the finger cavity between the them*

In a number of solid-walled dwellings investigated the internal wet-plaster finish was removed due to its poor condition, and a new internal wall lining of either plasterboard or insulated plasterboard was applied using dabs of adhesive to fix the new boards to the un-finished masonry wall. Figure 3-5 shows how the “inner leaf” of a solid wall can allow air exchange between the “finger cavity” of the solid wall and the dwelling interior through unfilled perpend and bedding layers between the bricks. The old internal plaster finish provided an effective air barrier, removing this (as in Figure 3-6) creates additional air leakage paths that were not present prior to refurbishment. Figure 3-7 illustrates these new post-retrofit air leakage paths, with air entering from the solid wall finger-cavity through gaps in the inner leaf and travelling around the plasterboard adhesive dabs behind the plasterboard on the internal wall.

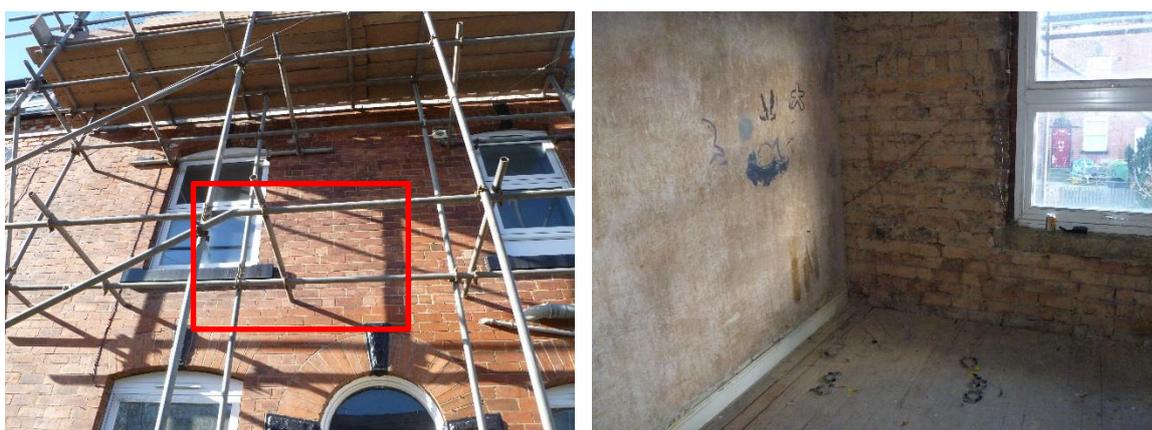
*Figure 3-6 Dwelling C-02 prior to application of IWI insulated plasterboard on the external wall and plasterboard on the internal wall.*

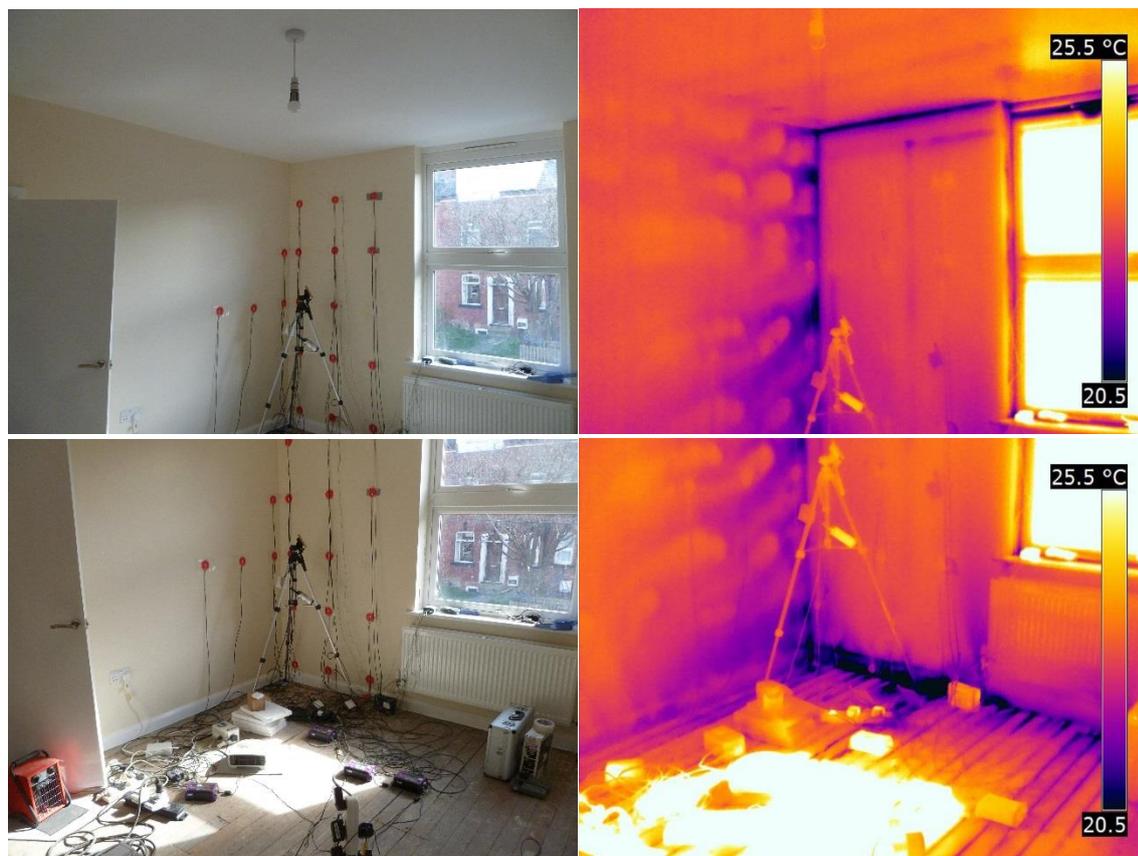
Figure 3-7 Dwelling C-02 under depressurisation following refurbishment.

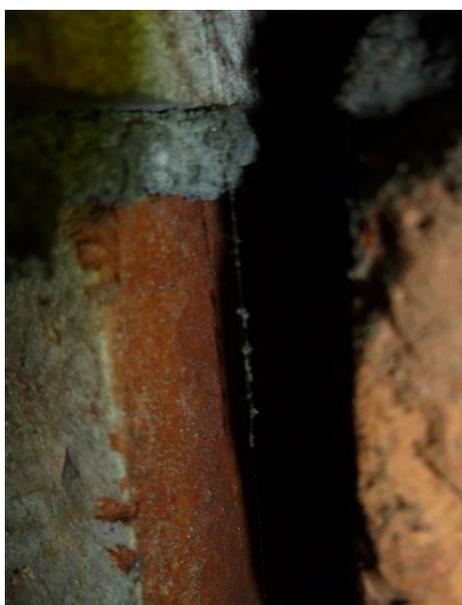
Figure 5-3 Cavity in Solid Brickwork External Wall

Inspections of the solid brickwork external walls at the properties under assessment have revealed that the volume between the two masonry leaves tied together with headers is not completely filled with mortar. The cavity shown in Figure 5-3 is largely composed of air with a fraction of brick headers and mortar. Thermal modelling was undertaken to assess the effect of a notional air cavity on the  $\Psi$ -value and  $f_{RSI}$  of each junction design. An equivalent thermal conductivity ( $\lambda_{eq}$ ) was calculated for the air cavities. The heat flow in the cavities in the ground floor, party wall and partition junctions was deemed to be predominately horizontal permitting a single  $\lambda_{eq}$  to be calculated for the air cavity layer in these thermal models. Based on the bonding of the masonry shown in Figure 5-4, a brick header fraction of 0.054 and an air fraction of 0.946 were calculated using measurements obtained on site. A  $\lambda_{eq}$  for the air layer was calculated as 0.105 W/m·K using Equation 3 by inputting a  $\lambda$  of 0.067 W/m·K for the air (BSI, 2007) and a  $\lambda$  of 0.770 for the brick headers (Anderson, 2006). The  $\lambda_{eq}$  of the mortar filled cavity layer was calculated as 0.931 W/m·K using the same fractions but the  $\lambda$  of air was exchanged for the  $\lambda$  of mortar. The quantity of mortar in the air cavity could not be determined and as a result in the calculation was simplified to exclude the effect of the mortar droppings.

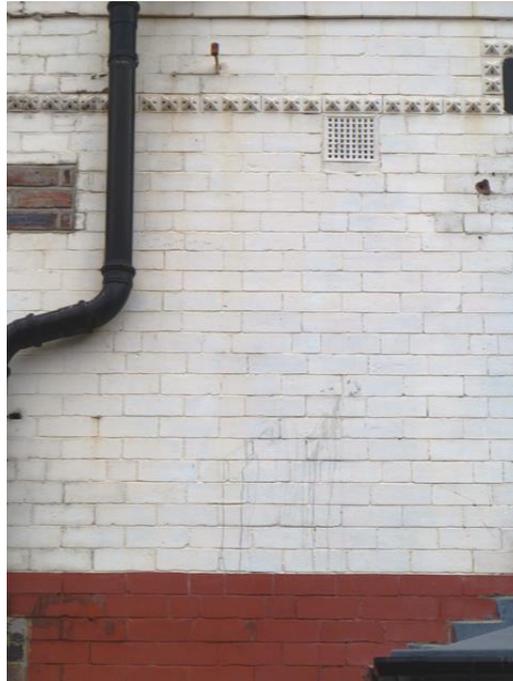
Figure 5-4 Brickwork Bonding
