Nadir, HM (2024) Evaluation of Water Quality and Scarcity Issues for Sustainable Water Management Strategy in Twin Cities of Rawalpindi/ Islamabad, Pakistan. International Journal of Environment and Geoinformatics, 11 (3). pp. 76-89. ISSN 2148-9173 DOI: <https://doi.org/10.30897/ijegeo.1487205>

Evaluation of Water Quality and Scarcity Issues for Sustainable Water Management Strategy in Twin Cities of Rawalpindi/ Islamabad, Pakistan

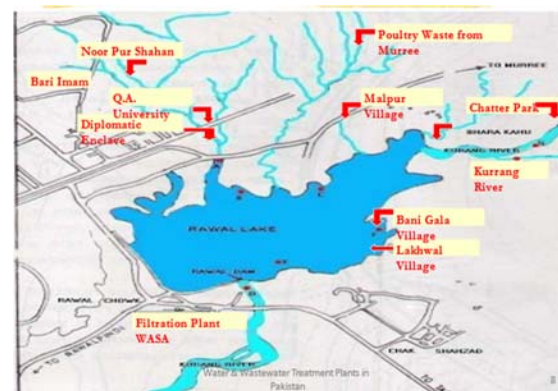
Fig. 1: Catchment area of Rawal Lake reservoir (Ali, 2014).

Salkar, 2015; Nadir and Ahmed, 2023). In this paper, the Rawal Lake reservoir in Pakistan (A South Asian developing country) has been considered as a case study by analysing the physical/ chemical/ biological factors of water quality parameters and supply/ demand gaps to elucidate the water security/ scarcity in the capital/ twin cities of Islamabad/ Rawalpindi. Rawal Lake is an artificial water reservoir of 8.8 km² constructed in the foothills of Margalla National Park on the outskirts of Islamabad (the capital of Pakistan) in the 1960s. Its primary objective is to store and supply water to the twin cities of Rawalpindi and Islamabad as drinking water. Water and Sanitation Authority (WASA) Rawalpindi and Capital Development Authority (CDA) Islamabad are the managing authorities (Daud *et al.*, 2017; Docslib, 2023; WASA,2022; Qureshi, 2023). The main feeding water stream is Kurang River, along with 3 other big and 43 small streams from Murre Hills and the local areas, as shown in Figure 1 (Ali, 2014).

American Public Health Association (APHA, 1985) in line with the methods/ procedures adopted by other organisations/ researchers (Ahad *et al.*, 2005; Kodarkar, 1992; Mitra and Gupta, 1999; Patel and Poll, 2003; Prajapati, 2004; Zhang *et al.*, 2006; Mahreen and Sana, 2014) to make the water drinkable as per World Health Organization (WHO) standards (WHO, 2023). All the samples were collected in the first week of April 2022 and July 2022 to compare the regular water inflow during spring and excessive surface runoff during monsoon season. Data regarding the demand/ supply of water from Rawal dam, Khan Pur dam and Simply dam, supply of water from the tube wells extraction/ pumping of water to Rawalpindi city/ cantonment areas and depletion of groundwater/ lowering of water table statistics were obtained from WASA Rawalpindi (WASA, 2022) and Military Engineering Services Rawalpindi (MES, 2022) for analysing water scarcity issues. The area is located in the foothill of Margalla in the suburbs of the capital city of Islamabad (Figure 1) (Ali, 2014). The main feeding water stream is Kurang River from the East, with 46 small streams coming from Nur Pur Shahan, Burray Imam, Quaid-e-Azam (QA) University/ diplomatic enclave in the West/North West, Murre Hills in the North, Chatat Park and Mulpur in North East, Bani Gala and Lakwal in the East. The Lake's excess water is spilt out to the south in the Kurang River again. In this study, raw water samples were collected from Korrang River, Burry Imam, and Rawal Lake Reservoir, and treated water samples were collected from the Rawal Lake water treatment plant (RLWTP) to compare the water quality before/ after the treatment, as shown in the catchment area map in Figure 1 (Ali, 2014).

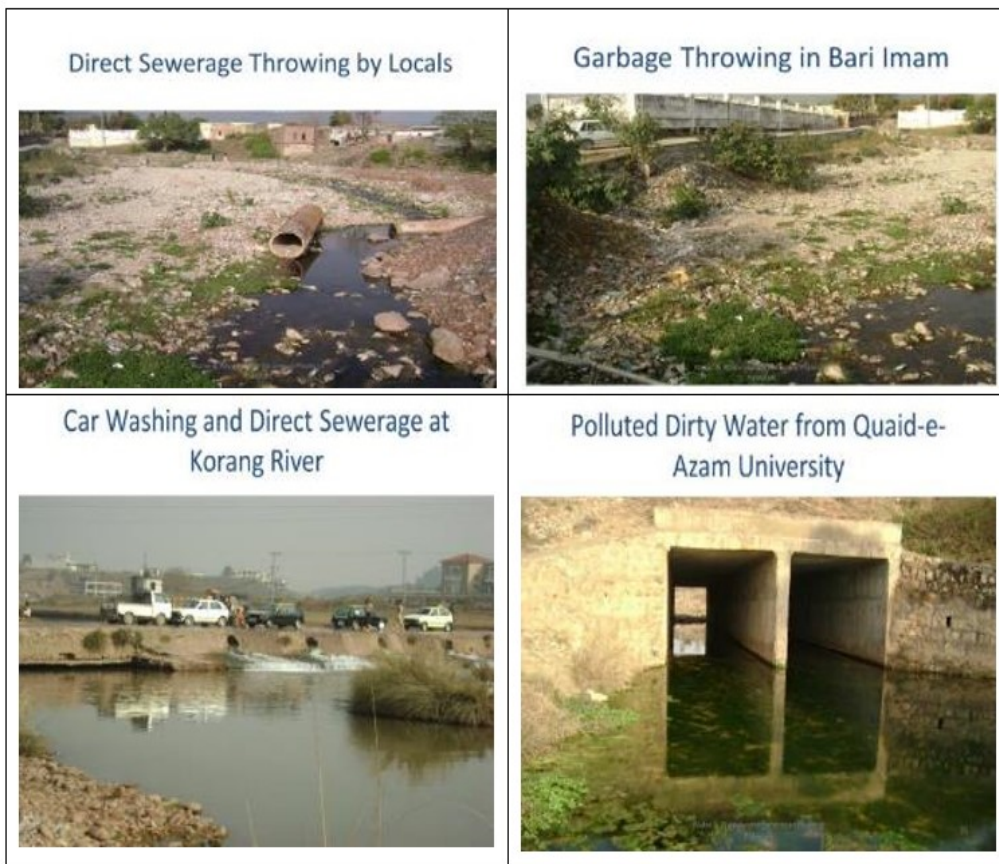
Fig. 4: Contamination sources in the water streams feeding the Rawal Lake (Ali, 2014).

All the impurities, sediments/ metals, faecal coliform and reduced dissolved oxygen show the substandard quality of water and uncontrolled behaviour of people living in the catchment area which throw garbage, mix sewerage and uncontrolled use of chemicals by farmers/ industries. This situation indicates poor implementation of drinking water regulations specified by the WHO/ UNESCO/ Pakistan government, bad catchment management, the absence of proper sewerage treatment plants prior to final discharge of wastewater into water streams, uncontrolled/ unhygienic disposal of solid waste and poor water resource management by related authorities. Surface water quality is essential as it affects human health and well-being of aquatic life. Anthropogenic influences and natural processes deteriorate surface water and blight its use for drinking, industrial, agricultural, recreational or other purposes. Different sources of pollution in the streams are shown in Figure 4 (Ali, 2014).

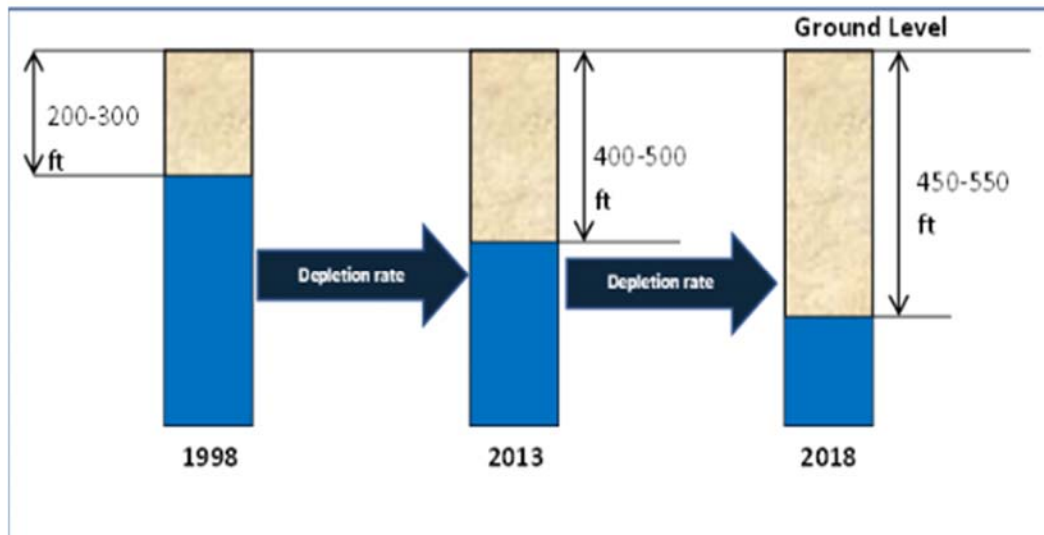
Fig. 6: Groundwater levels and drawdown situation in Rawalpindi/ Islamabad 1998-2018 (Mehreen and Sana, 2014; MES, 2022).

in Figure 6 (Mehreen and Sana, 2014). Therefore, proper monitoring/ management of tube wells boring to a specific limit should be implemented to avoid an accelerated pace of drawdown. Moreover, cleaning/ maintenance/ dredging of reservoirs/ feeding channels to regulate their intended capacity/ discharge for a long-term life should be ensured. Military Engineering Services Pakistan (2022) studied overall water scarcity/ quantity issues in the twin cities of Rawalpindi/ Islamabad. It observed that in 1951, it had

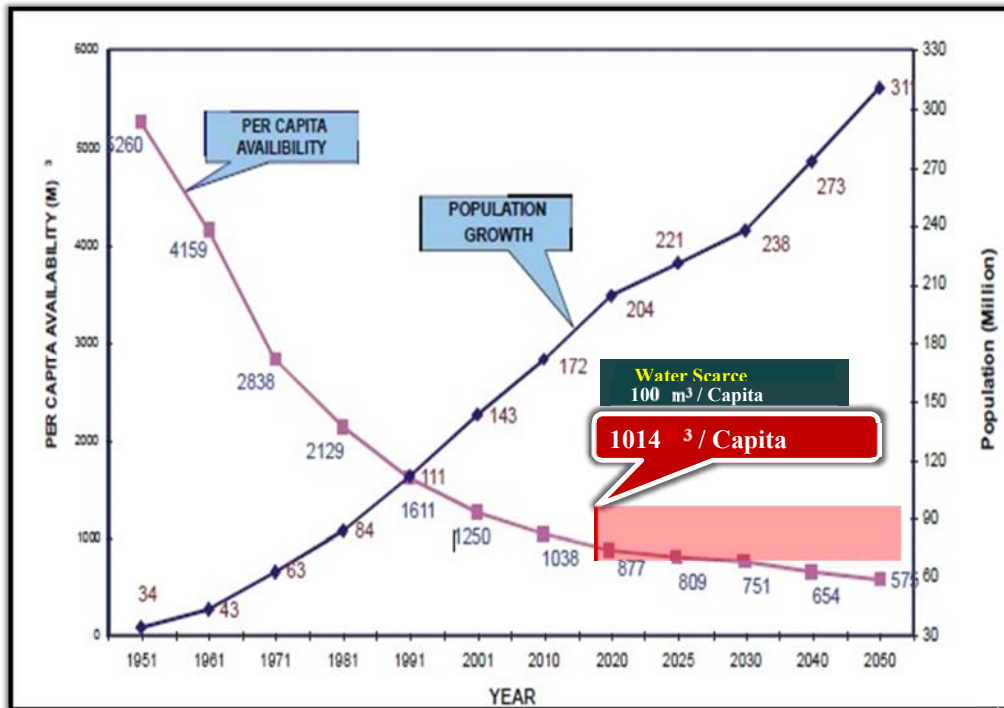
Fig. 7: Per capita annual demand and water scarcity statistics – Pakistan (MES, 2022).

excess water with 5260 m³/ person/ annum, which has reduced to 1014 m³/ person/ annum in 2018 (water scarcity level) and is projected to reach a dangerous drought level of 575 m³/ person/ annum in 2050 as shown in Figure 7a (MES, 2022). Rawalpindi and Islamabad will likely face a shortfall of 661 MGD projected in 2050 as per a depletion rate of 2% and an increase in population if the situation remains the same, as shown in Figure 7b (MES, 2022).

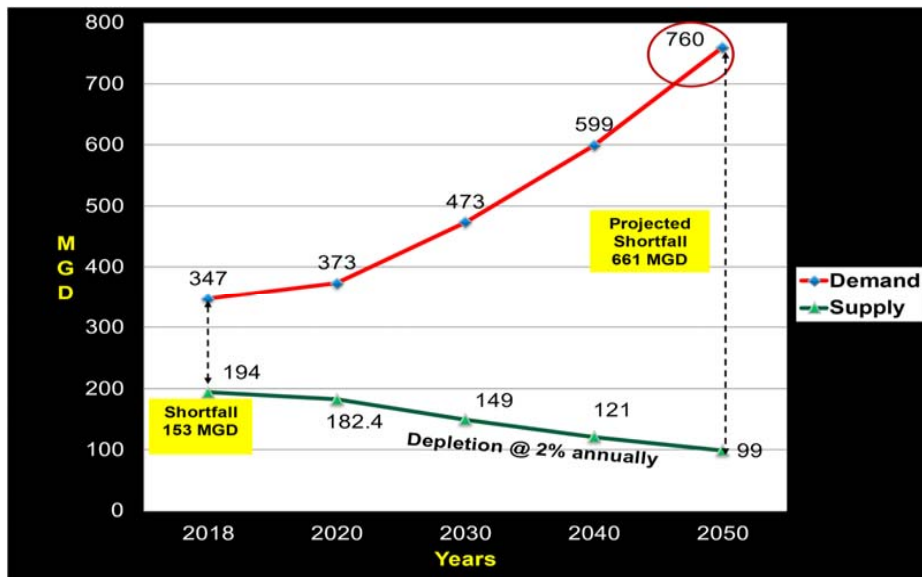
Fig. 8: Future water scarcity/ projected demand - Rawalpindi/Islamabad (MES, 2022).

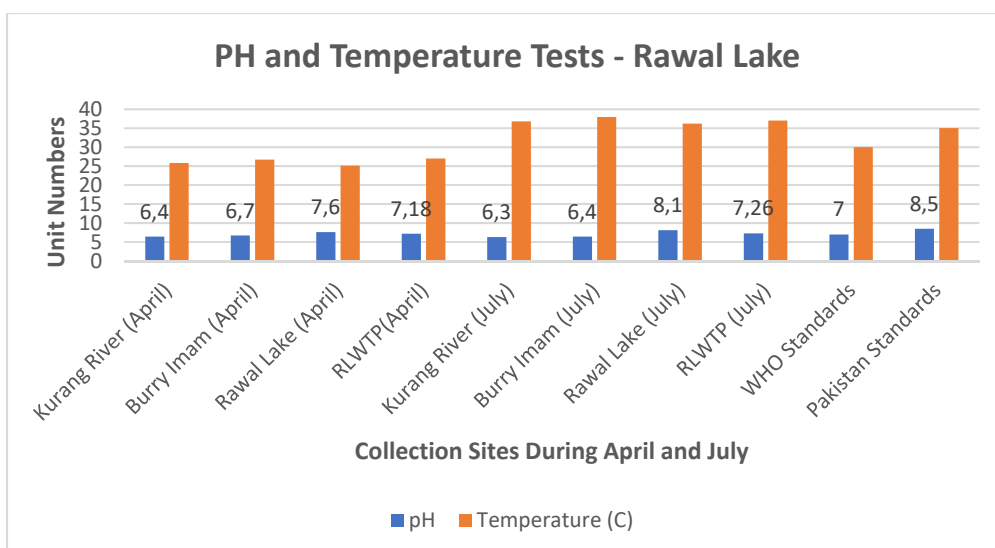
Fig. 9: PH and temperature test results - Rawal Lake

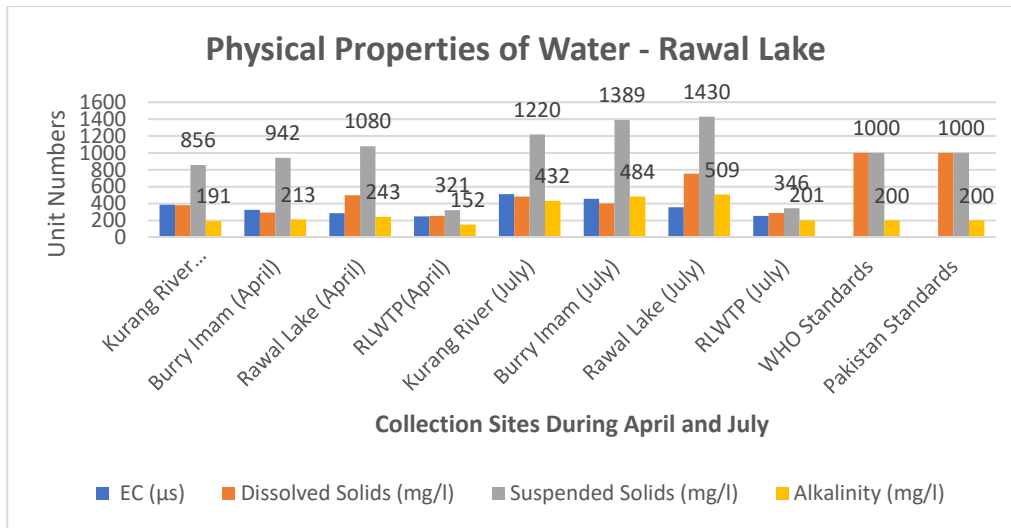
Fig. 10: Physical properties parameters - Rawal Lake

Dissolved and suspended solids exceeded the upper. Test values of water samples collected in July 2022 exceeded the water standards/ limits due to heavy rains/ surface runoff and washing off of clay, soil, garbage and pollutants from water streams into the reservoir, which caused more turbidity and impacted watercolour. The suspended solids reduce dissolved oxygen levels, which is very dangerous for aqua life, especially in Monsoon months. Dissolved oxygen

(DO) was found to be lesser than the dead level range of 5 mg/l attributed to the mixing of sewerage, the presence of contaminants, and the growth of algae/ coliform bacteria, thus causing the death of Fish/ micro-organisms in the reservoir commonly seen in July - August every year in Rawal Lake as shown in Figure 11 (Sana, 2017). Alkalinity was found to be more than the limit of 200 (Table 1).

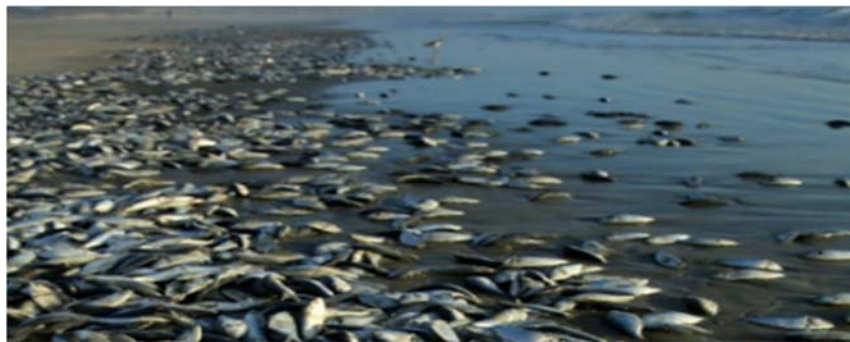
Fig. 11: Dead Fish In Rawal Lake due to contamination/ decreased DO in July 2017 (Sana, 2017).

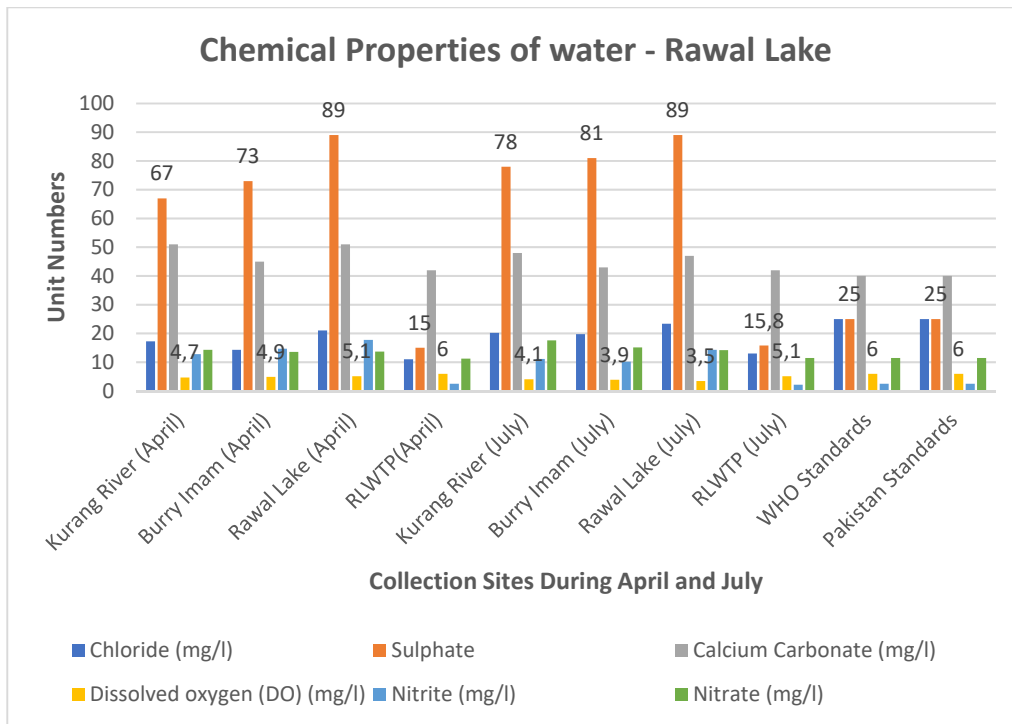
Fig. 12: Comparison of chemical properties of water - Rawal Lake

Table 1 shows the results of chemical testing parameters. Chloride and Sulphate were found within the permissible limit. Calcium carbonate almost exceeded the standard limit of 40 mg/l. Nitrite and Nitrates exceeded the limits and elucidated uncontrolled use of chemical fertilisers in the catchment farmlands and mixing of untreated wastewater. Heavy metals, especially Cadmium, Nickel, Lead, Zinc and Copper were observed dangerously high, which can cause fatal diseases like cancer. Table 1 illustrates that faecal coliform bacteria was in alarmingly high numbers, elucidating the disposal of untreated human/animal waste and the sewage mixing in the Lake. However, testing treated water samples for detecting chemicals, heavy metals, and bacteria collected from the Rawal Lake water treatment plant (RLWTP) demonstrated satisfactory/within-the-range results except for lead particles ($Pb \geq 0.41 \text{ mg/l}$), exhibiting efficient water treatment at

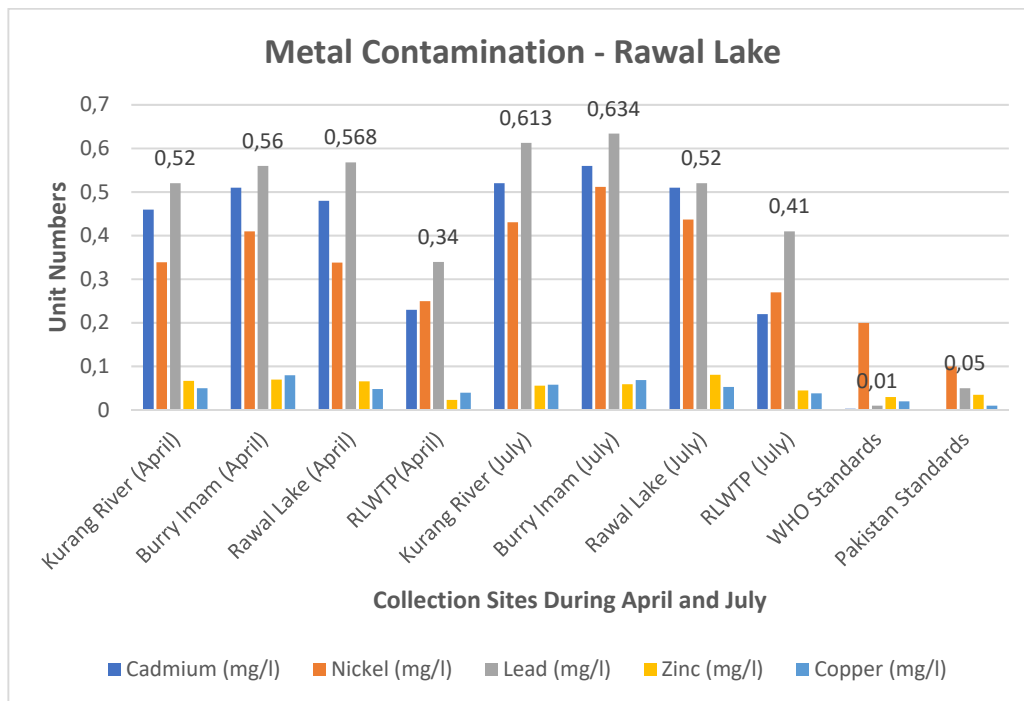
Fig. 13: Metal contamination parameters - Rawal Lake

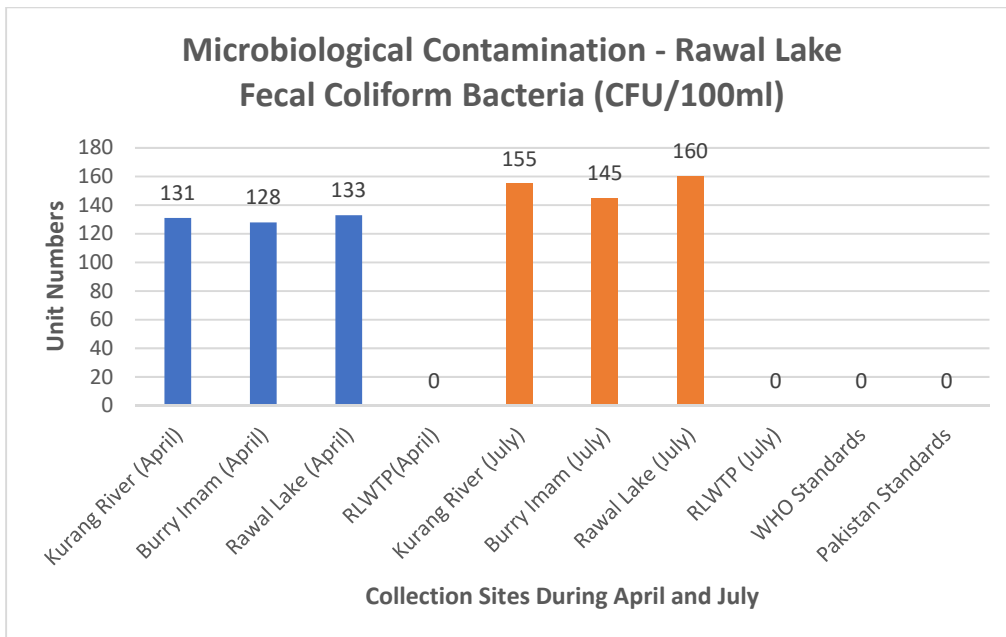
Fig. 14: Microbiological contamination - Rawal Lake
