External walls partially filled with insulation, and the potential to “top-up” the residual cavity.

Literature Review

November 2015

Dominic Miles-Shenton, Chris Gorse and Felix Thomas

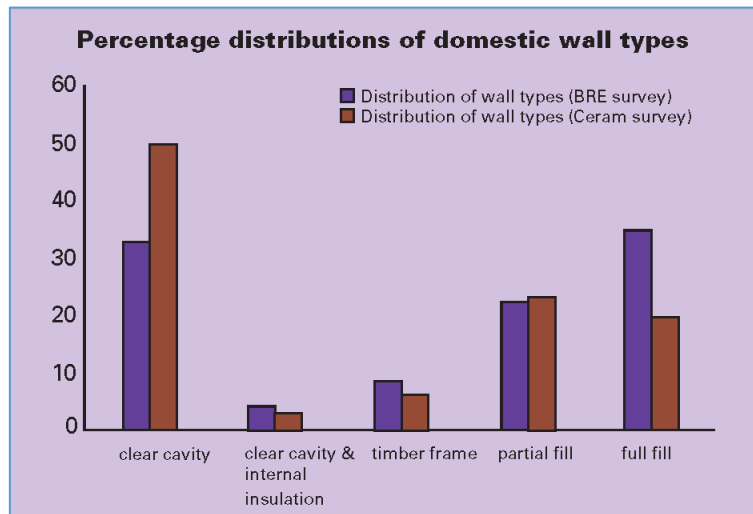
Figure 2 UK wall types distribution (Little, 2014)

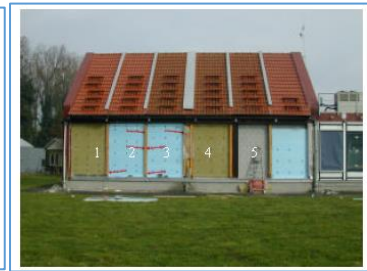
Figure 11 Partially filled test walls displaying lower than expected R-values compared to fully filled test walls (Hens et al., 2006)

Height Cm	Wall 1 S, full fil	Wall 2 S, part. fill	Wall 3 S, part. fill	Wall 4 S, full fill	Wall 5 E, full fill
Calculated	2.90	3.05	3.05	2.90	2.90
Measured					
230 cm	3.19	2.82	2.04	3.19	2.88
160 cm	3.34	2.66	2.67	2.86	3.29
30 cm	2.26	1.61	1.55	2.14	1.68
Weighted average	2.99	2.38	2.20	2.72	2.72
Loss in %	-	22	28	6	6

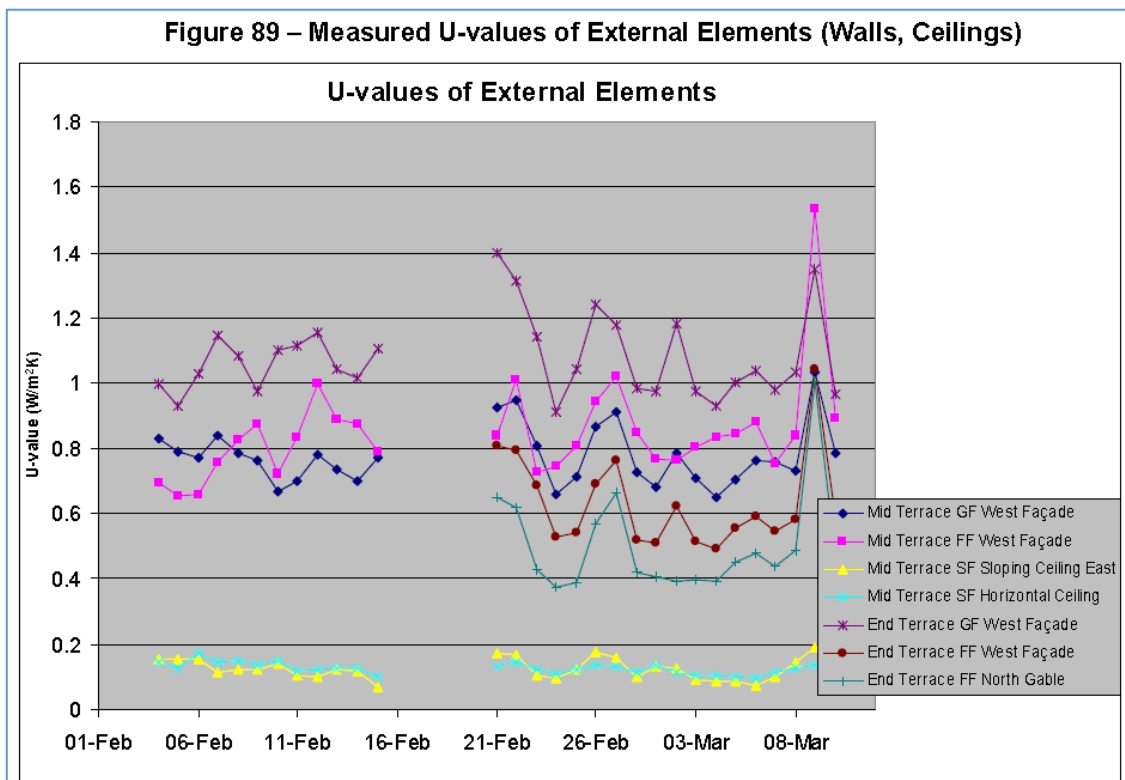
Figure 12 External wall in-situ U-value measurements from Wingfield et al., 2009

In Wingfield *et al.* (2009) the partially-filled external cavity walls were measured during the course of coheating test undertaken to assess the performance of a cavity party wall pre- and post-filling for a project funded by Eurisol. This study showed a range in external wall U-values throughout the period of investigation (Figure 12) that were greater than anticipated. The external walls failed to achieve the design value of 0.29 W/m²K during the test (Figure 13). Only the gable wall of the end-terrace property tested displayed an average daily mean in-situ U-value that was less than double that of the design, it was suggested that this may be due to it being a large expanse of uninterrupted wall (without openings) making it easier to build. The report also measured air velocity in the external wall cavities and suggested a simplified link between measured U-value and wind speed (Figure 14) suggesting some type of wind-washing of the external walls; however, wind direction was not examined. Some deconstruction of the test houses was allowed. This revealed issues with the partial fill rigid board insulation (Figure 15) which is expounded upon in some detail in the report, and further illustrated with images from other Leeds Beckett University (formally Leeds Metropolitan University) publications.

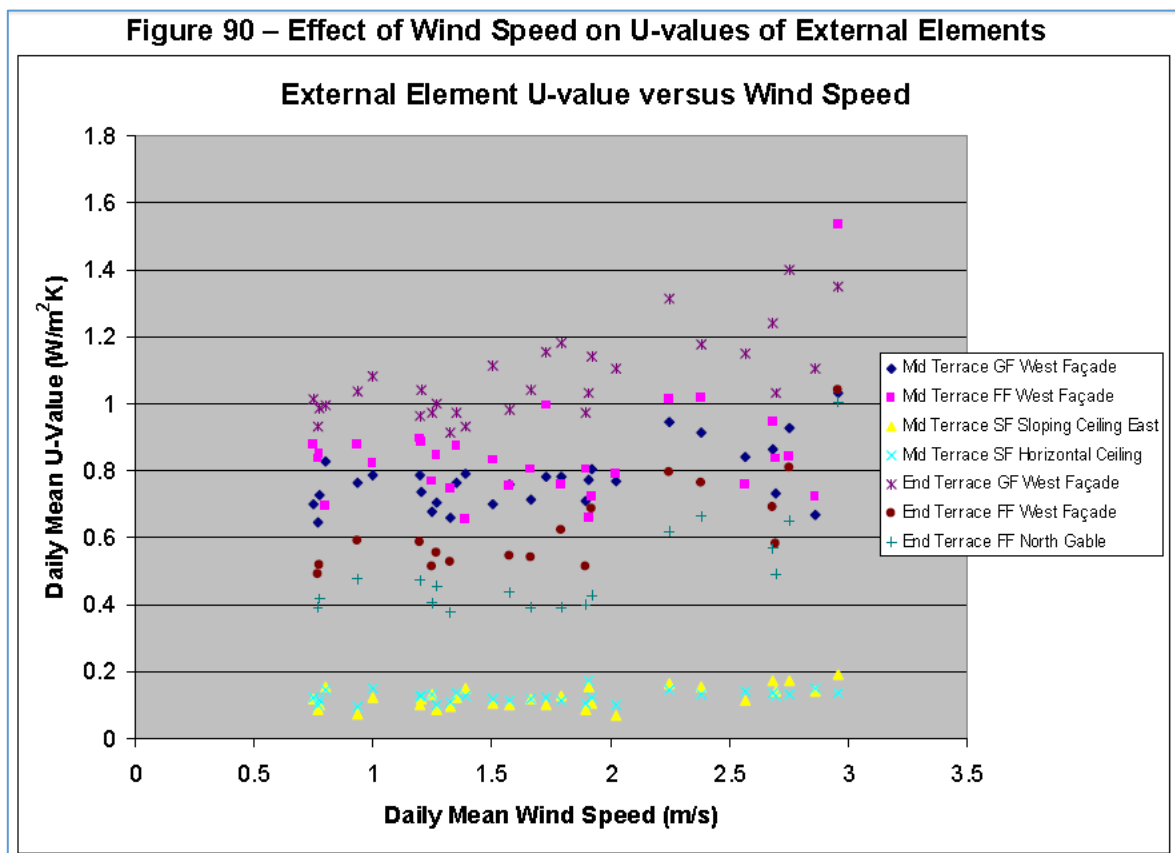
Figure 14 Effect of wind speed on the external wall in-situ U-value measurements, from Wingfield et al., 2009

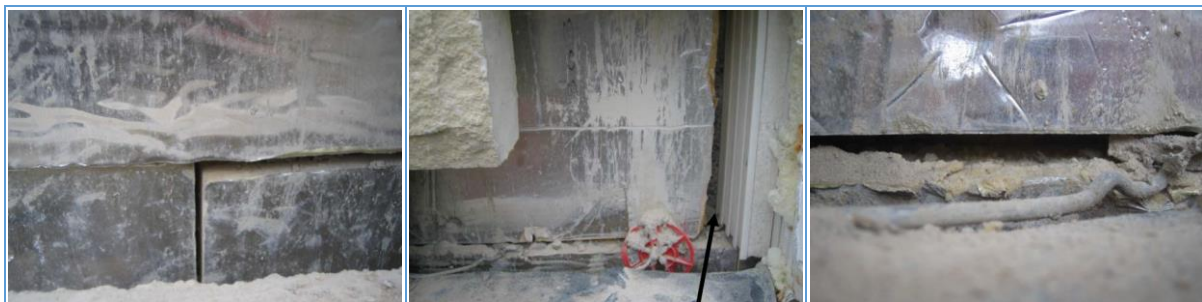
Figure 15 Deconstruction allowing gaps to be seen in the partial-fill insulation, from Wingfield et al., 2009.

Other common examples of gaps around partial-fill insulation boards, as shown in Figure 23 and Figure 24, would prove simpler to quantify the benefits of ‘topping-up’ the residual cavity; where the gaps between the insulation boards and the inner leaf are minimal but areas of the inner leaf are directly exposed to the external wall cavity. In cases such as these, topping up the residual cavity with insulation would have maximum effect. Examples of this type were detected and reported on in Wingfield *et al.* (2009), where the external walls displayed daily mean in-situ U-value of more than double the theoretically obtained design values (Figure 12, Figure 13 and Figure 15).

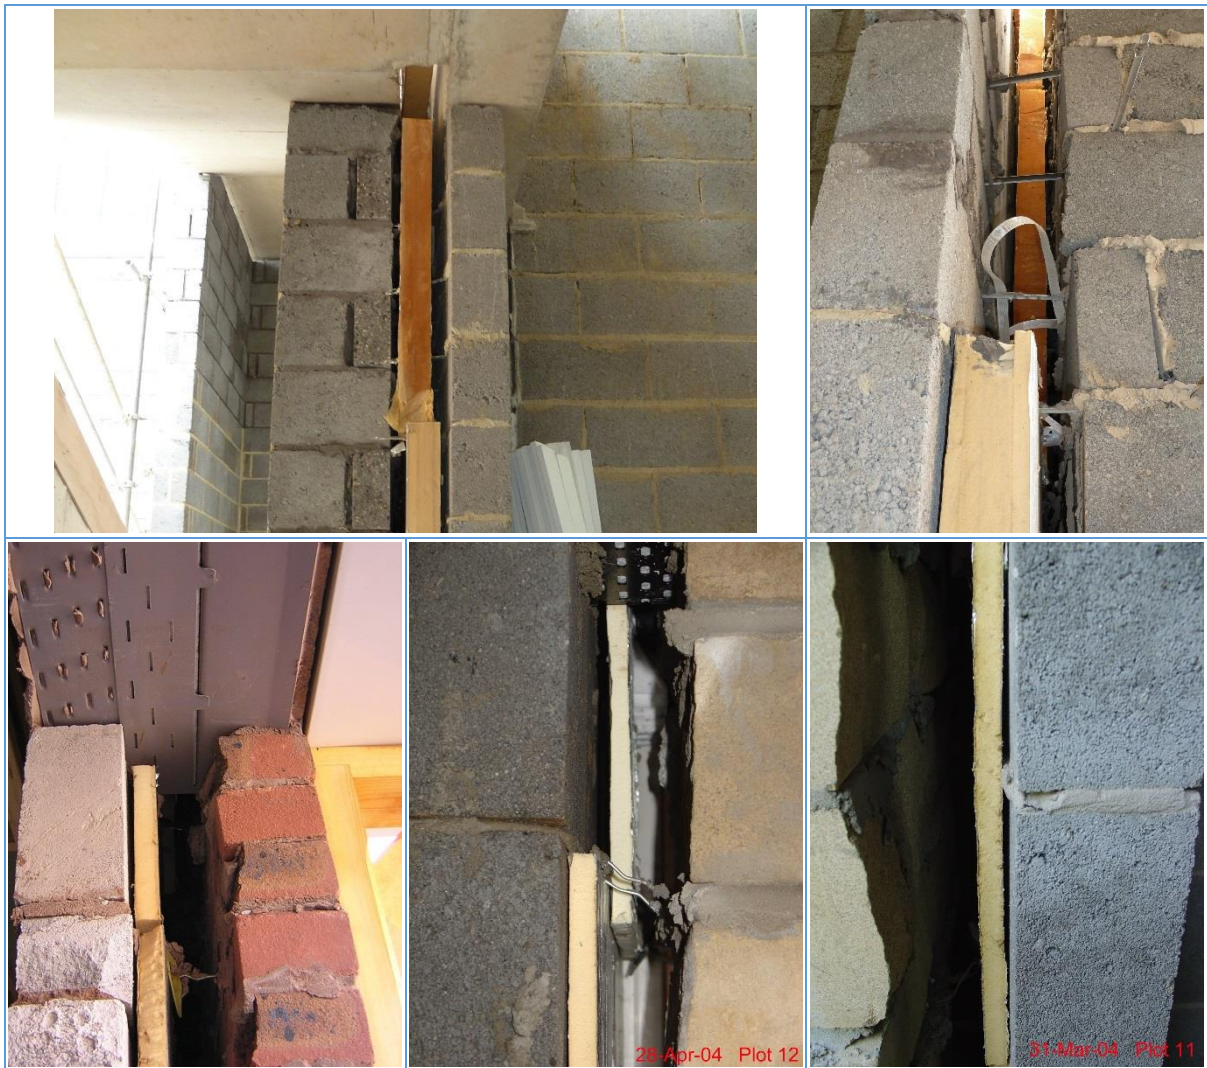
Figure 21 Partial-fill boards are not positioned flush with the inner leaf blockwork

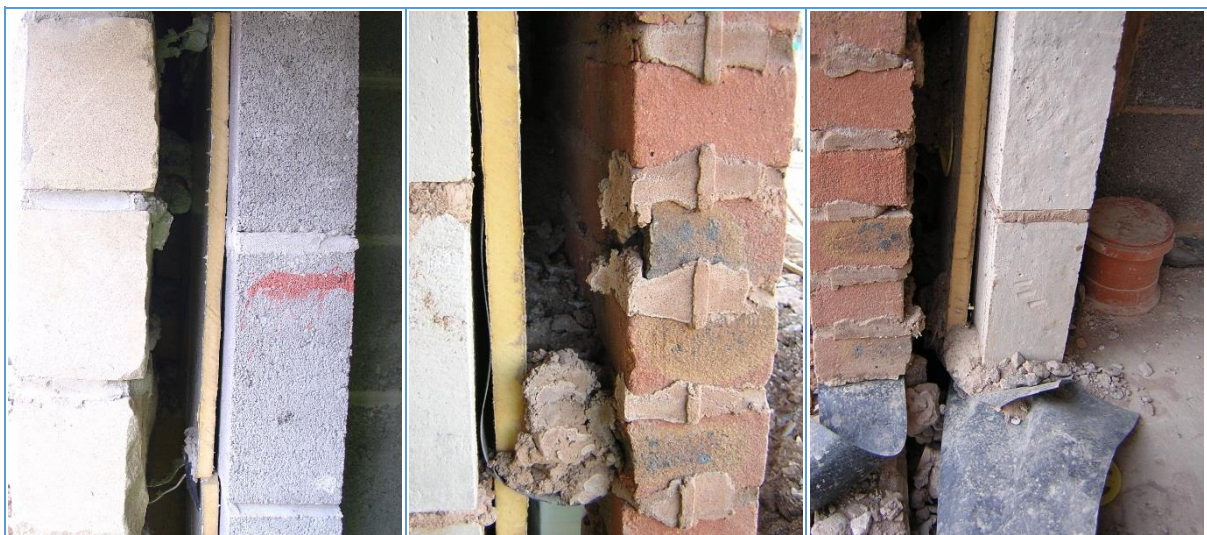
Figure 22 Partial-fill insulation affected by mortar snots

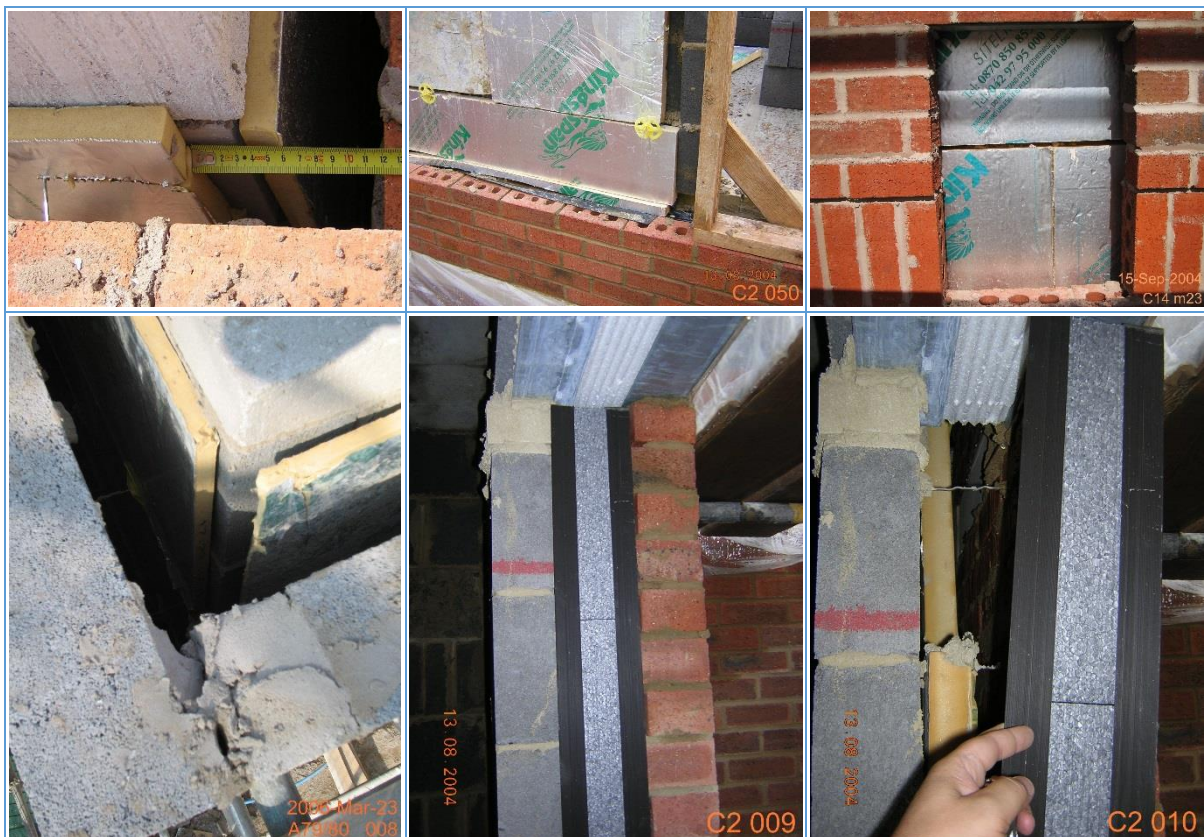
Figure 23 Gaps between and around partial-fill insulation boards

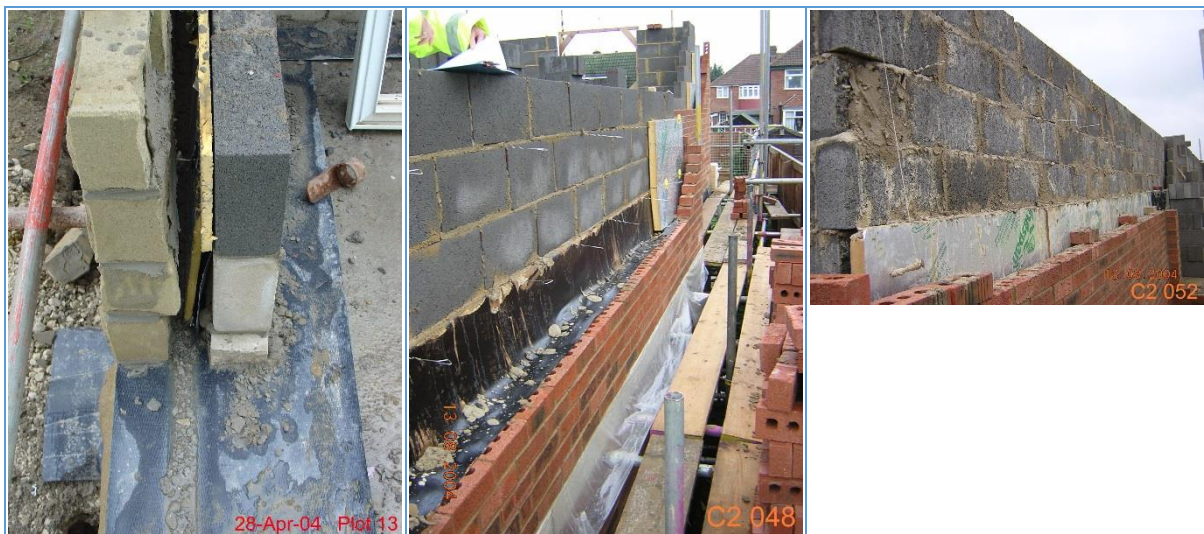
Figure 25 Issues with partial-fill insulation around cavity trays

Figure 25, Figure 26 and Figure 27 show other commonly seen issues with partially-filled external walls where ‘topping-up’ the residual cavity by injecting insulation through the external leaf might not prove to be as successful as desired. Figure 25 shows a common issue with the installation of any insulation, not just partial-fill, where cavity trays prevent the insulation achieving good contact with the inner leaf, filling the residual cavity from the outside will reinforce thermal resistance on the cold side of the existing insulation, but would not solve the issue of air gaps on the warm side. Figure 26 shows another common issue with partial-fill, where the first course of insulation boards or batts only starts at dpc level or sits neatly on the first row of wall ties, rather than extending the prerequisite distance below floor insulation level. In the first case shown in Figure 26 ‘topping-up’ would not address this problem due to the cavity tray closing off the external cavity below floor level; however, for the other two examples filling the residual cavity would also fill the uninsulated cavity below floor level and provide additional thermal resistance around the ground floor perimeter that is missing from the original construction. Figure 27 introduces further issues around cavity tray, those at lintels where insulation is often inadequate and may present problems for ‘topping-up’ close to the eaves junctions.

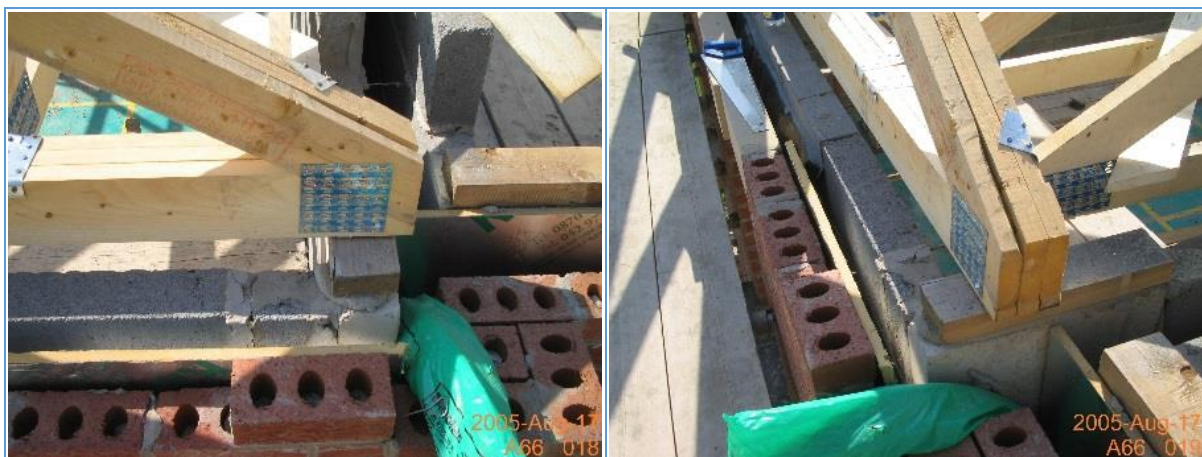
Figure 29 Staggers and other more complex junctions

Figure 29 and Figure 30 show junctions of the external wall cavity, with both adjacent external wall cavities and with party wall cavities, and illustrate how issues with the continuity of the partial-fill insulation layer arise. Small staggers in the external wall often result in no wall ties being present in the short sections of wall normal to the main façade, making it impossible to fit retaining clips to ensure contact between the insulation and inner leaf. Party wall junctions can also result in similar issues, although this is usually mitigated by the inclusion of a cavity stop sock. In both cases the ‘top-up’ insulation introduced to fill the residual external wall cavity would reduce the unplanned additional heat loss at these junction.

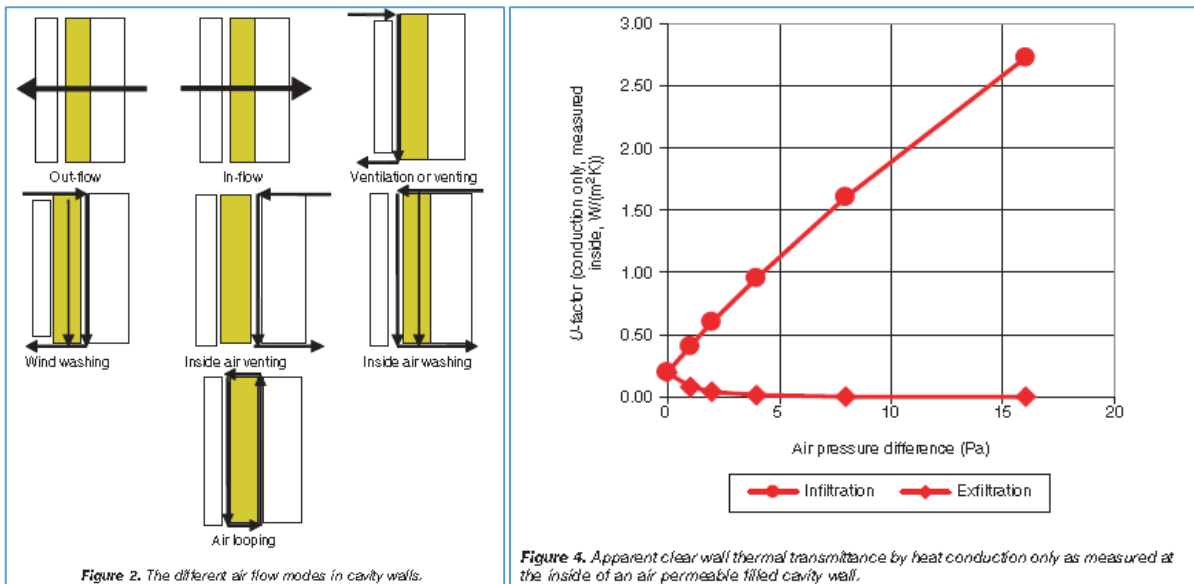
Figure 31 Effects of air movement around insulation boards within cavities and through the entire wall (Hens *et al.*, 2007).

other buildings measured. As such, the reduction in measured thermal conductance with height up the wall could be seen to support the model proposed by Hens and displayed in Figure 31; where infiltrating air will have the effect of raising the in-situ U-value, and exfiltrating air causing the opposite effect as the cooler air enters at the ground floor and warmer air leaves above the zero-point level⁴, in this case somewhere just below the 2nd intermediate floor. The test house shown in Figure 35 was typical of current new-build in terms of airtightness (mean air permeability of 6.6 m³/(h.m²) @ 50Pa), with fully-filled external wall cavities (blown mineral fibre – Rockwool Energy Saver). The cavity insulation may have increased the air resistance of the cavity and hence increased air dwell time in the cavities; if so, the effect seen in this example could be expected to be even more severe in a typical partial-fill construction, and potentially reduced by ‘topping-up’ the residual cavity with additional material.

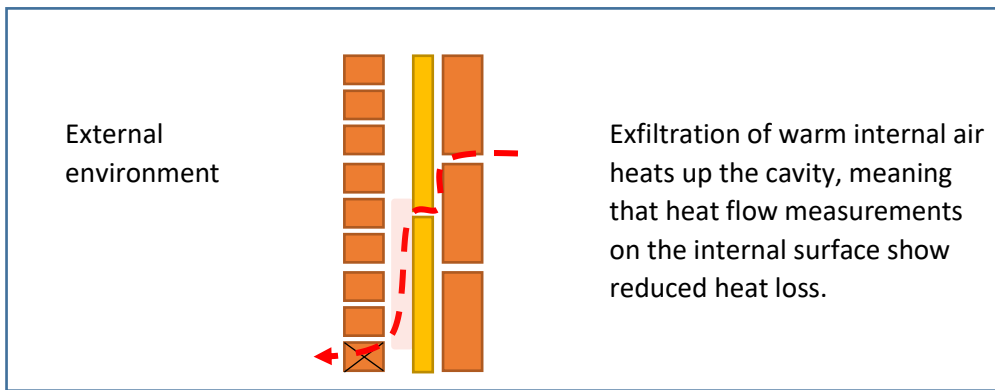
Figure 32 Effect of infiltration and exfiltration on the measurement of conductive heat flow.

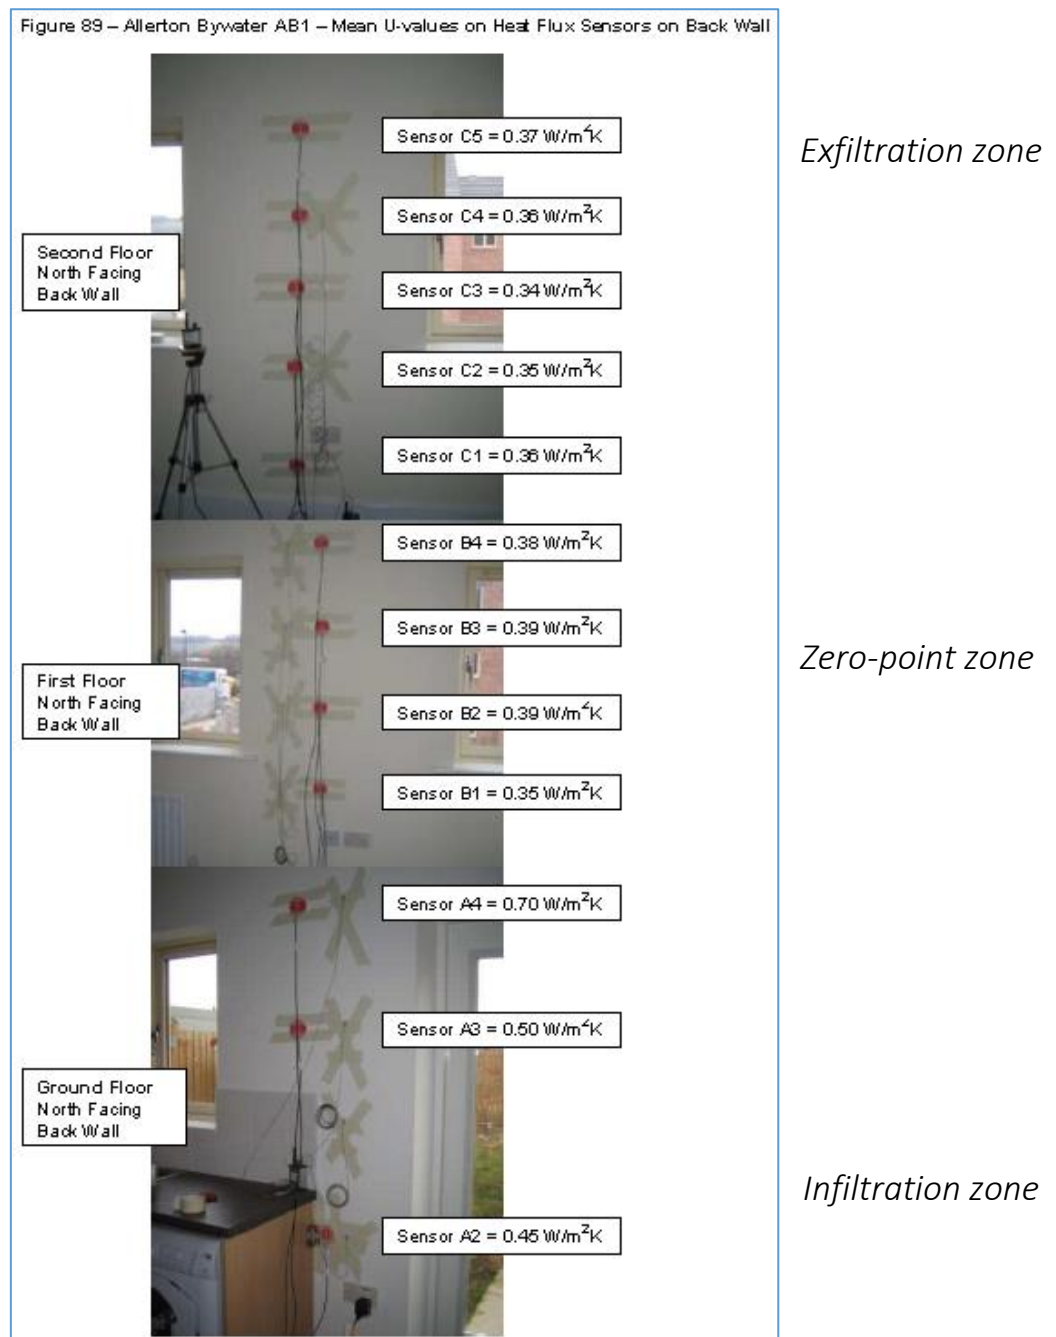
Figure 35 Effect of altitude on measured in-situ U-values (Wingfield et al., 2011)

Wingfield et al. (2011) measured U-values through the entire height of a 3-storey masonry-cavity town house throughout the course of a coheating test, and showed how the mean U-values varied with altitude (Figure 35). This test house was in a fairly sheltered location, so prevailing windward and leeward pressure-driven infiltration/exfiltration was much reduced compared to many of the

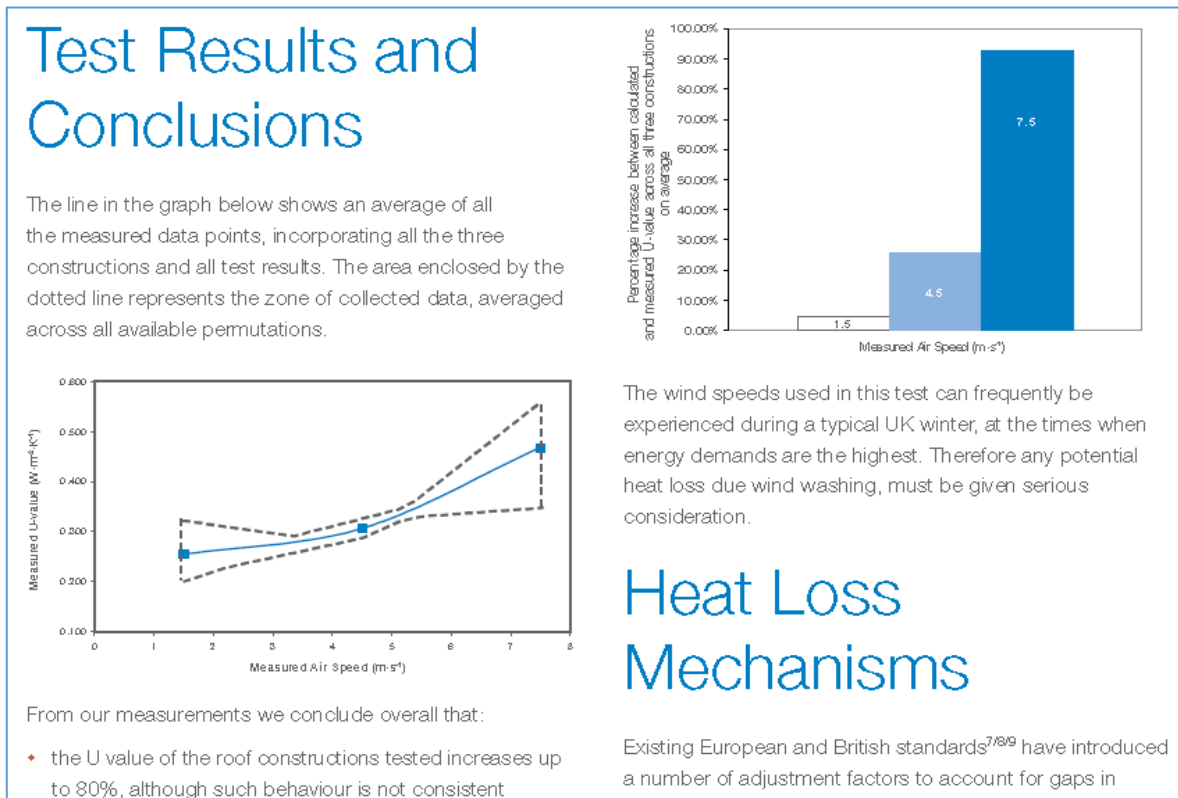
Figure 38 Effect of air movement on measured U-values of roof structures (BBA, 2012)

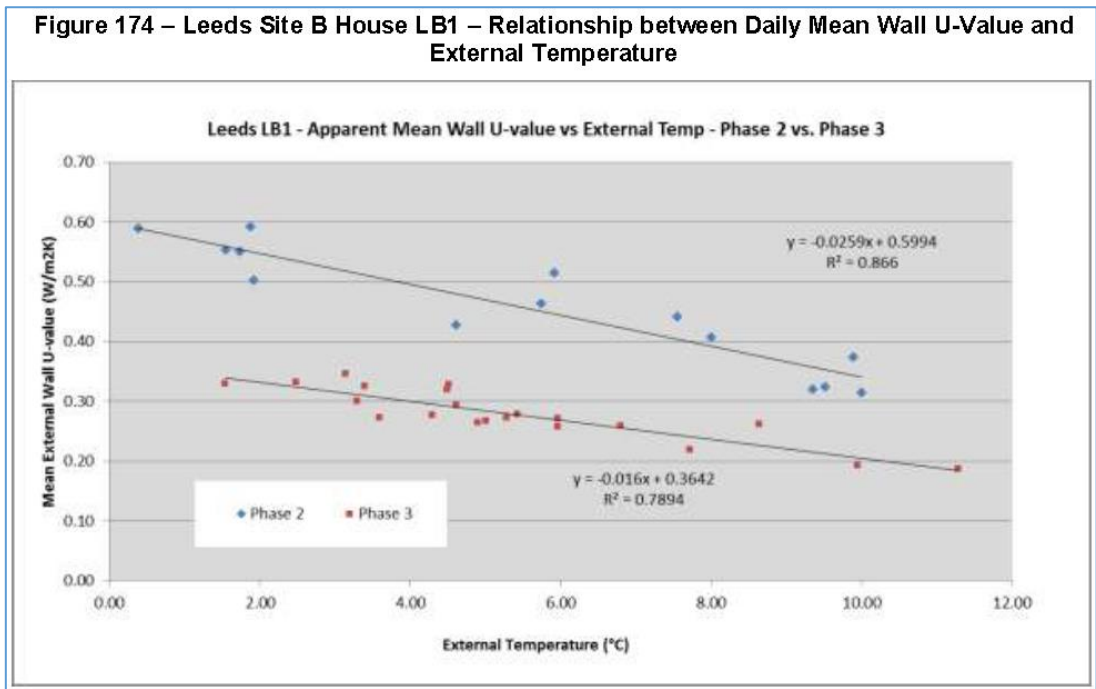
Figure 44 Variation of mean daily in-situ U-value with daily average external temperature, before (Phase 2) and after (Phase 3) residual cavity top-up (Wingfield et al., 2011)

Another interesting outcome of topping-up the residual cavity from Wingfield *et al.* (2011) was the effect of external temperature on the measured in-situ U-value. Figure 44 plots the calculated apparent daily mean U-values of the external gable wall against daily average temperature for both the original wall (Phase 2) and the topped up wall (Phase 3). The original partially filled wall appears to deteriorate (in terms of thermal resistance) at an increased rate compared to the topped-up external wall as the external temperature decreases; with the difference between the two phases increasing as the external temperature falls – the exact time when the better performance would be most beneficial.
