Glew, D and Johnston, D and Miles-Shenton, D and Thomas, F (2019) Retrofitting suspended timber ground-floors; comparing aggregated and disaggregated evaluation methods. Building Research and Information. ISSN 0961-3218 DOI: <https://doi.org/10.1080/09613218.2019.1681927>

## Retrofitting suspended timber ground-floors; comparing aggregated and disaggregated evaluation methods

# Retrofitting suspended timber ground-floors; comparing aggregated and disaggregated evaluation methods

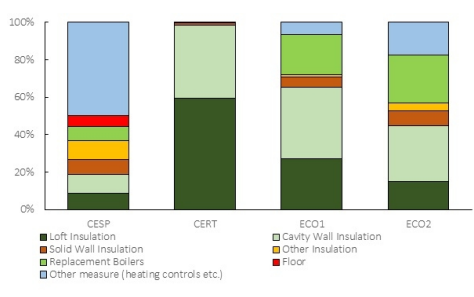
Figure 1, Retrofit measures installed via Government Schemes, excluding low energy lighting and double glazing

31  
32  
33 *Figure 1, Retrofit measures installed via Government Schemes (excluding low energy lighting and double*  
34  
35 *glazing)*  
36  
37  
38

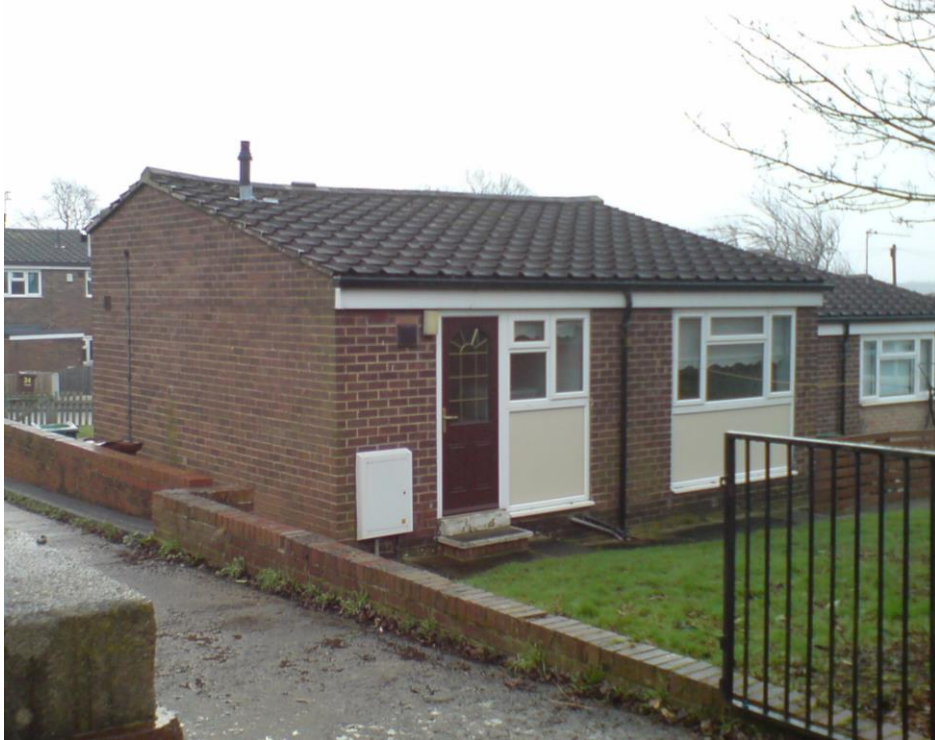
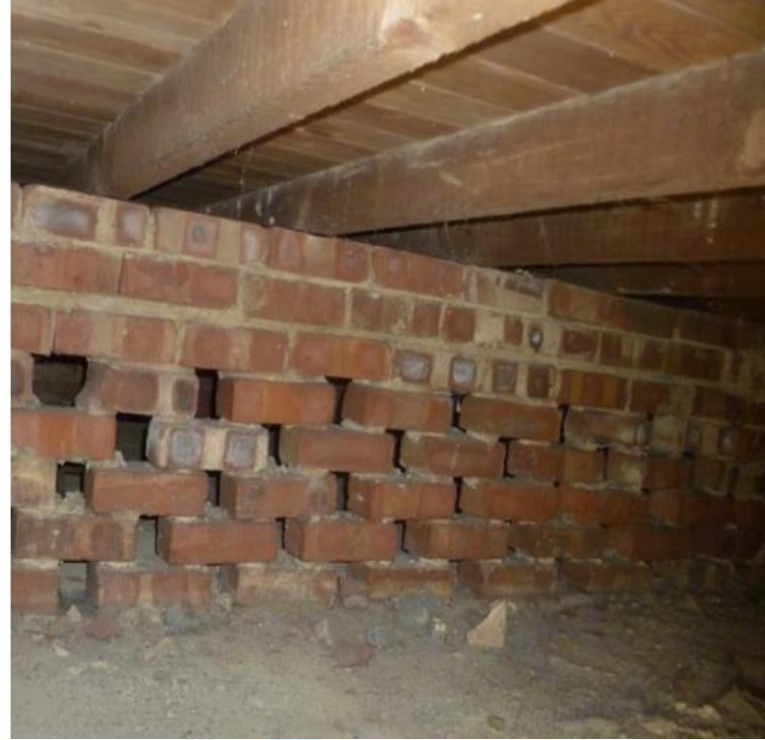
1  
2  
3  
4 *Figure 2, West-facing elevation of the case study dwelling (left) and honeycomb sleeper walls in the under floor void*  
5  
6 *(right)*  
7  
8

42  
43  
44 The test dwelling used in the research was a 1-bedroom bungalow (see Figure 2). There are  
45  
46  
47 around 2 million bungalows in the UK (DCLG, 2016), of which around 12% are 1-bedroomed  
48  
49  
50  
51 (VOA, 2014). Bungalows have a large floor area to heat loss area ratio, so may receive  
52  
53  
54  
55 proportionally greater benefits from suspended timber ground floor insulation than other  
56  
57  
58  
59  
60

14  
15  
16 The case study dwelling has a ground floor area of 44 m<sup>2</sup>, and is a stepped and staggered  
17  
18  
19 end-terrace bungalow, which was built in the 1960s and is orientated East to West. The North  
20  
21  
22 side of the dwelling is sheltered by a separate group of stepped and staggered terraced  
23  
24  
25 bungalows. The external walls are of traditional brick and block cavity construction, wet  
26  
27  
28 plastered internally, with the 60 mm external wall cavity previously retro-filled with mineral fibre  
29  
30  
31 insulation. The dwelling has a cold pitched roof, with 200 mm mineral wool insulation located  
32  
33  
34 at ceiling level. It is double-glazed throughout and has an uninsulated suspended timber  
35  
36  
37 ground floor. A concrete stepped raft foundation is located beneath the floor, resulting in a 660  
38  
39  
40 mm crawl space. Floor joists run east to west and are supported on honeycomb brick sleeper

41  
42  
43 walls (see Figure 2). Five 229 x 76 mm (9" x 3") airbricks are located on the east and west  
44  
45  
46 elevation (three on the east and two on the west), providing underfloor ventilation. The cavity  
47  
48  
49 party wall is of block construction, wet plastered internally, and has a 60 mm unfilled cavity.  
50  
51  
52 Purpose provided ventilation is achieved via trickle vents on the window heads and intermittent  
53  
54  
55 extract fans in the kitchen and bathroom.  
56  
57  
58  
59  
60

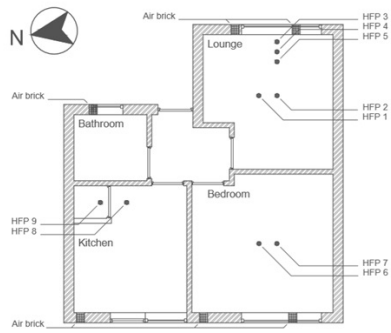
Figure 3, Ground floor plan illustrating the location of the floor HFPs

55  
56  
57  
58 to ascertain whether proximity to the airbrick influenced the measurements. Sleeper walls in  
59  
60

17  
18  
19  
20 *Figure 3, Ground floor plan illustrating the location of the floor HFPs*

14 A range of performance was observed in the first HFP array (1 to 9) across the floor. On  
15  
16 inspection of the HFPs, there was some uncertainty as to the extent to which HFP3 maintained  
17  
18 contact with the suspended timber ground floor surface throughout the tests. This HFP was  
19  
20 located near to an airbrick and close to the joist and external wall intersection. This location  
21  
22 not only made the application of the suspended timber ground floor insulation more difficult  
23  
24 but could have resulted in the thickness of the suspended timber ground floor insulation being  
25  
26 compromised. However, the exact reason for this result was not possible to determine using  
27  
28 the non-destructive testing methods available to the research team during the test periods.  
29  
30 With respect to HFP9, a separate access tunnel was required for services below HFP9,  
31  
32 meaning that the thickness of the insulation applied may have also been reduced in this area.

34  
35  
36 Other variability was observed in the pre-retrofit *in situ* U-values. An increase in *in situ* U-value  
37  
38  
39 was observed the greater the distance from the airbrick located on the east elevation (HFP3,  
40  
41  
42 4 and 5). This result appears to be counter intuitive. Conversely, post-retrofit, the pattern was  
43  
44  
45 reversed. Additionally, there is some uncertainty over the contact maintained by HFP3  
46  
47  
48 throughout the test, although this would not explain the result obtained pre-retrofit at HFP  
49  
50  
51 location HFP4.  
52  
53

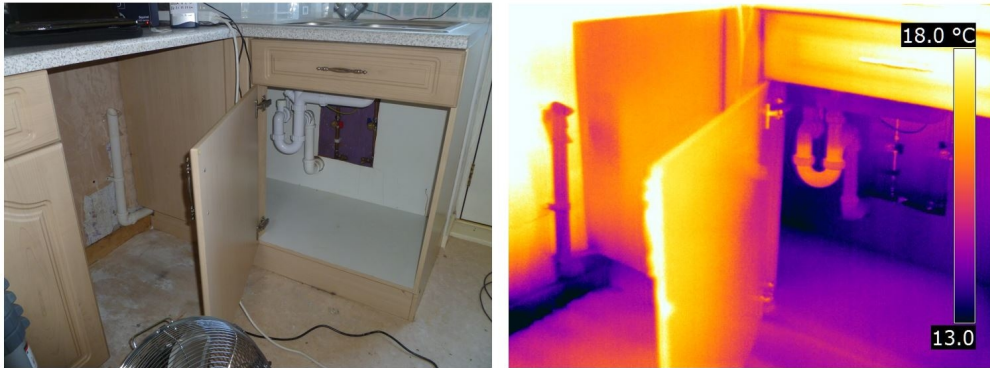
Figure 4, Infiltration around service penetrations through the ground floor

1  
2  
3 anomalies, such as thermal bridging, transient effects or other surface effects. Pre-retrofit air  
4  
5  
6 leakage identification, using thermography, revealed substantial air leakage around the floor  
7  
8  
9  
10 perimeter, through floorboard joints, around trickle vents and at service penetrations through  
11  
12  
13 the external wall. A number of these areas of air leakage are illustrated in the thermographs  
14  
15  
16 contained within Figures 4, 5 and 6 respectively.

17  
18  
19  
20 *Figure 4, Infiltration around service penetrations through the ground floor*

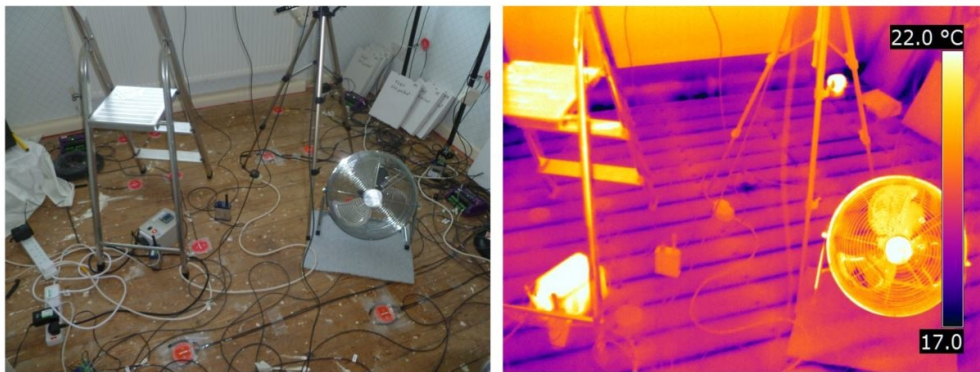
Figure 5, Infiltration through the ground floor

21 *Figure 5, Infiltration through the ground floor*

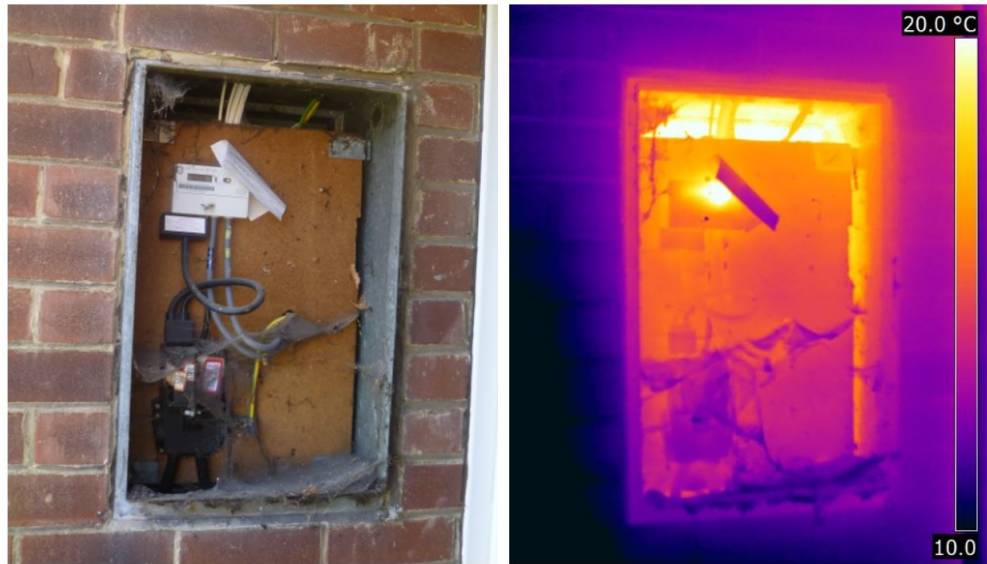
Figure 6, Exfiltration through unsealed electricity meter open to interior of dwelling

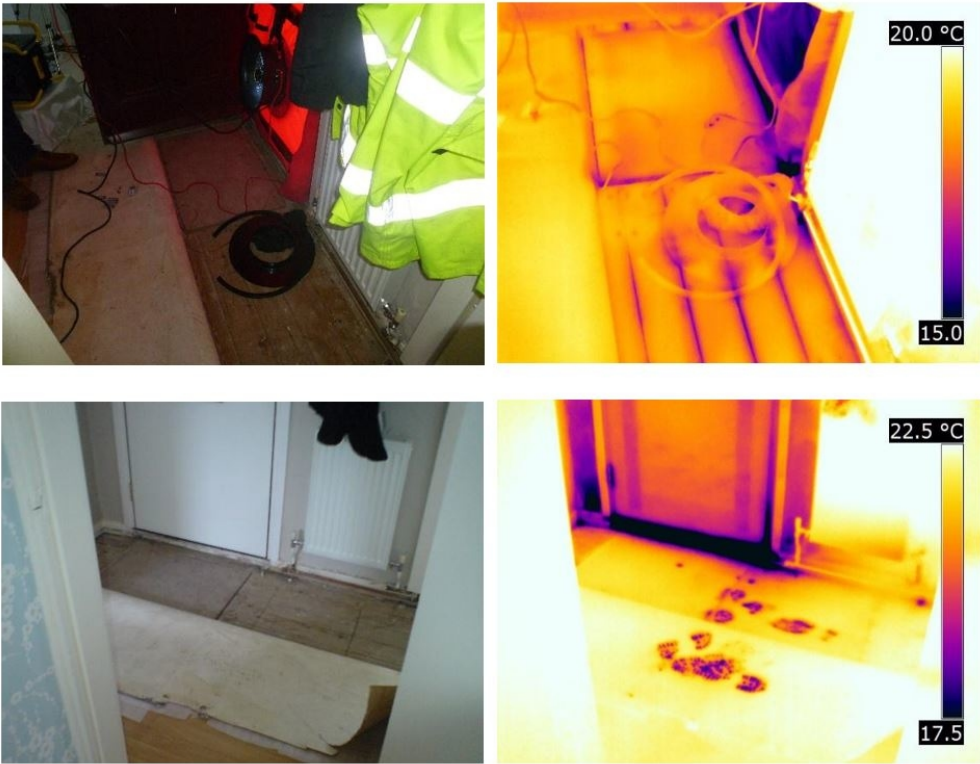
Figure 7, Infiltration through hallway floor pre retrofit (top) and post retrofit (bottom)  
203x158mm (120 x 120 DPI)

44 Despite observing reduction in infiltration through the ground floor (see Figure 7), poor air  
45  
46  
47 tightness was still observed around trickle vents and also at external wall penetrations. It is  
48  
49  
50 not possible to identify how much of the observed reduction in infiltration could be attributed  
51  
52  
53 to the ground floor insulation compared to the ancillary sealing around service penetrations,  
54  
55  
56 since both were conducted in one staged retrofit, as in accordance with the product  
57  
58  
59  
60

12  
13 *Figure 7, Infiltration through hallway floor pre-retrofit (top) and post-retrofit (bottom)*  
14

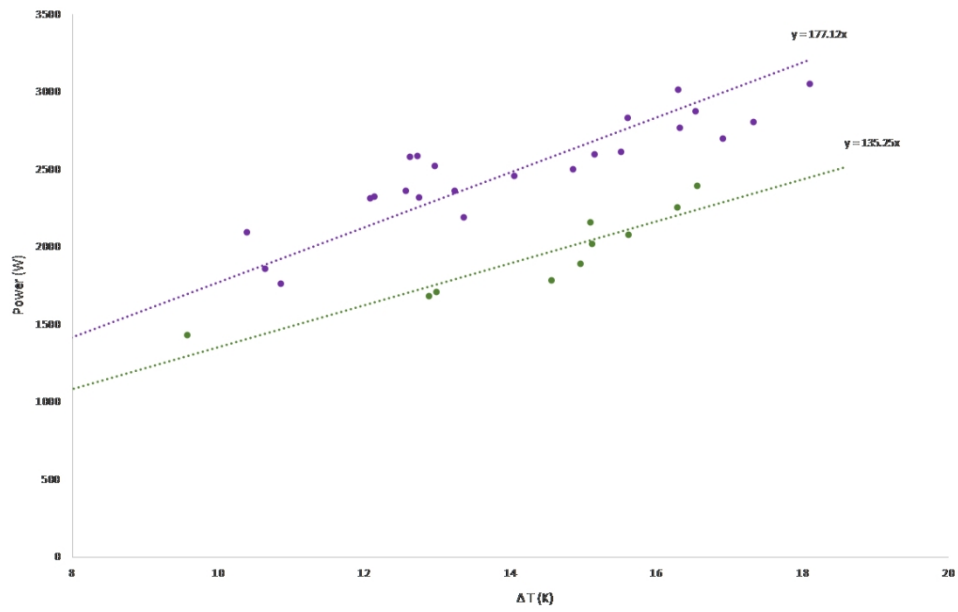
Figure 8 Whole house HTC for dwelling pre- and post- retrofit

32  
33  
34 The addition of floor insulation has resulted in the aggregate HTC of the case study dwelling  
35  
36  
37 reducing from  $178 \pm 14$  W/K pre-retrofit, to  $135 \pm 11$  W/K post-retrofit. A separate assessment  
38  
39  
40 of the standard errors associated with the multiple linear regression analysis only were found  
41  
42  
43 to be  $\pm 5$  W/K (adjusted  $r^2 = 0.95$ ) pre- and  $\pm 6$  W/K (adjusted  $r^2 = 0.87$ ). The measured whole  
44  
45  
46 dwelling HTC can be further disaggregated into an approximated fabric and background  
47  
48  
49 ventilation heat loss by applying *Sherman's ratio*; the  $N_{50}/20$  assumption (Sherman, 1987), to  
50  
51  
52 the pre- and post-retrofit air leakage rates. This results in an approximated reduction in the  
53  
54  
55 HTC attributed to background ventilation of 18 W/K.  
56  
57  
58  
59  
60

1  
2  
3 The overall measured reduction in HTC of  $43 \pm 18$  W/K represents a 24% improvement in the  
4  
5  
6 HTC attributable to the ground floor retrofit. This is substantially higher than the 13 W/K (11%)  
7  
8  
9 reduction in HTC previously found by Farmer et al. (2017). In addition, the improvement in  
10  
11  
12 airtightness observed by Farmer et al. (2017) was only 8%, in comparison to 40% for this case  
13  
14  
15  
16 study. Additionally, their retrofit took place on a two-storey end-terraced dwelling in which the  
17  
18  
19 ground floor represented a much smaller proportion of the overall heat loss area. This  
20  
21  
22 indicates the benefit of ground floor retrofits may be related to the dwelling form and condition.  
23  
24  
25  
26 This case study dwelling was only half as airtight as the average UK house, had floor coverings  
27  
28  
29 removed and had a large ground floor area to heat loss area ratio, thus savings are likely to
